AATD TR10-D-93

US Coast Guard ASIST Probe Evaluation on a H-65 Dolphin

May 2010

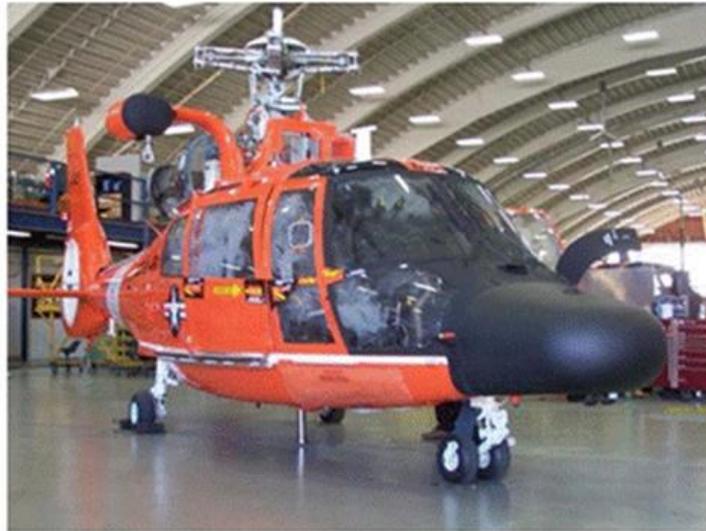
Figure 1 – Aircraft with Probe Installed

The aircraft used for both the GRT and the static testing was Coast Guard Aircraft #6583, an MH-65C with the ASIST Probe installed (Figure 1).

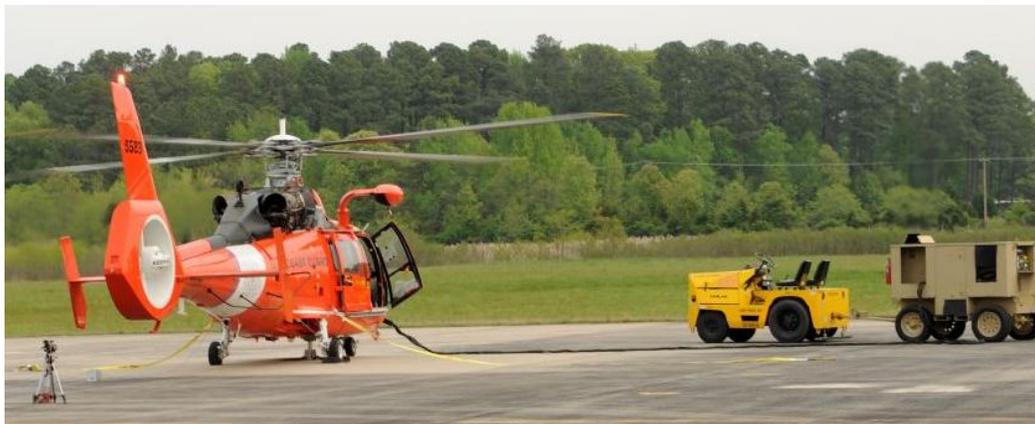
Figure 2 – Aircraft At Tethered Hover Pad

The aircraft was tested at the AATD tethered hover pad (Figure 2), facing a northwest direction (Figure 3). The Auxiliary Ground Power Unit (AGPU) was used to provide ground power because the aircraft onboard electrical generators tend to shut down at low rotor RPM. As a safety precaution, tie down straps (yellow straps visible in Figure 2) were attached from the aircraft to the ground, but remained slack so that they do not interfere with the resonance characteristics of the aircraft.

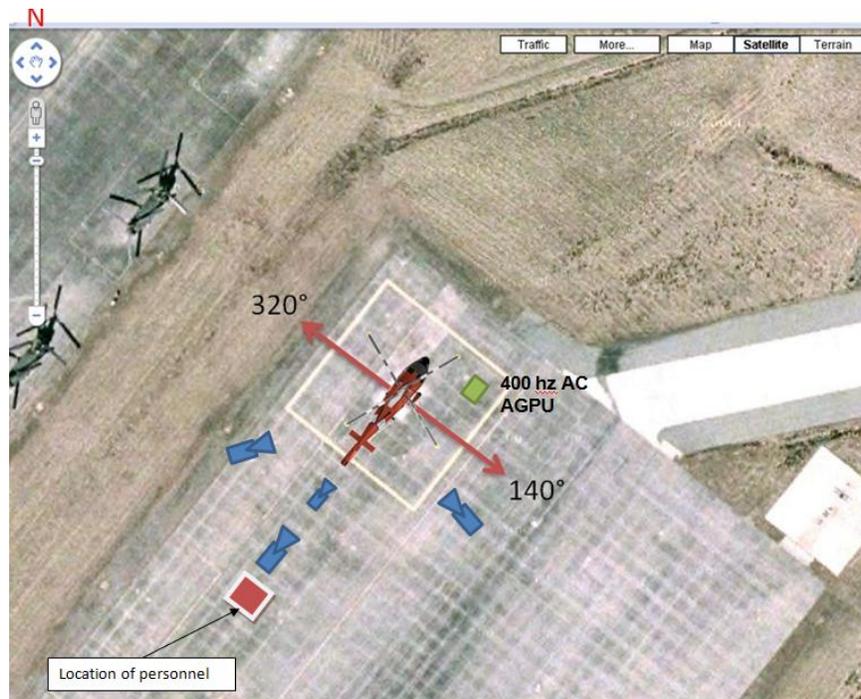
Figure 3—Test Setup and Camera Locations

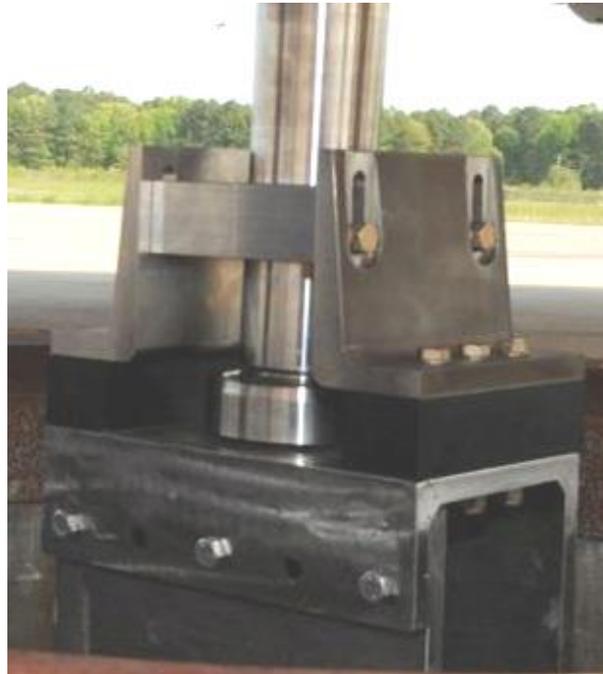
Figure 4—RSD Simulator Test Fixture

For the first GRT test sequence, the probe was installed on the aircraft, but was retracted into the airframe. For the tests with the ASIST probe attached to the RSD simulator, the probe was extended and attached to an AATD fabricated test fixture that simulated the geometry, and stiffness of the RSD capture device (Figure 4). The RSD capture claw that surrounds the probe was designed to approximate the lateral stiffness of the RSD simulator and fabricated from 17-4 stainless steel, 1025 heat treated as is the actual RSD.

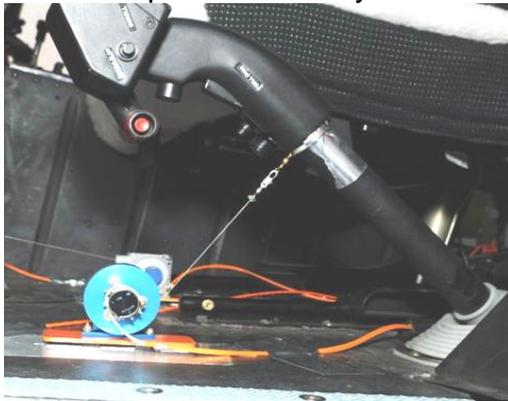
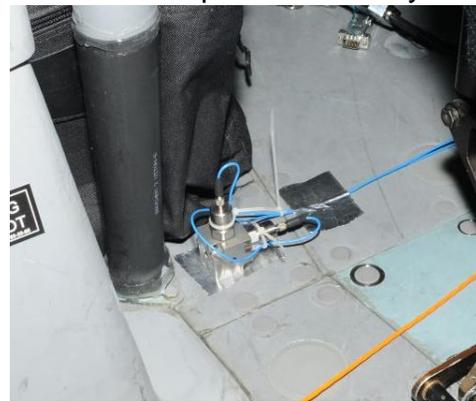
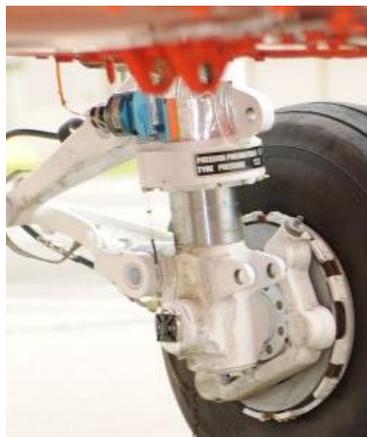
a. – lateral displacement of cyclic control

b.- fore/aft displacement of cyclic control

c. - displacement of collective

d. - acceleration in cabin

e.- displacement and acceleration of gears

Figure 5 – Instrumentation Locations On Aircraft

Acceleration and displacements on the aircraft were recorded by ALC personnel at various points on the aircraft (Figure 5), to include: nose and main landing gear accelerations, and displacements, cyclic control and collective control displacements, and acceleration inside the cabin. Data was collected at a 100 Hz sample rate with a 5 Hz low-pass filter .

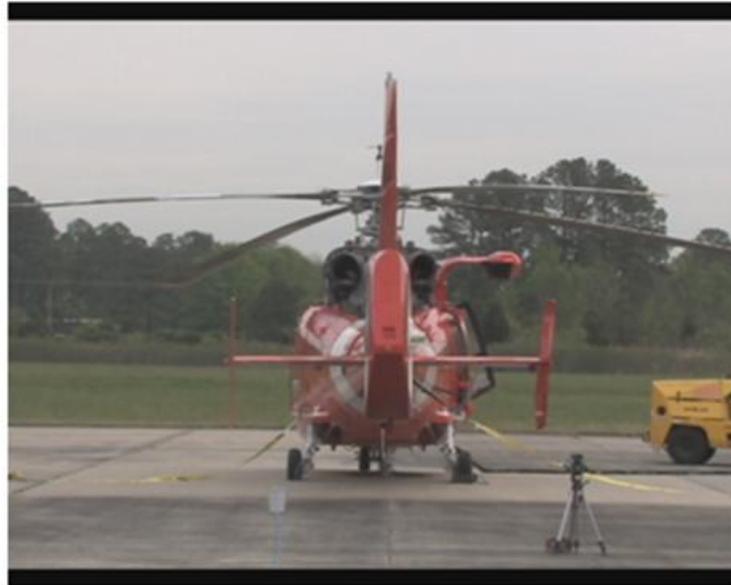
Figure 6 – Camera Locations, Overall Aircraft

Video was used to capture the test events. Real time video cameras were placed in strategic locations to capture motions of the aircraft due to ground resonance (Figure 6), as well as interactions at the probe / RSD simulator interface (Figure 7). All ground resonance testing was conducted on the hover pad (Table 1). For the static roll tests, the aircraft was rocked by personnel to obtain the airframe roll natural frequency. Once the aircraft was rocking on the two main landing gears, the number of cycles that occurred over a ten second interval were counted. This can be used to calculate the natural frequency of the airframe (without rotors spinning). For the dynamic tests, rotor RPM, excitation type and frequency, and engine torque were recorded by AATD test personnel prior to execution of each test sequence.

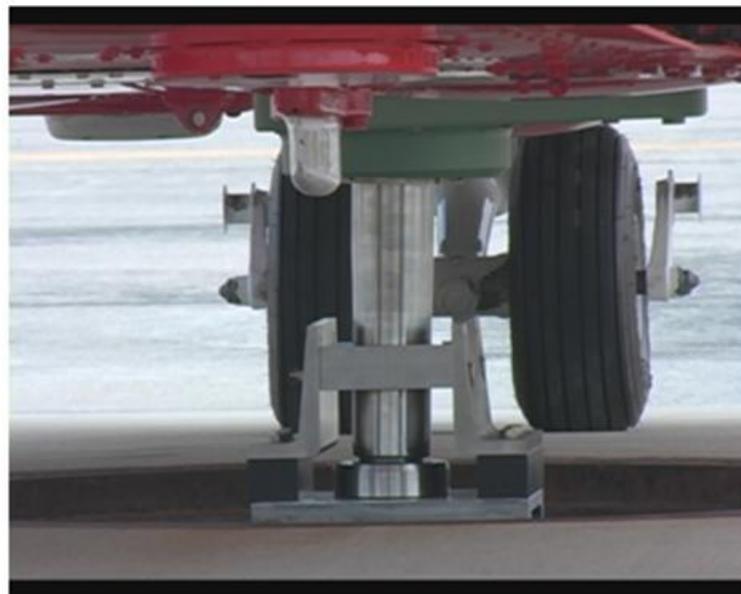
Figure 7 – Camera Locations – Probe Close Up

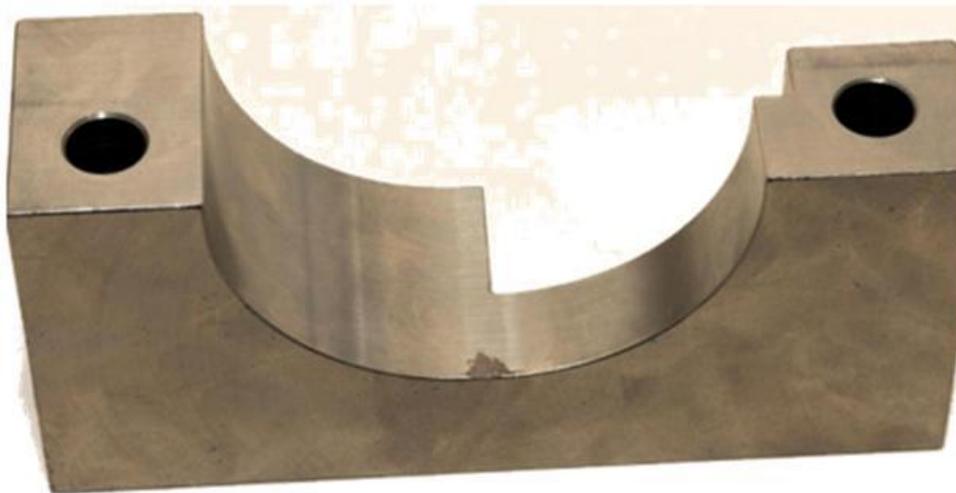
Figure 11 – Damage on RSD simulator fixture post-test

Figure 12 – Damage on RSD simulator fixture post test

After testing was complete the RSD simulator and the probe were inspected. At some time during the twenty three tests, the probe impacted the RSD simulator and caused marring on both the probe and RSD simulator. The RSD simulator was fabricated of the same material as the actual RSD: 17-4 Stainless Steel, 1025 heat treated.

There was minimal difference in the results of dynamic excitation tests of the baseline aircraft and the aircraft with the ASIST probe attached to the RSD simulator. Post test inspection found scratching and marring of the RSD simulator fixture and the ASIST probe due to vibratory contact between the two parts.

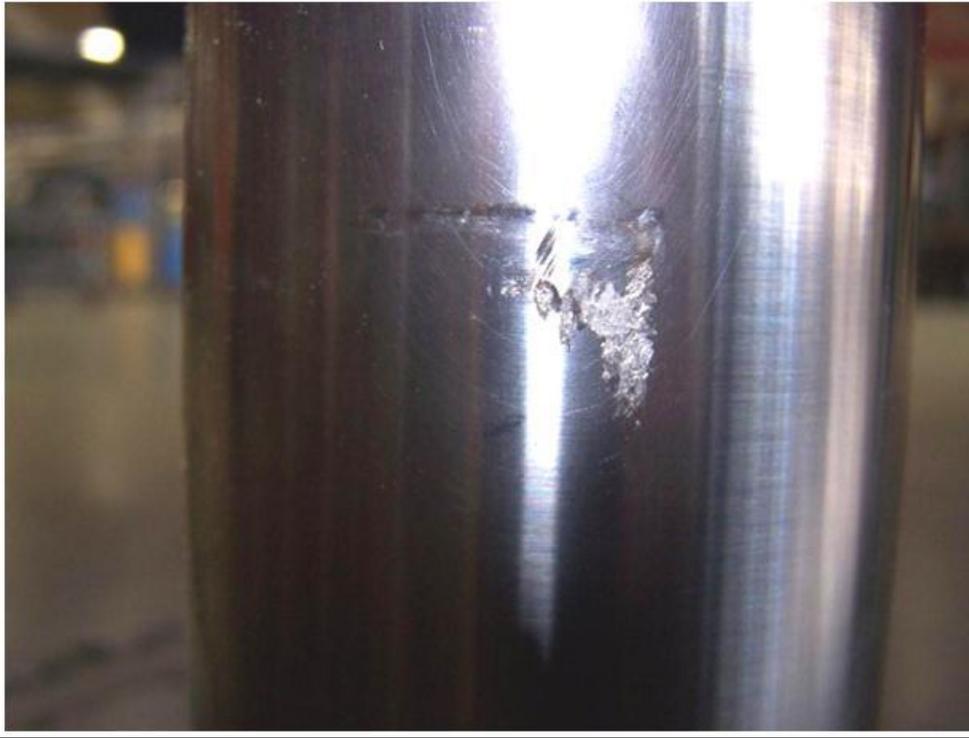
Figure 13 – Damage on probe post test.

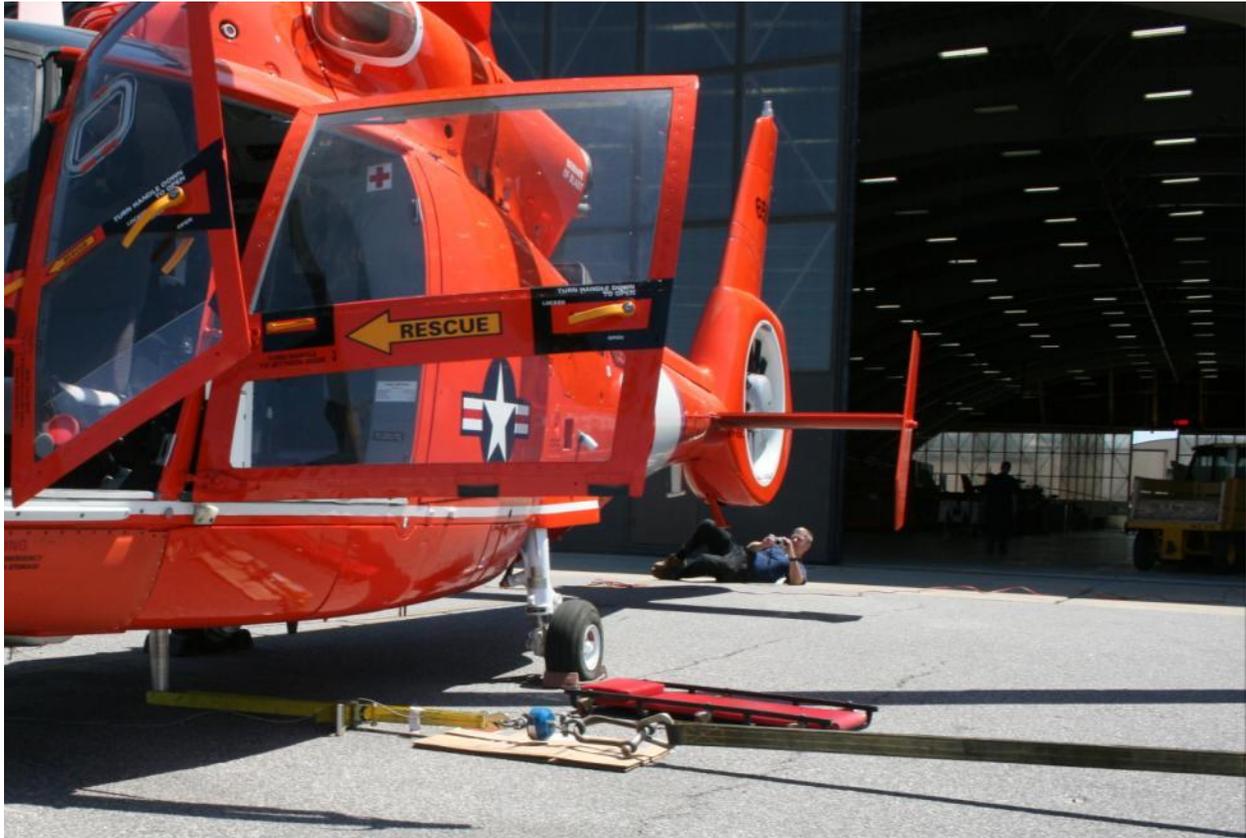
Figure 18 – Static Load Test Setup, 270 Deg. (Port) Load Case

A manual load actuator was attached to the probe via a cargo strap with a load cell in-line (Figure 18). Load was applied up to 2000 lbs in five directions (Table 6) and near parallel with the ground as practical. Five strain surveys were taken between 0-2000 lbs (e.g. 0lbs, 500lbs, 1000lbs, 1500lbs, 2000lbs). Strain gauges were zeroed prior to testing. Resistance calibration was conducted on the data acquisition system pre-test and post test. The aircraft did not move during the conduction of the testing.

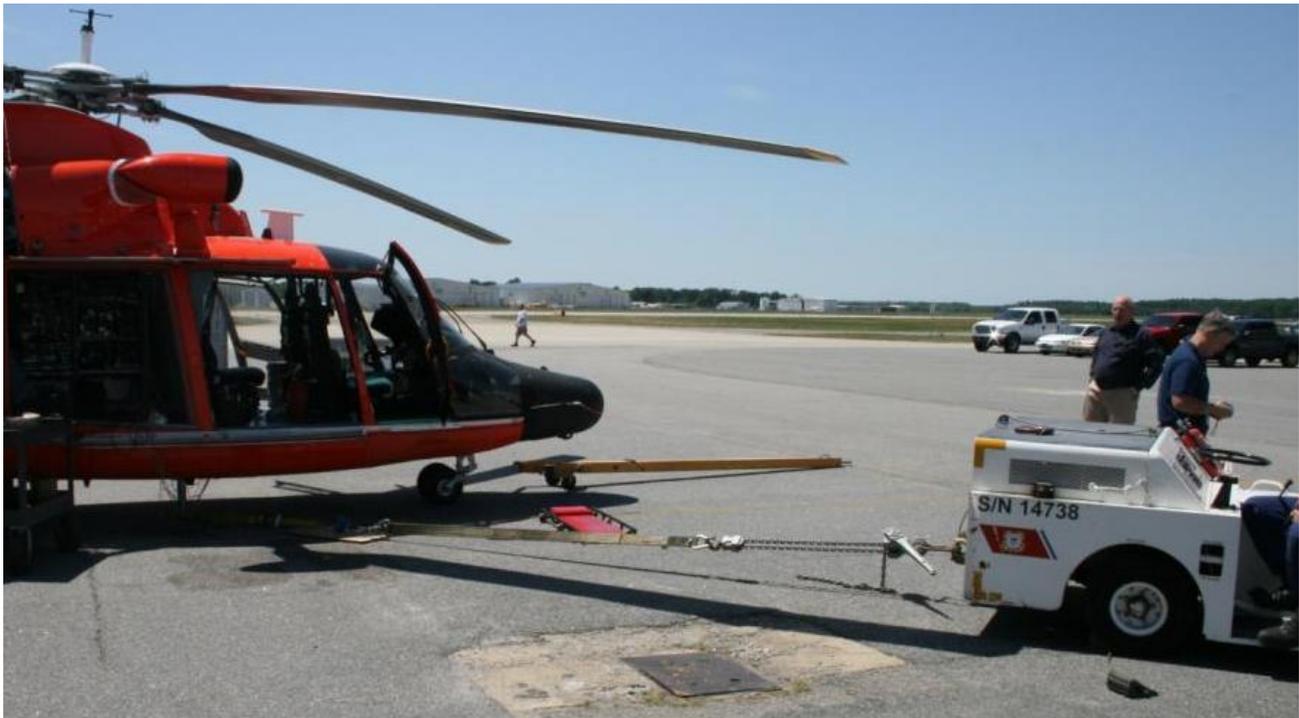
Figure B4 – 45 deg. Load Case
