Pseudo Dynamic Testing and Seismic Rehabilitation of Iraqi Brick, Bearing and Shear Walls

Ghassan K. Al-Chaar, Steven C. Sweeney, Jonathan C. Trovillion,
Orange S. Marshall, and Brendan Danielson

April 2008

Final Report

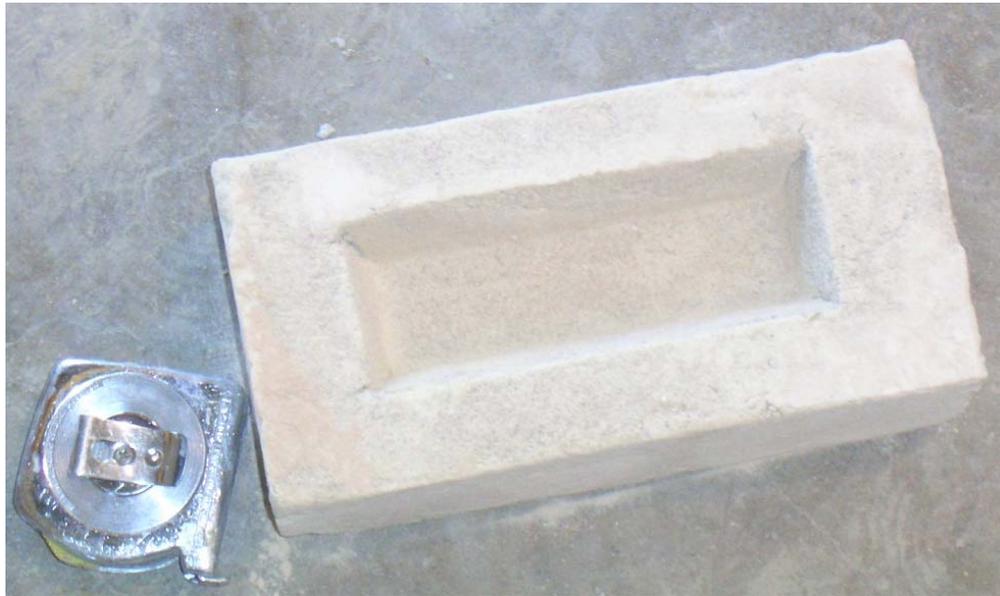
Figure 1. Single brick unit.

Compressive strength tests of the brick were performed according to the ASTM C67. The brick units have grooves, which is atypical of U.S. units, therefore they were tested both with and without mortar filling the grooved area. Compressive strength for the mortar-filled brick is calculated based on the cross-sectional area while the compressive strength of brick units with no mortar fill (equivalent to face shell bedding with concrete masonry units) was calculated based on net facial area around the grooves. Figure 2 shows a typical brick setup before testing and Figure 3 shows a typical failure of single brick unit under compressive load. Figures 4 through 13 show the different modes of failure of various specimens. Figures 14 through 21 show stress-strain curves for these tests. Table 3 lists maximum compressive stress and corresponding strain of single brick units. The average flat-wise compression stress for the units is 766 psi.

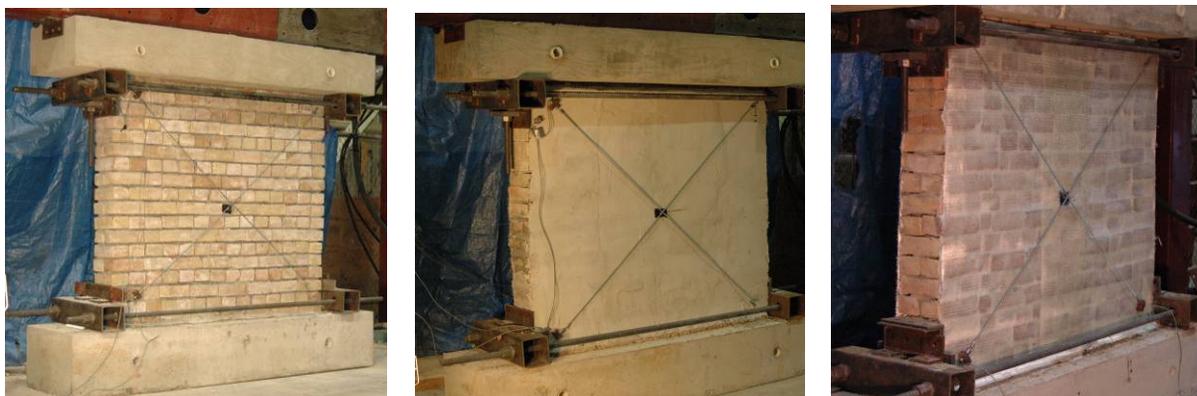
Figure 47. Bare wall (left), Saint Gobain cementitious FRP System (center), and SikaWrap FRP system (right).

The walls (Figure 47) were built as instructed by the sponsor with every stretcher course topped by a header course, totaling 18 courses. The top and bottom courses were designed to be partially embedded in the concrete beam to prevent failure at the interface surfaces. Figure 48 shows brick configuration detail.

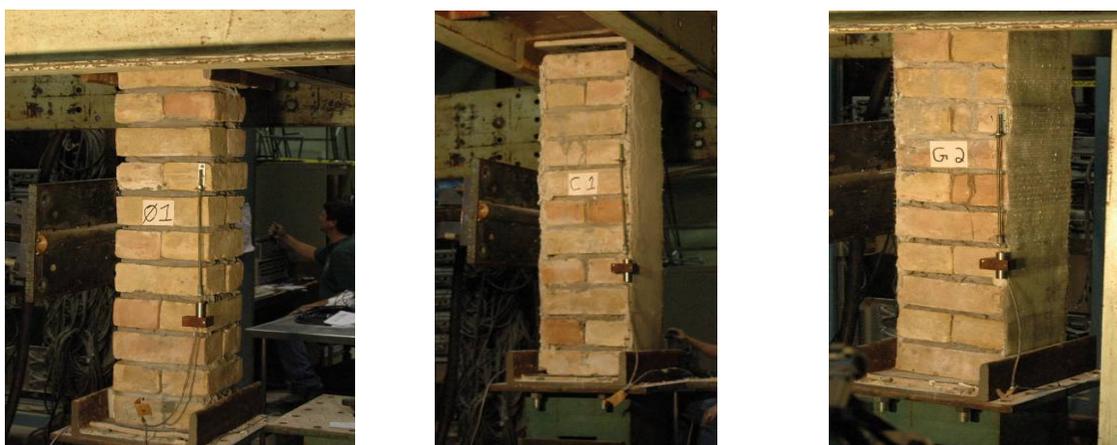
Figure 49. Representative specimens of all series tested under pure compression, bare specimen (left), Saint Gobain cementitious FRP system (center), and SikaWrap FRP system (right).

The out-of-plane set consists of 24 specimens of a double-wythe wall strip with 11 courses. The cross sectional area is 9 x 9 in. and the height is 36 in. Six wall strips (two from each series) out of the 24 were tested under pure compressive load, i.e., zero lateral load. The purpose of these six wall strip tests is to determine maximum compressive stress values for each series and to apply percentages of these values on the 18 wall strips intended to be tested under out-of-plane cyclic load combined with percentage of vertical stress at failure. Figures 49 and 50 show representative specimens of each group.

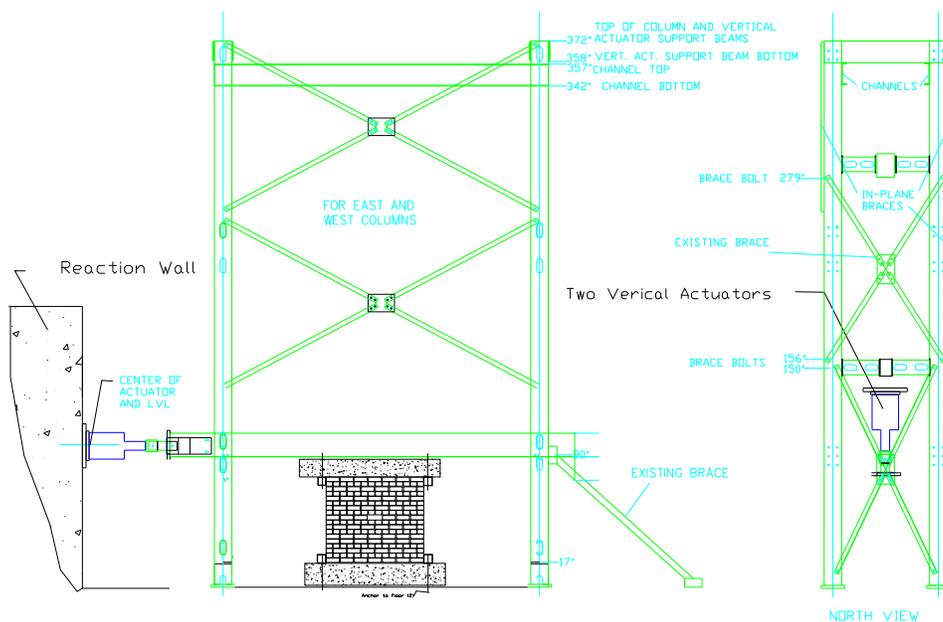
Figure 51. Loading frame for in-plane tests.

For the in-plane tests, a steel frame (Figure 51) was fitted with a horizontal steel header beam running north-south, attached to two 50-kip vertical actuators to put axial pressure on the specimen. A 100-kip actuator was fixed horizontally to a shear bearing wall and attached to the horizontal header beam at the south end. The 100-kip actuator has a minimum length of 107.75 in. with a 40-in. stroke. Supports were attached to the frame at the same end. The specimen was placed lengthwise in the north-south direction beneath the steel beam and was fixed to the steel beam by its R/C header beam and bolted to the floor through its R/C base beam.

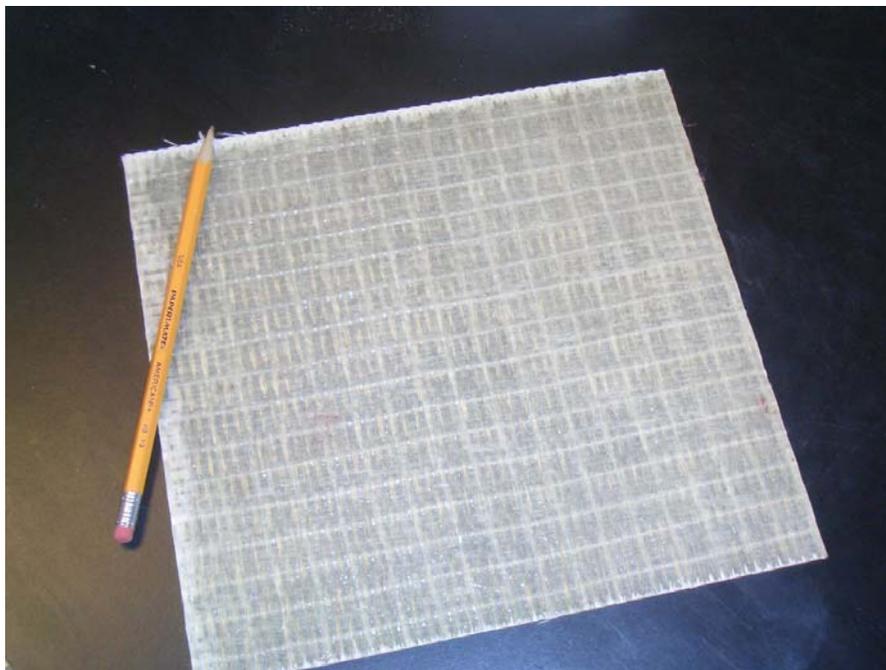
Figure 53. SikaWrap fabric.

gether, a minimum 6-in. of overlay was applied. Each sheet was then coated with Sikadur 300 epoxy using a paint roller until it became saturated and the bricks beneath could be clearly seen. The samples were then allowed to dry overnight. Table 6 lists the materials used for SikaWrap FRP system, and their proportions. Table 7 lists the basic material properties of SikaWrap FRP system.

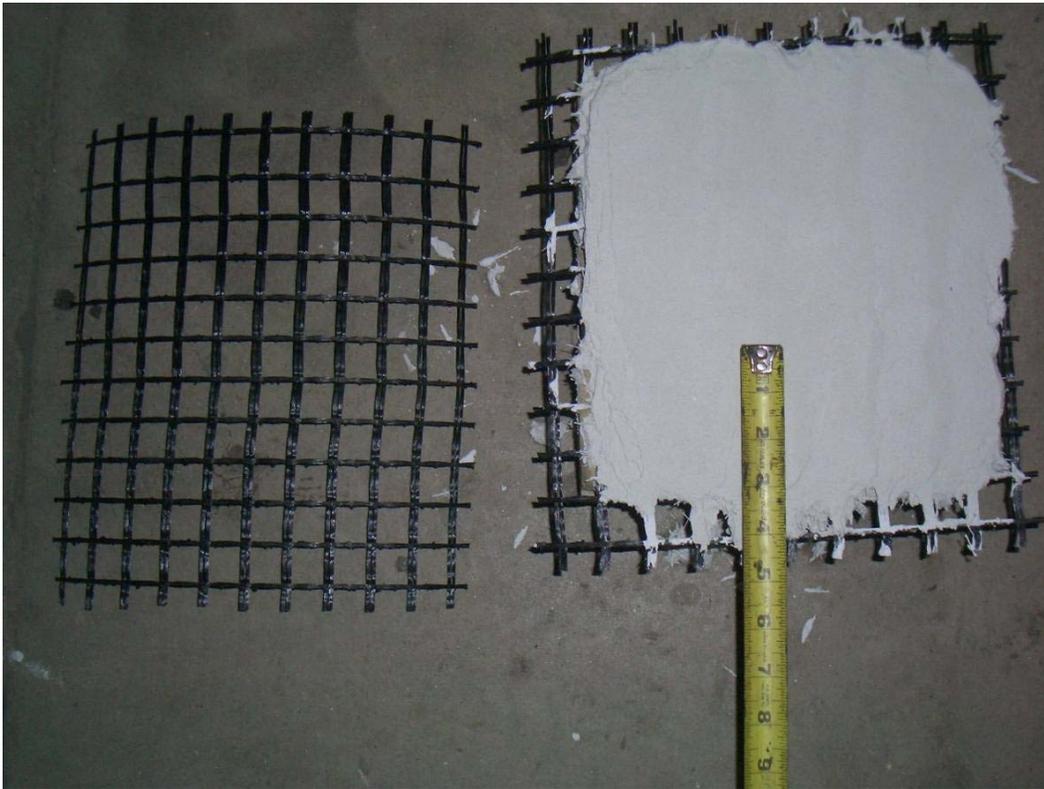
Figure 54. Coated Saint Gobain glass grid produced by Saint Gobain technical fabrics.

The brick wall strengthened with SFC, a composite of Saint Gobain Glass grid (Figure 54) produced by Saint Gobain Technical Fabrics; and Quick-Wall[®], manufactured by the Quikrete Companies was tested in in-plane shear. Table 8 lists the proportions of materials used in the Saint Gobain Glass grid system.

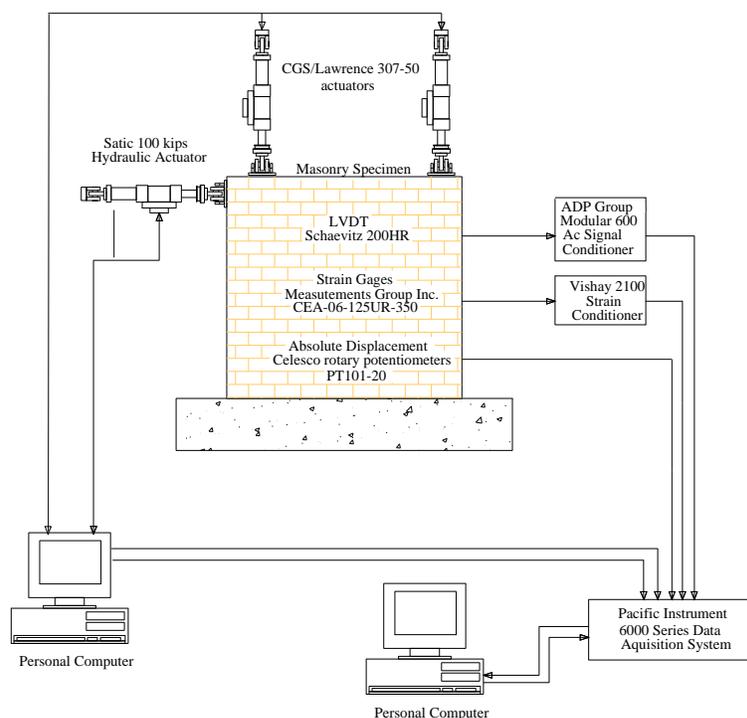
Figure 55. Functional block diagram of instrumentation, data acquisition, and test control systems.

All of the transducer output signals were connected to a 128 channel Pacific Instruments Model 6000 series data acquisition system and 6033-3 DC signal conditioning boards (Figure 55). The 6033-3 boards can provide DC signal conditioning, and can also be configured to measure the voltage outputs from the other signal conditioning used in the tests. The system was controlled by a personal computer through an instrument controller interface buss. The record channels were scanned at a predetermined sampling rate, and the data were recorded as unformatted binary files on the personal computer.

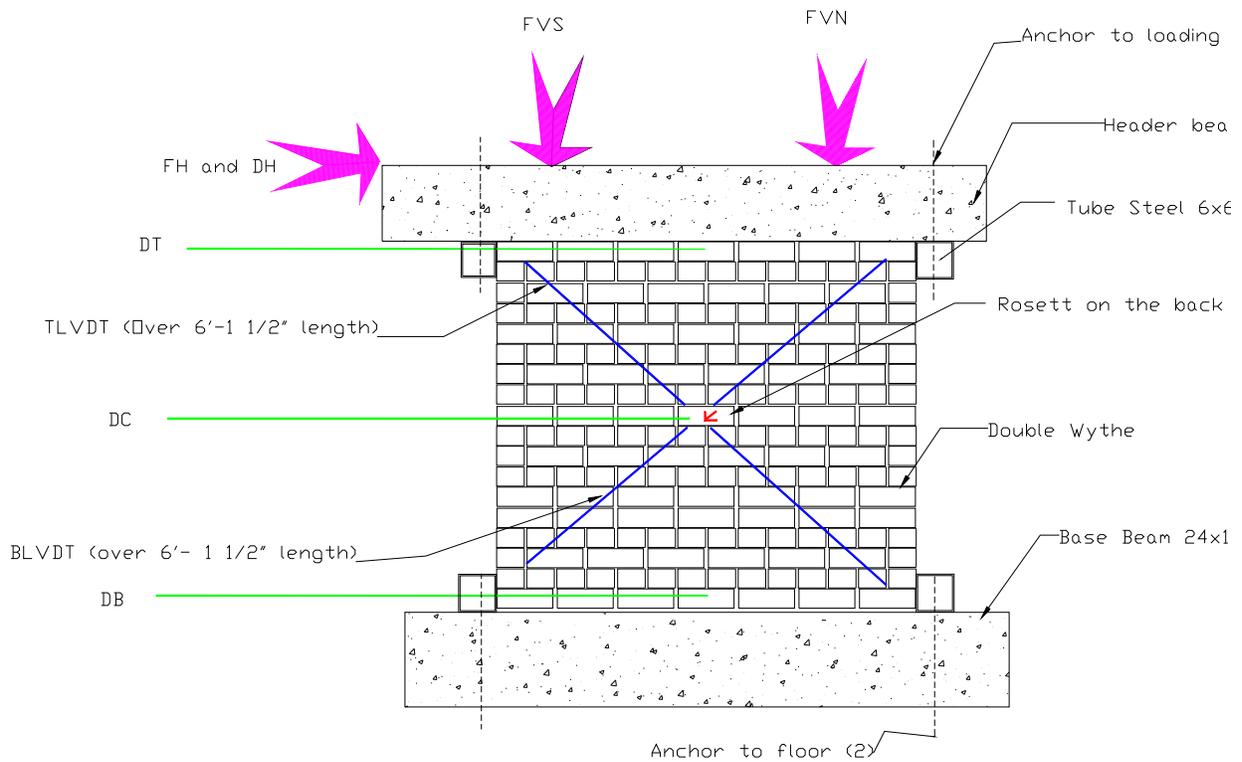
Figure 56. Instrumentation for the in-plane testing.

Electrical resistance strain gage rosettes were installed at the center brick of the in-plane test specimens. These strain gage rosettes were Vishay Micro-Measurements Group Model CEA-06-250UR-350 electrical resistance strain gages with constantan grids and complete polyamide encapsulation. The rectangular rosette consisted of three gages in a +45/0/-45 arrangement. Each sensing grid is 0.250 in. long by 0.120 in. wide. Each gauge was connected to a Vishay Measurements Group Model 2120B signal conditioner and 2110B Power supply to provide excitation voltage, balancing, and signal amplification. In this configuration, the strain gage formed one arm of the wheatstone bridge, and the remaining three arms were composed of precision resistors located in the signal conditioner.

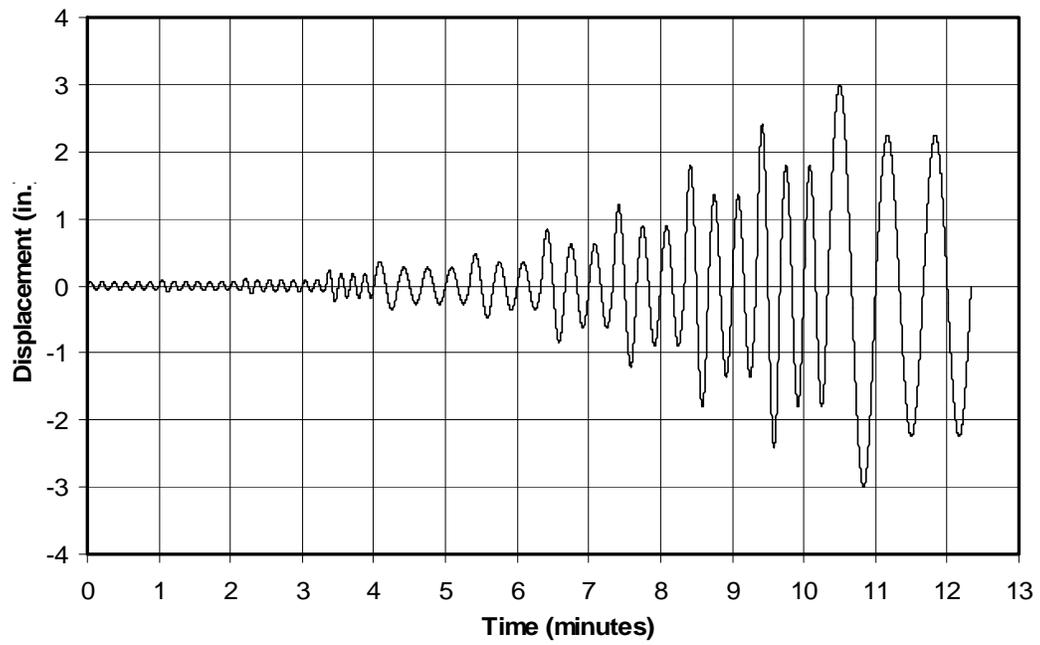
Figure 59. Modified CUREe loading history used for all lab specimens.

After considering all of these loading protocols, the CUREe method seemed best suited for the test on the brick wall models. The main reason was the incorporation of trailing cycles into the loading history. This enables the force-displacement relationship to stabilize before reaching the next primary cycle. Although the SEAOC method also included similar cycles, the total number of cycles needed to complete this test would have caused too much damage to the test specimen. Table 13 lists the different cyclic loading methods. The CUREe Loading History was modified to meet the test duration and loading rate appropriate for tested models (Figure 59).

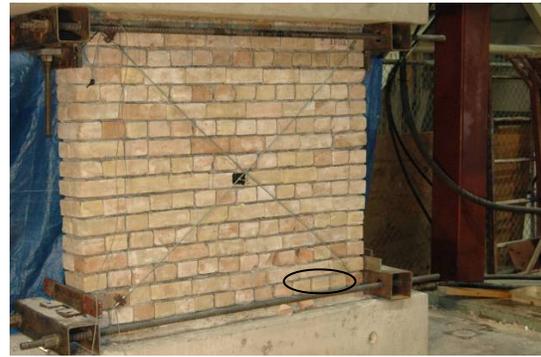
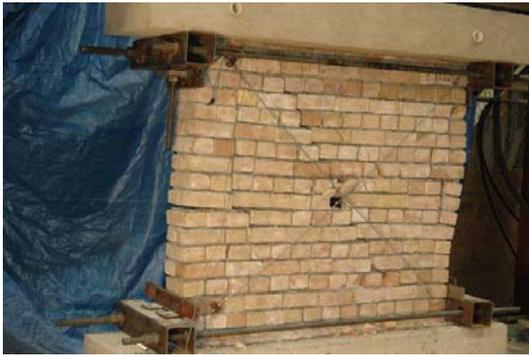
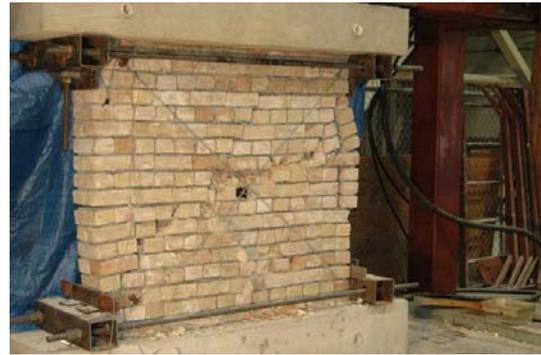
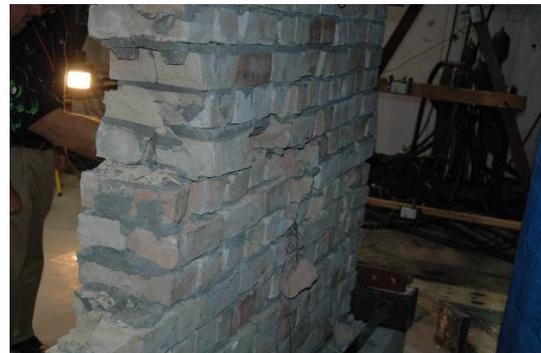
Figure 60. The modes of failure for IP-02 specimens.

b. Wall spalling in a brick in the 4th course.

c. Wall formation of X cracks under cyclic loads.

d. Cambered wall edge.

f. Collapsed edge of the wall (Section view).

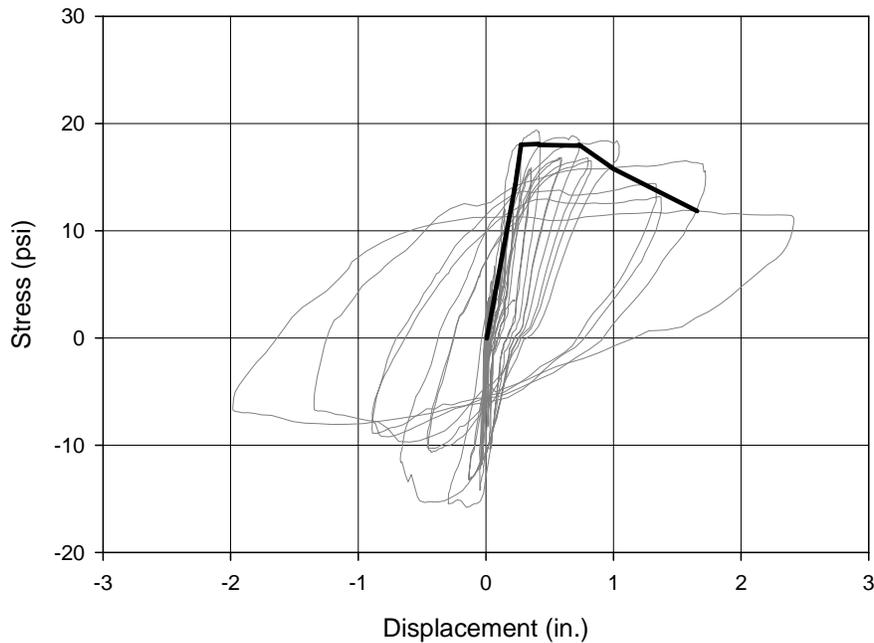
Figure 61. Specimen IP02 hysteresis curve for load versus displacement and backbone curves.

For analysis, the horizontal load data was converted to pounds and divided by the cross-sectional area of the appropriate specimen to obtain the stress value in pounds per square inch (psi). The corresponding displacement values were adjusted by the initial offset value such that the values would start at zero. The data was examined for slippage and unstable behavior, and data collected during the unstable behavior of the model was trimmed. This modified data was transferred to SigmaPlot and graphed (Figure 61). From the load displacement curves shown in light grey, a backbone curve was developed (shown in black). The backbone curve was developed by drawing a single line through the intersecting points of the first cycle of each increasing displacement cycle.

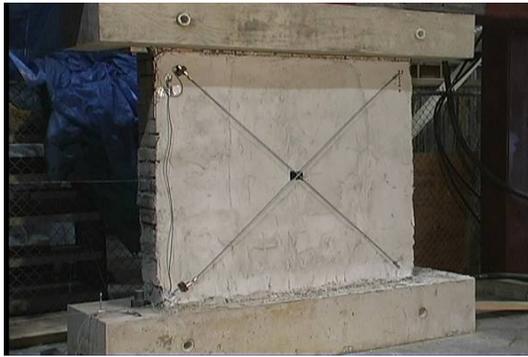
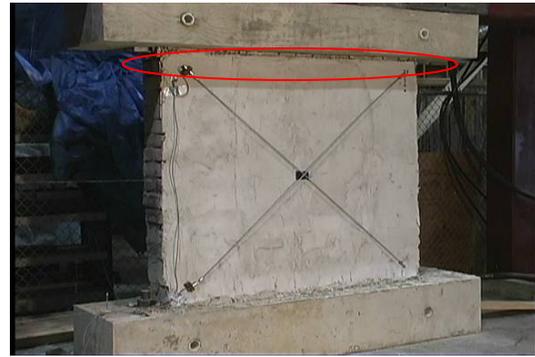
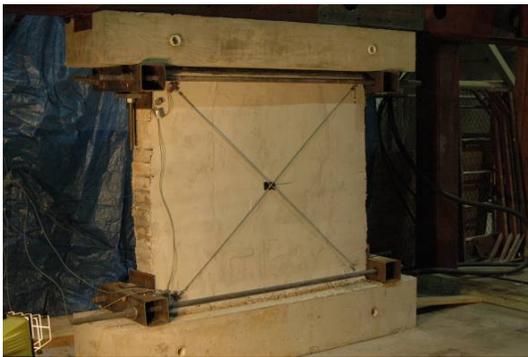
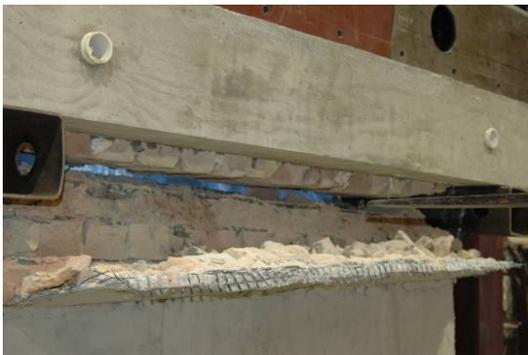
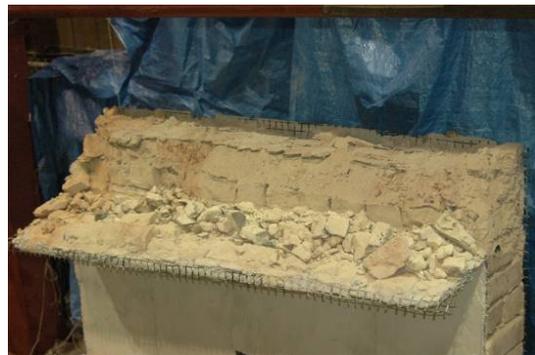
Figure 62. The modes of failure for IP-C1 specimens.

This run was tested without the corner loading steel tubes. All load transfer from the loading beam to the wall had to occur through shear between the concrete loading beam and the brick. Because the FRP overlay was not bonded to the concrete loading beam, the FRP did not contribute to the transfer of load. Because of this, a weak shear plane existed, and horizontal shear failure in the top brick course was observed.

a. IP-C1 Wall prior to testing. Direct load on the header concrete beam.

b. IP-C1 Wall after testing horizontal shear failure in the top course of the brick.

c. IP-C1 Wall prior to testing with loading tube steel beam at the corners.

e. IP-C1 Wall after monotonic loading follow the above cyclic testing. Horizontal shear failure through the FRP.

f. IP-C1 Wall after monotonic loading and after removing the unsound brick along the failure surface.

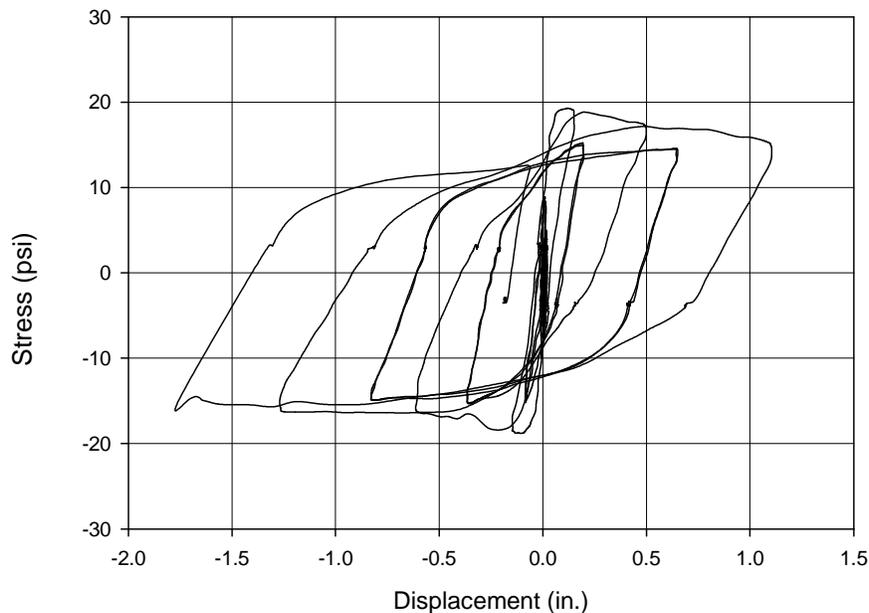
Figure 63. IPC1 pretest.

The maximum value of stress reached in this run was 19.3 psi at a displacement of 0.1 in. The maximum displacement value reached was 1.8 in and corresponded to a stress value of 13.4 psi (Figure 63).

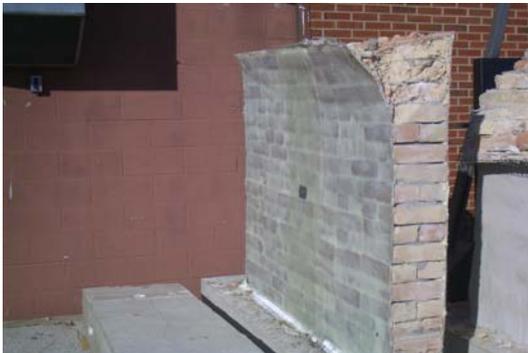
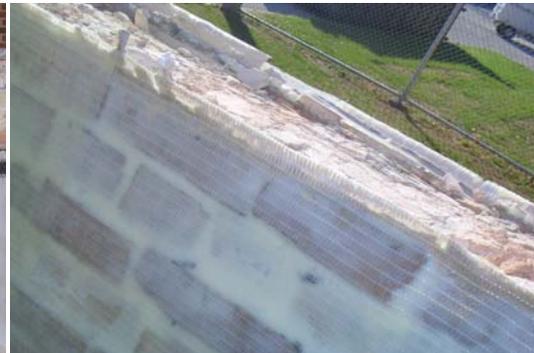
Figure 66. The modes of failure for IP-G1 specimens.

c. IP-G1 Wall corner crushing started under cyclic testing loading and was aggravated under monotonic loading.

d. IP-G1 Wall after monotonic loading follow the above cyclic testing. Horizontal shear failure underneath the FRP is evident.

e. IP-G1 Wall after monotonic loading and after removing the unsound brick along the top failure surface.

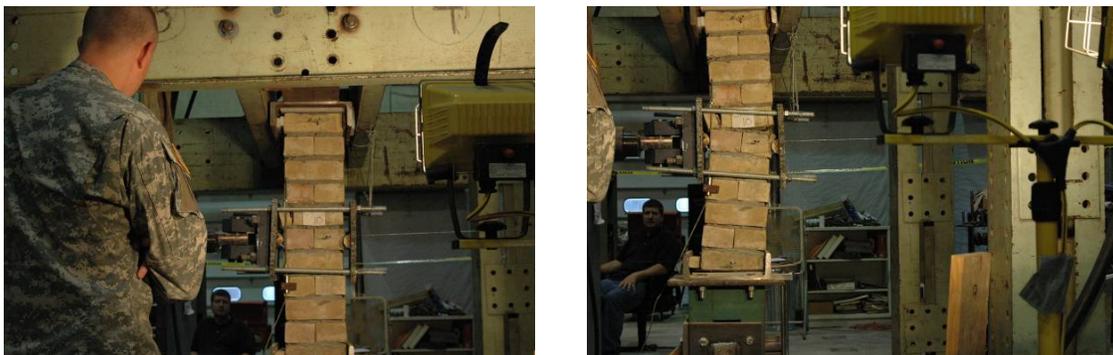
Figure 73. Bare Specimen 010, before test (left) and after test (right).

Failure initiated with spalling of the 7th course followed by rocking about the hinge that formed at the point of loading (Figure 73).

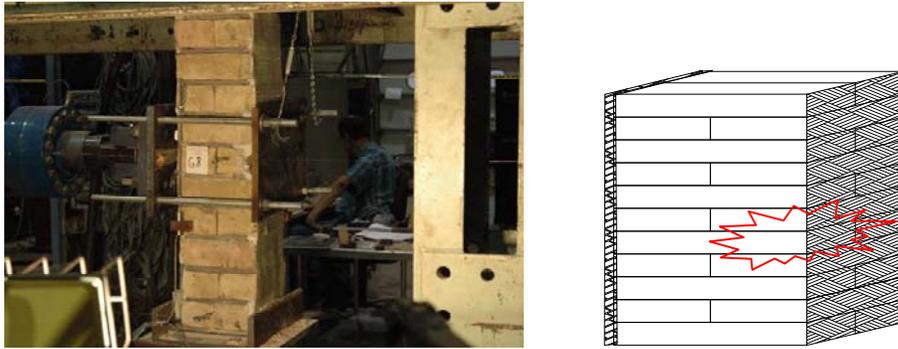
Figure 83. Specimen G8 with Sika Wrap Hex, before test (left), and sketch showing the point of failure (no picture is available) (right).

This specimen failed in a very sudden and brittle fashion, just below the loading point and resulted in loss of the specimen (Figure 83).

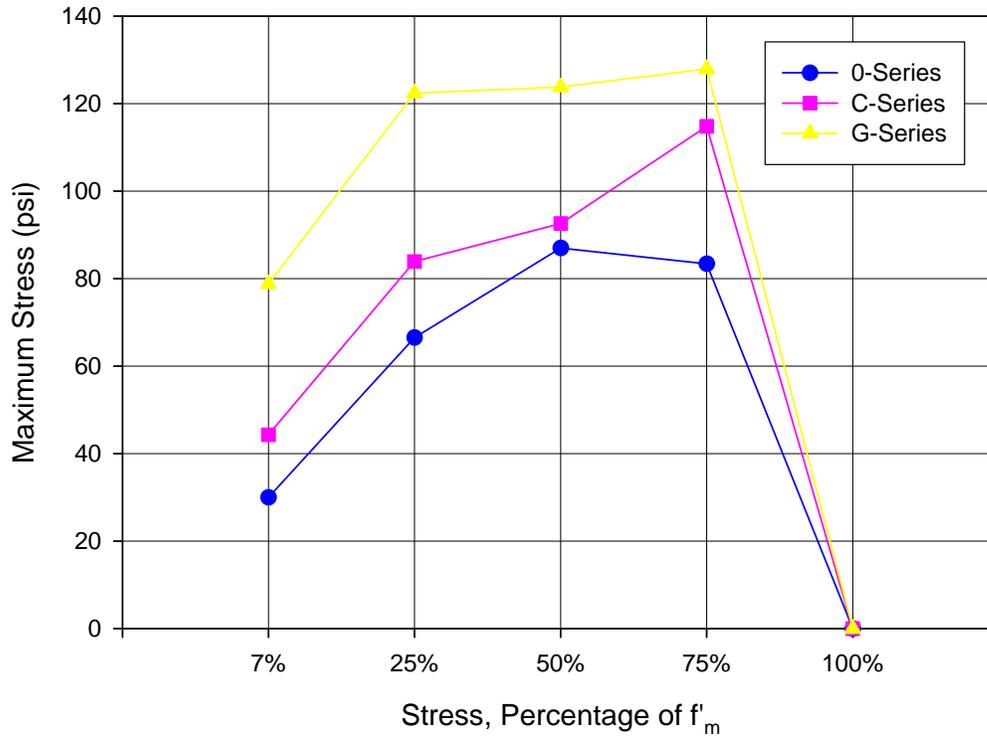
Figure 103. Axial stress v. maximum stress for each specimen type.

Table 18 and Figure 103 summarize the maximum shear stresses of the wall strips associated with the percent of failure load applied axially. The curves in Figure 104 were plotted assuming linear relationship between the data points. The G-series has better performance; however, the Sika Wrap's appearance may put it at a disadvantage. The maximum lateral shear stresses for the C- and G-series occurred at a vertical stress of 75% f_m , while for the O-series the maximum lateral shear stress occurred at about 50% of f_m vertical stress. In the case of the C- and G-series, the GFRP provided some confinement for the masonry, holding the surface together and allowing for higher compressive forces at the surface. At the expected service loads, the C-series showed a 14.3 psi shear-stress improvement, and the G-series showed a 48.8 psi shear-stress improvement compared to the bare-brick specimen. Table 19 lists maximum shear stresses for all series under various vertical loading, for comparison.
