Naval District Washington – Anacostia Annex Building Survey

Adam Smith and Sunny Stone

September 2009

Final Report

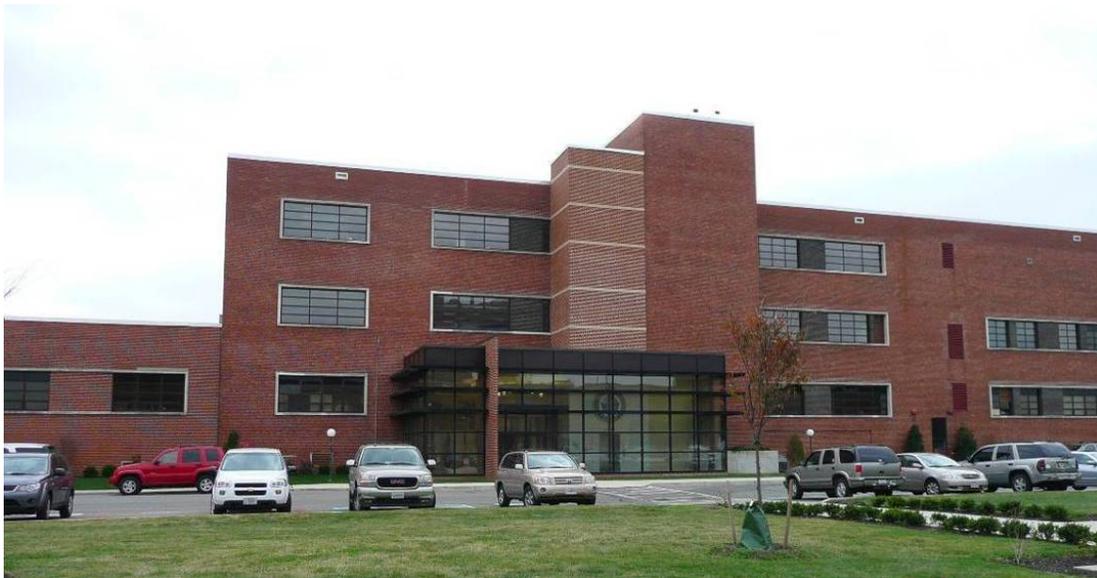
Figure 67. Building 168 west facade.

- *Criterion A: Event.* Building 168 (and its heater plant Building 169) were the primary photography lab for the Department of the Navy during World War II and the Cold War. The Navy assembled all photograph montages and photographs at this site.
- *Criterion C: Design/Construction.* Building 168 (and its heater plant Building 169) were designed by the Eastman Kodak Corporation for the Department of the Navy. Its design is a modified Government Deco with long horizontal lines only broken by a large stair tower at the entrance. The aspects of integrity are very high on this building. An addition was attached to the north at the former loading dock, the original windows were changed out, and the entrance was changed to allow for accessibility issues.

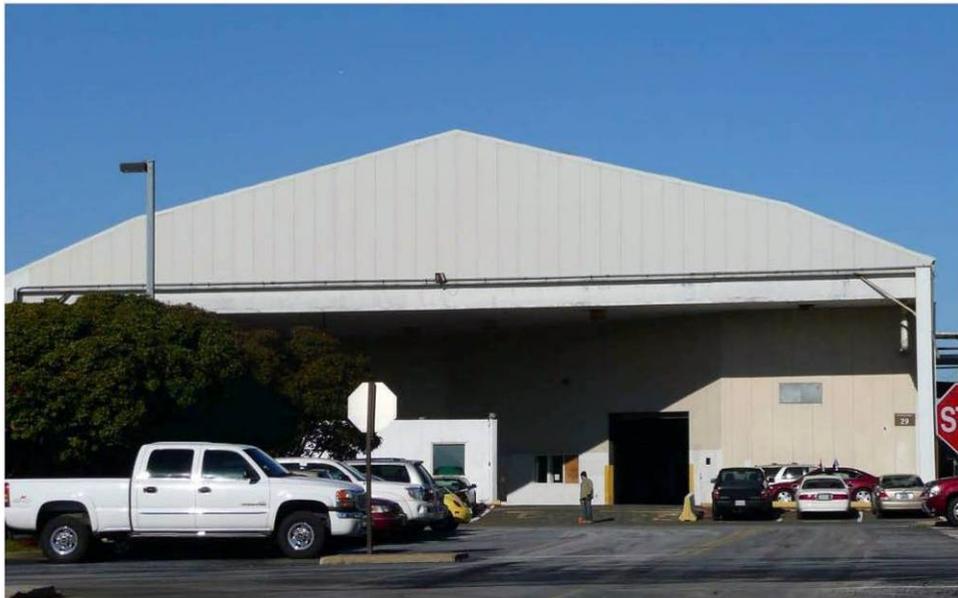
Building 29 – east elevation

Building 29 is in good condition; however, the key architectural elements of the hangar have been modified. The original metal track hangar doors with multi-pane steel industrial windows on the west elevation have been removed and the openings have been filled in with metal panels. The original metal tracks and guides used to operate the doors on the west elevation are intact. The original metal track doors on the east elevation have been removed and a new inset entry and exterior wall have been constructed. The original bands of multi-pane steel industrial windows on the north and south elevations have been removed and the openings have been covered with newer metal siding.

The original crimped metal roof, rectangular footprint, and massing are intact. The majority of the original metal siding has been replaced.

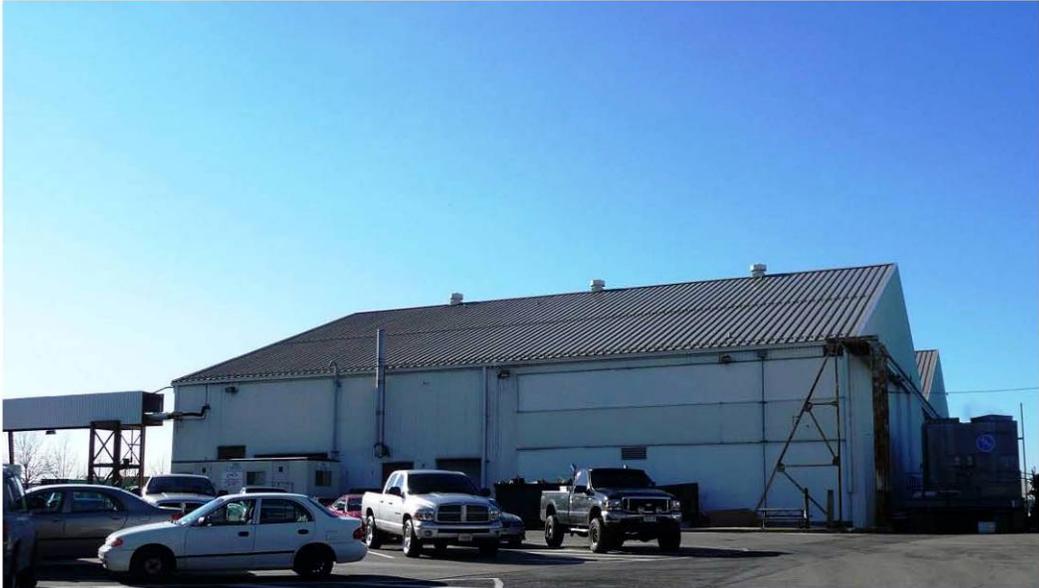
Building 47 – north elevation

The original crimped metal roof, rectangular footprint, and massing are intact. The majority of the original metal siding has been replaced, along with the entry doors, windows, and roll-up doors.

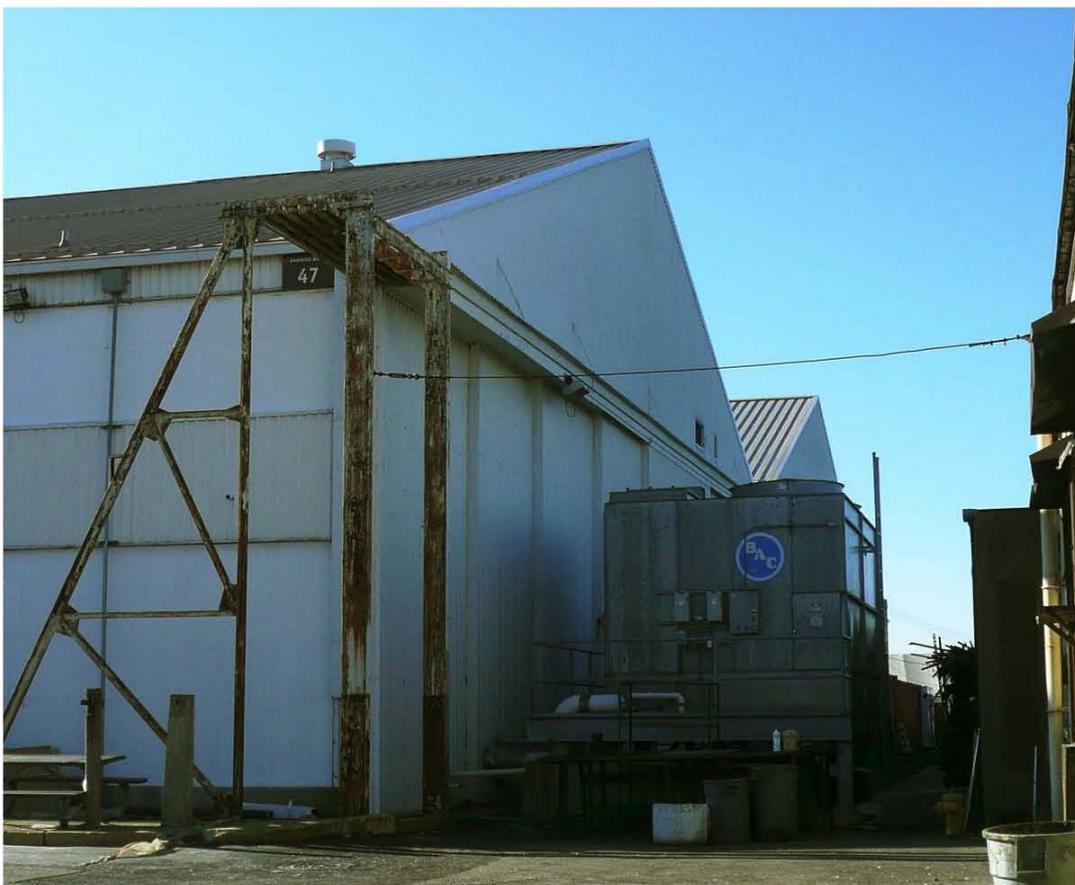
Building 47 – west elevation with original retractable door mechanisms

Building 47 is in good condition; however, the key architectural elements of the hangar have been modified. The original metal track hangar doors with multi-pane steel industrial windows have been removed and the openings have been filled in with metal panels, and the bands of multi-pane steel industrial windows have been removed and the openings have been filled in or covered over. The original metal tracks and guides used to operate the doors on the west elevation are intact.

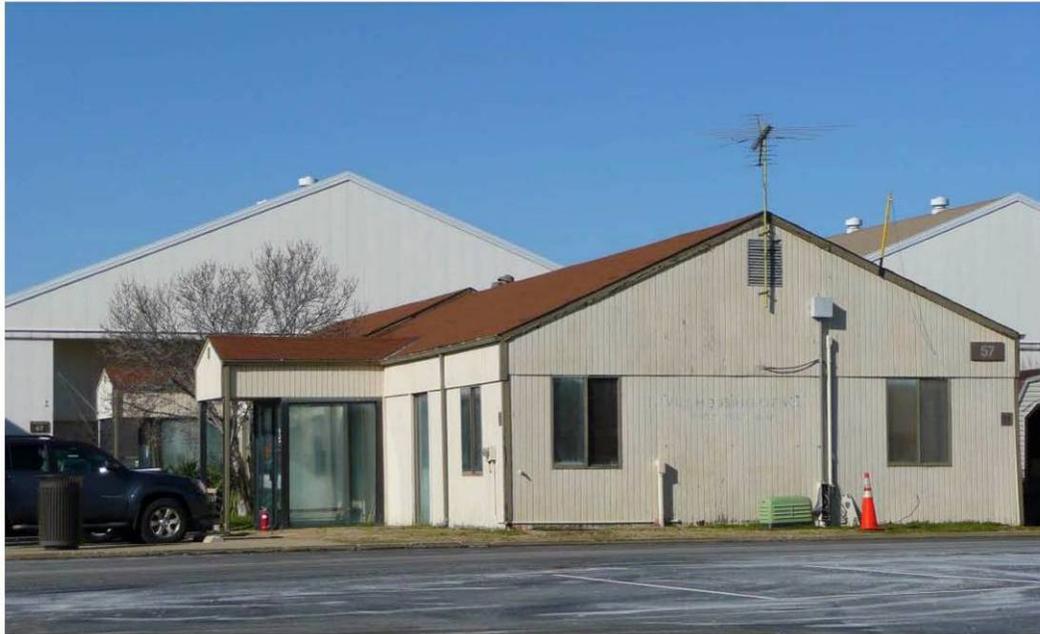
Building 57 – oblique view of the south (front) and east elevations

The south (front) elevation has two entrances sheltered by vestibule additions. The vestibules are constructed of metal and frame, and plate glass. There are replacement slider windows on this elevation.

Building 57 is in good condition; however, all of the original architectural features and materials have been removed and replaced with newer materials. The original metal siding has been replaced with vertical wood siding. The original metal roofing has been replaced with three-tab asphalt shingles. The original windows have been replaced with metal slider windows. At some point, two vestibule additions were constructed on the south elevations over the entrances.

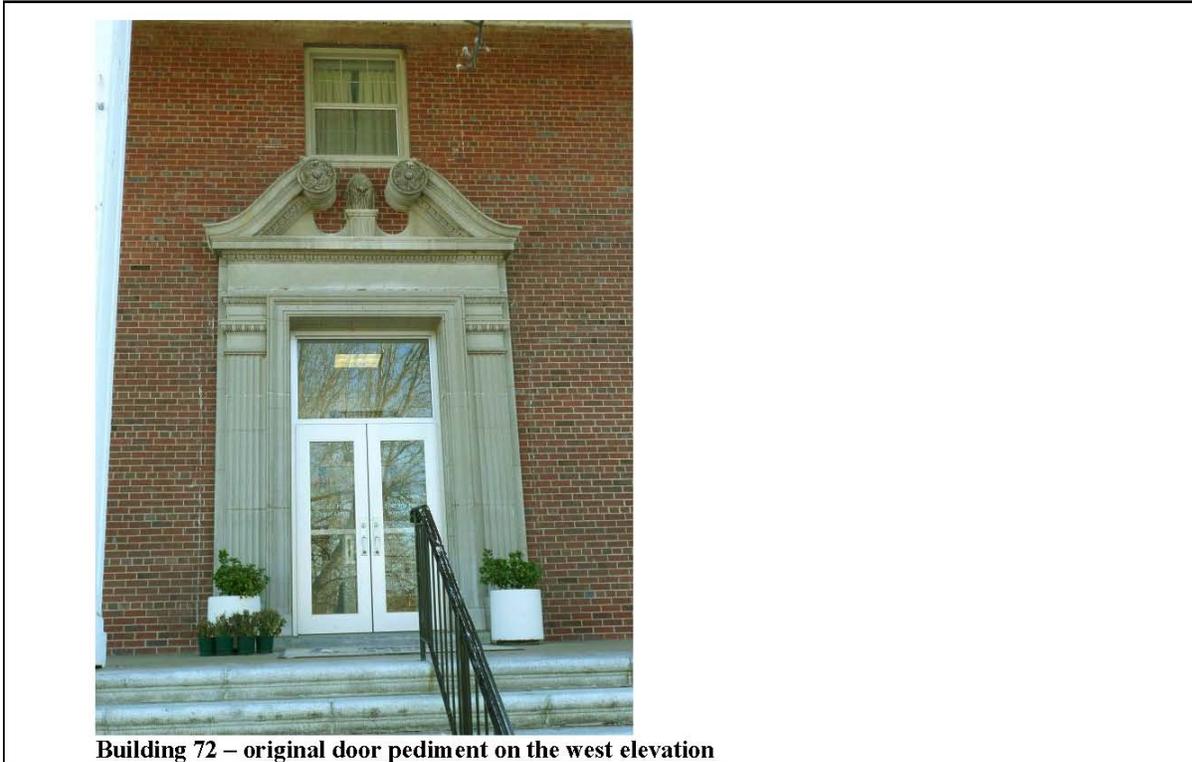
Building 72 – original door pediment on the west elevation
