U.S. ARMY RESEARCH, DEVELOPMENT AND ENGINEERING COMMAND

ECBC-TR-797

**HAZARDOUS WASTE REMOVAL OPERATIONS
CONDUCTED IN SUPPORT
OF THE BZ AGENT/MUNITIONS DISPOSAL FACILITY
REMEDiation PROJECT**

September 2010

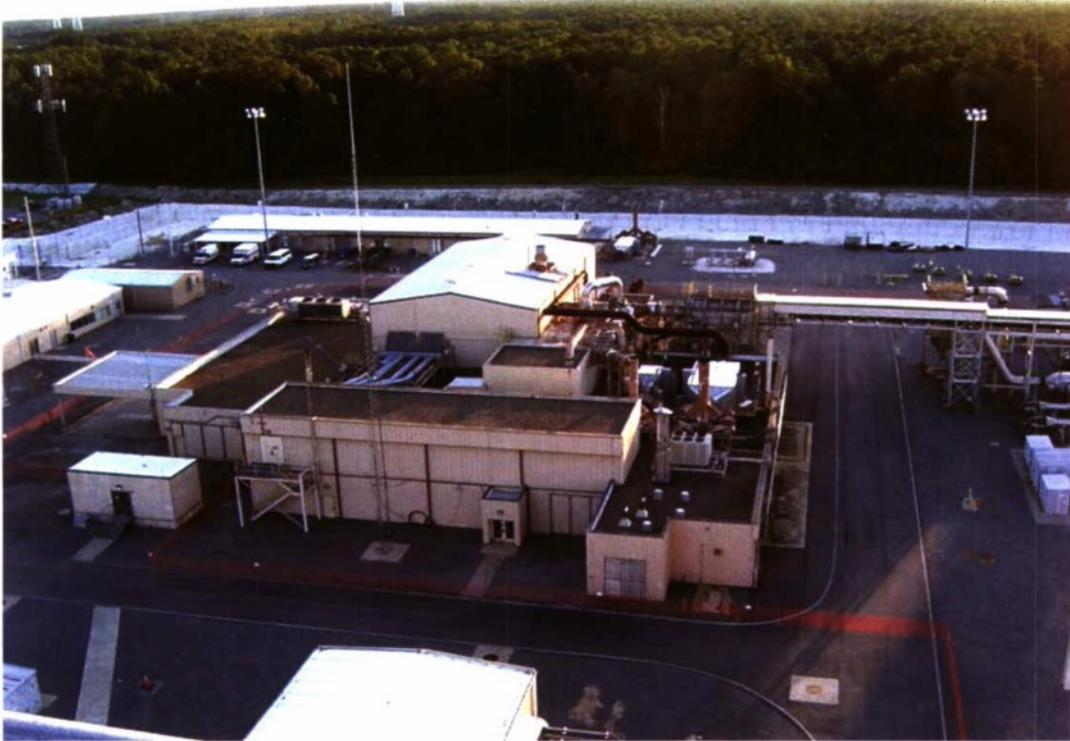
Figure 1. BZDF Facility

The BZDF (Figure 1) was constructed for the safe disposal of a munitions stockpile containing 3-quinuclidinyl benzilate (BZ). The BZDF operated for approximately 18 months and ceased agent destruction operations in 1990. The BZDF was Resource Conservation and Recovery Act (RCRA) clean closed by the Pine Bluff Arsenal (PBA) as determined by the Arkansas Department Pollution Control and Ecology (ADPC&E) (now referred to as the Arkansas Department of Environmental Quality [ADEQ]) Hazardous Waste Division on August 20, 1990. The BZDF destroyed BZ in the form of munitions, powdered agent in drums, and liquid agent in drums. These different forms of BZ were demilitarized by separate processes during operations. Munitions were processed by means of an autoclave that was used to inert the BZ fill and explosives. These munitions were then sent to a Deactivation Furnace System (DFS), where the munitions were heated to 1,000 °F for a specified period of time. The residues from this operation were processed through the Heated Discharge Conveyor (HDC).

BZ liquid drums were processed in Metal Parts Furnace (MPF) #1 and #2. The liquids were evaporated in the furnaces and the vapors were combusted in the primary fume burners above the furnaces to destroy the BZ. MPF #3 and #4 were used to destroy the materials and secondary wastes from unpacking munitions and contaminated materials from BZ processing. A Common Afterburner (AFB) and Pollution Control System (PCS) handled the combustion gases from all six BZDF incinerators. Drums containing BZ agent in the form of powder were processed through the Liquid Incinerator (LIN). The powder was mixed into slurry with acetic acid and pumped into the incinerator, where the BZ was destroyed.

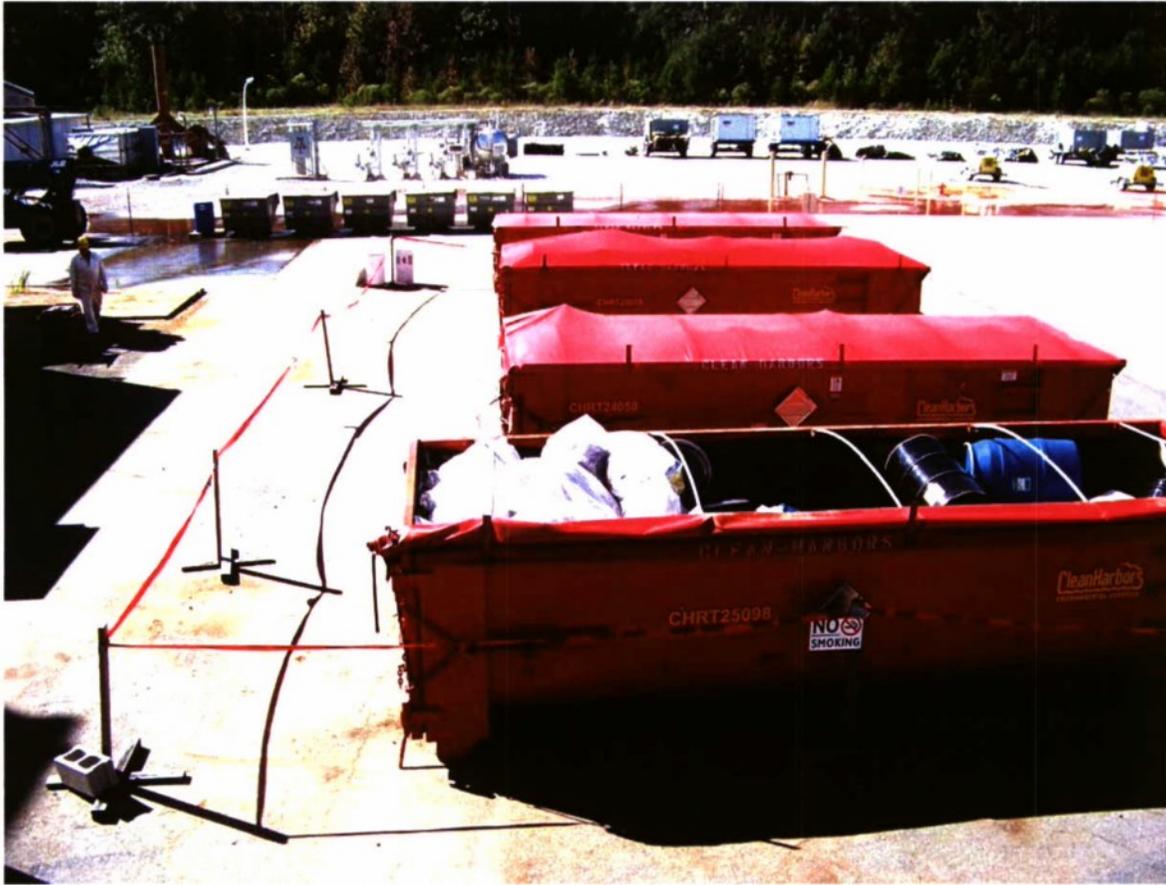
Figure 2. Hazardous Waste Disposal Roll-off Containers

This refractory brick, slag, and/or ash waste was removed by ECBC during remediation operations and placed into lined roll-off containers (Figure 2) that were labeled in accordance with the management practices listed in the ECBC BZDF Waste Management Plan. The accumulation start date began with the day that waste material was first placed into the container; although waste material was continually added until the container was full. The area was inspected daily and documented on the ECBC 90-Day Hazardous Waste Area Inspection Form. A total of three roll-off containers were used to contain the waste generated from the removal of material from the remediation of the BZDF furnaces, Common AFB, PCS, and associated ducting.

The roll-off boxes used to contain the ash, brick, and slag from remediation activities were removed from the BZDF on November 11, 2008. This material was transported to Clean Harbors Lone Mountain Facility in Waynoka, OK. The material was removed from the roll-off containers, where it was prepared for macro encapsulation at Clean Harbors Landfill. A Certificate of Disposal was generated and provided to ECBC on December 2, 2009.

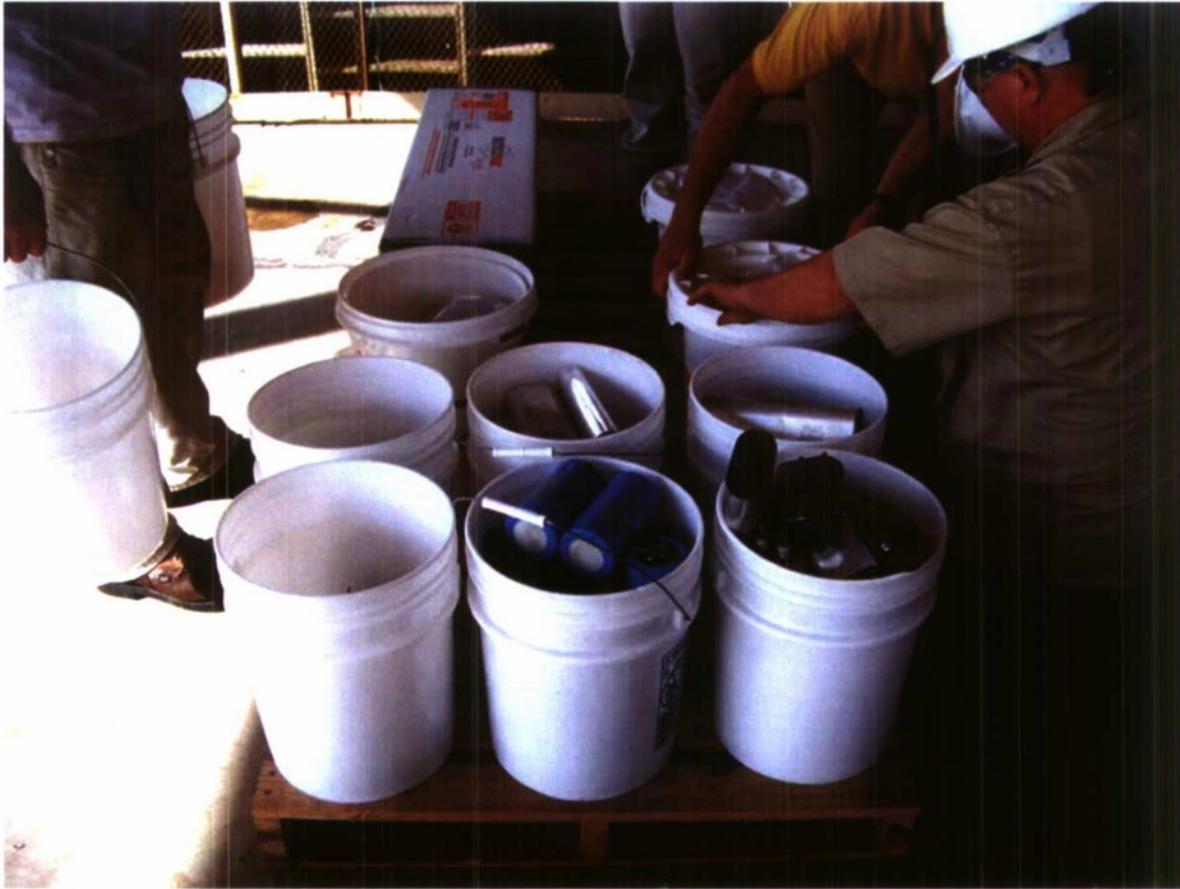
Figure 3. Hazardous Waste Segregation

During the waste removal process, other materials such as used motor oil, compressor fluid, used coolant, fluorescent light ballasts, capacitors, and water contaminated with oily sludge were removed. These materials were identified using generator knowledge and Material Safety Data Sheets (MSDS) to categorize and appropriately designate the substances as Non-RCRA regulated waste. These materials were placed into the proper storage containers, labeled, and managed accordingly. These wastes were stored and managed in the appropriate < 90 day hazardous waste storage areas designed by URS. When necessary, samples were taken from these materials to ensure that the waste did not contain any RCRA listed waste or polychlorinated biphenyls (PCBs) of the Toxic Substances Control Act (TSCA) at or above the limit of 50 parts per million (ppm).

Universal wastes were generated as part of the remediation process at the BZDF. Fluorescent light bulbs, lead acid batteries, nickel cadmium batteries, and mercury ampoules from vacuum gauges were collected throughout the BZDF. These materials were properly identified, labeled, and managed in <90 day hazardous waste storage areas designed by URS (Figure 3). Leaking batteries and broken fluorescent bulbs were labeled as hazardous waste and managed accordingly.

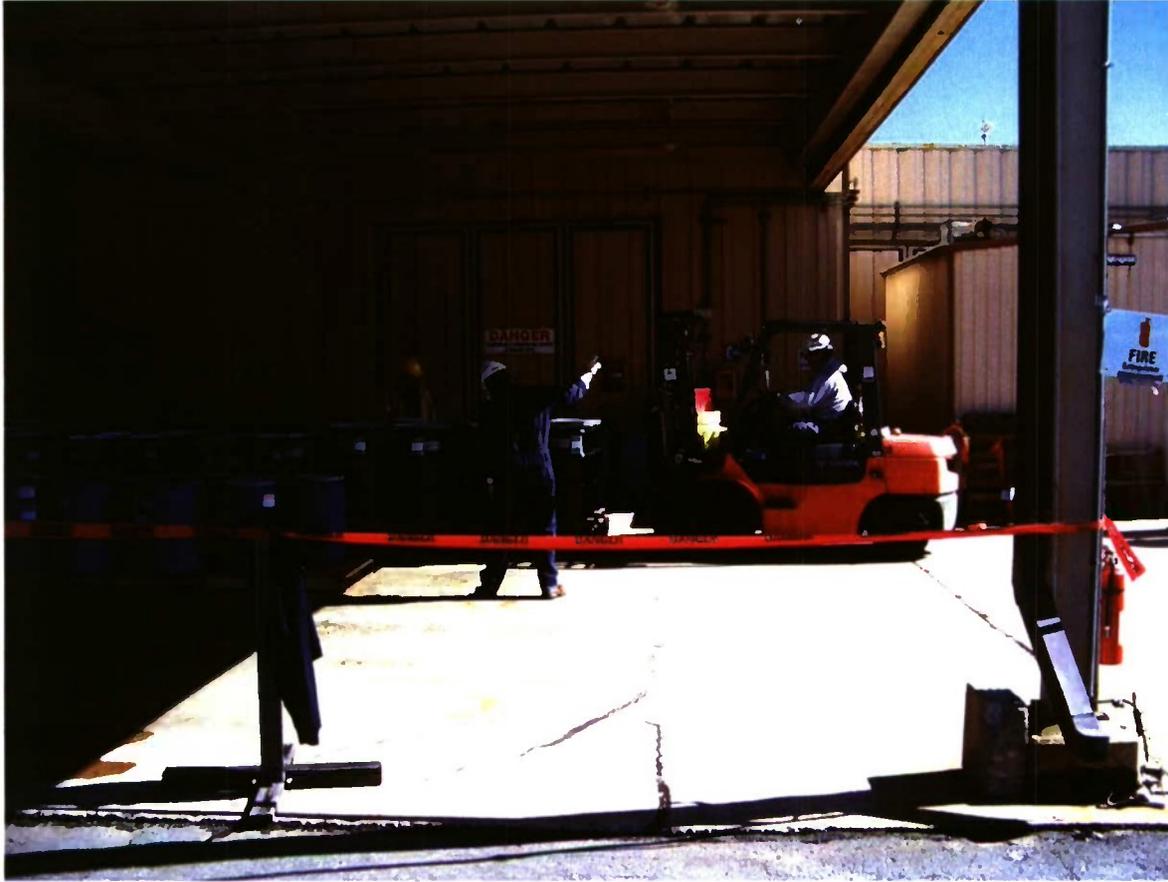
Figure 4. <90 Day Hazardous Waste Storage Site

Good housekeeping practices were followed, as seen in Figure 4, to ensure the waste storage areas were easily accessible and unobstructed so that activities could be conducted safely. Containers were clearly labeled, the contents easily identified, and minimum aisle space was maintained to ensure wastes were stored correctly. All applicable waste storage regulations were followed to ensure that the areas met the

requirements in the ECBC BZDF Waste Management Plan, PBCDF waste management expectations, and all state and federal regulations.

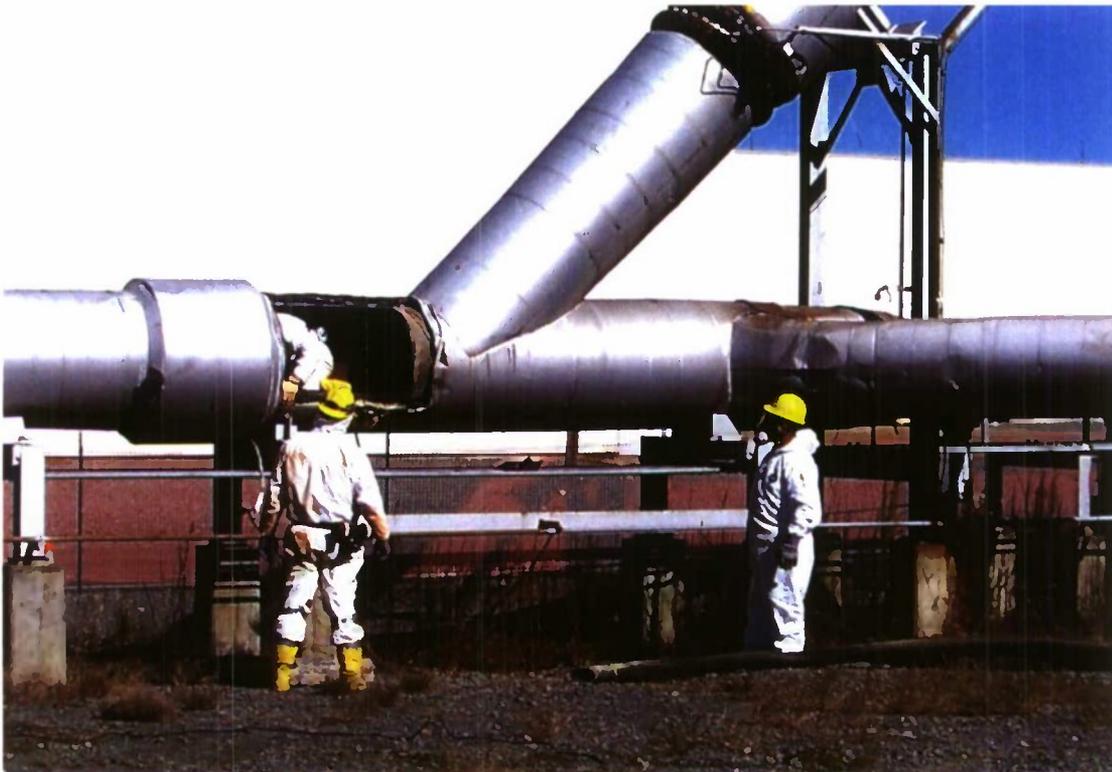
Figure 5. Hazard Waste Remediation of Pollution Control System Ducting

The Common AFB, exterior to Building 57-110 (which housed the furnaces), was disassembled as necessary to remove all refractory and ash that had Toxic Characteristic Leachate Procedure (TCLP) metals above the regulatory thresholds. The Pollution Control System (PCS) and associated ducting was also cleared of all material including ash, rust scaling and debris that exhibited TCLP metals concentrations above regulatory limits.

Specific BZDF areas for potential remediation were identified as the Drum Preparation Area, Equipment Room #1, MDA, MUA, MIN, Fire Water System, Toxic Change Area, MPF, HDC, DFS, Common AFB, LIN, Chemical Distribution System, Support Area, Control Room, BZDF Roof, Sample Enclosure 1, Sample Enclosure 2, and PCS (including associated ducting, Figure 5). See Figure 6 for the layout of Building 57-110.

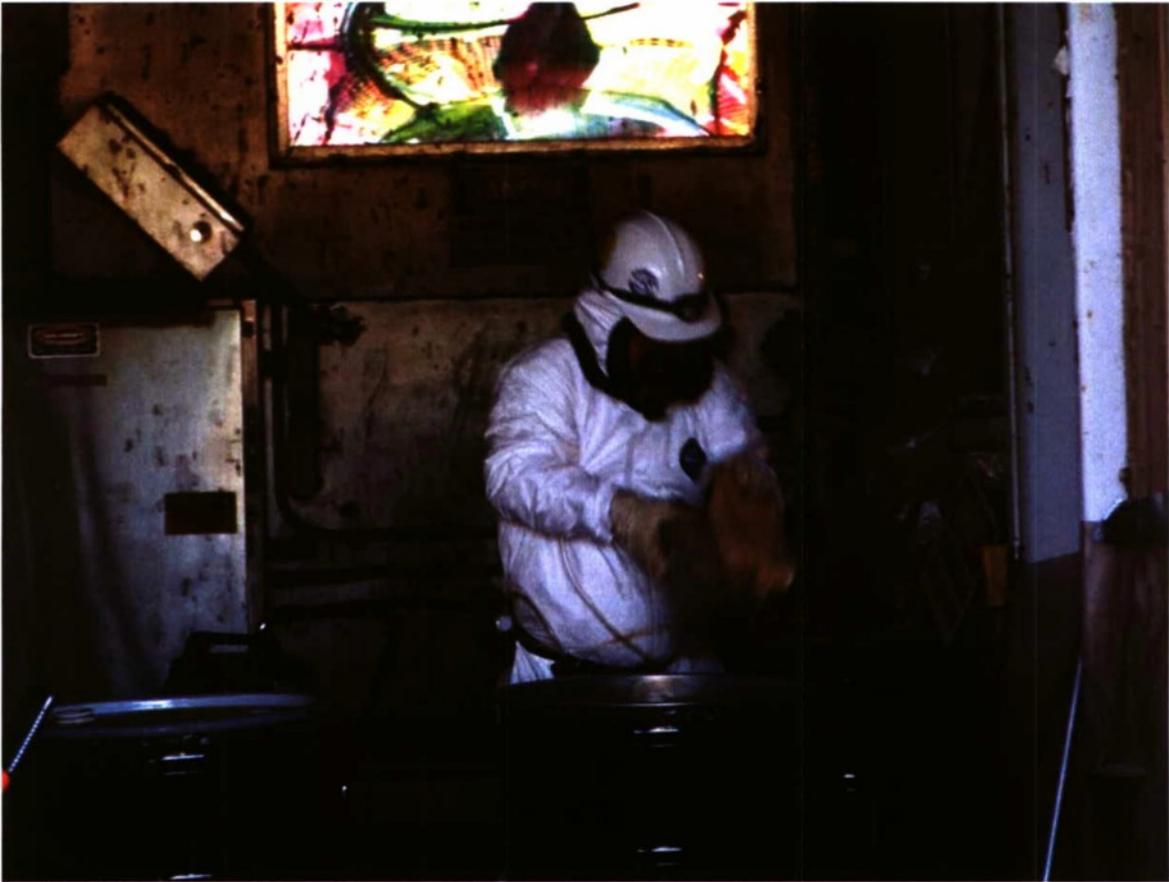
Figure 7. Contaminated Refractory Removal

A survey team performed inspections of each designated section of the BZDF identifying all suspected hazardous waste to be removed (i.e., mercury gauges, lead components, leaking batteries, smoke detectors, ash, refractory, petroleum products, etc.). Areas that were suspected for heavy metals were sampled and analyzed to determine contamination levels. The sampling results can be found in the BZDF Remediation Project Final Sampling Report. Remediation was achieved by physically removing the items of concern (Figure 7). Removal operations consisted of demolition of equipment, vacuuming debris (Figure 8), and/or draining or pumping out hazardous liquids. All operations were completed by section to ensure the safety of all remediation personnel. In areas that were contaminated with heavy metals, post remediation samples were collected to confirm clearance below EPA TCLP thresholds. If levels were found to be above EPA standards, then ECBC continued remediation work of the equipment and/or area in suspect. After post remediation sampling was completed in each section, a review of sampling results and visual inspection were performed by ECBC and WDC. The inspection was documented and signed off on by both parties to finalize remediation activities for hazardous waste.

- 212 light ballasts
- 121 capacitors
- 290 gal of spent/used petroleum products
- 330 gal of coolant
- 4 gal of expired bleach
- 2,650 gal of oil/water
- six 55 gal drums of ash containing heavy metals
- 60 cubic yards of refractory contaminated with heavy metals

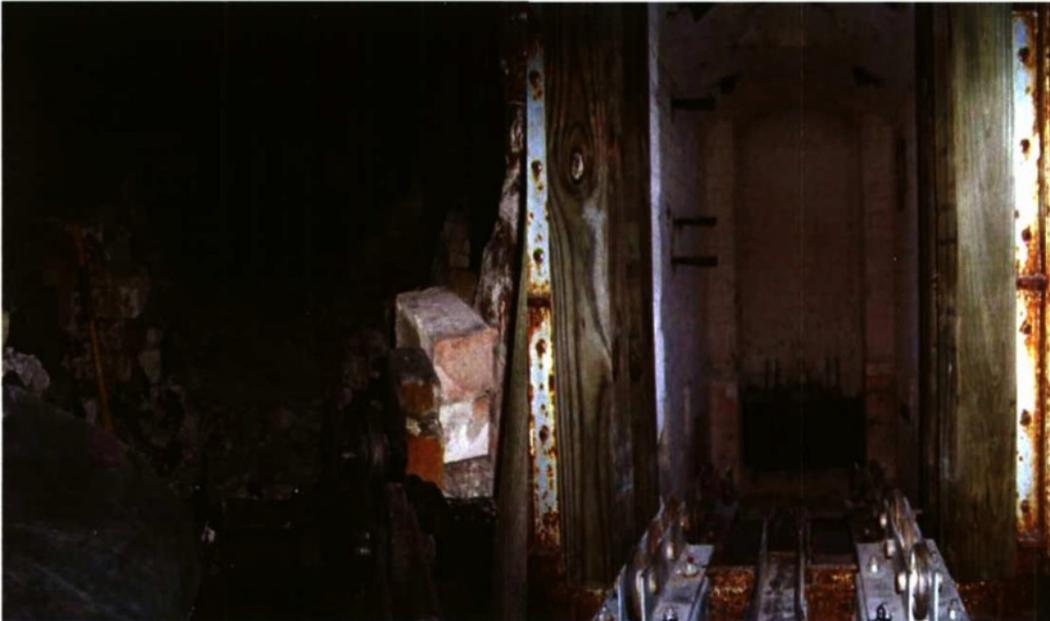
Figure 8. Pictures of Metal Parts Furnace Remediation

Before

After
