**US Army Corps
of Engineers®**
Engineer Research and
Development Center

Laboratory Testing of Architectural Exterior Wall Fins

Abstract: Ice and snow accumulation sliding from the exterior wall fins installed on the New Meadowlands Stadium in New Jersey, future home field for the New York Jets and New York Giants football teams, was recognized as a potential hazard to pedestrians. The objective of this test program was first to determine if the hazard existed with the standard fin and secondly to evaluate the performance of four ice retention devices (IRDs). A mock-up was assembled using four fins in a vertical stack with different angles. Four IRDs were tested: three were continuous strips and the fourth was a truncated cone attached to the fin at 12 inches on centers. The IRDs were mounted along the lower edge of the fin. To provide water drainage, all the IRDs were spaced off the fin using 3/16-inch plastic spacers. To assess the effectiveness of the IRDs under similar conditions, IRDs were only installed on the fins on the left side of the mock-up while the right side, or standard fin, was used as a control.

Project title and number: Evaluation of Sun Control Fins in Snow a

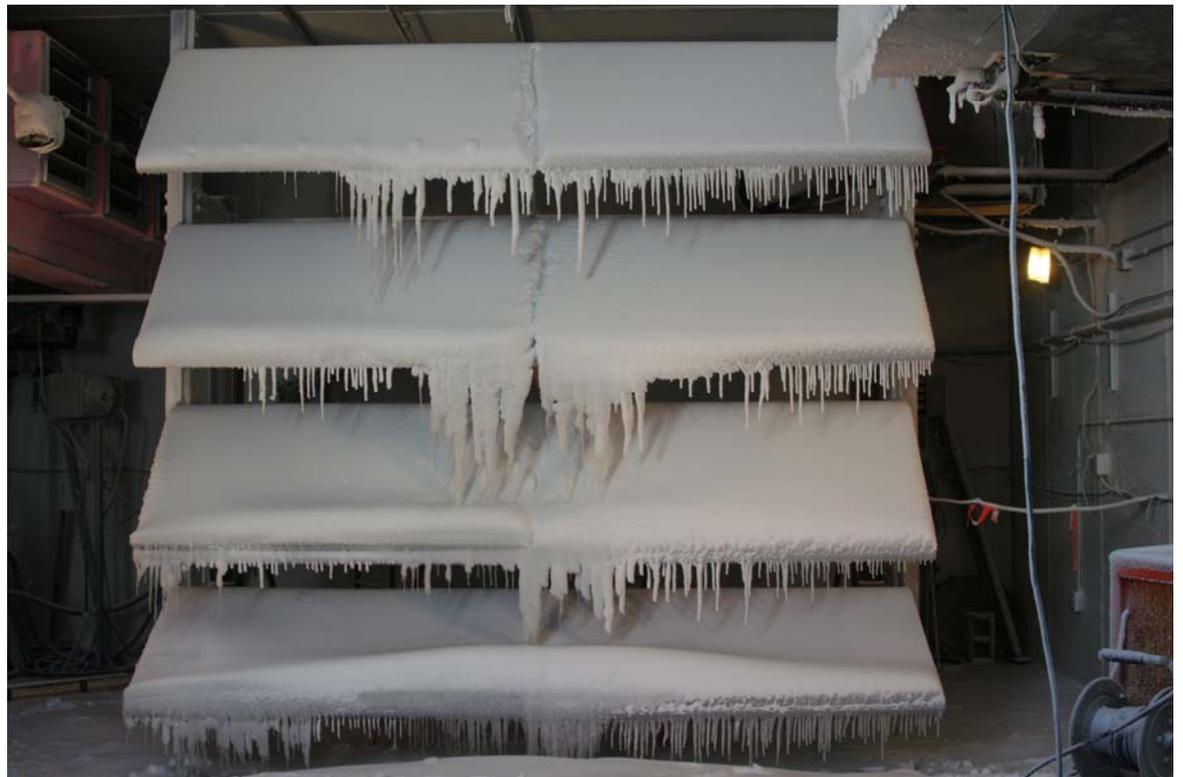
COVER: Initial condition of mock-up covered in snow and ice of varying thicknesses from 2.5 to 7 inches; ice retention devices are installed on the left side of the fin and the right side is used as the control.

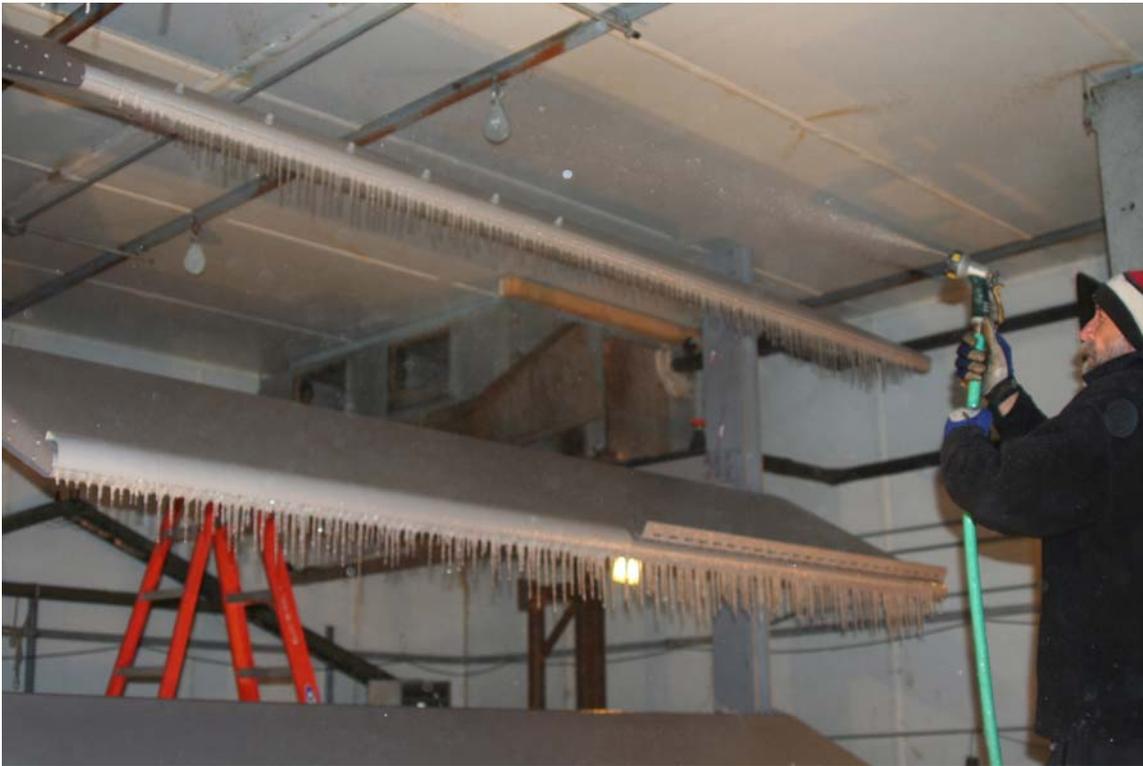
Figure 10. Icing of the model with a spray nozzle on a garden hose.

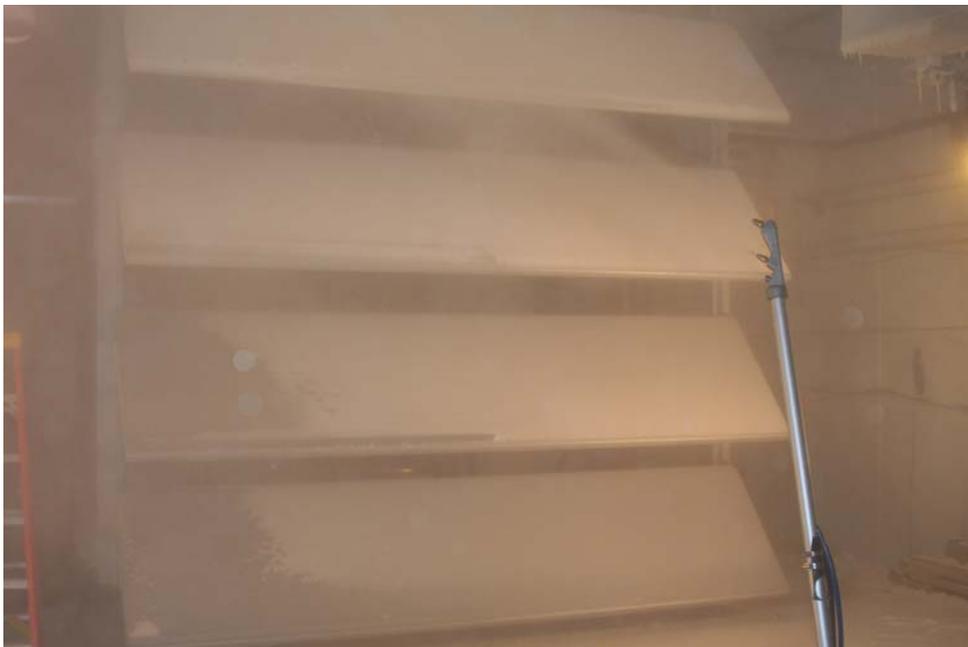
Figure 11. Snowmaking using a commercially available snow gun with an articulating head. A low-velocity fan is used to provide even distribution of the snow.

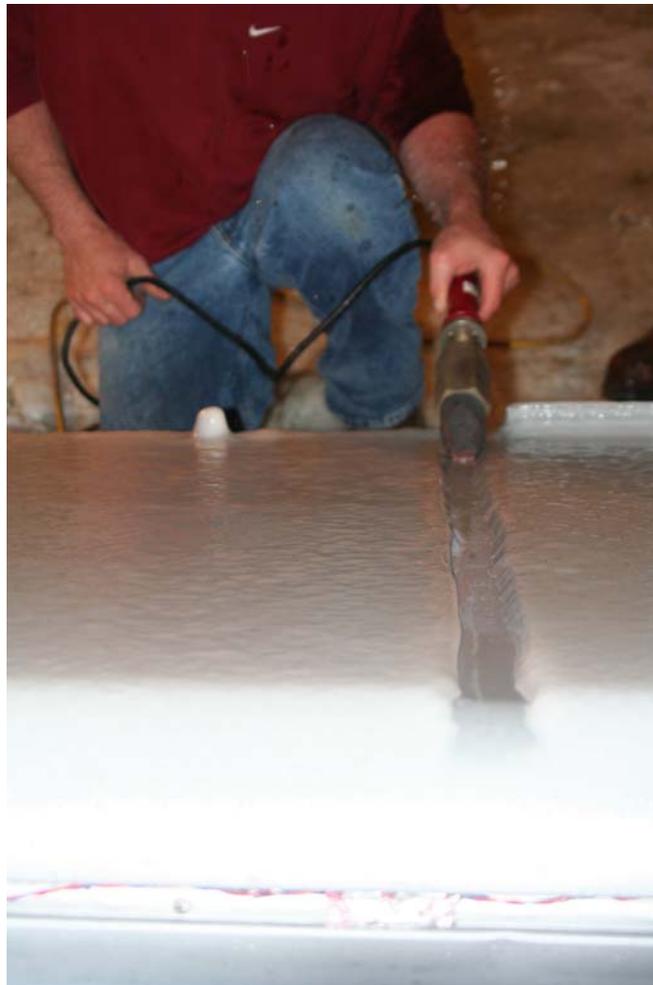
Figure 12. Deicing a vertical slot to isolate the modified side ("A") from the control side ("B").

To assure that the ice shedding process on the A and B sides of the fins were independent, a narrow strip on the vertical centerline of the fin was deiced before starting the test procedure. A hot iron as shown in Figure 12 was used to melt the ice or snow to minimize the area affected by the deicing procedure.

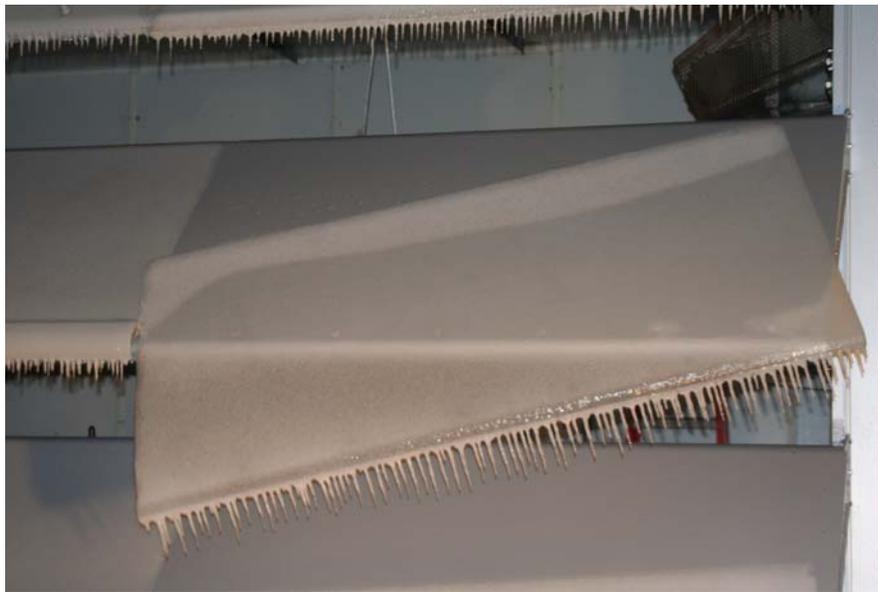
Figure 13. Ice cantilevered off the fin before breaking off as a large section.

was slower responding to the temperature rise; consequently there was no real loss in structural integrity of the ice or snow. With no real loss in strength, the accumulation could cantilever off the edge of the fin, in some instances up to 18 inches, before breaking (Figure 13). The size of the snow blocks picked up off the floor were large enough to seriously injure a pedestrian (Figure 14).

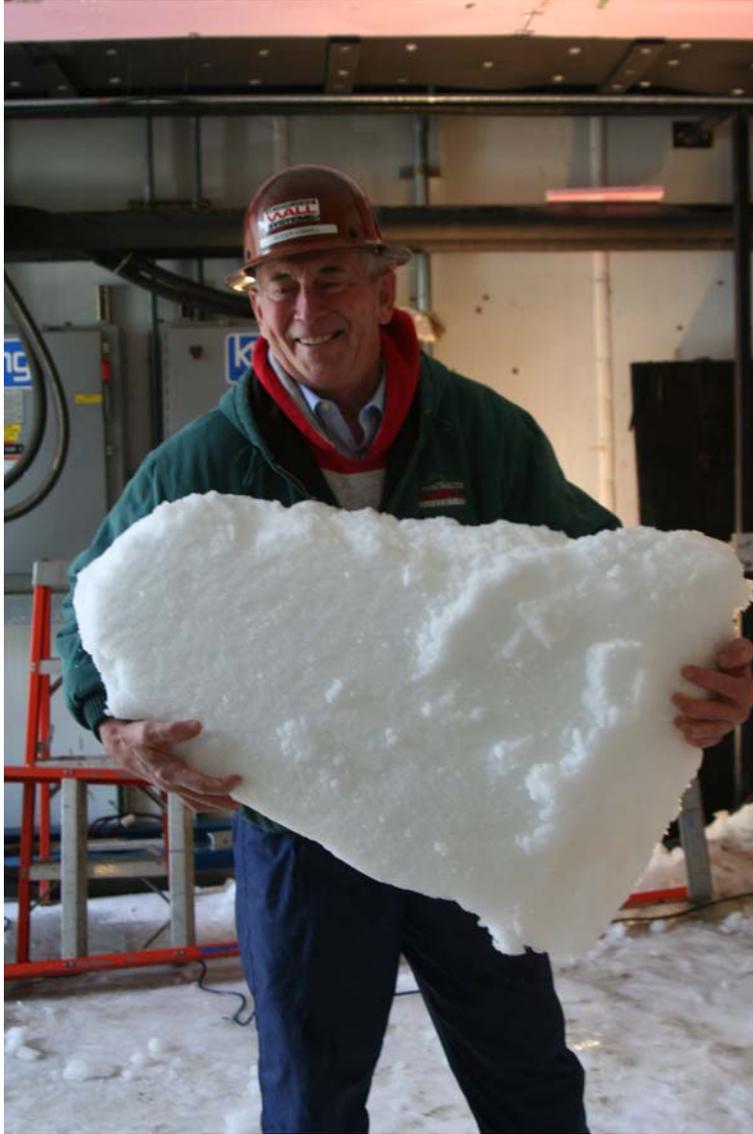
Figure 14. Piece of snow that fell off standard fin without the IRDs.

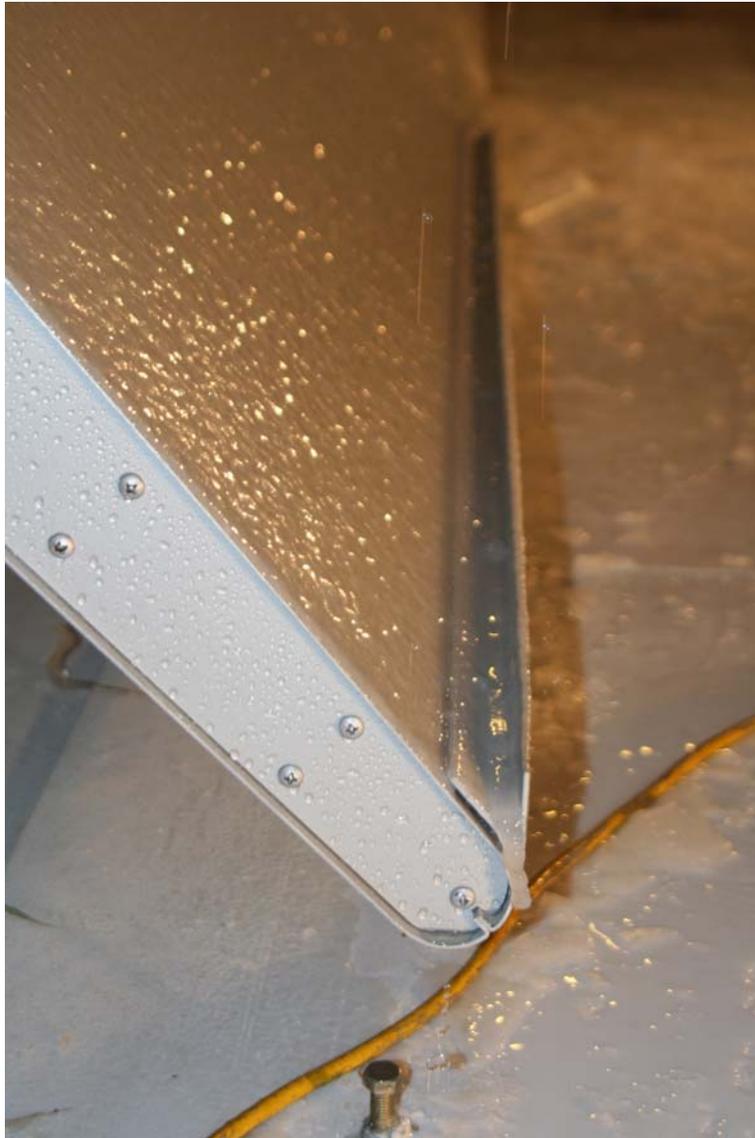
Figure 15. IRD option 1; with a frozen drainage path, the water is diverted to the end of the fin.

The continuous IRD options 1, 2, and 3 are problematic especially in icing conditions. The device is mounted along the lower edge of the fin and spaced off the fin 3/16 of an inch to allow water to drain under the IRD. In icing conditions, water freezes under the IRD and blocks the drainage paths. Water draining off the fin is redirected to the end of the fin. Ice forming in the trough between the fin and the top edge of IRD options 1, 2, and 3 is shown in Figures 15, 16, and 17, respectively.

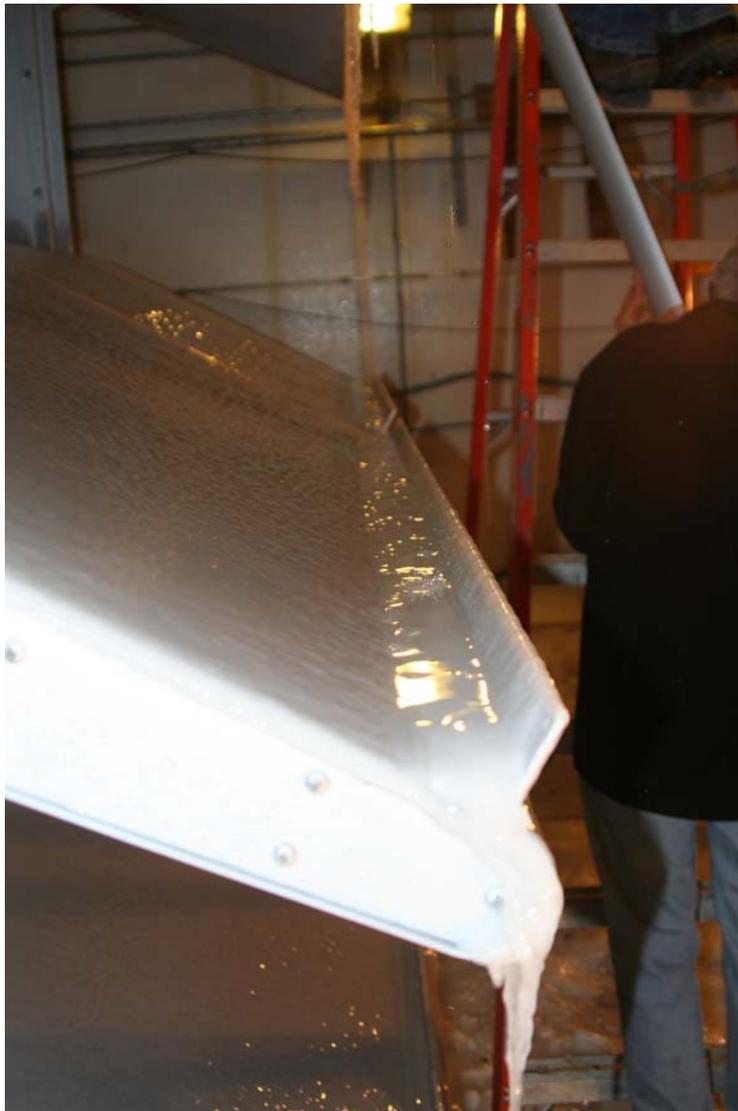
Figure 16. Similar to IRD option 1 shown in Figure 15, when the drainage path is frozen, the water is diverted to the end of the fin potentially forming a column of ice between adjacent fin stacks.

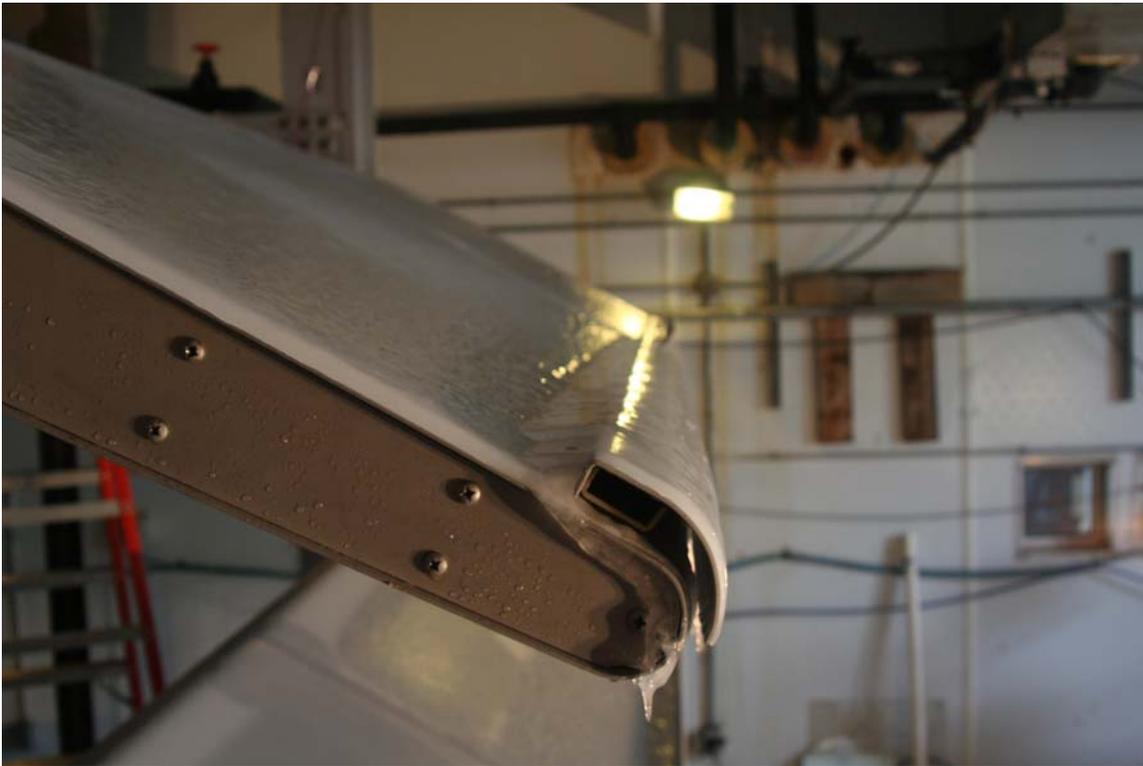
Figure 17. Top side of IRD option 3 showing the blocked drainage paths similar to IRD options 1 and 2.

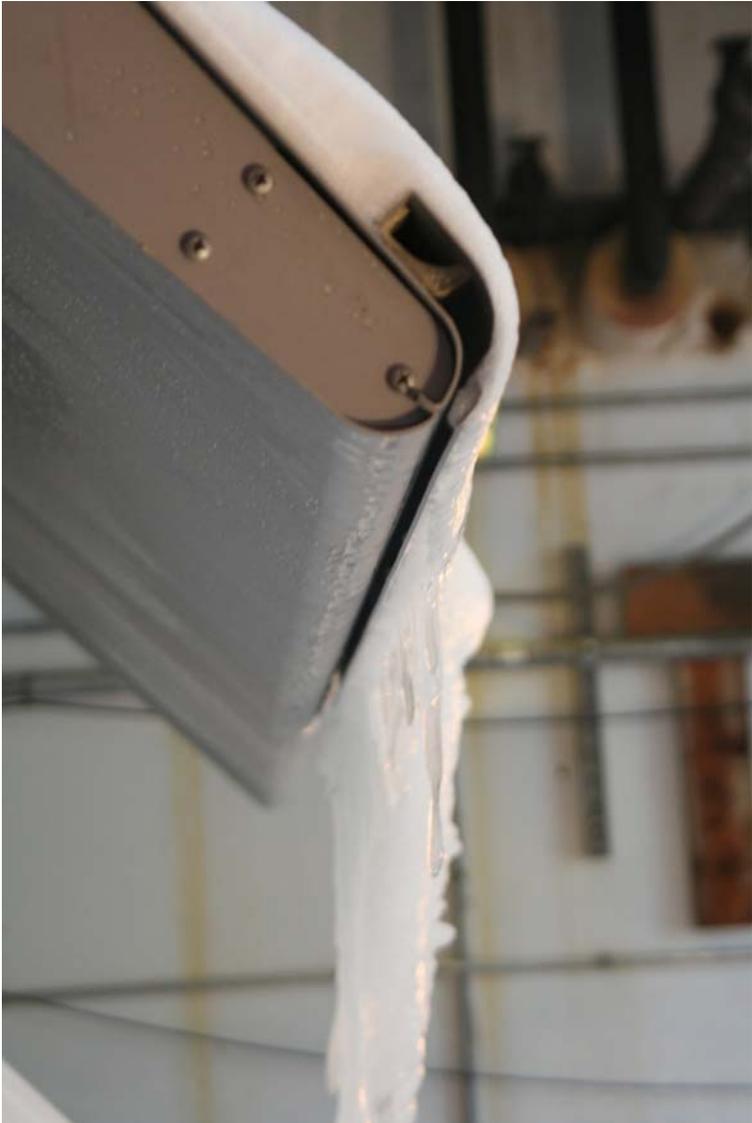
Figure 19. Underside of fin A3 during snow test.

The underside of fin A3 during an icing and snow test is shown in Figures 18 and 19, respectively. Icicles on the fin in Figure 18 indicate that water passed under the IRD before the drainage path froze. In contrast, the accumulated snow impedes the flow of water under the IRD, which freezes and blocks the drainage when saturated with water. The curved front face of the IRD does not provide any mechanical lock for the icicles, and it is conceivable that the warm air could melt the ice bond from the underside, leaving the icicles with limited attachment. Any wind could easily break the icicles free.

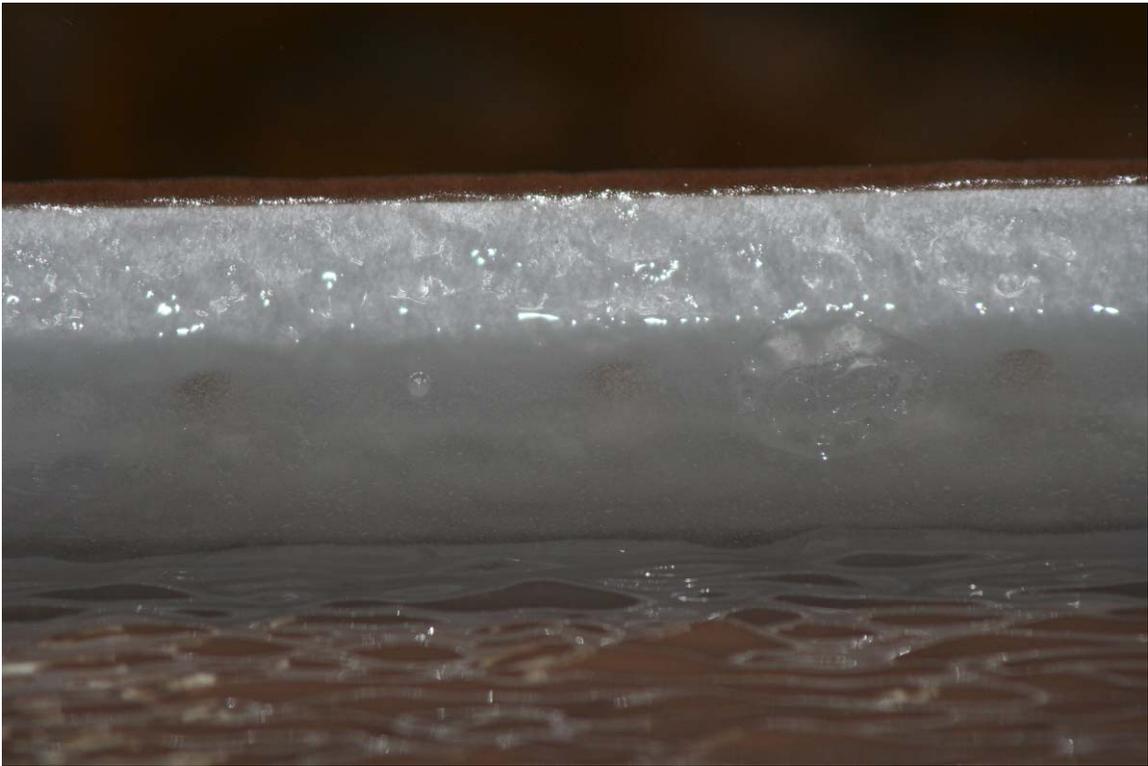
Figure 22. Top view of IRD 2a after 90 minutes of icing; the holes are iced over.

Although the drainage holes were significantly increased, they eventually plugged with ice (Figures 22 and 23) and the water was diverted to the end of the fin (Figure 24). It was concluded that the continuous barriers were not a viable IRD because the melt water was diverted to the end of the fin. Until the trough formed by the fin and the upper edge of the IRD was filled with ice, water would be diverted to the end of the fin. Collectively, the water from the adjacent stacks of fins could form a column of ice in the gap between the fins, presenting a new hazard. Once the ice was above the top edge of the IRD, water would flow over the IRD and form icicles on the leading edge of the fin. Icicles were attached to the fin by the adhesion and mechanical locking with the panel seam on the front edge of the fin. Solar heating could melt the surface adhesion, leaving just the limited strength of the mechanical locking with the panel joint to hold the icicles (Figure 25).

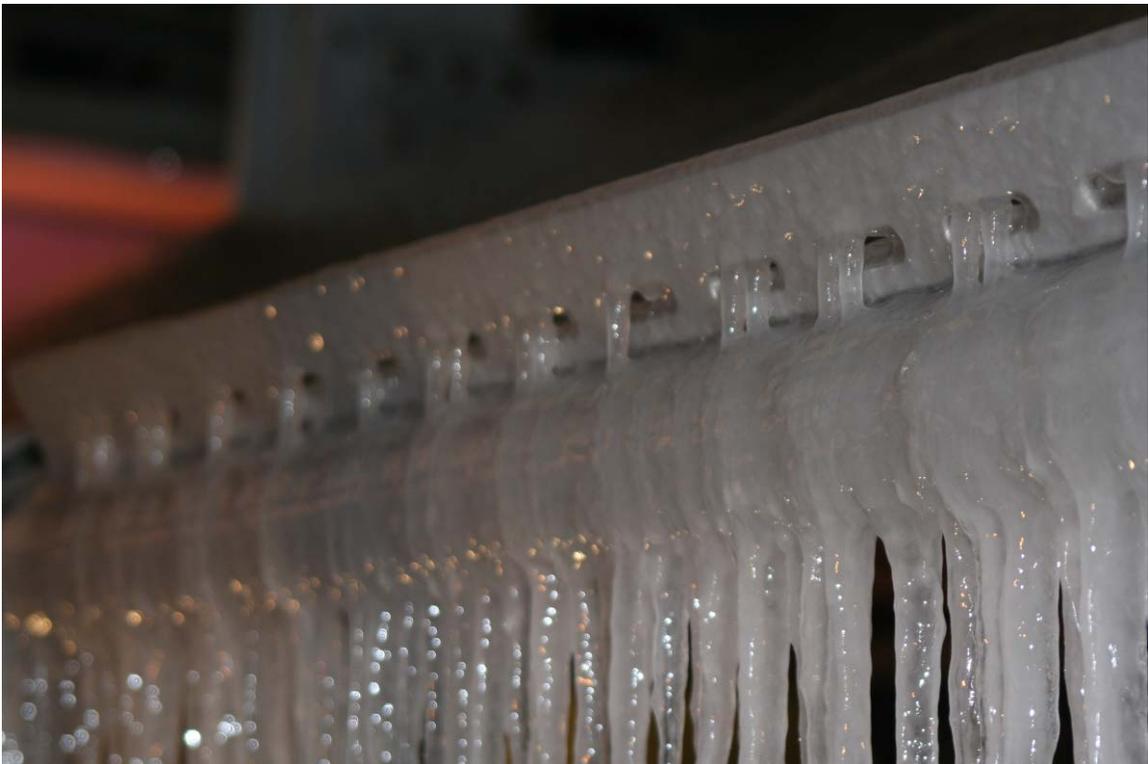
Figure 23. Lower edge of IRD 2b after 90 minutes of icing; although the slots are still open, they will eventually plug.

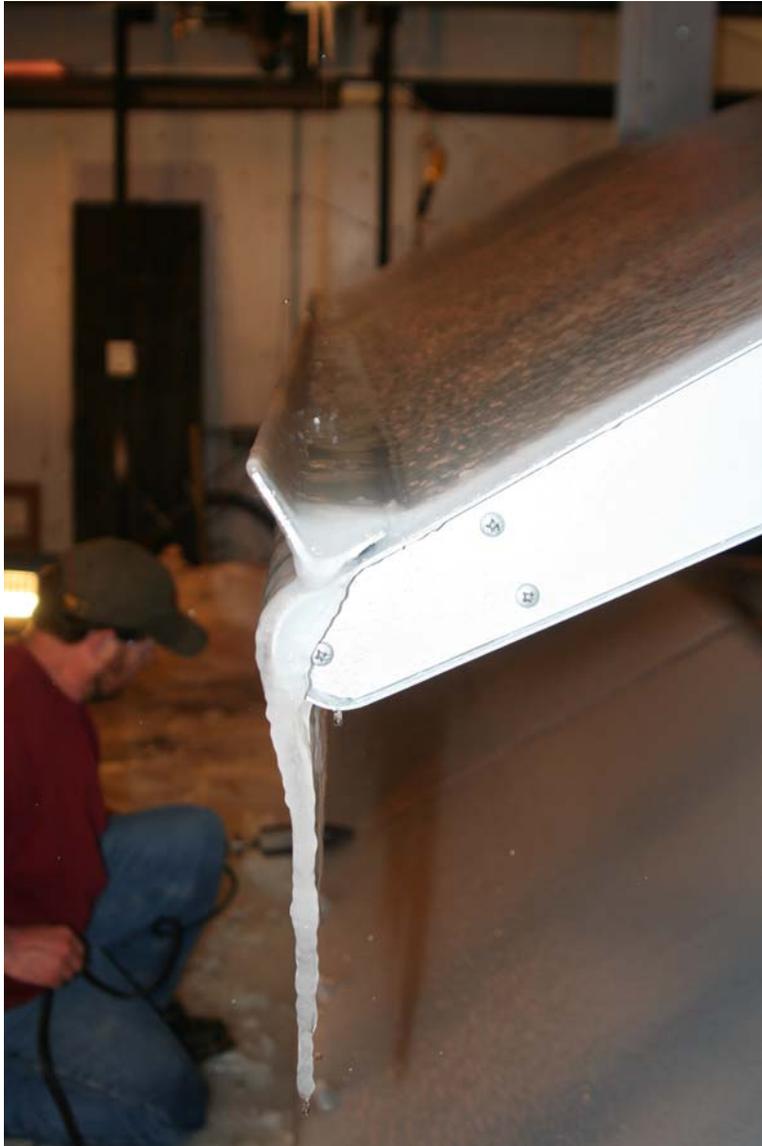
Figure 24. End view of fin 3b with IRD 2a in the foreground and IRD option 2 in the background. Drain paths and holes in the upright leg are frozen and the water is diverted to the end of the fin.

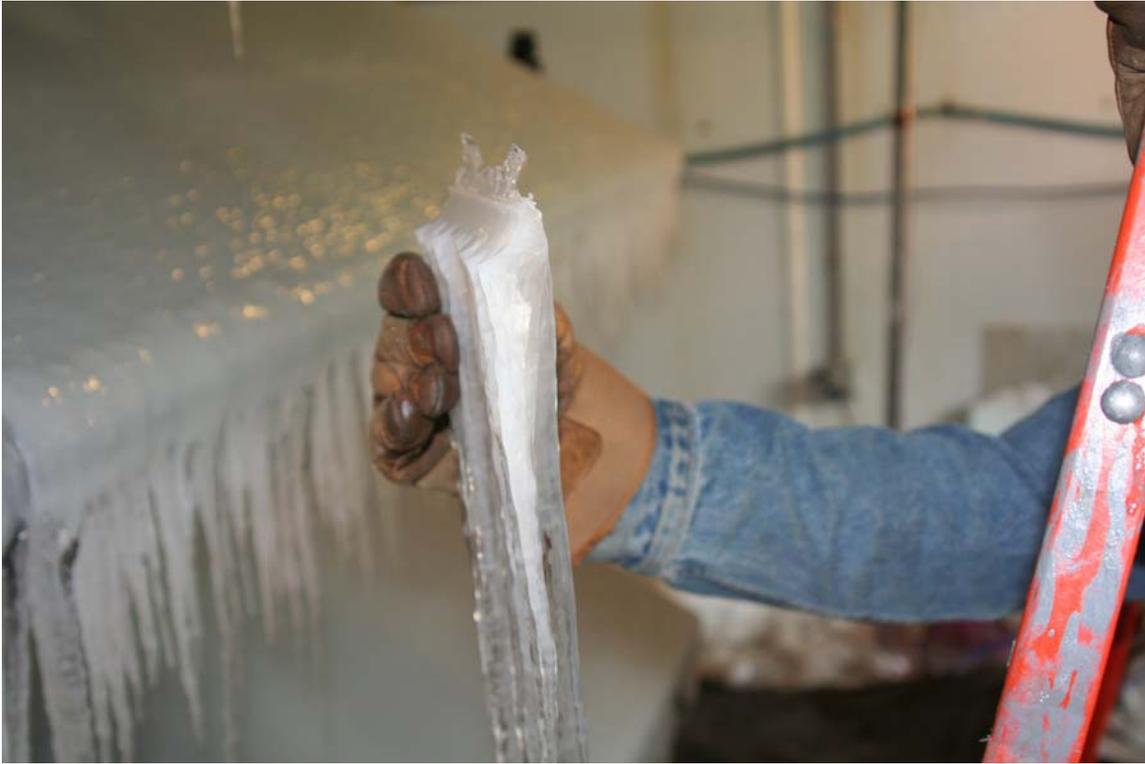
Figure 25. Mechanical locking of the icicles by the panel joint on the leading edge of the fin.

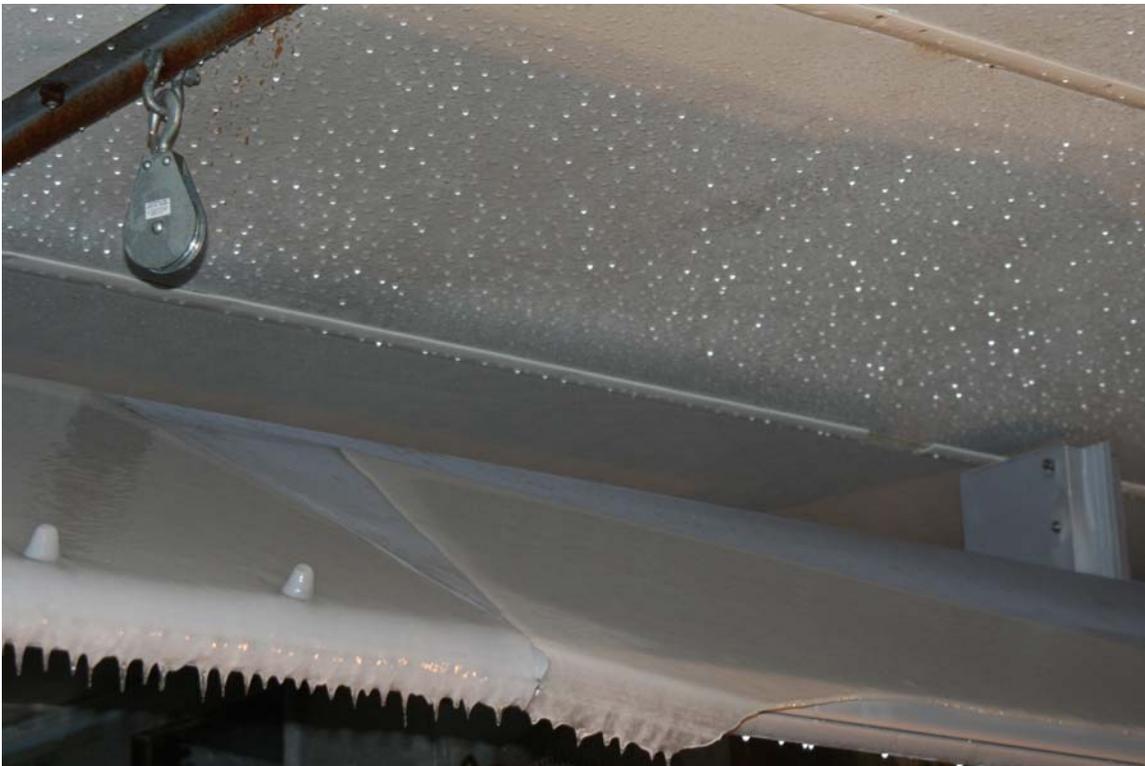
Figure 27. IRD option 4. The buttons 12 inches on center are encapsulated in ice and retain the sheet of ice (left), while the ice slides off without the IRD (right).

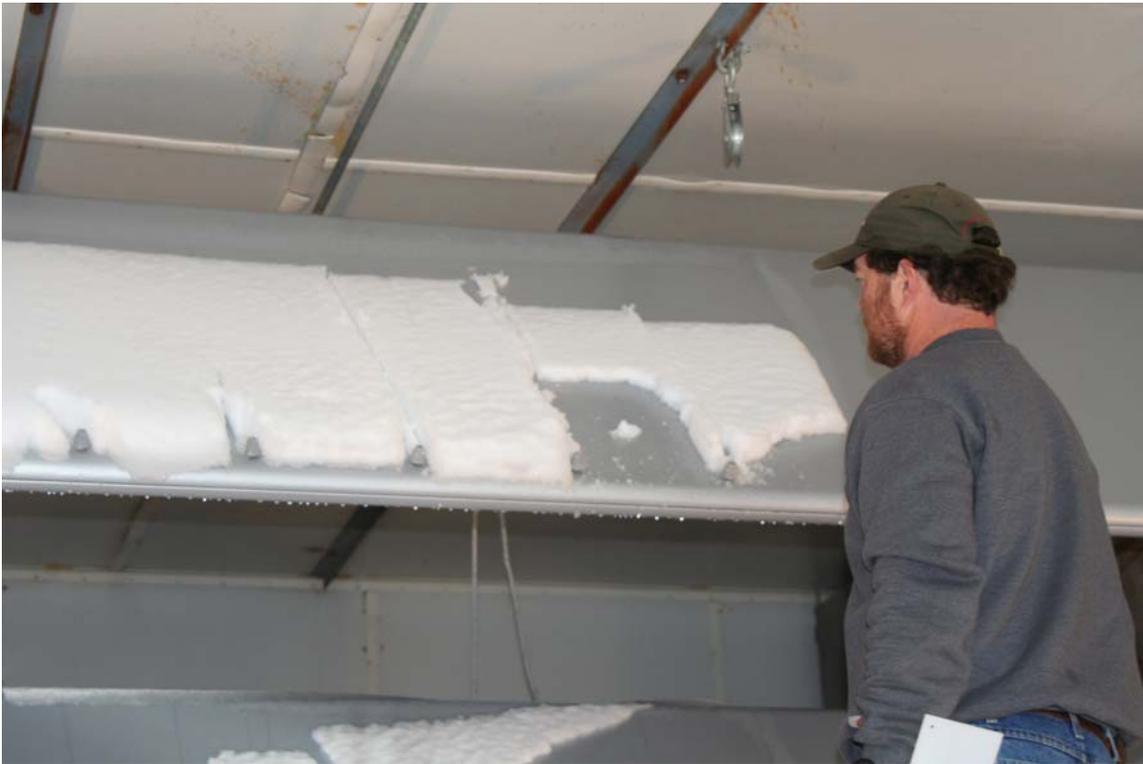
Figure 28. Separating the snow accumulation from the IRD to assess the size of the snow pieces falling off the fin.

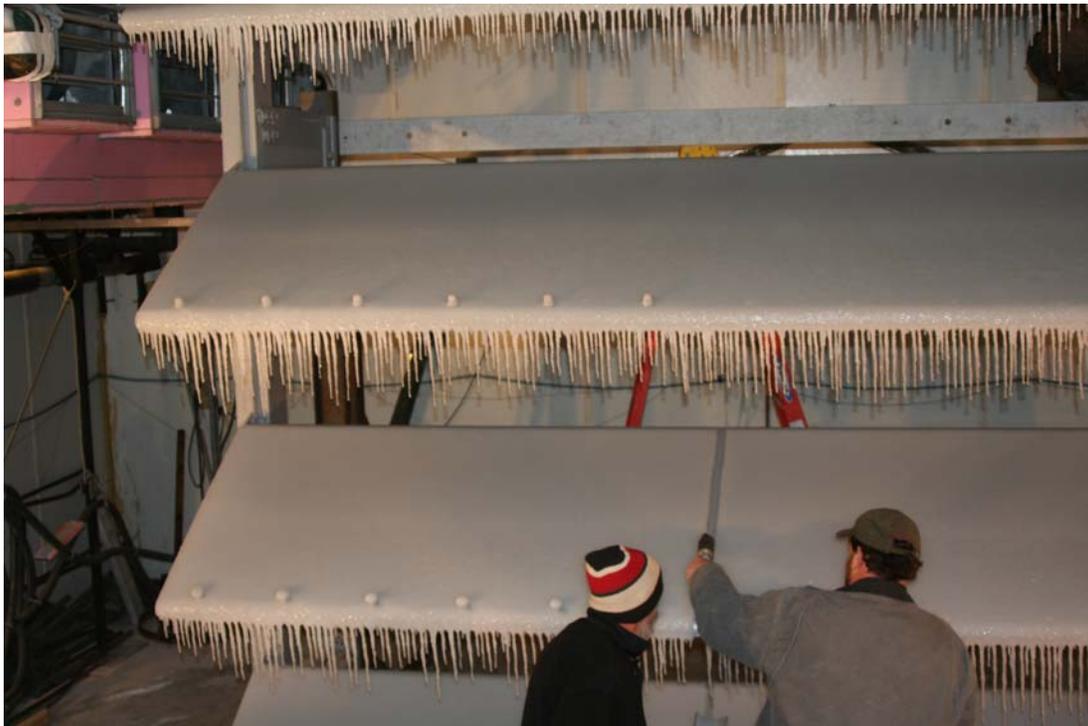
Figure 29. Initial condition for Test 5 with IRD option 4 installed on the A side of the fin. The B side is the standard, or control, fin.

IRD option 4 is a very simple device that is effective in stabilizing the accumulation without the limitations of the continuous IRDs. The consensus of the test team was that the buttons were the best alternative for retaining the ice. For the last test, the buttons were installed on the fins on the A side. The B side of the fin was the standard, or control, fin without any IRDs. The mock-up was covered in ice, varying in thickness from 3/8 to 1/2 inch. The initial conditions are shown in Figure 29 as the slot between the A and B sides is being deiced.

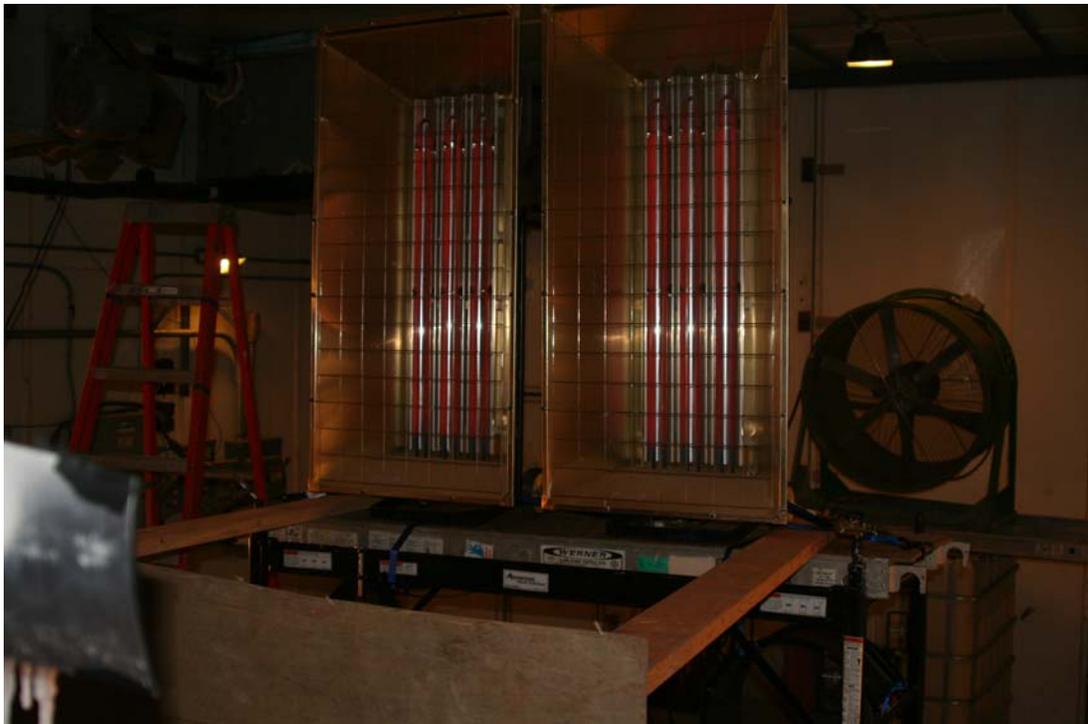
Figure 30. Using radiant heaters to simulate solar heating of the top fins (A3 and A4) while the bottom fins (A1 and A2) are shaded by the plywood.

The ramification of a heat source on the upper fins (e.g., an exhaust fan or solar heat) that melted the accumulation—with the melt water refreezing on the lower fins—was assessed in Test 5. Radiant heaters were used to heat the upper fins (A3 and A4) while the lower fins (A1 and A2) were shaded (Figure 30); the room was approximately 23°F. In the first phase, the heaters were cycled on until the water started dripping off the fins (approximately 15 minutes) then shut off to allow the melt water to refreeze (approximately 10 minutes). Seven cycles were conducted with melting on the upper fins and refreezing of the water on the shaded fins. In the second phase of testing, the heaters were moved away from the fins with the heaters on continuously for the next 6 hours while the room temperature was

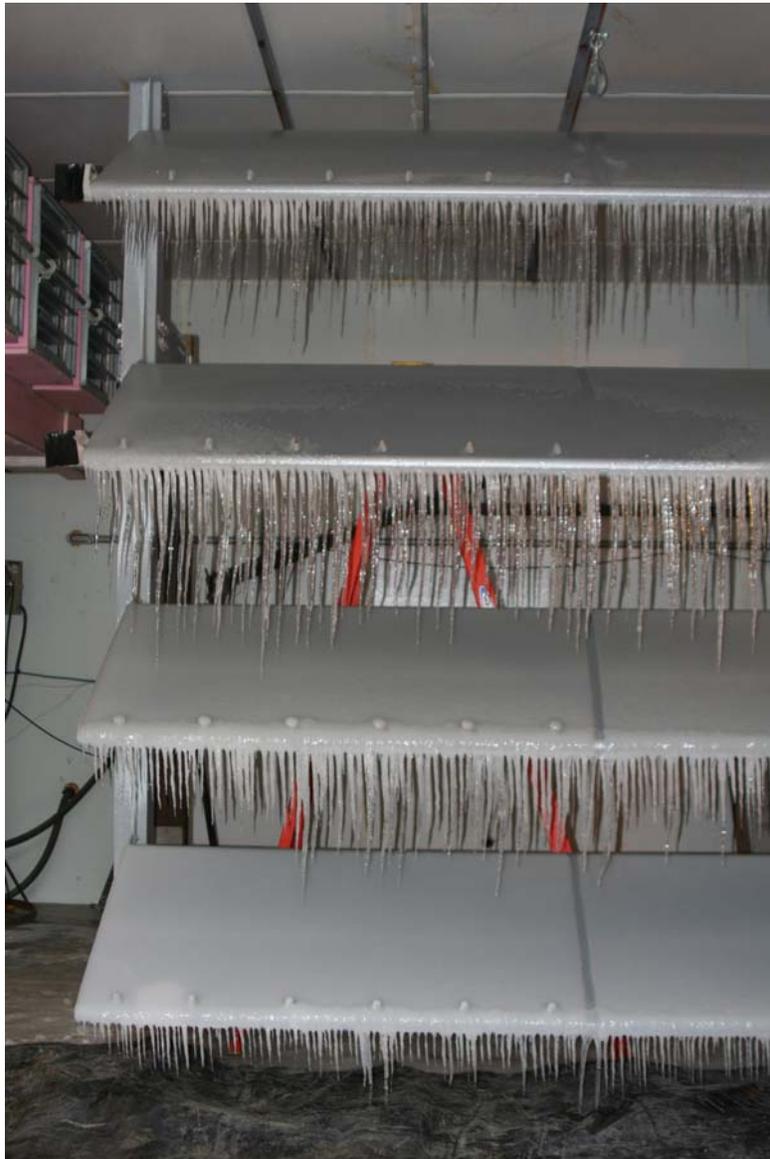
Figure 31. Icing conditions at the conclusion of heating fins A3 and A4 with radiant heaters while shading fins A1 and A2. The room temperature was approximately 23°F, and the melt water refroze on the lower panels.

maintained at 23°F. Ice conditions at the conclusion of phase 2 are shown in Figure 31. For phase 3, the refrigeration system was shut off and the ambient temperature was allowed to increase. A similar procedure was used in the previous tests. As in the previous test, the ice on the B side slid off as a sheet, while the ice on the A side melted in place. As shown in Figure 31, icicles will form and if they present a potential hazard they will have to be physically removed.

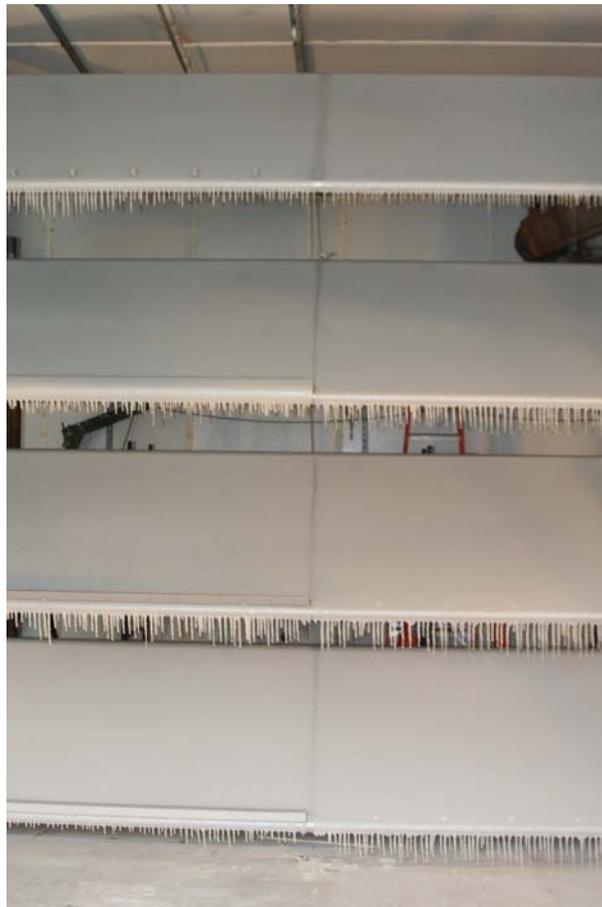
Figure 1.1. Initial conditions of fins with the vertical centerline deiced. The ice retention devices are installed on the A (left) side of the fins. The B (right) side is used as the control. IRD options 1, 2, 3, and 4 are installed on the A side of the fins, starting with option 1 on the bottom fin (A1) and progressing to option 4 installed on the top fin (A4).

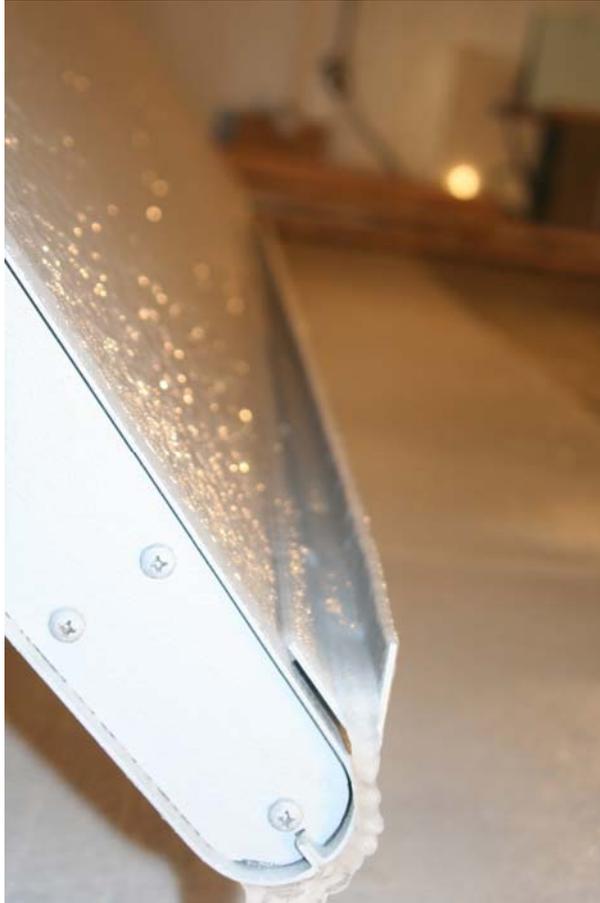
Figure 1.2. Fin A1 with IRD option 1 installed. Note the drainage paths are blocked with ice and the continuous IRD serves as a gutter.

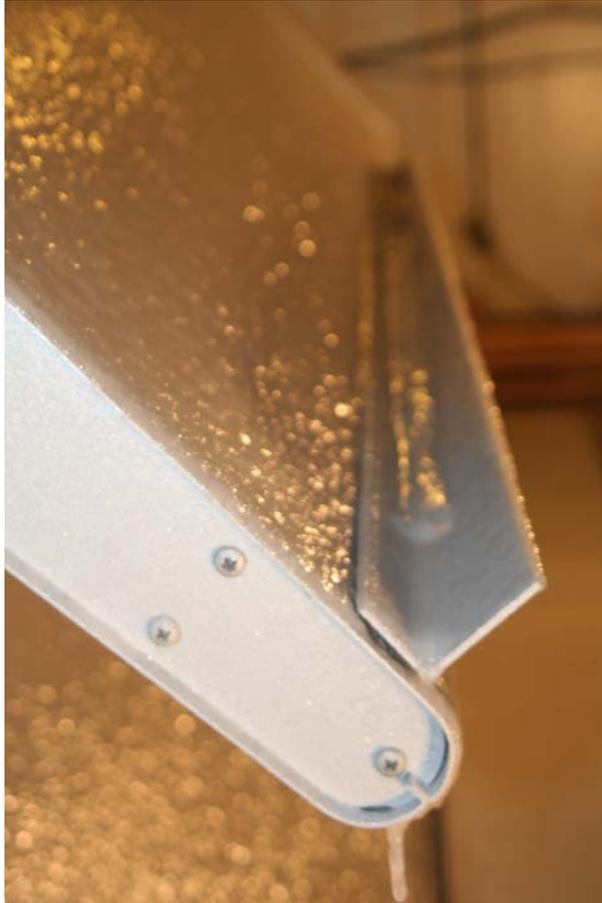
Figure 1.3. Fin A2 with IRD option 2 installed; the drainage paths are blocked with ice and the top edge of the IRD serves as a gutter.

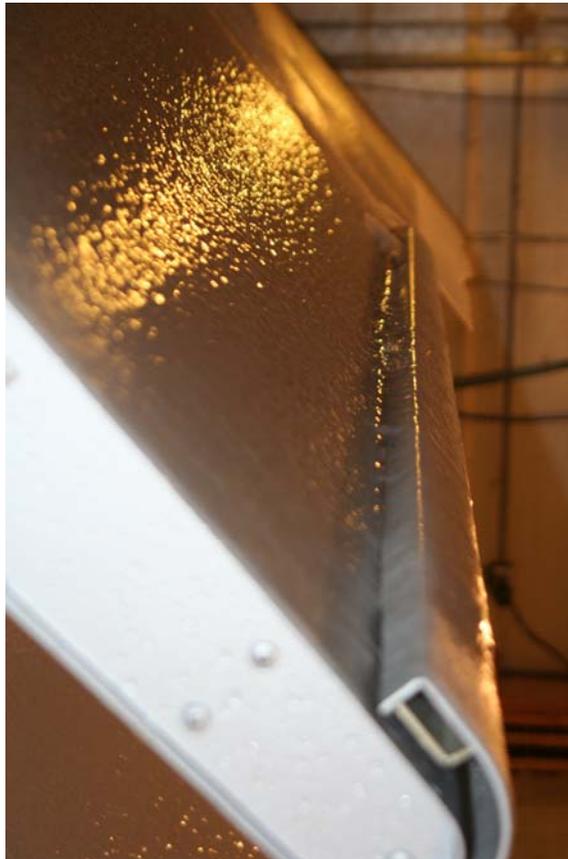
Figure 1.4. Fin A3 with IRD option 3 installed; the drainage paths are blocked with ice similar to Figures 1.2 and 1.3.

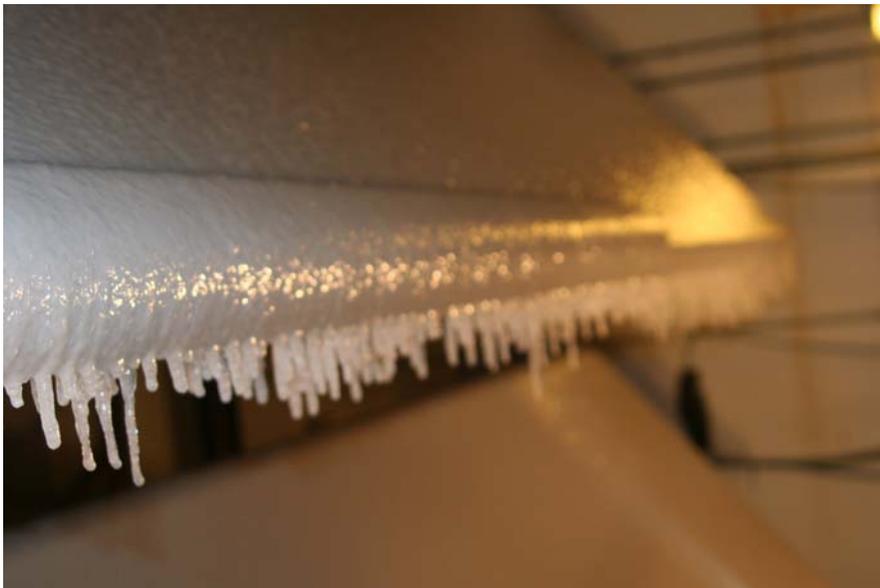
Figure 1.5. Leading edge of the fin A3 with IRD option 3 installed with the drainage paths blocked with ice as shown in Figure 1.4; water is running over the top and freezing.

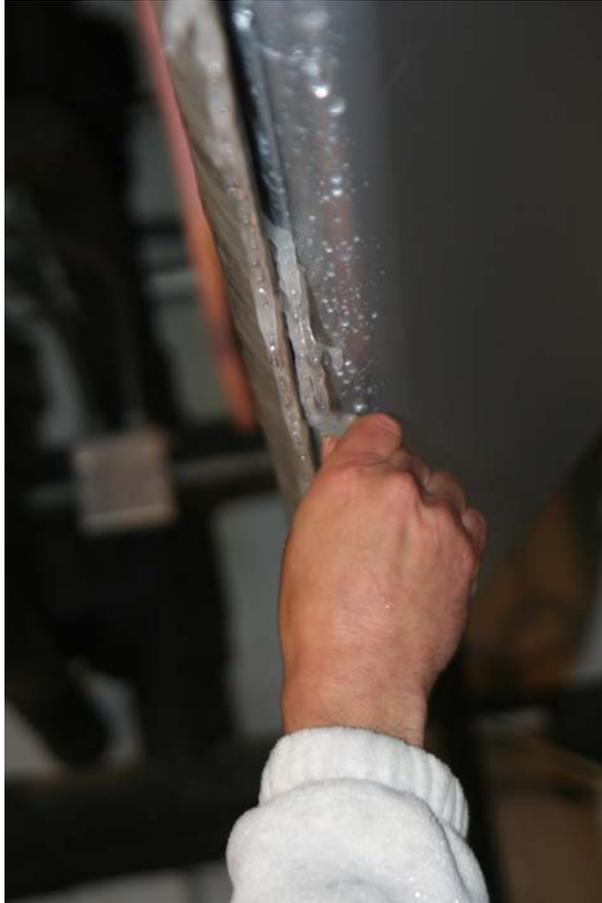
Figure 1.7. Removing the securely anchored icicles from the gap between the fin and IRD option 3 on fin A3 as the ice is melting.

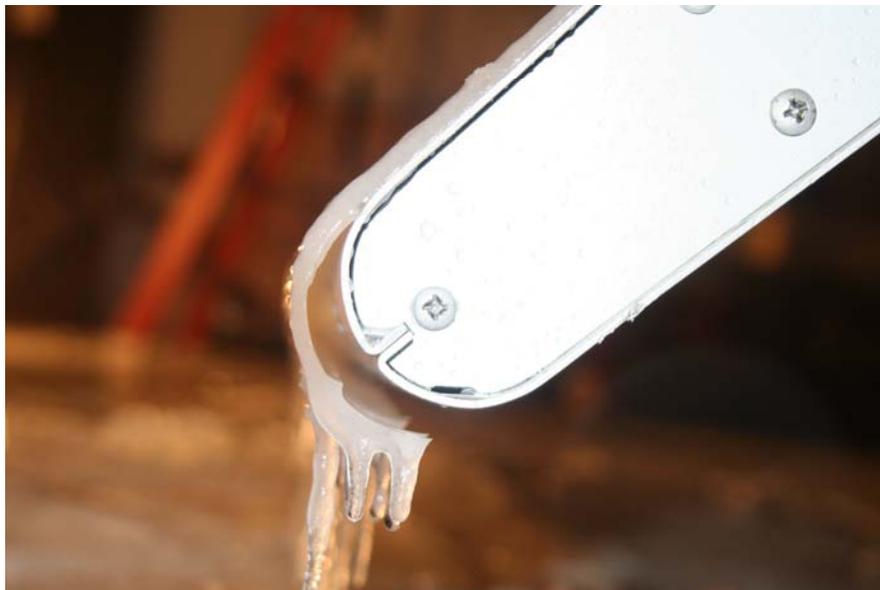
Figure 1.9. The ice sheet starts to slide off fin B1.

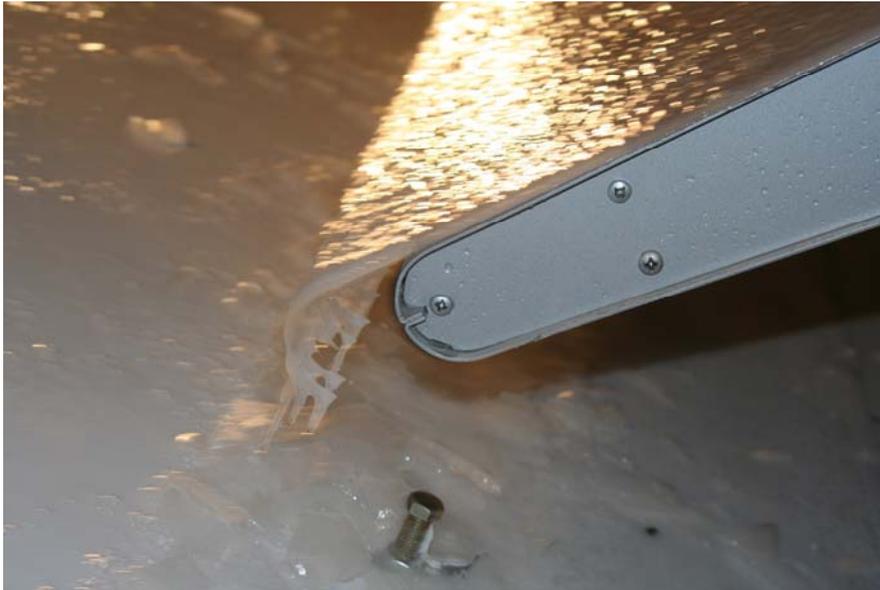
Figure 1.10. The ice sheet continues to slide off fin B1, photograph taken 3 minutes after Figure 1.9 above.

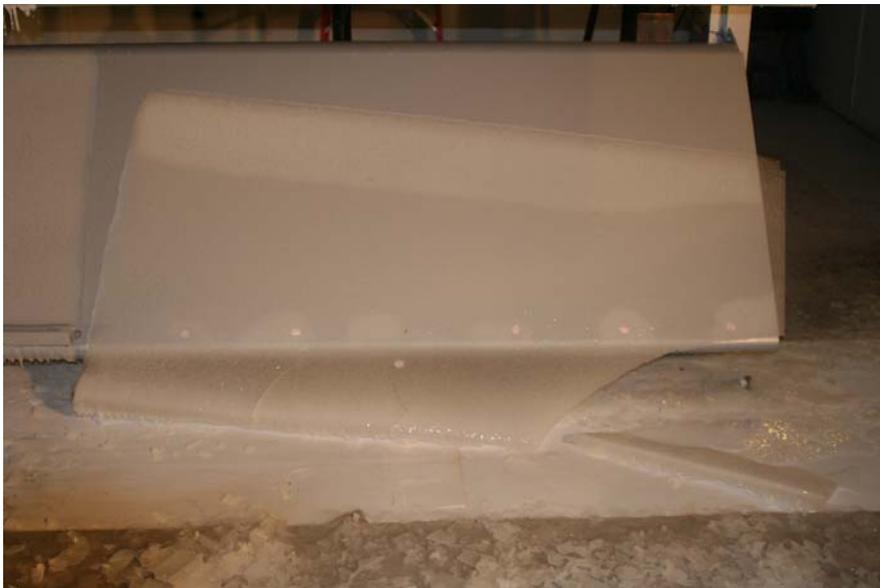
Figure 1.11. The ice sheet sliding off fin B1, 5 minutes after the photograph in Figure 1.9.
