**US Army Corps
of Engineers®**
Engineer Research and
Development Center

Laboratory Testing of Architectural Exterior Wall Fins

Abstract: Ice and snow accumulation sliding from the exterior wall fins installed on the New Meadowlands Stadium in New Jersey, future home field for the New York Jets and New York Giants football teams, was recognized as a potential hazard to pedestrians. The objective of this test program was first to determine if the hazard existed with the standard fin and secondly to evaluate the performance of four ice retention devices (IRDs). A mock-up was assembled using four fins in a vertical stack with different angles. Four IRDs were tested: three were continuous strips and the fourth was a truncated cone attached to the fin at 12 inches on centers. The IRDs were mounted along the lower edge of the fin. To provide water drainage, all the IRDs were spaced off the fin using 3/16-inch plastic spacers. To assess the effectiveness of the IRDs under similar conditions, IRDs were only installed on the fins on the left side of the mock-up while the right side, or standard fin, was used as a control.

Project title and number: Evaluation of Sun Control Fins in Snow a

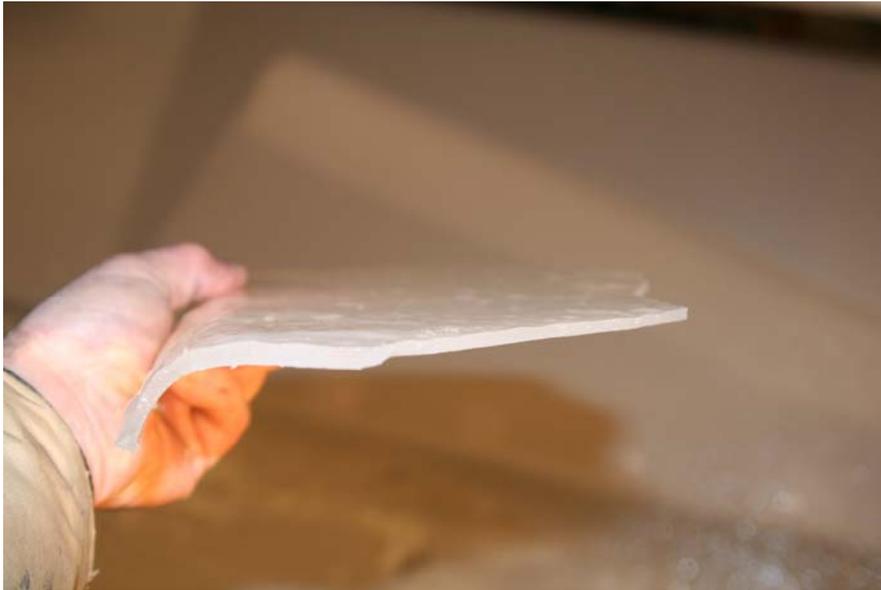
Figure 1.12. Piece of ice from fin B1.

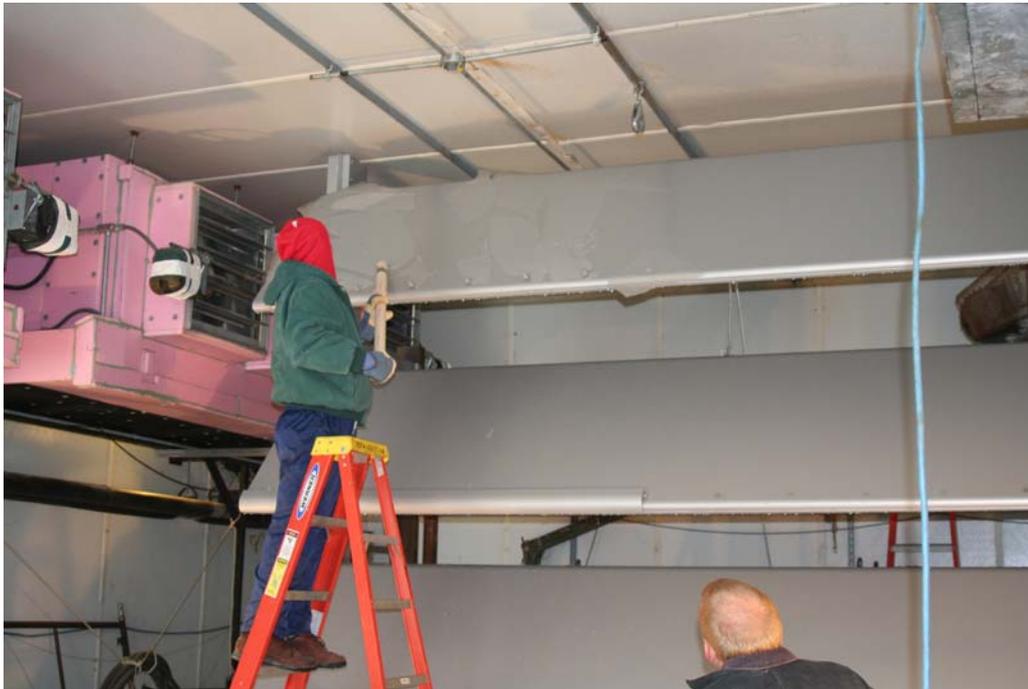
Figure 1.14. Manually removing the ice above the IRD on fin A4 is a very labor-intensive process.

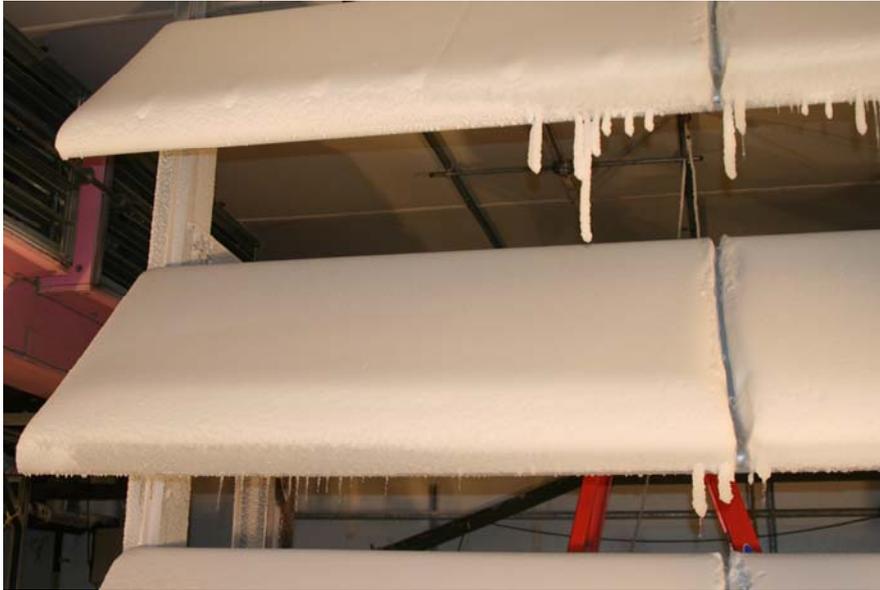
Figure 2.1. The initial condition of the top fins with the vertical centerline deiced. IRD option 4 is installed on the left side the top fin (A4), and the right side (B4) is used as the control. IRD option 3 is mounted on the left side of the lower fin in the photograph (A3) while the right side (B3) is used as a control.

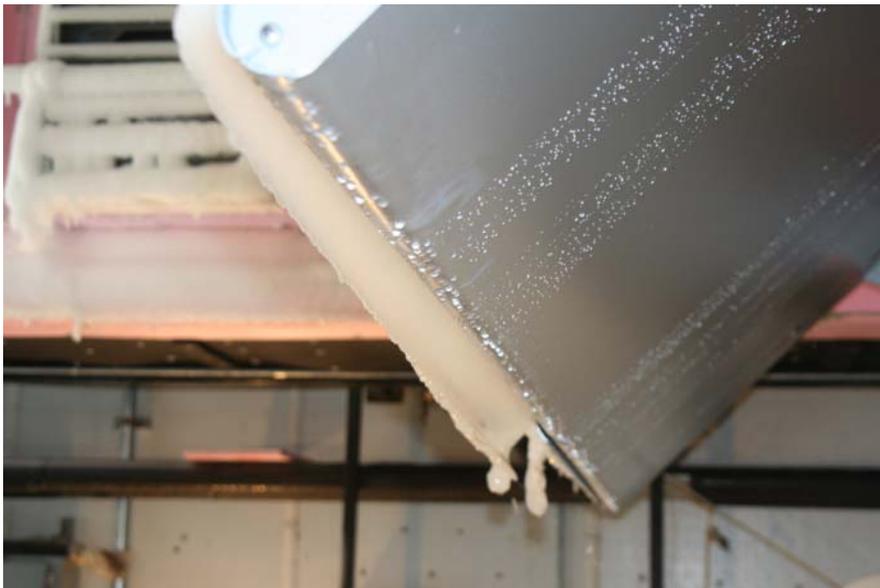
Figure 2.2. Underside of fin 3 with the ice sliding off the near side (B3) and while the ice is retained by IRD option 3 installed on the far side. The drainage path under IRD option 3 appears to be open on the bottom.

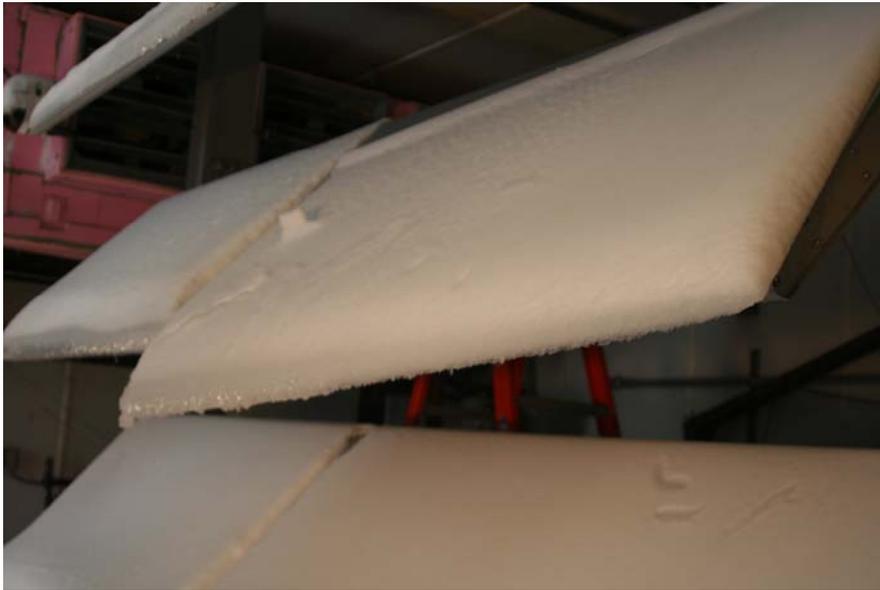
Figure 2.3. Snow is sliding off in mass on the right side of the fin (B3) while being retained by IRD option 3 on the left side (A3).

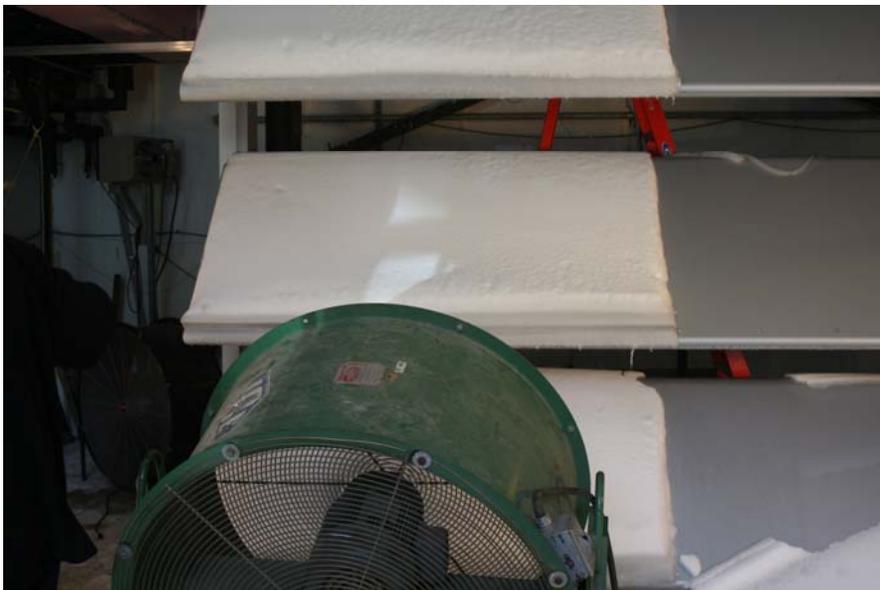
Figure 2.4. Fins on the A side of the mock-up are subjected to wind. Note that the snow slides off the fins on the B side of the mock-up.

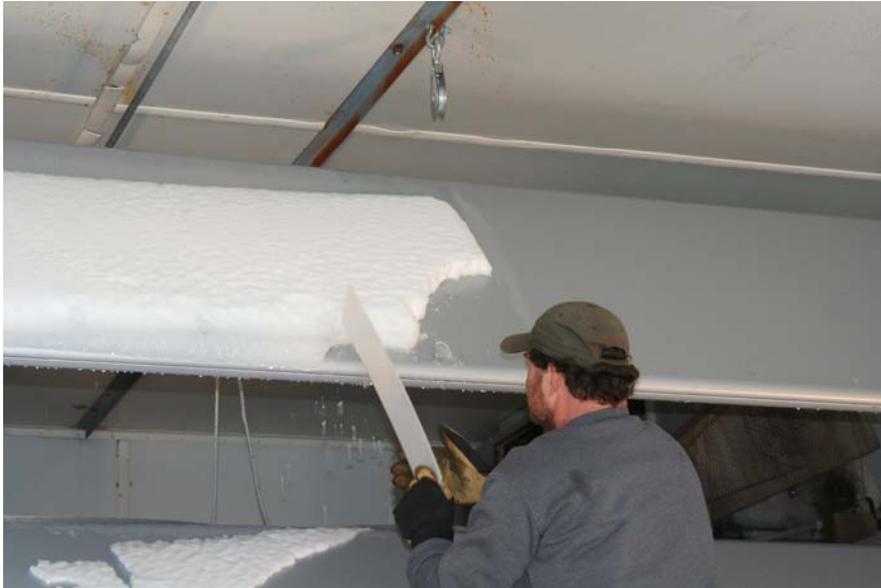
Figure 2.5. Testing the effectiveness of IRD option 4 by separating the snow from the IRDs.

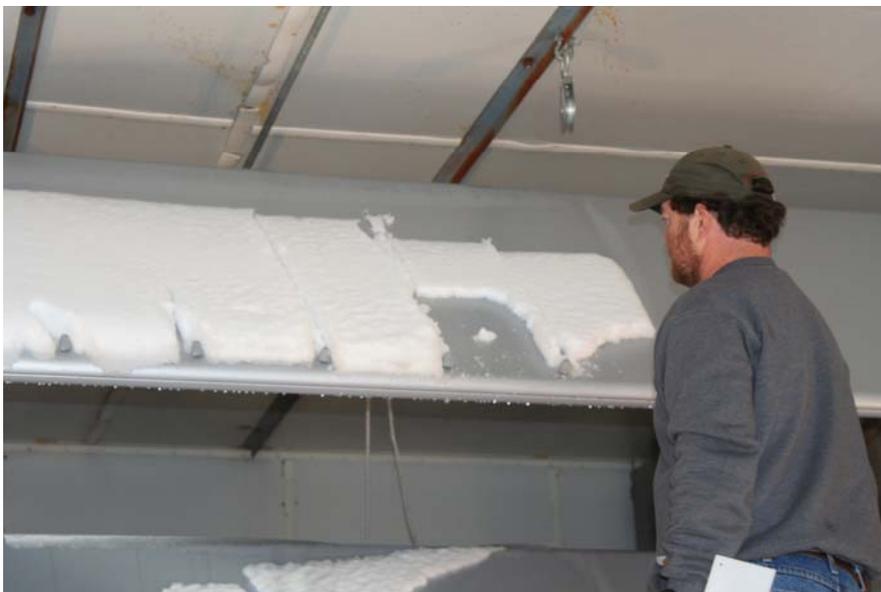
Figure 2.6. Snow can slide between IRD option 4, confirming that the IRD retains the snow.

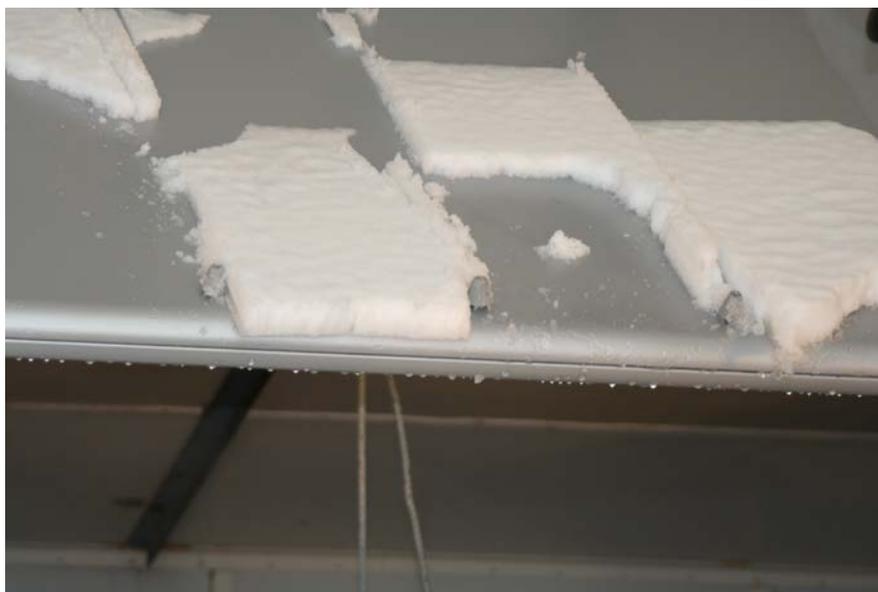
Figure 2.7. Sliding snow engages with IRD option 4 on fin A4. The width of snow pieces falling from A4 should be controlled by the spacing of IRD option 4 and the length of the pieces, limited by the bending strength of the snow cantilevering off the fin.

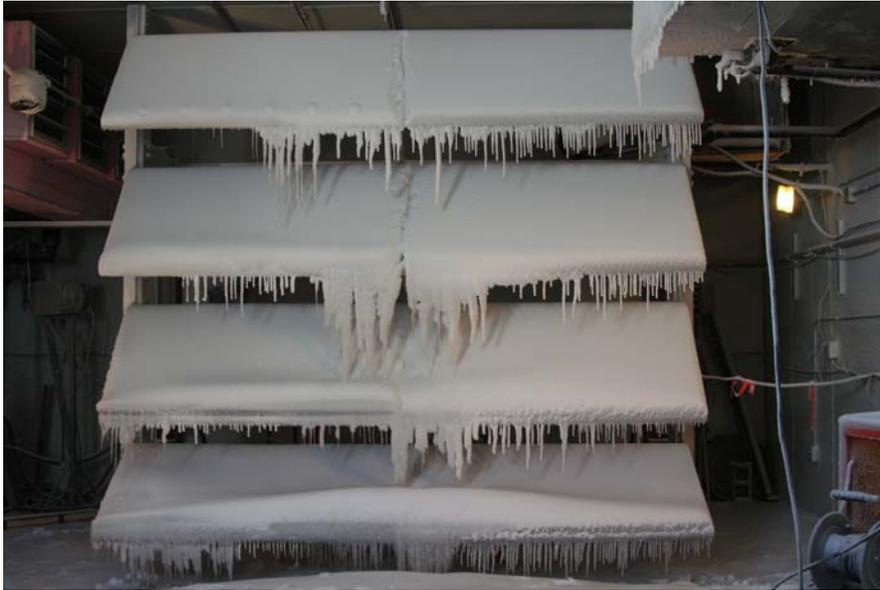
Figure 3.1. Initial condition of mock-up covered in snow and ice of varying thickness from 2.5 to 7 inches. IRDs are installed on the A, or left, side of the fin. The B, or right, side without the IRDs is used as the control. Fins are in configuration 3, i.e., top three fins are at 50° and the bottom fin is at 30°.

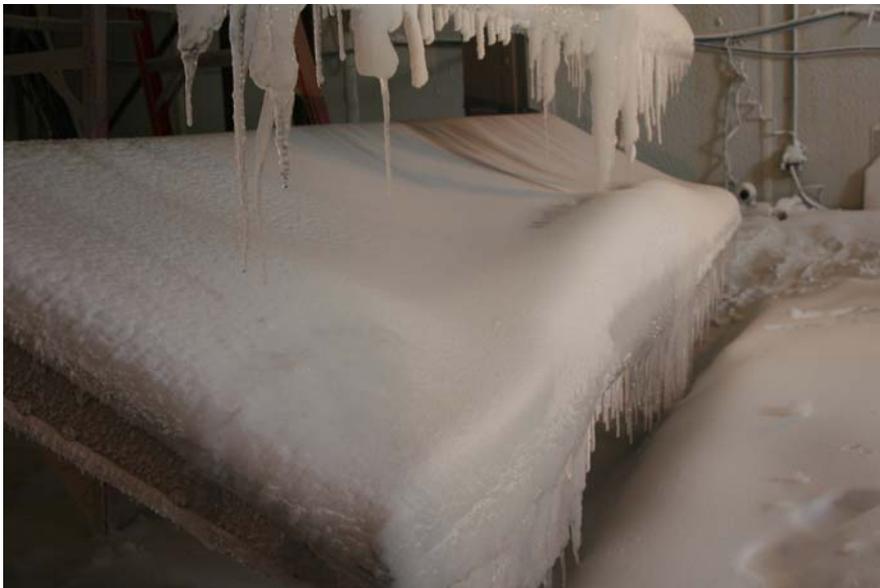
Figure 3.2. Initial condition of the bottom fin 1. IRD option 1 is on the near side (A1) and the control fin (B1) is on the far side.

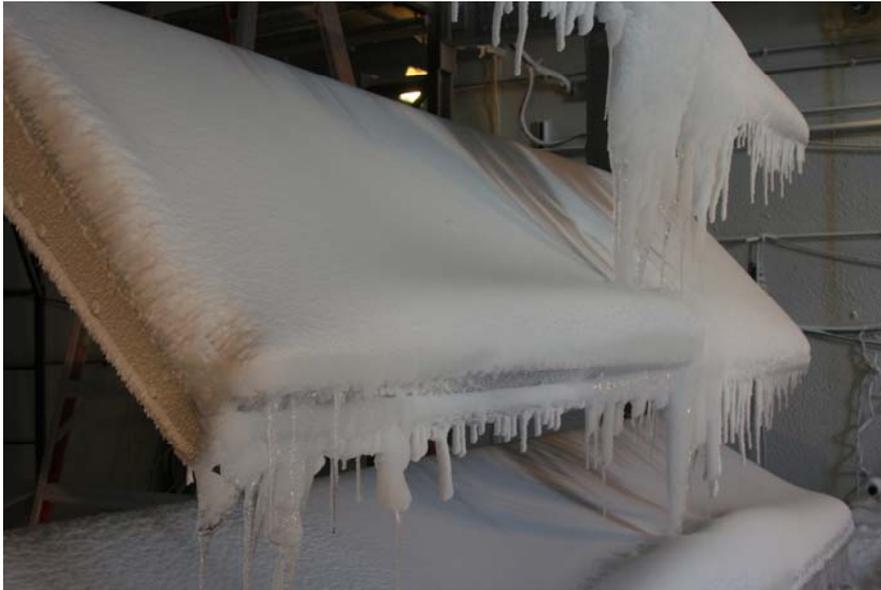
Figure 3.3. Initial condition of fin 2 with IRD option 2 on the left (A2) and the control (B2) on the right side of the photograph. Note the exposed bottom edge of the IRD that could be deiced by solar heating and subsequent shedding of the icicles.

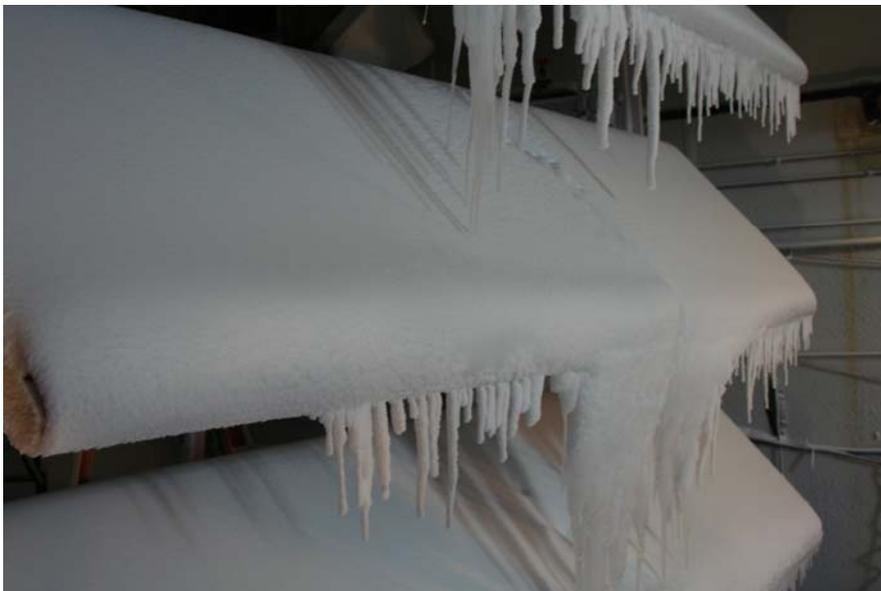
Figure 3.4. Initial condition of fin 3 with IRD option 3 on the A (left) side and the control on the B (right) side.

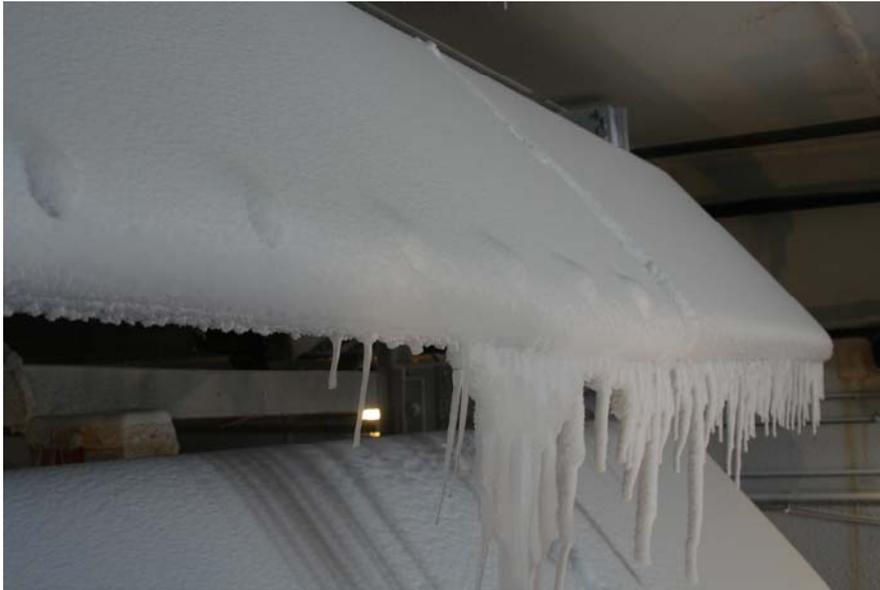
Figure 3.5. Initial condition of fin 4 with IRD option 4 on the A or left side (A4) and the control on the B or right side (B4).

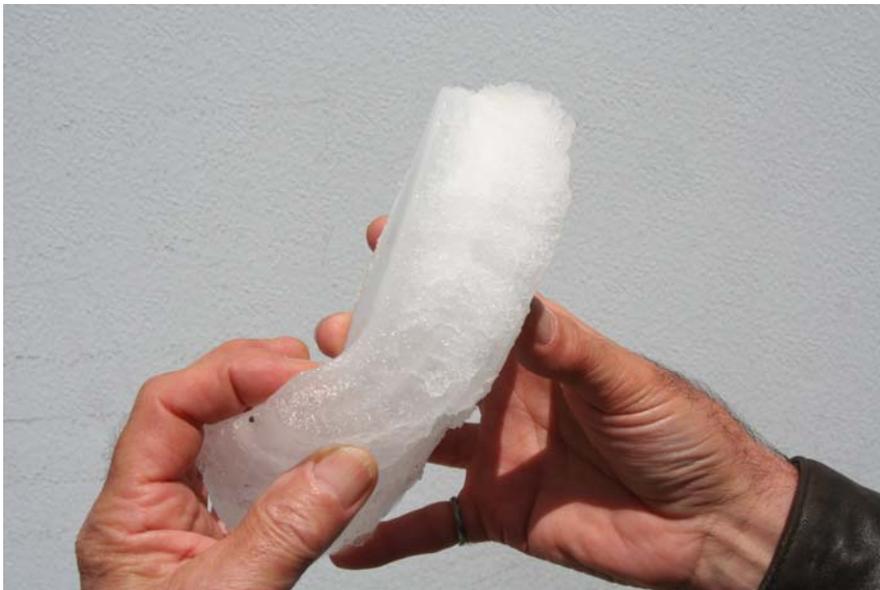
Figure 3.6. Cross section of ice that fell off fin B4. Note the layering of ice and snow, typical of a wet snow.

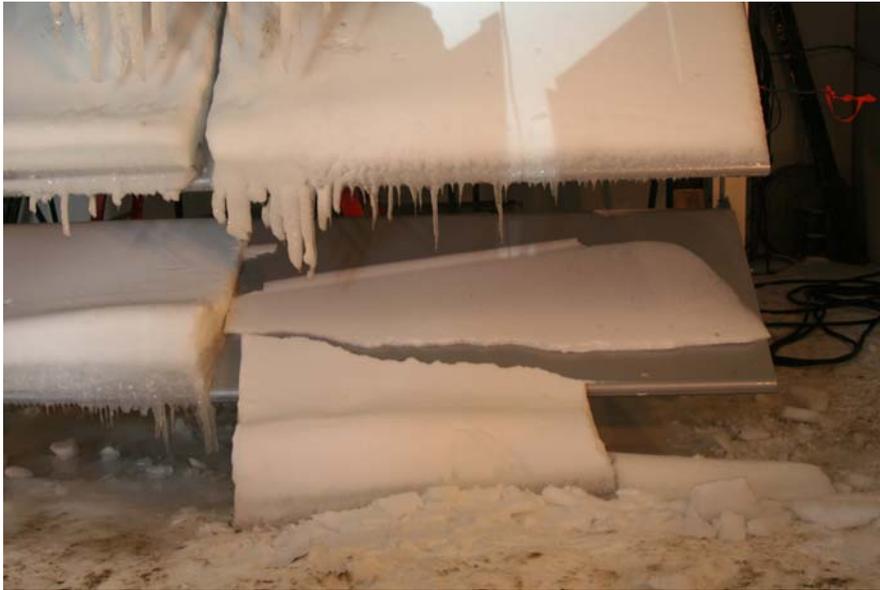
Figure 3.7. Snow sliding off fin B1. Note the size of the snow/ice block and the exposed cross section of the accumulation still on fin A1.

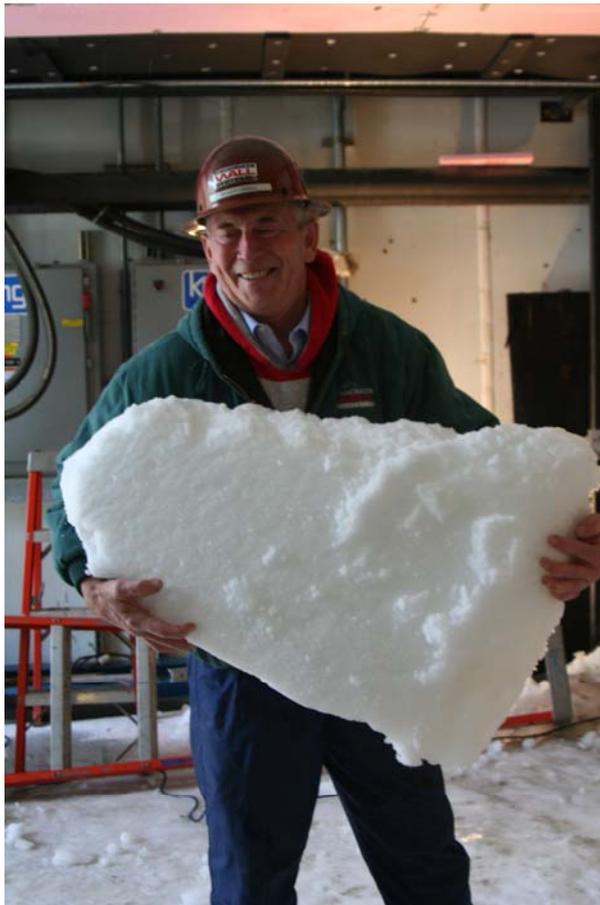
Figure 3.8. Piece of ice that fell off the control fin B3.

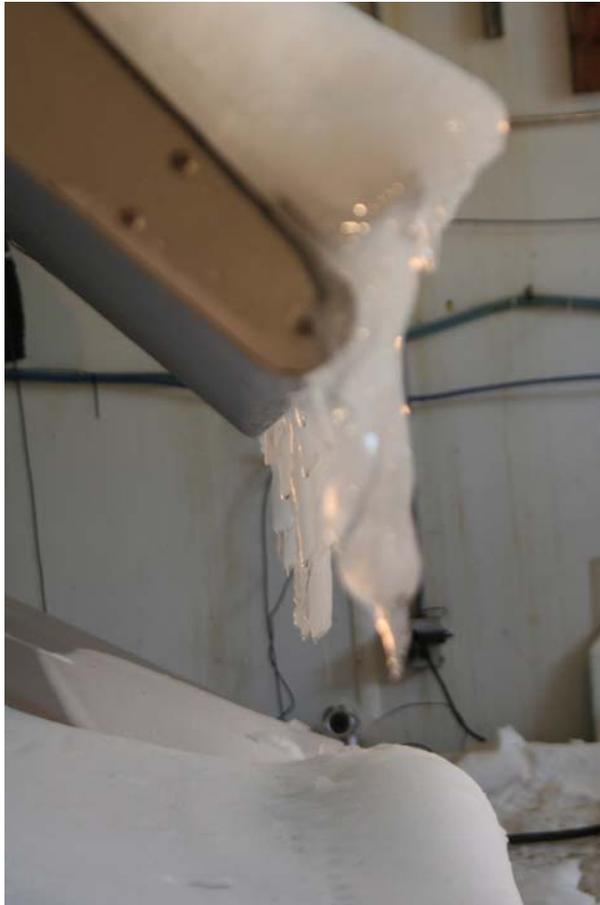
Figure 3.9. Melt water dripping off fin A2 at 50° onto the fin A1 at 30°. The concern was that the bottom fin extended beyond the edge of the upper fins due to the shallower angle. Melt water from the upper fins accumulated on the lower fin resulting in an excessive accumulation on the lower fin. As observed in the previous tests, the drip lines are uphill from the IRD. It was concluded that mixing the fin's slopes does not significantly change the size of the accumulation on the lower fin.

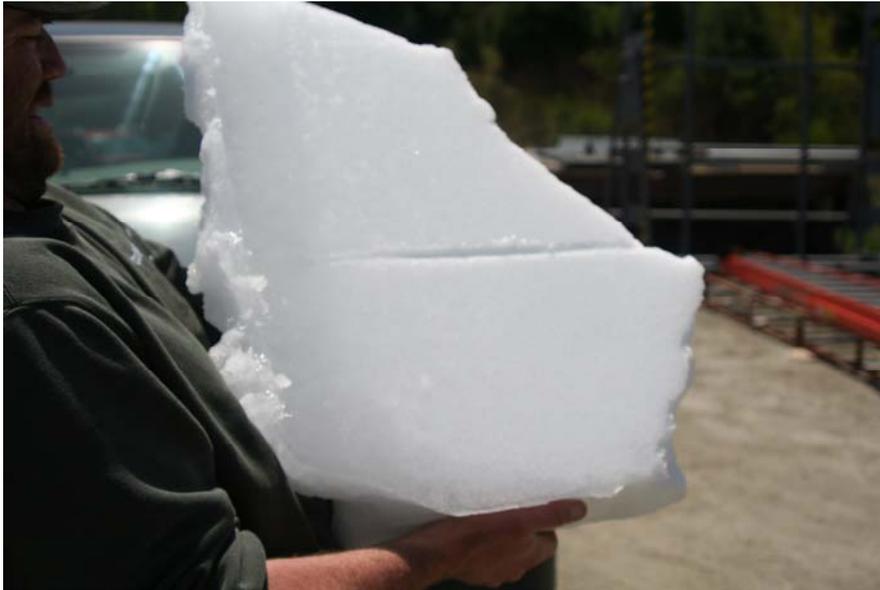
Figure 3.10. Piece of ice from fin B3. Note the scratch in the bottom of the piece that runs from the bottom of the fin on the left toward the top of the fin on the right.

When the IRD were removed from the B side of the fins, the metal skin had holes from the attachment screws, and a few holes had an upward dimple around the edge. To prevent the water from getting into the fins, the holes were covered with a 1-inch-diameter patch made from silver tape. During this test we observed that the dimples provide some mechanical locking between the ice/snow accumulation and the fin. In other words, the accumulations would slide off standard fins easier than observed in these tests (see Figures 3.10 and 3.11).

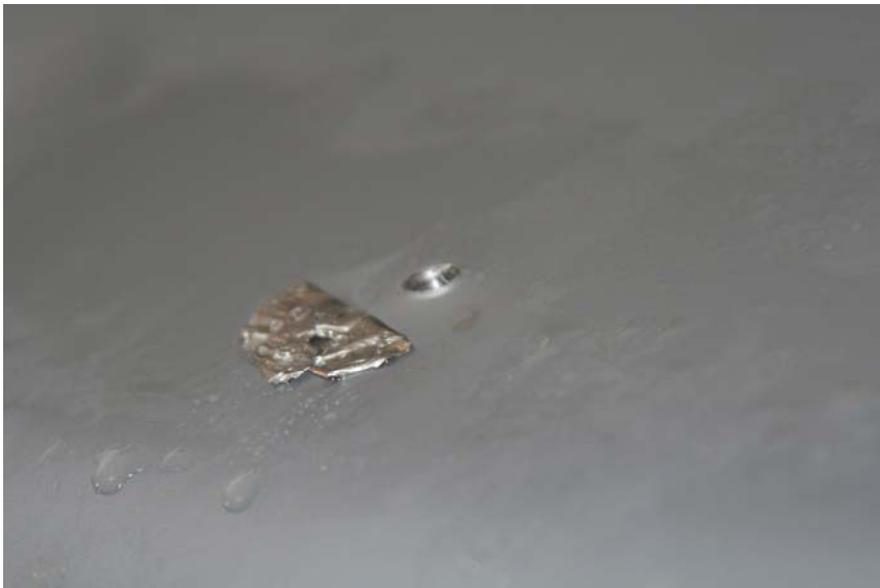
Figure 3.11. The mock-up arrived at CRREL predrilled for the IRDs along the bottom edge of the fins. To minimize the test matrix and compare IRD performance with control fins with similar accumulations, the IRDs were installed on the left or A side of the fin. The attachment holes were covered on the right or B side with 1-inch-diameter patches of foil tape. This particular hole was slightly dimpled, providing a mechanical lock for the snow as evidenced by the scratch in the piece of snow shown in Figure 3.10. The dimple may have impeded the ice shedding process during this study compared to a standard fin, reinforcing the need for IRDs.

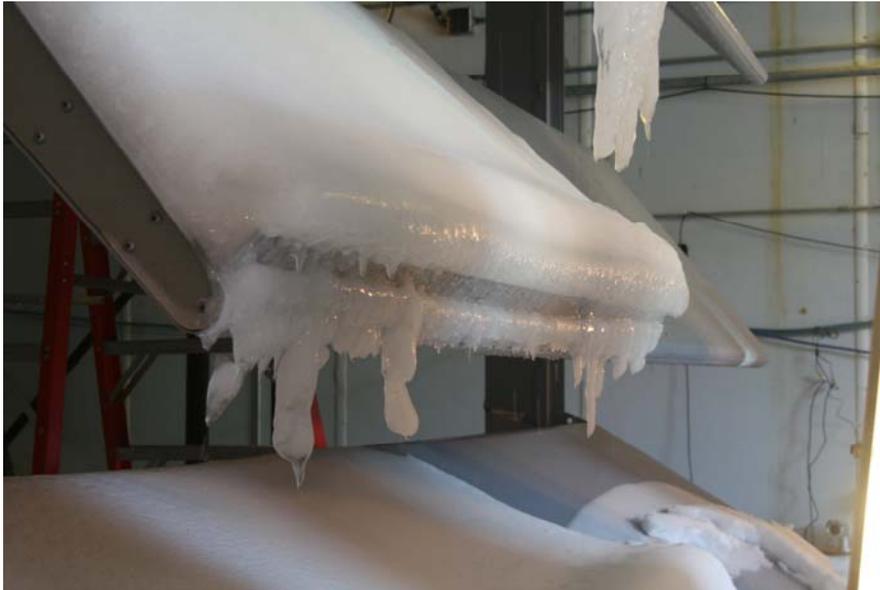
Figure 3.12. The question was raised regarding the icicle shedding process if the IRD were exposed to the sun, in particular IRD option 2 installed on fin A2. The exposed metal would conduct the solar heat, melt the anchor points for the ice, and subsequently large icicles could fall.

It was obvious that the barrier IRDs (i.e., options 1, 2, and 3) would retain the accumulations on the fins. The question was raised whether the icicles and ice on the lower edge of the fin would fall off if the exposed edges of the fin and IRDs were exposed to solar heating. IRD options 2 and 3 were of particular concern, considering that the exposed metal of the IRD would heat up and melt the adhesion (see Figure 3.12). Radiant heaters were used to simulate solar heating of the edge of the A1 and A2 fins as shown in Figure 3.13. Although the ice melted off the IRDs, the icicles remained anchored to the fin via the ice frozen in the drainage paths under the barriers. In this particular test, the icicles melted in place.

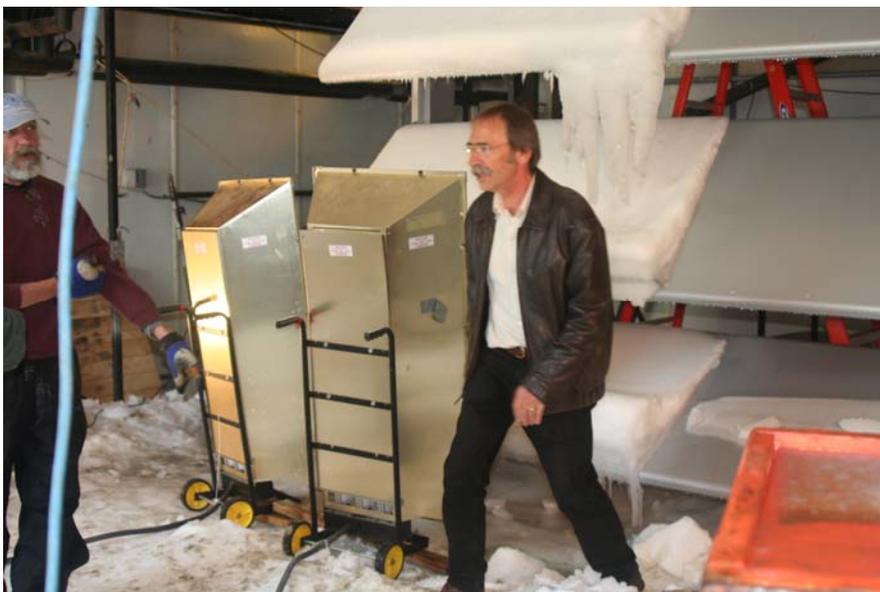
Figure 3.13. Radiant heaters are directed to the leading edges of fins A1, A2, and, to some extent, A3 to evaluate the effect of solar heating on the ice shedding process.

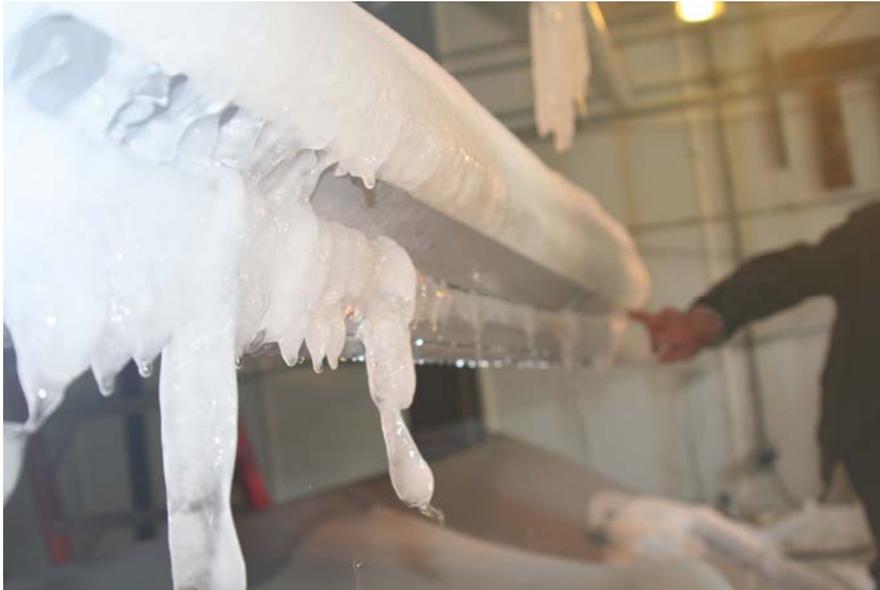
Figure 3.14. Exposed IRD option 2 on fin A2 following exposure to a radiant heater. The icicles melted before the ice in the drainage path anchoring the icicles started melting. In this particular test, the icicles melted in place.

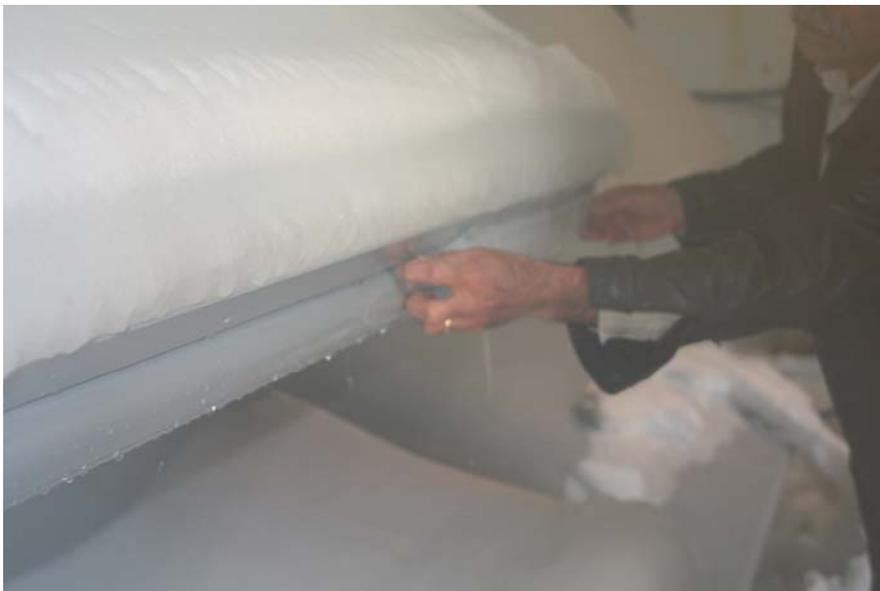
Figure 3.15. Lower edge of fin A2 and the remaining ice is firmly anchored by the ice in the drainage paths.

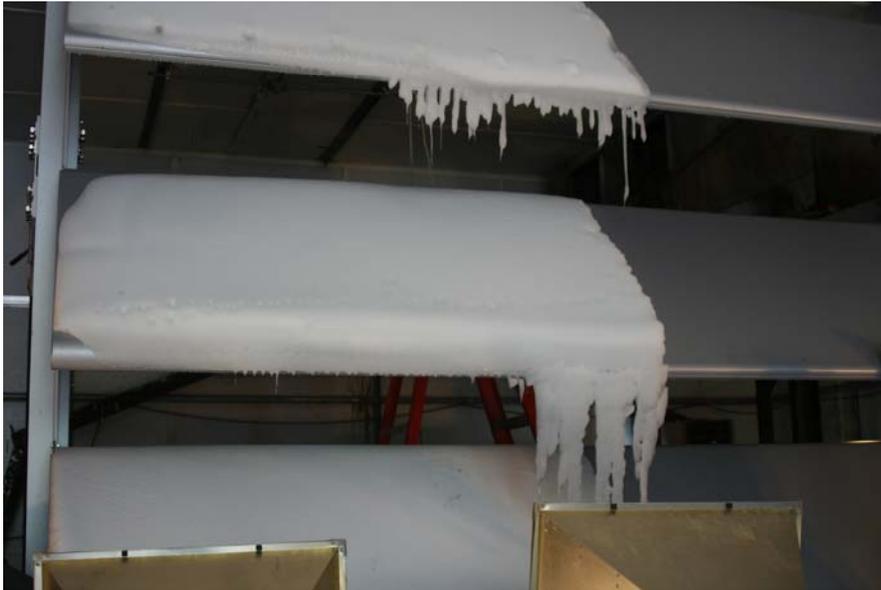
Figure 3.16. Condition of fins A3 and A4 after several hours of melting by ambient temperature and radiant heaters.

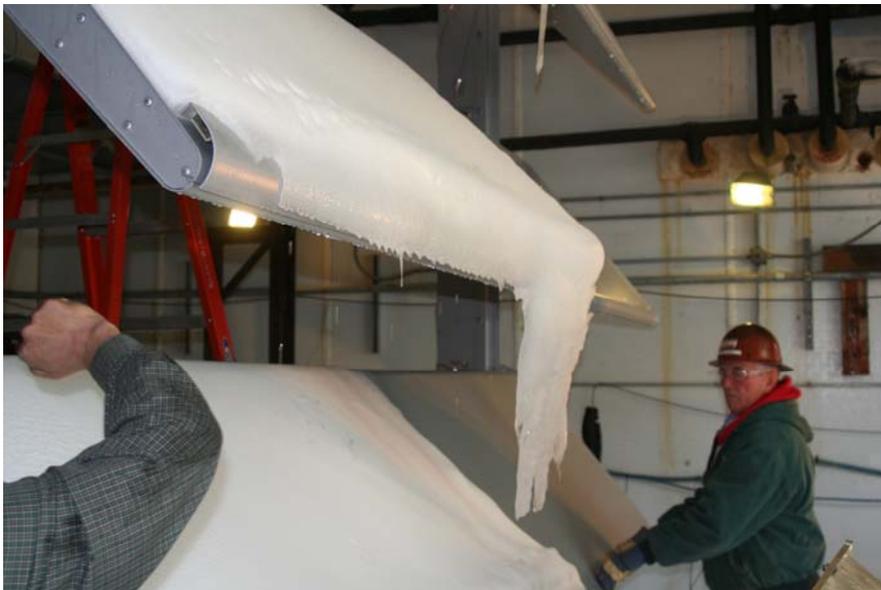
Figure 3.17. Even after vibrating the fins, the ice remains attached to the outer surface of fin A3 with IRD option 3.

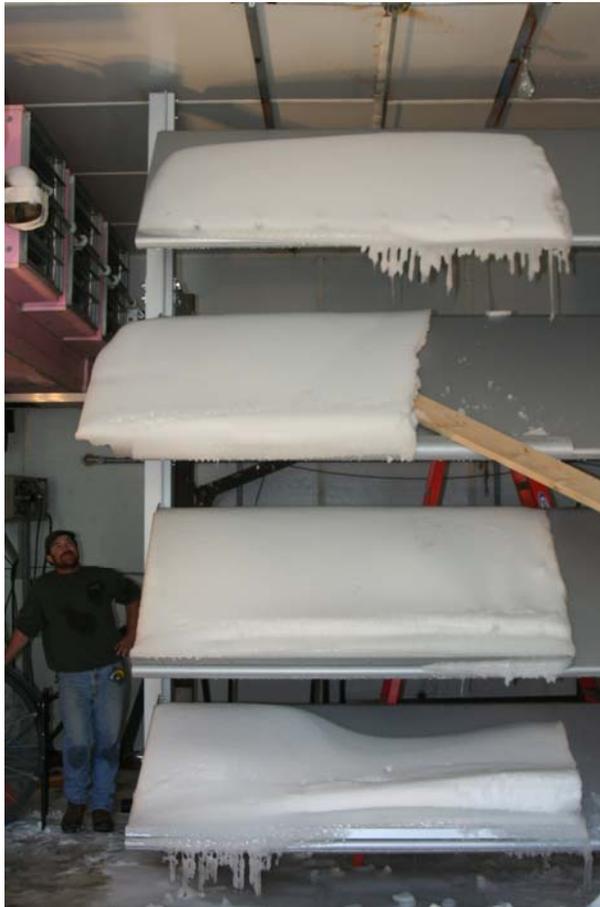
Figure 3.18. Snow mass can be pushed off the end of the fin, providing confidence that the IRDs retain the accumulation in place.

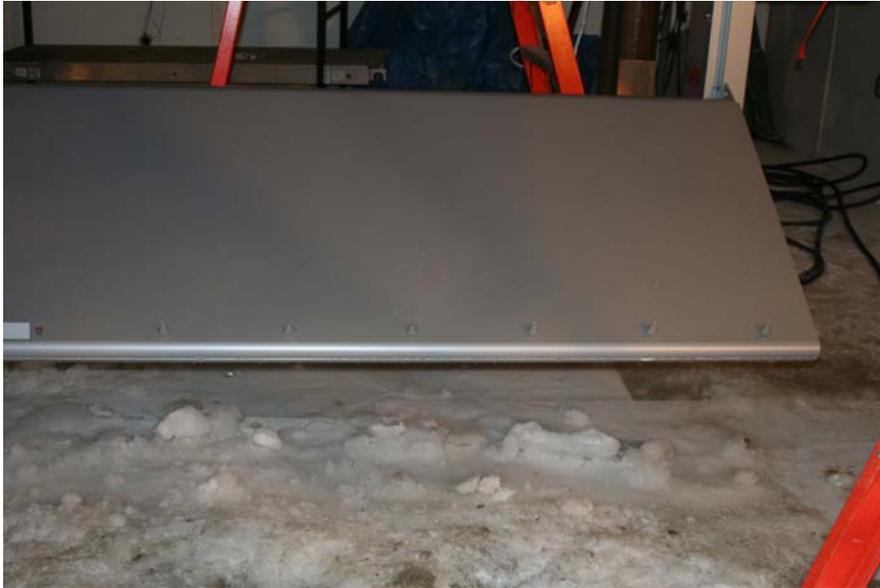
Figure 4.1. IRD option 4 installed on fin B1 before icing.

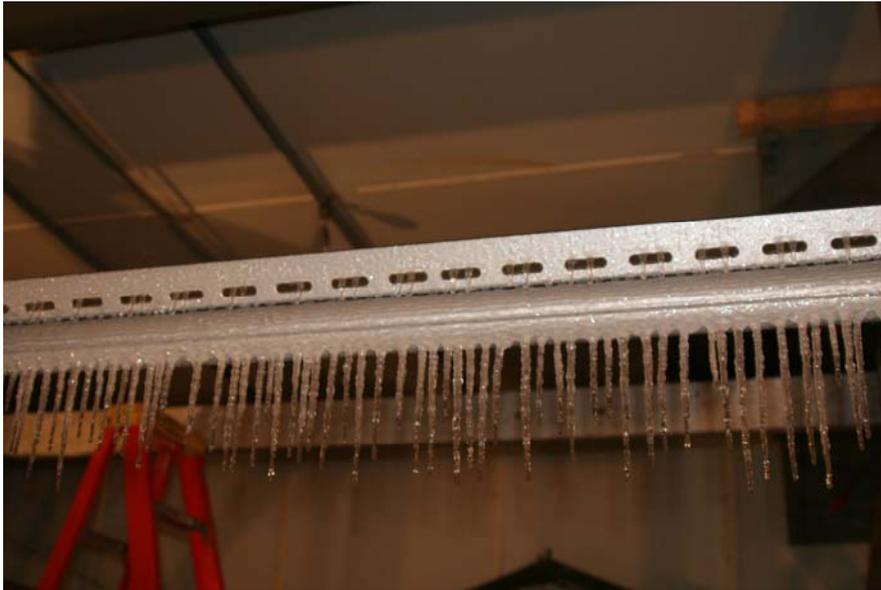
Figure 4.3. Condition of IRD option 3b (1/2- x 2-inch slots 3 inches on centers) on fin B3 after 40 minutes of icing.

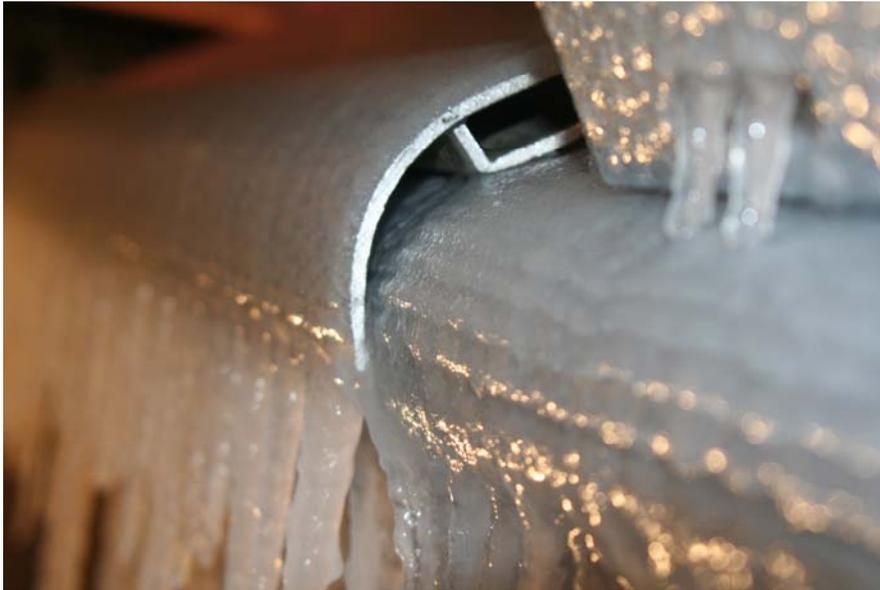
Figure 4.5. Icing of fin 3 after an hour of icing; option 3 is on the left (A3) and option 3b (B3) is on the right. With both IRDs, drainage paths are freezing. Water is flowing over the top of A3, and the slots in option 3b (B3) are starting to be plugged.

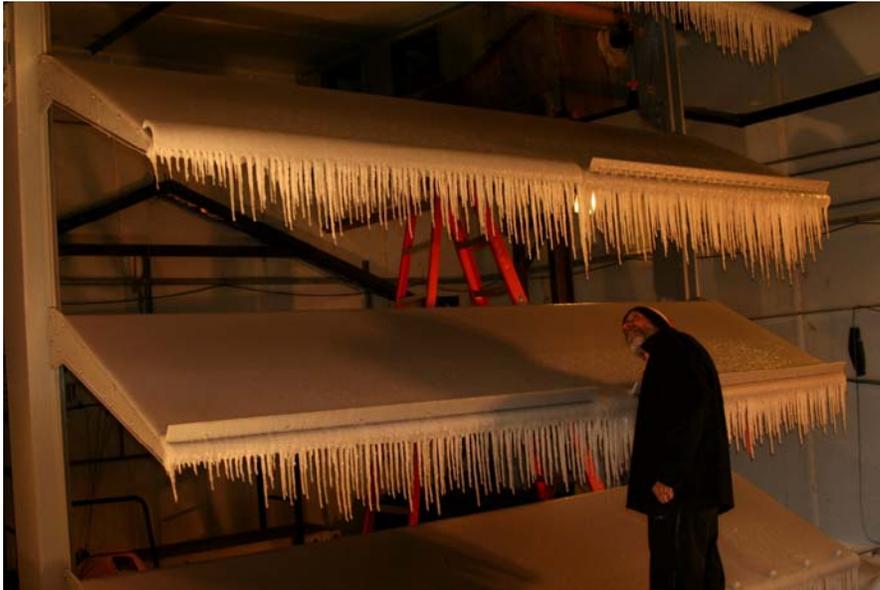
Figure 4.7. Icicles on fins 2 and 3 after 70 minutes of icing. Note the size of the icicles in the center of the fins.

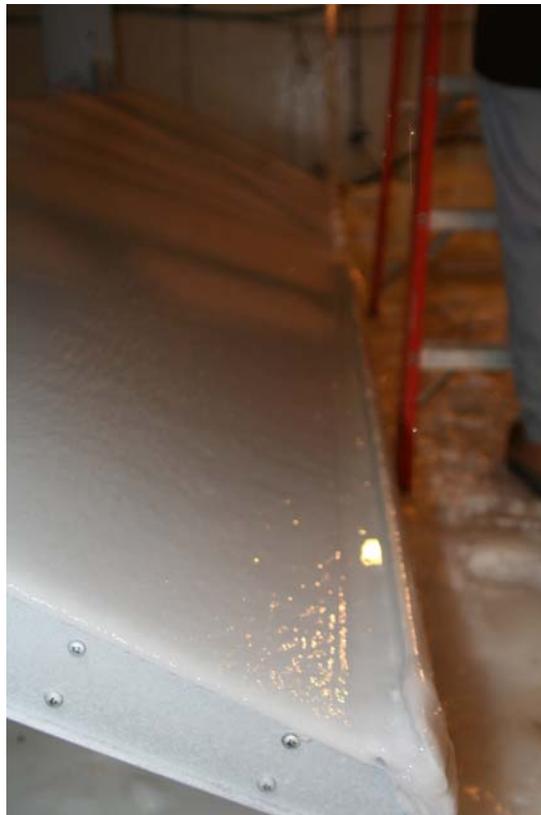
Figure 4.8. The drainage paths are frozen and the water is collecting and freezing behind IRD option 1 on fin A1.

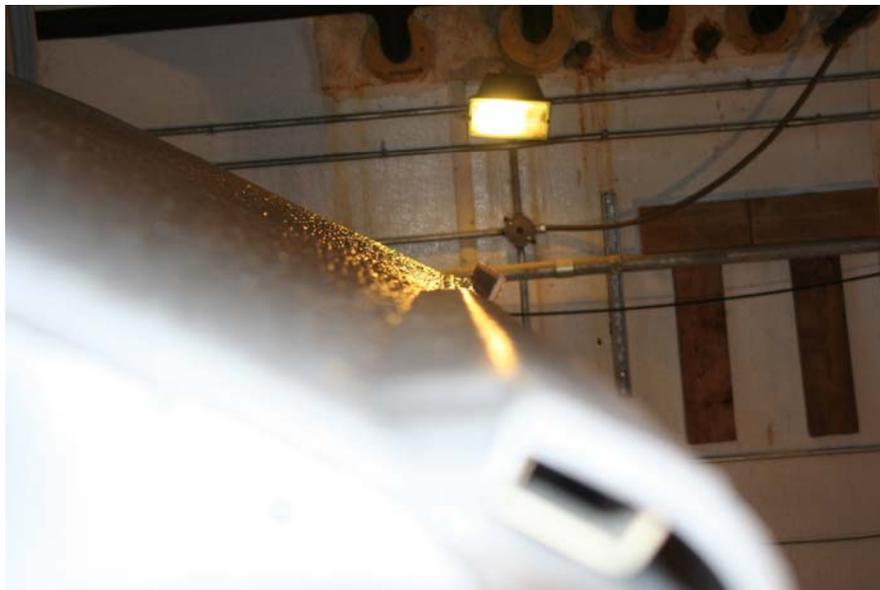
Figure 4.10. Sufficient water collected behind IRD option 3 to fill the gutter, and water is run over the front surface of the IRD forming icicles on the outer surface.

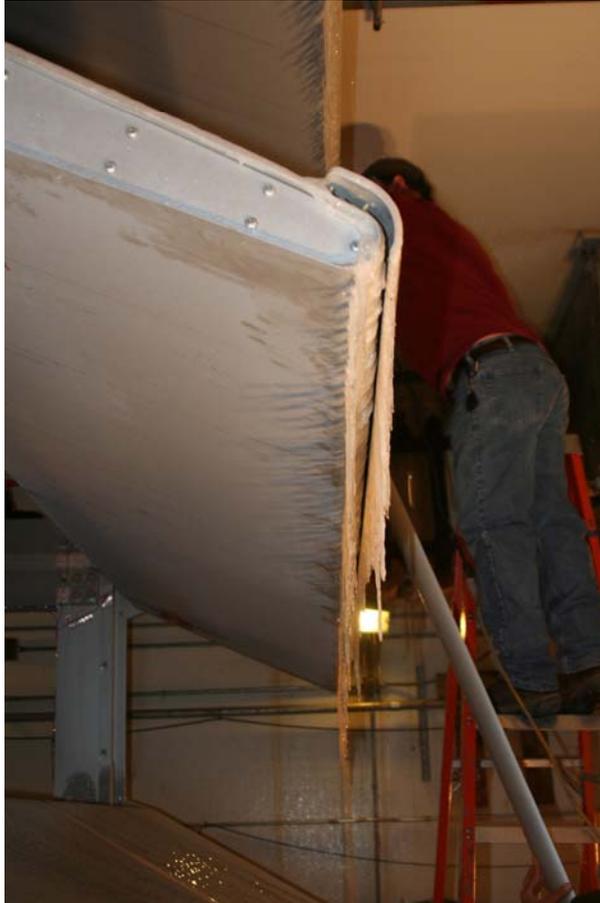
Figure 4.11. Bottom of fin B3 with IRD option 3. The majority of the icicles are attached to the front skin as the water is flowing over the top barrier as shown in Figure 4.10.

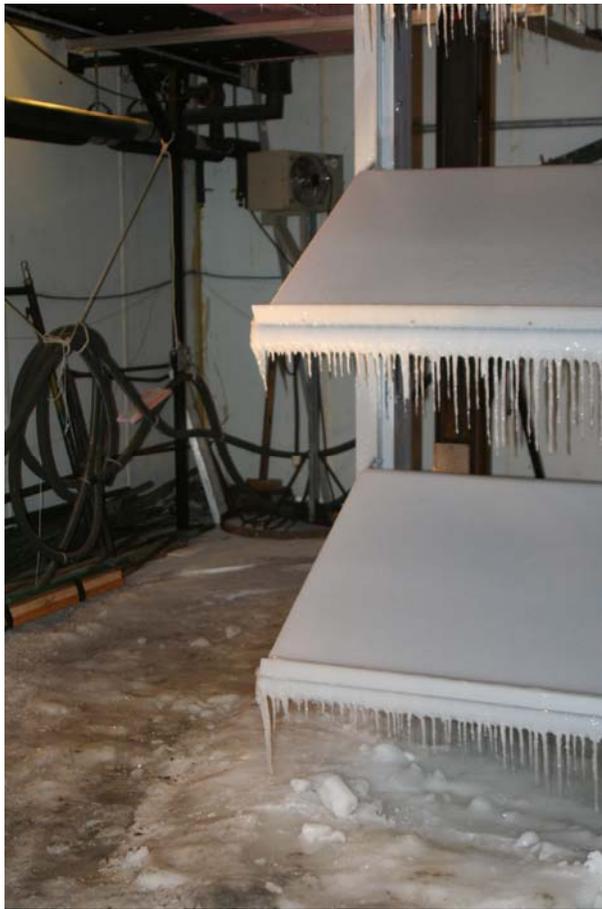
Figure 4.12. Left end of fins A1 and A2 with the larger icicles compared with the interior icicles.

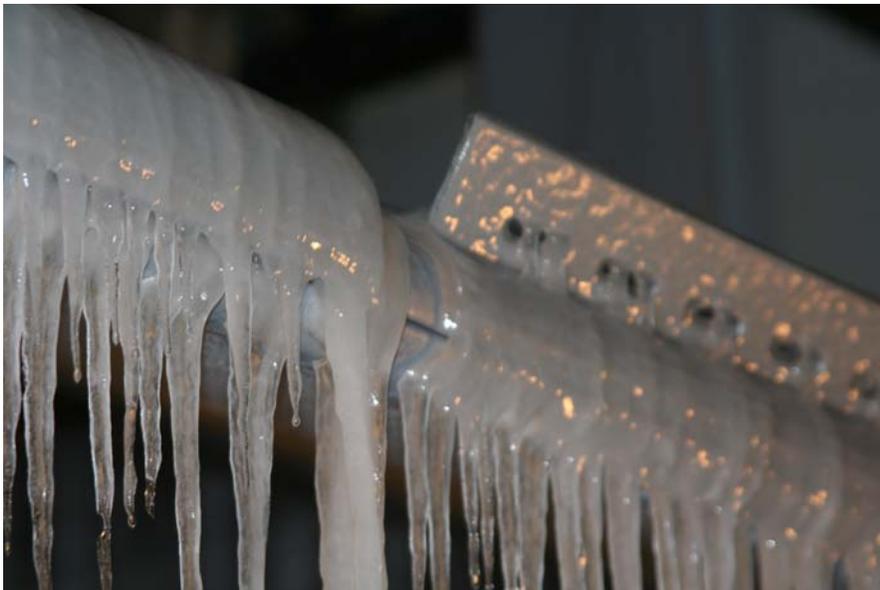
Figure 4.13. Although IRD option 3b had a larger drainage area, given time they would be plugged by ice.

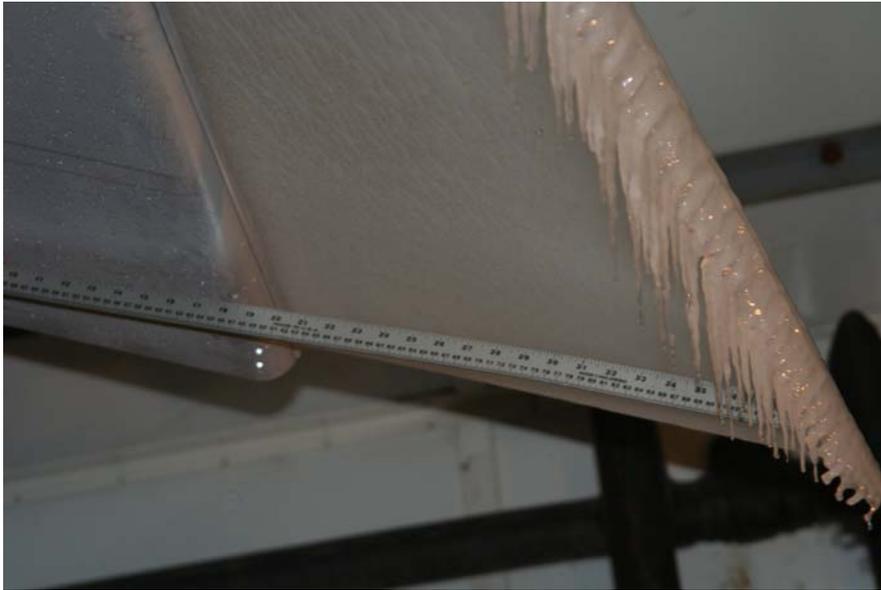
Figure 4.14. Ice accumulation on control fin B4 is cantilevered off the fin 16 inches just before it falls.

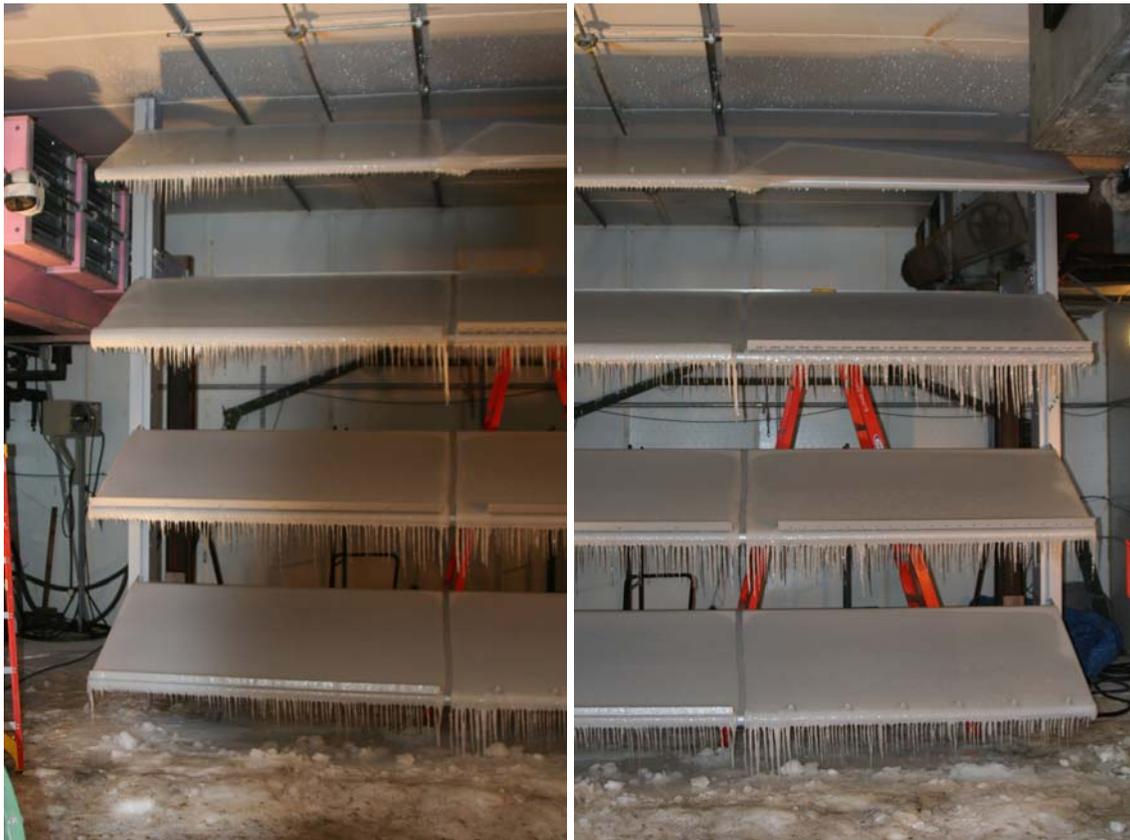
Figure 4.15. (Left) Fins on the A side after a couple of hours of warm up with most of the icicles melted. (Right) Fins on the B side with the ice still in place except on the top fin (B4) used as a control. The icicle melted in place on the fins with the IRDs.
