**US Army Corps
of Engineers®**
Engineer Research and
Development Center

Laboratory Testing of Architectural Exterior Wall Fins

Abstract: Ice and snow accumulation sliding from the exterior wall fins installed on the New Meadowlands Stadium in New Jersey, future home field for the New York Jets and New York Giants football teams, was recognized as a potential hazard to pedestrians. The objective of this test program was first to determine if the hazard existed with the standard fin and secondly to evaluate the performance of four ice retention devices (IRDs). A mock-up was assembled using four fins in a vertical stack with different angles. Four IRDs were tested: three were continuous strips and the fourth was a truncated cone attached to the fin at 12 inches on centers. The IRDs were mounted along the lower edge of the fin. To provide water drainage, all the IRDs were spaced off the fin using 3/16-inch plastic spacers. To assess the effectiveness of the IRDs under similar conditions, IRDs were only installed on the fins on the left side of the mock-up while the right side, or standard fin, was used as a control.

Project title and number: Evaluation of Sun Control Fins in Snow a

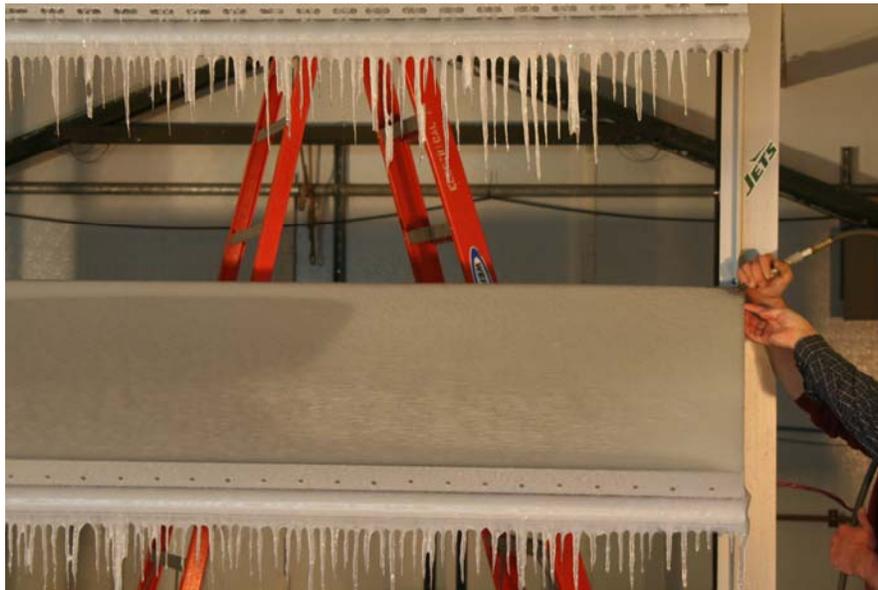
Figure 4.16. Using compressed air to simulate high wind that could lift the ice sheet. The air has displaced the water under the ice in the lighter areas, eliminating the suction provided by the water. The ice sheet could not be lifted off the fin even with the water suction eliminated.

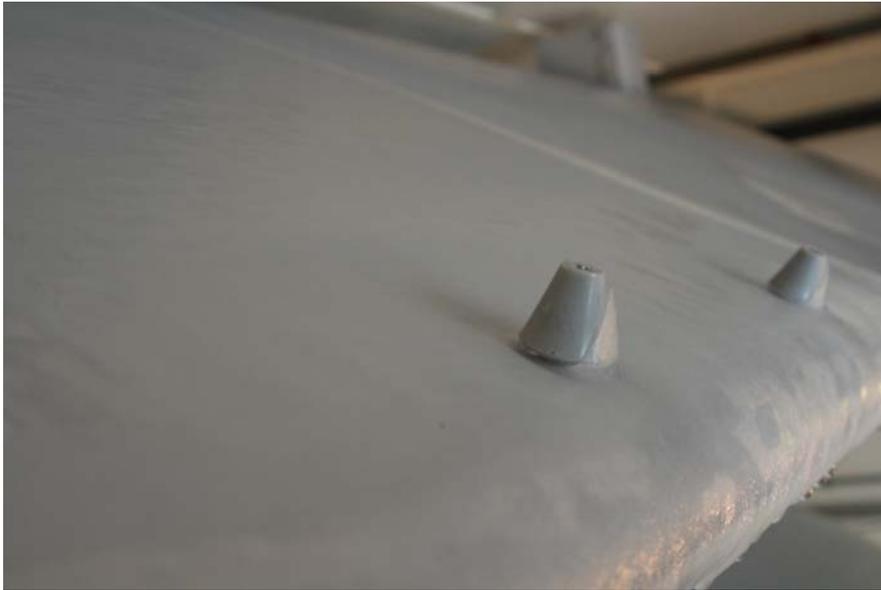
Figure 4.18. IRD option 4 is spaced off the fin $3/16$ inch and the shoulder provides a mechanical lock for the ice sheet to prevent it from being lifted. The light and dark areas indicate that the water is flowing under the ice.

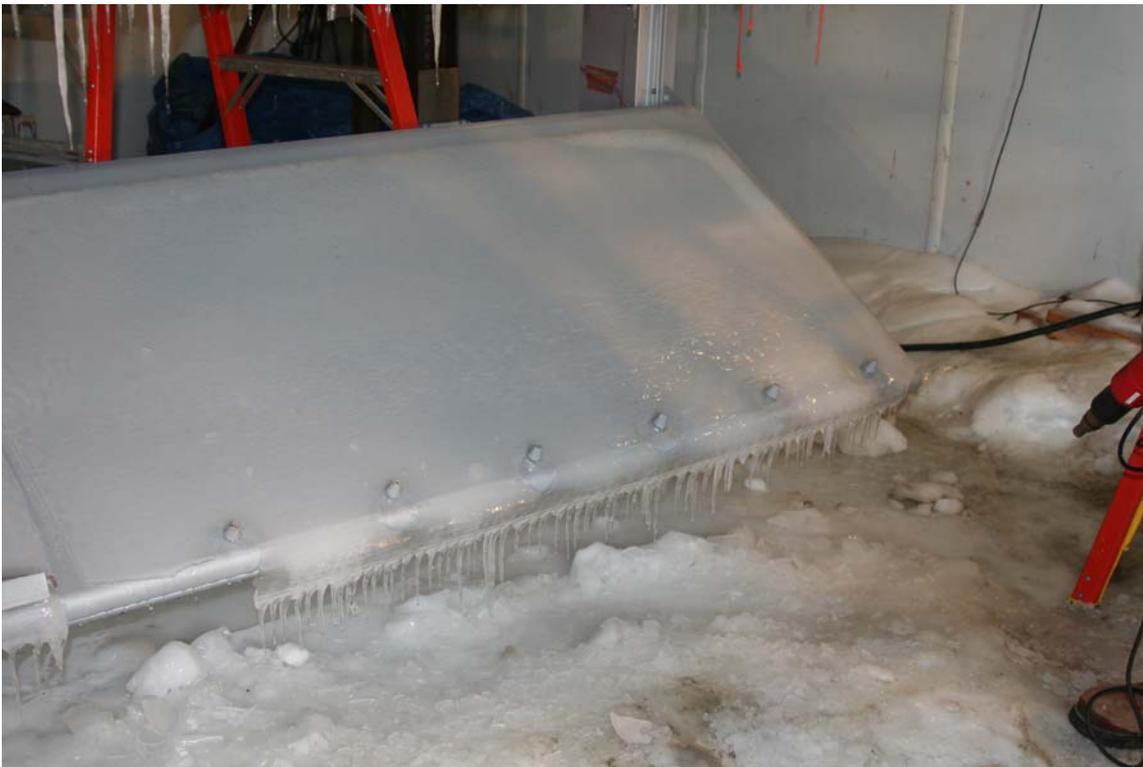
Figure 4.19. The ice around IRD option 4 on fin B1 was melted using a heat gun to verify the simple IRD would arrest sliding ice. Before all the IRDs were melted free, the ice sheet started to slide, reinforcing the recommendation that IRDs are necessary to prevent the ice from sliding off the fin. The IRDs did stop the moving ice sheet.

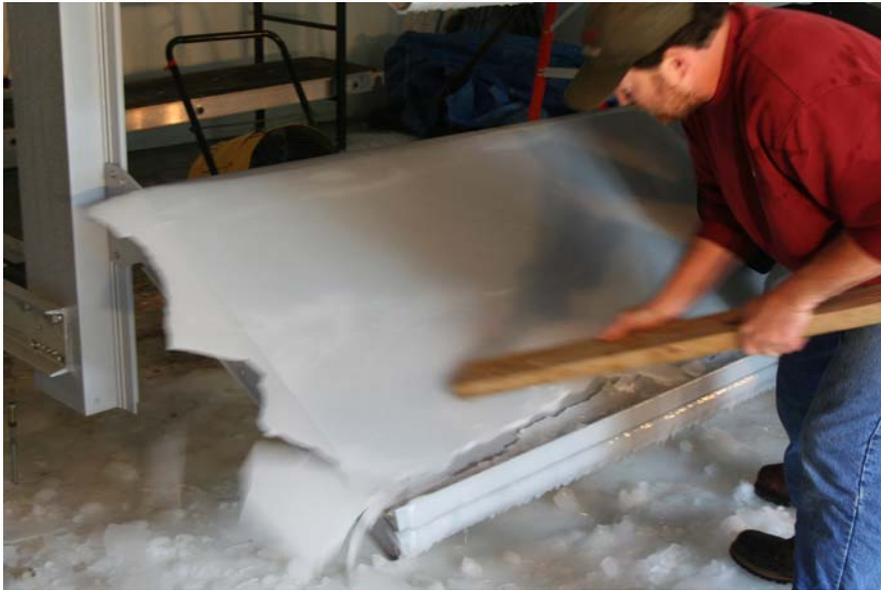
Figure 4.20. Breaking up the ice on fin A1, so it could slide off the edge of the fin.

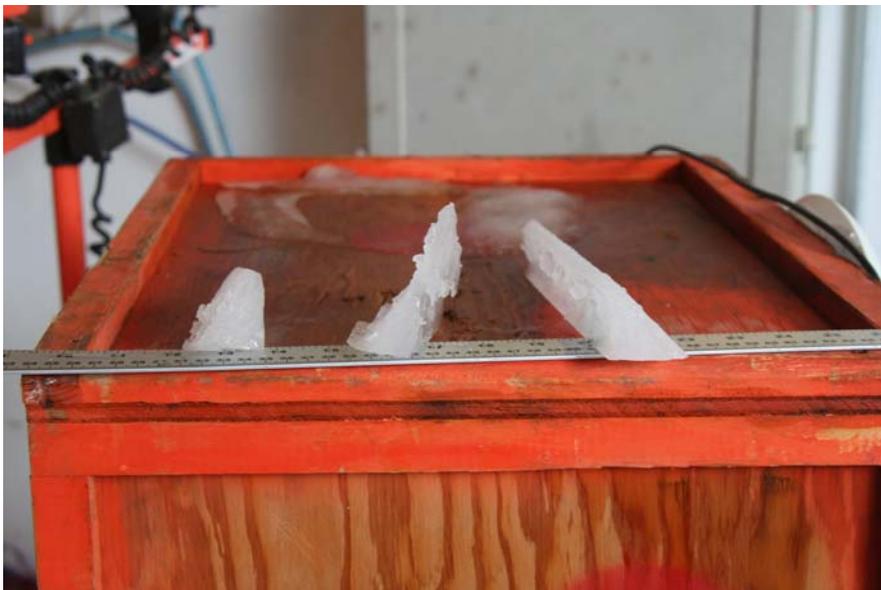
Figure 4.21. Ice accumulation from behind IRD options 1 and 2. Given the volume of ice, considerable melting would have to take place before the drainage paths under the IRDs would be open.

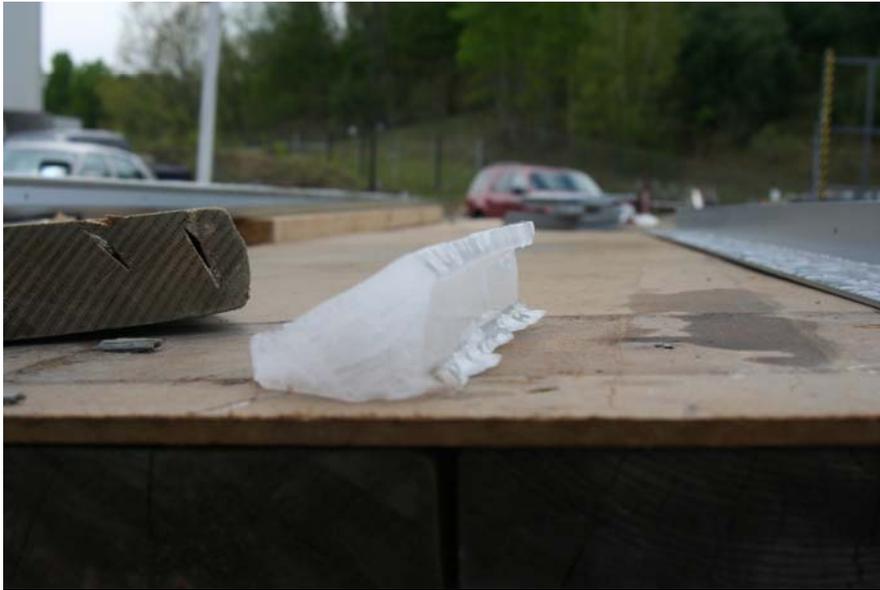
Figure 4.22. Similar to IRDs shown in Figure 4.21, the ice behind IRD option 3 also blocks the drainage path under the IRD. The surface on the right side of the ice mirrors the back of the IRD. The broken edges on the top and bottom are from the ice in the drainage path under the IRD and ice over the top of the IRD, respectively. Again, considerable melting would have to take place before the drainage paths would be open; in the meantime, the water would flow to the ends of the fin.

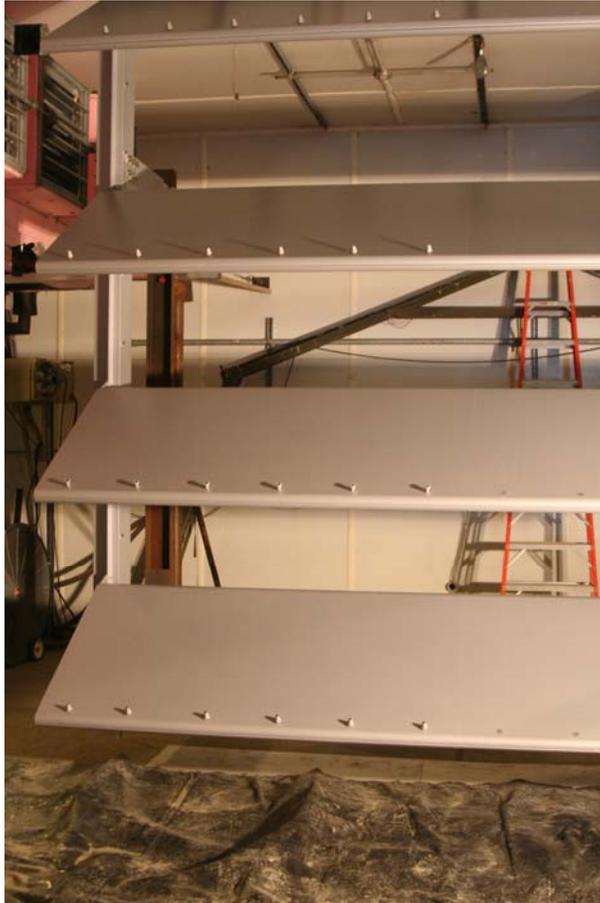
Figure 5.1. IRD option 4 installed on all the fins on the A side. The IRDs are inverted on fin A2 as shown in Figure 5.3.

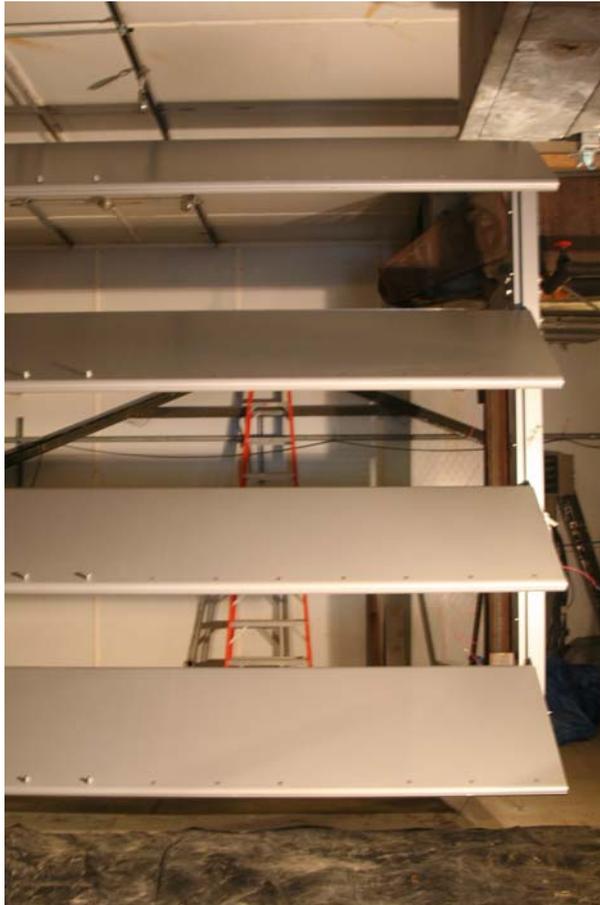
Figure 5.2. B side of the mock-up with no IRDs installed and the attachment hole covered with foil tape disc.

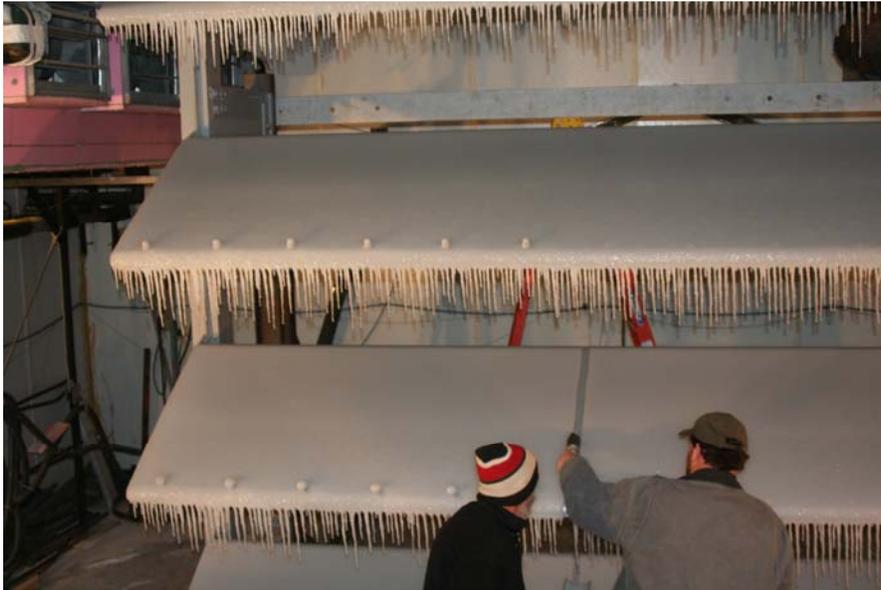
Figure 5.4 Initial condition of fins 2 and 3 while a slot between the A and B sides is being deiced with a hot iron.

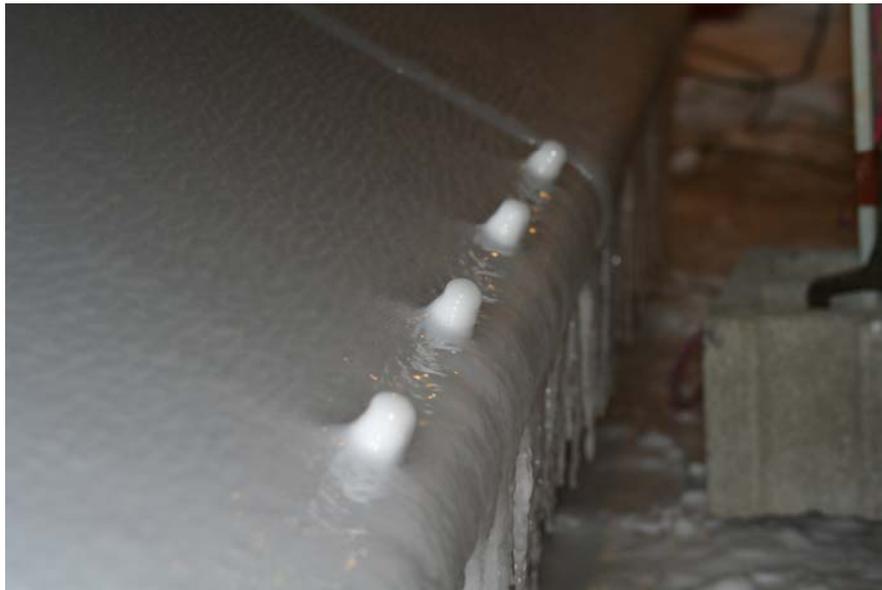
Figure 5.8. Condition of fin A1 following seven solar cycles.

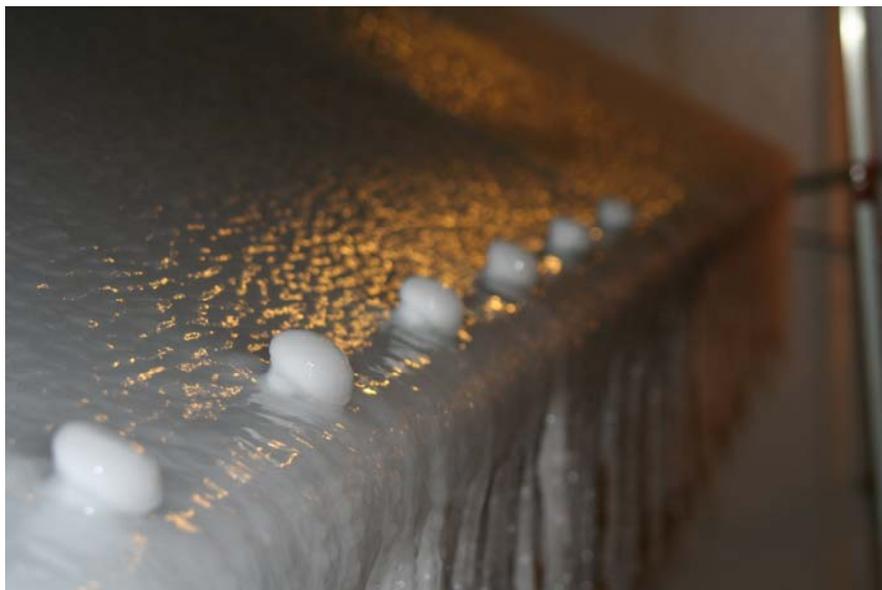
Figure 5.9. Condition of fin A2 following seven solar cycles.

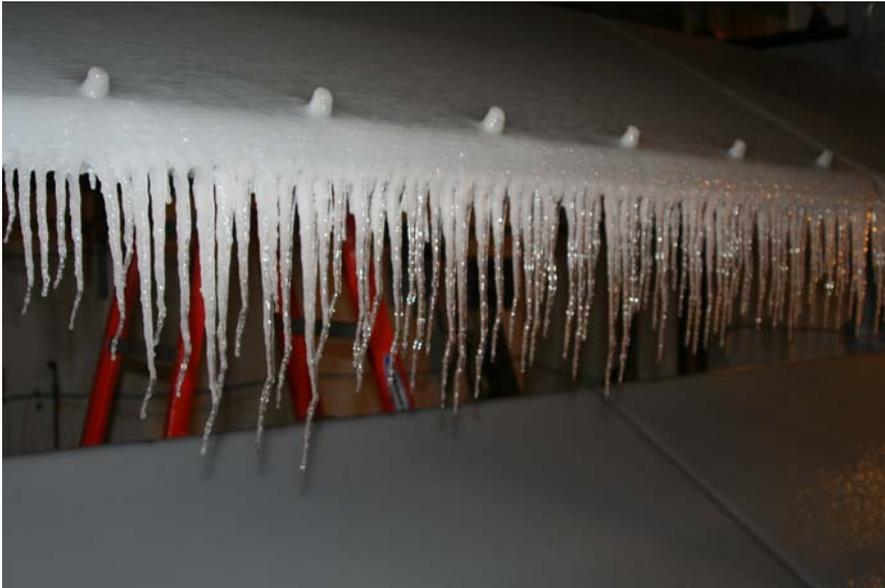
Figure 5.10. Condition of fin A3 following seven solar cycles.

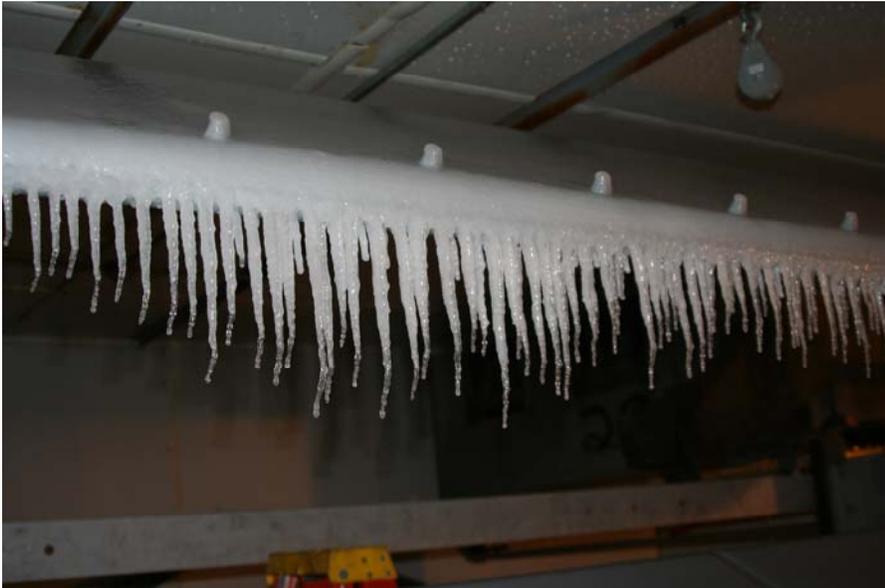
Figure 5.11. Condition of fin A4 following seven solar cycles.

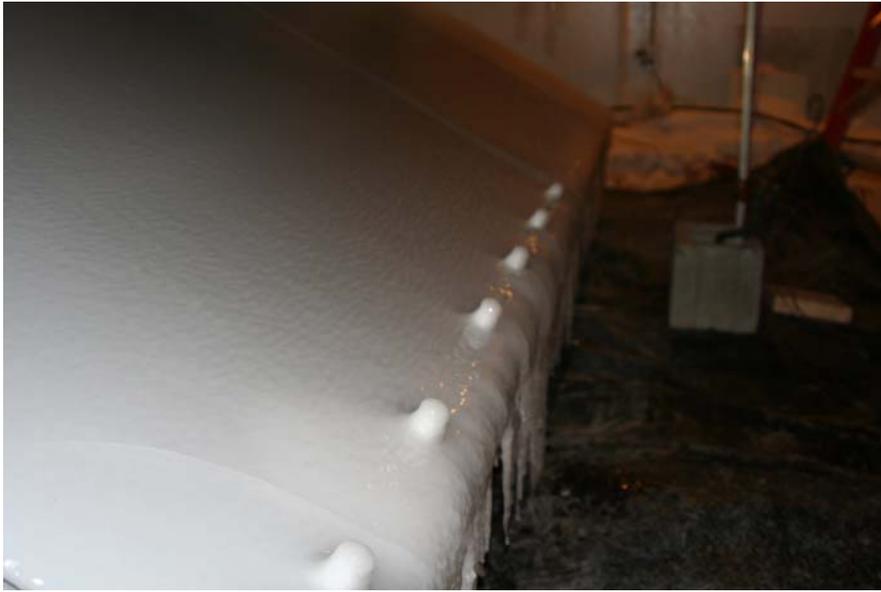
Figure 5.12. Condition of fin A1 after the infrared heaters were on for 5 hours with the room at approximately 23°F.

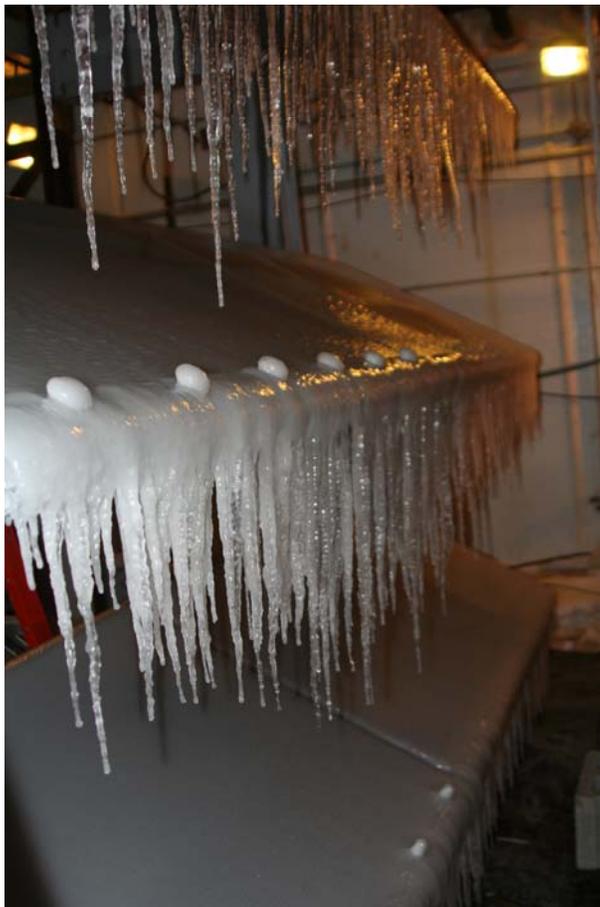
Figure 5.13. Condition of fin A2 at the same time as fin A1 shown in Figure 5.10. The melt water from fins A3 and A4 refroze on fin A2.

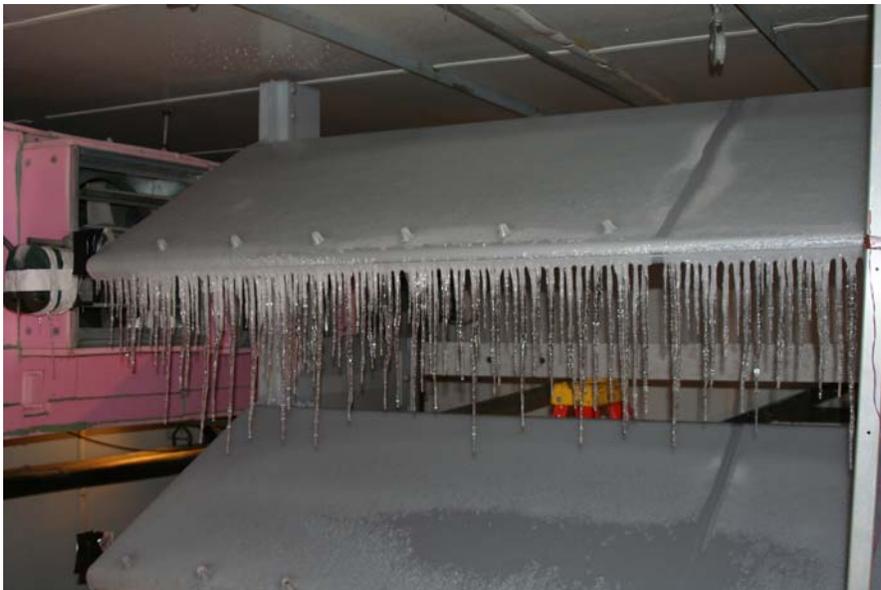
Figure 5.15. Condition of fin A4 at the same time as fin A1 shown in Figure 5.10.

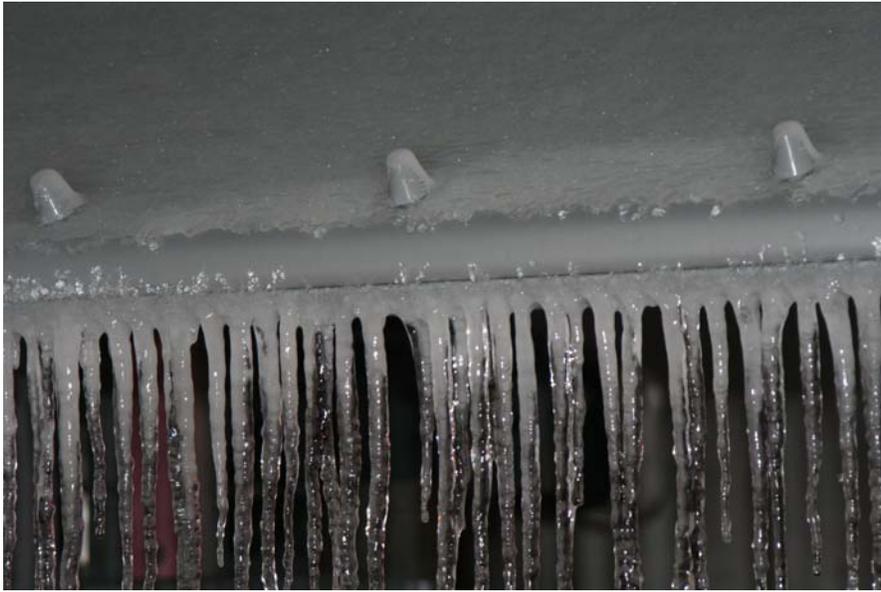
Figure 5.16. Close-up of the leading edge of fin A4 shown in Figure 5.13. The panel joint is providing mechanical anchoring for the icicles.

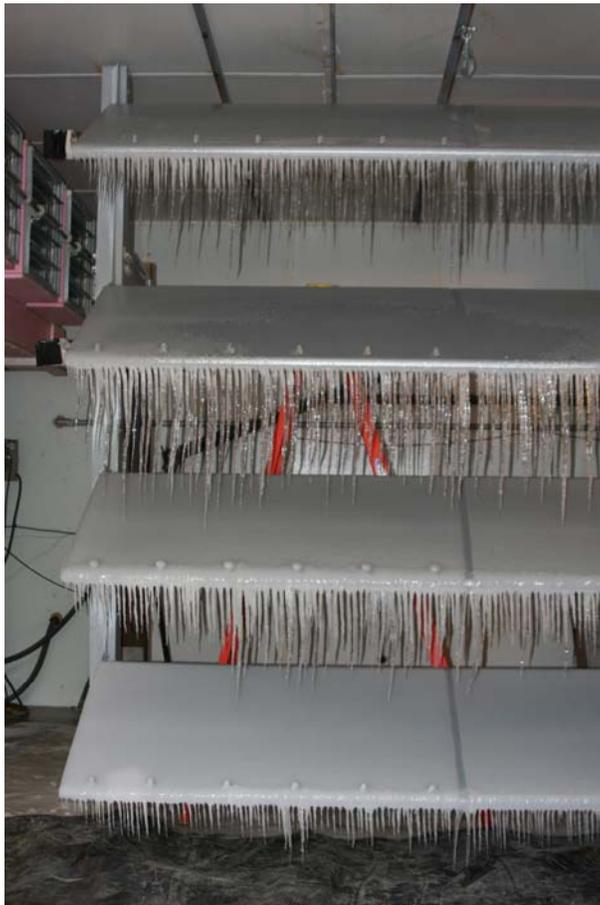
Figure 5.17. Condition of the A fins after the weekend at 23°F.

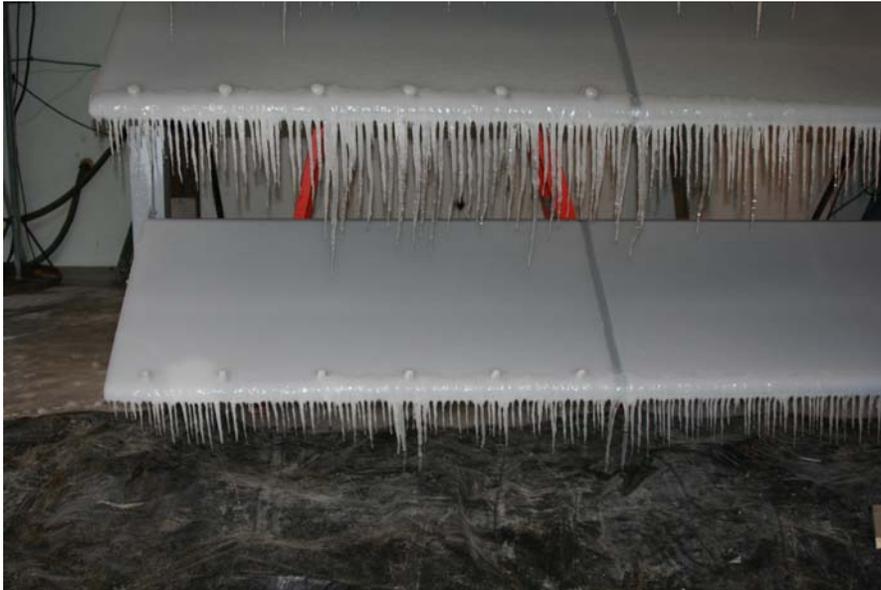
Figure 5.18. Close-up of fins A1 and A2. The bulk of the melt water from fins A3 and A4 refroze on fin A2.

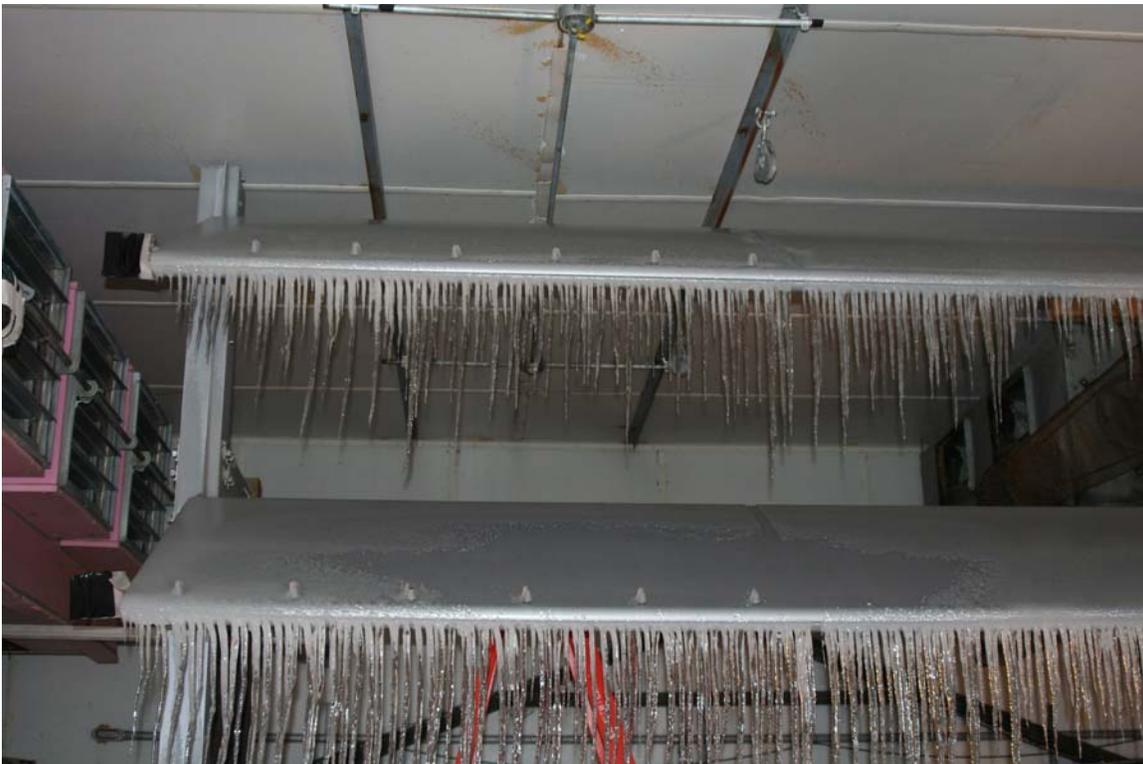
Figure 5.19. Close-up of fins A3 and A4; note the long thin icicles.

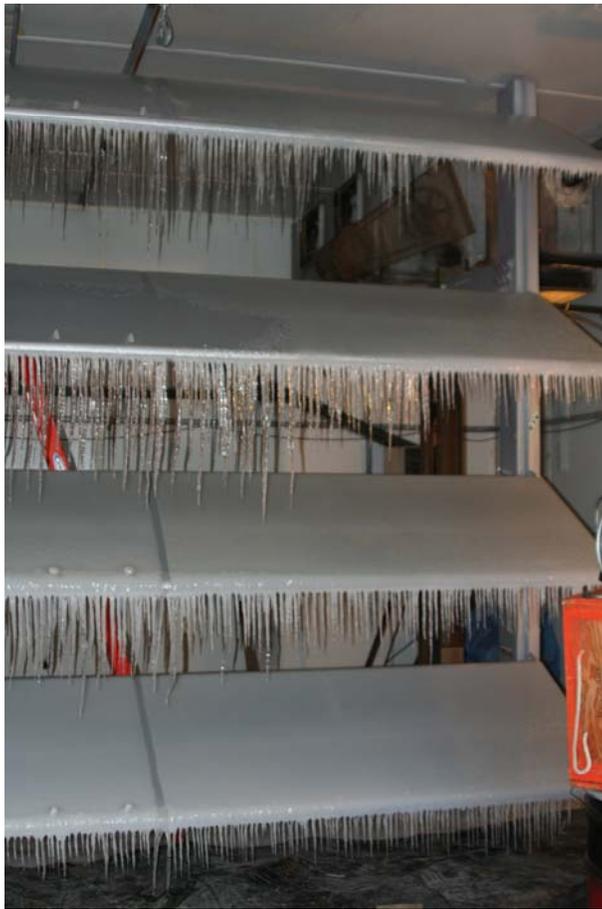
Figure 5.20. Fins on the B side; the radiant heaters on fins A3 and A4 did cause melting on fins B3 and B4.

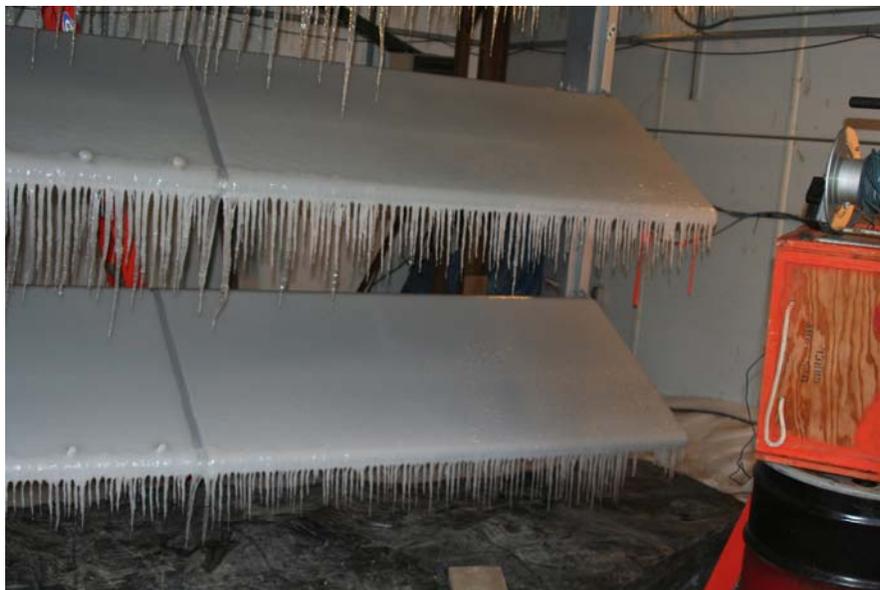
Figure 5.21. Close-up of fins B1 and B2.

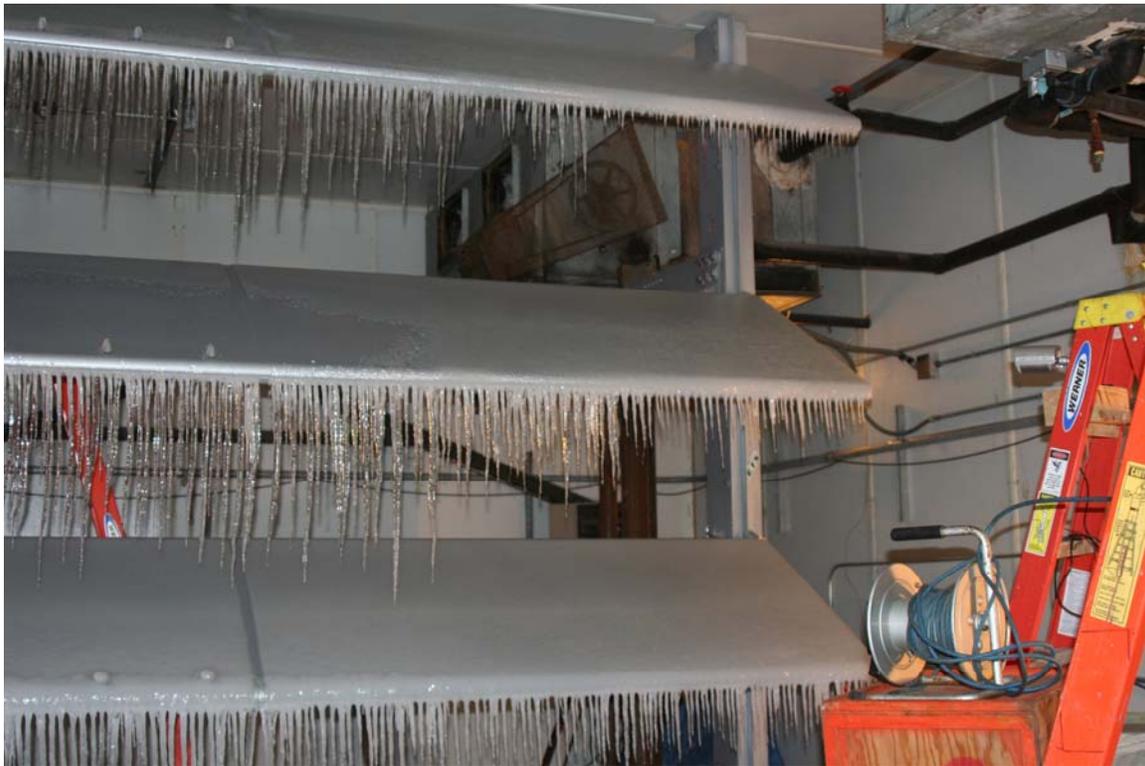
Figure 5.22. Fins B2, B3, and B4. Note the size of the icicles on the A side that was heated with the infrared heaters compared to the right side outside the range of the heaters.

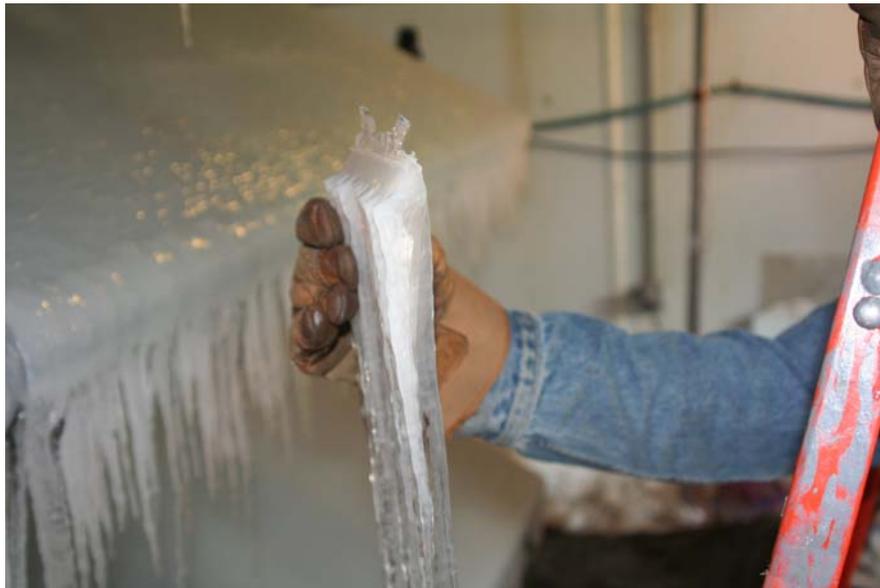
Figure 5.23. Icicle removed from fin B2. The ice mirrors the smooth face of the fin with a ridge as evidence of the mechanical attachment in the panel joint.

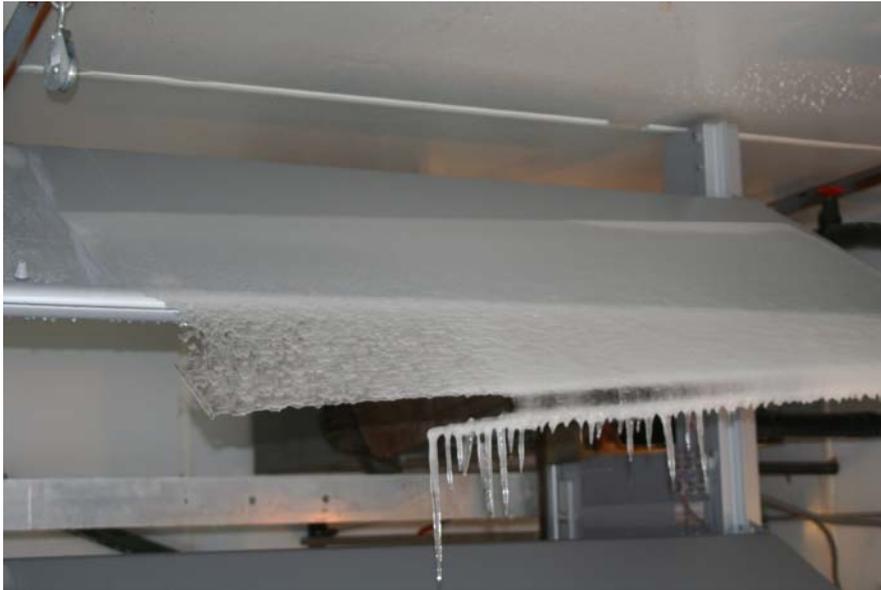
Figure 5.24. Ice sliding off fin B. Ice on the leading edge was melted by the infrared heaters used in the previous testing phase.

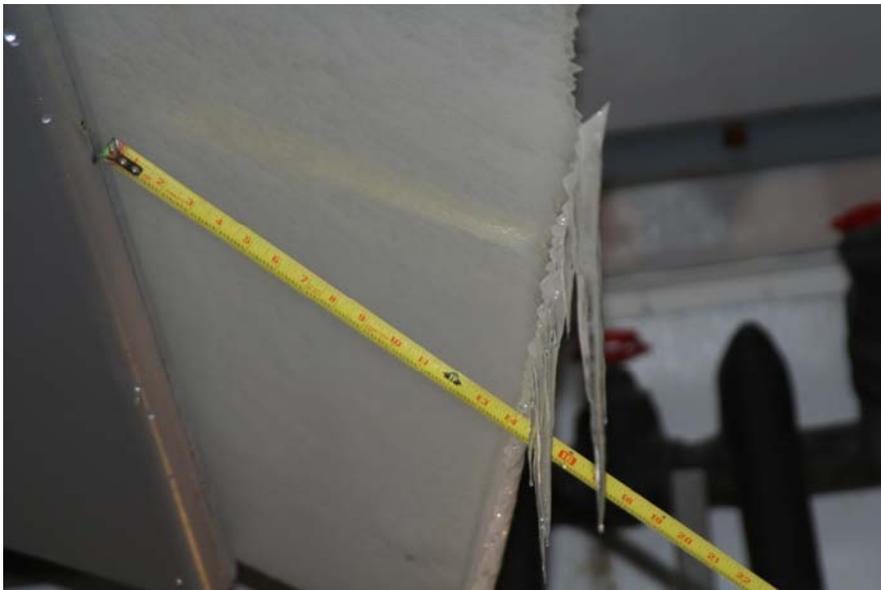
Figure 5.25. Ice sheet is cantilevered off fin B3 approximately 14 inches before it finally breaks along the edge of the fin.

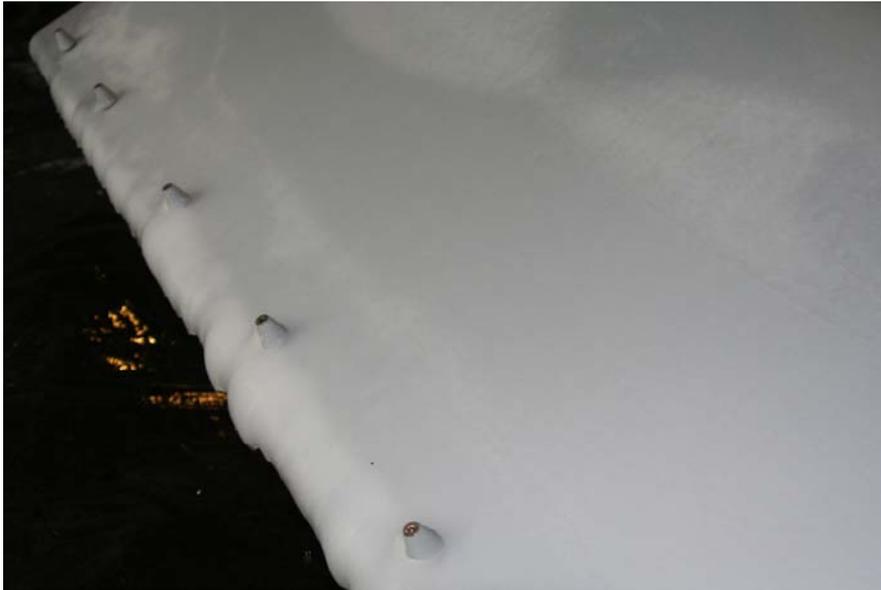
Figure 5.26. Fin A1 after a day of melting with just the IRD option 4 protruding through the ice accumulation.

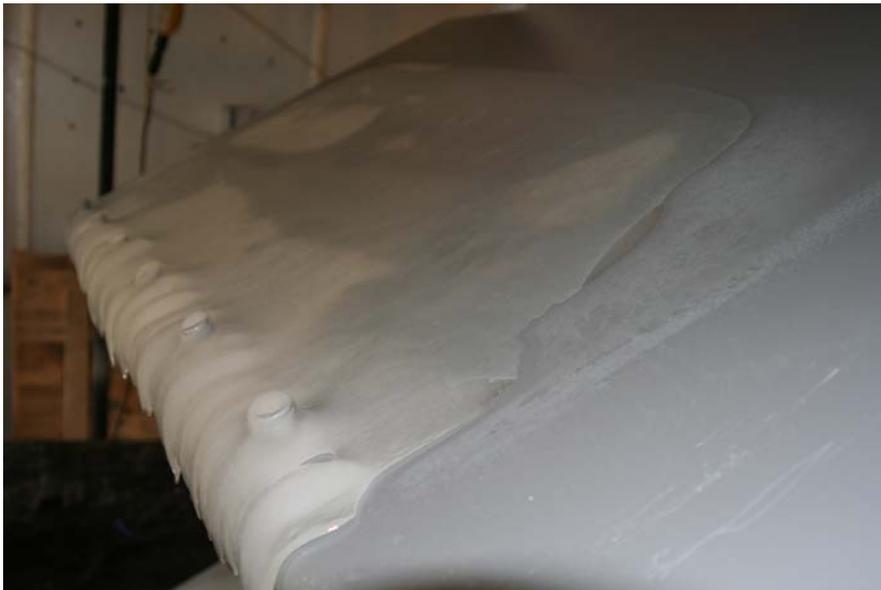
Figure 5.27. Condition of fin A2 after a day of melting with the inverted IRD option 4 protruding through the cover.
