Microbial Influenced Corrosion (MIC) Study

**National Defense Industry Association
Environment, Energy Security, &
Sustainability Conference**

May 23, 2012

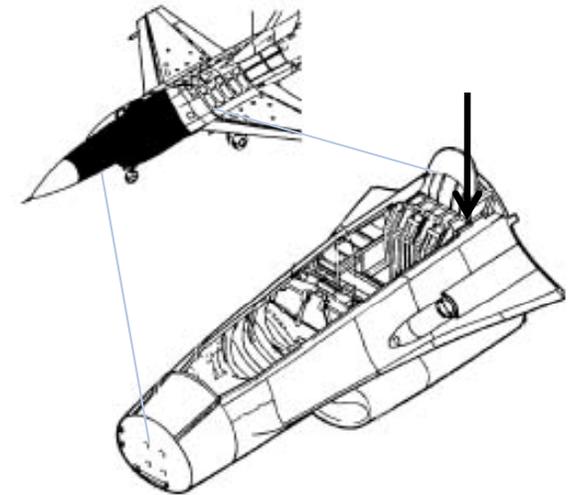
- Moisture routinely enters aircraft in different ways
 - open canopy, condensation, high humidity, Environmental Control System or ECS, etc...
- Moisture is absorbed and retained within insulation blankets used to seal lower walls and floor,
- No drain holes in aft area to remove moisture (B/D variants),
- Water collects and retained in low lying areas breaks down protective coating system and causes structural corrosion,
- Water and organic/inorganic nutrients support microbial growth.

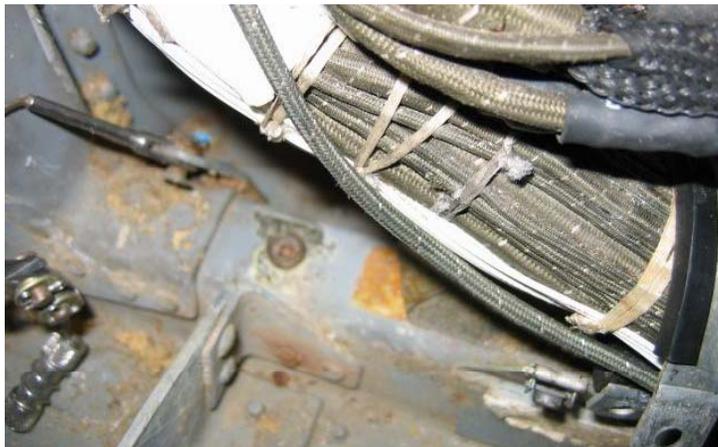
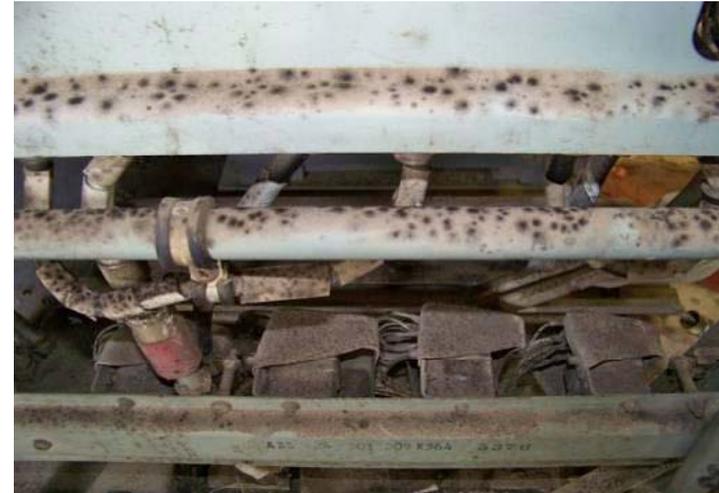
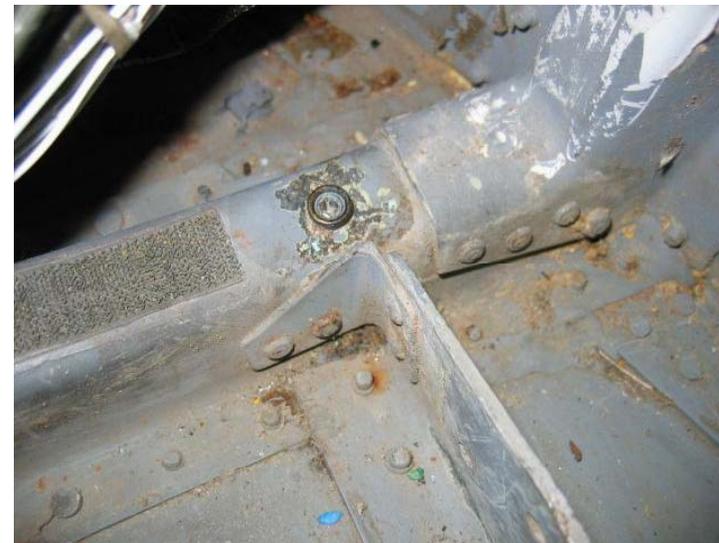
- Most damage confined to pitting corrosion of primary and secondary support structures
- Pitting corrosion morphology (i.e., tunneling suggests MIC)

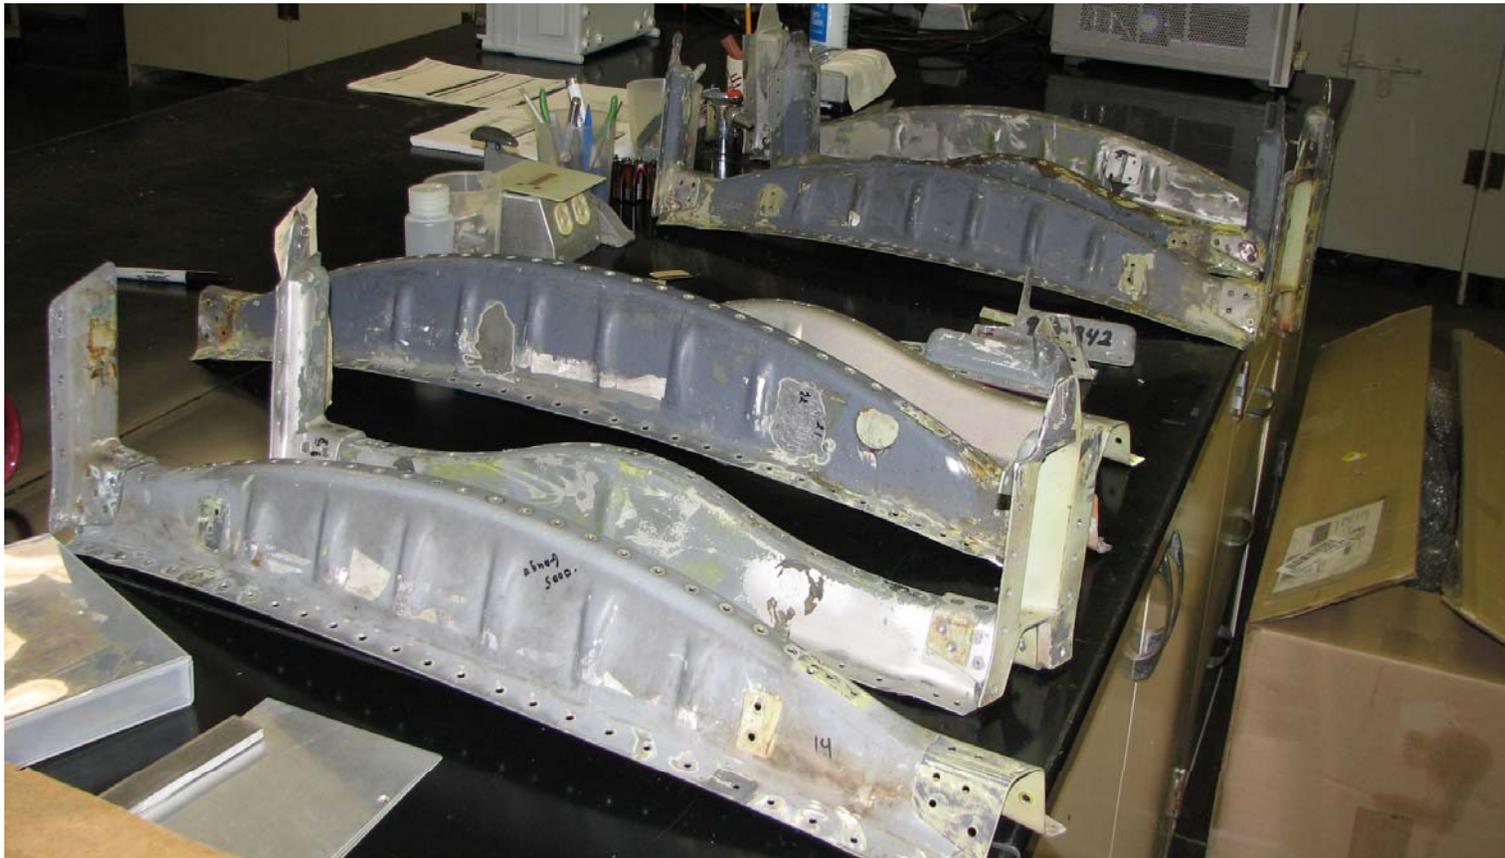
Condemned Aircraft Component Parts

- Sixty-three samples collected from similar parts and OML locations (control samples) on six aircraft at Hill Air Force Base

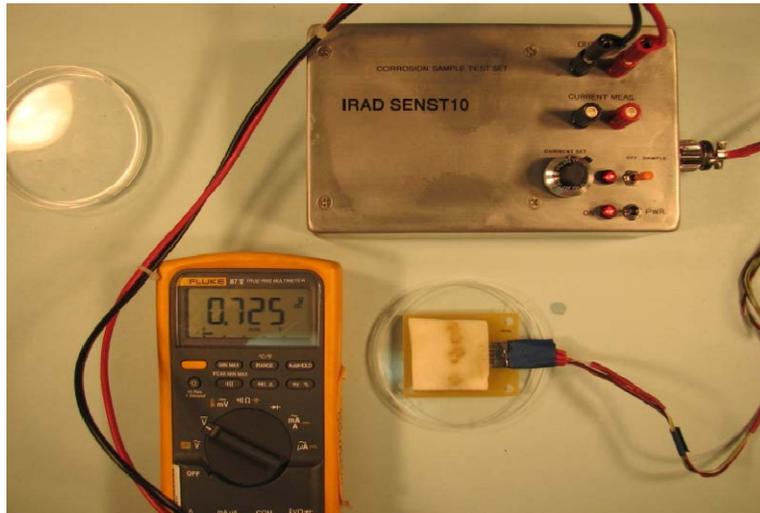
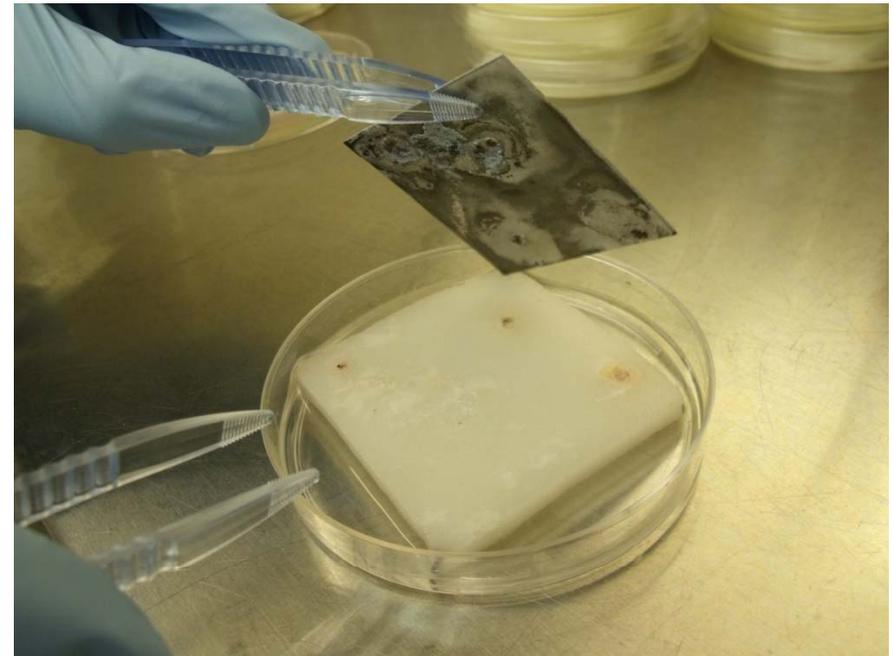
Weight-loss Coupons

Experimental Set-up

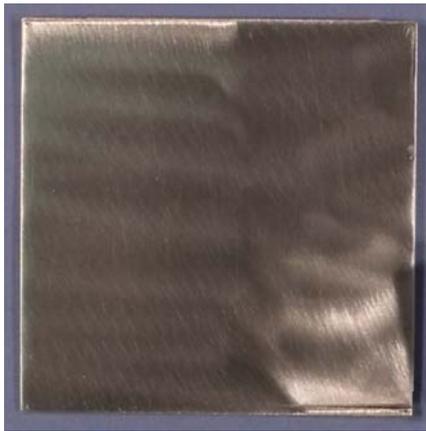
Bacteria Consortia

Aluminum Coupon Results: 1-month Exposure, Chemically Descaled

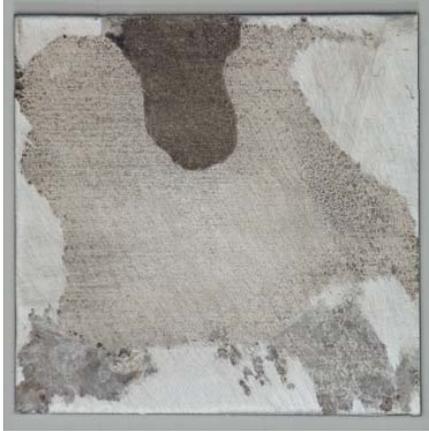
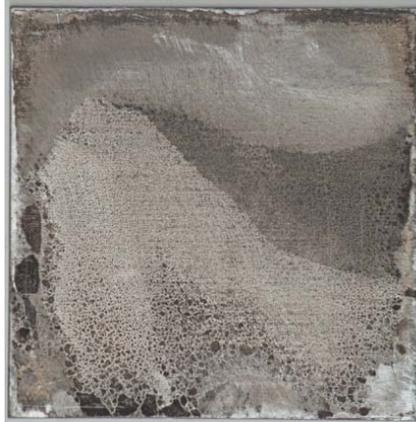
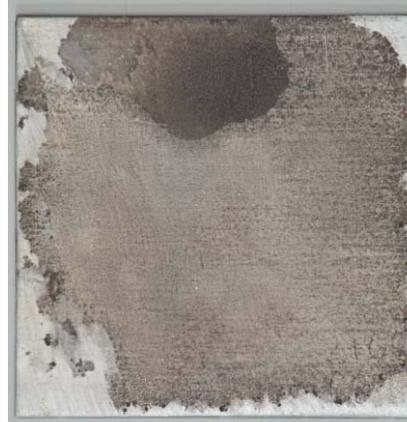
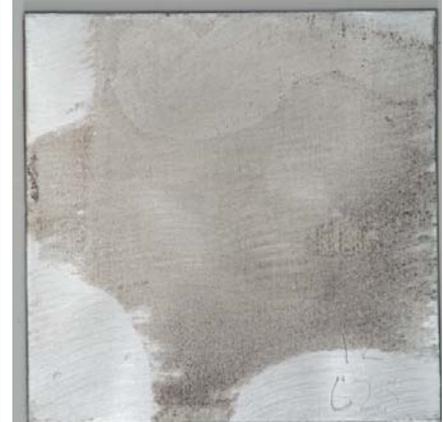
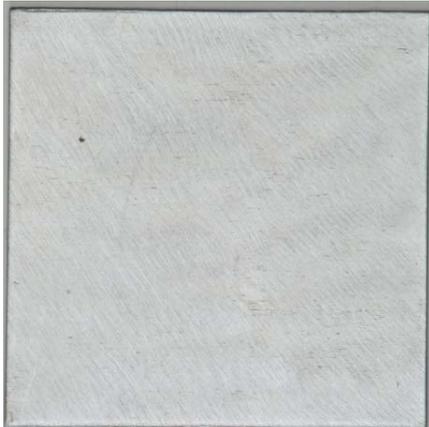
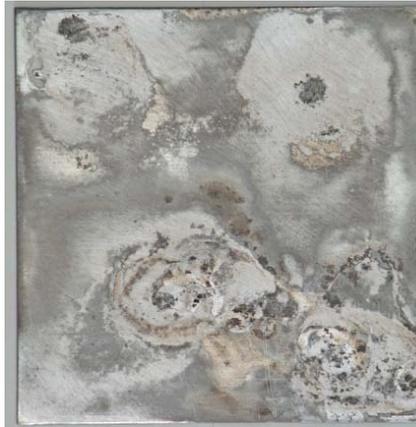
Aluminum Coupon Results: 2-month Exposure, Descaled

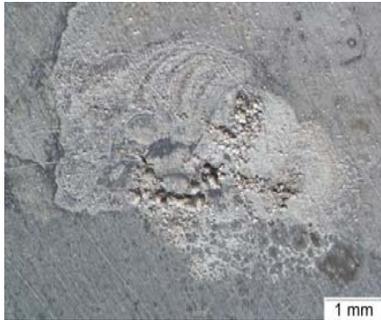
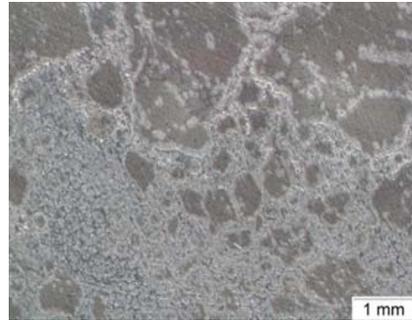
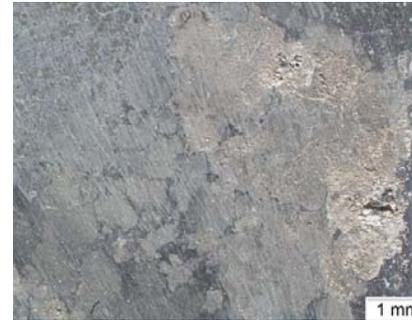
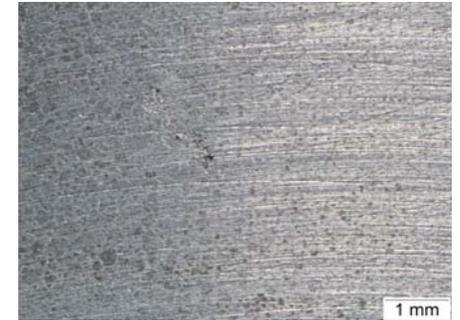
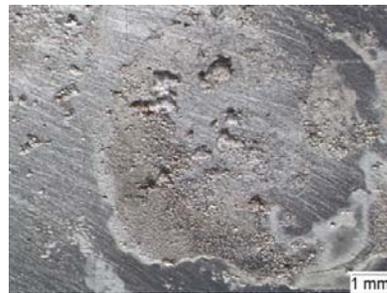
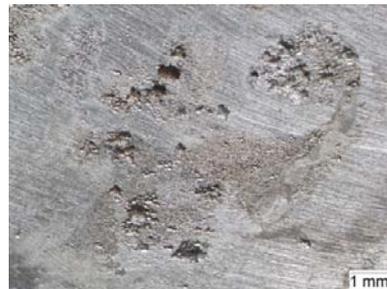
Al Coupon Results: 3 Month Exposure, Descaled - Optical Micrographs

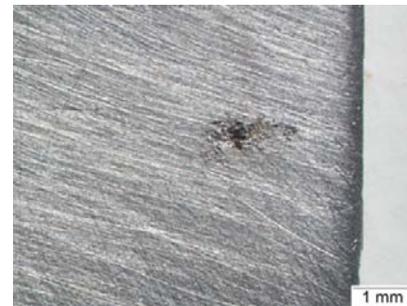
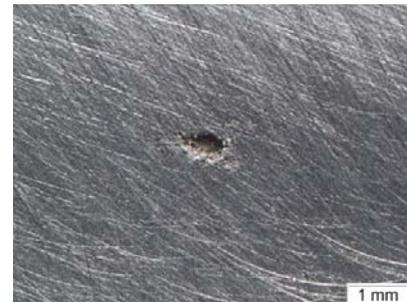
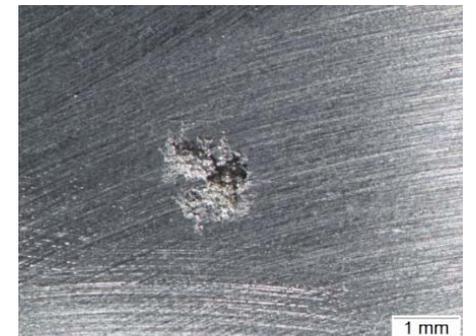
Aluminum Coupon Results: 3 Month Exposure, Cleaned (Representative Samples)

Dried biofilm and corrosion products inside pit area, with evidence of selective metal ion extraction or dealloying from metal or alloying networks

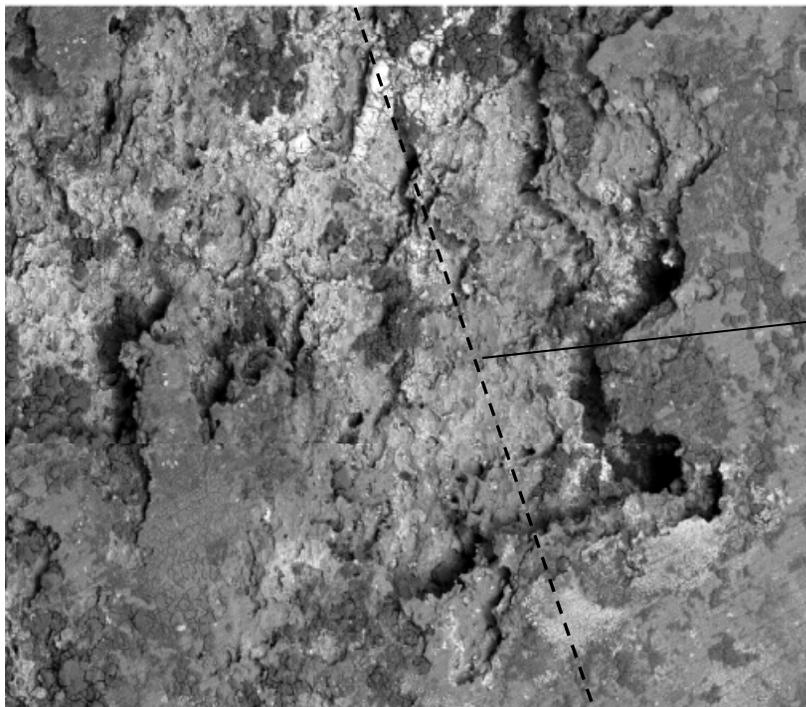
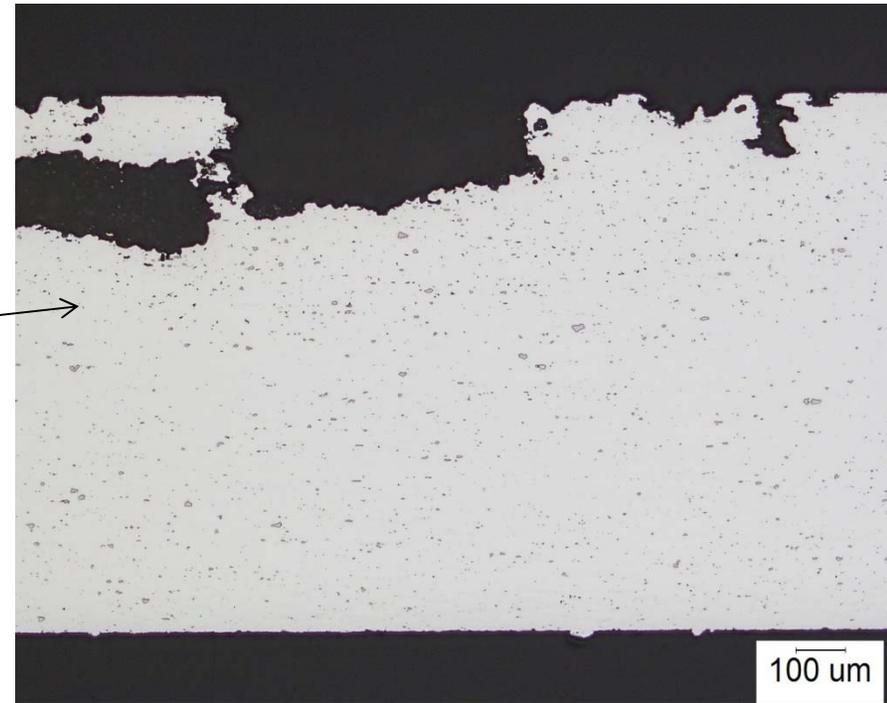
Coupon ID 305 Fungi Consortia

Aluminum Coupon Results: 3 Month Exposure, Descaled (Representative Samples)

305 Bottom Cleaned 75x bse

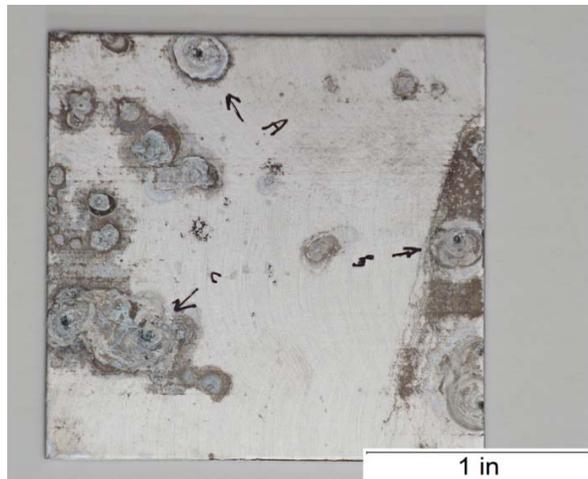
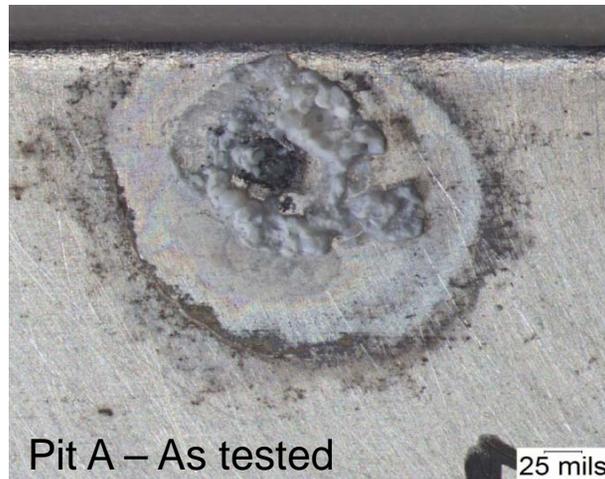
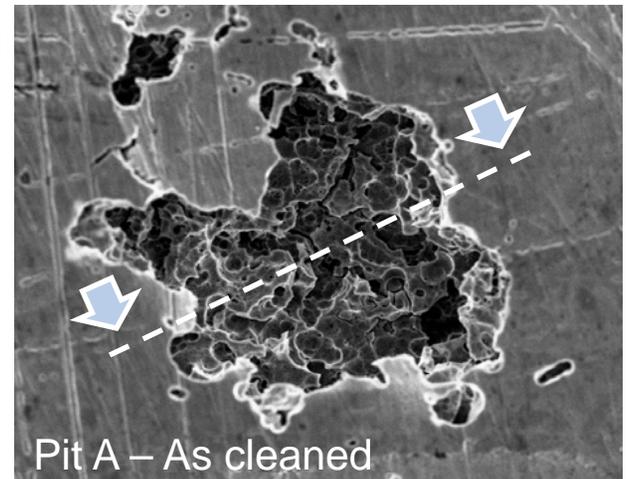
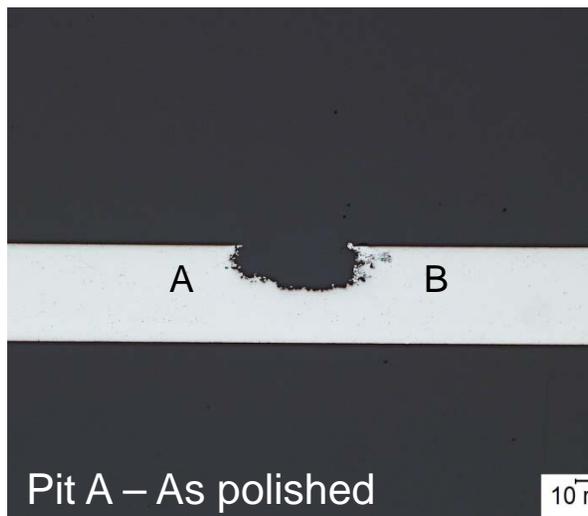
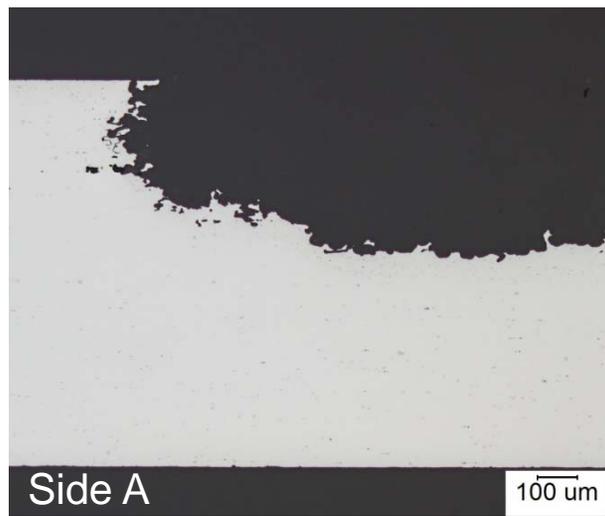
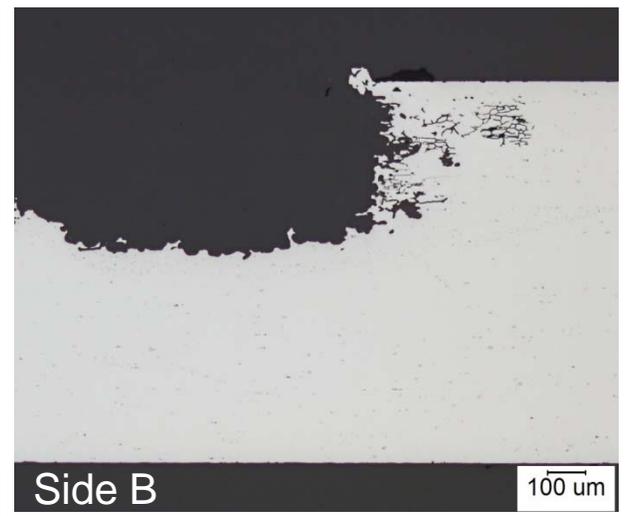
Coupon ID No. 722 (Aircraft Consortia)

| Coupon ID | Test Solution | pH | Discoloration | | Pitting, max (mils) | Comments |
|---|---|---|---|---|---|---|
| 722 | Aircraft Consortia | 7.5 | 22L-2P | G-NP | ~15 T | Edge corrosion pits – T deepest |

Aluminum Coupon Results: 3-month Exposure (Representative Sample)

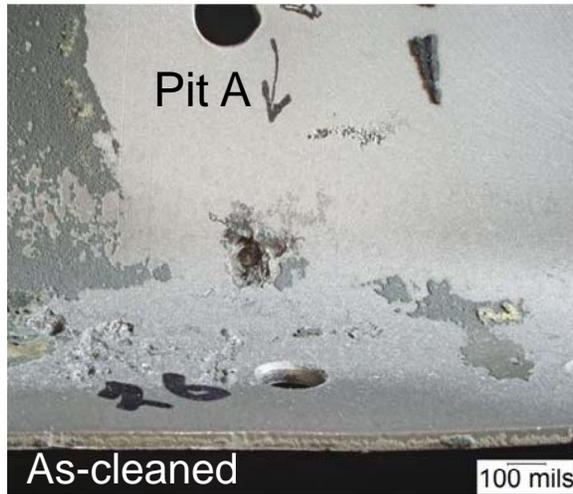
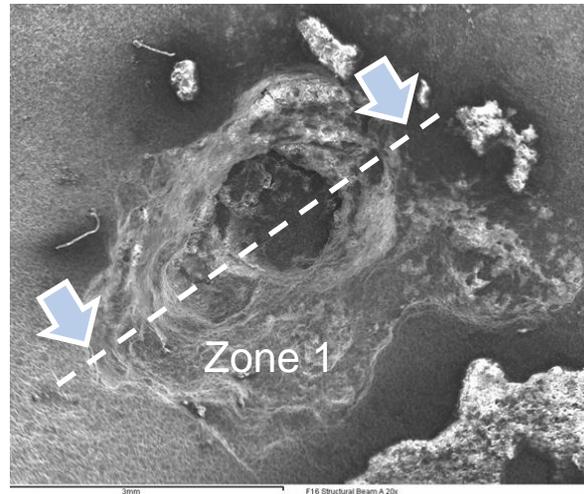
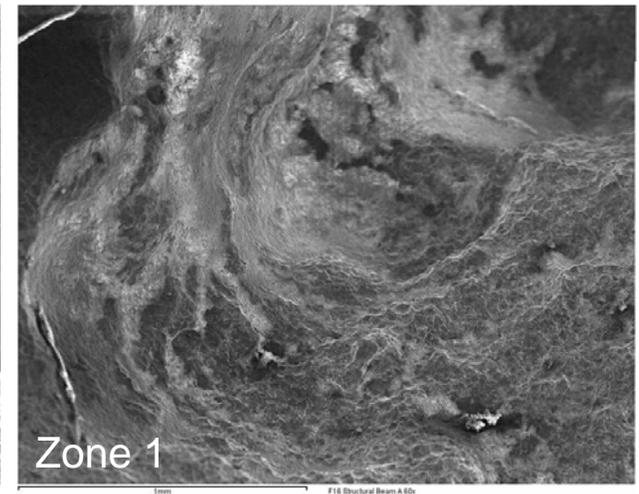
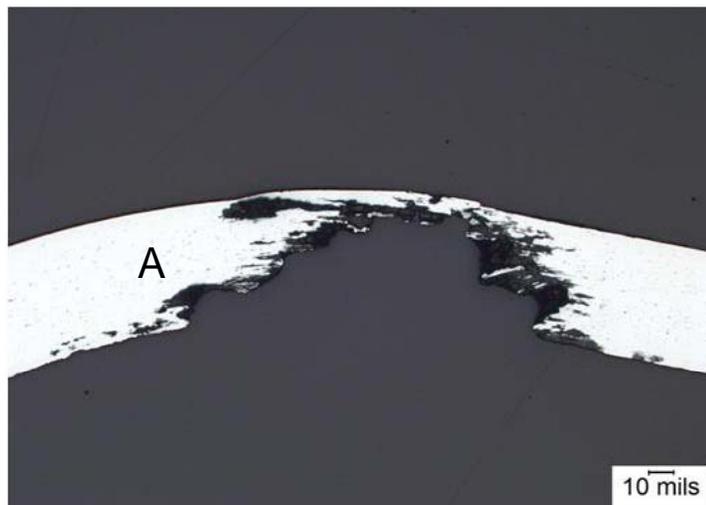
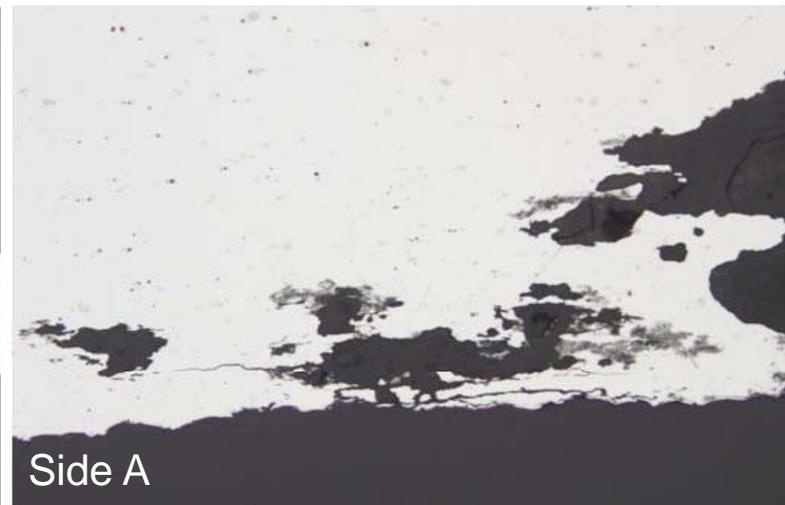
Aircraft Beam

Aluminum Parts Results: In-Service Exposure (Representative Sample)
