1. REPORT DATE (DD-MM-YYYY) 6 Dec 2012		2. REPORT TYPE Consultative Letter		3. DATES COVERED (From – To) July 2012 – November 2012	
4. TITLE AND SUBTITLE Stewart Air National Guard Base, NY, C-5M Painting Refurbishment Assessment			5a. CONTRACT NUMBER		
			5b. GRANT NUMBER		
			5c. PROGRAM ELEMENT NUMBER

SUBJECT: Consultative Letter AFRL-SA-WP-CL-2012-0068, Stewart Air National Guard Base, NY, C-5M Painting Refurbishment Assessment

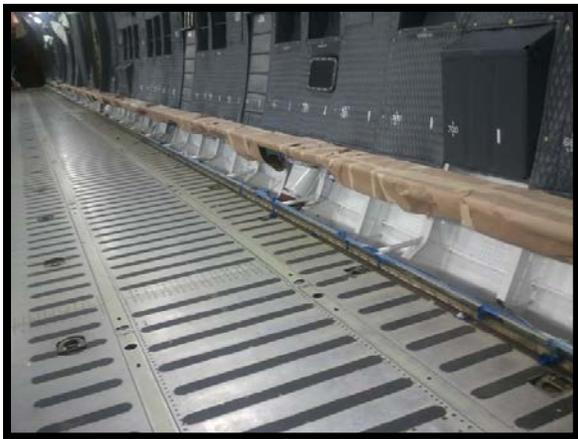
2. SURVEY PROCEDURES/DISCUSSION: The team from USAFSAM/OEC accomplished air sampling from 25-26 July and 30-31 July for chine coves (Figure 1) and flight deck (Figure 2) refurbishment processes, respectively. The two processes were unique from each other in that the chine coves are in a naturally ventilated open cargo area yet use isocyanate paints, while the flight deck area has restricted air flow yet uses water-based polyurethane paints.

Figure 1: Chine coves, pictured here in white

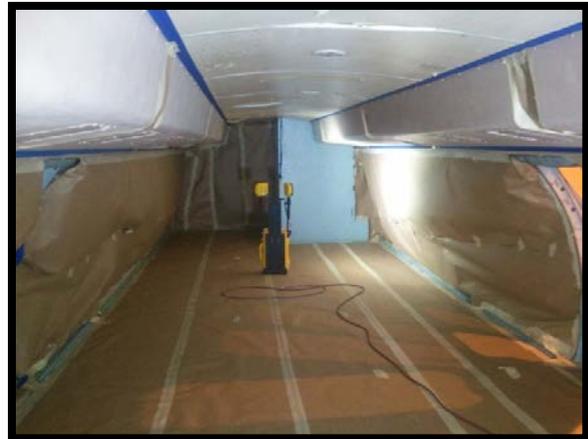
Figure 2: Flight deck

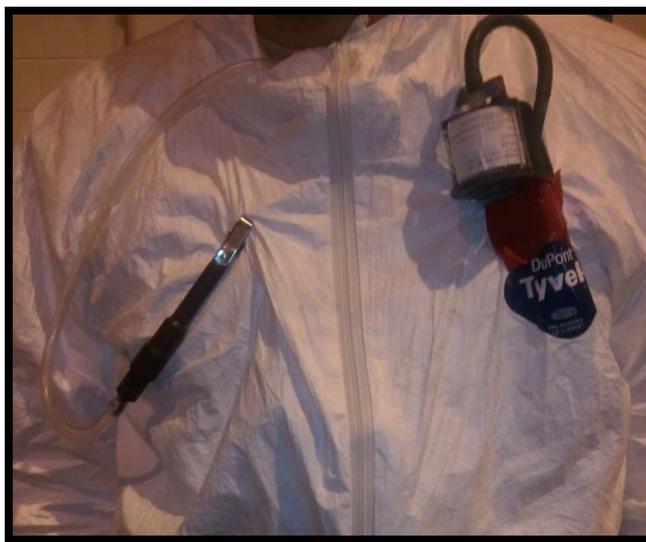
b. Due to a limited number of Iso-Chek™ samplers, only one representative painter was assessed using the Iso-Chek™ method per work shift. Additional Iso-Chek™ sampling by the local Bioenvironmental Engineering Flight could add statistical confidence to the hazard characterization. The Iso-Chek™ sampler was clipped to the shoulder of the painter within the breathing zone, while either a passive sampler or a charcoal tube sampler was clipped to the opposite shoulder of all four painters. The cassettes were held in place with a cassette holder, while the charcoal tube samplers were held in place with a tube holder in line with a low flow reducer (Figure 3). The flow rate for the Iso-Chek™ sampler was set at 1 liter per minute (Lpm). The flow rate for the charcoal tube sampler was set at 0.2 Lpm.

Figure 3: Iso-Chek™ and charcoal tube samplers

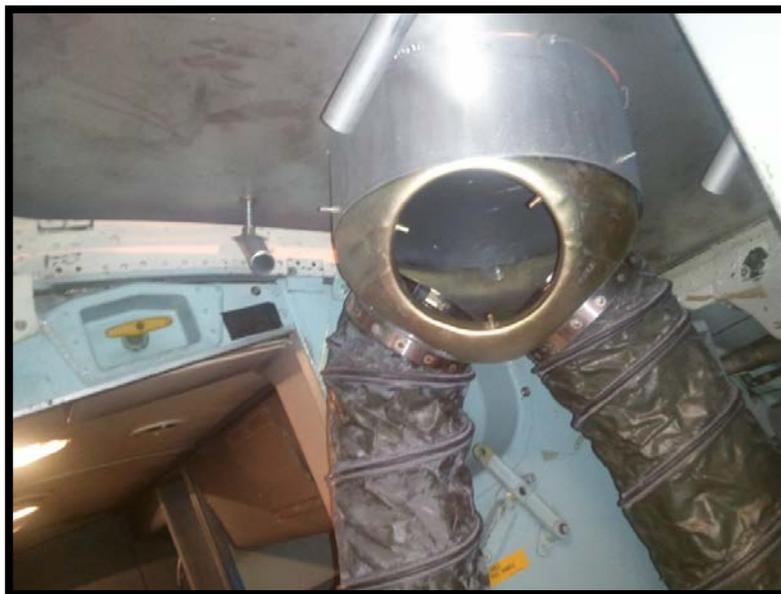
d. During the time of the chine cove survey, ample natural ventilation was provided by having both the forward and aft loading bay doors of the C-5 open and parallel to the open front and back hangar doors. These conditions provided variable cross-ventilation through the cargo compartment of the C-5. The outside hangar doors are kept closed during winter months. During flight deck sampling, an exhaust ventilation system was employed (Figure 4). However, only two of the three ducts were used, thereby significantly limiting the efficacy of the local exhaust due to the massive loss at the point of connection.

Figure 4: Local exhaust for flight deck painting operations

f. When painting in the flight deck, attach the third local exhaust duct for a third painter or cap the opening of the unused duct so that the flow of ventilation is maximized at the two painters' positions. A box fan could be placed near the access door to increase air movement if stagnant zones are a concern.
