PRON: R302C208R3
Focus: HOPE

Contract NO: W56HZV-05-C0721
WD-FH-0004 Task 2

Direct Deposition of Metal (DDM) as a Repair Process for Metallic Military Parts

1. REPORT DATE 20 JAN 2013	2. REPORT TYPE Technical Article	3. DATES COVERED 20-09-2010 to 20-01-2012			
4. TITLE AND SUBTITLE Direct Deposition of Metal (DDM) as a Repair Process for Metallic Military Parts		5a. CONTRACT NUMBER W56HZV-05-C0721			
		5b. GRANT NUMBER			
		5c. PROGRAM ELEMENT NUMBER

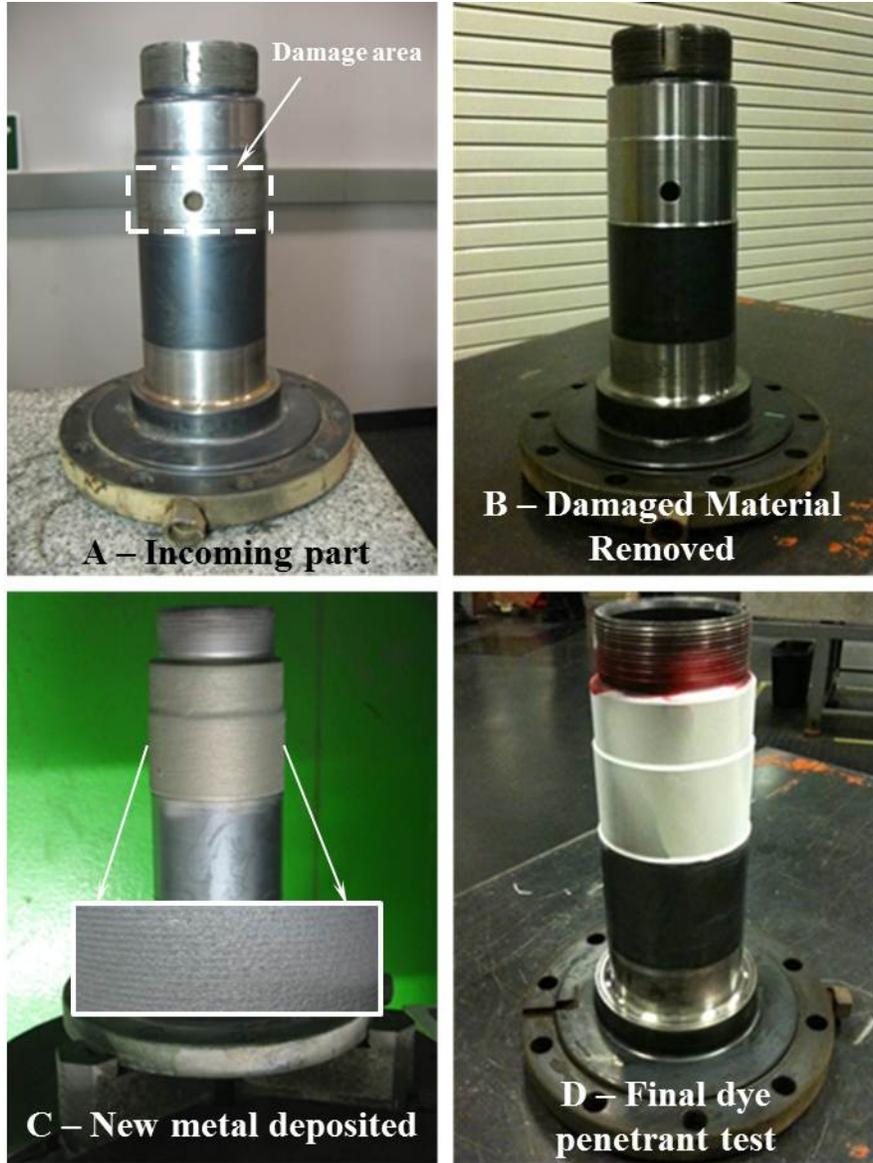
Figure 19: DDM repair process of M939 truck CTIS spindle

1. **Inspect the part:** Visually inspect the damaged part noting any noticeable defects (Figure 19-A).
2. **Baseline dimensioning:** Populate the pre-process inspection check sheet.

3. **Removal machining:** Using a Mazak 300 CNC machining center in a turning lathe configuration, remove the material from the damage area to a pre-determined diameter (Figure 19-B).

7. **Direct Deposition of Metal:** Using a pre-programmed tool path and DDM process parameters, the Hastelloy C276 is circumferentially deposited onto the prepared target surface in a layer-by-layer fashion (Figure 19-C).

9. **Dye penetrant test #2:** The completed part is dye penetrant tested again to ensure that it is free of flaws, cracks and pores (Figure 19-D).
10. **Final cleaning:** The part is completely cleaned and dried following the dye penetrant test.

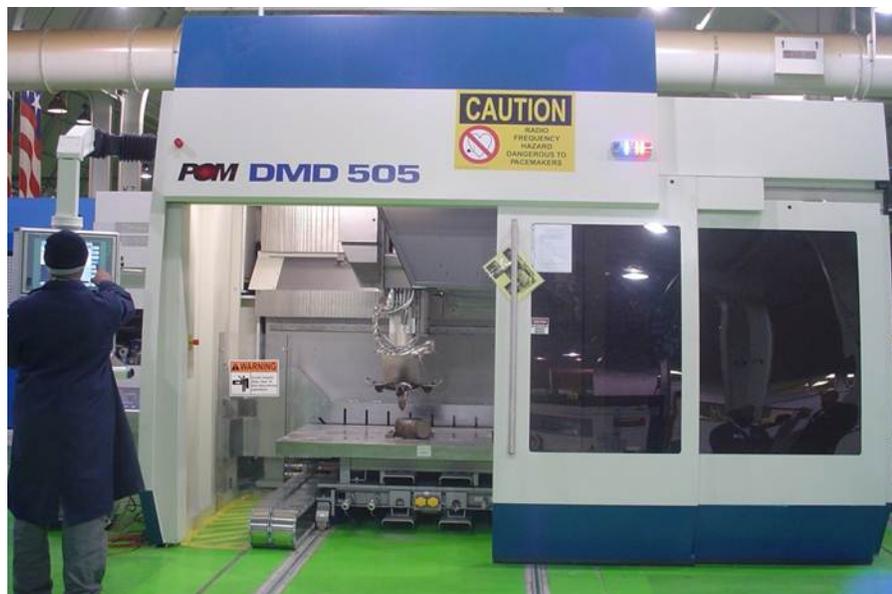
Figure A1: DMD 505 machine at Focus: HOPE Center for Advanced Technology

The POM DMD 505 machine is developed by POM Group based in Auburn Hills MI in collaboration with Trumpf Inc. The machine is designed to provide solutions for a multitude of material deposition tasks in the field of DDM application. The machine body is a torsion-resistant welded steel construction and designed for highest loads. The inherent rigidity of the machine body effectively prevents vibrations when changing directions. The use of weight-optimized laser-welded machine components, coupled with maintenance-free, digital three-phase servo motors, ensures optimal machine dynamics at high precision. Five NC controlled axes for 2D and 3D machining are located in the "flying optics" assembly. All guide ways are designed for the highest precision and protected against contamination and laser reflections. This ensures excellent machining quality and unsurpassed long-term reliability of the machine. The machine has a built in Trumpf CO₂ laser. The laser beam delivery system is purged with purified compressed air to ensure system reliability and uptime. The CO₂ lasers are mounted on a steel bracket attached to the machine body, thereby guaranteeing stable alignment between beam source and machine tool. Water-cooled telescope and bending mirrors ensure reliable continuous machine operation. A mirror telescope provides for the best possible adaptation of the CO₂ lasers to the variable beam path lengths of the beam guidance machine. AutoLas Plus is a system for automatic focus adjustment and programmable focus position during laser cladding. An alignment laser (pilot laser) of highest point stability is coupled into the beam guide way as a setup aid for the operator and for beam alignment. The laser beam is focused by means of copper mirror optics when cladding. The POM DMD SYSTEM is equipped with CO₂ lasers of the TRUMPF TLF series. TRUMPF TLF lasers are radio-frequency excited gas lasers. The laser power is infinitely adjustable. The excellent beam quality of the lasers ensures precise and dependable deposition results throughout the working range. The utilization of a radial turbine blower on magnetic bearings and an oil-free diaphragm vacuum pump reduces CO₂ laser maintenance to a minimum and ensures maximum availability. The integrated gas mixer unit
