Coating Performance in Duluth Superior Harbor—Part 1

RICHARD I. RAY AND BRENDA J. LITTLE, FNACE,
Naval Research Laboratory, Stennis Space Center, Mississippi

Nine coatings were evaluated for corrosion protection of carbon steel coupons and I-beams around Duluth Superior Harbor after 46 and 35 months, respectively. Coupons were intentionally scribed to metal before exposure. Part 1 of this article describes the coatings used and the locations of coupons and I-beams. Part 2, to be published in the October 2012 issue of MP, will discuss the results of the evaluation.

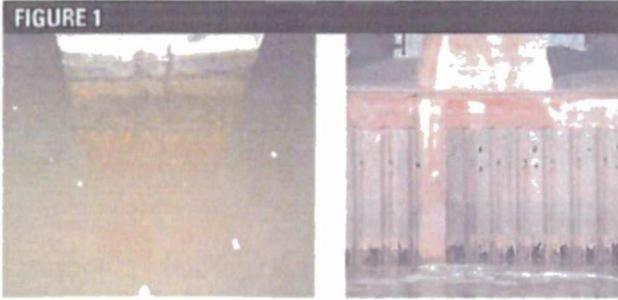
FIGURE 1
 Corrosion of pilings in DSH. Photos courtesy of Gene Clark, Wisconsin Sea Grant Program.

Sixteen miles (26 km) of carbon steel (CS) sheet piling (12-mm thick A328¹ cold rolled; used for docks, bridges, and bulkheads in the Duluth Superior Harbor (DSH) in Minnesota and Wisconsin are corroding at an accelerated rate of 3 mm/y or higher. Piling 30 years old or older are riddled with through-wall pitting (Figures 1[a] and [b]).

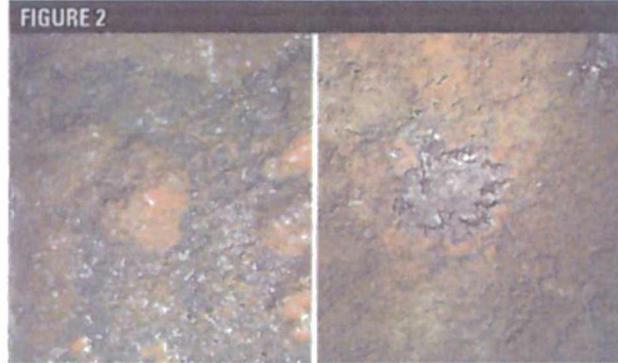
FIGURE 2
 (a) Wet corrosion tubercles and (b) dry corrosion tubercles on pilings in DSH.

The corroded pilings have an orange, rusty appearance characterized by tubercles (i.e., corrosion products and deposits covering areas of localized corrosion [Figures 2(a) and (b)]).

Divers reported that tubercles were randomly distributed from the waterline to ~3 m below the surface. Tubercles varied in diameter from a few millimeters to several centimeters and when removed, large and often deep pits were exposed. Divers also reported that the attached zebra mussel (*Dreissena polymorpha*) population was dense and few tubercles were observed below 3 m. Zebra mussels are small, fingernail-sized mussels native to the Caspian Sea. They were first observed in Lake St. Clair, Minnesota in 1988 and have since spread to all of the Great Lakes.

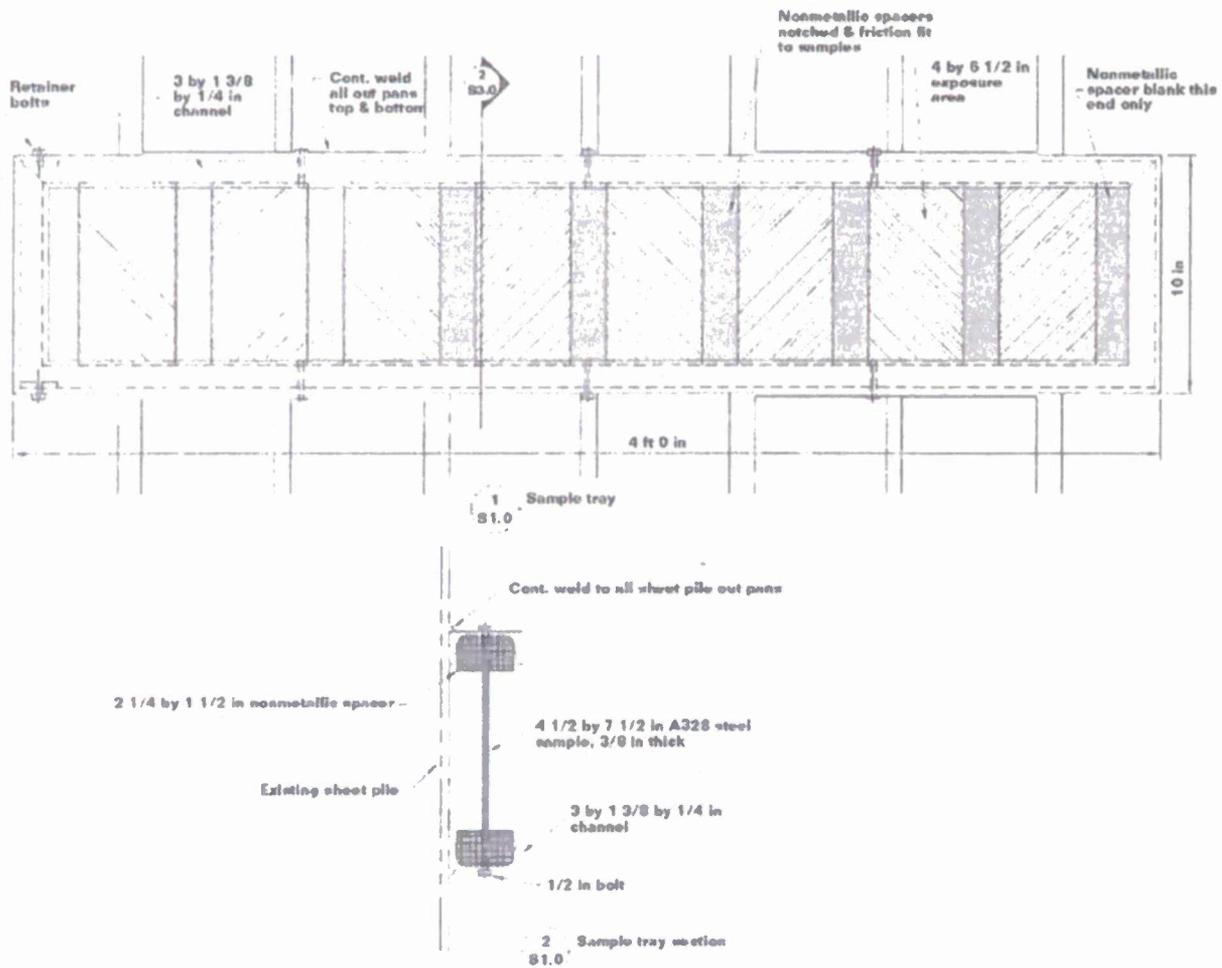
FIGURE 3

CS coupons in a sample tray at DSH.

Divers from AMI Consulting Engineers (Superior, Wisconsin) installed trays for coupons and I-beams. Eight sample trays containing eight 4.5 by 7.5 by 1.2-in (114 by 190 by 30-mm) thick A328 steel sample coupons per tray (Figure 3) were prepared.

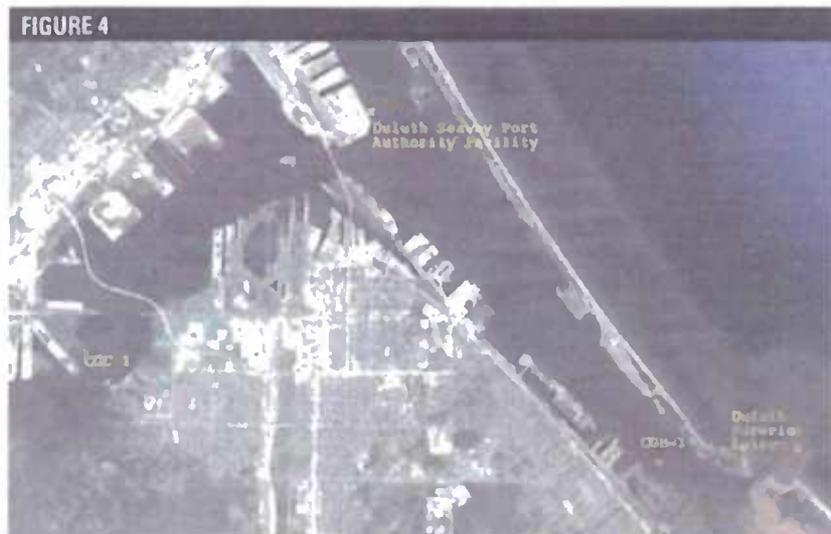
DSH sample locations, CGB-1, CGC-1 (coupons), and the Duluth Seaway Port Authority Facility (I-beams).

Each sample tray contained four coated and four uncoated steel coupons. A report³ prepared for the U.S. Army Corps of Engineers provides details about tray and coupon installation. Trays and coupons were installed on November 7, 8, and 13, 2007. Coupons were retrieved from two locations, U.S. Coast Guard Cell B (CGB-1) and U.S. Coast Guard Cell C (CGC-1) (Figure 4), in September 20, 2011. Table 1 presents coupon coating descriptions.

thority Facility (Figure 4) in September 2008. Table 2 provides I-beam coatings descriptions.

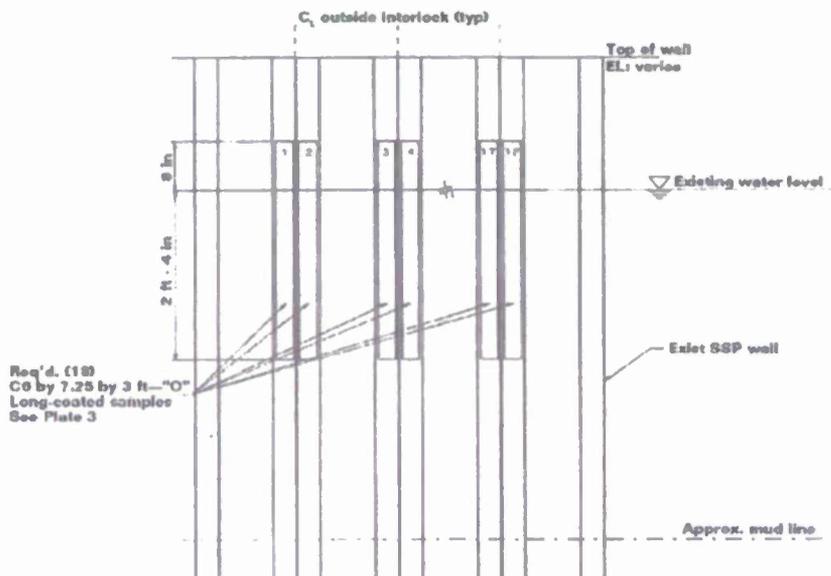
FIGURE 5

I-beam sample tray design and installation.

Trays designed to contain I-beams, 6 by 7 1/4 by 36 in (152 by 184 by 914 mm), were prepared (Figure 5) and installed at the Duluth Seaway Port Au-
