**AFRL-RH-WP-TP-2013-0073**

## **GLATZ PROTOTYPE SEAT IMPACT TESTING**

**Interim Report for January 2012 to May 2013**

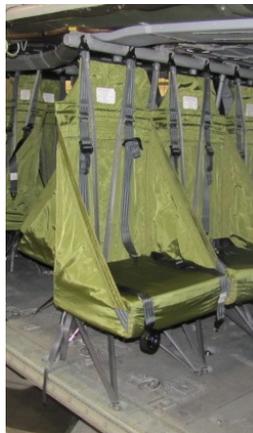
**Figure 1. Glatz Aeronautical Prototype Seat**

The Glatz seat is shown in Figure 1.

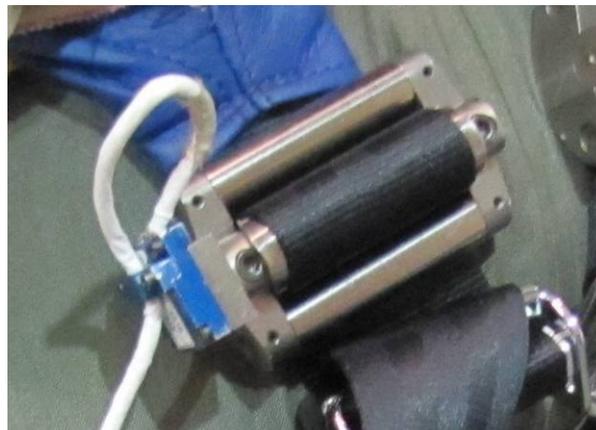
**Figure 5. Restraint Belt Load Cell**

The restraint instrumentation included in-line belt load cells (Figure 5). For several tests use of the lap belt load cells were not used as they would interfere with the restraint operation.

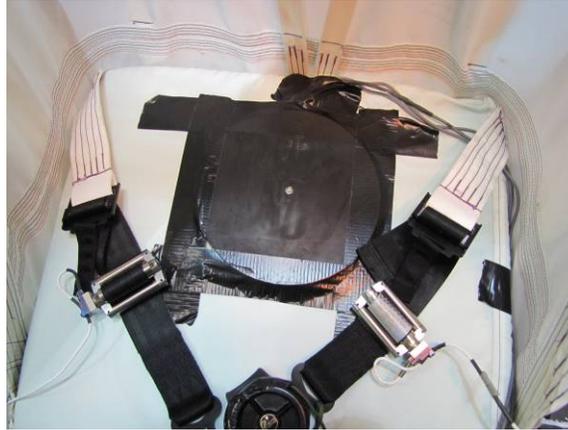
**Figure 6. Seat Pan Accelerometer Pack**

The seat instrumentation included three linear accelerometers encapsulated in a disk that was taped to the top of the seat pan fabric just under the manikin's buttocks. This is seen in Figure 6.

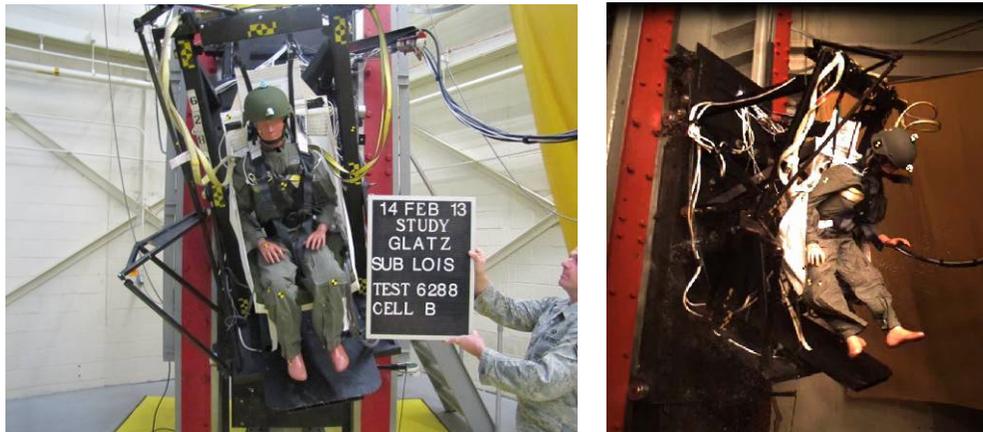
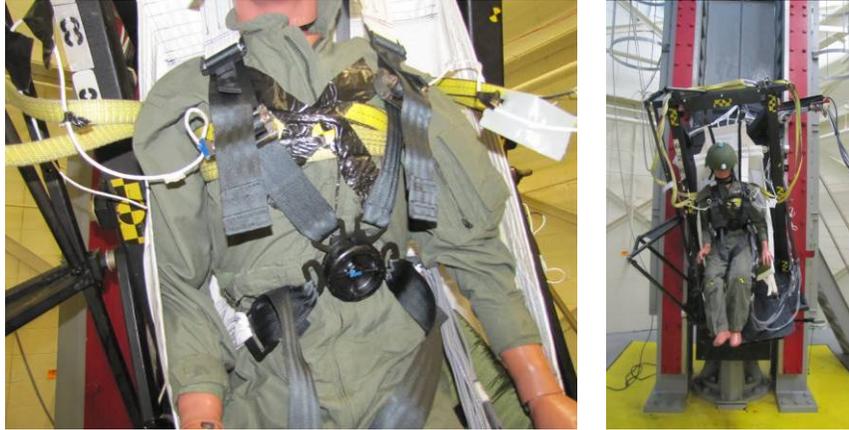
VDT6288 is a retest of VDT6223. Pictures from the test are shown in Figures 7 and 8. The lap belt load cells were not used during the test as there was no additional belt length available due to the size of the manikin. The lap restraint was tightened as far as possible, though a pre-load was not possible. The seat structurally stayed intact during the test. There was no ripping of the seat seen post test. However, the manikin rebounded and ‘bounced’ up off the seat pan after the initial impact, causing a high chest acceleration with a peak of 82.42g and a lumbar Z force of 1469.94lbs, exceeding the lumbar load limit of 933lb compression limit. The restraint buckle came up into the chest of the manikin.

**Figure 7. VDT6288 (L) Manikin position pre-test (R) Manikin rebound after initial pulse**

**Figure 8. VDT6288 (L) Restraint Buckle post-test (R) Manikin position post test**

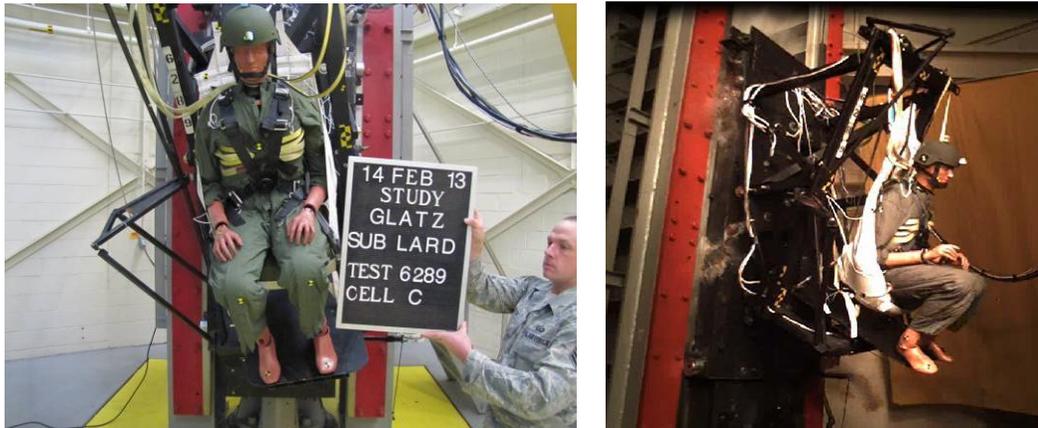
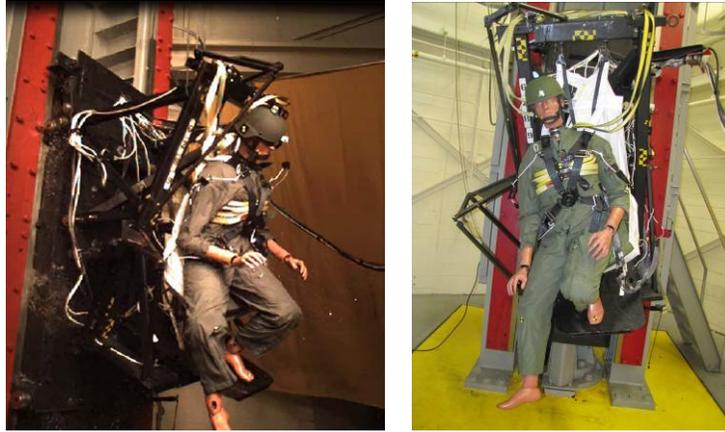
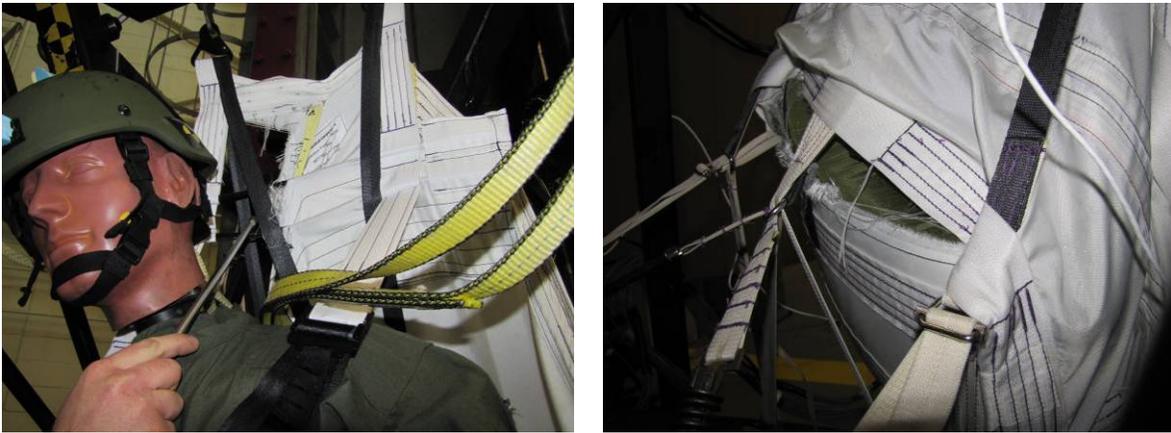
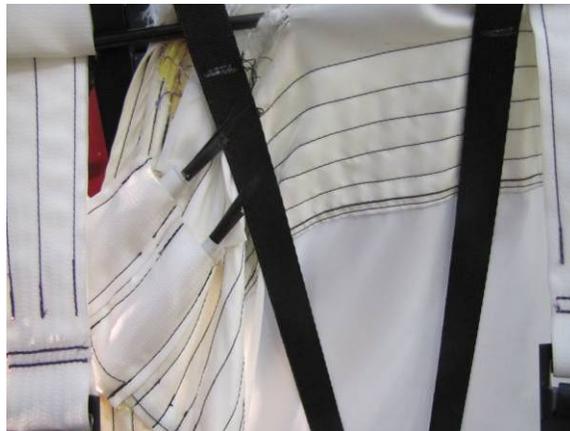
VDT6289 is a retest of VDT6226. Pictures from the test are shown in Figures 9, 10, 11, and 12. The lap belt load cells were usable with LARD. As the seat descended during the impact, the fabric on the upper right seat back ripped, and the spreader bars broke. The junction of the seat pan and the seat back ripped as well. However, the seat stayed attached to the fixture. As with VDT6288, the manikin rebounded after the initial pulse, though the resultant chest acceleration and peak lumbar Z force are within limits. It was decided not to continue testing with this version of the seat. After inspection of the seat, it is believed that there were deviations from the drawings supplied to the manufacturer that could have contributed to the structural failure of the seat.

**Figure 9. VDT6289 (L) Manikin initial position (R) Seat ripping during test**

**Figure 10. VDT6289 (L) Manikin rebound (R) Manikin post test**

**Figure 11. VDT6289 (L) Seat back ripping (R) Seat pan ripping**

**Figure 12. VDT6289 Spreader bar break**

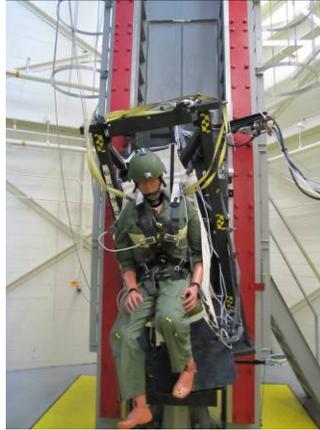
VDT6290 is a re-test of both VDT6226 and VDT6289. Pictures from the test are shown in Figures 13, 14, and 15. The seat structurally stayed intact during the impact, and all mounts remained attached to the fixture. There was some ripping of the stitching in the left spreader bar area. As with VDT6289 the manikin rebounded after the initial pulse, though the resultant chest acceleration and peak lumbar Z force are within limits.

**Figure 13. VDT6290 (L) Manikin initial position (R) Restraint**

**Figure 14. VDT6290 (L) Impact (R) Manikin rebound**

Figure 15. VDT6290 Manikin post test

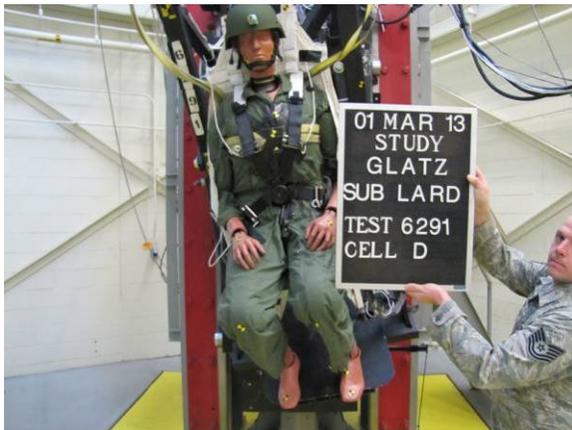
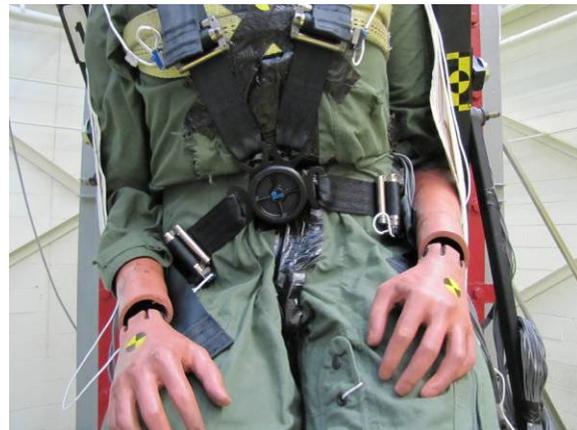
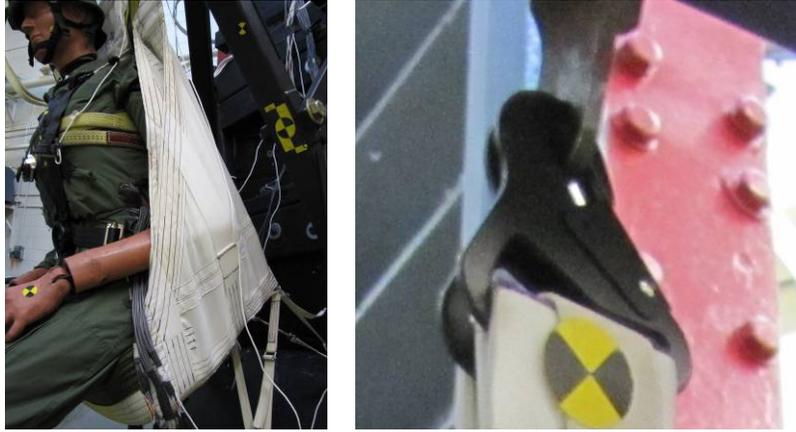
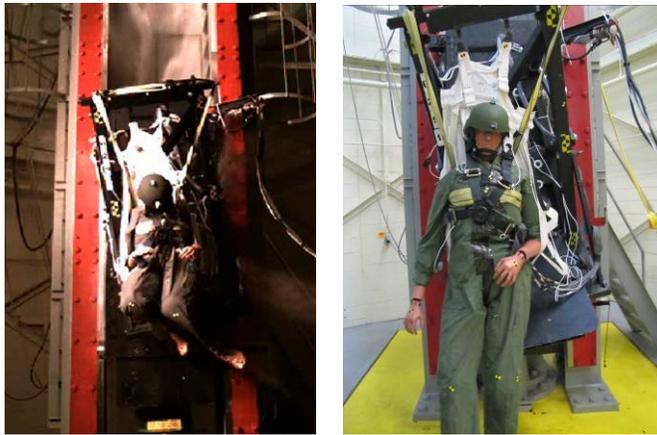
VDT6291 is the first Glatz test in Cell D. Pictures from the test are shown in Figures 16, 17, 18, and 19. One seat structure was embedded within another seat. Two upper attachment hooks were used on each side. During the impact one of the left upper attachment hooks broke. The manikin submarined out of the seat and was held by the restraints and safety tethers. Peak chest resultant acceleration was 57.09G, close to the limit of 60G. Peak lumbar Z force was 2045.31lb, below the limit of 2234.77lbs.

Figure 16. VDT6291 (L) Manikin initial position (R) Restraint

Figure 17. VDT6291 (L) Double seat structure (R) Double hooks

Figure 18 VDT6291 (L) Manikin impact and seat rip (R) Manikin post test

Figure 19. VDT6291 (L) Seat upper attachment (R) Broken upper attachment

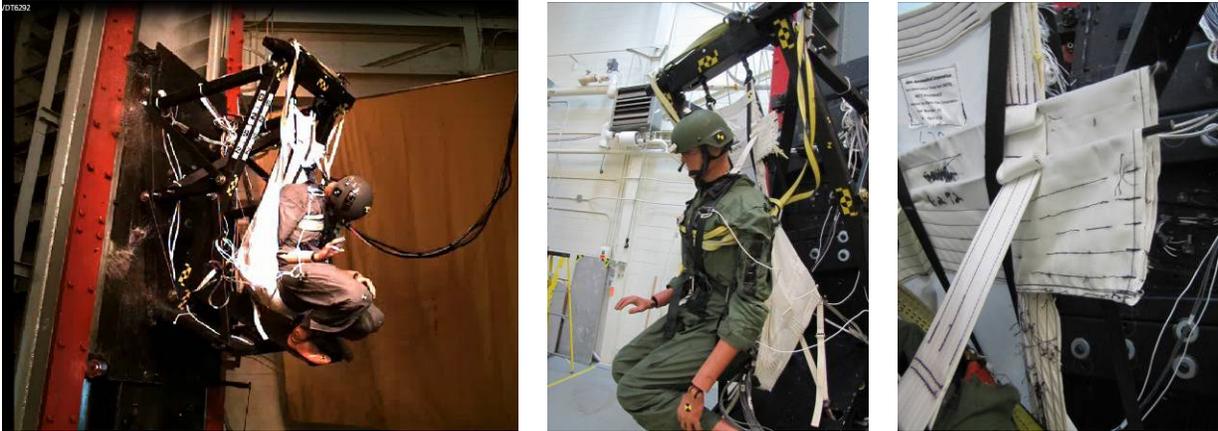
**VDT6292 – Cell C2, CV, Mrk5Mod2C, LARD, 31.48g, 44.58ft/s, 27.4ms rise time**  
 VDT6292 used a remanufactured seat from test VDT6290. Pictures from the test are shown in Figure 20. The purpose of the test was to see how a remanufactured seat responded to a second

Figure 20. VDT6292 (L) Impact (M) Manikin final position (R) Ripping upper left

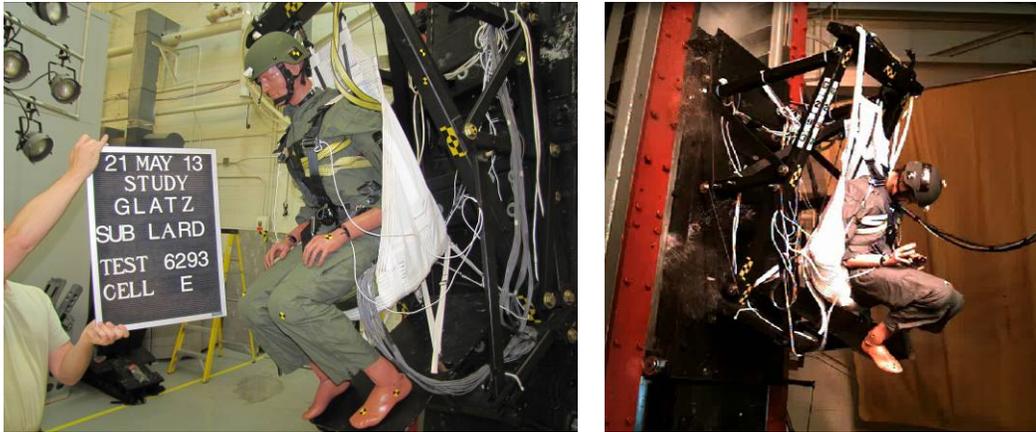
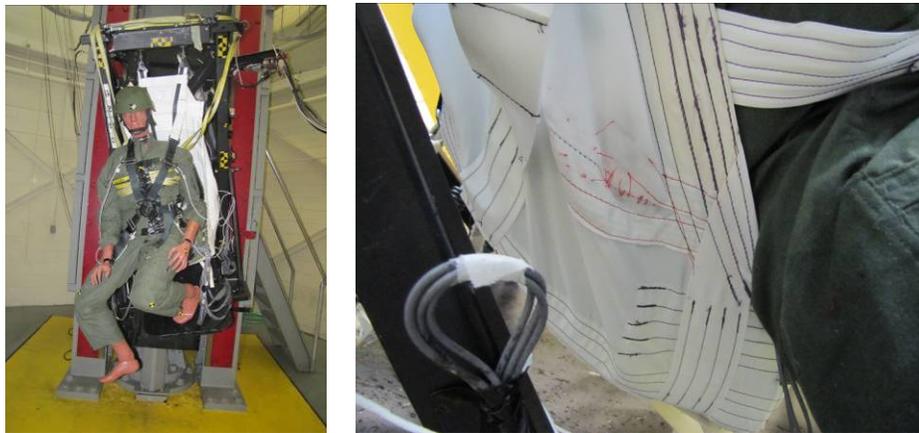
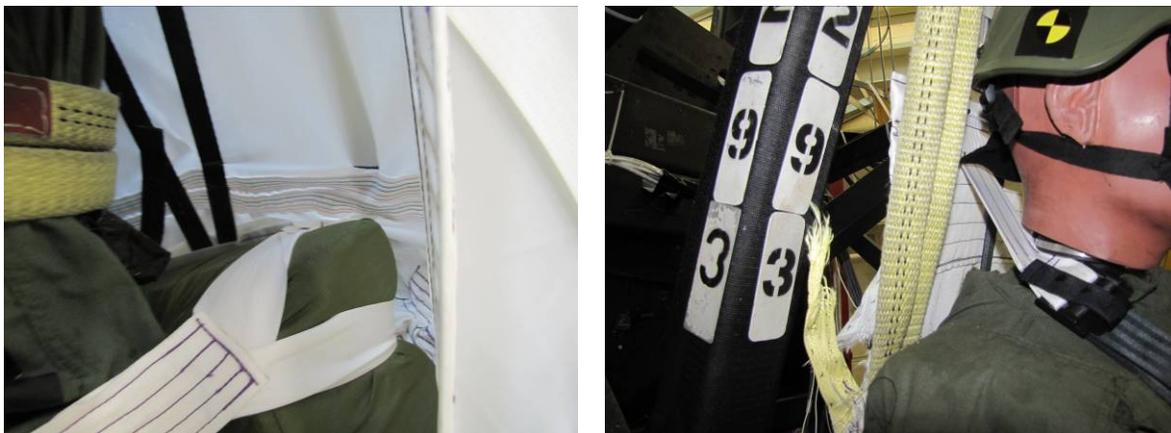
VDT6293 was the second test at the intermediate crash impact level. Pictures from the test are shown in Figures 21 and 22. The seat was a new seat and not one re-manufactured from a previously-tested seat. The manikin was successfully restrained in the seat during the test. As with VDT6292 the manikin began submarining in the seat, though the restraint successfully held the manikin during the impact. Rip stitching along the back and side of the seat pan successfully broke during the impact. The lap belts remained fixed to the seat structure. There was ripping of stitching close to the upper right spreader bars, though the seat successfully restrained the manikin during the impact. The peak chest resultant acceleration was 45.48g with a peak lumbar Z force of 1757.42lb. Both are within the injury criteria used for this program.

Figure 21. VDT6293 (L) Manikin pre-test, (R) Seat and manikin during test

Figure 22. VDT6293 (L) Manikin Post Test (R) Rip stitching on right seat pan

Figure 23. VDT6293 (L) Lap belt restraint post-test (R) Upper right stitching ripping

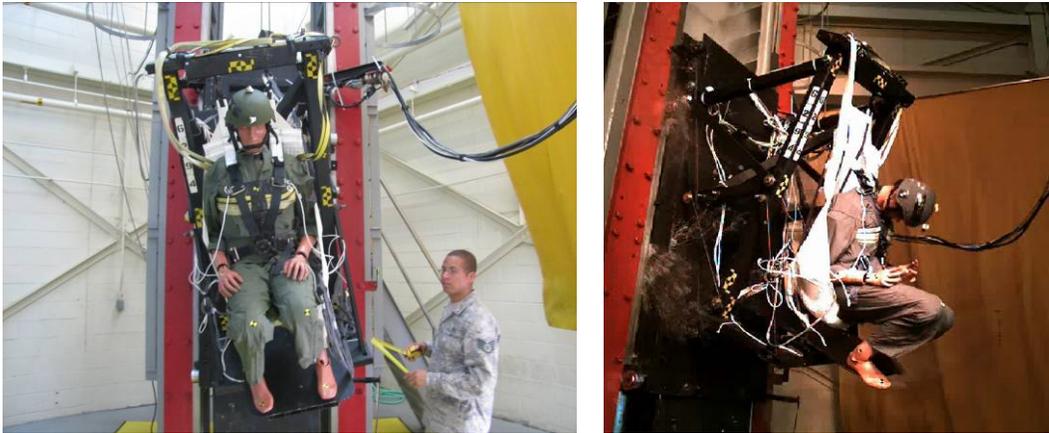
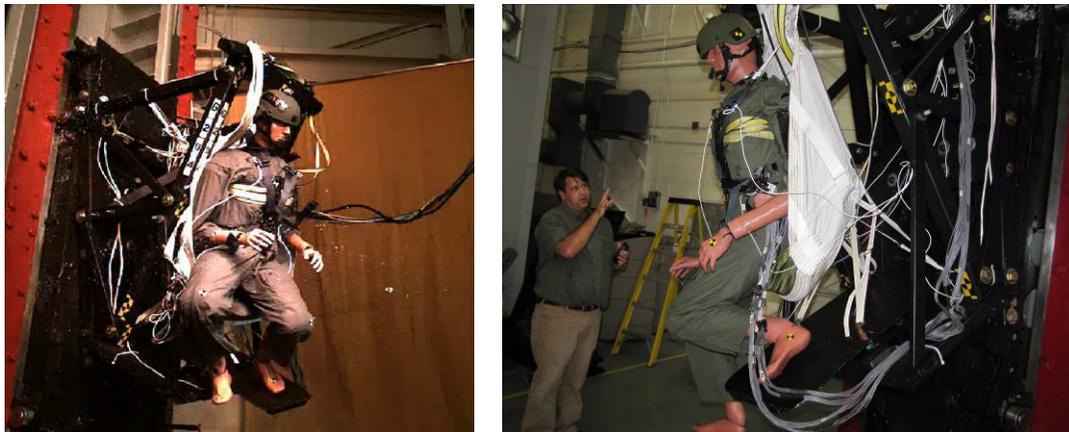
Pictures from the test are shown in Figures 24, 25, and 26. The upper right portion of the seat close to the spreader bars broke. The manikin remained in the seat, though considerable rebound of the manikin was seen after the primary crash impact. Also, considerable submarining of the manikin was seen during the impact as the restraint buckle was forced into the manikin's abdomen and chest. The manikin's spine was out of position post-test. A peak chest resultant acceleration of 55.31g and a peak lumbar Z force of 2118.09lb were recorded. Both are within the established injury criteria used for this program.

**Figure 24. VDT6294 (L) Manikin position pre-test (R) Manikin during impact**

**Figure 25. VDT6294 (L) Manikin swinging left to right during rebound (R) Manikin position post-test**

Figure 26. VDT6294 (L) Right lap belt post-test (R) Right upper ripping

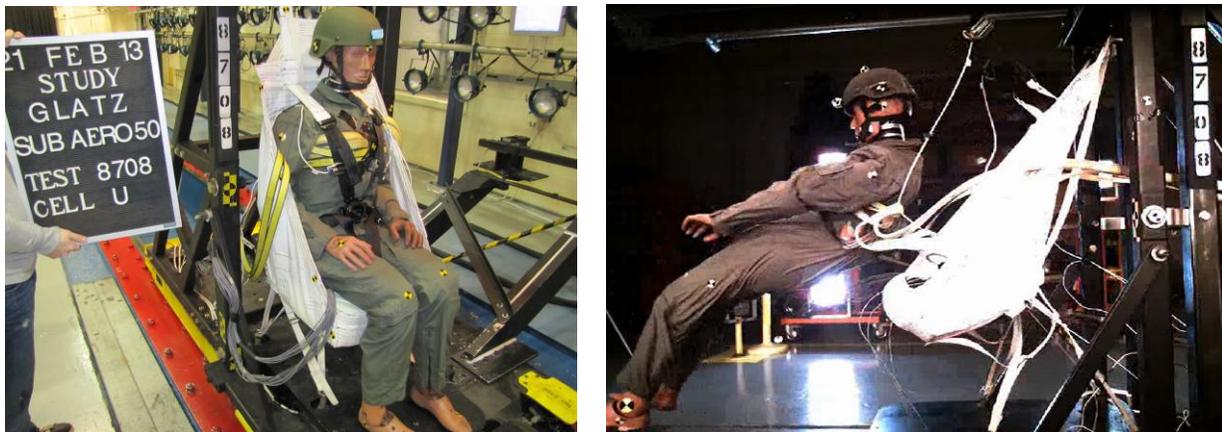
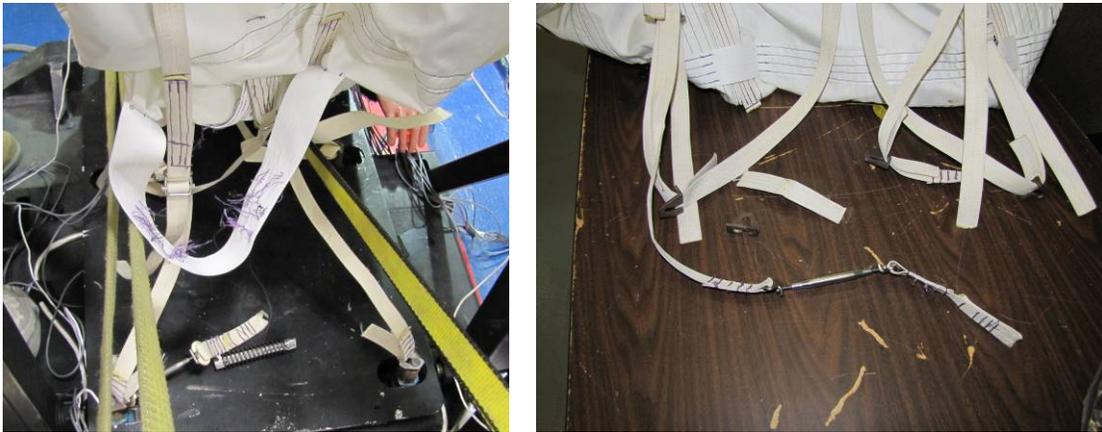
This HIA test was the only PH test conducted with the Glatz seat and the only test with a HB50 manikin. Pictures from the test are shown in Figures 27, 28, and 29. The test was conducted to determine structural integrity of the seat. The torso belts appear to detach during the impact, fully loading the lap belt. The lap belt completely detached from the seat structure, and the manikin was no longer restrained in the seat. The rear attachment webbing tensioners broke during the impact as the seat and manikin are pulled towards the front of the sled.

Figure 27. HIA8708 (L) Manikin initial position (R) Manikin flying off seat

Figure 28 HIA8708 (L) Manikin position post test (R) Lap belt

Figure 29. HIA8708 Broken webbing tensioners

will require additional modifications to improve energy attenuation capability during a crash event. In the Pure Horizontal test, the seat structurally failed, suggesting that further redesign is necessary.
