# **PZT Active Frequency Based Wind Blade Fatigue to Failure Testing Results for Various Blade Designs**

R. J. WERLINK

13. SUPPLEMENTARY NOTES <b>See also ADA580921. International Workshop on Structural Health Monitoring: From Condition-based Maintenance to Autonomous Structures. Held in Stanford, California on September 13-15, 2011 . U.S. Government or Federal Purpose Rights License.</b>

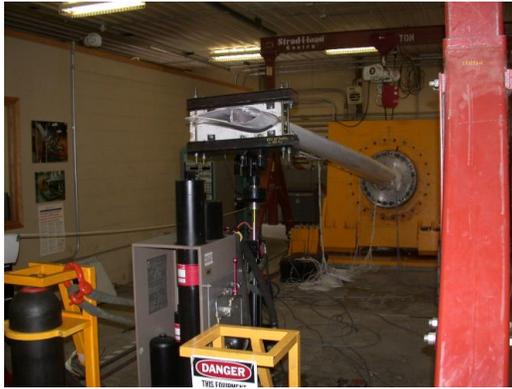
Figure 2 shows the Fatigue Test loading for the CX-100 and TX-100 blades (Free blade ends were cut off to aid in control of loading)

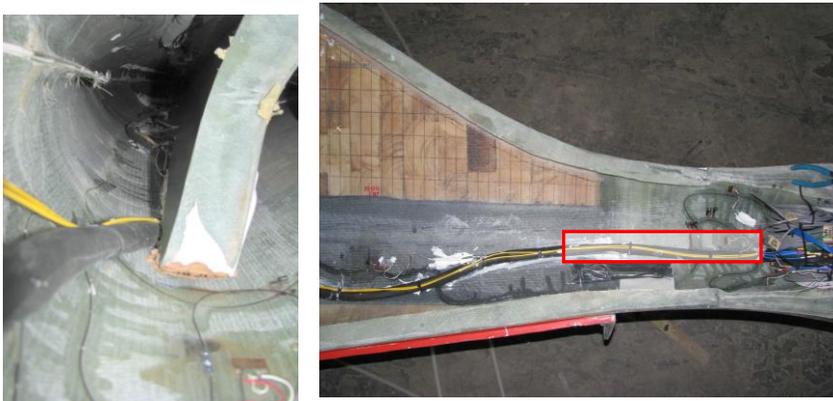
The defect shown below was unintentional manufactured into the Sensor Blade; one of the sensor cable bundles, inside the blade, were accidentally sandwiched between the high-pressure skin and the spar cap, in a critical area in the root section of the blade. However the defect provided an opportunity to evaluate Health monitoring system response

Figure 9 shows the location of the void under the shear web

the red rectangle shows the problem area located between 0.4-0.8

meters under the shear web.

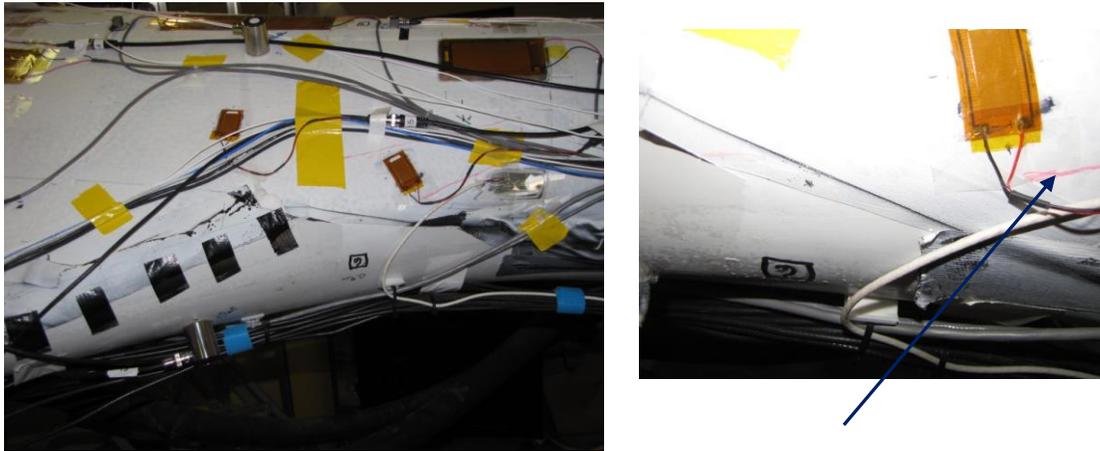
Figure 10 Results of Sensor Blade Fatigue Test

Early surface cracks noticed at 25k load cycles near internal shear web bonding cable manufacturing defect Figure showing manufacturing cause delamination<sup>7</sup>

The early edge surface cracks were likely caused by the manufacturing defect, delimitation occurred below the surface very close to PZT sensor 3 and it showed a much higher output voltage reflecting the high strain. After this the fatigue loads were taken up by other structure with blade failure occurring finally through the shear web showing up on the opposite side. See below for post test photographs:
