Encrypted Tracking System (ETS) Integration for  
Maryland Natural Resources Police (NRP) and the  
Maritime Tactical Operations Group (MTOG)

NRL/PU/8140--13-586  
October 2013

#### 4.1 NRP 104, *Calvert*

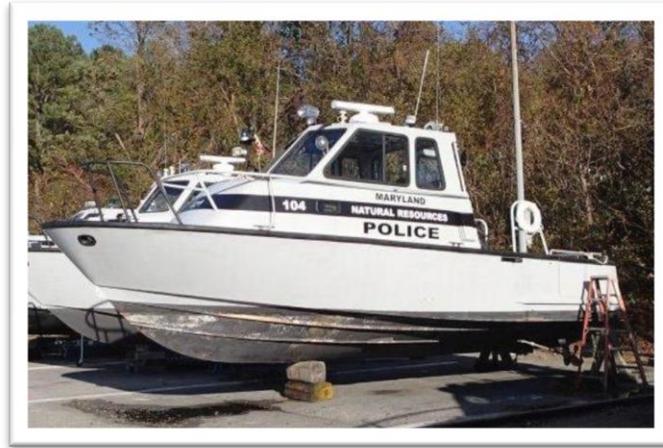
Figure 4.1.1 NRP 104, *Calvert*

This Boston Whaler was deemed too large for the garage, requiring work to be performed while dry docked outdoors (see Figure 4.1.1 NRP 104, *Calvert*). The vessel's mast was unsuitable for the antenna installation because its oval shape would not accommodate the cable clamps, and it did not have sufficient area to accommodate the two antenna mounts.

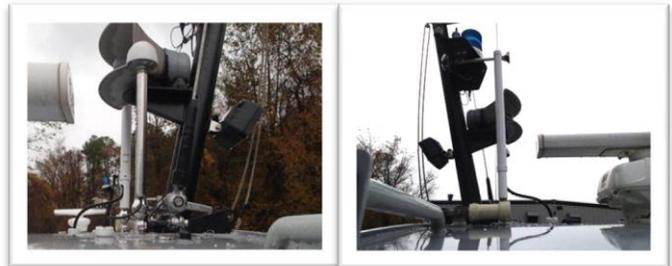
Figure 4.1.2 GPS and VHF Antennas

The GPS and Very High Frequency (VHF) antennas were installed on the roof of the vessel (see Figure 4.1.2 GPS and VHF Antennas). The vessel's internal cable ways were used for antenna cable routing (see Figure 4.1.3 Cable Access). The transponder was mounted on the console (see Figure 4.1.4 Transponder), and it was connected to the existing Garmin chart plotter.

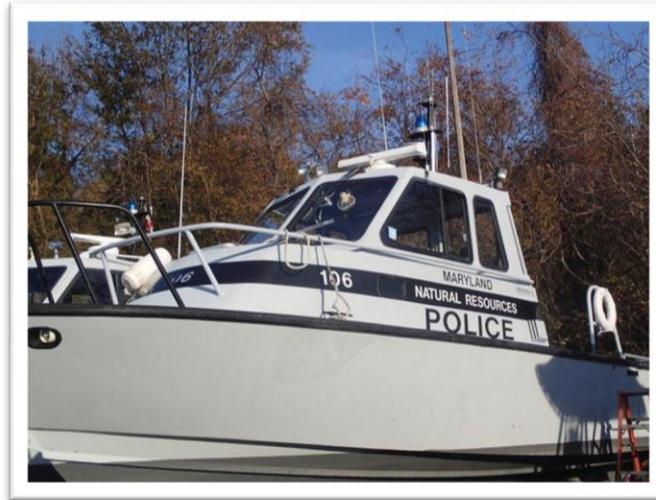
Figure 4.2.1 NRP 106, *St. Mary's*

This Boston Whaler was deemed to be too large for the garage, requiring work to be performed while dry docked outdoors (see Figure 4.2.1 NRP 106, *St. Mary's*).

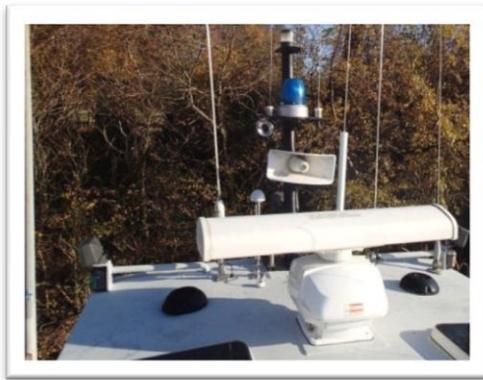
Antenna installation was similar to NRP 104 and no difficulties were encountered (see Figure 4.2.2 Antenna and Figure 4.2.3 Transponder). The GPS and VHF antennas were installed on the roof of the vessel. The vessel's internal cable ways were used for antenna cable routing. The transponder was mounted on the console (see Figure 4.2.4 Console), and it was connected to the existing Garmin chart plotter.

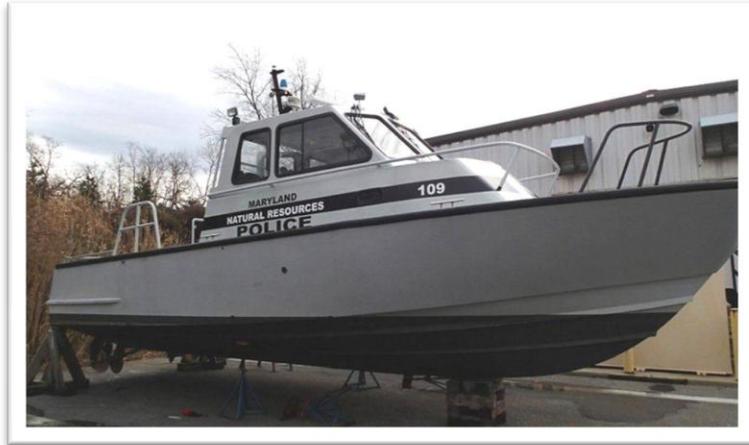
Figure 4.3.1 NRP 109, *Worcester*

This 36 foot Sea Ark required the installation of new cable clams to accommodate the VHF and GPS cables and to ensure water tight integrity (see Figure 4.3.1 NRP 109, *Worcester*).

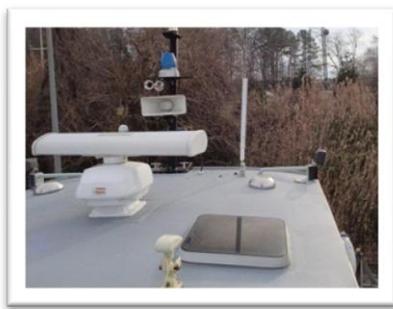
Figure 4.3.2 Antenna

The antenna mounts for the GPS and VHF antennas were mounted to existing antenna mounting locations (see Figure 4.3.2 Antenna). The transponder was located on the starboard dash and the cables were routed down the window channel with the radar control cable (see Figure 4.3.3 Transponder). Power and ground lines were run to the electrical panel. Power for the unit is provided by the Radar power switch.

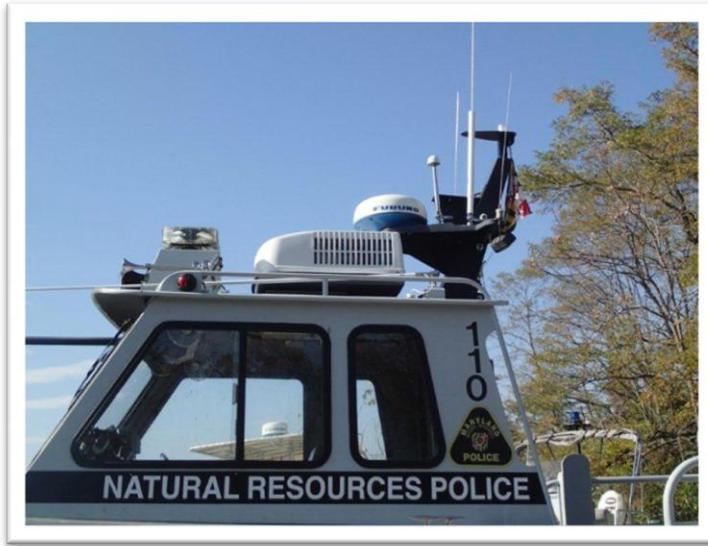
Figure 4.4.1 NRP 110, *National Harbor*

This 25 foot Sea Ark had sufficient space for the antenna mounts and antennas to be mounted while still leaving clearance for the infrared camera (see Figure 4.4.1 NRP 110, *National Harbor*). A power source/switch for the transponder was identified on the power panel. This vessel did not have a shelf under the port console.

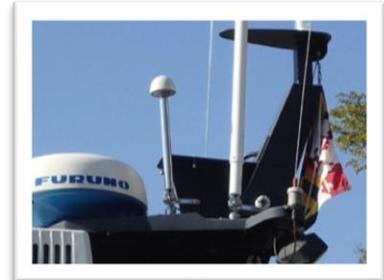
Figure 4.4.2 Antenna

GPS and VHF Antennas were located on the mast and cable clams were installed in the mast to accommodate the cables (see Figure 4.4.2 Antenna). Cable routing was straight forward with no issues. The transponder was wired to the power panel. The transponder was mounted under the lower edge of the console and positioned to allow for sufficient space between the port passenger seat and the unit (see Figure 4.4.3 Console and Figure 4.4.4 Transponder). This location is preferred for ease of operation of the AIS unit.

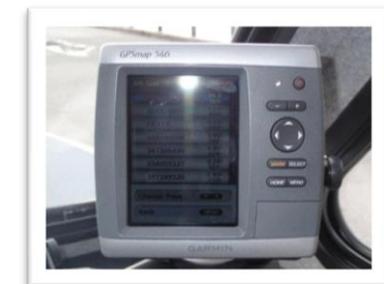
Figure 4.4.5 Garmin

The transponder was configured in accordance with the installation checklist. The integration of the chart plotter (see Figure 4.4.5 Garmin) was completed after troubleshooting indicated that Garmin uses a non-standard labeling for their communications wiring schematic, which caused delays in the integration of the system. Once the correct wiring scheme was identified, the integration was easily completed.

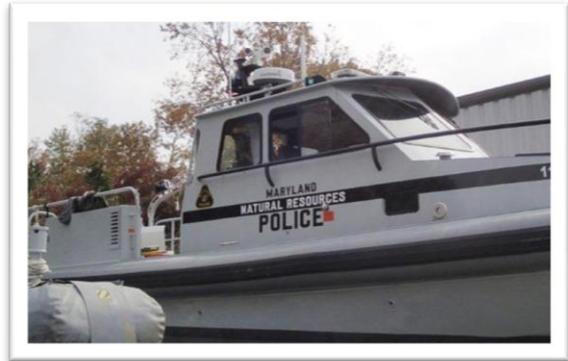
Figure 4.5.1 NRP 111, *Mattawoman*

This 45 foot Sea Ark (see Figure 4.5.1 NRP 111, *Mattawoman*) did not have sufficient space on the mast to install the GPS and VHF antennas. A roof mount would require cable routing to go through the lower galley and head in order to reach the console. There was no room on the NAV power switch to accommodate the AIS unit.

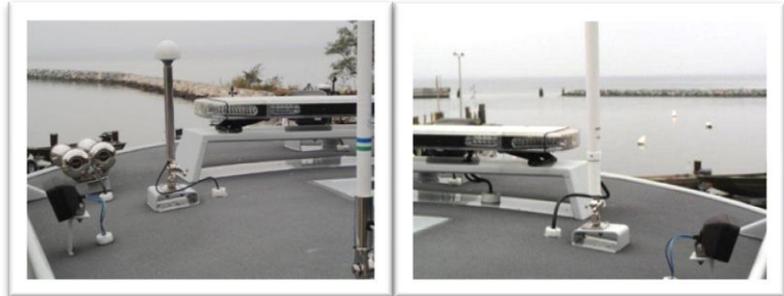
Figure 4.5.2 Antennas

Two antenna mounts forward of the mast were used for antenna installation (see Figure 4.5.2 Antennas). The transponder was located on the pilot side of the console toward the centerline, allowing for clearance of other equipment and ease of integration with the Garmin 7215 navigation system (see Figure 4.5.3 Transponder).

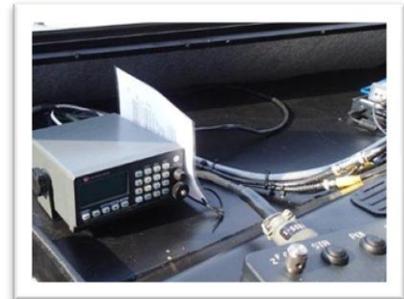
Figure 4.5.3 Transponder

Power for the transponder was taken from the main power panel switch. A terminal block was installed in the console to integrate the AIS unit with the Garmin Navigation system.

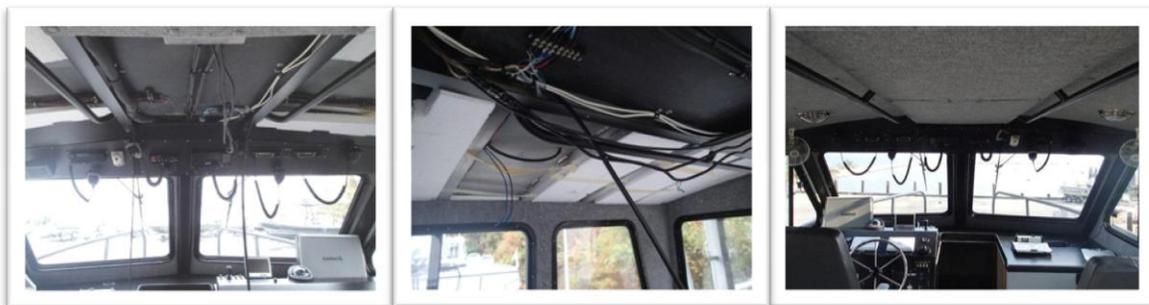
Figure 4.5.4 Ceiling Cables

To install the cables between the antennas with the transponder, all the ceiling panels in the cabin, lower galley area, and head were removed. Upper cabin power lines to the station lighting and ventilation fans were hard-wired and had to be cut out to remove the panels. The upper cabin lights and fans were reconnected using connectors that allow panel removal without cutting the power cables. After cable routing was accomplished, ceiling panels were reinstalled (see Figure 4.5.4 Ceiling Cables).

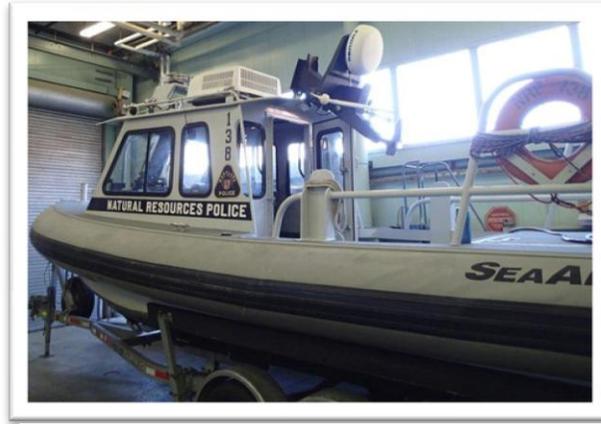
Figure 4.6.1 NRP 138, *Piney Point*

This 25 foot Sea Ark had sufficient space for the antenna mounts and antennas to be mounted while still leaving clearance for the infrared camera (see Figure 4.6.1 NRP 138, *Piney Point*). A power source/switch for the transponder was identified on the power panel.

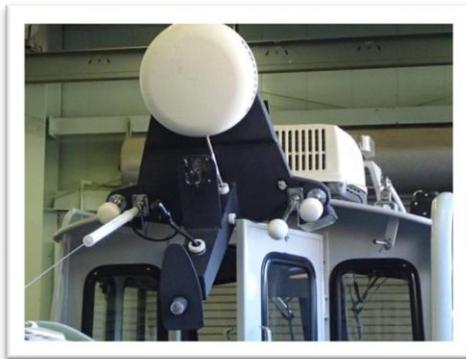
Figure 4.6.2 Mast

GPS and VHF Antennas were located on the mast and cable clams were installed in the mast to accommodate the cables (see Figure 4.6.2 Mast). The transponder was wired to the power panel. The transponder was mounted to the lower edge of the console and positioned to allow for sufficient space between the port passenger seat and the unit (see Figure 4.6.3 Transponder). The integration of the transponder and Garmin chart plotter was completed and verified.

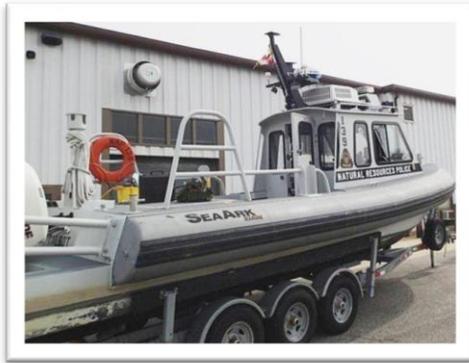
Figure 4.7.1 NRP 139, *Talbot*

This is a 25 foot Sea Ark (see Figure 4.7.1 NRP 139, *Talbot*). The radar display and radio prohibited access to the cable chase. There was sufficient space in the console to flush-mount the transponder.

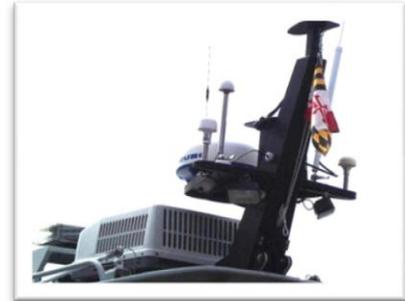
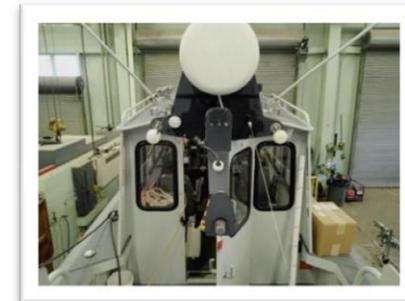
Antennas were installed on the mast (see Figure 4.7.2 Mast & Antenna and Figure 4.7.3 Mast) and antenna cables were routed through the overhead and down the cable chase in the center of the window (see Figure 4.7.4 Overhead). The Forward Looking Infrared (FLIR) camera laptop mount was attached on the deck amidships between the pilot and passenger (see Figure 4.7.5 Console). Power for the transponder was connected to the SPARE switch on the Direct Current (DC) power panel.

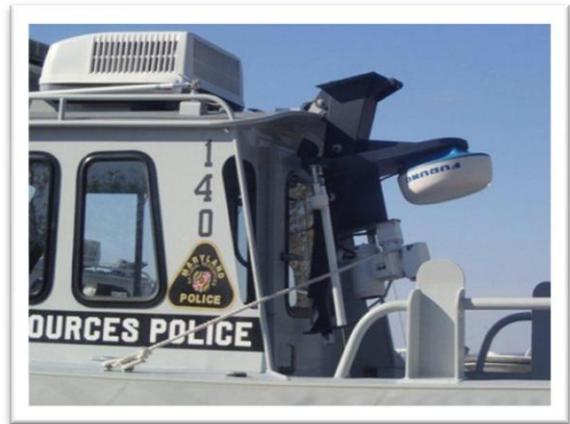
Figure 4.8.1 NRP 140, *Baltimore*

This 25 foot Sea Ark had sufficient space for the antenna mounts and antennas to be mounted while still leaving clearance for the infrared camera (see Figure 4.8.1 NRP 140, *Baltimore*). A power source/switch for the transponder was identified on the power panel.

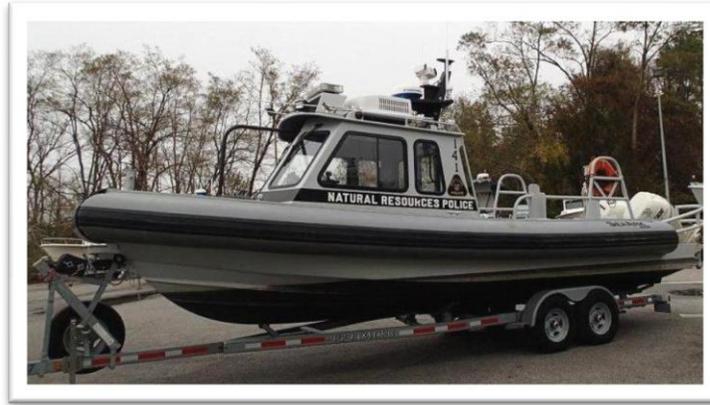
Figure 4.9.1 NRP 141, *City Dock*

This 25 foot Sea Ark had sufficient space for the antenna mounts and antennas to be mounted while still leaving clearance for the infrared camera (see Figure 4.9.1 NRP 141, *City Dock*). A power source/switch (Spare) for the transponder was identified on the power panel.

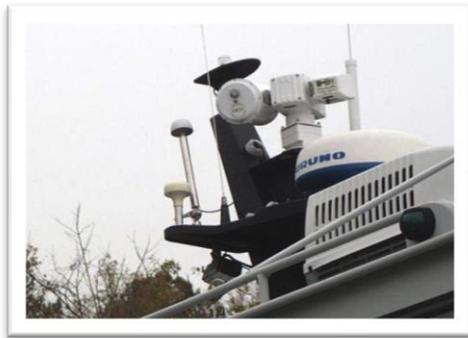
GPS and VHF Antennas were located on the mast and cable clams were installed in the mast to accommodate the cables (see Figure 4.9.2 Starboard Antenna and Figure 4.9.3 Port Antenna). The transponder was wired to the power panel. The transponder was mounted on the lower edge of the console and positioned to allow for sufficient space between the port passenger seat and the unit (see Figure 4.9.4 Transponder). This location is preferred for ease of operation of the AIS unit. The integration of the transponder and Garmin chart plotter was completed and verified.

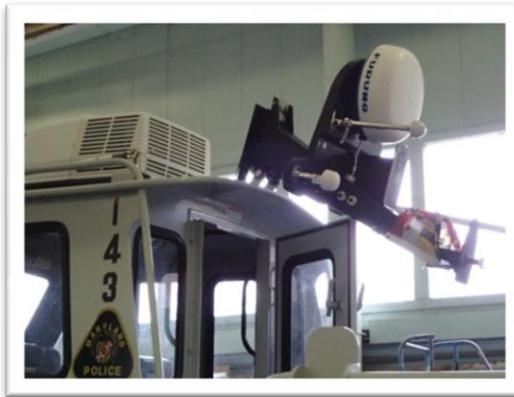
Figure 4.10.1 NRP 143, *Deal Island*

This 25 foot Sea Ark had sufficient space for the antenna mounts and antennas to be mounted while still leaving clearance for the infrared camera (see Figure 4.10.1 NRP 143, *Deal Island*). A power source/switch (Spare) for the transponder was identified on the power panel.

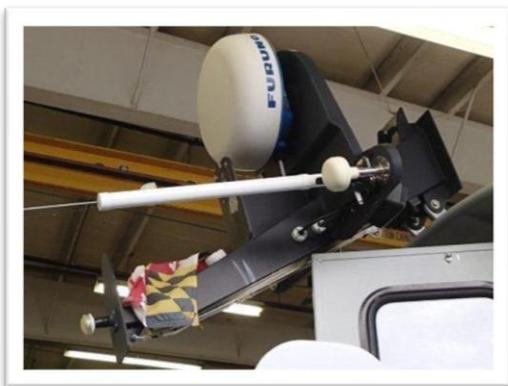
Figure 4.10.2 Mast & Antenna

GPS and VHF Antennas were located on the mast and cable clams were installed in the mast to accommodate the cables (see Figure 4.10.2 Mast & Antenna). The transponder was wired to the power panel. The transponder was mounted on the shelf below the port side console (see Figure 4.10.3 Console and Figure 4.10.4 Transponder). The integration of the transponder and Garmin chart plotter was completed and verified.

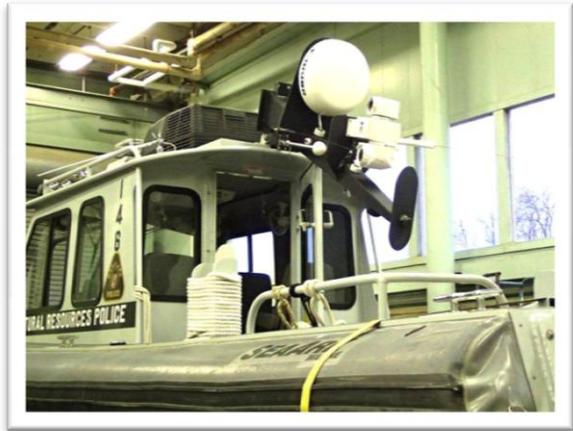
Figure 4.12.1 NRP 146, *Solomon's Island*

This 25 foot Sea Ark had sufficient space for the antenna mounts and antennas to be mounted while still leaving clearance for the infrared camera (see Figure 4.12.1 NRP 146, *Solomon's Island*). A power source/switch (Spare) for the transponder was identified on the power panel.

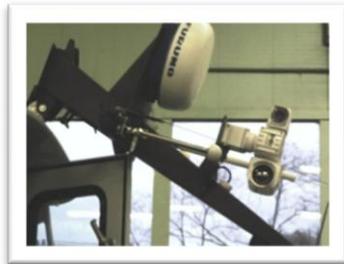
GPS and VHF Antennas were located on the mast and cable clams were installed in the mast to accommodate the cables (see Figure 4.12.2 Mast and Figure 4.12.3 Antenna). The transponder was wired to the power panel. The transponder was mounted on the shelf below the console on the port side (see Figure 4.12.4 Transponder). The integration of the transponder and Garmin chart plotter was completed and verified (see Figure 4.12.5 Garmin).

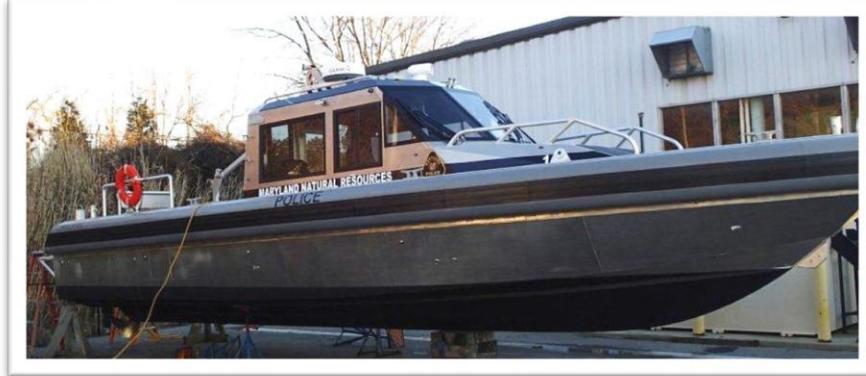
Figure 4.13.1 NRP 147, *Severn*

This 38 foot Metal Shark had an unused mounting cleat on the roof of the vessel (see Figure 4.13.1 NRP 147, *Severn*). A power source/switch (Spare) for the transponder was identified on the power panel.

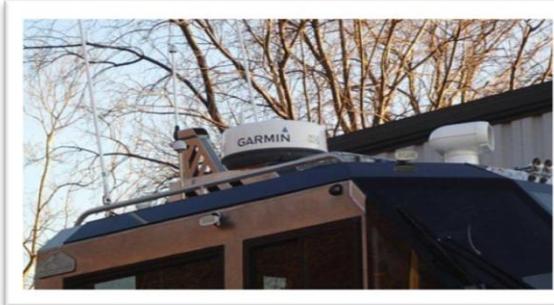
GPS and VHF Antennas were located on the mast and cable clams were installed in the roof to accommodate the cables (see Figure 4.13.2 Antenna and Figure 4.13.3 Wiring). The transponder was wired to the power panel. The transponder was installed onto the console and flush-mounted on the port side of the console (see Figure 4.13.5 Console and Figure 4.13.4 Transponder). The integration of the transponder and Garmin 7000 series chart plotter was completed and verified.

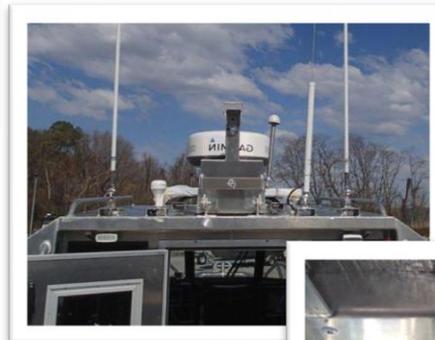
Figure 4.14.2 Antenna

The VHF antenna mount was installed to an available bracket next to the mast. The GPS antenna and mount were installed onto the side of the mast below the camera mounting area (see Figure 4.14.2 Antenna). Penetrations for the cables were made and the cable glands installed (see Figure 4.14.3 Overhead). A hole was cut into the port side console to flush-mount the transponder (see Figure 4.14.4 Transponder). Power and ground cables were routed from the transponder to the Starboard Side DC power panel. The circuit breaker and switch were then tested and the cables terminated. The cables for the GPS and VHF antennas were routed through the ceiling and down the windshield cable chase, terminated and connected to the transponder. All cables were secured into place and the ceiling panels were reinstalled.

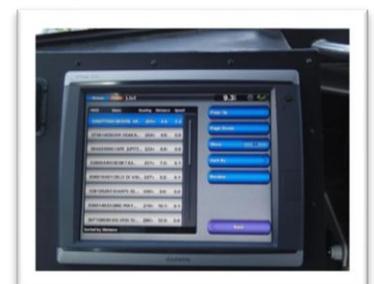
Figure 4.14.5 Plotter

The Data cable was routed to a suitable area in the Port electrical bay. A terminal block was installed to make the connections, and the chart plotter (see Figure 4.14.5 Plotter) was connected on NMEA channel 2.

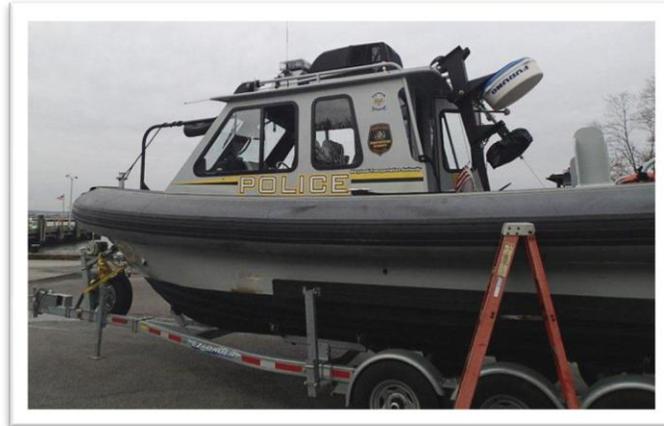
Figure 4.15.1 MD Transportation Authority Police, *Marine One*

This 25 foot Sea Ark had sufficient space for the antenna mounts and antennas to be mounted while still leaving clearance for the infrared camera (see Figure 4.15.1 MD Transportation Authority Police, *Marine One*). A power source/switch (Spare) for the transponder was identified on the power panel.

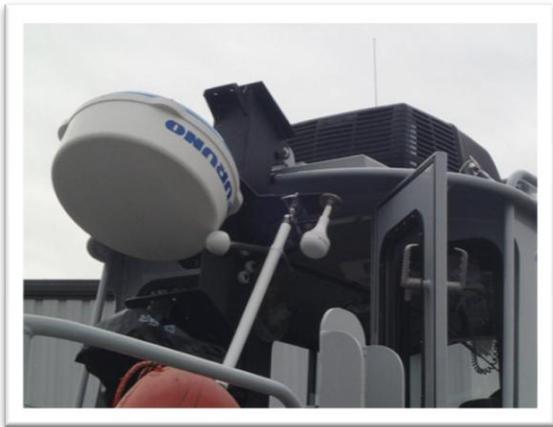
Figure 4.15.2 Mast & Antenna

GPS and VHF Antennas were located on the mast and cable clams were installed in the mast to accommodate the cables (see Figure 4.15.2 Mast & Antenna). The transponder was wired to the power panel. The transponder location was discussed with the vessel operator and located to the port side below the console on a built-in tray (see Figure 4.15.3 Transponder). The integration of the transponder and Garmin chart plotter was completed and verified.

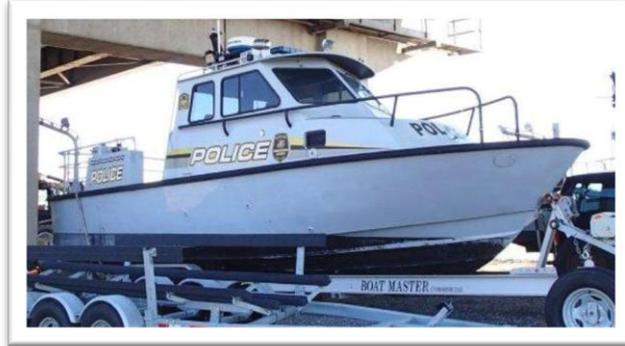
Figure 4.16.1 MD Transportation Authority Police, *Marine Two*

This older, 36 foot Sea Ark was located under the Key Bridge in Dundalk, Maryland, and required a gasoline generator to provide 110 voltage alternating current (VAC) power for the installation (see Figure 4.16.1 MD Transportation Authority Police, *Marine Two*). Antenna mount installation areas and a spare power switch were identified. The vessel was equipped with a RDP139 chart plotter, which does not support AIS.

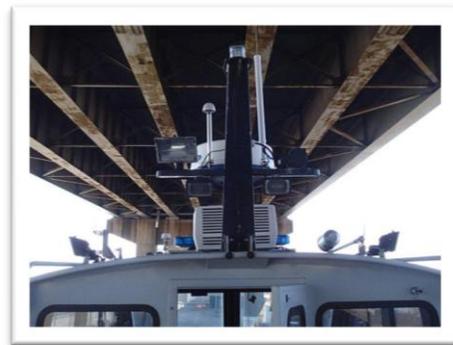
Figure 4.16.2 Antenna

The mast was lowered, and antenna mounts were installed. Access holes were cut into the mast to accommodate cables. Cable glands were installed and cable ends were terminated. Antennas were installed and the cables were routed into the cabin (see Figure 4.16.2 Antenna). The center ceiling panels and an access plate were removed to allow for cable routing. Cables were routed down the window cable chase, and an access hole was made to route the cables to the transponder and the power panel. The transponder was mounted and the GPS and VHF cables terminated (see Figure 4.16.3 Transponder). The power and ground cables were routed through the cable chase to the power panel in the console.

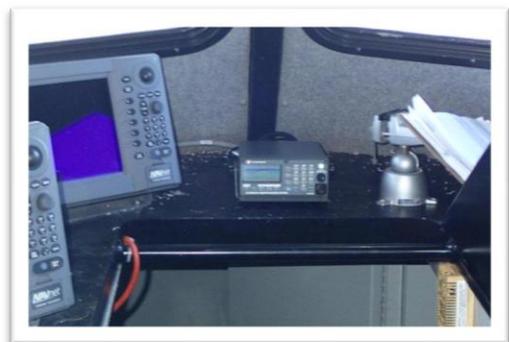
Figure 4.16.3 Transponder

The power panel was temporarily removed for cable installation. A 6-pin Furuno data cable was installed to facilitate future upgrade of the chart plotter to a model that supports AIS (e.g. Furuno RDP149). The data cable was connected to the transponder and Data 2 of the RDP139 chart plotter. This data cable is interchangeable between the two units.

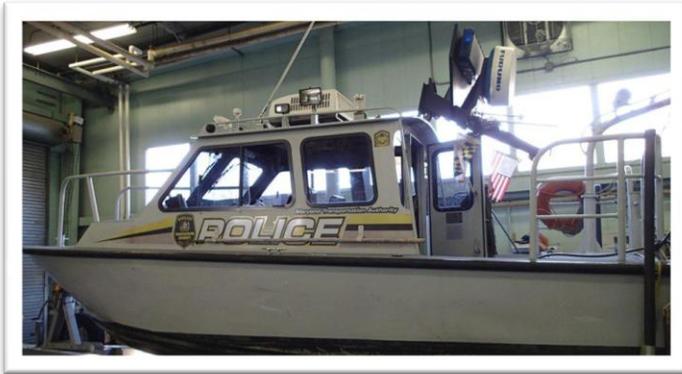
Figure 4.18.1 MD Transportation Authority Police, *Marine Four*

This was the oldest Sea Ark vessel in this group of ETS integrations. The vessel contained a V-berth forward, making cable installation problematic (see Figure 4.18.1 MD Transportation Authority Police, *Marine Four*). Radios were installed onto a tray covering the ceiling panel in the main cabin, inhibiting panel removal (see Figure 4.18.2 Cabin).

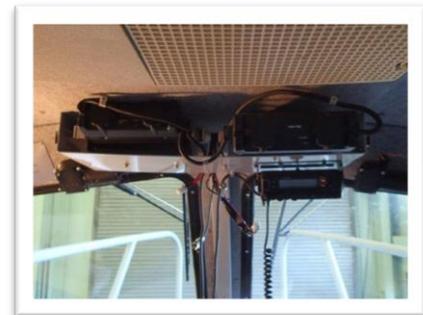
Figure 4.18.3 Cables

Several ceiling panels in the berth were removed to allow access. Cables were routed above the ceiling panel (see Figure 4.18.3 Cables) and down the wind screen beside the cable channel and fastened with cable clams. The transponder was located on the top port console between the Furuno 1833C radar display and the GD 1700C chart plotter (see Figure 4.18.4 Transponder). The transponder power was collocated with the chart plotter power switch.

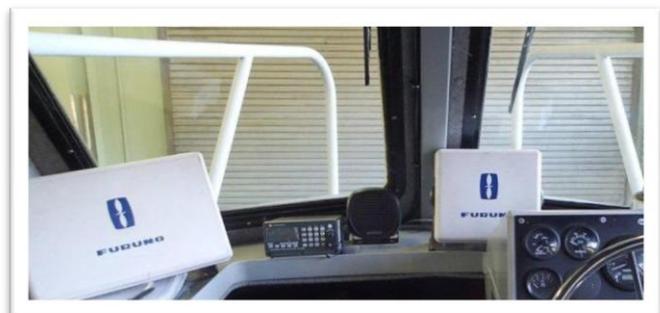
Figure 4.18.4 Transponder

The data cable was installed; however, the Furuno units are incompatible with AIS. The firmware for these units must to be updated for the integration of the Protec-M to function.

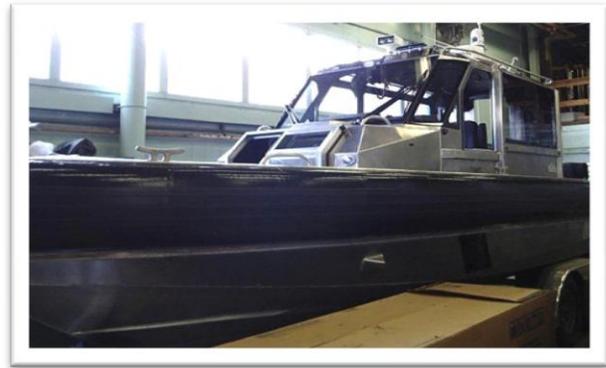
Figure 4.19.1 Annapolis City Police, *Annapolis*

The ETS integration was the first installation of this type on the 25 foot Metal Shark vessel and all ceiling panels required removal to determine the approach (see Figure 4.19.1 Annapolis City Police, *Annapolis*). Existing cables were traced one at a time (due to small size of the cable chase) to determine the access point to the cable chase (see Figure 4.19.2 Cable Access).

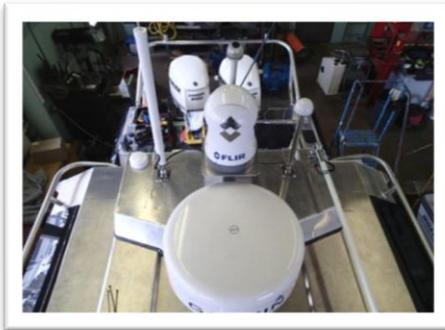
Figure 4.19.3 Antenna

The GPS and VHF cables were pulled through the cable chase from the antennas (see Figure 4.19.3 Antenna) with some difficulty due to 90 degree bends. Two access cuts were made in the chase to allow for a fish tape. With consultation of the vessel operator, the transponder was flush-mounted in the console (see Figure 4.19.4 Transponder). The template was installed and all cables and air conditioning vents were removed from the inside of the console. Pilot holes were drilled and an opening was cut in the console for the transponder. The VHF and GPS antenna cables were terminated and the power and communication cables were routed to the power panel access point (see Figure 4.19.5 Power Panel). The power cable was terminated in the first available spare circuit breaker. The grounds were terminated to the grounding bus. All cables were secured in place. The communications cable for the Garmin 5212 chart plotter was integrated with the transponder.

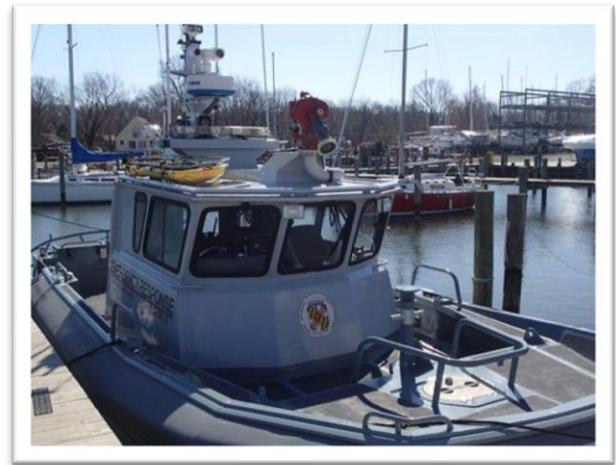
Figure 4.20.1 Anne Arundel County Police, *Patriot*

Integration on this 35 foot Moose boat required an in-depth survey to determine equipment locations (see Figure 4.20.1 Anne Arundel County Police, *Patriot*). The mast is twice the size of the Sea Ark vessels; three people and a come-along are needed to raise and lower it for the integration. The VHF and GPS antenna mounts were located on the forward portion of the mast beside the light bar. There was no obvious access to the cable tray that runs the length of the vessel. There was no area on or under the console to accommodate the transponder. No access to the cable tray was found above the main ceiling panel or above a smaller ceiling panel in the head.

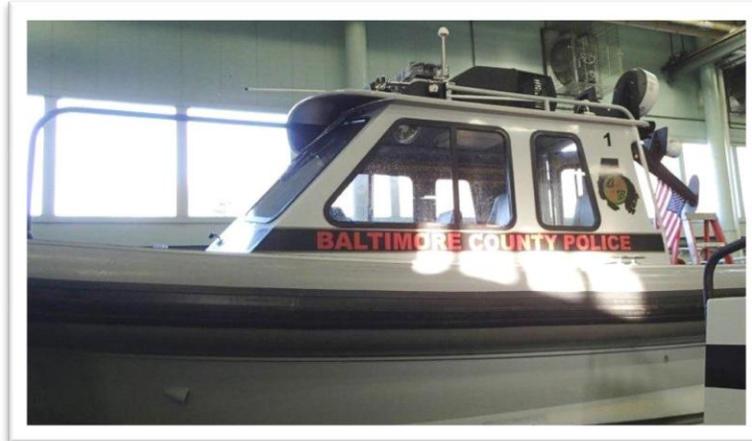
Figure 4.21.1 Baltimore County Police, *MARINE 1*

This 25 foot Sea Ark did not have sufficient space to install the antenna mounts and antennas, and allow enough clearance for the camera system (see Figure 4.21.1 Baltimore County Police, *MARINE 1*). A power source/switch for the transponder was identified on the power panel.

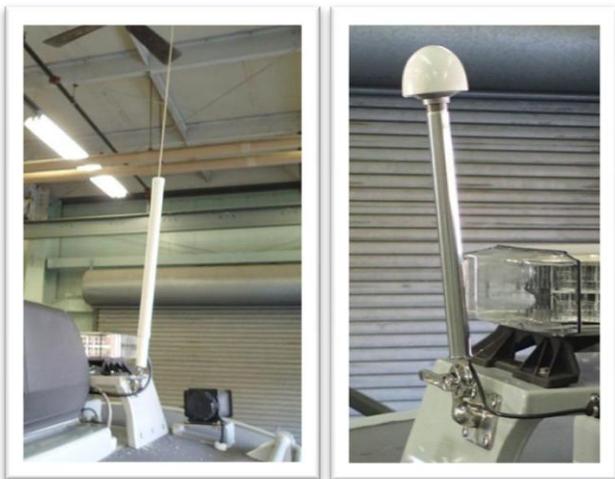
Figure 4.21.2 Antennas

The antenna mounts and antennas were located on the sides of the light bar bracket (see Figure 4.21.2 Antennas). Cable clams were installed in the roof to accommodate the cables. The transponder was wired to the power panel. The transponder was installed on the side of the shelf below the console on the port side (see Figure 4.21.3 Transponder). The integration of the transponder and Garmin 4212 chart plotter was completed and verified.

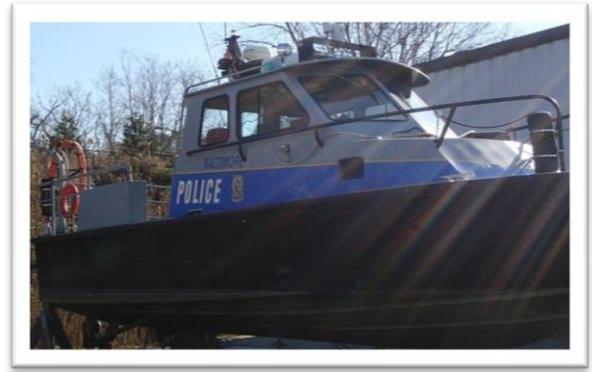
Figure 4.22.1 Baltimore Police Department, *Dauntless*

This older, 36 foot Sea Ark did not have an area on the mast suitable for antenna installation (see Figure 4.22.1 Baltimore Police Department, *Dauntless*).

A bracket that covers the forward light bar and serves as a mount for one of the camera systems was used as a mounting location for the antenna mounts (see Figure 4.22.2 Side View of Antennas and Figure 4.22.3 Antennas). Access holes were drilled, and cable clams were installed. The cables were routed through the roof panel and down through the electrical cabinet. The transponder was mounted to the starboard side console and positioned to give the boat operator a clear view of the unit (see Figure 4.22.4 Transponder). The chart plotter and radar system on this vessel are not compatible with AIS. The data cable was provided to the operator for future integration to an upgraded radar/plotter.

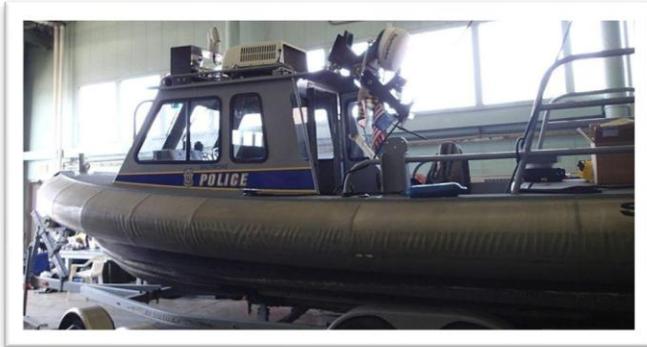
Figure 4.23.1 Baltimore Police Department, *Ram 9828*

This 25 foot Sea Ark had GPS and VHF antennas on the mast (see Figure 4.23.1 Baltimore Police Department, *Ram 9828*). A power source/switch for the transponder was identified on the power panel.

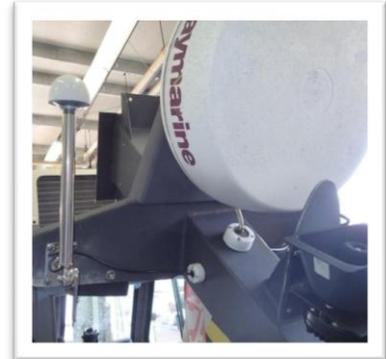
Cable clams were installed in the mast to accommodate the cables (see antenna and mast at Figure 4.23.2 Mast and Figure 4.23.3 Antenna). The transponder was wired to the power panel. The transponder was mounted on the lower edge of the console and positioned to allow for sufficient space between the port passenger seat and the unit (see Figure 4.23.4 Console and Figure 4.23.5 Transponder). Chart plotter integration was not accomplished because the Furuno 1850WDF chart plotter is not AIS capable.

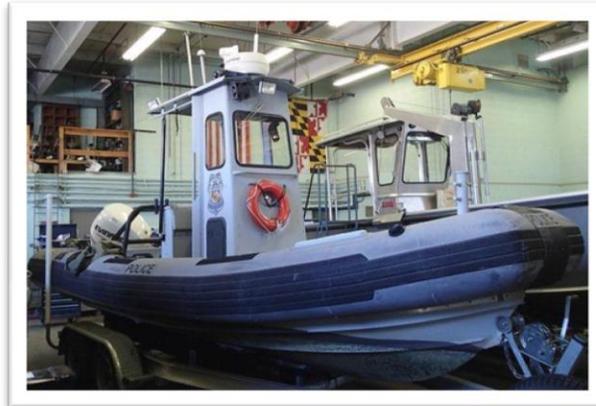
Figure 4.24.1 Baltimore Police Department, *Hurricane 1*

This 18 foot Zodiac had an open cockpit with an aluminum cover over the cockpit and part of the passenger area (see Figure 4.24.1 Baltimore Police Department, *Hurricane 1*). The electronics enclosure located above the console did not have sufficient space to mount the transponder. There was sufficient space available on the console for mounting the transponder.

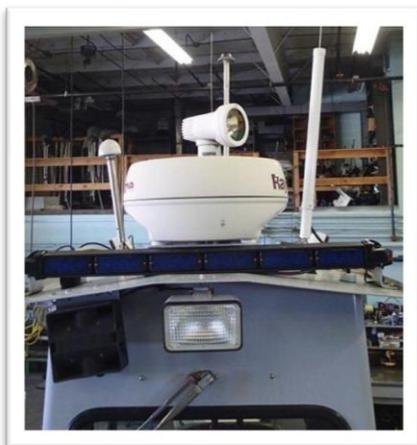
Figure 4.24.2 Antenna

The antenna mounts were installed directly onto the roof (see Figure 4.24.2 Antenna). Cable clams were located forward to allow for routing the cables to the electrical/battery compartment. The antenna cables were routed down to the electronics compartment and power was supplied to the unit using the spare 15 ampere circuit breaker. The transponder was flush-mounted (see Figure 4.24.3 Console with Transponder). The Radar/Chart Plotter on this vessel is a Raymarine C80 with only one NMEA connection. This connection is used by the ICom VHF-DSC radio. This installation was problematic because of the limited space available to access the electronics compartment. On 21 February 2013, upon request of the vessel operator, the input from the DSC radio on *Hurricane 1* was removed and the data cable was terminated for connection between the AIS transponder and the C80 multi-function display. The C80 was configured for AIS operation and the vessel name and MMSI was verified; the radar was functioning properly.

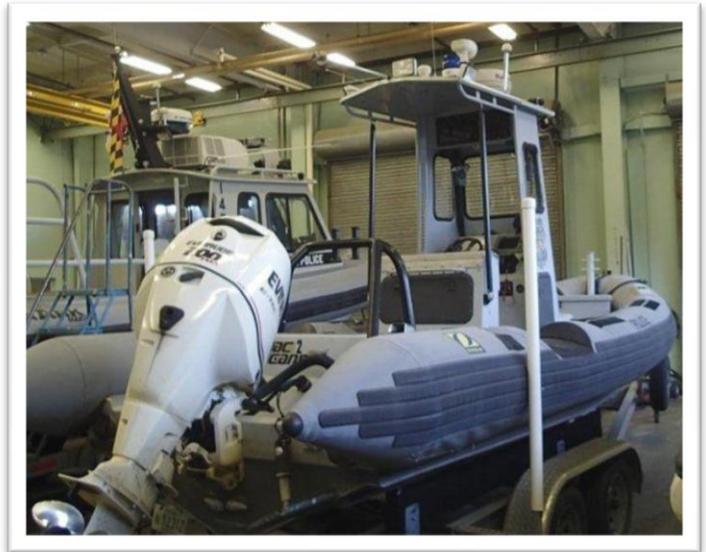
Figure 4.25.1 Baltimore Police Department, *Hurricane 2*

This 18 foot Zodiac had an open cockpit with an aluminum cover over the cockpit and part of the passenger area (see Figure 4.25.1 Baltimore Police Department, *Hurricane 2*). The electronics enclosure located above the console did not have sufficient space to mount the transponder, nor was there sufficient space available on the console for mounting the transponder.

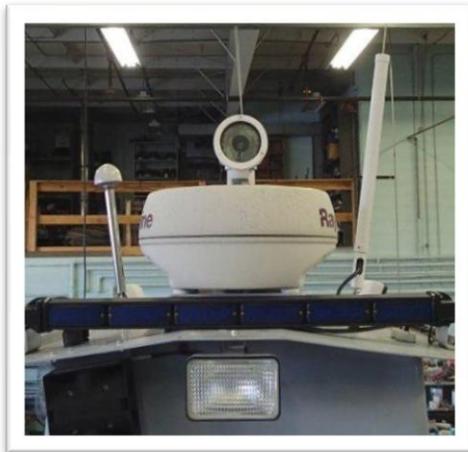
Figure 4.25.2 Antenna

The antenna mounts were installed directly onto the roof (see Figure 4.25.2 Antenna).

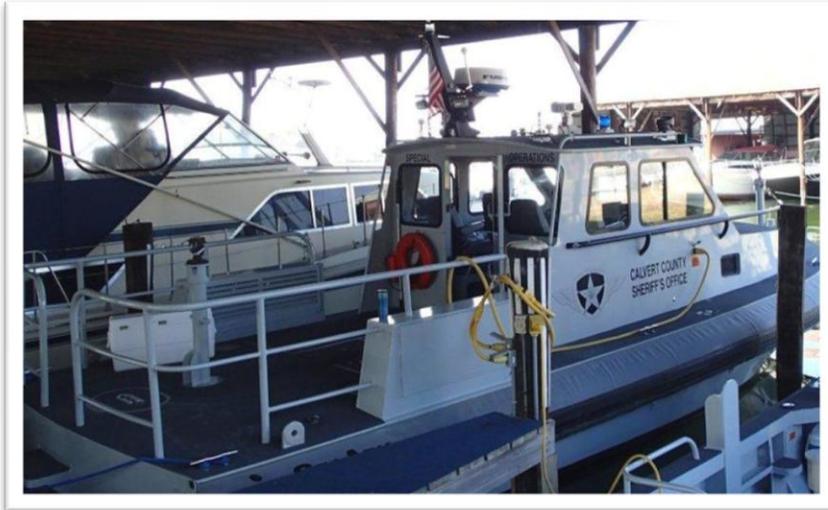
Figure 4.26.1 Calvert County Sheriff, *SPECOPS 2*

This 36 foot Sea Ark did not have a power source/switch available for use (see Figure 4.26.1 Calvert County Sheriff, *SPECOPS 2*).

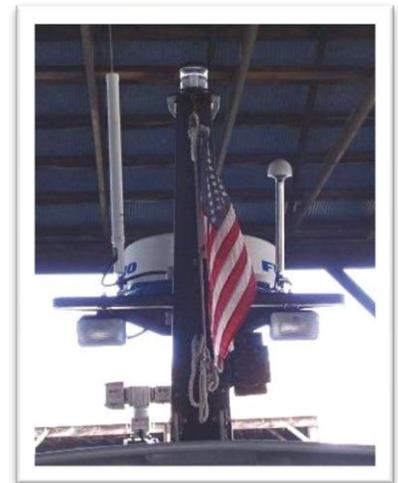
Figure 4.26.2 Antennas

GPS and VHF antennas were located on the mast, and cable clams were installed in the mast to accommodate the cables (see Figure 4.26.2 Antennas). The power for the unit was provided directly from the DC main switch and can be switched at the pilot's power console. The transponder was installed on the console shelf behind the radar display unit (see Figure 4.26.3 Console and Figure 4.26.4 Transponder).

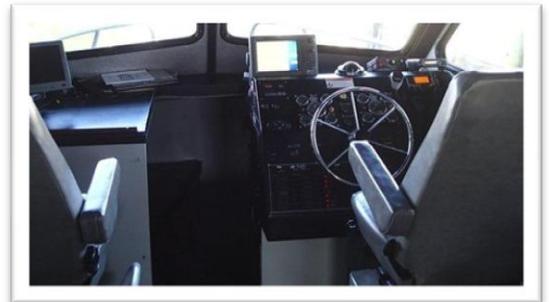
Figure 4.26.3 Console

The integration of the transponder with the Furuno RDP-149 Multifunction display was not successful. The RDP149 requires that AIS data is input on Data port 2, which was in use by another piece of equipment, most likely the DSC radio. A cable was fabricated to attempt to input the AIS data on Data port 4. Data port 4 read the AIS data but does not display the data on the chart plotter. The Furuno interconnection chart shows that AIS data is only parsed on Data port 2. The vessel operator plans to discuss the issue with superiors to see if the system using Data port 2 can be input on Data port 4 without causing system issues. The data ports have dissimilar pin outs and the cables would need to be re-terminated for each piece of equipment.

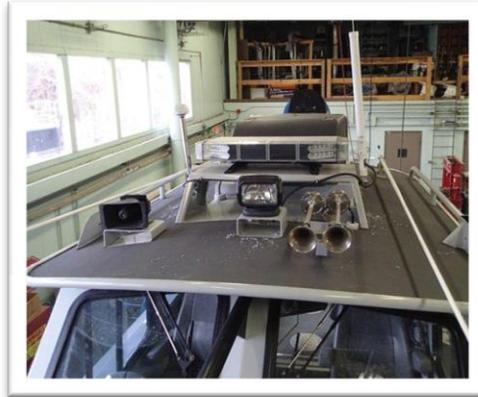
Figure 4.27.1 Calvert County Sheriff, *SPECOPS 3*

This 25 foot Sea Ark did not have sufficient space to install the antenna mounts and antennas while allowing enough clearance for the camera system (see Figure 4.27.1 Calvert County Sheriff, *SPECOPS 3*). A power source/switch for the transponder was identified on the power panel.

The antenna mounts and antennas were located on the sides of the light bar bracket. GPS and VHF antennas were installed, and cable clams were placed in the roof to accommodate the cables. The transponder was installed on the shelf below the console on the port side (see Figure 4.27.2 Console and Figure 4.27.3 Transponder). The integration of the transponder and Garmin chart plotter was completed and verified.

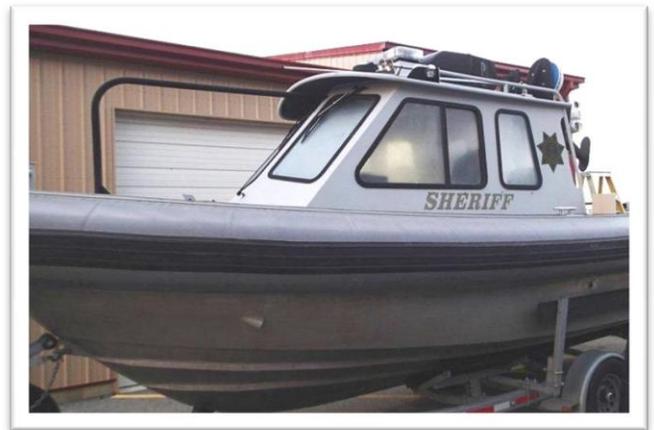
Figure 4.28.1 Charles County Sheriff, *Boat 1*

This 25 foot Sea Ark did not have sufficient space to install the antenna mounts and antennas, and still have enough clearance for the camera system (see Figure 4.28.1 Charles County Sheriff, *Boat 1*). A power source/switch (GPS) for the transponder was identified on the power panel.

The GPS and VHF antenna mounts and antennas were located on the sides of the light bar bracket (see Figure 4.28.2 Antennas). Cable clams were installed in the roof to accommodate the cables. A power source/switch (GPS) for the transponder was integrated. The transponder was installed on the side of the shelf below the console on the port side (see Figure 4.28.3 Console and Figure 4.28.4 Transponder). The integration of the transponder and Garmin chart plotter was completed and verified.

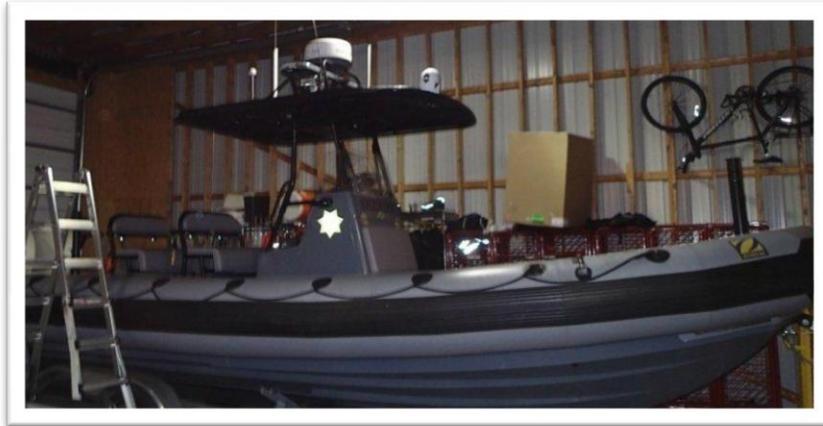
Figure 4.29.1 Charles County Sheriff, *Boat 2*

This 24 foot Zodiac had an open cockpit with a canvas cover over the cockpit and part of the passenger area (see Figure 4.29.1 Charles County Sheriff, *Boat 2*). There were no readily available points for the antenna mounts nor was there sufficient space on the console to mount the transponder.

The antenna mounts were installed on an available roof support brace (see Figure 4.29.2 Antennas). Cable clams were co-located with each of the mounts and the signal cables were routed through the roof and down a support pipe to the electronics enclosure. The electronics enclosure located above the console was the only option for installation of the transponder (see Figure 4.29.3 Console & Transponder). A pass-through was cut to accommodate the incoming signal cables and the outgoing power, ground and communications cables. An access was cut into the forward vertical support pipe to allow routing of the power, ground and communications cables to the electrical bay inside the console. The cable way had very limited space to run the cables. A patch cable was fabricated to replace the much larger data communications cable in the cable run. The chart plotter is a Garmin 4212; a NMEA communications cable was provided for communications between the plotter and transponder. All cables required extensions to allow for the length of run.

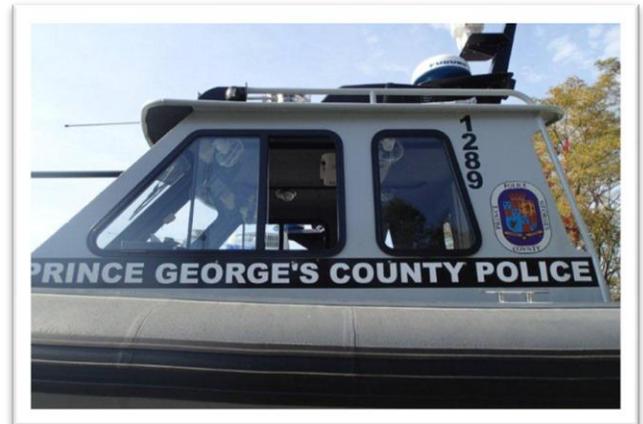
Figure 4.30.1 Prince Georges County Patrol Vessel, PG1289

This 25 foot Sea Ark patrol vessel had identified GPS and VHF antenna locations (see Figure 4.30.1 Prince Georges County Patrol Vessel, PG1289). This vessel was equipped with shelving on the port side below the console that was available for placement of the transponder.

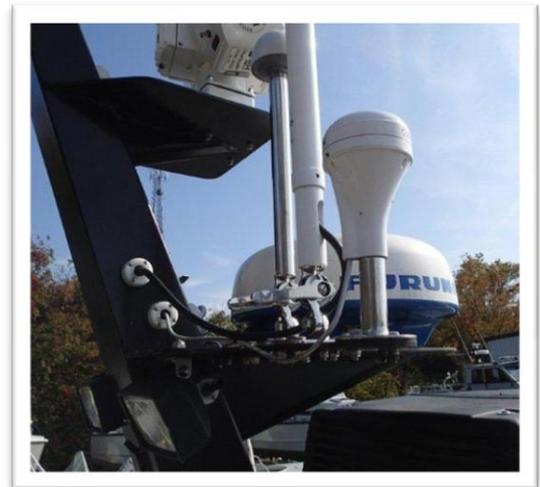
Figure 4.30.2 Antennas

The vessel is equipped with a Garmin 541S chart plotter that has an integrated data and power cable. Several hours were spent attempting to identify a communications error between the AIS and the chart plotter. A second visit on 7 November 2012 was required to continue troubleshooting, and an additional visit was needed to repair a severed cable. During the troubleshooting, it was noted that the vessel had been stored with the mast open during several days of inclement weather. The mast, VHF connector, and VHF antenna were filled with water, which caused an initial Voltage Standing Wave Ratio (VSWR) error during transmission.

Inspection of the GPS cable from the antenna to the transponder revealed that the cable had been severed at the mast opening. An additional site visit was required to repair the cable and complete the integration.

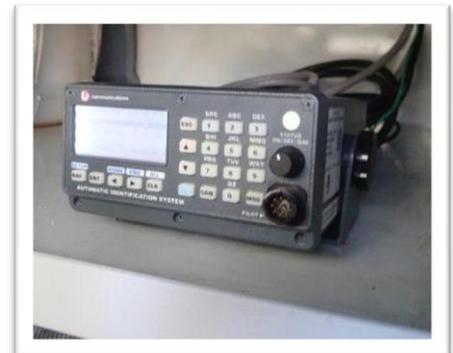
Figure 4.30.3 Transponder

The GSP and VHF antennas were installed (see Figure 4.30.2 Antennas), and cable clams were installed onto the mast to accommodate the required cabling. The transponder was installed on the port side shelving (see Figure 4.30.3 Transponder).

The unit was transmitting and verification of the operational status of the unit was conducted using a Furuno FA100 AIS transponder. Verification was made of both transmit and receive signals.
