KIRKUK CANAL CROSSING
KIRKUK, IRAQ

SIGIR PA-05-011
MARCH 7, 2006

Kirkuk Canal Crossing, Kirkuk, Iraq

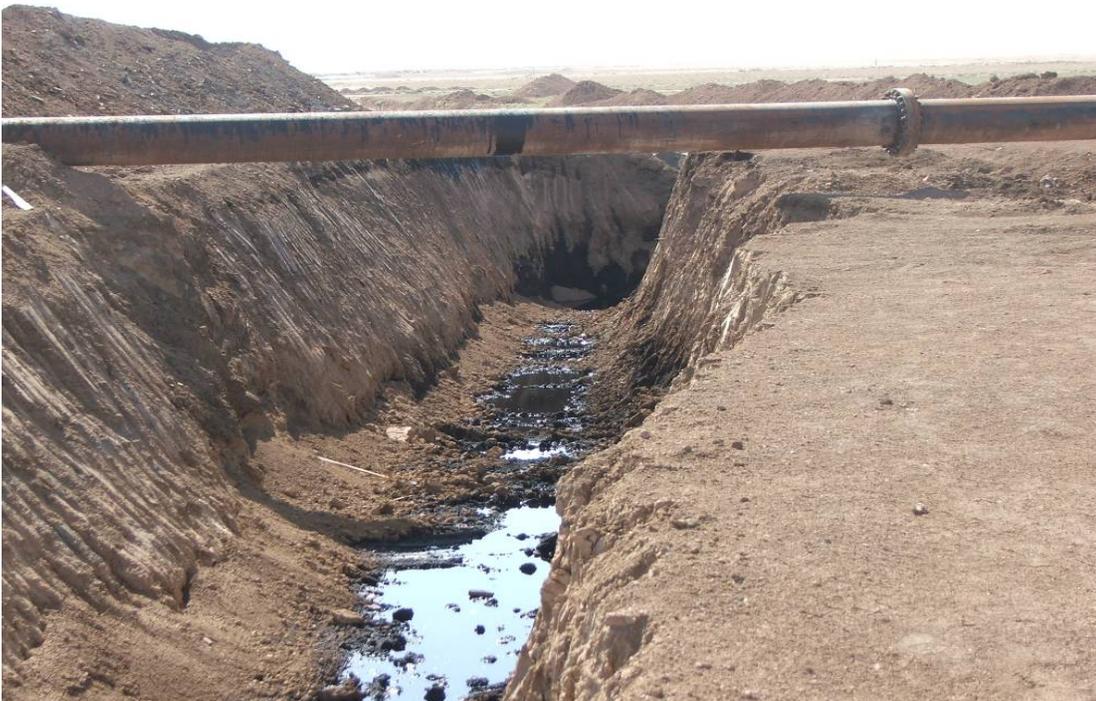
shows excavation of trenches for placement of the pipeline. Site photo 4 shows excavation of soils in the culvert crossing the KIC. Site photo 5 shows excavations with oil seeps.

Site Photo 5: Common Example of Pipeline Excavation with Oil Seepage

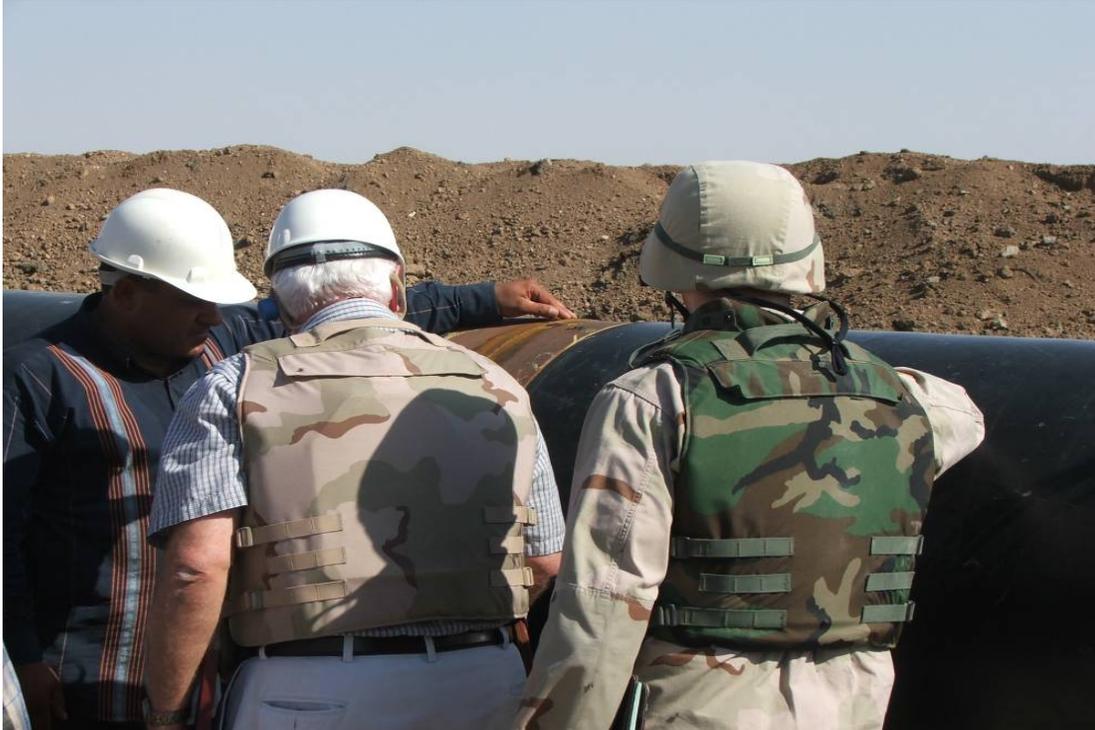
During the site visit, the assessment team observed the contractor's QC Manager effectively working with the subcontractor's QC Inspector and other subcontractor supervisors. In one instance, the contractor's QC Manager pointed out welding and pipe cover problems. The message was presented in a positive manner and it appeared that the subcontractor's QC Inspector became more aware of the expected quality level. Site Photo 8 shows a subcontractor's QC inspector, contractor's QC manager and QAR discussing a weld that needs rework.

Site Photo 8: Subcontractor QC Inspector, Contractor's QC Manager, and QAR Discuss a Weld That Needs Rework

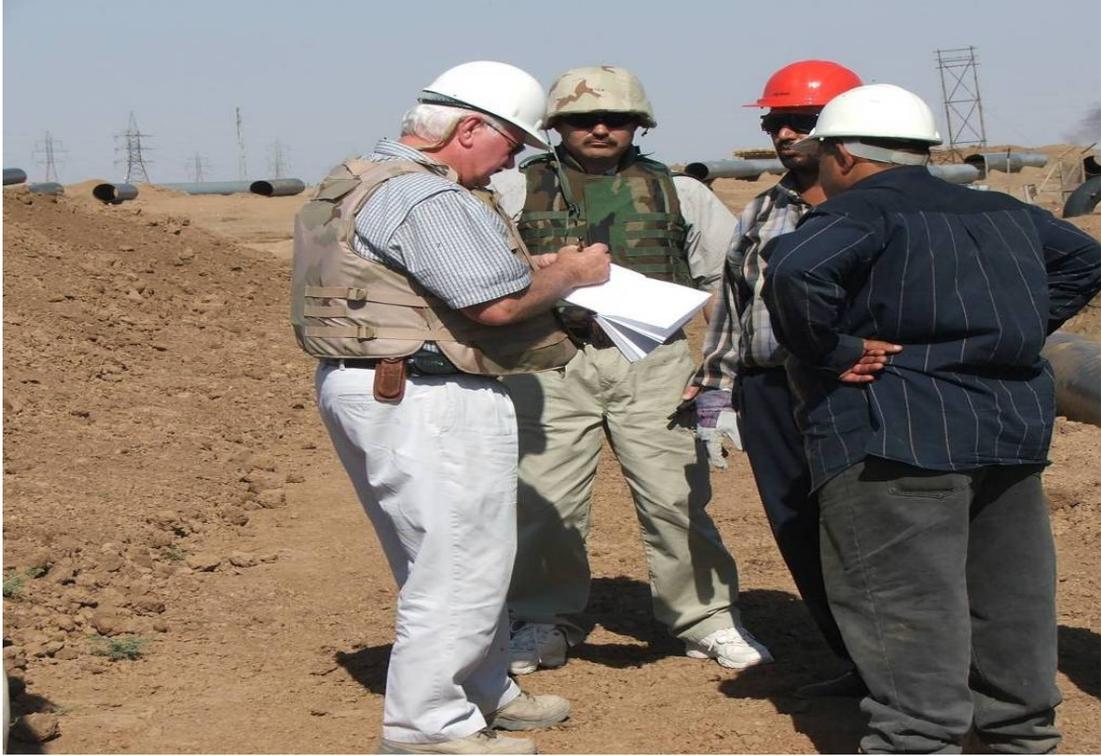
In another instance, we observed the contractor's QC Manager discuss a pipe placement problem with subcontractor personnel. Specifically, oil that seeped into the pipeline's excavation presented a fire and safety hazard to welders and construction workers. To ensure safety and quality workmanship, the contractor's QC Manager explained how to place clean sand and a heavy duty plastic material (tarp) in the excavation to form a protective barrier between the oil and workers. Site Photo 9 shows a contractor's QC manager explaining how to place protective liner in the pipeline excavation.

Site Photo 9: Contractor's QC Manager Explains How to Place Protective Liner in the Pipeline Excavation
