ERDC/CERL TR-14-1

Corrosion-Resistant Roof with Integrated Photovoltaic Power System

Final Report on Project F09-AR04

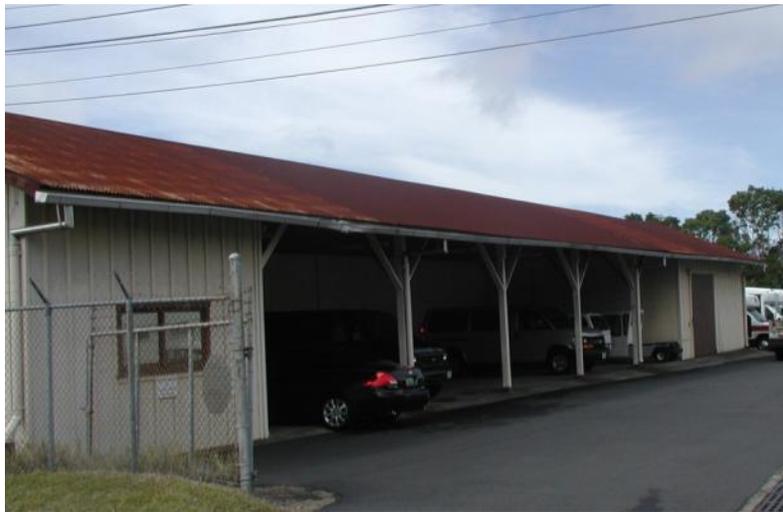
Figure 1. Building 84.

Building 84, which is located in a service-utility section at KMC, was selected for the demonstration. The building (Figure 1) was constructed in 1946. It is used primarily as a warehouse and for vehicle storage, with some office and storage space on the east and west ends. It has one level with approximately 5,500 sq ft of flooring. The main section of the building has a gable roof and open bays along the north wall for vehicle access and parking. Figure 2 shows a layout of the building sections. There are two additions on the south side of the building's main section that have monoslope ("shed") roofs (Figure 3). The roofs on all three sections of the building were made of corrugated metal panels, and were severely corroded as a consequence of time in service.

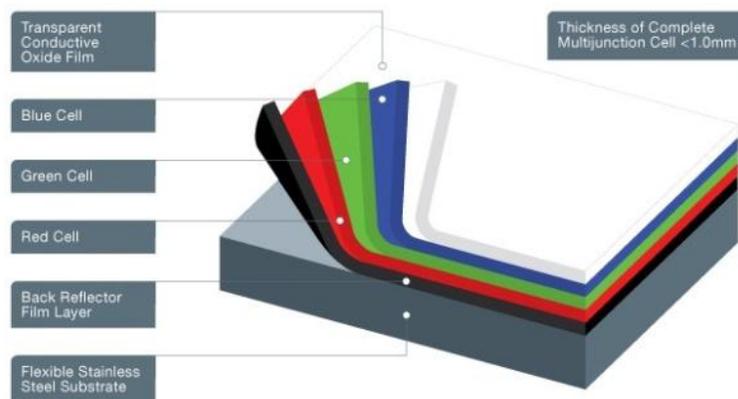
Figure 4. Thin-film photovoltaic cell (www.Unisolar.com).

The demonstrated PV modules are manufactured by depositing a thin film of amorphous silicon onto a metal substrate. The film material includes three layers of semiconducting material (Figure 4). The bottom, middle, and top semiconducting layers absorb red, green, and blue light, respectively, for maximum capture of energy from the solar spectrum. A reflective film is adhered below the PV layers and bonded to a flexible stainless steel substrate. The top, exposed layer of the appliqué is a transparent, electrically conductive oxide film. The PV modules are backed with an ethylene propylene copolymer adhesive material that includes a microbial inhibitor.

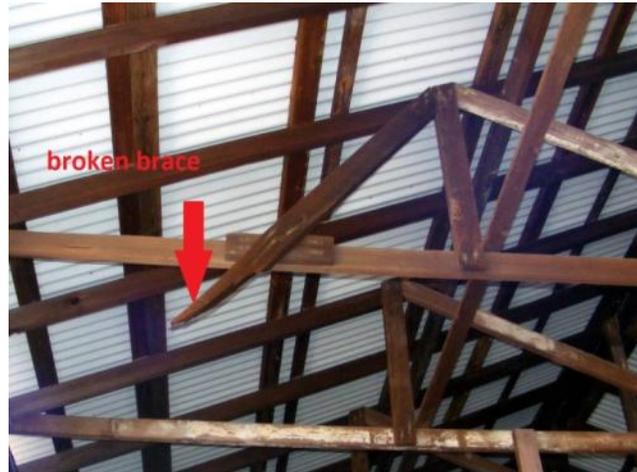
Figure 5. Original gable truss structure.

Based on a site survey, documentation of the existing construction, and a structural analysis, the existing wooden roof framing system for Building 84 was determined to be inadequate for supporting the new roofing system and its design live load (Figure 5). Therefore, it was decided to replace the roof framing. Truss configuration and design loads are shown in Figure 6. The engineering drawings for the new framing system and roof are provided in Appendix A. A roof live load of 19 pounds per square foot was required for a replacement gable roof having a slope of 5:12.

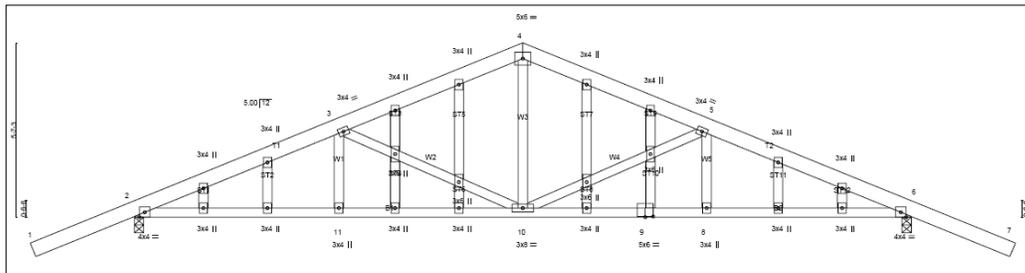
Figure 7. Replacement gable end truss.

For the gable roof section of the building, a fabricated metal plate-connected gable truss system (Figure 7 and Figure 8) was designed with trusses installed at 2 ft on-center. The replacement trusses were constructed of treated lumber to resist insect damage. Permanent longitudinal bracing of the roof trusses was achieved by using nominal 2 x 4 in. members connected to the top and bottom ends of the truss king posts.

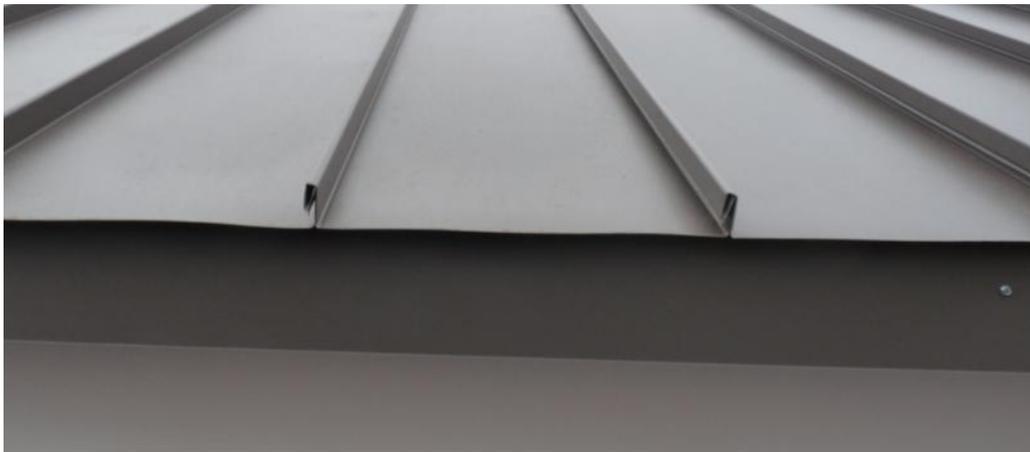
Figure 9. Eave end of new standing seam metal roof.

The selected SSMR utilizes 16 in. wide, 24 gauge, 50 ksi aluminum-zinc coated roof panels. The standing seam is 1.5 in. high and has a snap-lock configuration. The profile of the roofing panels can be seen in Figure 9. The panels are coated with a PVDF organic coating on the external facing surface and polyester enamel on the interior-facing surface. The high-performance coating provides greater scratch and mar resistance than previous generation PVDF coatings. Polytetrafluoroethylene (PTFE) is included in the coating to resist stains and improve cleanability. The coating complies with Cool Roof Energy Council, Energy Star, and LEED 2009 standards.

Anchoring of the metal panels at the eave is provided by fixed metal clips. With the line of fixity being provided at the eave, accumulated panel contraction and expansion is designed to occur at the ridge, which is concealed beneath a ridge cap.

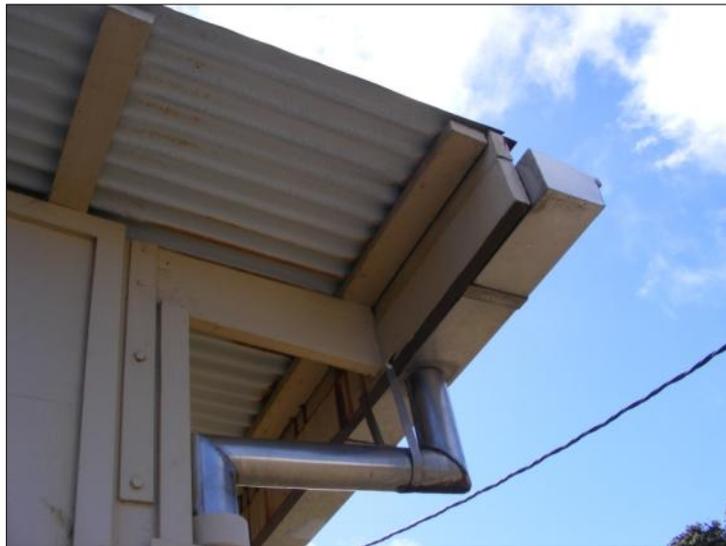
Figure 10. Original gutter and downspout leader.

The original roof gutters were constructed of stainless steel (Figure 10), having a rectangular cross section measuring 6 in. wide by 4 in. high. The primary downspouts were painted 4 in. diameter polyvinyl chloride (PVC) piping with a 45 degree elbows at the discharge end. With the gutters and downspouts being in very good condition, they were salvaged and reinstalled after the new roof system was installed. Due to the slight increase in the eave length of the new roof, the original downspout leader had to be changed. The existing downspout hardware was modified with 4 in. PVC pipe as shown in Figure 11.

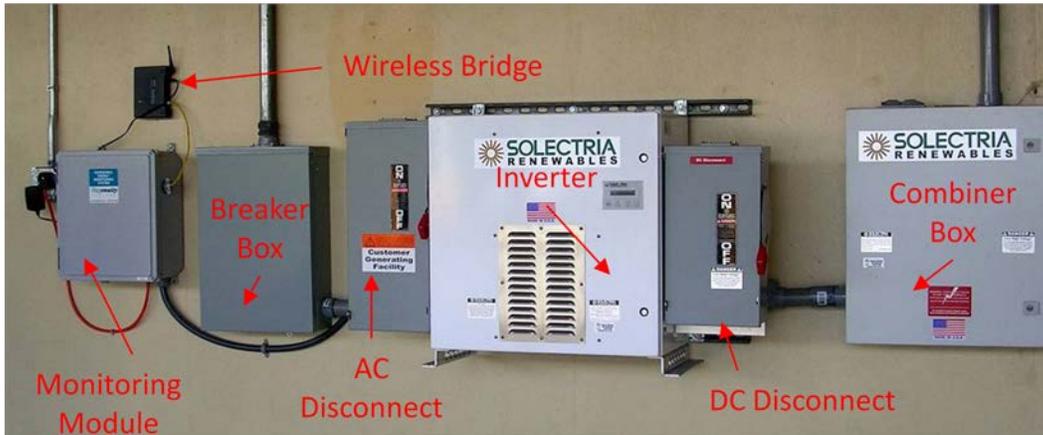
Figure 12. Inverter and associated hardware.

The inverter and associated hardware, which include a combiner box, two disconnects, and a system-monitoring module, are shown as installed in Figure 12. The Solectria PVI 15 kW inverter is housed in a weatherproof National Electrical Manufacturers Association (NEMA) 3R steel enclosure. The inverter converts DC produced by the solar array into AC that suitable for powering the building or supplying the electrical grid. Internally, the current generated by the inverter is run through a filter, a delta/wye transformer, and electromagnetic interference (EMI) filters. The inverter’s specifications are provided in Table 2.

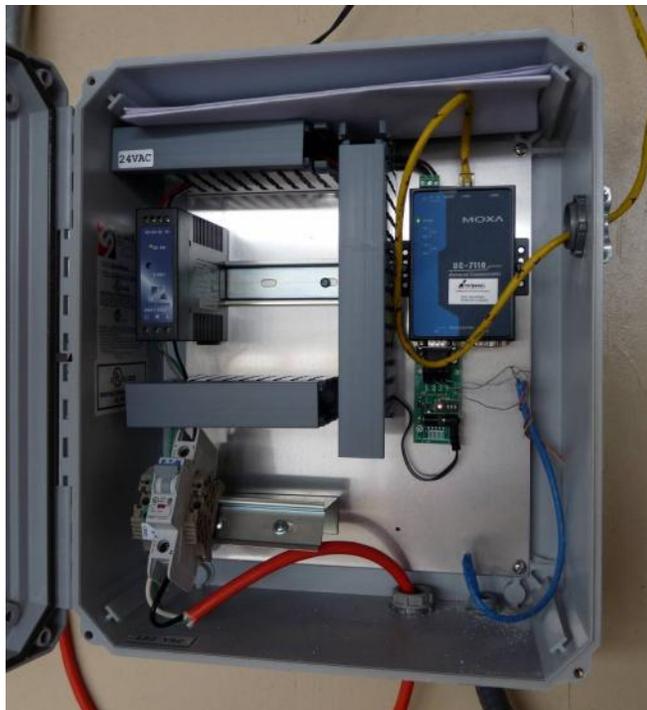
Figure 14. Interior of monitoring module enclosure.

The monitoring module, manufactured by Fat Spaniel Technologies, allows remote monitoring and recording of its performance. The interior of the monitoring module enclosure is shown in Figure 14. Above the module is a wireless bridge that provides communication between the monitoring system and the KMC guest wireless computer network.

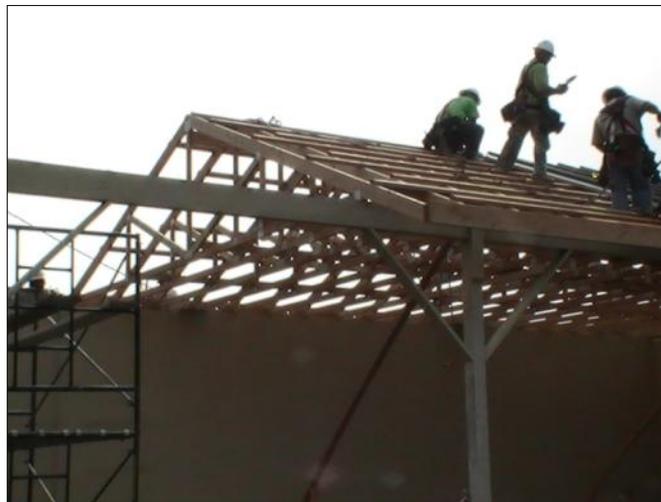
Figure 15. Truss installation.

The roof trusses and associated bracing were assembled on the ground before being lifted and placed onto the building. The installation of the new trusses is shown in Figure 15. This construction method helped prevent damage to the trusses, which are weak in the out-of-plane direction, and improved work safety by minimizing rooftop assembly work. Once the trusses were in place, the purlins were attached. Before installing the horizontal x-bracing, the SSMR system was installed.

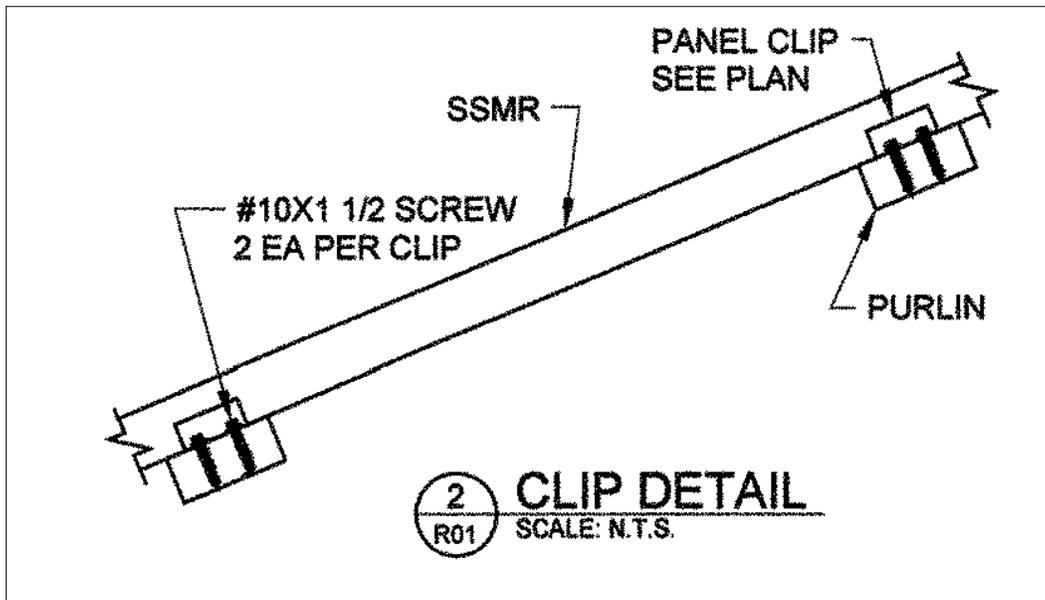
Figure 16. Clip detail.

Roof panels were formed and cut to proper length. Panels were installed perpendicular to the roof ridge. Roofing clips, which secure the metal panels to the structure, were installed at the side laps of the roof panels and at each purlin location. Panel clips were attached to purlins using #10 x 0.5 in. wood screws (detail shown in Figure 16). Before adjacent roof panels were seamed together, a construction-grade flexible silicon joint sealant was field-applied within the seam. Eave flashing and gutters were installed as shown in the eave detail provided in Figure 17. For the gable

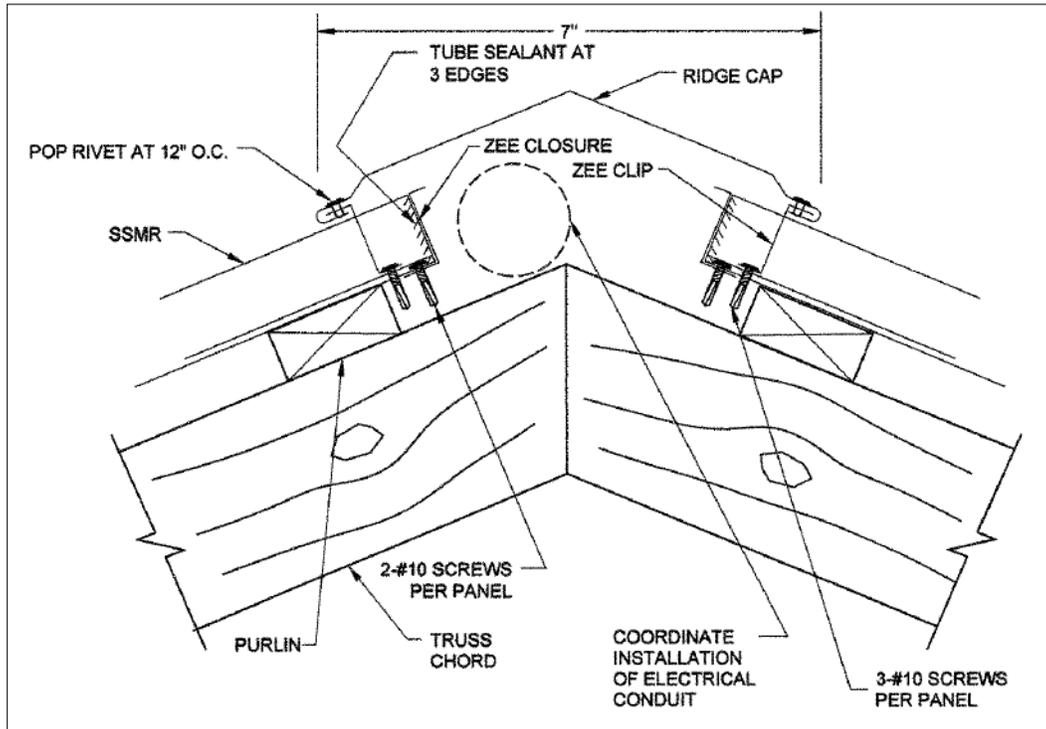
Figure 18. Ridge detail.

roof, the roof cap flashing at the ridge was design and installed to allow for unrestricted panel movement at the ridge (Figure 18). For the two shed roofs, the flashings at the headwall-to-roof intersection were installed as shown in Figure 19 to also allow for thermal movement.

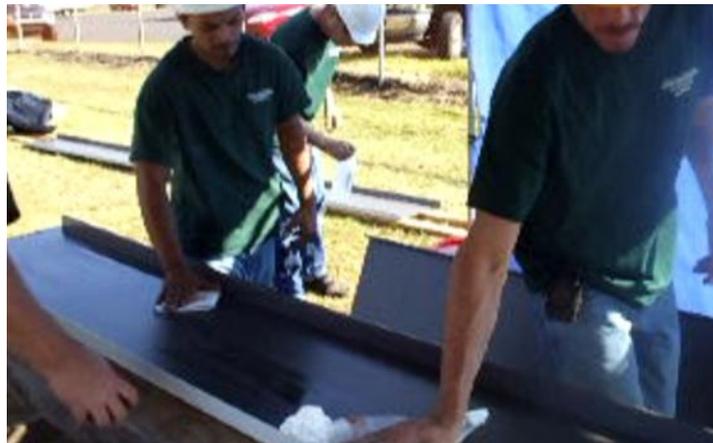
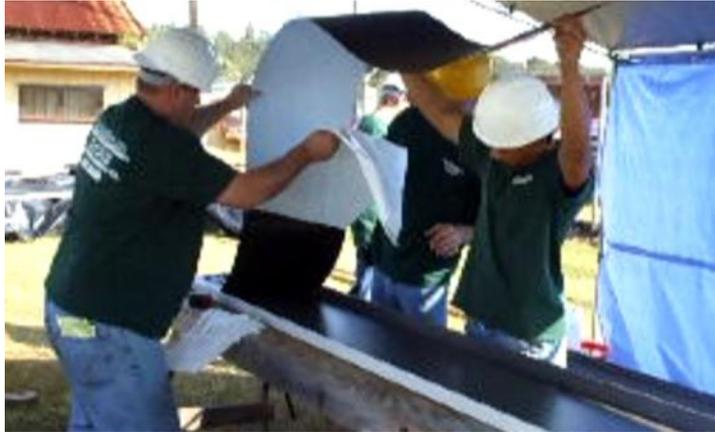
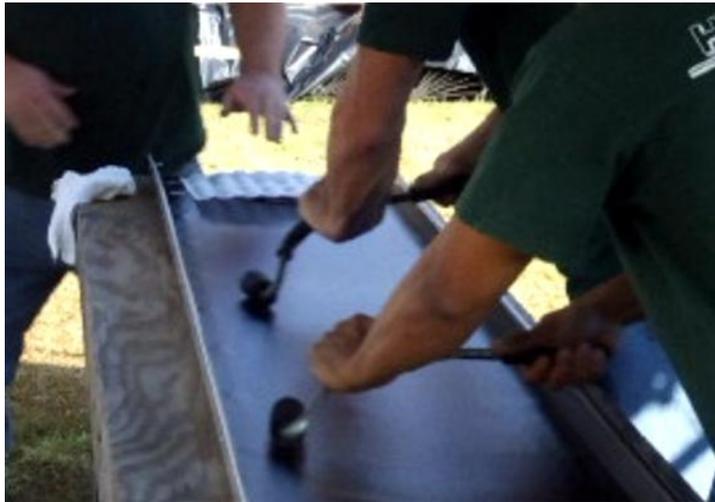
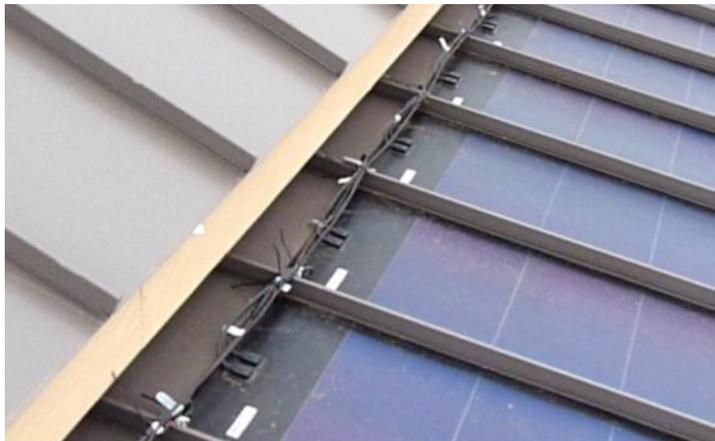
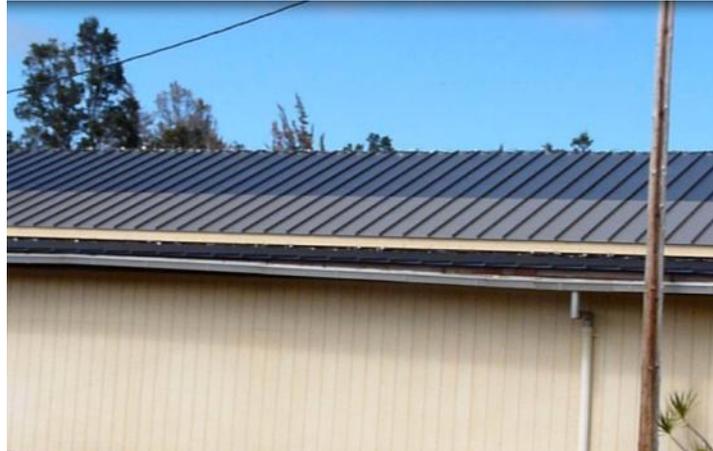
For the gable roof, the modules were applied to the roof panels before the roof sections were installed, as recommended by the manufacturer. The panel surfaces were first wiped with a solvent (Figure 20). Next, the release paper was removed from the back side of the PV appliqués (Figure 21) and each module was pressed in place against the panel using a rubber roller to avoid the formation of air bubbles at the interface (Figure 22). The metal panels were then raised to the rooftop, with the ends having electrical connectors placed upslope (Figure 23). Figure 24 shows the PV modules installed on the gable roof section.

Figure 20. Roof panel surface wiped with solvent before applying PV module.

Figure 21. Removal of release paper from back of PV module.

Figure 22. Pressing PV module in place against metal roof panel using rollers.

Figure 23. Electrical connectors located at upslope end of PV modules.

Figure 24. PV modules installed on gable roof section of Building 84.

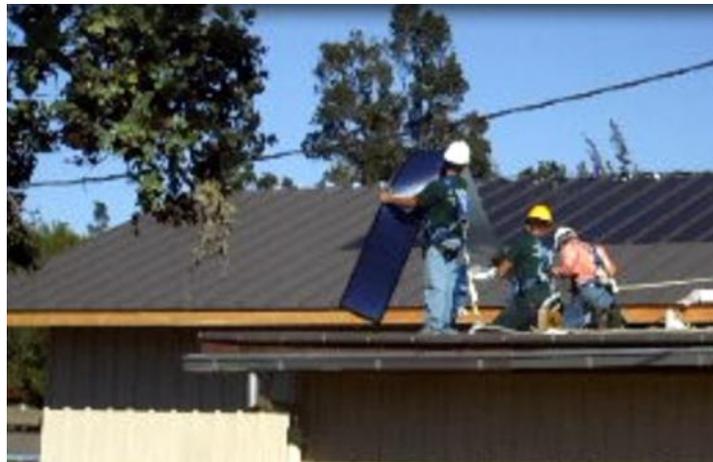
Figure 25. Application of PV modules on shed roof section.

For the two shed roofs, the PV modules were placed on the metal panels after the panels were installed on the roof (Figure 25). This order of work was decided upon so the replacement shed roofs could first be used as working surfaces while placing the SSMR system on the gable roof. Once the gable roof was completed, the PV modules were installed on the metal shed roof panels. Application of the solar modules to the already installed shed-roof panels required the same steps as previously described for the gable roof panels, but with the additional safety considerations given for working at roof level.

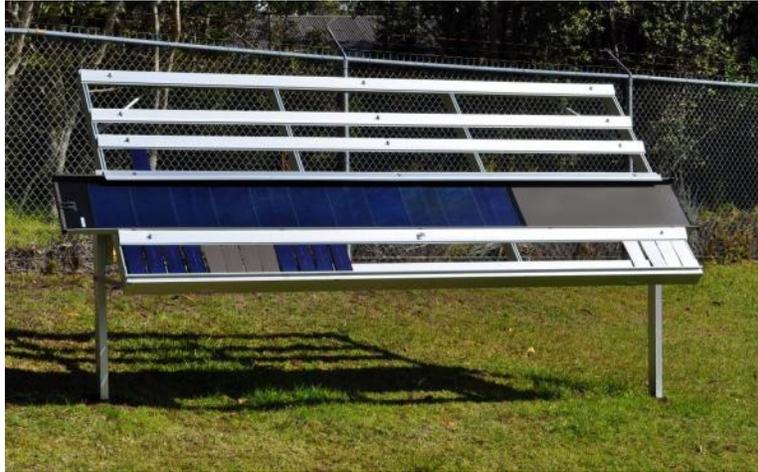
Figure 26. Exposure rack.

Two identical sets of coupons of the coated metal panels and PV laminate were constructed—one set to be placed on an exposure rack at the KMC site (Figure 26) and the other set to be subjected to accelerated corrosion testing in the laboratory. (In this discussion the term *PV laminate* refers to a small sample of the PV material cut from a module.) Four different configurations of test coupons were made. These included coated metal panel (as supplied by the SSMR manufacturer) both with and without the PV laminate applied; and metal panel with only zinc-aluminum coating and no PVDF, both with and without the laminate applied. For each configuration, three coupons were scribed and one was unscribed. Scribing of the bare metal coupons was performed according to instructions in ASTM D1654, *Standard Test Method for Evaluation of Painted or Coated Specimens Subjected to Corrosive Environments*. However, the method had to be altered for the coupons covered with PV laminate material. A rotary disc with a fin cutoff disc was used to cut through the PV laminate and into the metal material to achieve a scribe as close as possible to the ASTM requirement.

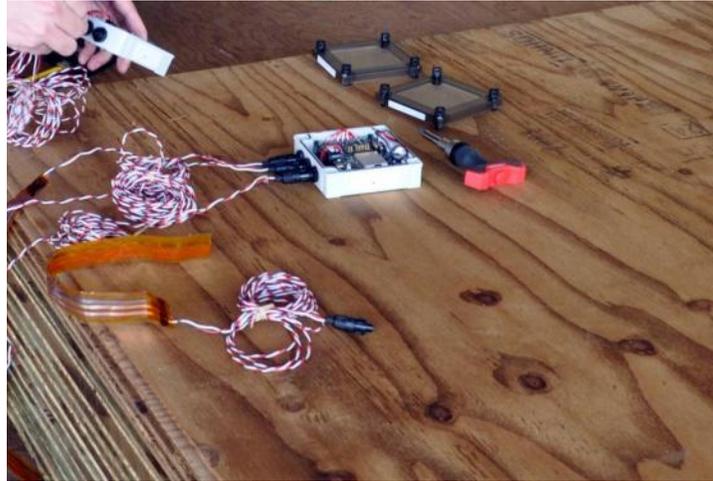
Corrosion conditions at the interface between the PV appliqué and metal roof panel are being monitored using a non-operational mockup of a PV module and roofing panel installed on the exposure rack. Four experimental corrosion sensors manufactured by Aginova, Inc., have been placed at different points along the interface. A sensor and its data-logger box are shown in Figure 27. An additional sensor is mounted on a coupon of roofing material with an inert section of PV attached to act as a control. The sensors record wetness and corrosivity data hourly.

Figure 27. Ribbon sensor (near left center) with recording box.

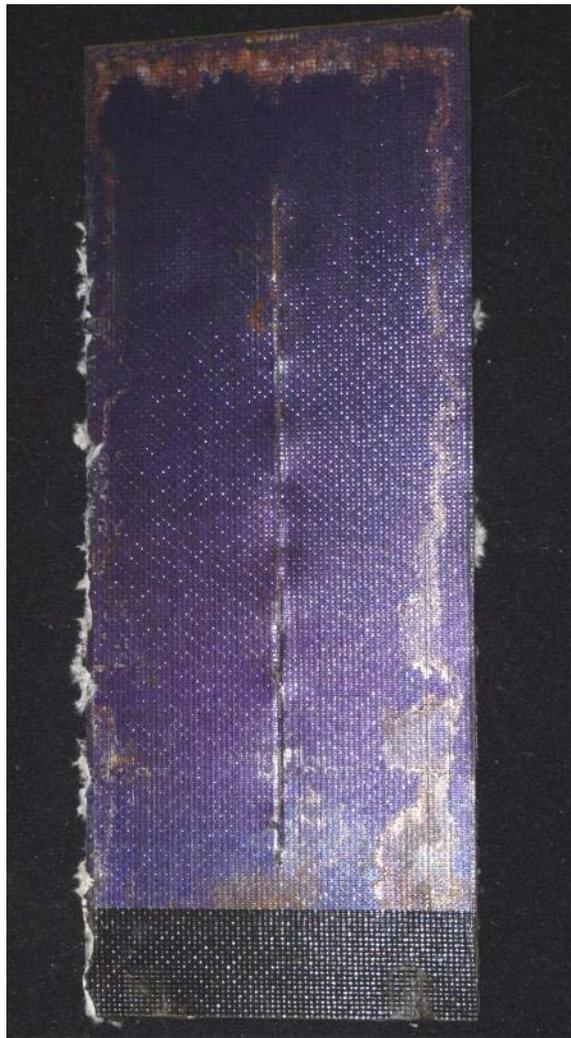
The observations of the accelerated-aging coupons are summarized in Table 3. The coupons with PV laminate and no scribe performed well. This may be attributable the gummy nature of the appliqué adhesive, which behaves like a sealant to inhibit moisture penetration. However, the coupons with the scribed PV laminate did show some corrosion effects (Figure 28), which were advancing beneath the top surface of the laminate material. This result was not replicated on the same scribed coupon configurations that were mounted on the exposure rack; the outdoor coupons were not exposed to the same levels of chlorides and surface wetness that occur in accelerated testing, and the conditions for the oxygen concentration cell corrosion were not present. Therefore, it seems possible that a damaged

Figure 28. Corrosion occurring at the cut edges and along the scribe of the PV laminate material (accelerated-weathering coupon).

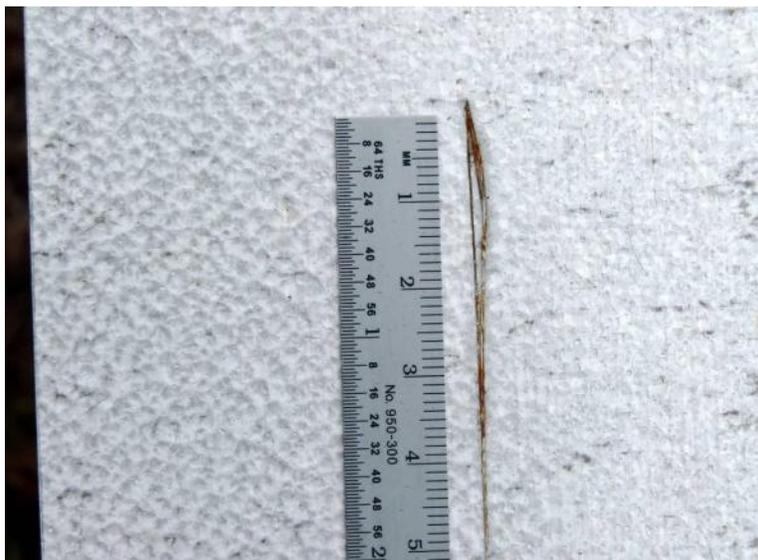
The set of coupons placed on the exposure rack at KMC were visually inspected after 6 months. Examination showed that the coupons displayed no evidence of corrosion, with the exception of the uncoated metal panel coupons, which began to show corrosion in the scribes and also spots of corrosion elsewhere. An example is shown in Figure 29.

Figure 29. Corrosion on scribe on uncoated coupon from exposure rack.

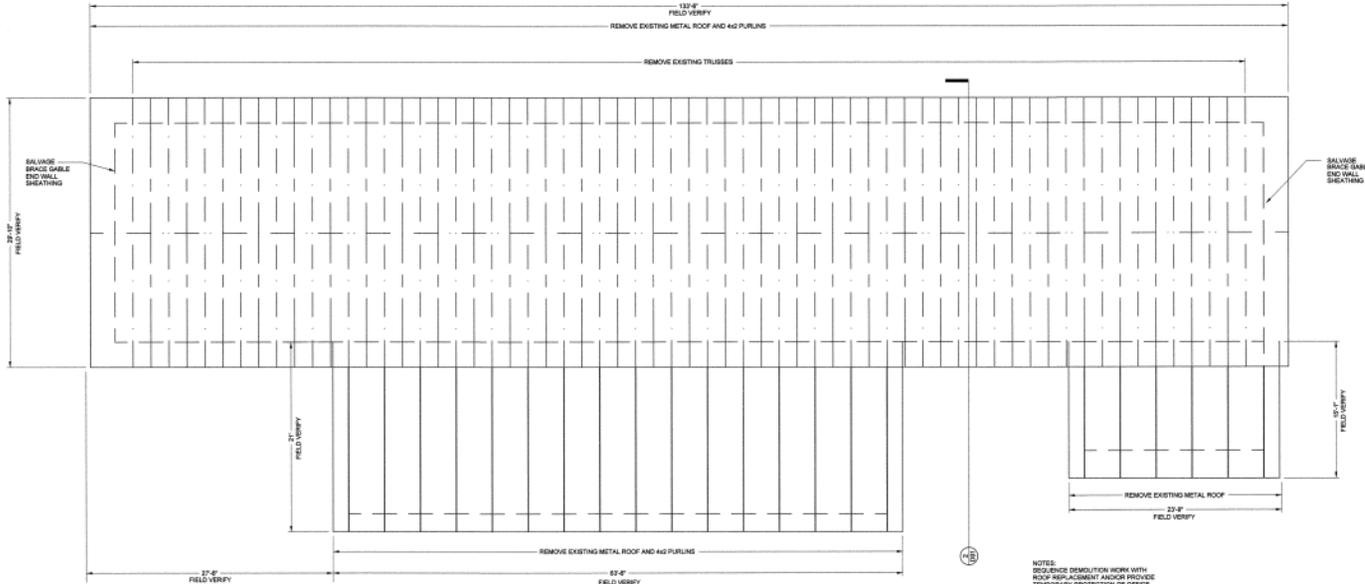
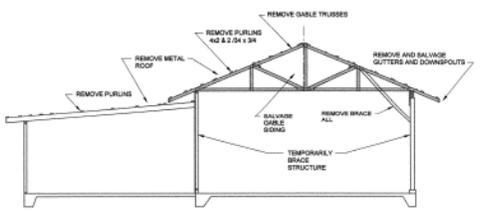
NOTES:
 SEQUENCE DEMOLITION WORK WITH ROOF REPLACEMENT AND/OR PROVIDE TEMPORARY PROTECTION OF OFFICE AND STORAGE AREAS.

DEMOLITION PLAN
 SCALE 3/16" = 1'-0"

DEMOLITION - SECTION
 SCALE 3/16" = 1'-0"

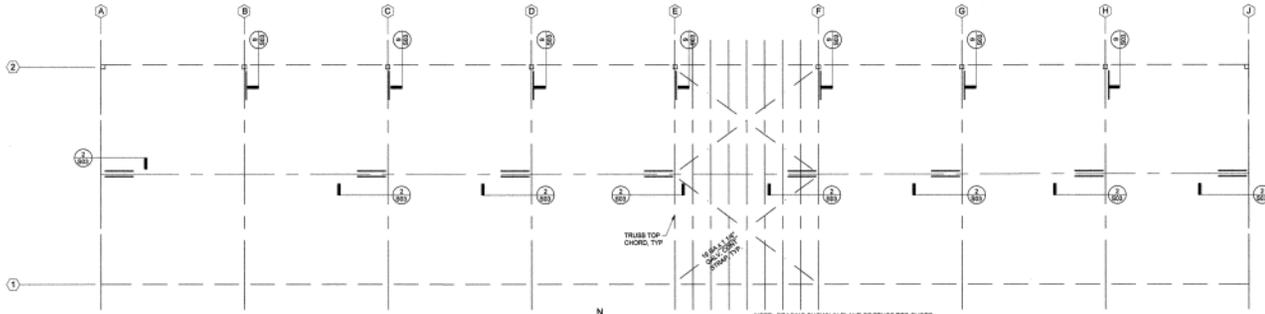
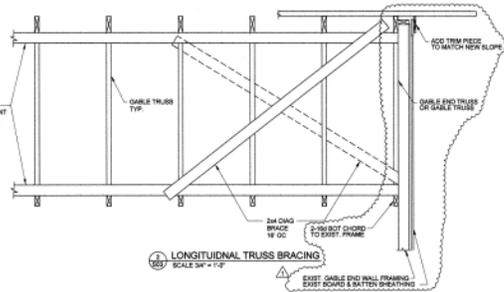
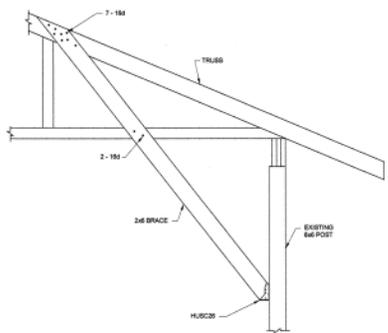
TRUSS BRACING PLAN
SCALE 3/4" = 1'-0"

LONGITUDINAL TRUSS BRACING
SCALE 3/4" = 1'-0"

POST BRACE
SCALE 3/4" = 1'-0"

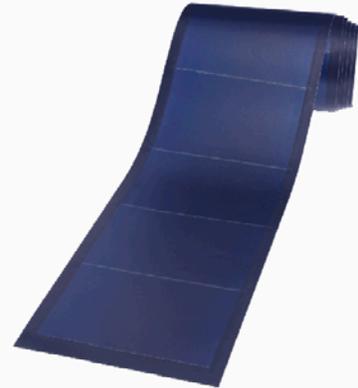
Refer to manufacturers installation guide for approved substrates and installation methods

*e.g., Multi-Contact (MC®) Connectors

Flexible

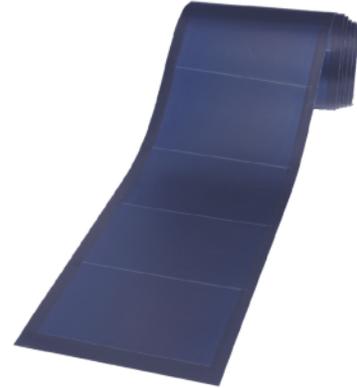
- High Temperature and Low Light Performance
- 5-Year Limited Product Warranty
- Limited Power Output Warranty:
 92% at 10 years, 84% at 20 years, 80% at 25 years (of minimum power)
- Quick-Connect Terminals and Adhesive Backing
- Bypass Diodes for Shadow Tolerance

Performance Characteristics

Rated Power (P_{max}): 144 Wp
 Production P_{max} Tolerance: $\pm 5\%$
