ERDC/CRREL TN-14-2

Shelter Deployment at Former Army Camp Tuto, Greenland

Final Report

Under Engineering for Polar Operations, Logistics, and Research (EPOLAR)
EP-ARC-11-17, "Inflatable Airbeam Structure"

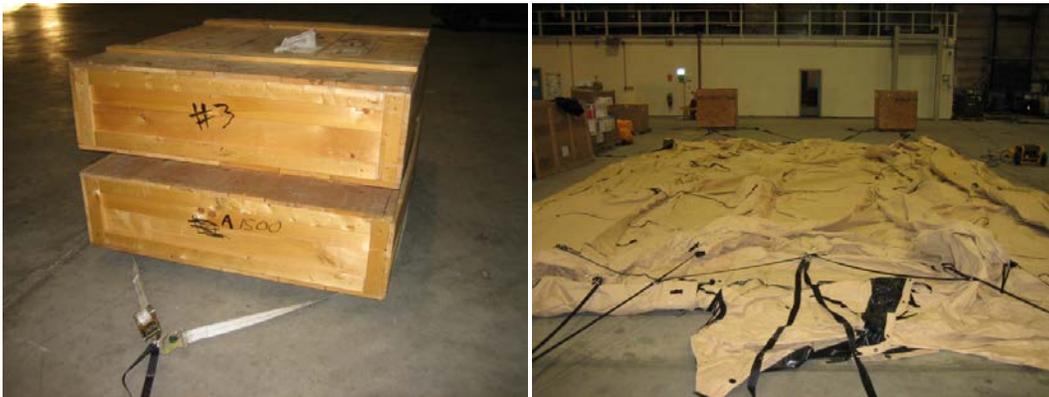
Because of the concrete floor, we developed an improvised anchoring system for the trial deployment. This system consisted of come-along straps tightened around the base of several heavy crates as depicted in Figure 1.

Figure 1. Anchor points used in trial shelter deployment.

These anchor points were sufficiently rigid to erect the shelter system and to apply tension to the guy lines. During inflation, there were minor leaks detected in the manifold system, preventing the shelter system from fully deploying. Upon further inspection, we noted that a fitting for the pressure relief valve was misaligned during assembly at the manufacturer's facility, creating a relatively large moment arm that would twist itself when the shelter was rolled up for transport (Figure 2). This issue was quickly addressed and resolved.

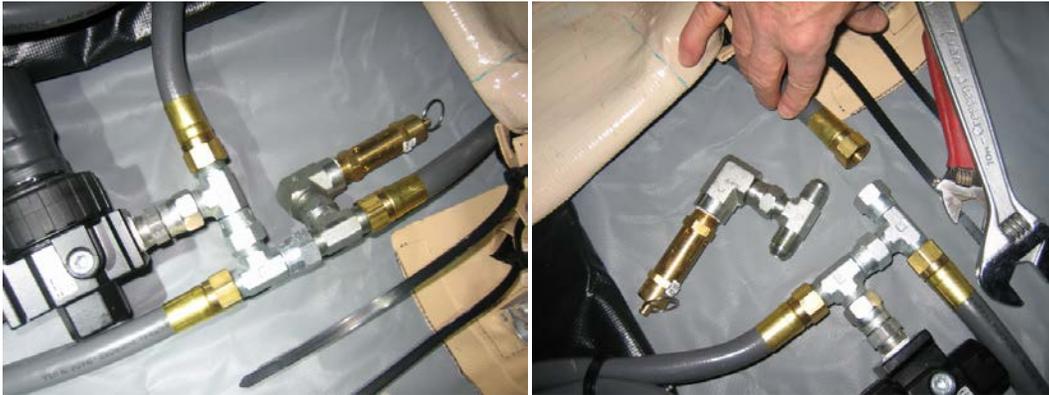
Figure 2. Misaligned valve and disassembly prior to repair.

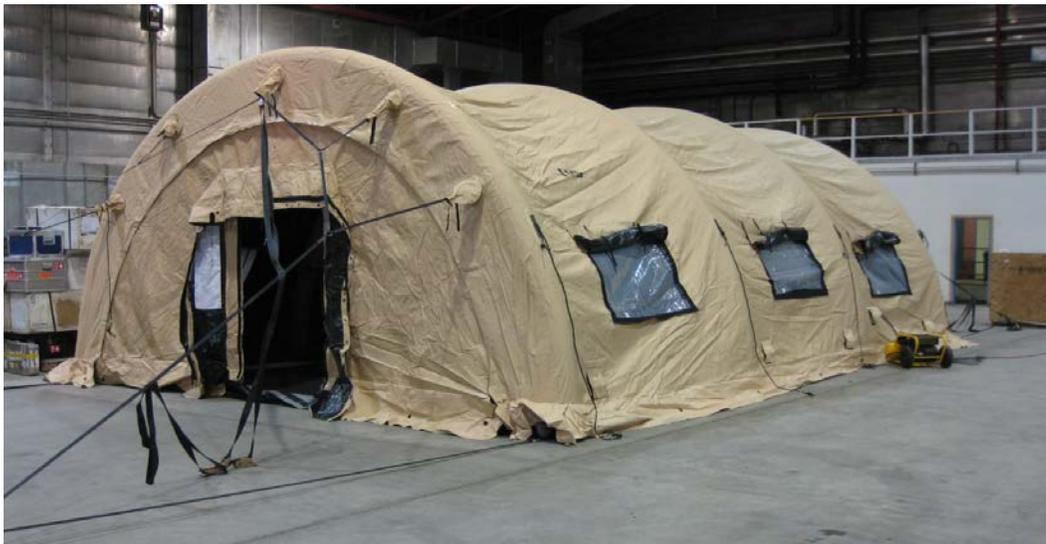
We ceased airbeam inflation upon reaching 45 psi. At this point, the airbeam frame component of the shelter was rigid. Because the improvised anchor points began to shift as the ratchet straps were further tightened down, the shelter fabric appears saggy in Figure 3 though this was acceptable for indoor trial and training purposes.

Figure 3. Shelter system erected in Hangar 8 on 5 March 2011.

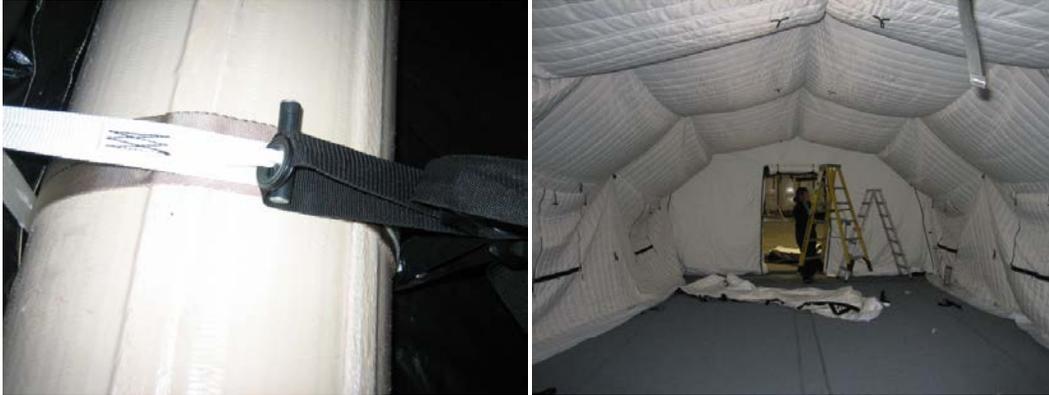
Camel Manufacturing, the contractor responsible for integrating the Thinsulate material into a thermal liner, opted for a novel approach in fastening the liner to the shelter interior. By using a sleeved pin pushed through a loop, one could easily attach and remove the liner by pushing the T-shaped assembly through a grommet on the liner straps (Figure 4).

Figure 4. The sleeved-pin assembly pushed through a liner grommet and the installed liner.

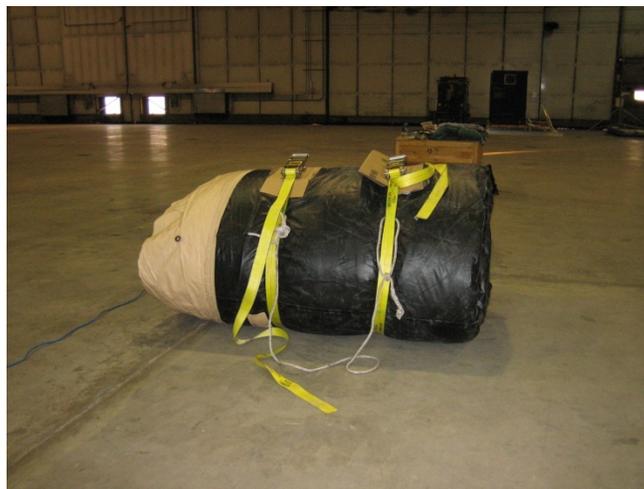
After liner installation and a thorough shelter inspection, the shelter was “struck.” First, we opened the air release valves and then vacuumed air out of the airbeams. Finally, we rolled up and ratchet strapped the complete assembly for transport to the remote test site. The shelter system with the installed thermal liner rolled up into a cylinder shaped bundle (Figure 5) that was no more than 6 in. larger in diameter than the shelter rolled up without a liner.

Figure 5. Rolled-up and ratchet-strapped shelter with liner installed.

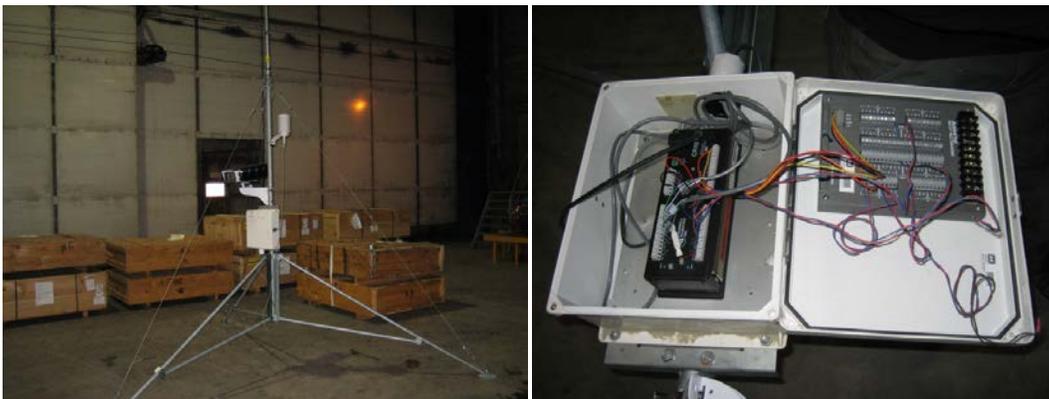
In addition to the standard Campbell Scientific sensor arrangement, there were several third-party sensors, a battery bank, a video camera, and solar panels installed onto the weather station. Throughout the test duration, the station recorded simultaneously temperature, humidity, wind speed and direction, and video footage while sharing a time stamp to ease correlation during analysis of the data at a later date. Figures 6 and 7 depict the weather station tri-pod frame and associated accessories.

Figure 6. Weather station video camera, temperature and humidity sensors, and control box.

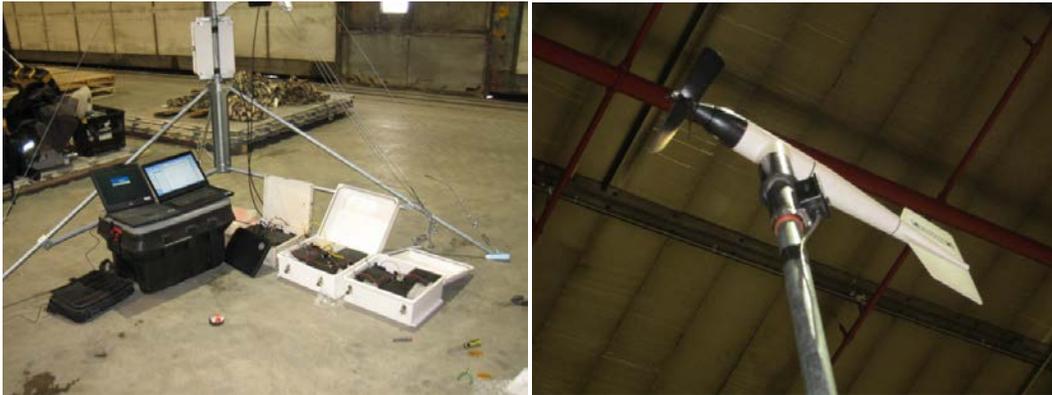
Figure 7. Battery boxes and anemometer.

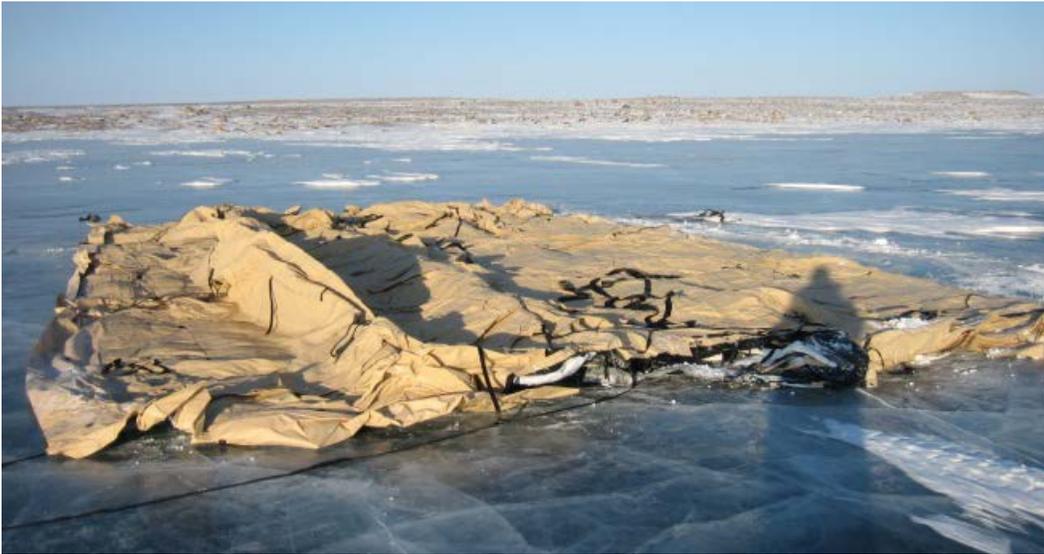
We deployed the shelter on 9 March 2011. We chose a frozen lake as the deployment site to facilitate durable anchoring with drilled V-threads. Initially, we unrolled and flattened out the shelter on the ice (Figure 8), taking great care by pulling on guy lines simultaneously to ensure that the shelter was square. We encountered some difficulty during the process of squaring off the shelter, which can be attributed primarily to fabric stiffness from "over-nighting" the bundled-up shelter outdoors at -30°F (-34°C). Finally, we laid out the guy lines in a squared-off fashion to assist in properly locating the anchor points.

Figure 8. Unrolled and squared-off shelter, deployed 9 March 2011 on a frozen lake.

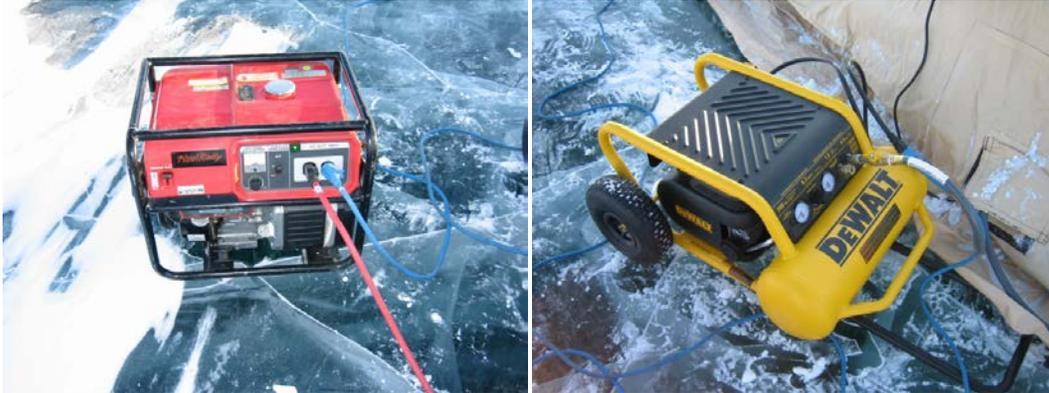
Inflation of the airbeam structure was facilitated by a 1.8 hp Dewalt air compressor connected to a Honda 2500 W generator running off of JP-8 diesel fuel (Figure 11). Both the compressor and generator maintained 100% operability at -20°F ambient. The air compressor's pressure regulator was set by the shelter manufacturer to shut off at approximately 45 psi. This value was specified in the shelter operating manual as the required inflation pressure to maintain maximum wind load and deflection resistance.

Figure 11. The 2500 W generator and 1.8 hp air compressor.

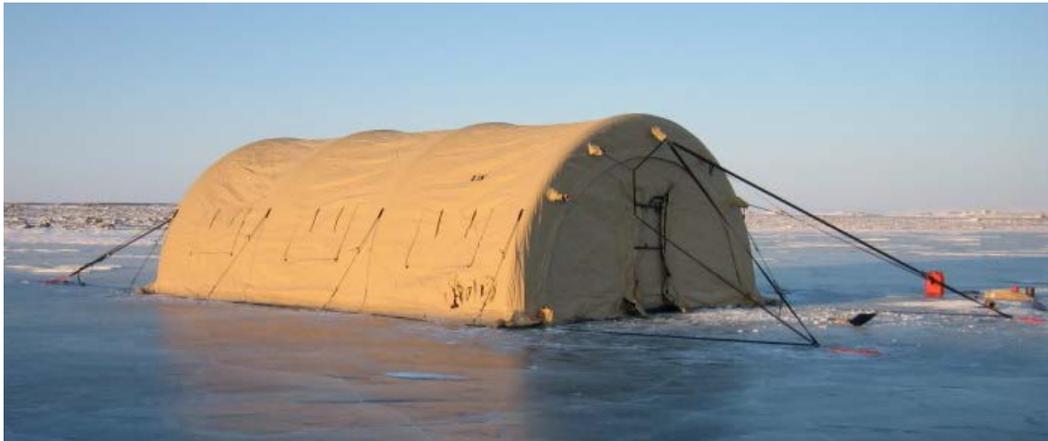
Once the air compressor achieved the target pressure level, we shut it off and closed the air manifold valves on the shelter. We then further tensioned the front and rear main guy lines to stretch the shelter fabric into shape. We encountered some difficulty during the tensioning process. Regardless of the amount of tension that we applied by tightening the ratchet straps, the fabric refused to ease into a tensioned state and smooth out (Figure 12). Most likely this was due to the fabric having become too stiff and rigid from being overnighted in a “packed state” while at -30°F .

Figure 12. Fabric droop experienced due to stiff shelter-skin fabric.

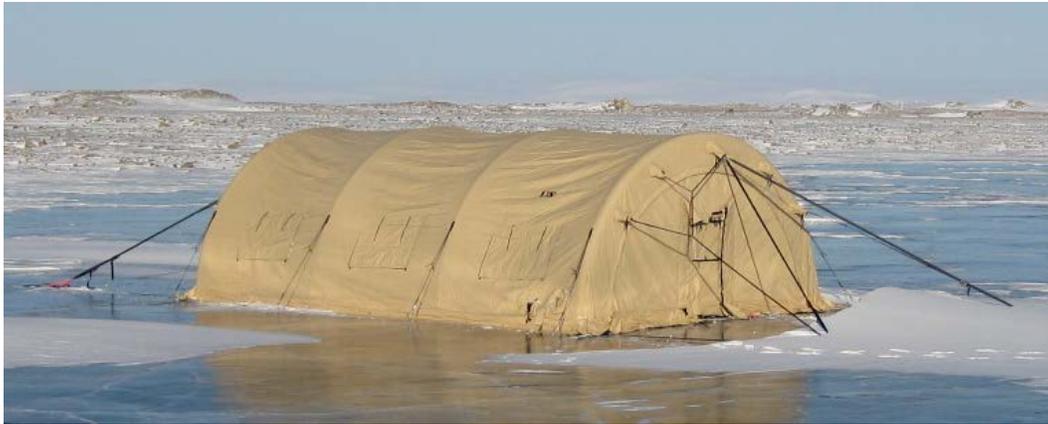
The shelter initially performed well during moderately high winds (average > 30 mph, gusts > 40 mph) on 11 March and 13 March. After this period, air temperatures dropped below -10°F for the remainder of the deployment. The shelter was still intact on 19 March 2011, but the outer skin continued to droop despite repeated efforts to tighten the guy lines (Figure 17). Close inspection revealed the presence of fine cracks in the outer skin (Figure 18), which likely resulted from flapping of the loose fabric.

Figure 17. Shelter intact on 19 March 2011 but with drooped and wrinkled outer skin despite tight guy lines.

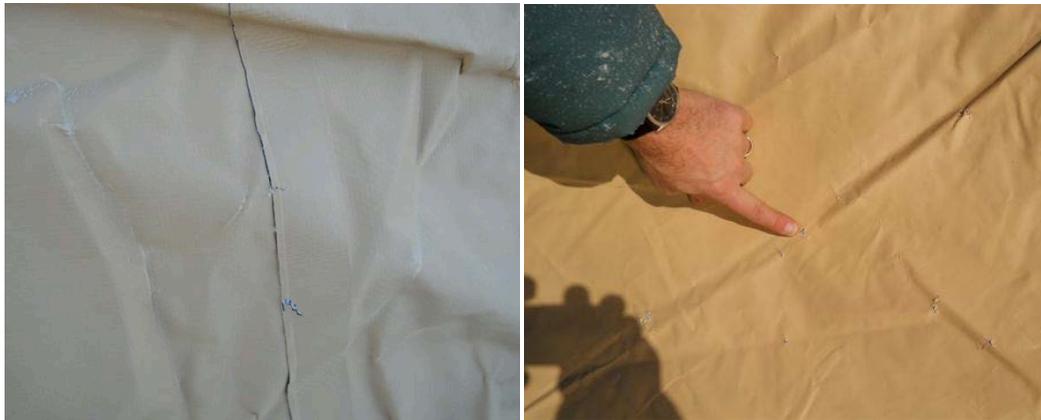
Figure 18. Evidence of fabric cold cracking observed on 19 March 2011.

NSRDEC plans to develop a test procedure through which shelter fabrics may be exposed to similar conditions as experienced during the aforementioned shelter failure while remaining in a laboratory environment. A Gelbo flex test is a possible method to simulate the buffeting and tensioning of shelter skin fabrics while deployed in windy environments. The Gelbo flex test, originally designed to evaluate boots, allows for fabrics to be evaluated under compound stressing. It does so by enacting an axial tension load on the cylindrically-wrapped fabric sample while simultaneously counter-rotating either end of the fabric cylinder to induce the compound stresses that often result in composite fabric disassociation.

To further increase the viability of the simulation, the testing equipment along with fabric samples will remain in an extreme-cold environment for the duration of the test. The objective is to induce similar cold-cracking failure modes as experienced in the Greenland shelter deployment. Several fabric samples from different vendors will be evaluated against the Greenland shelter baseline to determine the fabric composition that is the most survivable polar-climate shelter-fabric solution.

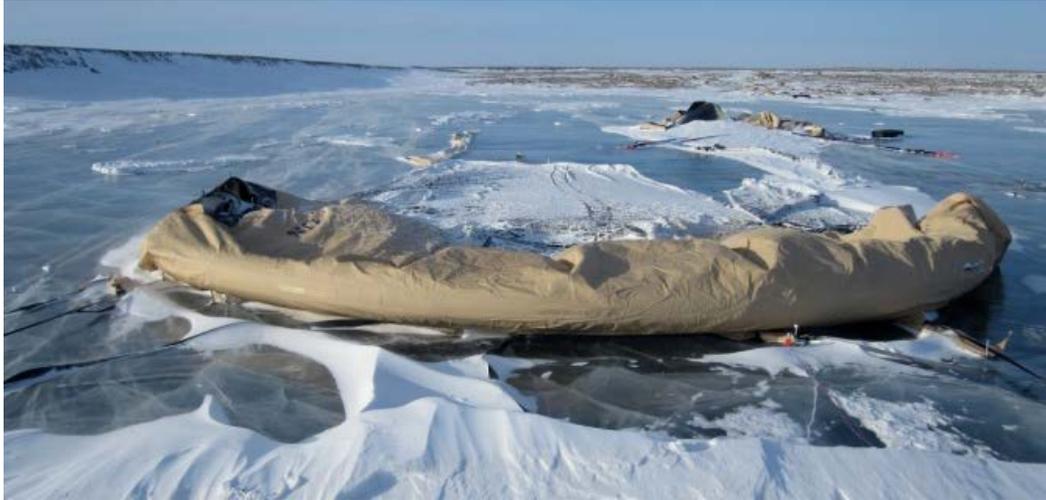
Winds diminished, and we were able to return to the site on 22 March 2011. It was immediately clear that the storm had destroyed the shelter. The outer skin had shredded, and 80% of the structure had been blown away by the wind (Figure 19).

Figure 19. Remains of the shelter after the 20–22 March 2011 storm. Anchored guy lines retained the front and rear airbeams, but most of the outer skin and the two middle airbeams were blown far downwind.

We determined that the failure was not due to user delinquency in airbeam maintenance or the use of inappropriate anchoring methods. Throughout the evaluation, operational airbeam pressures remained 45–50 psi, and V-thread anchors remained 100% intact. Sufficient evidence exists showing that the shelter skin fabric succumbed to cold cracking from the combination of extreme cold temperatures and flapping during high winds (Figure 20). Total failure probably occurred at a rapid pace whereby cracked fabric in the tension load-bearing shelter skin tore abruptly in high winds, shearing the shelter system from its anchored front and rear airbeams. Only the front and rear airbeams and their associated end-wall fabric remained attached to the guy lines and anchors in the ice. We found the two remaining airbeams at the downwind end of the frozen lake. Both were still pressurized (inflated) with no damage sustained. Unfortunately, the video record ended (memory full) with the shelter still intact a few hours before the period of peak winds, so we cannot identify the exact sequence of shelter destruction.

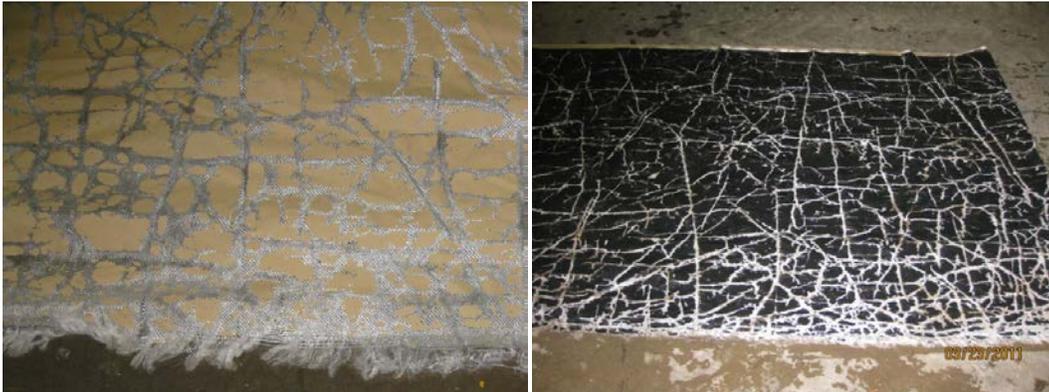
Figure 20. Recovered piece of shelter outer skin showing cold cracking and torn fabric.
