Cadmium Repair Alternatives on High-Strength Steel

January 25, 2006

13. SUPPLEMENTARY NOTES 26th Replacement of Hard Chrome and Cadmium Plating Program Review Meeting, January 24-26, 2006, San Diego, CA. Sponsored by SERDP/ESTCP.

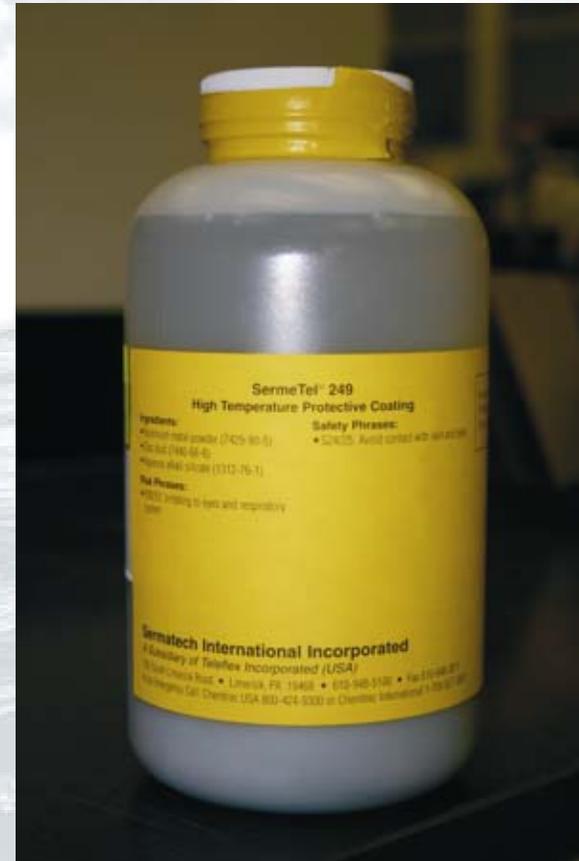
- **Sermetel 249, an aqueous inorganic metallic coating applied at room temperature. Contains Zinc and Aluminum powder. Brush or Spray application.**

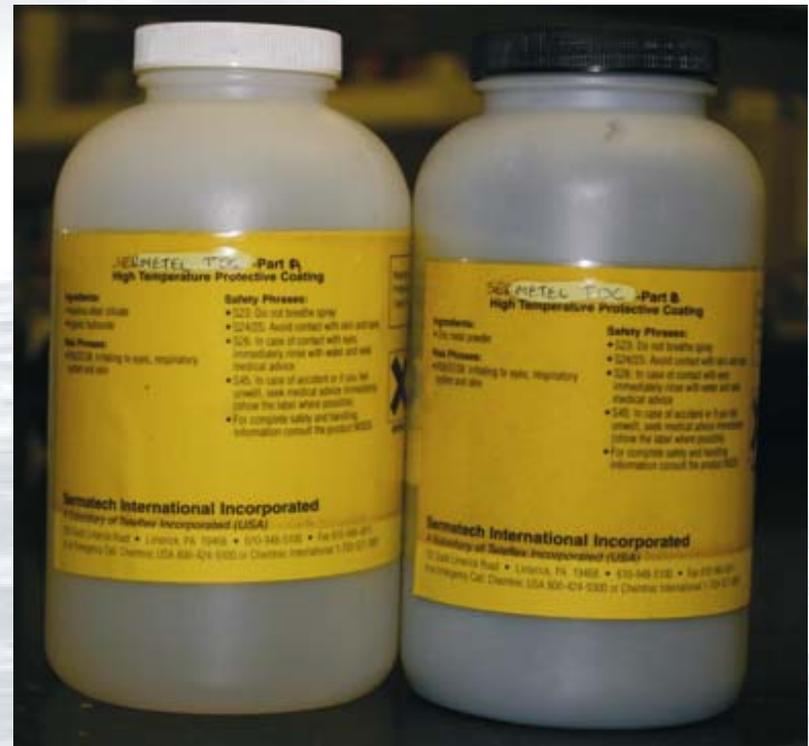
- **Sermetel TDC, is a waterborne, inorganic, self curing, room temperature coating. Can be spray or brush on. Two part mix, binder and Zinc Powder**

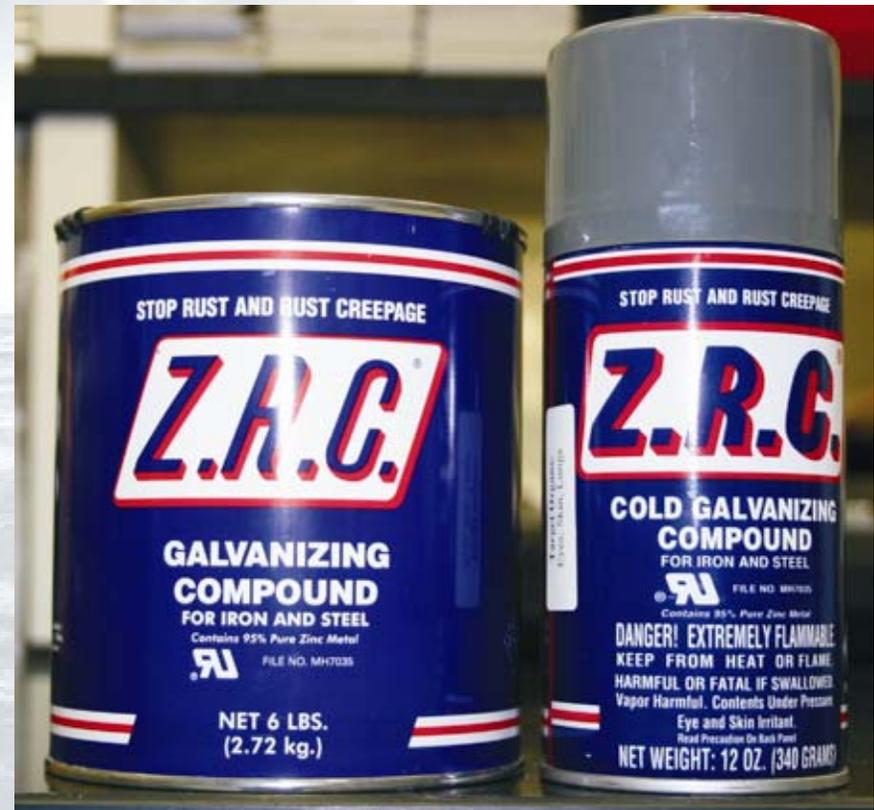
- **Z.R.C Cold Galvanizing Compound, aerosol or brush on. 95% Zinc Powder, Acetone, MEK and Propane. Applied at room temperature, self curing.**
- **Aerosol Cans used for this test**

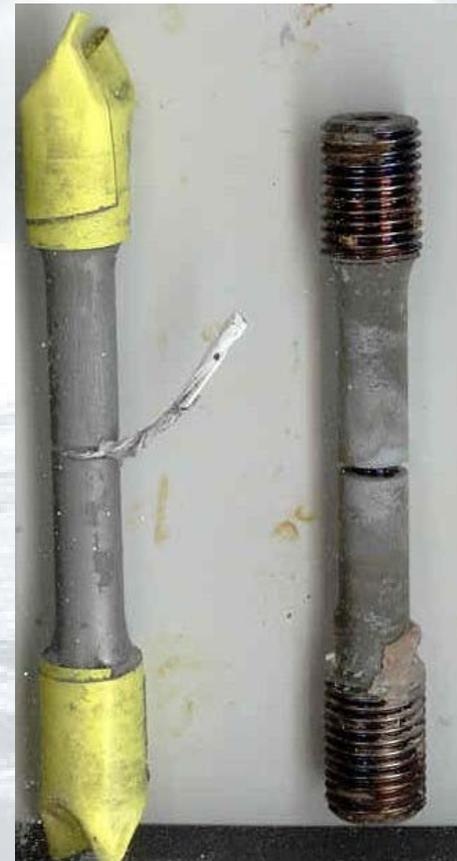
- Done in 2 phases, phase 1 of round bar testing along with bare corrosion results will determine phase 2 testing.
- All specimens tested at 45% of tensile strength for 150 hrs.
- All Specimens must pass to be considered Non-Embrittling
- Specimens tested immersed in DI water, Sea Water per ASTM 1154 and Anti-Icing fluid per Mil-A-8243, 4ea
- Phase 2 testing featured round bars that were “damaged”, the groove was taped off, and undamaged.

“Damaged” round bars

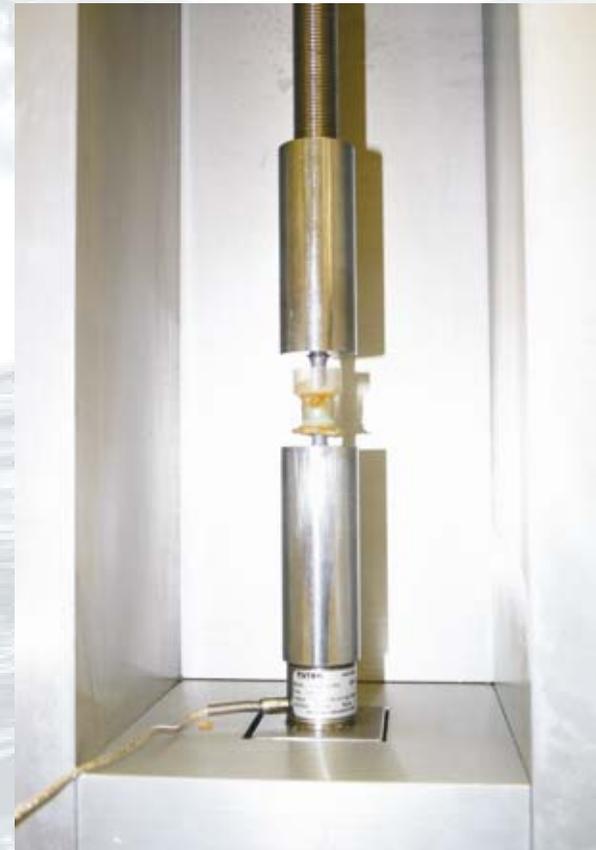
Round Bar Test in Progress

- **Sermetel TDC and 249 were not tested due to poor results in phase 1 testing and bare corrosion data.**
- **ZRC Cold Galvanizing failed 2 of 4 damaged coating in sea water and passed all four DI water and anti-icing fluid tests**
- **Cadmium plated round bars only 3 of 24 failed.**
- **ZRC Cold Galvanizing and cadmium plating had very similar results**

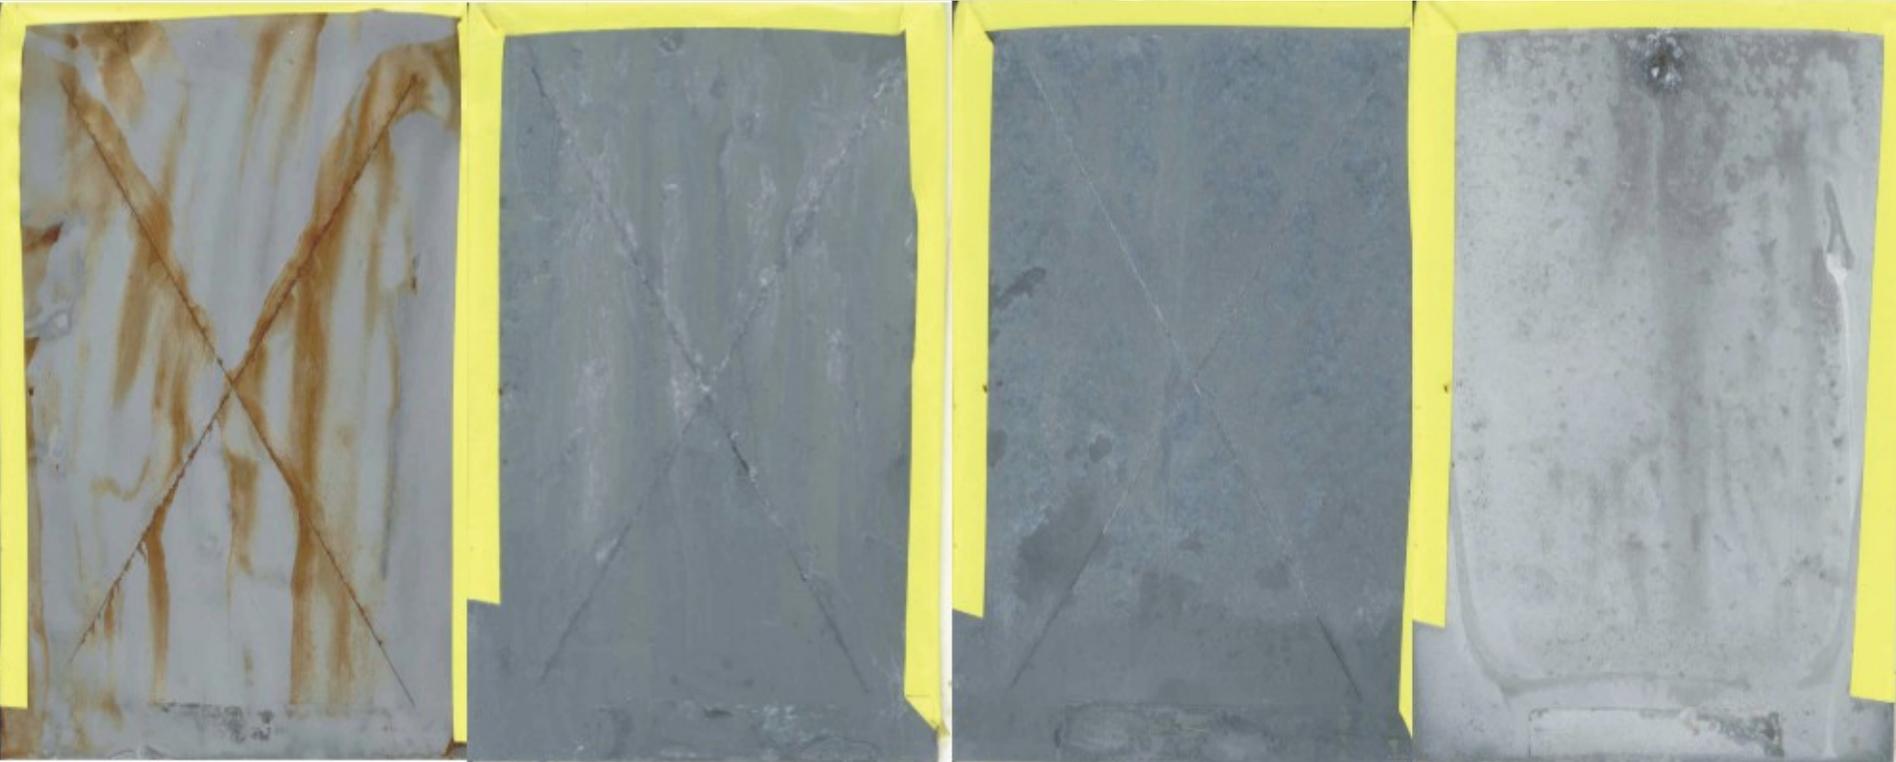
Bare Corrosion Test 24 hrs ASTM B117

Sermetel 249

Sermetel TDC

**ZRC Cold
Galvanize**

**Cadmium
Plating**

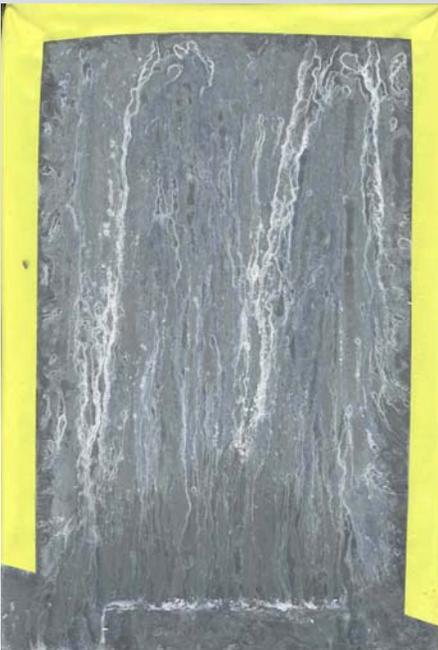
Bare Corrosion Test 7 Days ASTM B117

**Sermetel
TDC**

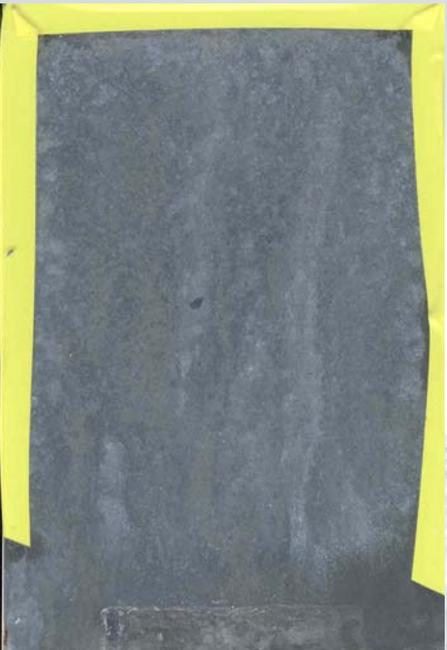
**ZRC Cold
Galvanize
unscribed**

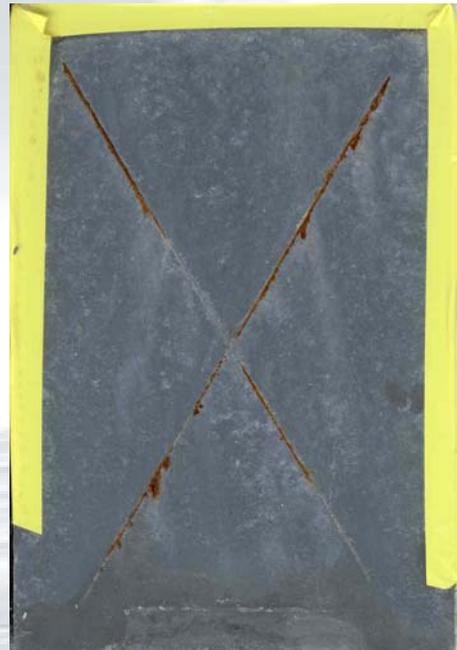
**ZRC Cold Galvanize
scribed**

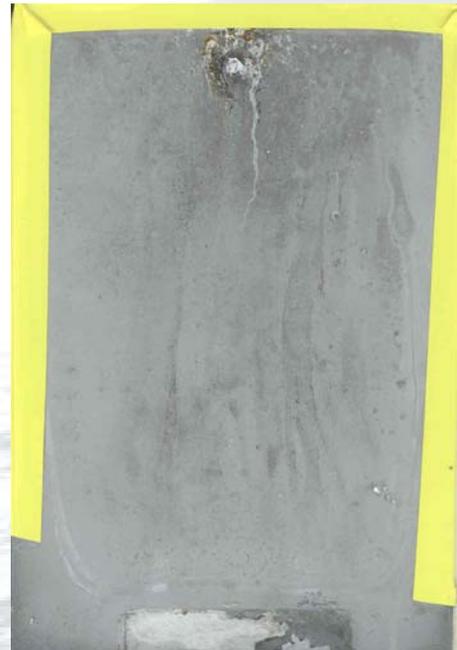
**Cadmium
Plating**

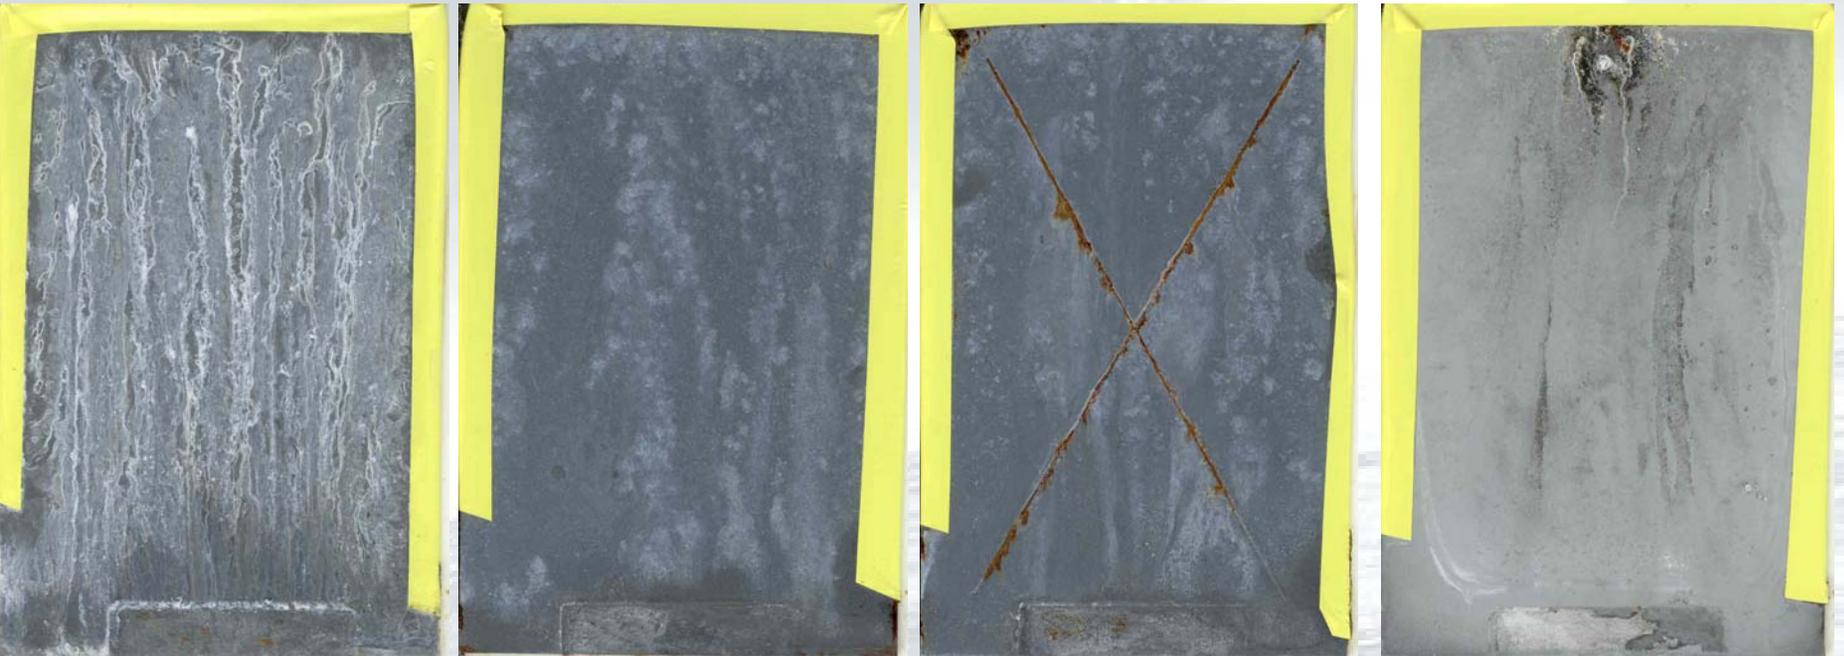
Bare Corrosion Test 14 days ASTM B117

**Sermetel
TDC**

**ZRC Cold
Galvanize
unscribed**

**ZRC Cold Galvanize
scribed**

**Cadmium
Plating**

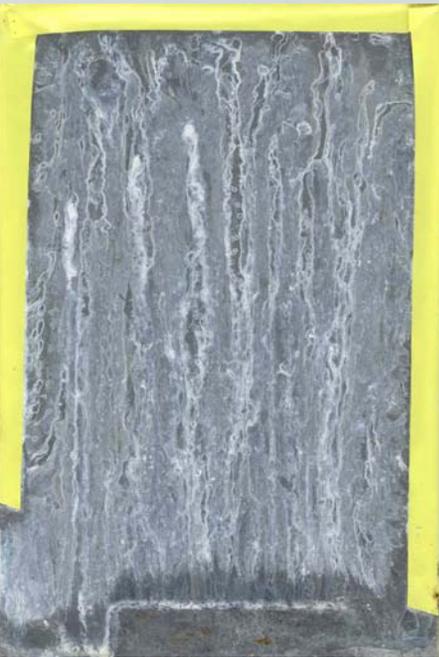
Bare Corrosion Test 21 days ASTM B117

**Sermetel
TDC**

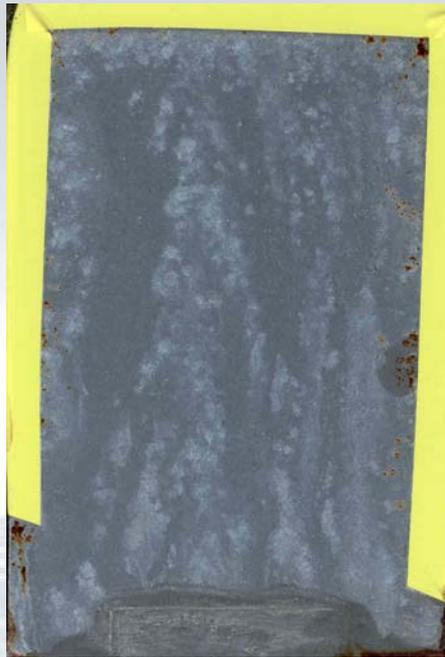
**ZRC Cold
Galvanize
unscribed**

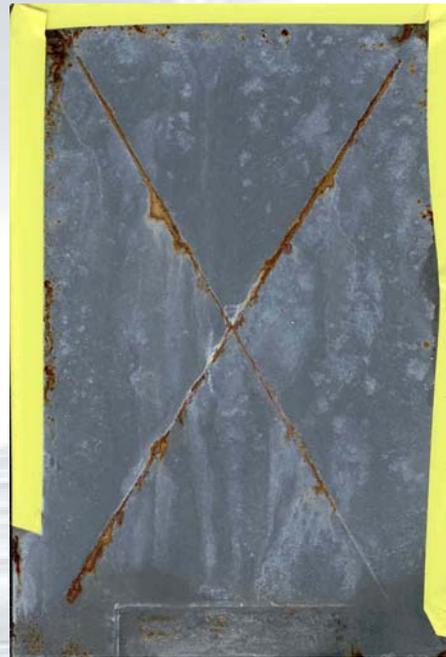
**ZRC Cold Galvanize
scribed**

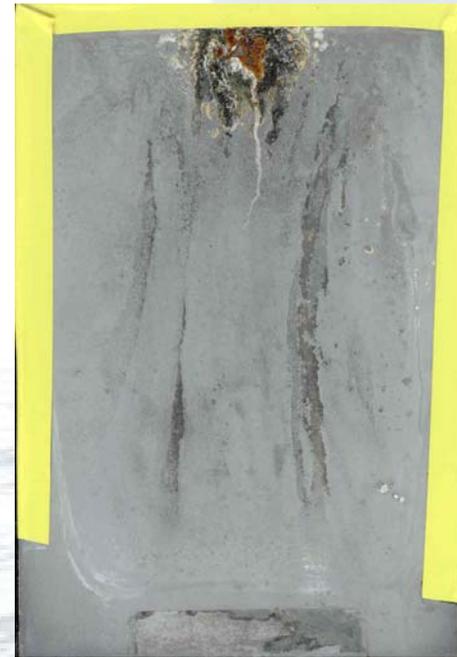
**Cadmium
Plating**

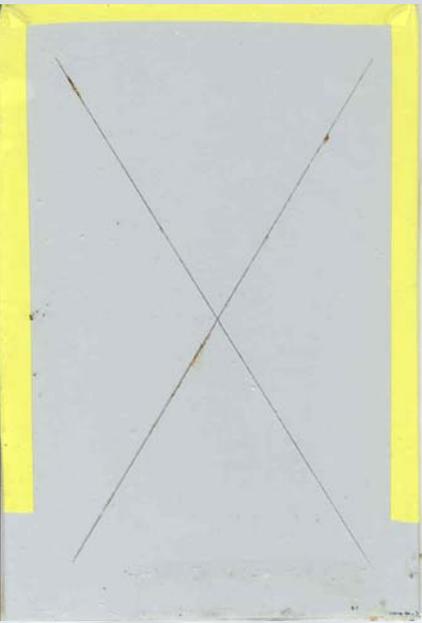
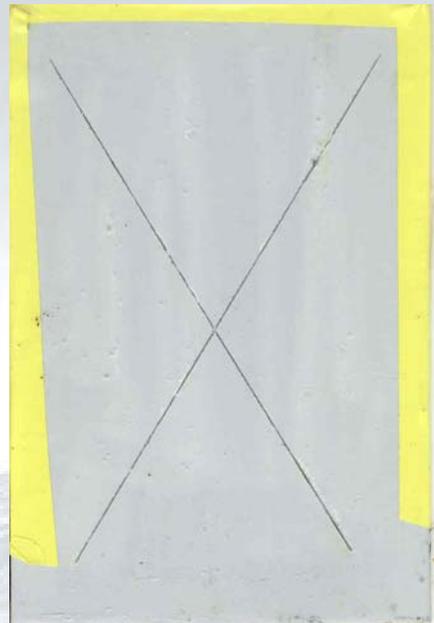
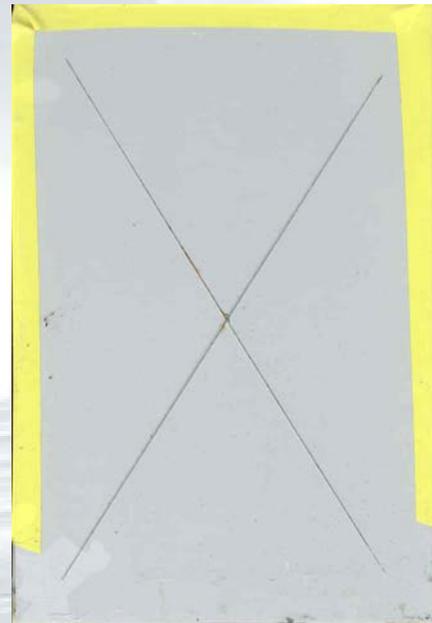
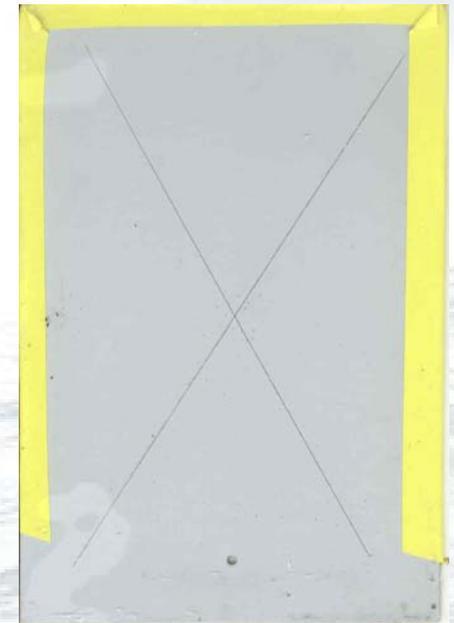
Painted Corrosion 24 Hrs ASTM B117

Sermetel 249

Sermetel TDC

**ZRC Cold
Galvanize**

Cadmium Plating

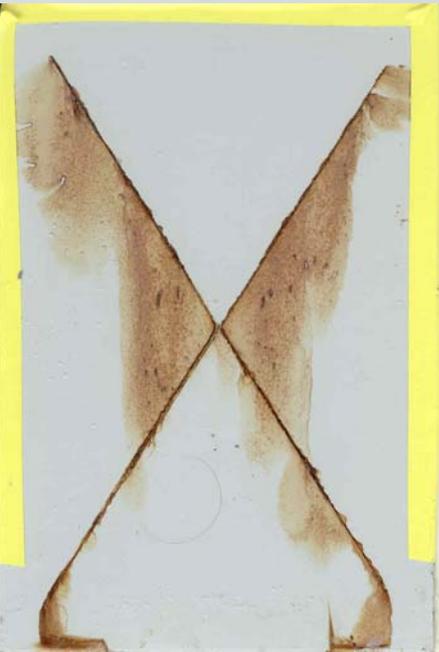
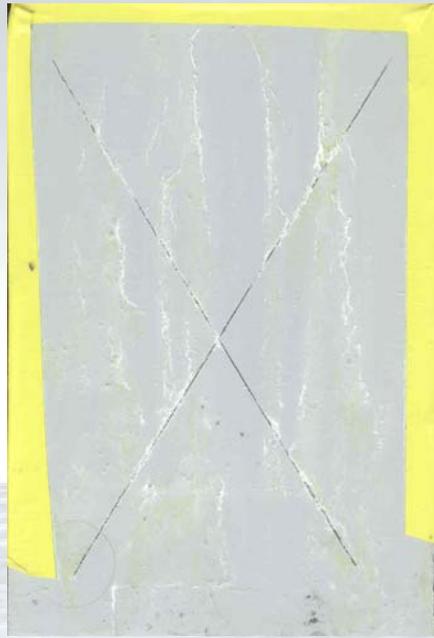
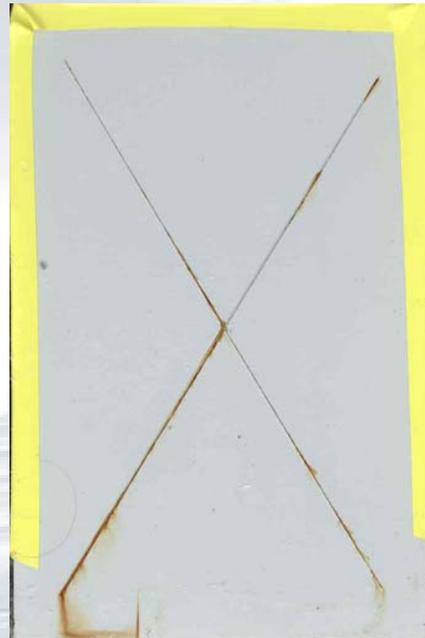
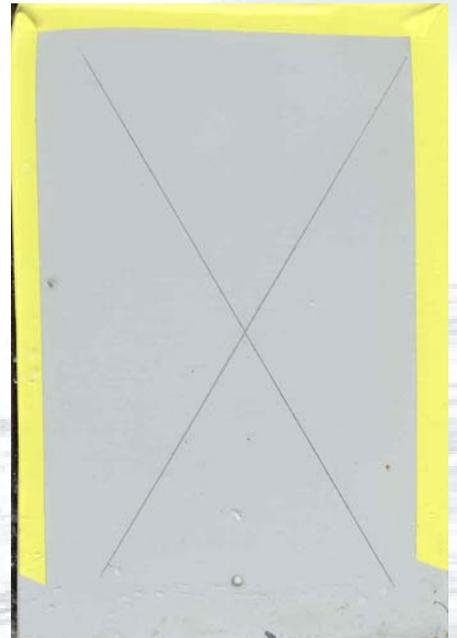
Painted Corrosion 7 Days ASTM B117

Sermetel 249

Sermetel TDC

**ZRC Cold
Galvanize**

Cadmium Plating

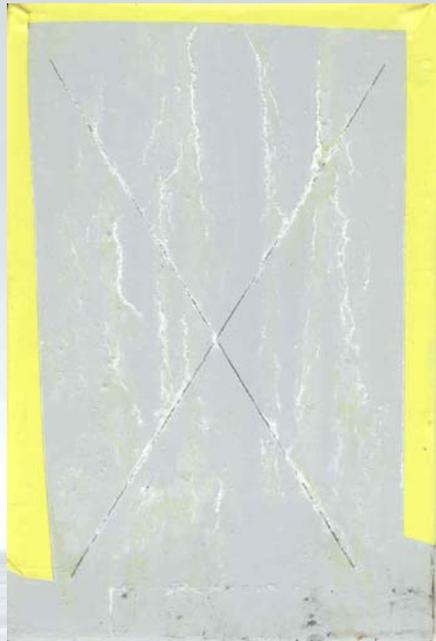
Painted Corrosion 14 Days ASTM B117

Sermetel TDC

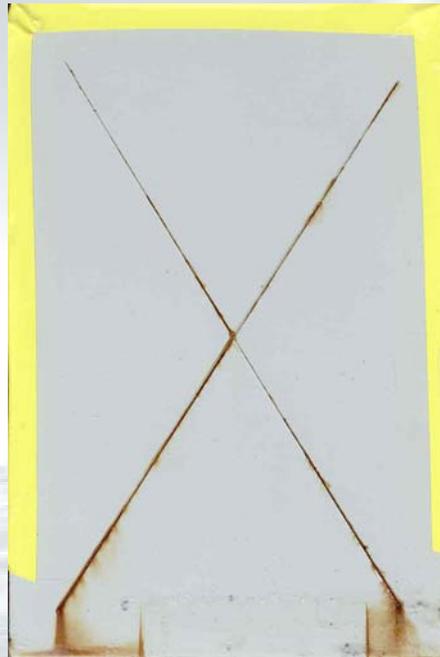
**ZRC Cold
Galvanize**

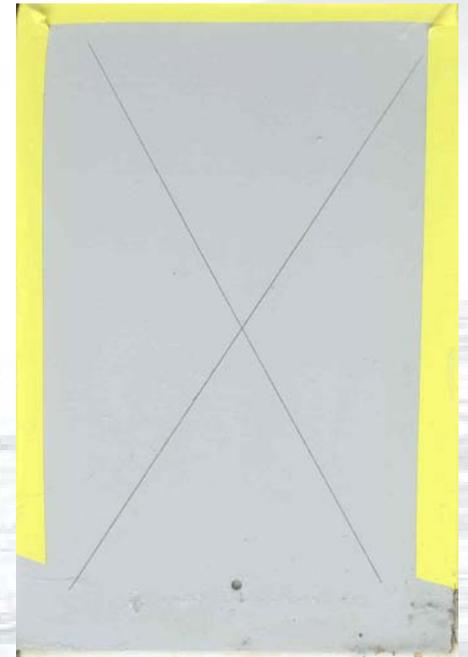
Cadmium Plating

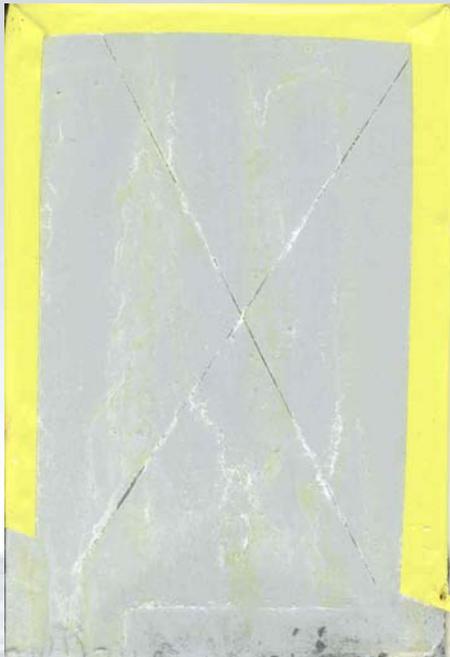
Painted Corrosion 21 Days ASTM B117

Sermetel TDC

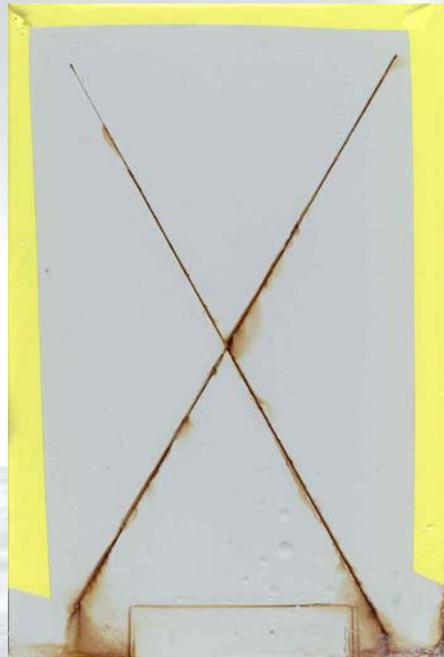
**ZRC Cold
Galvanize**

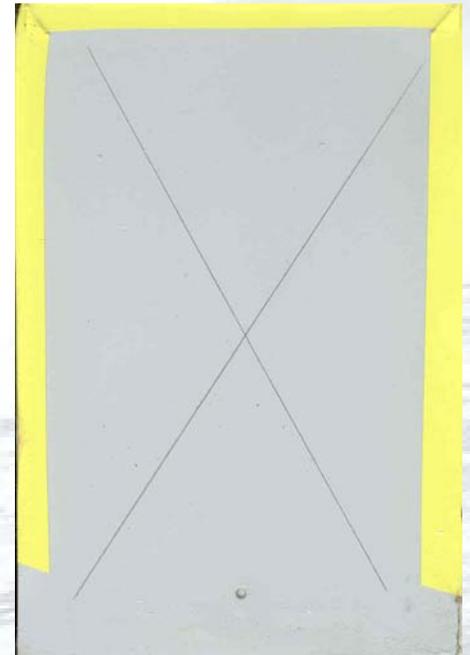
Cadmium Plating

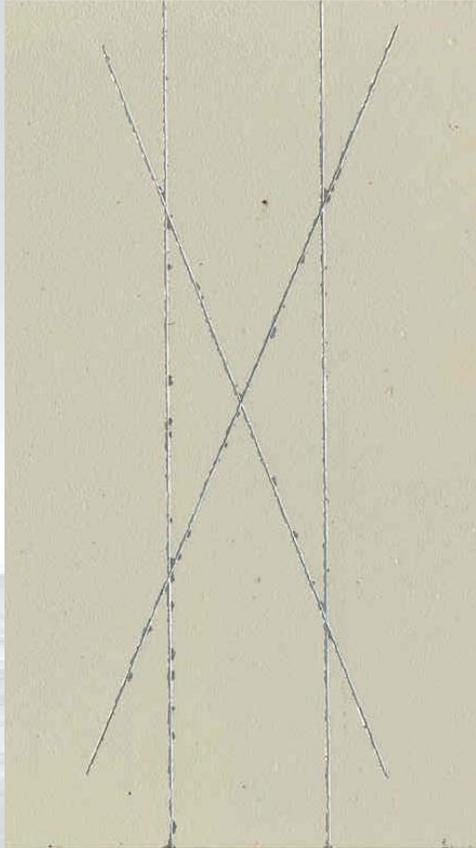
**53022 7 Day Wet
Over ZRC CG**

- Tested Primer on bare steel and Primer on ZRC Cold Galvanize to steel.
- Used 3 primer systems, Mil-PRF-53022, MIL-PRF-85582N, MIL-PRF-23377 Class C2.
- Each primer system tested Dry, 1 day wet at room temperature, 4 days wet at 120 F, 7 days wet at 150 F.
- Averaged a rating of 4 for all ZRC Cold Galvanizing tests.
- ASTM D 3359 Method A, ratings based on paint removed after peeling tape, 5 being the best no peeling or removal, 4 trace peelings or removals, 3 jagged removals up to 1/16", 2 jagged removals up to 1/8", 1 removal of most area's under the tape and 0 removal beyond the area of the X

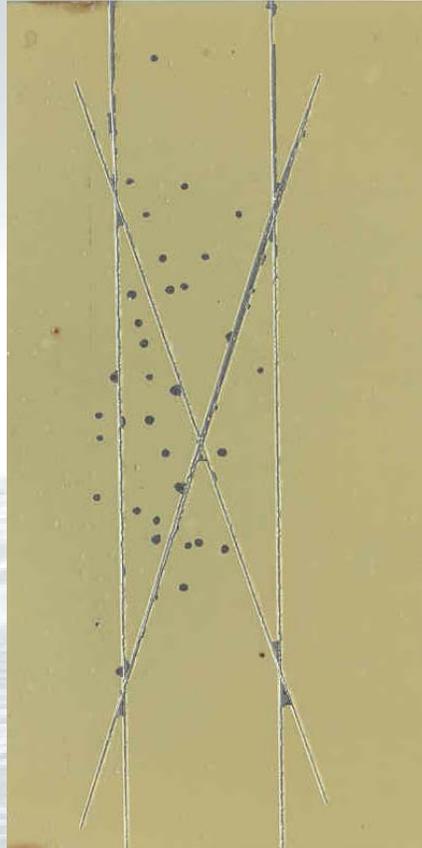
**23377C 7 Day Wet
Over ZRC CG**

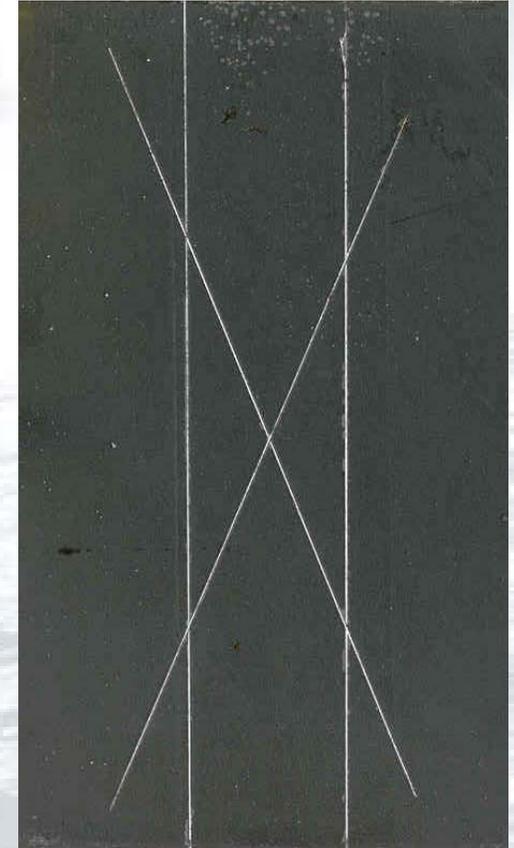
**85582N 7 Day Wet
Over ZRC CG**
