March 6, 1936

Preliminary Heat Treatment
of
Chromium Plated Steel

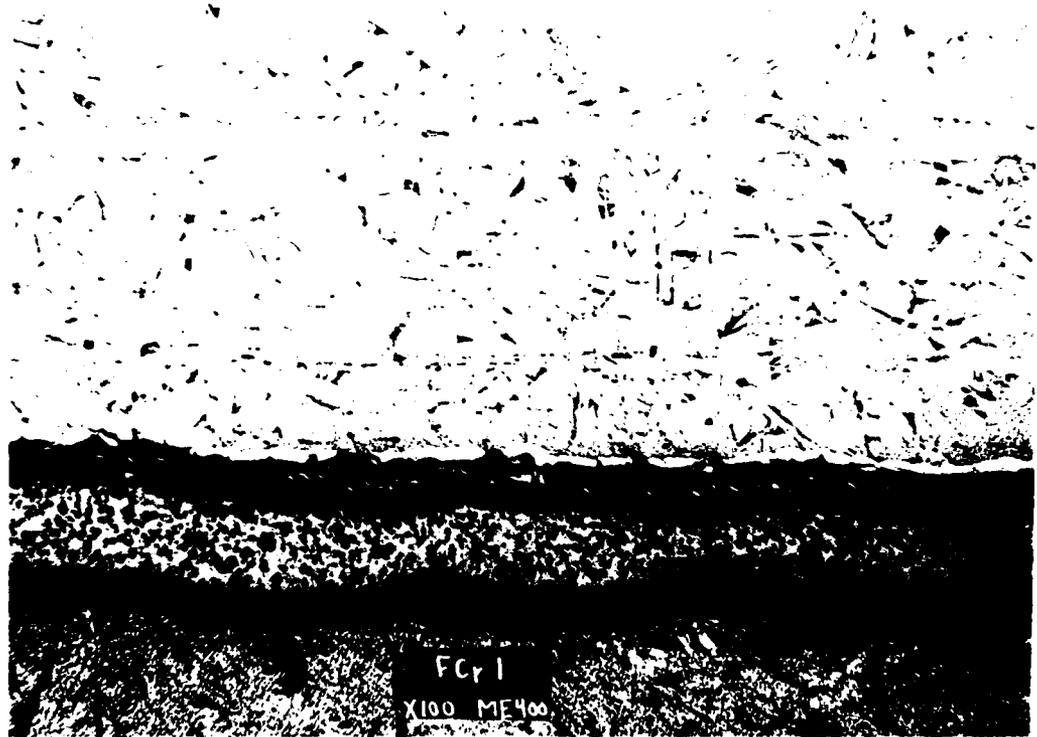
FIG. 1

Fig. 1 X100 FCr 1 Shows the plating to be discontinuous.
ME 400

1. The thin layer specimens showed many spots where the plating had not adhered. The spots showed up as spongy or porous areas. There were places where the plate showed signs of exfoliation. There were also many more or less radial cracks. Such conditions would afford little corrosion resistance.

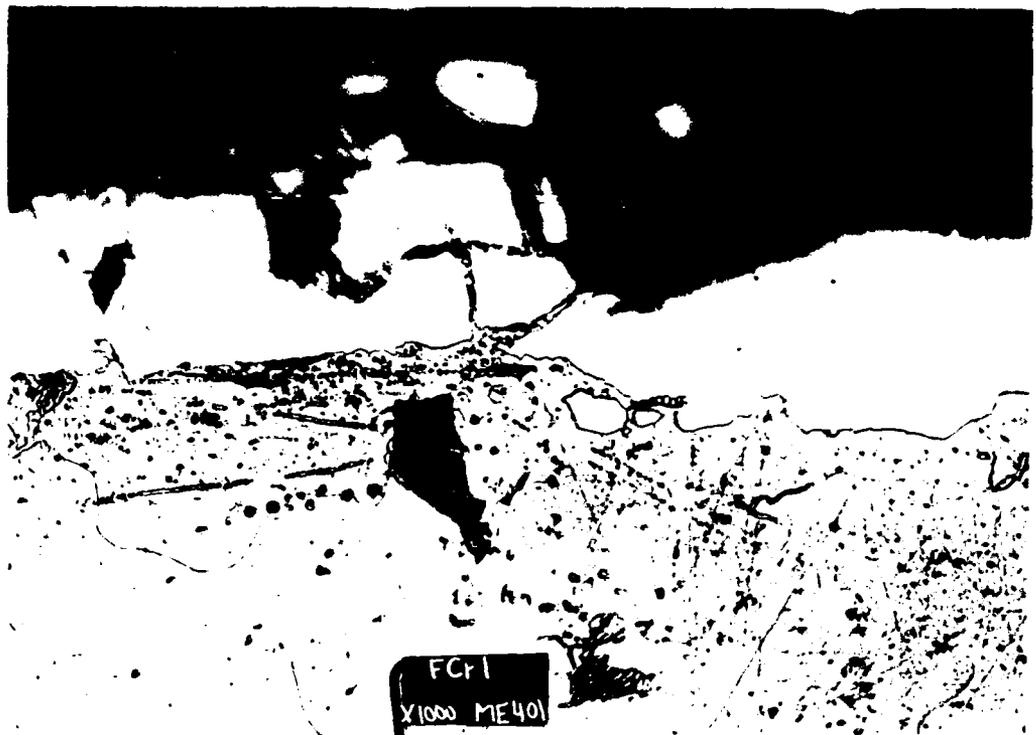
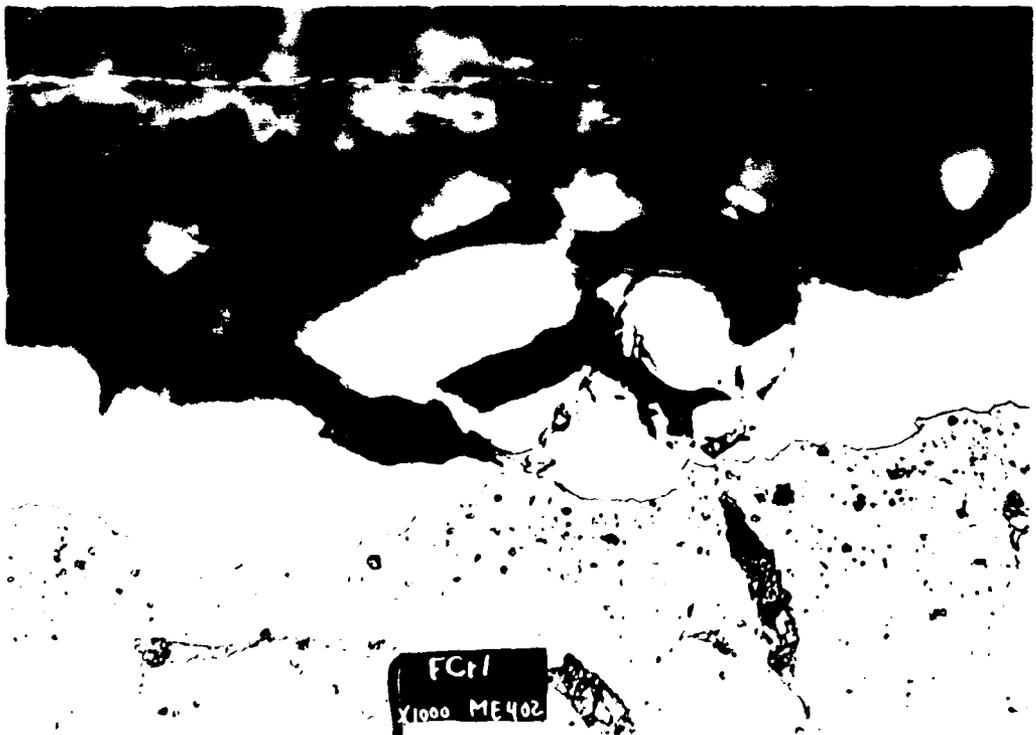
FIG. 2

Figs. 2 & 3 X1000 F Cr 1 Show areas of expoliation of
the plate. ME 401, 402

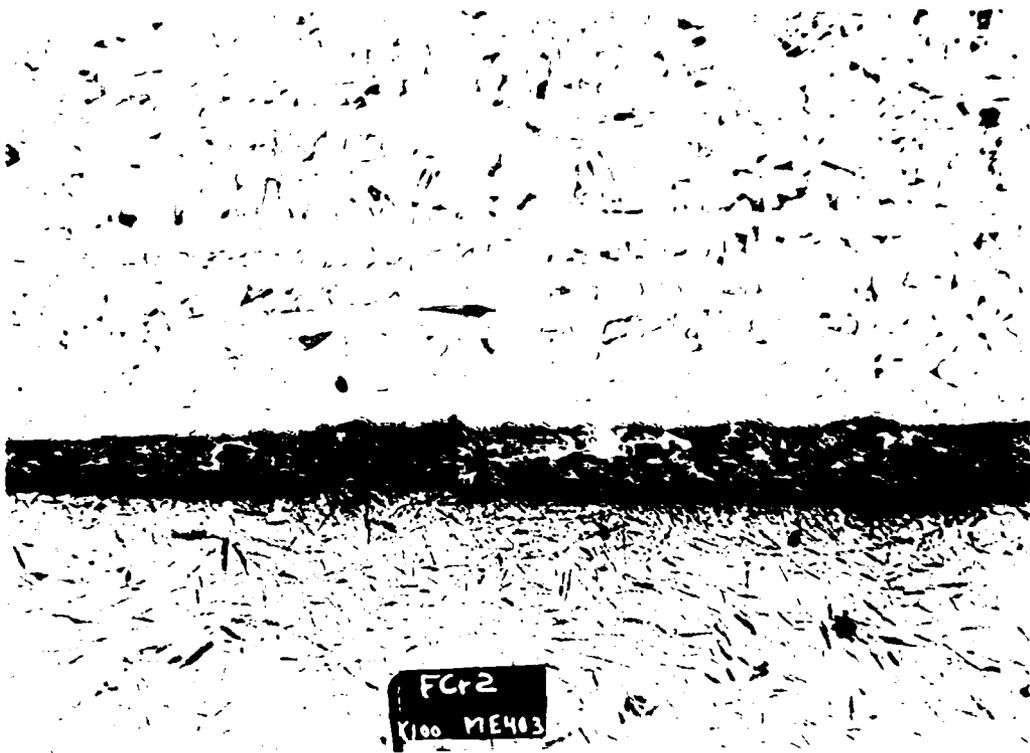
FIG. 4

Fig. 4 X100 F Cr 2 Shows the plating to be discontinuous.
ME 403

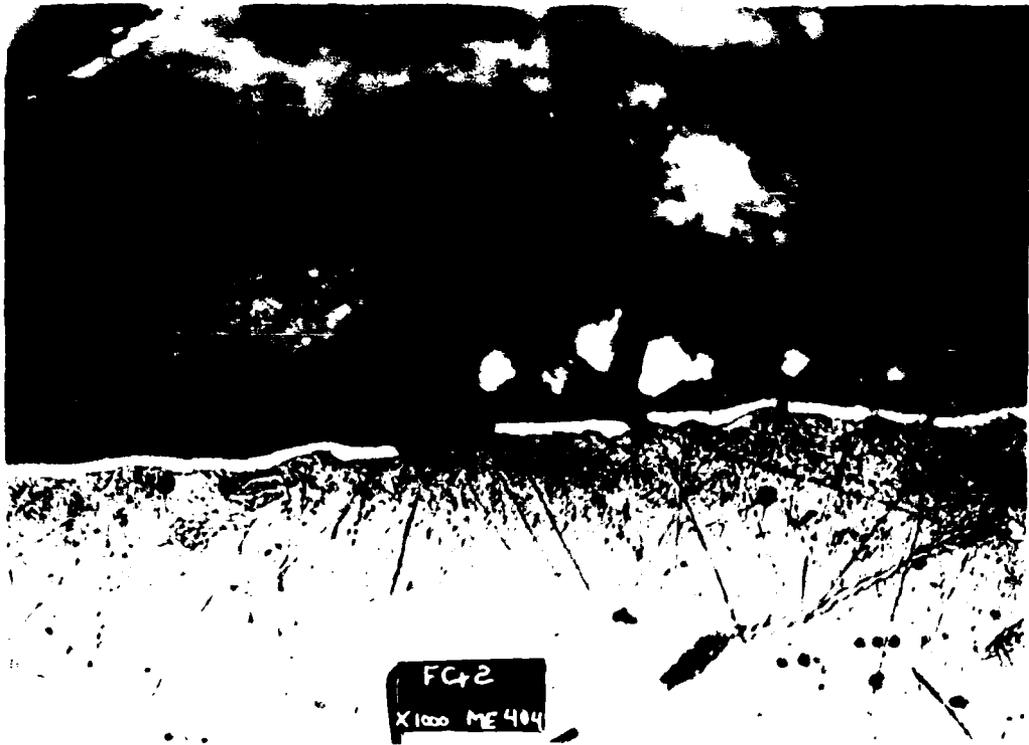
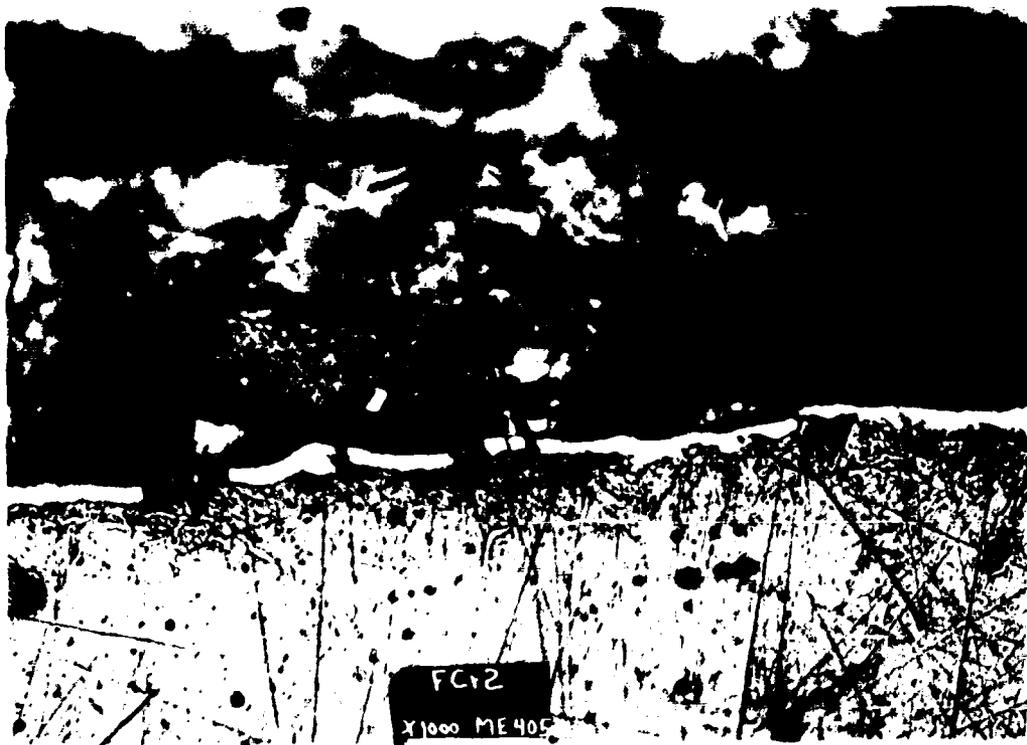
FIG. 5

Figs. 5 & 6 X1000 F Cr 2 Show areas where plating did
not adhere. ME 404, 405

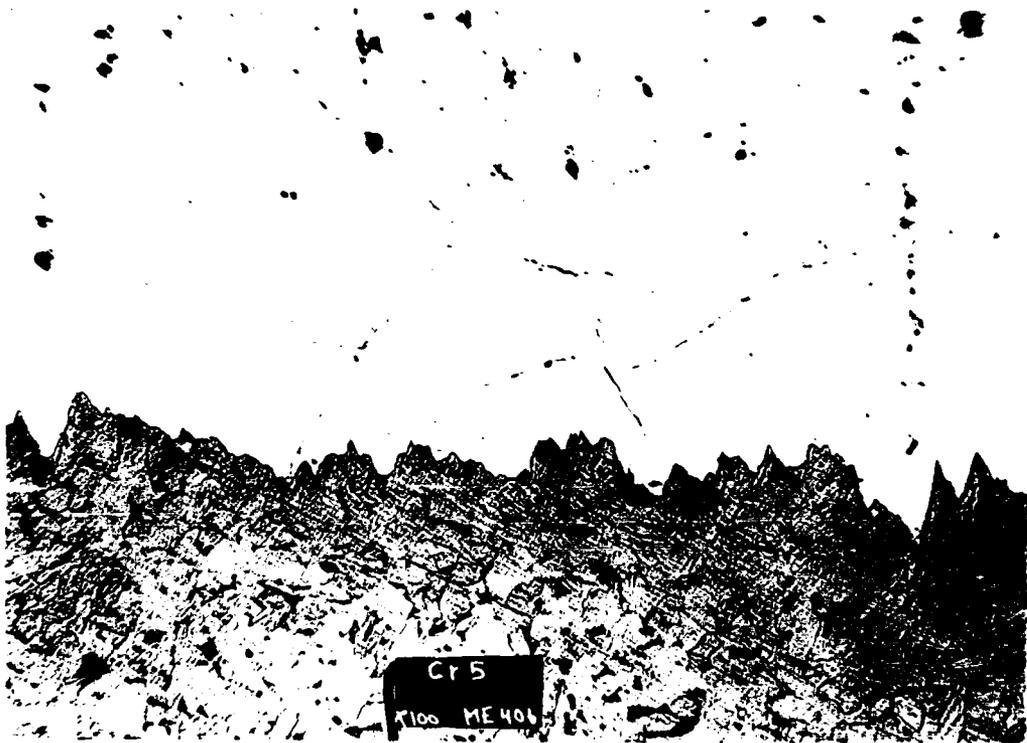
FIG. 7

Fig. 7 X100 F Cr 5 Shows cracking in the thick plate
near the steel. ME 406

2. The thick layer specimens (as plated) showed many long and short cracks in the plate. These cracks ran from the steel outward far into the plate; others started and

finished entirely in the plate. Most of the cracks occurred in the inner third of the plate thickness; in this zone there was little porosity. The porosity increased toward the outside.

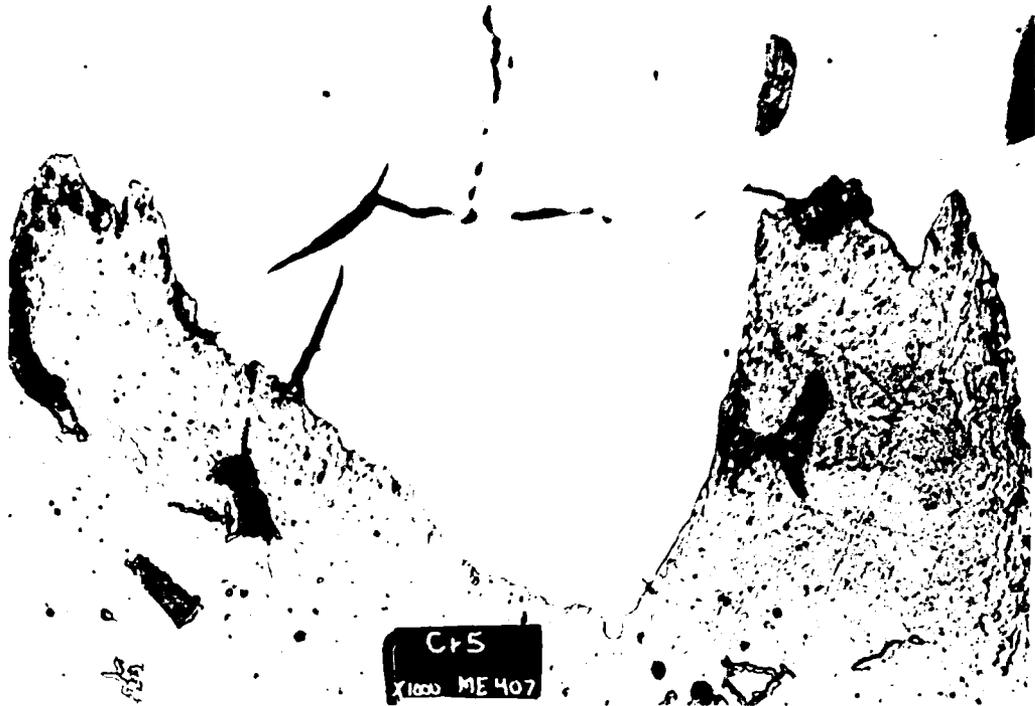
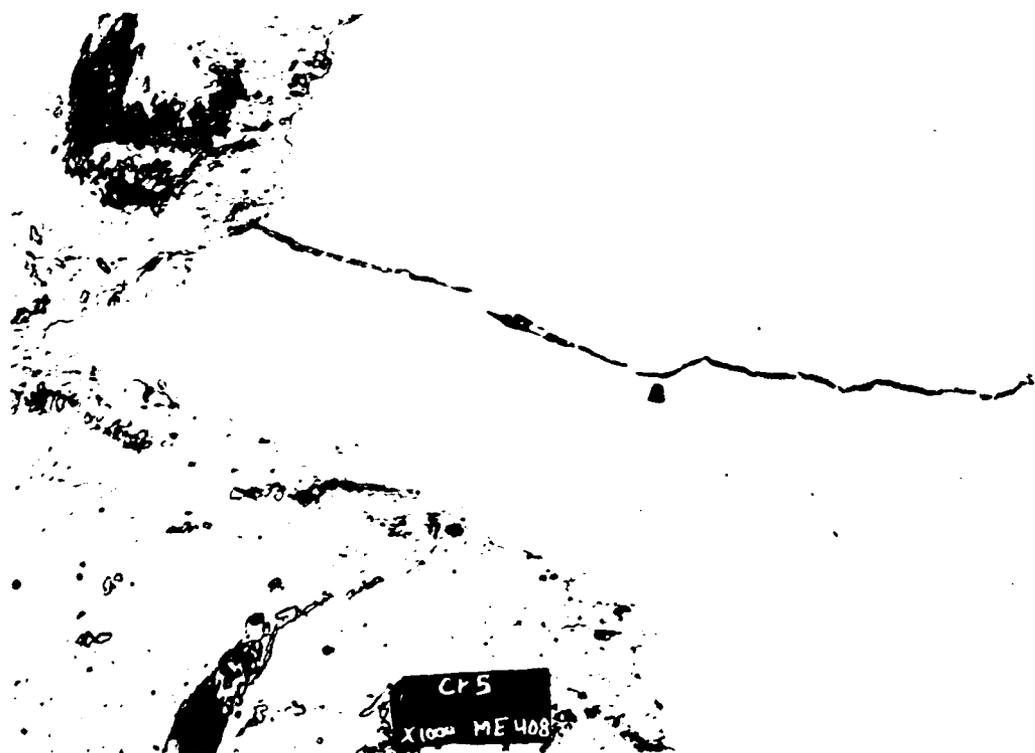
FIG. 8

Figs. 8 & 9 X1000 F Cr 5 Show cracks in the plate near
the steel. ME 407, 408

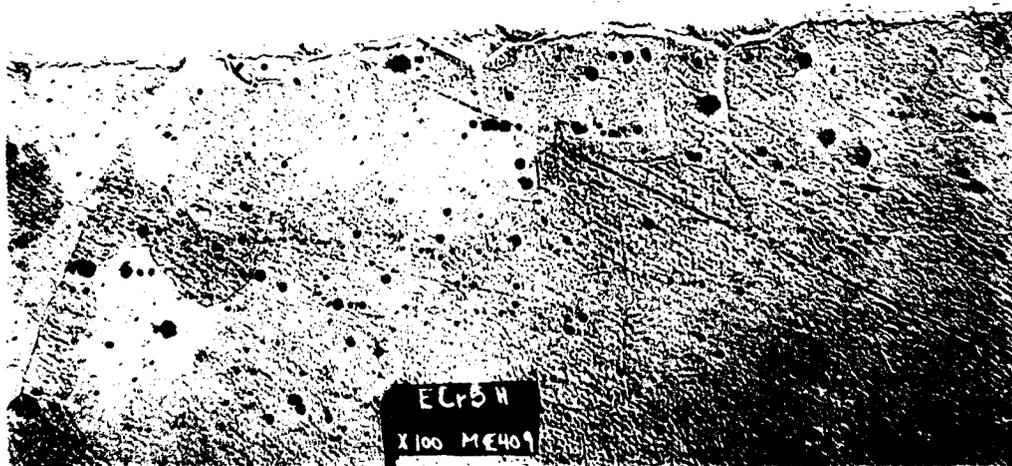
FIG. 10

Fig. 10 X100 F Cr 5H Shows no cracking of the plate,
considerable alloying with the
steel especially along grain
boundaries. ME 409

3. The heat-treated specimen showed considerable alloying, especially along grain boundaries. No cracks were found, but numerous irregular and discontinuous, narrow films of (probably) chromium oxide were found in locations similar to the cracks in the nonheat-treated specimen. The inner 2/3 of the plate thickness showed little porosity. The outer 1/3 was badly oxidized. The oxides appeared as cubic crystals along the grain boundaries and scattered about. Good corrosion resistance should be expected if the outer 1/3 was removed.

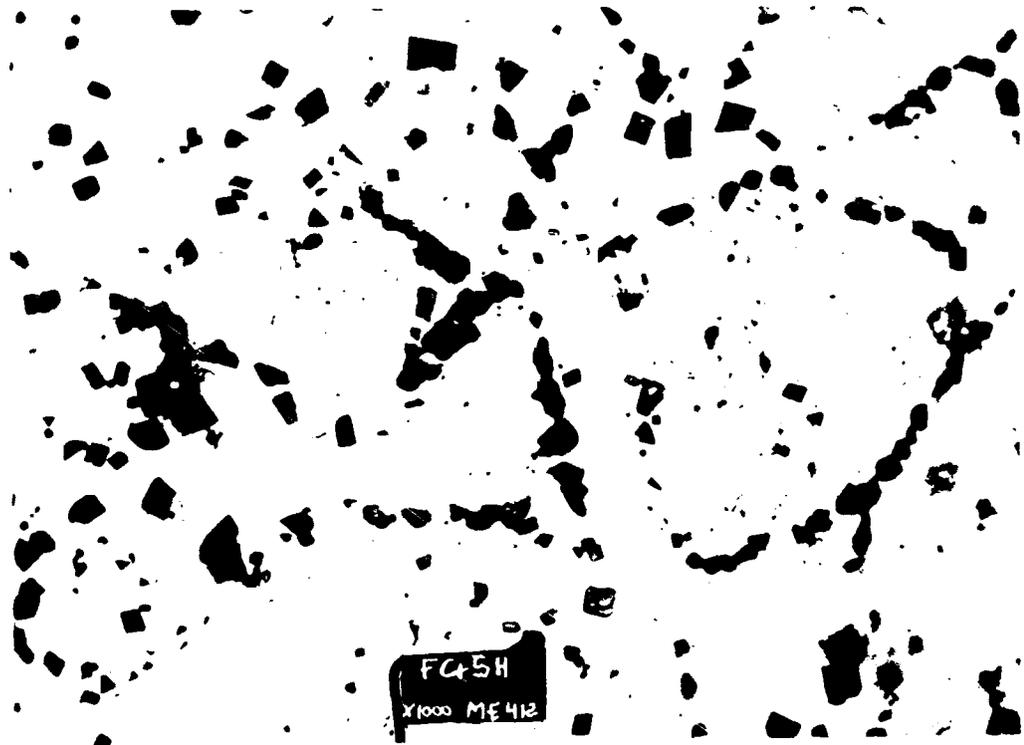
FIG. 13

Fig. 13 X1000 F Cr 5H Shows that the outer zone of the
plate was badly oxidized. The
oxides occur as cubic crystals
located in the grain boundaries
and scattered throughout the grains.
ME 412
