ROYAL AIRCRAFT ESTABLISHMENT

REPORT No: MET.54

SOME METALLOGRAPHIC  
OBSERVATIONS RELATING TO  
THE FATIGUE OF METALS

June 1950

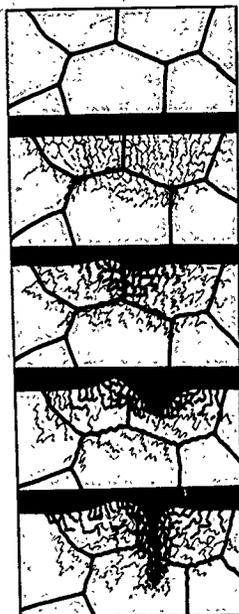
FIG. 25

1. ORIGINAL, ANNEALED GRAIN STRUCTURE
2. BREAK-UP OF GRAINS INTO SMALL FAINTLY DEFINED CRYSTALLITES
3. THE APPEARANCE OF MORE SHARPLY DEFINED CRYSTALLITES WITH FLOW OF THE METAL NEAR THE SURFACE
4. MORE WIDESPREAD CRYSTALLITE FORMATION AND AN INCREASE IN THE MAGNITUDE OF THE CORRUGATIONS
5. THE FORMATION OF A DEEP GROOVE WHICH EVENTUALLY INITIATES A CRACK. A REGION OF CLEARLY DEFINED CRYSTALLITES PRECEDES THE ROOT OF THE CRACK

THE SEQUENCE OF CHANGES OCCURRING IN THE STRUCTURE OF AN ALUMINIUM 1% SILVER ALLOY WHEN SUBJECTED TO HIGH CYCLIC STRESSES

Fatigue and crack formation in alloys at higher stress levels is however a different process. Figure 25 is a schematic series of diagrams showing the sequence of events leading to the formation of a crack at a high stress level in the Aluminium -  $\frac{1}{2}$ % Silver alloy. The features observed in the final stage are shown in Figure 26 in which the root of the crack is seen to be progressing through a region of crystallites. In the copper specimens the formation and propagation of cracks was nearly always associated with the twin bands as shown in Figure 27.
