AEROSPACE VEHICLE PROTECTION
from
ATMOSPHERIC ELECTRICAL HAZARDS

Lightning & Transients Research Institute
Minneapolis, Minnesota
L & T Report 384
Contract No. AF 33(616)-7828

Quarterly Report No. 1
Covering the Period
January 1961 through March 1961

Airship Lightning Protection Braid Studies - II

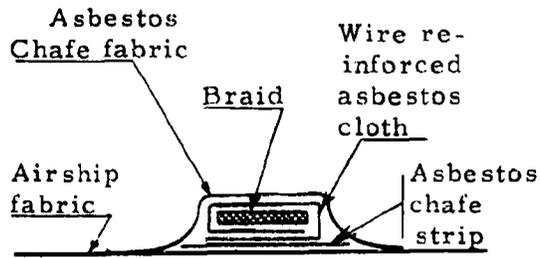
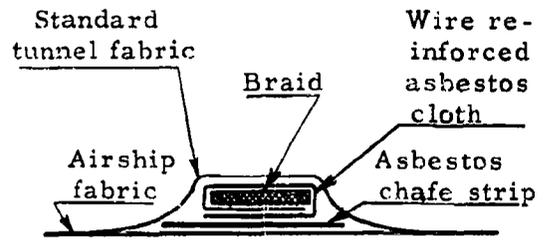
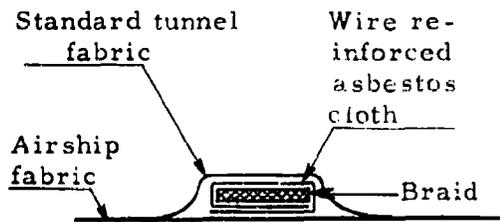
Figure 1. Component parts of airship test strip.

A strip of airship fabric with aluminum braid diverter strips was tested to determine its vulnerability to damage resulting from being hit by a lightning stroke. The aluminum protective braid, having a cross sectional area equivalent to a #6 solid wire and serving as the lightning current carrier, was passed through a fabric tunnel which held the braid in the center of the strip. As in Figure 1, the fabric test strip was divided into four sections, each with different tunnel or chafing strip materials.

Test section I consisted of the airship fabric, an asbestos chafing strip glued to the fabric, and the protective braid inside an asbestos fabric tunnel. The entire braid was covered with wire reinforced asbestos cloth with double thickness on the side next to the airship fabric.

Test section II consisted of the airship fabric, an asbestos chafing strip glued to the fabric, and an asbestos wrapped braid inside a tunnel of standard fabric.

Test section III consisted of the airship fabric, the asbestos wrapped protective braid, and the standard tunnel fabric without the asbestos chafing strip.

Test section IV consisted of the airship fabric, the asbestos wrapped protective braid, and an airship fabric tunnel with no asbestos chafing strip.

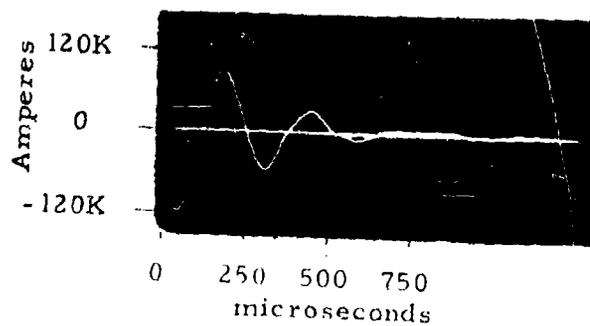
Figure 2. High current, medium duration generator waveform.

The mechanical effect on the system caused by electromagnetic forces on conductors carrying lightning frequency magnitude currents was checked utilizing LTRI's high, medium duration, current generator. For the tests using this generator, the peak oscillatory currents were about 120 KA at 4 kcs. The waveform is shown in Figure 2. The heating effect of lightning was reproduced by a 200 coulomb generator having the waveform shown in Figure 3. The laboratory test setups were designed to simulate as severe conditions as possible, consistent with conceivable stroke approach paths, to determine the effects of stress in the airship fabric caused by mechanical forces and high heat concentration.

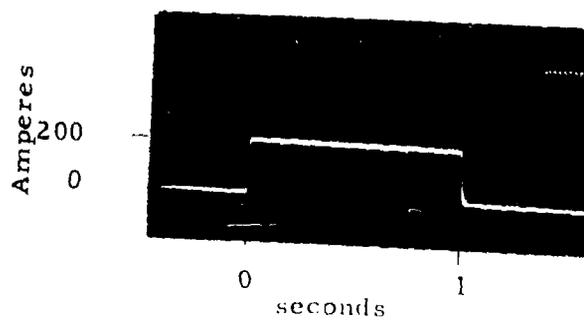
Figure 3. Two hundred coulomb discharge waveform.

An important consideration in the vulnerability of an airship from the effects of lightning stroke is one of heating. If the airship fabric is heated to a temperature of above 140^oF. the material can be weakened. To duplicate the heat component of a natural lightning stroke, a long duration discharge of 200 amps for one second or 200 coulombs was passed through the braid.

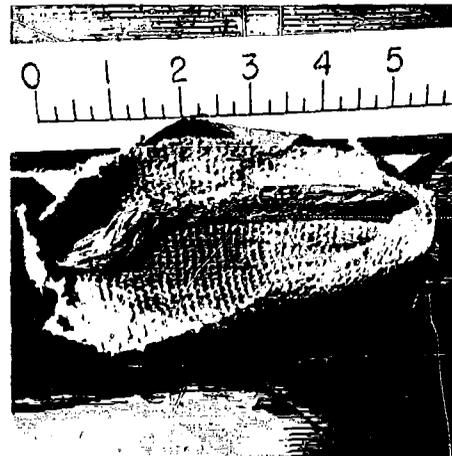
Figure 7. Damage to airship test section III from lightning currents.

(a) High current damage to standard tunnel fabric and asbestos braid wrap.

(b) High current damage to braid.

(c) Tunnel fabric condition after 200 coulomb discharge.

(d) Braid condition after 200 coulomb discharge.

The blast damage from the 120 KA peak current stroke was not severe. A 4" hole was torn in the standard fabric tunnel. In this test the asbestos braid wrap was not torn open. As shown in Figure 7 (a), the stroke current only separated the strands of the asbestos wrap. About 50% of the braid strands shown in Figure 7 (b) were vaporized. The airship fabric was only moderately warm after the stroke.

The damage to section III from the 200 coulomb discharge was similar to section II in that a hole was not burned through the underside of the asbestos braid wrap as illustrated in Figure 7 (c). However, unlike section II, a 1/2" hole was burned through the braid shown in Figure 7 (d). The standard tunnel fabric or adhesive burned at the arc point for 10 seconds after the discharge. This did not contribute to the heating of the airship fabric as the fabric was only slightly warm to the touch.

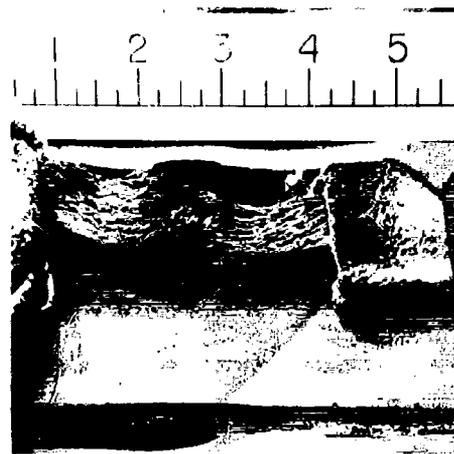
Figure 8. Damage to airship test section IV from lightning currents.

(a) Braid condition after high current stroke.

(b) Braid condition after 200 coulomb discharge.

(c) Tunnel fabric condition after 200 coulomb discharge.

(d) Airship fabric scorch caused by 200 coulomb discharge.

not tear easily to release the pressure as the light standard tunnel fabric does. The aluminum braid, shown in Figure 8 (a), was severed at the arc point probably because the heat confined in the tunnel aided in vaporizing the metal. Evidently the pressure inside the tunnel built up to the point where it released itself by breaking the glued seam between the tunnel and the airship fabric. Note that the tunnel was blown off of section I in the same manner where the heavier asbestos tunnel material was used.

The 200 coulomb discharge to section IV melted the braid strands at the arc contact point as shown in Figure 8 (b). The tunnel fabric hole of Figure 8 (c) is similar to that of the other three sections. A 1/2" hole burned through the double thick asbestos wrap under the braid and scorched the airship fabric as shown in Figure 8 (d). The underside of the airship fabric was too hot to touch immediately after the discharge and thus was weakened.

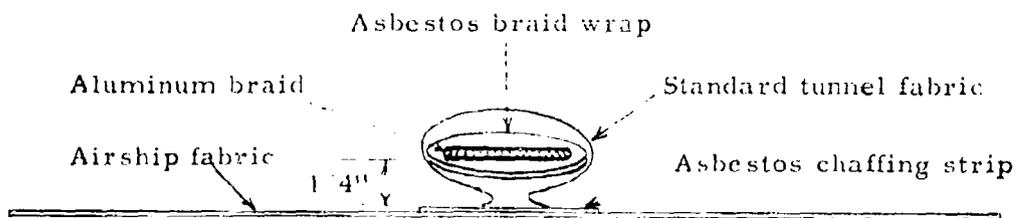
Figure 10. Cross section of test strip showing 1/4" spacing.

In sections II and III the braid is held above the airship fabric by approximately 1/4" as shown in Figure 10. This retards heat conduction from the braid to the airship fabric. This is compared to the braid being held tight against the airship fabric in sections I and IV. The chafing strip on sections I and II aids in protecting the airship fabric from arc heat and from mechanical punctures.

- (3) Initially section II appeared the best of the four Lakehurst test sections because the tunnel cover fabric blew open easily and an air space (see Figure 10 of report) between the asbestos wrap and envelope fabric provided heat insulation protection. However, all sections caught fire and burned for a short period in still air after application of the long duration current component and, since the standard fabric tunnel used in section II can support combustion, it is not considered acceptable. While the air space in section II provided heat insulation during our tests, it may be difficult to prevent the braid from sagging to the envelope on the airship.

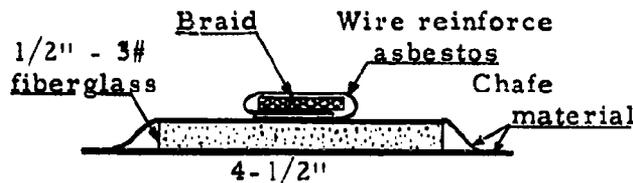
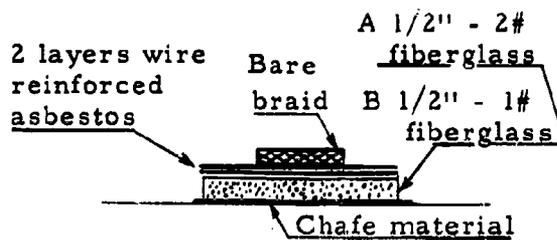
Figure 11. Experimental lightning protection braid sectors with no temperature rise.

300A - 14 seconds 420 = Q
 No temperature rise
 90% of strands melted
 Chafe material burned crisp
 (under braid)

320A - 1 second 320 = Q
 No temperature rise
 60% of braid strands melted
 Top chafe material scorched

280A - 14 seconds 392 = A
 No temperature rise
 50% of braid strands melted
 1" hole burned in braid and wire
 reinforced asbestos

100A - 2.6 seconds 260 = Q
 No temperature rise

A 100A - 2 seconds 200 = Q
 No temperature rise

B 100A - 2 seconds 200 = Q
 No temperature rise

100A - 2 seconds 200 = Q
 No temperature rise

Since the sections tested were not satisfactory from a heating and fire hazard point of view, we tested various configurations of the available materials as shown in the test drawings of Figures 11 through 15 attached. A thermocouple was used to measure the temperature of the underside of the fabric. From these results it appears that, for example, using the materials and basic design of Lakehurst section I, a satisfactory system may be made by using a three layer asbestos wrap and about two layers for the asbestos chafing strip. The chafing strip should be widened to about 2 feet to protect against spraying molten metal. Increasing the wrap thickness helps confine the arcs and reduces metal spray, while increasing the chafing strip thickness helps reinforce the envelope as well as providing heat insulation. If such a system is not too heavy, a sample strip should be made up and tested. A lighter tunnel cover fabric would be preferable. If a lighter tunnel fabric is used with an air space, as in Figure 10 of the report, only one chafing layer probably would be necessary.

Satisfactory test configurations using fiberglass alone required a one inch thickness of 3# fiberglass (see Figure 13, upper right hand corner) or 16 layers of fiberglass cloth (see Figure 11, upper right hand corner). While fiberglass might be obtained with a special weave having sufficient stretch to follow the airship envelope expansion and contraction, there does not appear to be much difference between the fiberglass and asbestos insulation for our purposes. The specific heat of asbestos is slightly higher than glass. The asbestos burns away but similarly the fiberglass melts away to about the same degree. The best available Minnesota Mining fire retardant adhesive was obtained and tested. Minnesota Mining EC-1324 adhesive burned briefly when used as a cement on or near the braid. During tests the Lakehurst test strip also showed flashes of fire which propagated along the strip, probably due to burning adhesive residue. These flashes immediately extinguished. An adhesive which will not burn briefly under our test conditions has not been located. Until such an adhesive can be located, a minimum of adhesive should be used with any residue located as far away from the braid as possible.

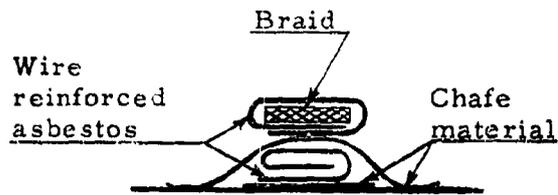
Figure 12. Experimental lightning protection braid sectors with temperature rise to less than 100°F.

180A - 2 seconds 360 = Q
 Temperature rise to 90°F
 1" dia hole burned in braid and
 2 thicknesses of WRA

170A - 2 seconds 340 = Q
 Temperature rise to 95°F
 1" dia hole burned in braid and
 1 thickness of WRA

100A - 2 seconds 200 = Q
 Temperature rise to 95°F
 No hole burned in WRA

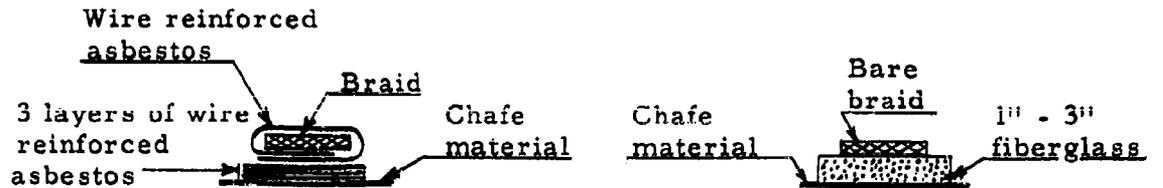
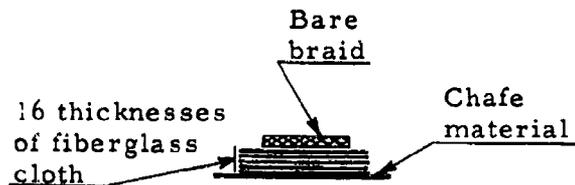
Figure 13. Experimental lightning protection braid sectors with temperature rise of between 100° and 135°F.

340A - 1.4 seconds 476 = Q
 Temperature rise to 105°F
 Top layer - the WRA burned through

240A - 1.4 seconds 336 = Q
 Temperature rise to 125°F
 1/2" deep hole burned in fiberglass
 80% of braid strands melted

100A - 2 seconds 200 = Q
 Temperature rise to 115°F
 A 1/4" dia ball of molten aluminum layed on the WRA after arc

120A - 2 seconds 240 = Q
 Temperature rise to 118°F

320A - 1.4 seconds 448 = Q
 Temperature rise to 130°F
 14 thicknesses burned through

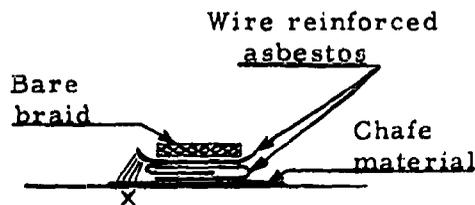
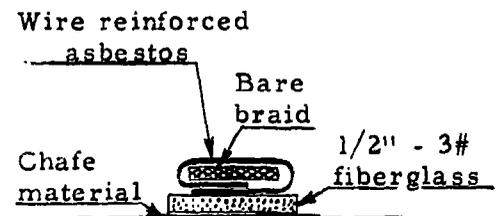
Figure 14. Experimental lightning protection braid sectors -
 temperature rise to over 135°F.

150A - 2 seconds 300 = Q
 Temperature rise to 225°F
 Arc burned hole through fiberglass

160A - 1.2 seconds 192 = Q
 Temperature rise to 135°F

180A - 2 seconds 360 = Q
 Temperature rise to 165°F at X
 point on airship fabric. Hole
 burned through top thickness of
 WRA and arc contacted fabric as
 shown.

250A - 1 second 350 = Q
 Temperature rise to 210°F where
 hole burned through fiberglass
 70% of braid strands melted
 1" dia hole burned in wire
 reinforced asbestos.

300A - 1.4 seconds 420 = Q
 Temperature rise to 215°F where
 hole was burned through fiberglass
 60% of braid strands melted
 1-1/2" dia hole burned in wire
 reinforced asbestos

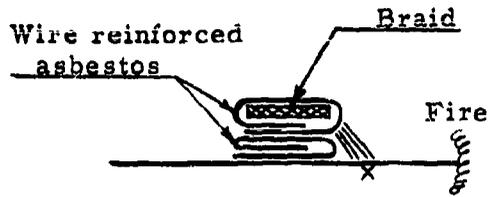
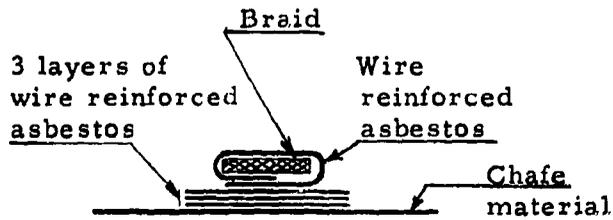
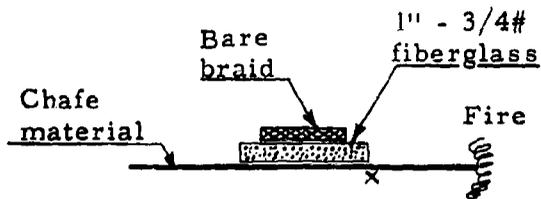
Figure 15. Experimental lightning protection braid sectors.
 Fires started.

180A - 2.2 seconds 396 = Q
 Airship fabric was burned crisp
 at the X mark. A fire started at
 the edge of the airship fabric.

340A - 1.4 seconds 476 = Q
 No temperature rise under arc point.
 A fire started at edge of airship fabric.

300A - 1.4 seconds 420 = Q
 2" hole burned in fiberglass
 Airship fabric burned crisp at
 X mark. Fire started at edge of
 airship fabric.
 75% of braid strands melted
