MATERIALS INVESTIGATION, SNAP 50/SPUR PROGRAM
PART I. Creep-Rupture Properties of Stress-Relieved TZM Alloy

TECHNICAL DOCUMENTARY REPORT NO. APL-TDR-64-116, PART I
OCTOBER, 1964

AF Aero Propulsion Laboratory
Research and Technology Division
Air Force Systems Command
Wright-Patterson Air Force Base, Ohio

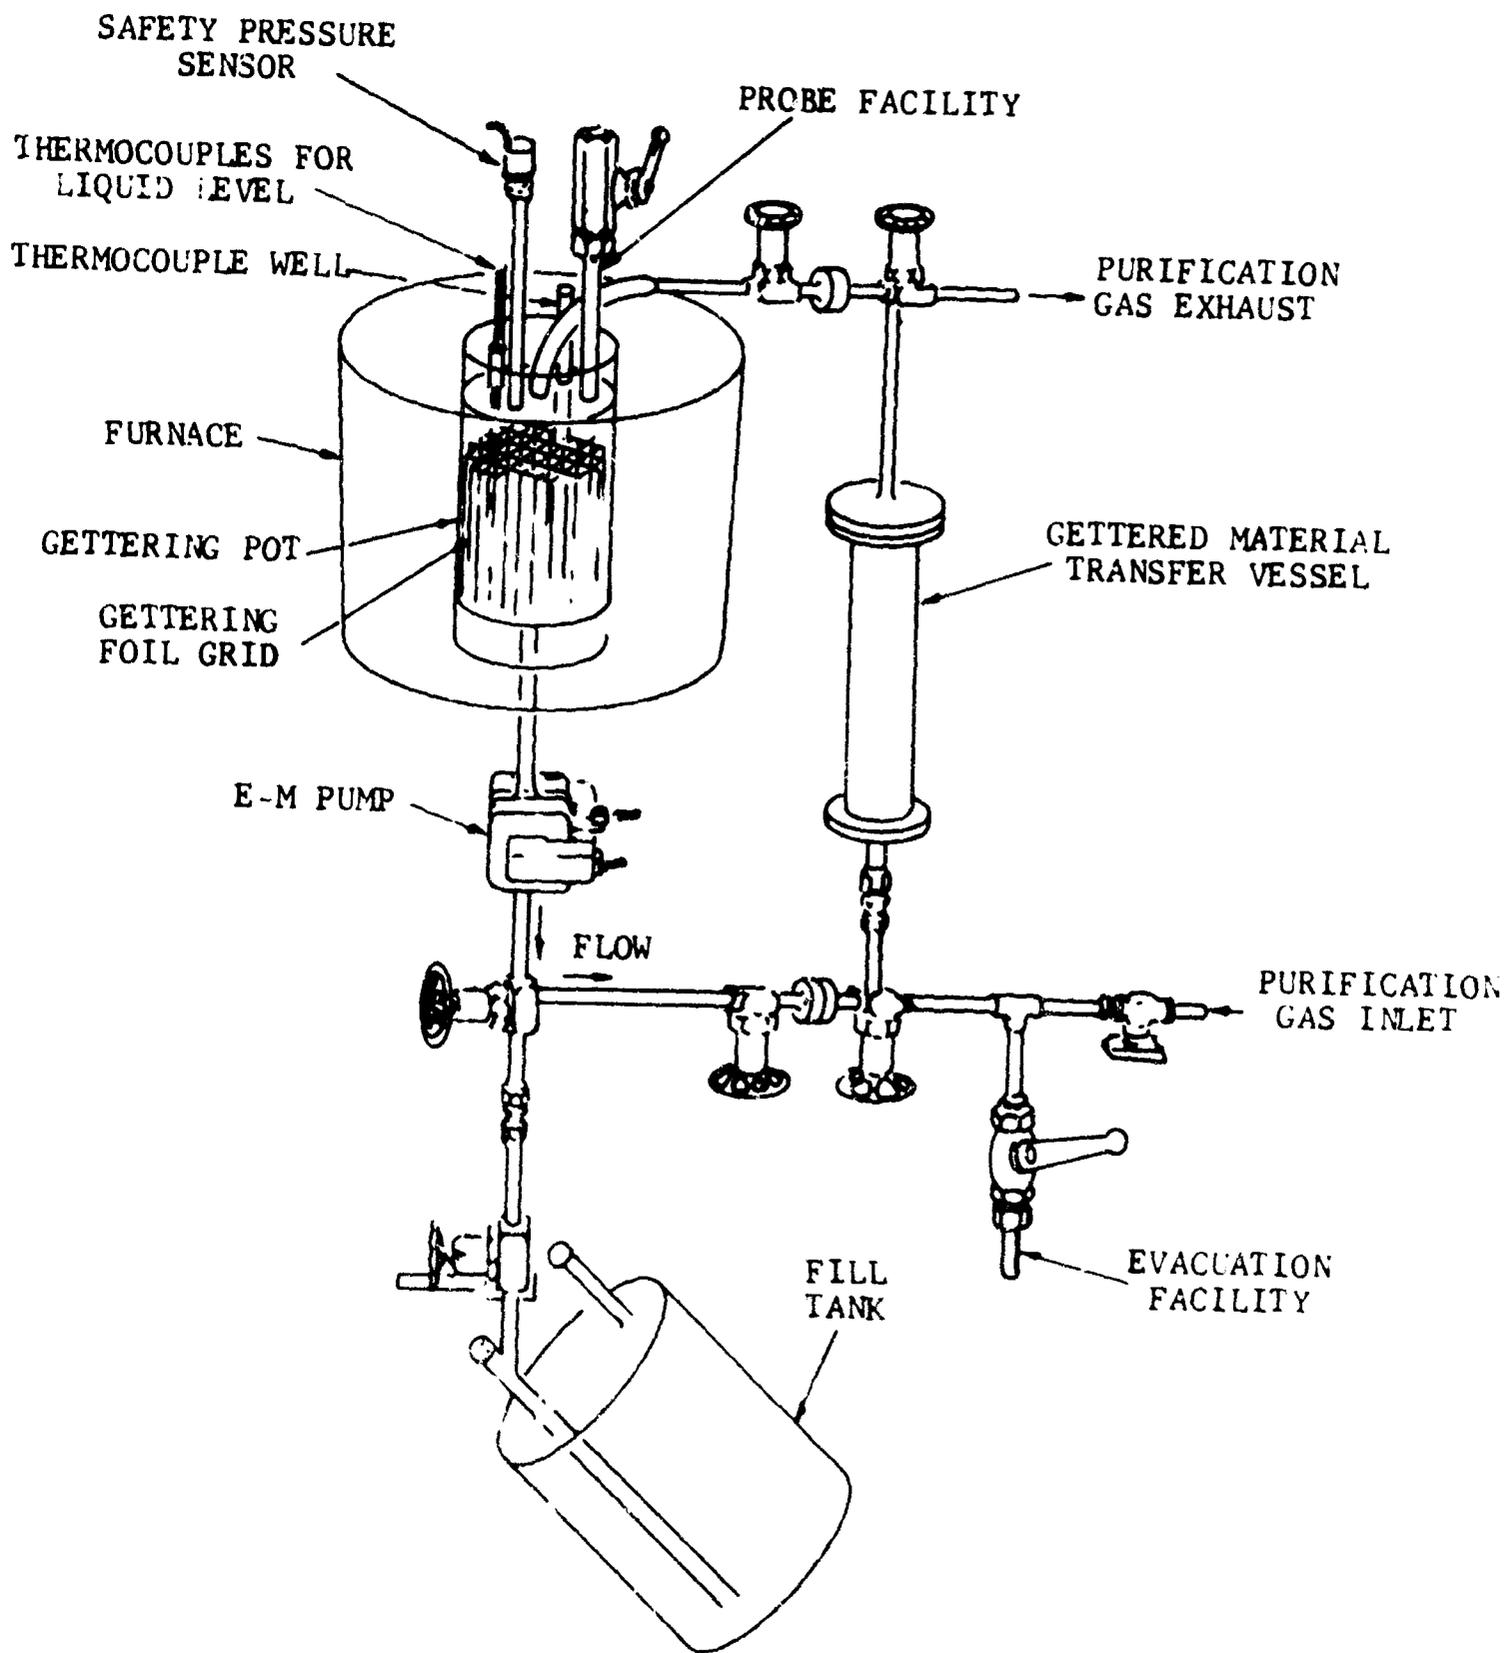
FIGURE 2. POTASSIUM HOT-GETTERING LOOP

Although the purity of this potassium was more than adequate for charging the creep-rupture specimens, it was subjected to a hot-gettering step in order to minimize contamination during the transfer and specimen-charging operations. Figure 2 illustrates the hot-gettering loop. Potassium from the shipping container (fill tank) was melted and transferred by gas pressure to the gettering pot. The liquid was then circulated through the loop at 1200°F for at least 24 hours. The gettering foil was a Zr - 30 w/o Ti alloy, 5 mils thick. All valves were of the sealed, bellows type.

After the gettering period, the potassium was frozen in the transfer vessel; this vessel was then removed from the loop at the two flanges in the horizontal legs and transferred to a glove box. The glove box was evacuated and backfilled with pure helium. One end of the transfer vessel was then fitted with an orifice plate and the other with a screw-operated plunger.

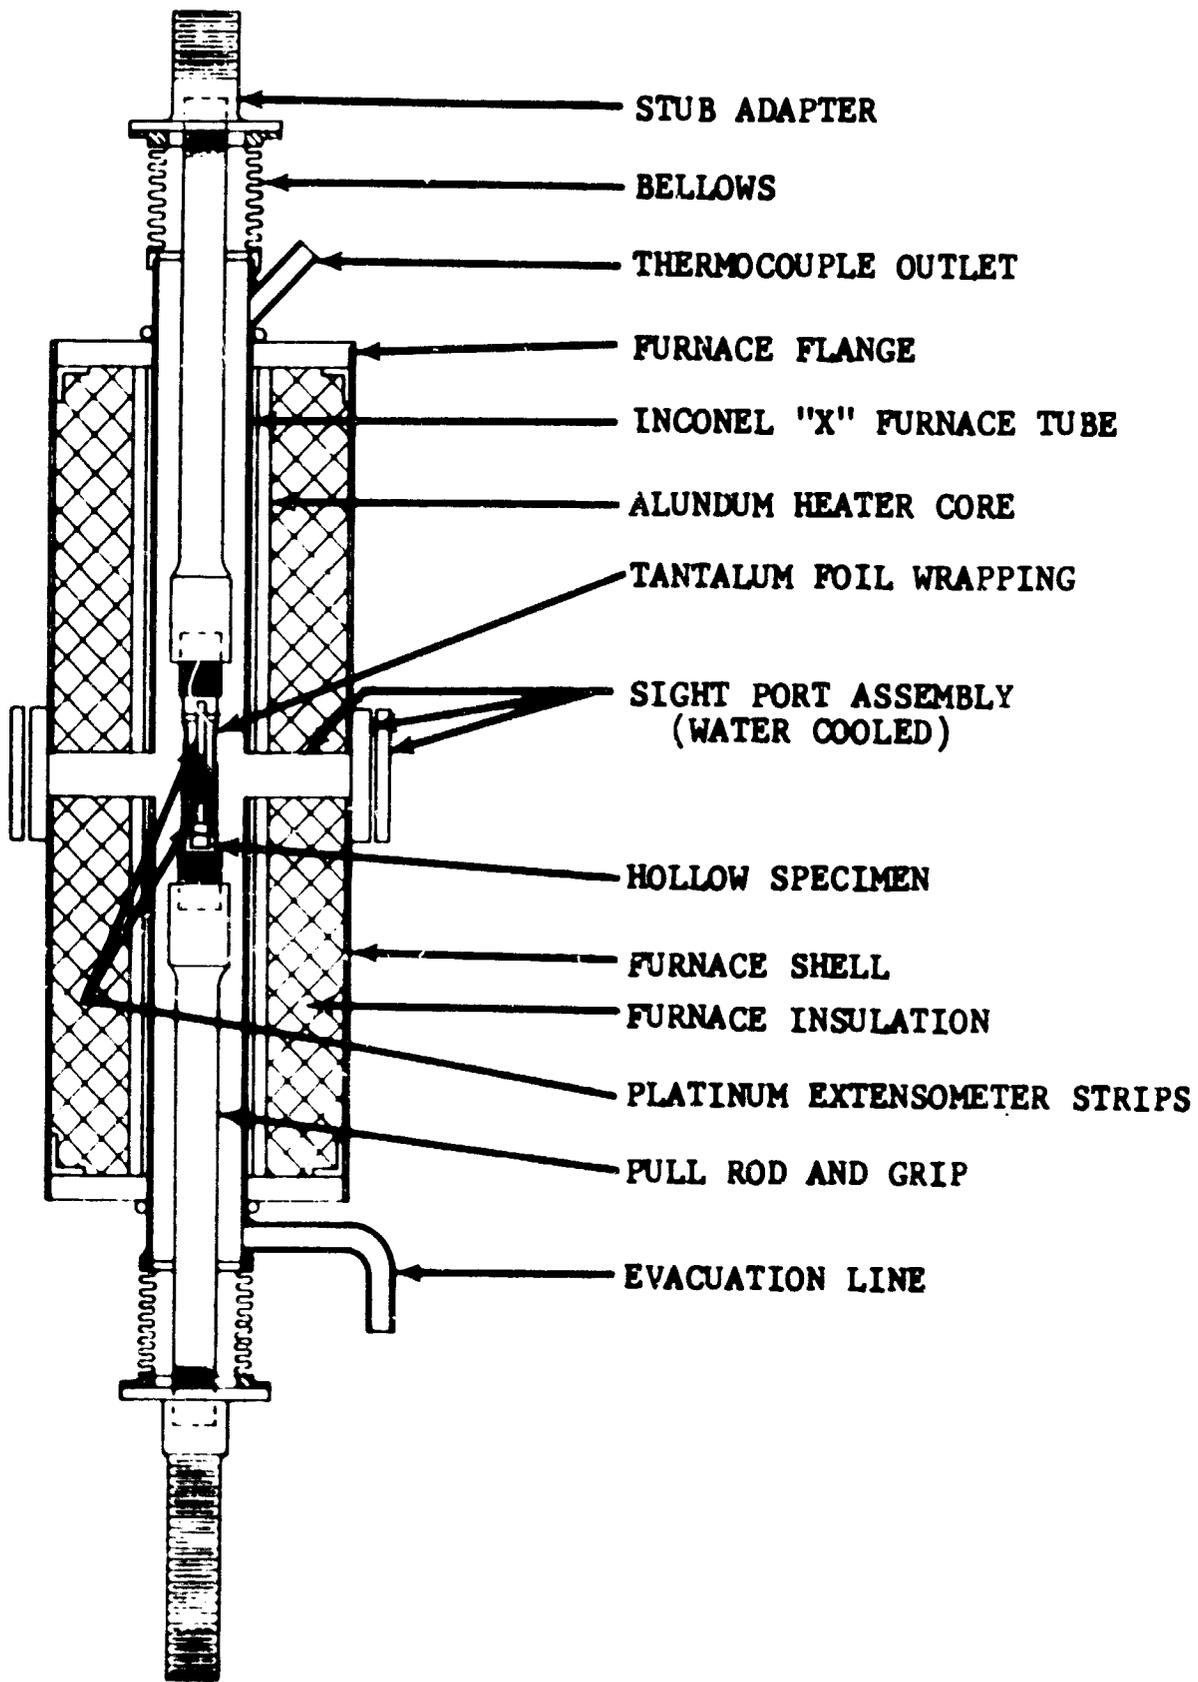
FIGURE 3. SCHEMATIC ARRANGEMENT OF CONVENTIONAL TEST APPARATUS UTILIZED FOR DETERMINING EFFECT OF POTASSIUM VAPOR ON CREEP OF TZM ALLOY

The apparatus utilized for conducting the creep-rupture experiments on the TZM alloy is shown schematically in Figure 3. Figure 4 shows a portion of the vacuum-creep-test laboratory at Battelle, illustrating the creep frames, lever system, mechanical and diffusion pumps, and method of making optical strain measurements.

The specimens were stressed by placing dead weights on a hanger attached to the rear of the load lever. The mechanical advantage was approximately 9:1, varying slightly from unit to unit. Each unit was equipped with an electric timer, which started when the load was applied and stopped automatically when the specimen ruptured. In routine operation during most tests, the vacuum system maintained a chamber pressure that was well below the bottom of the scale (10^{-3} torr) on a thermocouple-gauge indicator. Some of the newer units were equipped with ionization gauges, normally indicating 5×10^{-5} to 5×10^{-4} torr during a test.

The furnace resistance windings were Hoskins 875 alloy for the 1800°F runs and molybdenum for the 2000°F runs. The windings were tapped at nine axial locations to permit short sections at hot zones to be shunted out, thus maintaining a uniform axial temperature in the specimen. A thermocouple-actuated Foxboro controller regulated the specimen temperature at the desired value within about 5 degrees at 2000°F .

- (5) The ends of the pull bars were fitted with stub adapters, and the whole assembly was inserted in the furnace tube (Figure 3) and sealed to the water-cooled bellows flanges with Neoprene gaskets. The six thermocouple leads were brought out through an insulating elastomeric vacuum seal in the water-cooled thermocouple outlet tube.

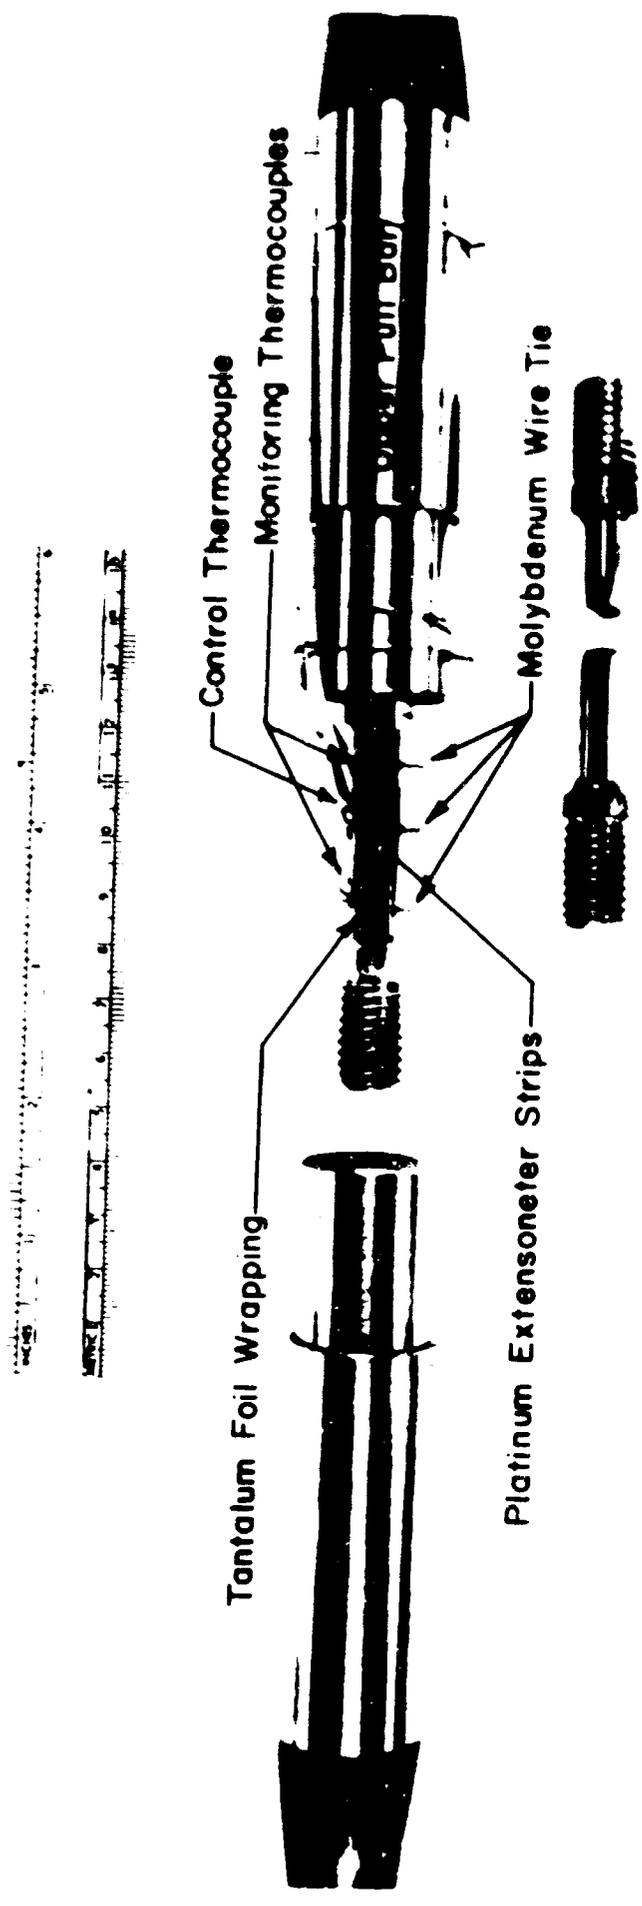
FIGURE 5. SPECIMEN AND PULL BARS PARTIALLY ASSEMBLED;
 BELOW, RUPTURED TZM SPECIMEN

- (1) The upper and lower pull rods (which were fabricated from stress-relieved TZM bar stock) were threaded onto the specimen ends.
- (2) The gauge section of the specimen was wrapped with two strips of 1-mil-thick tantalum foil, overlapping about an inch in the center. The wrapping, secured with molybdenum wires, can be seen in the partial assembly in Figure 5. The tantalum foil served to getter traces of reactive gases in the vacuum chamber, thereby reducing contamination of the specimen surface during a test.

- (3) Three Chromel-Alumel thermocouples were wired to the specimen--one in the middle and one near each end of the gauge length--with the beads tight against the tantalum, as shown in Figure 5. In test, the center thermocouple was attached to a Foxboro controller which regulated the current to the furnace. The other two thermocouples were periodically monitored to insure axial temperature uniformity.

- (4) Overlapping platinum extensometer strips were wired at each end of the specimen shoulder, utilizing the circumferential V-grooves (Figure 1) to hold the molybdenum wires in place. One pair of such strips is visible in Figure 5; the other pair is 180 degrees away (behind the specimen). During a test, the separation of the fine reference marks scribed on the sliding platinum strips was measured periodically with a traveling microscope focused through the chamber sight port (Figure 4), which resulted in the direct measurement of strain in the gauge length.

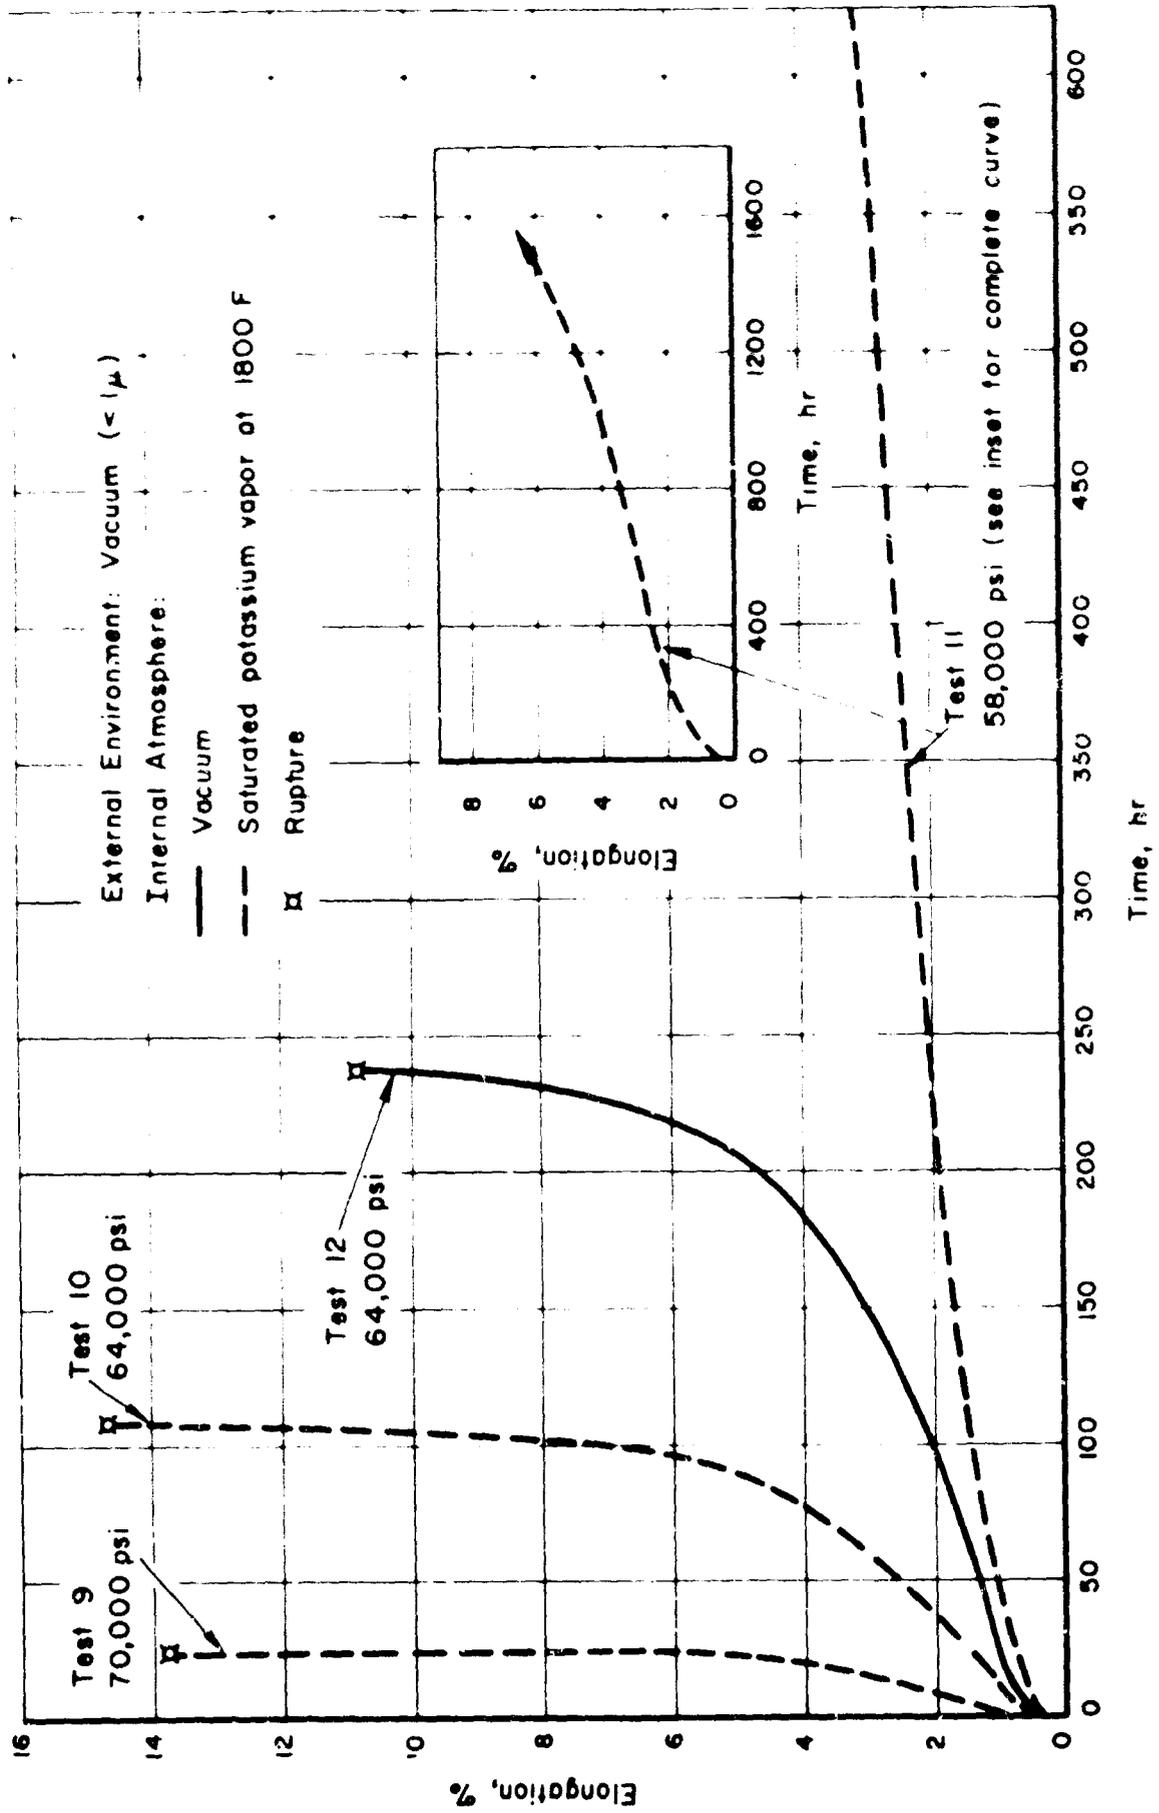
FIGURE 6. DEFORMATION-TIME CURVES FOR STRESS-RELIEVED TZM ALLOY AT 1800 F

Twelve creep-rupture experiments were conducted during this investigation--seven at 2000°F and five at 1800°F. The test conditions and results are summarized in Table 1 and in Figures 6 through 10.

Comparison of the deformation-time curve in Figure 6 for Test 10 with that for Test 12 (the same stress and temperature) shows the potassium-exposed specimen to have a higher creep rate and shorter rupture life than the inert-atmosphere specimen. However, the reverse is true when Tests 5 and 6 are compared in Figure 7. This inconsistency seems to be the result of simple data scatter, rather than any real effects of environment.

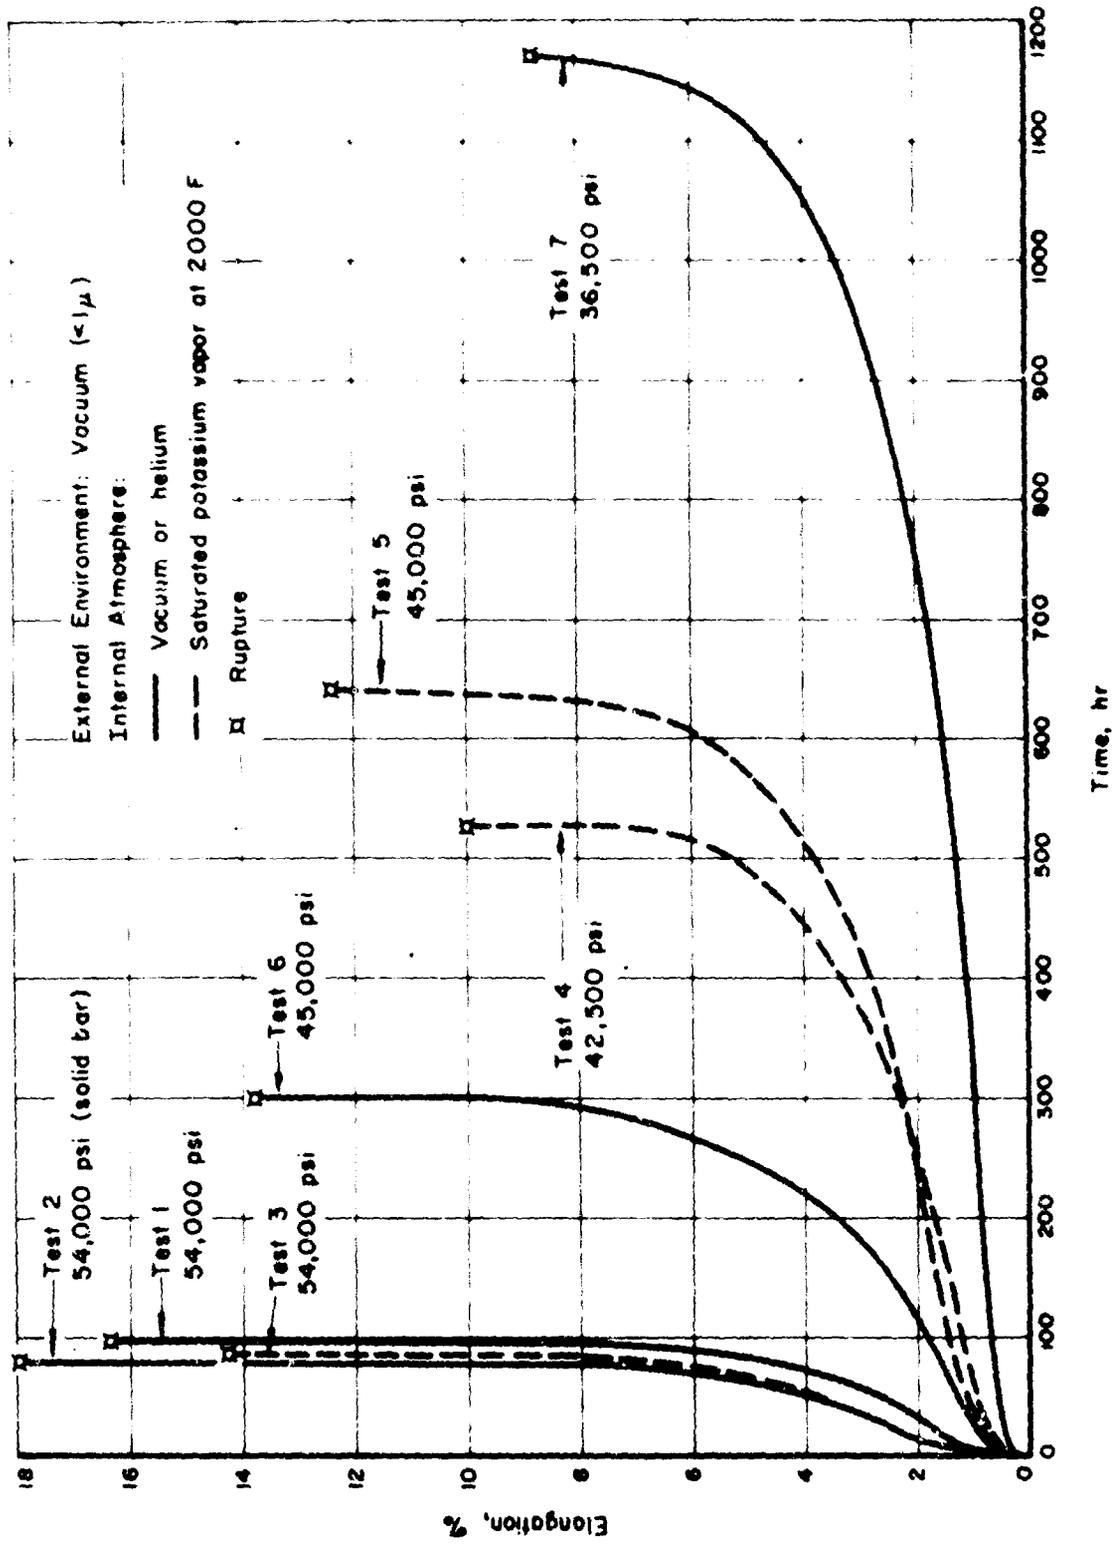
FIGURE 7. DEFORMATION-TIME CURVES FOR STRESS-RELIEVED TZM ALLOY FOR 2000°F WITH AND WITHOUT POTASSIUM-VAPOR ENVIRONMENT

The purpose of Test 2 (solid specimen - no internal pressure) was to get a quick experimental check of this. As can be seen from the very good agreement of the creep curve for Test 2 with those for Tests 1 and 3 in Figure 7, the internal pressure seemed to have no effect on the creep-rupture results. Test 2 also provided confidence that hollow specimens (even without multiaxial-stress considerations) give results comparable to those obtained with solid specimens.

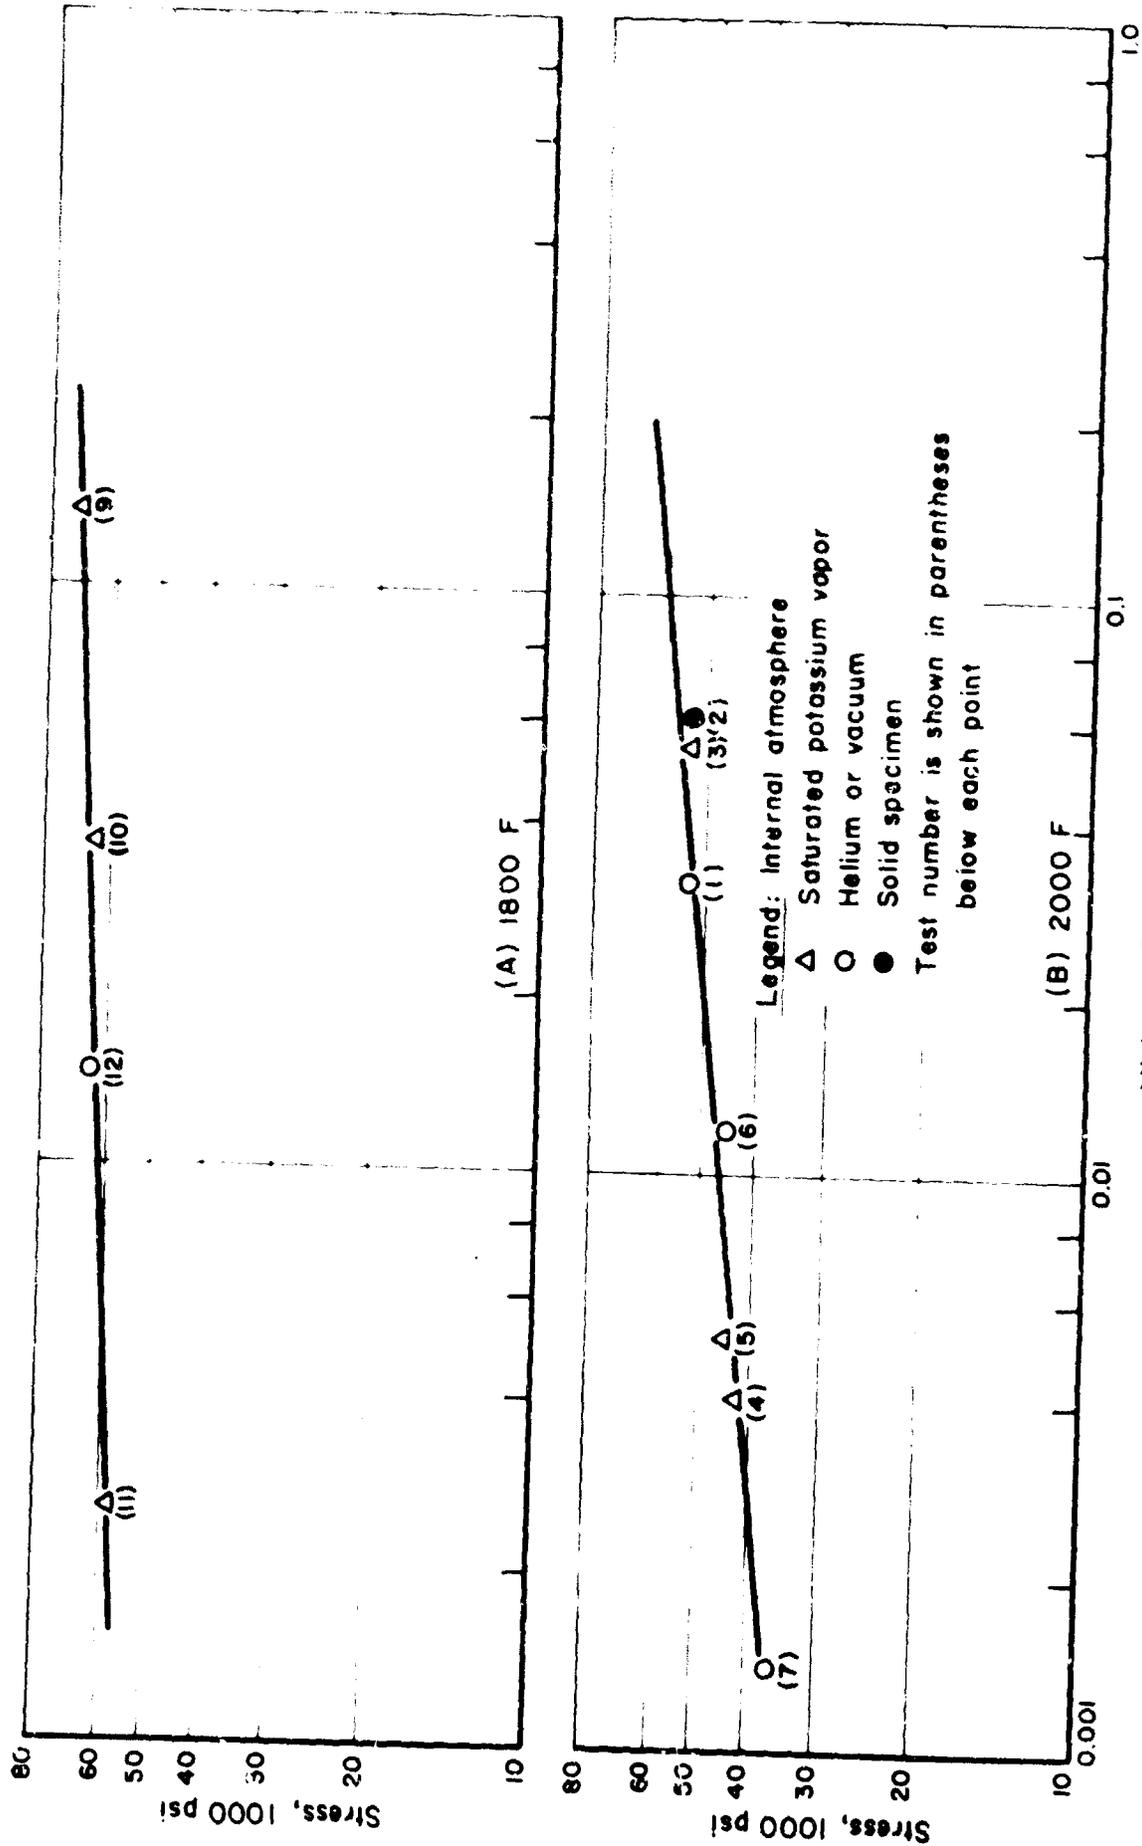
FIGURE 8. STRESS VERSUS MINIMUM CREEP RATE FOR STRESS-RELIEVED TZM ALLOY AT 1800° AND 2000°F

The latter conclusion was reached from careful study of Figures 8, 9, and 10. Figures 8(a) and 9 correlate all the 1800°F test results, and Figures 8(b) and 10 correlate all 2000°F test results, with allowances for the accelerated creep in the later stages of Tests 4 and 7, owing to thermocouple reactions. These curves show that any influence the potassium vapor may have had on the stress-rupture behavior of the TZM in these experiments was small compared with that of other factors contributing to scatter in the data. The inert-atmosphere points seem to be more or less randomly interspersed among the potassium-vapor points.

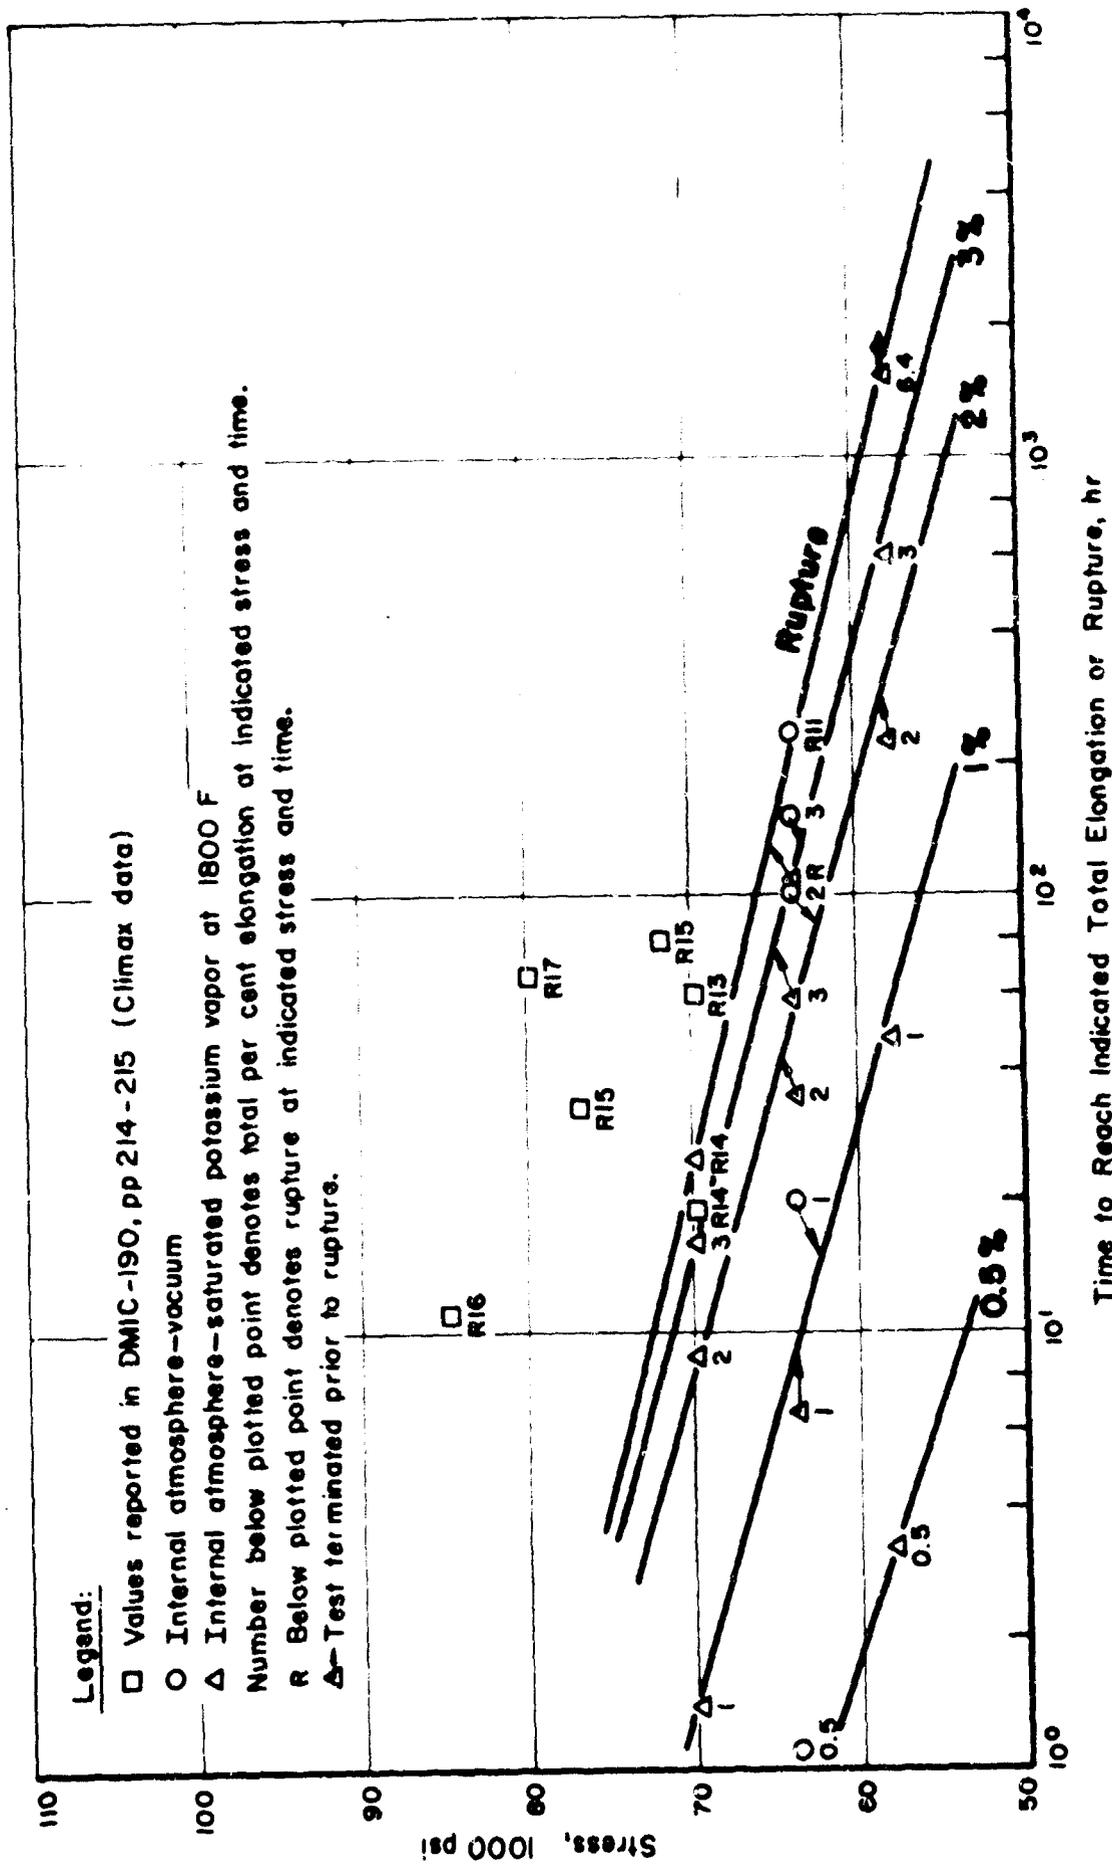
FIGURE 9. DESIGN CURVES FOR STRESS-RELIEVED TZM ALLOY AT 1800°F

The six 1800°F stress-rupture points from DMIC-190, plotted in Figure 9 for comparison purposes, show a great deal more scatter than do the results of the present investigation. Either the TZM material, the test conditions, or both were not consistent in the Climax tests. However, since five of the Climax points lie above the rupture curve in Figure 9, the material used by Climax must have been more creep-resistant. The Climax stress-rupture at 2000°F (Figure 10) show considerably better alignment with the newly generated 2000°F rupture curve.

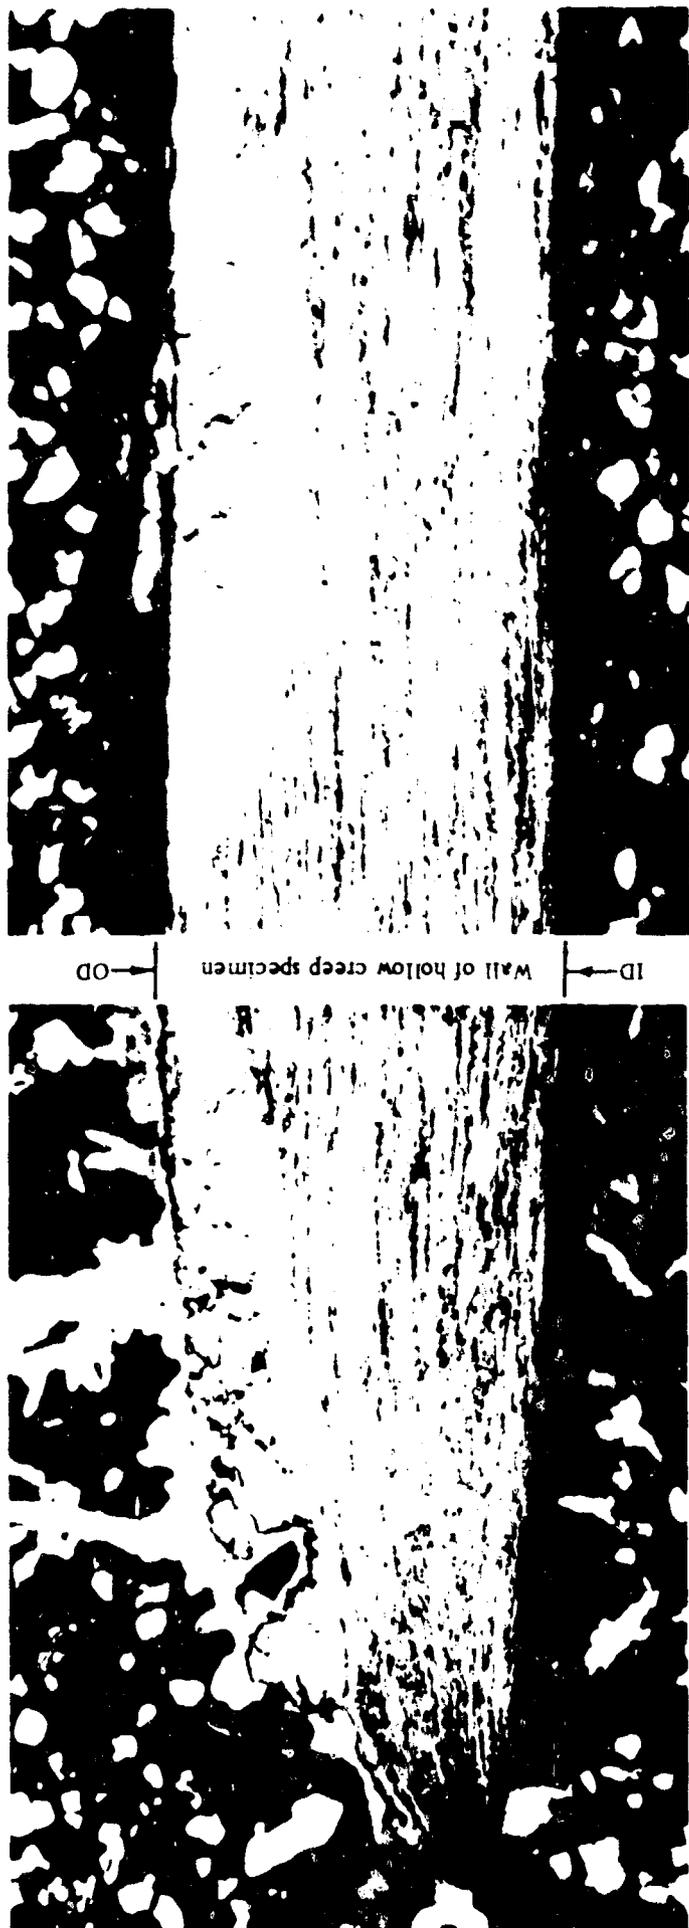
FIGURE 11. LONGITUDINAL SECTIONS THROUGH ZONES WHERE CHROME-ALUMEL THERMOCOUPLE BEADS REACTED WITH TZM IN SPECIMEN 7

Figure 11 shows photomicrographs of sections of a specimen where reactions with the thermocouple beads had occurred. The reaction zones are sharply defined by the recrystallized grain structure. It was not considered worth while to do any detailed analytical work on the reaction products, since the problem can be circumvented in any future tests by inserting a ceramic barrier under the thermocouple bead. A reasonable guess is that the nickel in the thermocouple wires (Chromel is 90 Ni - 10 Cr and Alumel is 94 Ni - 3 Mn - 2 Al - 1 Si) diffused through the tantalum foil and into the surface of the TZM, lowering the recrystallization temperature in the Ni - Mo alloy region to below the 2000°F test temperature.

The recrystallized zones have significantly lower strength than the parent TZM. In two of the specimens (Tests 4 and 7), rupture occurred directly through such reaction zones. One of these is shown in Figure 11a, and Figure 11b shows how the grain boundaries in the recrystallized area separate under the tensile stress.

50X Murakami's Etch
 a. Ruptured End
 b. Other End of Same Specimen

This is one of two specimens which broke at a reaction zone. Irregular white layer on OD is nickel plate applied to protect edge during polishing.

Note grain-boundary cracks and piece of tantalum foil wrapping on OD.

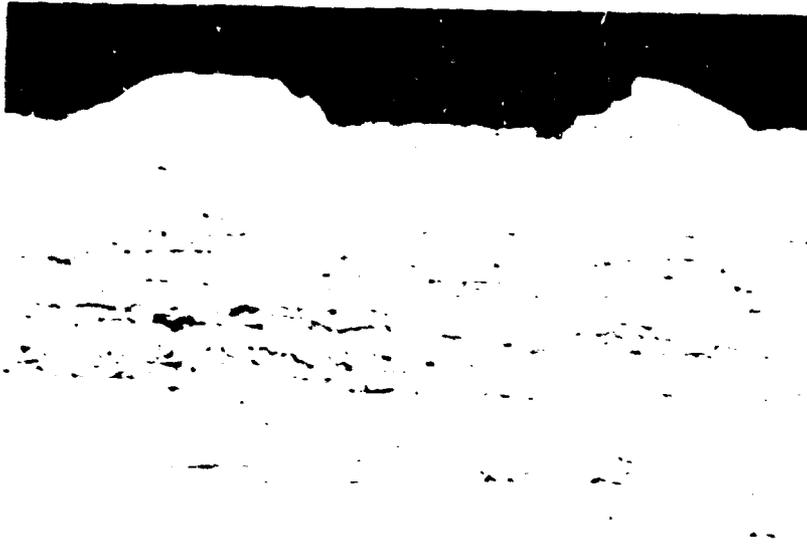
FIGURE 12. CRYSTAL DEPOSITS FOUND ON ID SURFACE OF SPECIMEN 5, WHICH RUPTURED AFTER 641.3 HOURS AT 2000 PSI UNDER 45,000 PSI STRESS

Representative crystal deposits from Test 5 (2000°F, 641.3 hours) are shown in Figure 12. Microprobe analysis showed the metallic crystals to be 99 plus percent molybdenum. They were tightly adherent to the TZM surface. The nonmetallic needles, which were found only in one isolated region (Figure 12b), were identified by x-ray diffraction as K_2MoO_4 .

a. Region of Greatest Concentration of Metallic Crystals

b. Region Showing Clusters of Nonmetallic Needles Among Metallic Crystals

c. Cross Section of Two Metallic Crystals on ID Surface
