NASA TN D-8006

FRICITION AND WEAR OF  
CARBON-GRAPHITE MATERIALS  
FOR HIGH-ENERGY BRAKES

*Robert C. Bill*

*Lewis Research Center*

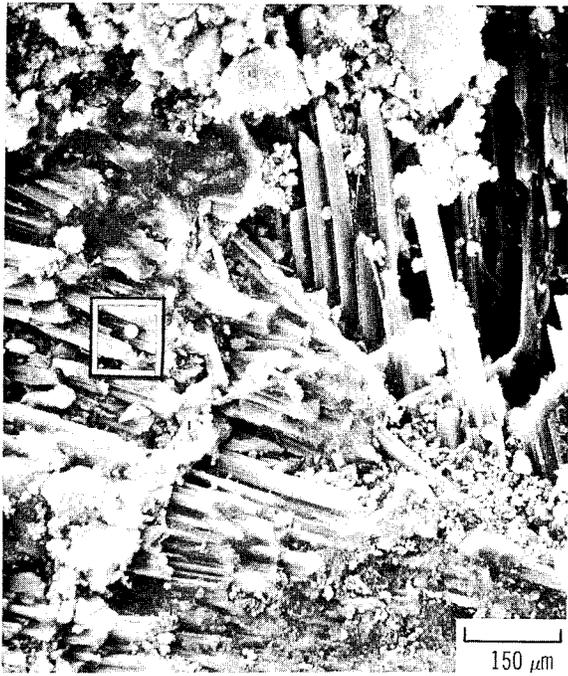
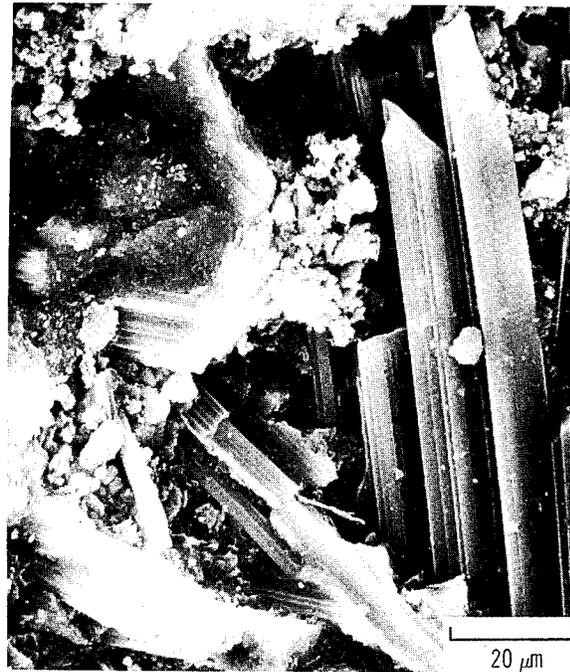
(a) Area of exposed fiber structure.

(b) Region in (a) showing fiber structure of reinforcing cloth.

(c) Enclosed region in (a).

Figure 11. - Surface of graphite-cloth-reinforced composite (GCRC) after sliding against a graphite-cloth-reinforced disk in simulated-stop – speed-variation test shown in figure 10.

shown in figure 10. The severe wear was accompanied by the generation of clouds of loose carbon debris being spewed from the contact area. The condition of the GCRC pad surface after such a sliding exposure was significantly different from that shown in figure 9. Exposed fibers are obvious in the SEM photographs of figure 11. A remarkable feature of the GCRC material shown in these photographs is the very irregular, sharp-edged fiber cross section. The lack of any coherent shear layer on the pad sliding surface is good evidence that fiber exposure ultimately leads to the disruption of this layer. The shape of the fibers and the high mechanical strength associated with them would enable them to act as potentially abrasive constituents on the pad surface.
