**EIELSON AIR FORCE BASE INFILTRATION
POND STUDY**

Final Technical Report for the Period 24-28 July 1995

EIELSON AIR FORCE BASE, ALASKA, INFILTRATION POND STUDY

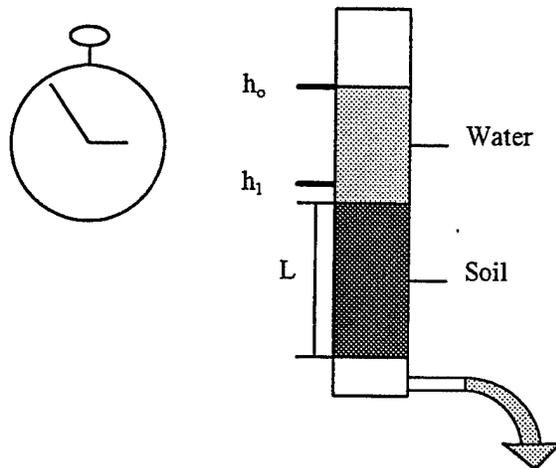
**FIGURE 1.
FALLING HEAD PERMEABILITY TEST**

To assess the permeability of the sediment, OEB personnel attempted to conduct an on-site test. In this procedure, water is placed on top of a column of the sediment, and the time for the water level in the test column to fall a specified distance is measured. Figure 1, below, illustrates the method.

The hydraulic conductivity of the soil, k , is calculated by the equation, $k = L/t \ln(h_0/h_1)$, where t is the amount of time it takes the water level to drop from h_0 to h_1 (Adapted from Freeze & Cherry, 1979), and L is the length of the soil column.

The low conductivity of the sample, however, made it impossible to conduct this test in the field because there was no visible migration of the water through the sludge column. Thus, OEBW sent a batch of the sludge to the Soil and Crop Science laboratory at Texas A&M University. In a similar test, Texas A&M placed an aliquot of the sludge into a plastic double ring infiltrometer, designed by McNeal & Reeve (1964). Water was loaded on top of the sample, and the effluent water volume measured over the course of 5 days to determine the hydraulic conductivity of the sludge. See Appendix B for the laboratory report of the permeability test.

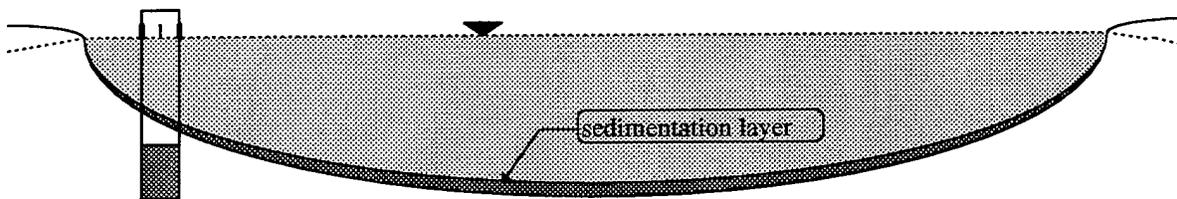
**FIGURE 2.
STAND PIPE DIAGRAM**

6. EAFB could install several (6-12) stand pipes to handle overflow conditions. Figure 2, below, illustrates this option. The stand pipes would be 12 to 24 inch diameter pipes set below the impermeable layer. The section of the pipe below the sediment layer would be screened or slotted to allow migration of water through this section. When the pond levels reach the height of the influent slots on the stand pipe, the water would percolate into the underlying strata. The bottom sediment would have to be cleaned from the standpipe before the pipes would operate properly. These pipes could be installed near the shore line.

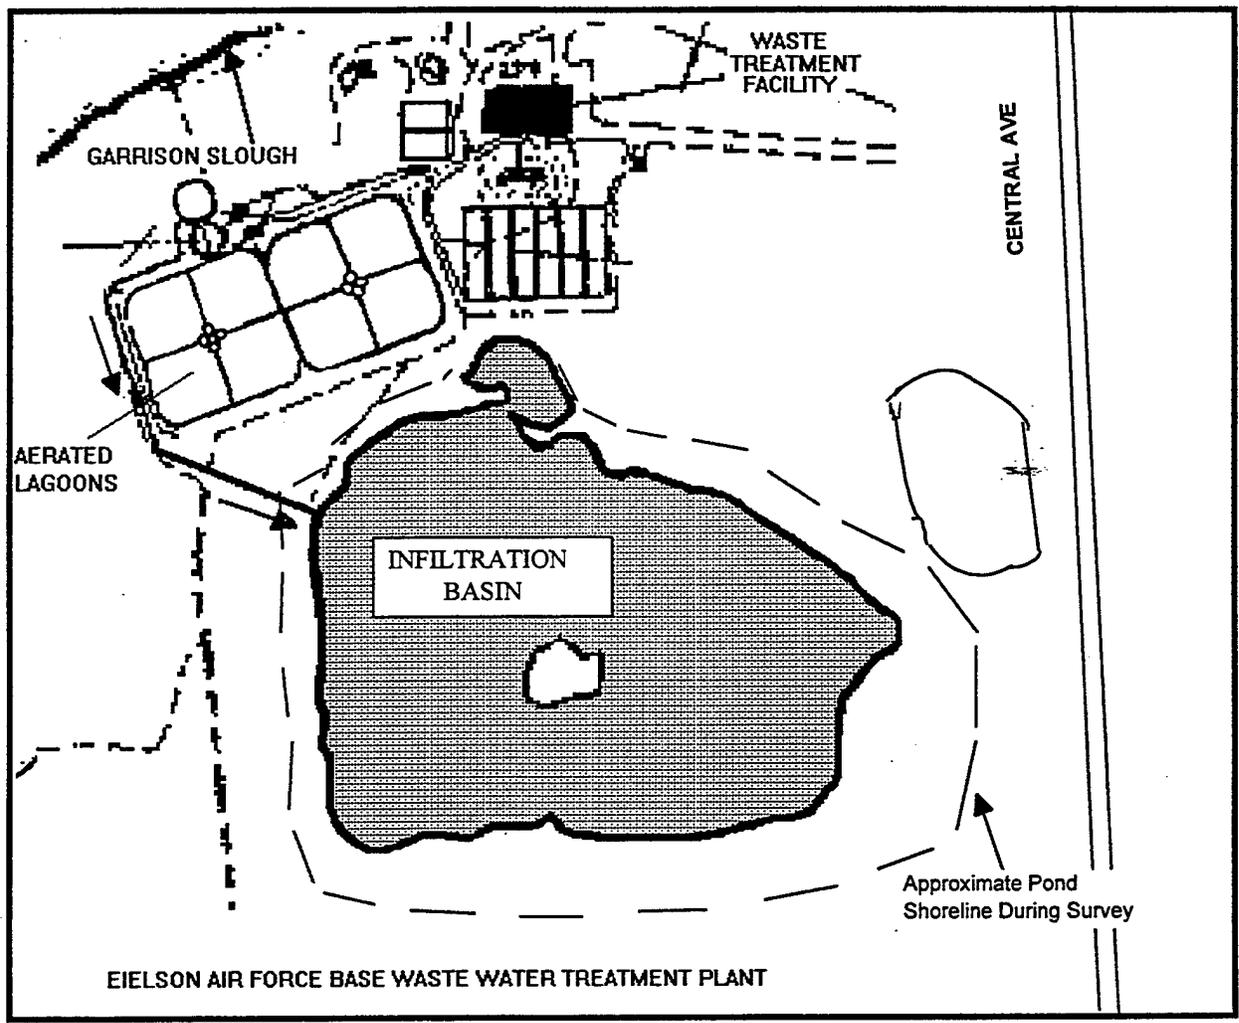
FIGURE A-2
INFILTRATION BASIN

Figure A-1 of Appendix A shows the site location map for the WWTP infiltration basin. It was apparent during the survey that the infiltration pond has become larger than it has historically been. Figure A-2 Shows the approximate shoreline location during the survey. A barbed wire fence around the original perimeter of the pond was almost completely submerged in the water at the time of this survey. WWTP personnel indicated that this fence was entirely above the water in the past. Figures A-3, A-4, and A-5 of Appendix A provide photos taken on 28 September 1995, which show how the water extends beyond the fence line. OEBW believes that the water level was higher during the survey than at the time of these photographs, but does not have pictures for comparison.

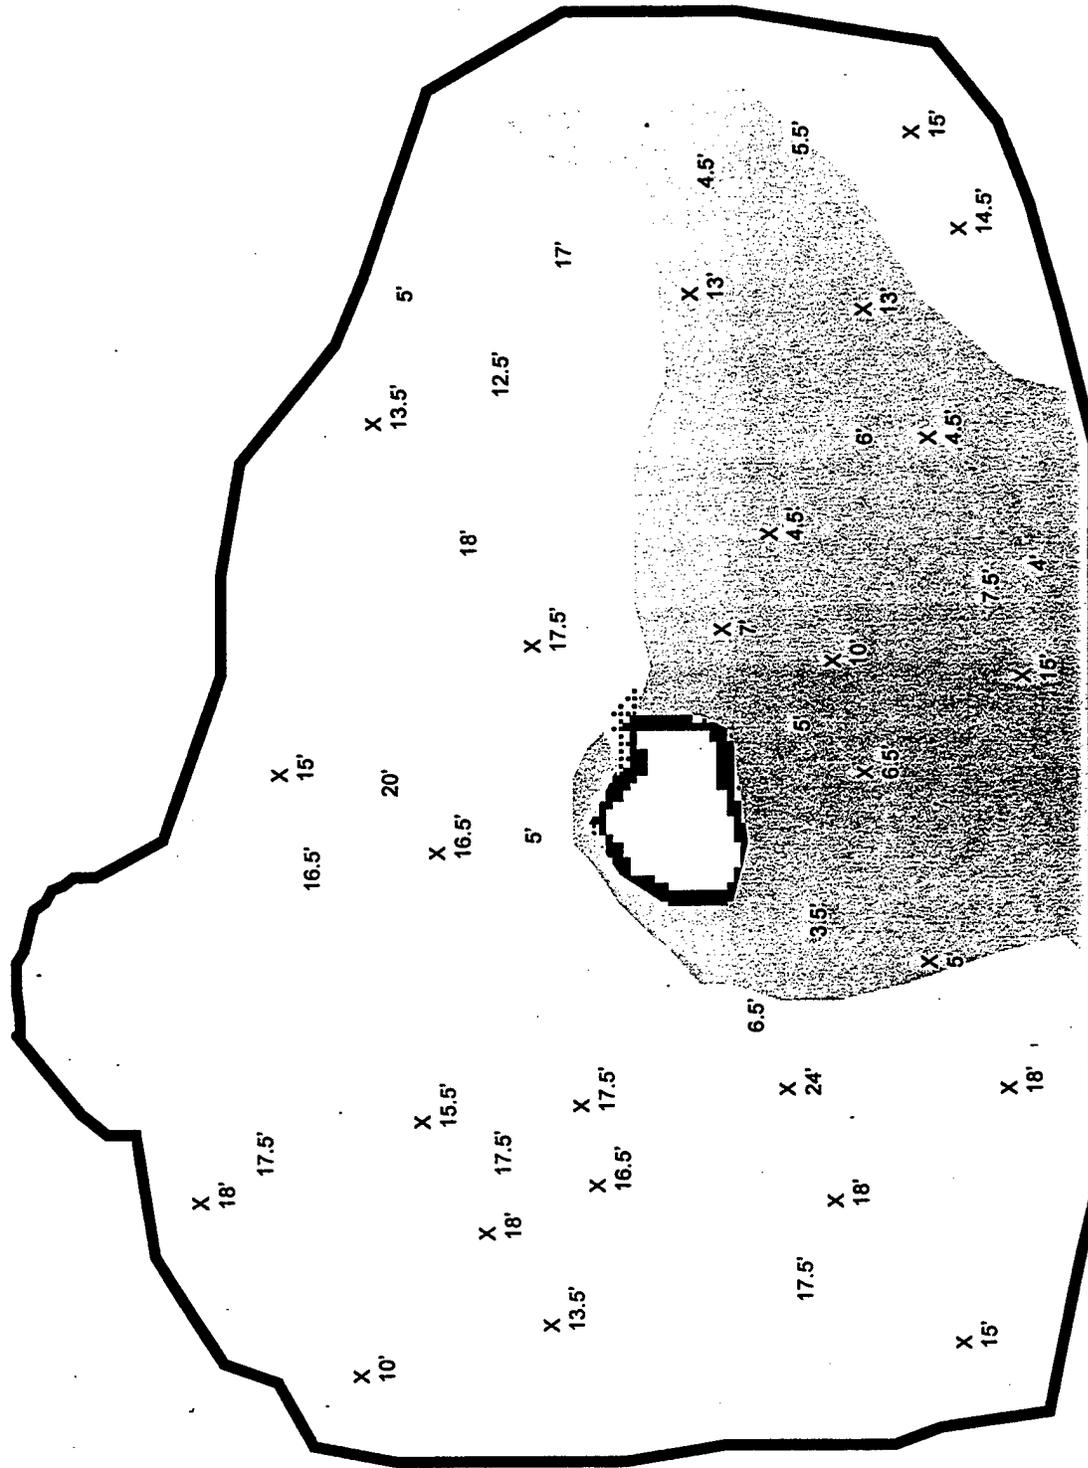
FIGURE A-6. INFILTRATION BASIN SAMPLING LOCATIONS AND DEPTH MEASUREMENTS

Figure A-6 shows the approximate location of sediment samples, and the water depth at each location. The sediment in the infiltration basin was dark green in color and had a mild odor of decaying biological matter. The character and consistency of the sediment was fairly constant throughout the pond, except at locations to where the pond had recently extended. At these locations, OEBW observed significant amounts of coniferous needles, leaves, sticks, and bark or grass, and little collectible sediment. These locations were near the edges of the pond where tree stumps and the surrounding barbed-wire fence protruded from the water. This information, along with past aerial photos, indicate that the pond has not always covered these areas, and that it is, indeed, increasing in size.

X - Marks Sampling Location

- Indicates Areas with Tree Stumps

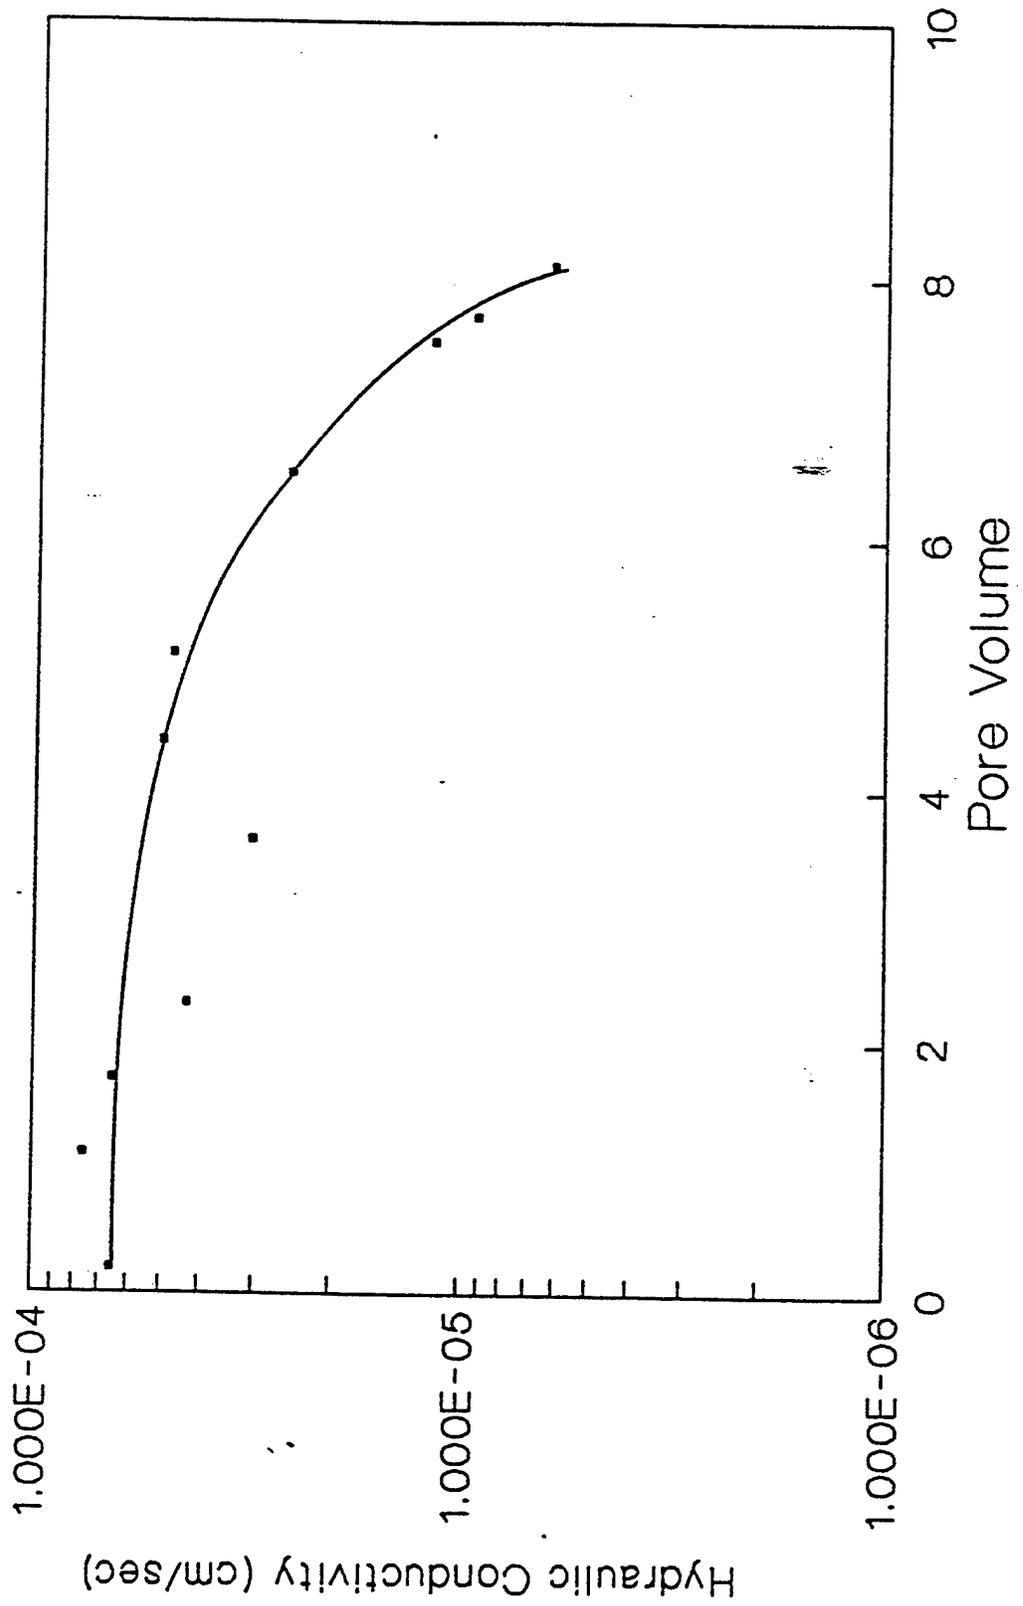
The hydraulic conductivity as a function of pore volume is presented in the following table and is shown graphically in the attached figure.

The sample had an initial hydraulic conductivity of about 6.5 x 10⁻⁵ cm sec⁻¹ over the first two pore volumes of effluent. Some particle migration was observed as sediment in the outflow tube and collection vessel. The hydraulic conductivity then showed a steady decrease until by the passage of 8 pore volumes of leachate the conductivity had decreased by 1 order of magnitude to 6.1 x 10⁻⁶ cm sec⁻¹.

I attribute this decrease to a combination of some slight settling of the lightly compacted sample and the migration of fine colloidal particles into the pores where they inhibit the flow of water. Considerable swelling of the material was also observed over the test period. Thus, I would anticipate this sludge to have an initial conductivity in the range of 6×10^{-5} cm sec⁻¹ and that it may decrease by as much as one order of magnitude over time. It is also likely that larger decreases in conductivity could be achieved if the material were compacted after placement. It is also likely that the conductivity will be increased if the sludge is allowed to dry prior to placement.

The hydraulic conductivity of the pond sediment is on the order of 10^{-5} to 10^{-6} cm/sec. This is in the general range of silt/loess, glacial till, or limestone, dolomite, and sandstone rocks. In comparison, sand and gravel, or karst limestone have conductivities on the order of 1 to 10^{-2} cm/sec (Freeze and Cherry, 1979). Also, 10^{-6} cm/sec is the conductivity often required for material lining a landfill. This indicates that the sediment in the bottom of the infiltration basin is impermeable relative to the underlying sand and gravel. The laboratory results indicate that the conductivity of the sediment might even be less than 10^{-6} cm/sec for a consolidated sample (the sample that OEB submitted to the laboratory was disturbed). The results in Appendix B show that through the duration of the test, the conductivity was decreasing, which is likely due to consolidation of the material.

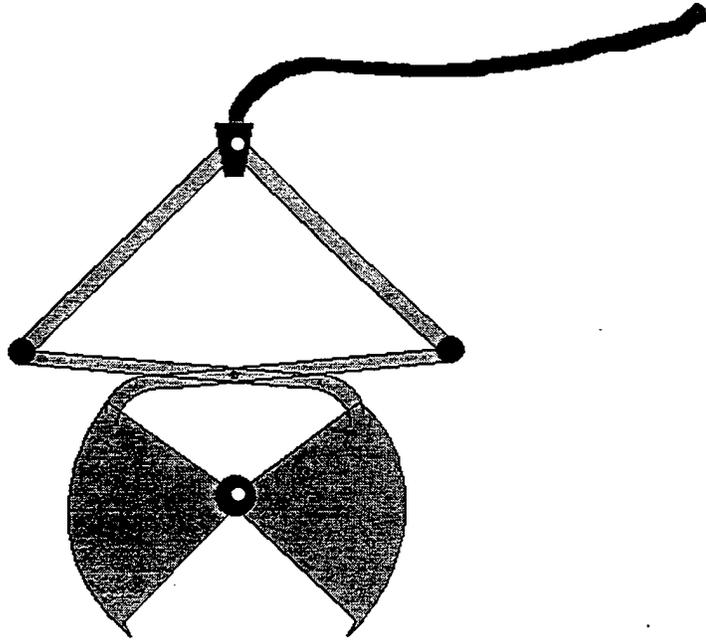
PONAR DREDGE SAMPLER

In order to characterize the sediment for disposal alternatives, equal amounts of sludge samples from each sampling location were collected with a ponar dredge and placed into a large glass jar. This composite sample was thoroughly mixed, and aliquots taken and placed in the appropriate sample containers for Toxicity Characteristic Leachate Procedure (TCLP) analyses. The TCLP procedures included metals, pesticides, herbicides, volatile and semivolatile organic compounds, and reactivity. OEB personnel took duplicate samples for quality control purposes to insure the reproducibility of the analytical results.
