*Coastal Inlets Research Program*

## **Shark River Inlet, New Jersey, Entrance Shoaling: Report 1, Desk Study**

Nicholas C. Kraus and Mary C. Allison

September 2009

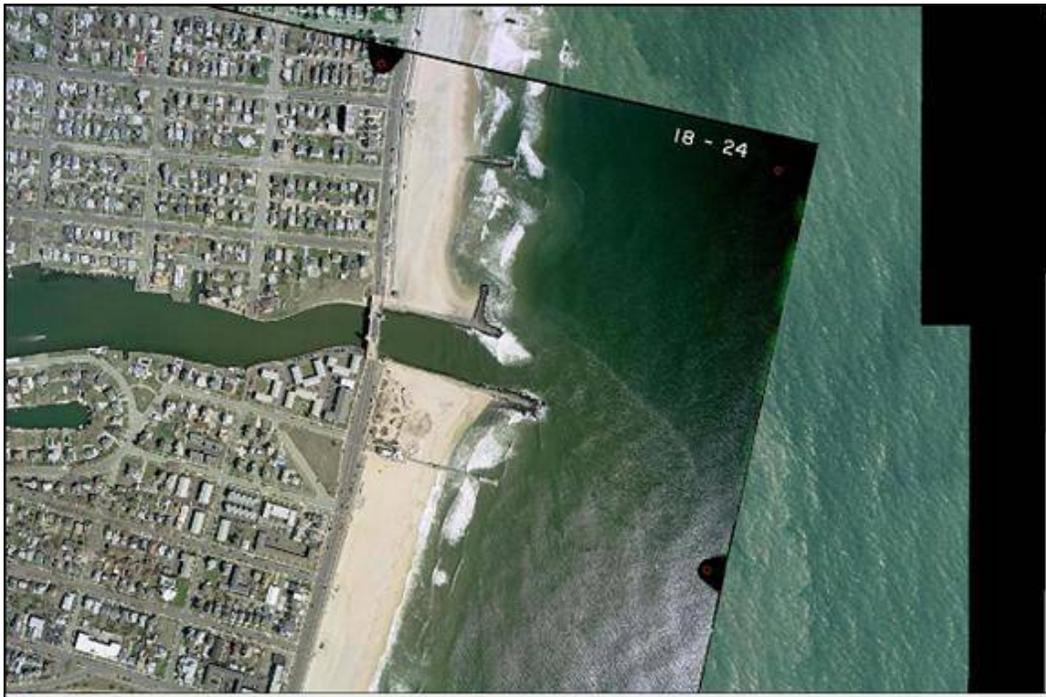
Figure 1. Shark River Inlet entrance, NJ, inset area photographed 13 April 2003.

Shark River Inlet is located in Monmouth County, NJ, and is the southernmost coastal inlet maintained by the New York District (Figures 1 and 2). There is no significant river flow to the estuary, which is fed by several small streams. The inlet is served by a federally maintained navigation channel connecting the estuary of the Shark River and the Atlantic Ocean.

The inlet is stabilized by two parallel rock jetties, owned and maintained by the State of New Jersey. Two curved jetties were constructed in 1915 and, between 1948 and 1951, the State rebuilt and realigned the jetties to extend straight to the ocean (Angas 1960). Although these jetties have

experienced maintenance since 1951, the parallel configuration has continued with the north and south jetties, 525 ft and 950 ft long, respectively, and 300 ft apart. A 500-ft-long shore-parallel external spur extends northward from the north jetty and was built to protect the landward end of the jetty during northeasters. The Federal navigation project includes the entrance channel, which is 18 ft deep and 150 ft wide, from the Atlantic Ocean to a point 500 ft landward of the inlet, connecting to a channel 12 ft deep and 100 ft wide into the bay.

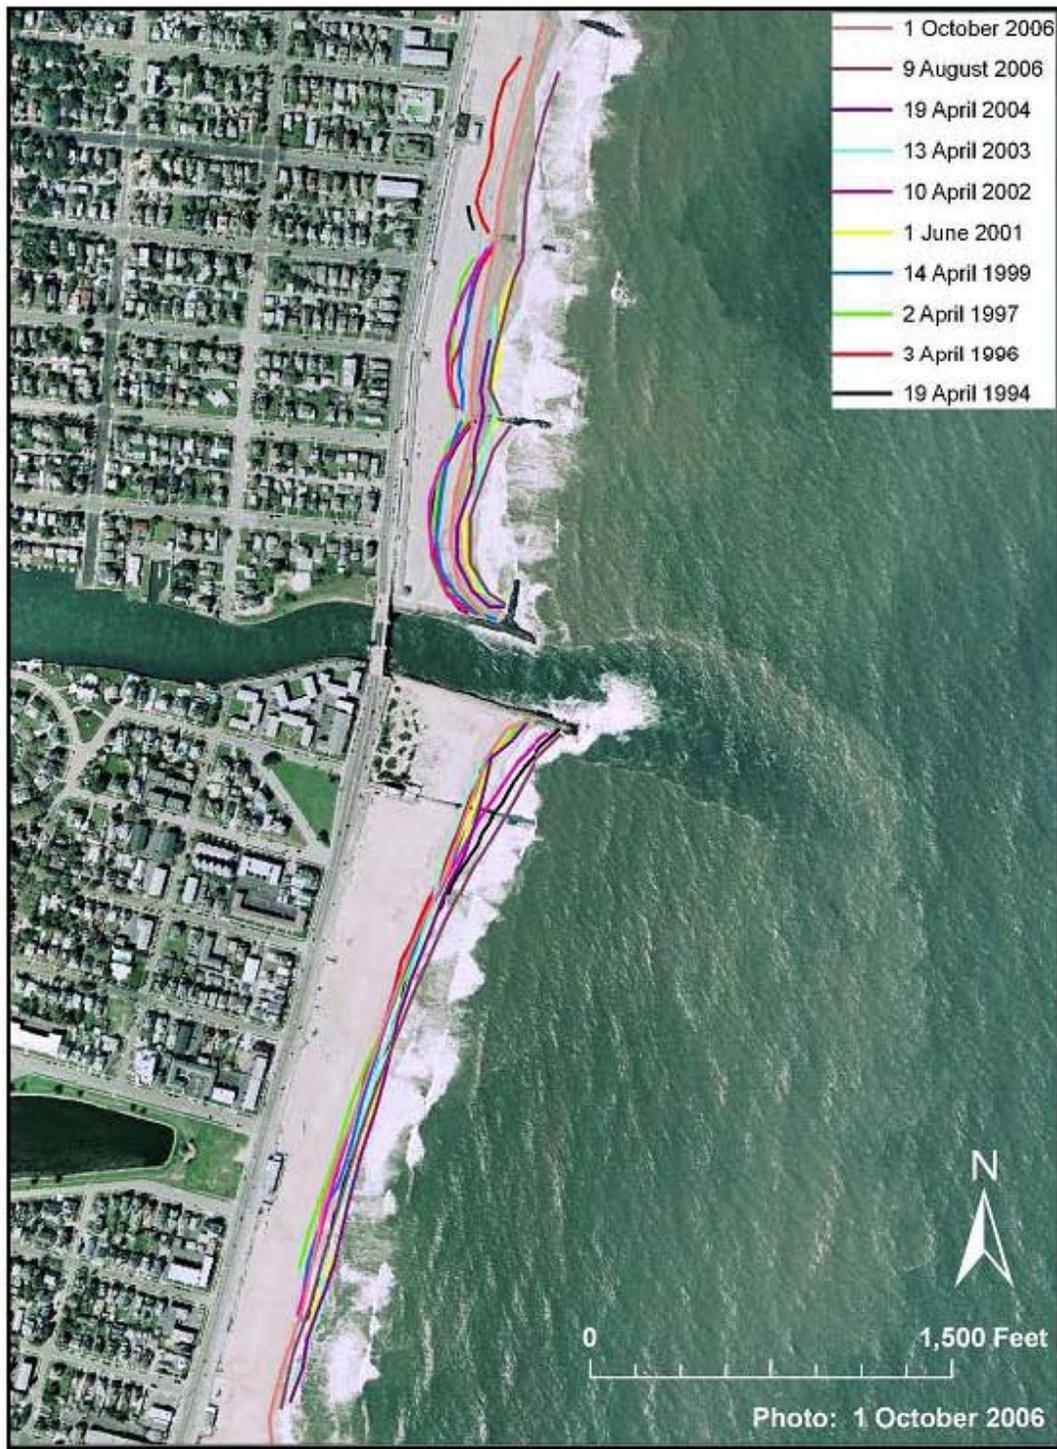
Shoreline position in the vicinity of the inlet, from April 1994 to October 2006, was examined from aerial photography made available by the New York District, as summarized in Figure 3. The shoreline was interpreted as the visually identified wet-dry line, without tidal (water level) correction. The figure shows that the shoreline adjacent to the south jetty has been fully impounded, apart from seasonal change, similar to the situation described by Angas (1960). The shoreline adjacent to the north jetty advanced subsequent to the renourishment in 1999-2000, and the segment of shoreline behind the spur also varies in position, but maintains an advanced position protecting the landward base of the jetty. The seaward positions of the shoreline on both sides of the inlet suggest that sand can readily enter its entrance or move onto the newly formed ebb shoal. The large impoundment area adjacent to the south jetty indicates a consistent net longshore sand transport to the north.

Figure 3. Shoreline change at Shark River Inlet entrance, NJ, 1994-2006.
