Small Project, Big Stability Problem The Block Church Road Experience

August 4, 2005 ISC Conference St. Louis, MO

Jonathan E. Kolber, P.E.

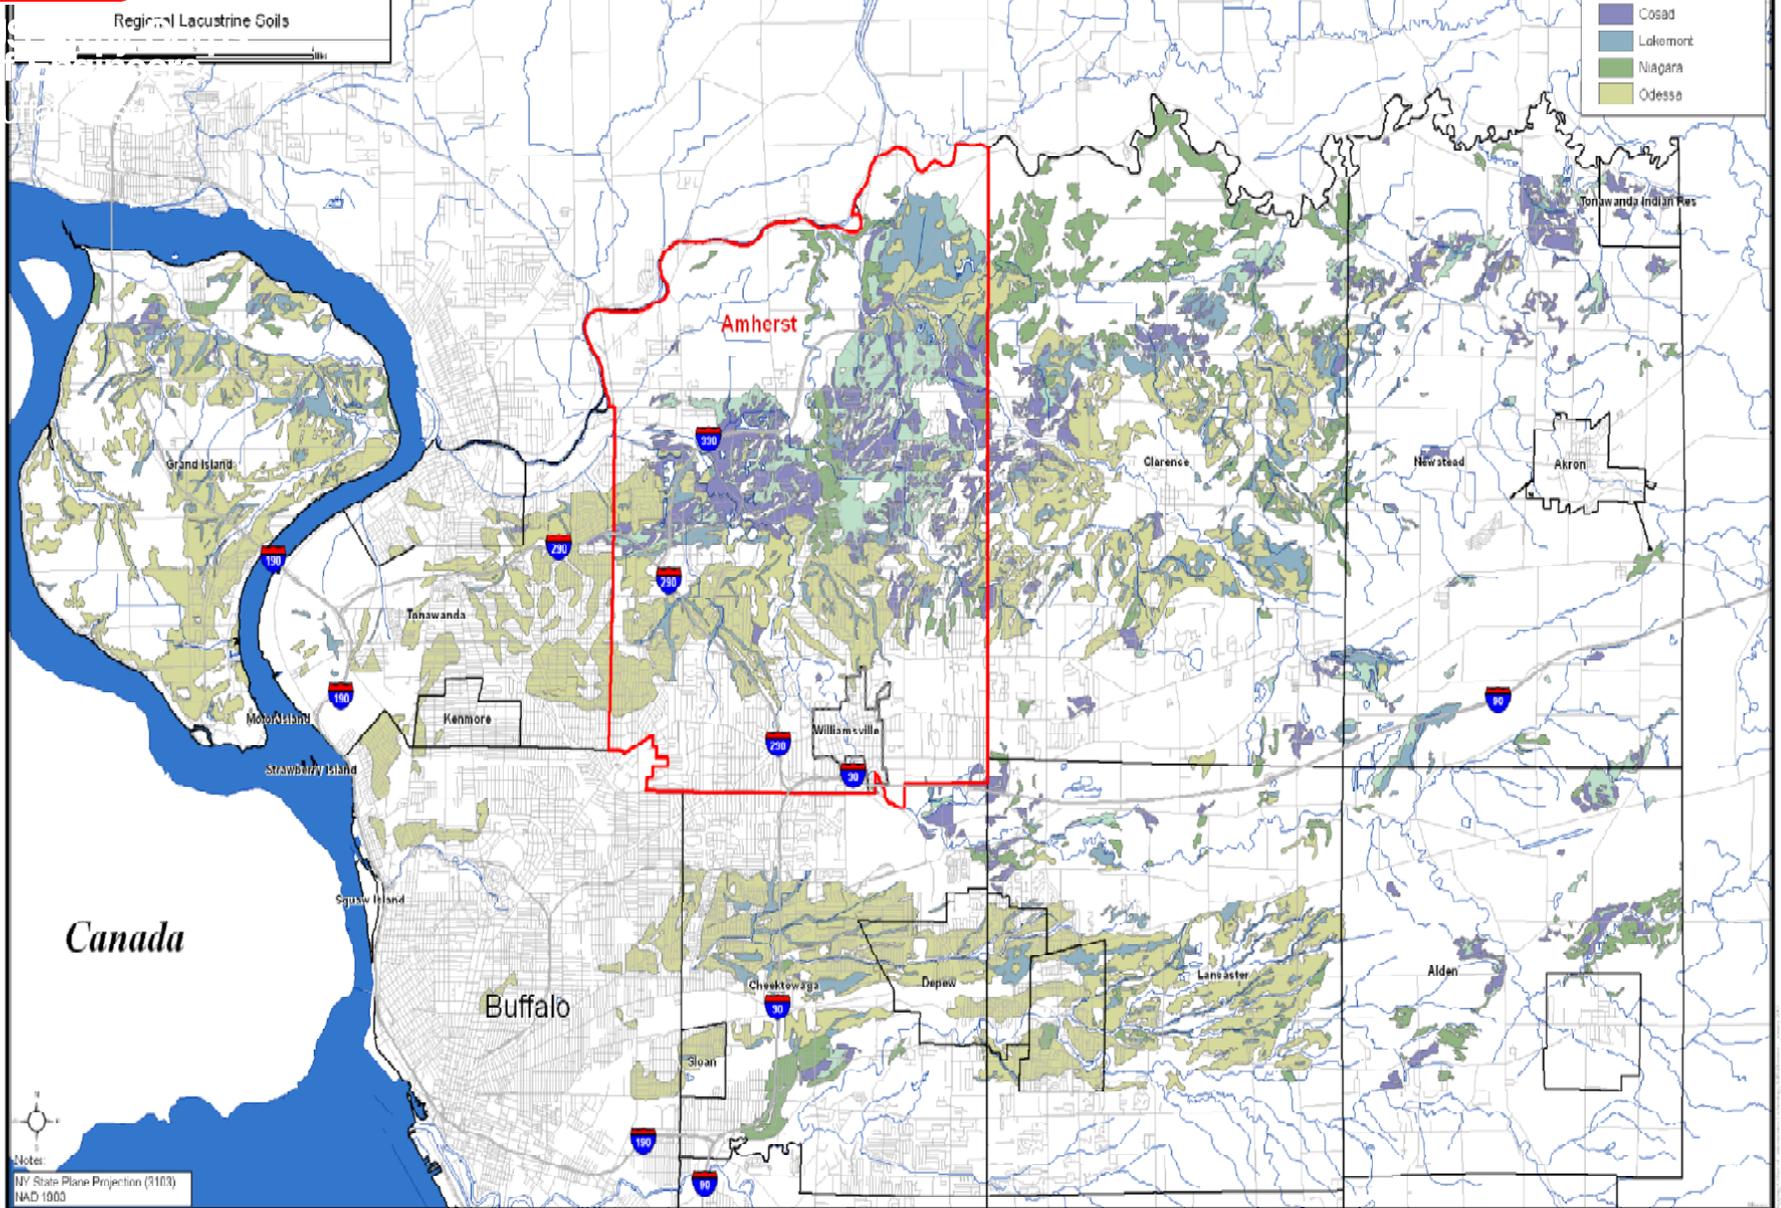
Regional Lacustrine Soils

- Chockitowaga
- Cosad
- Lakemont
- Niagara
- Odessa

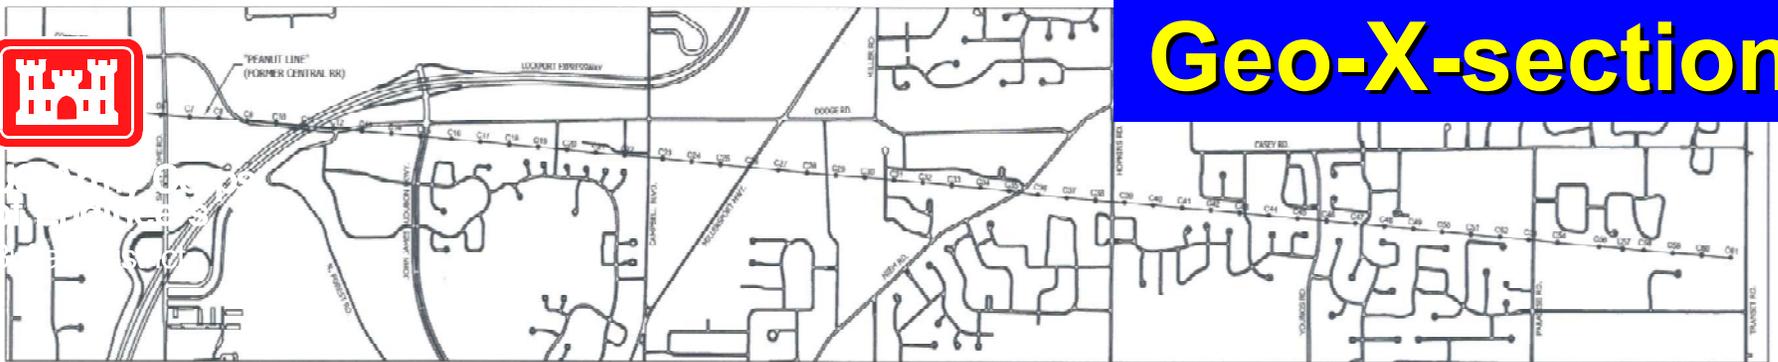
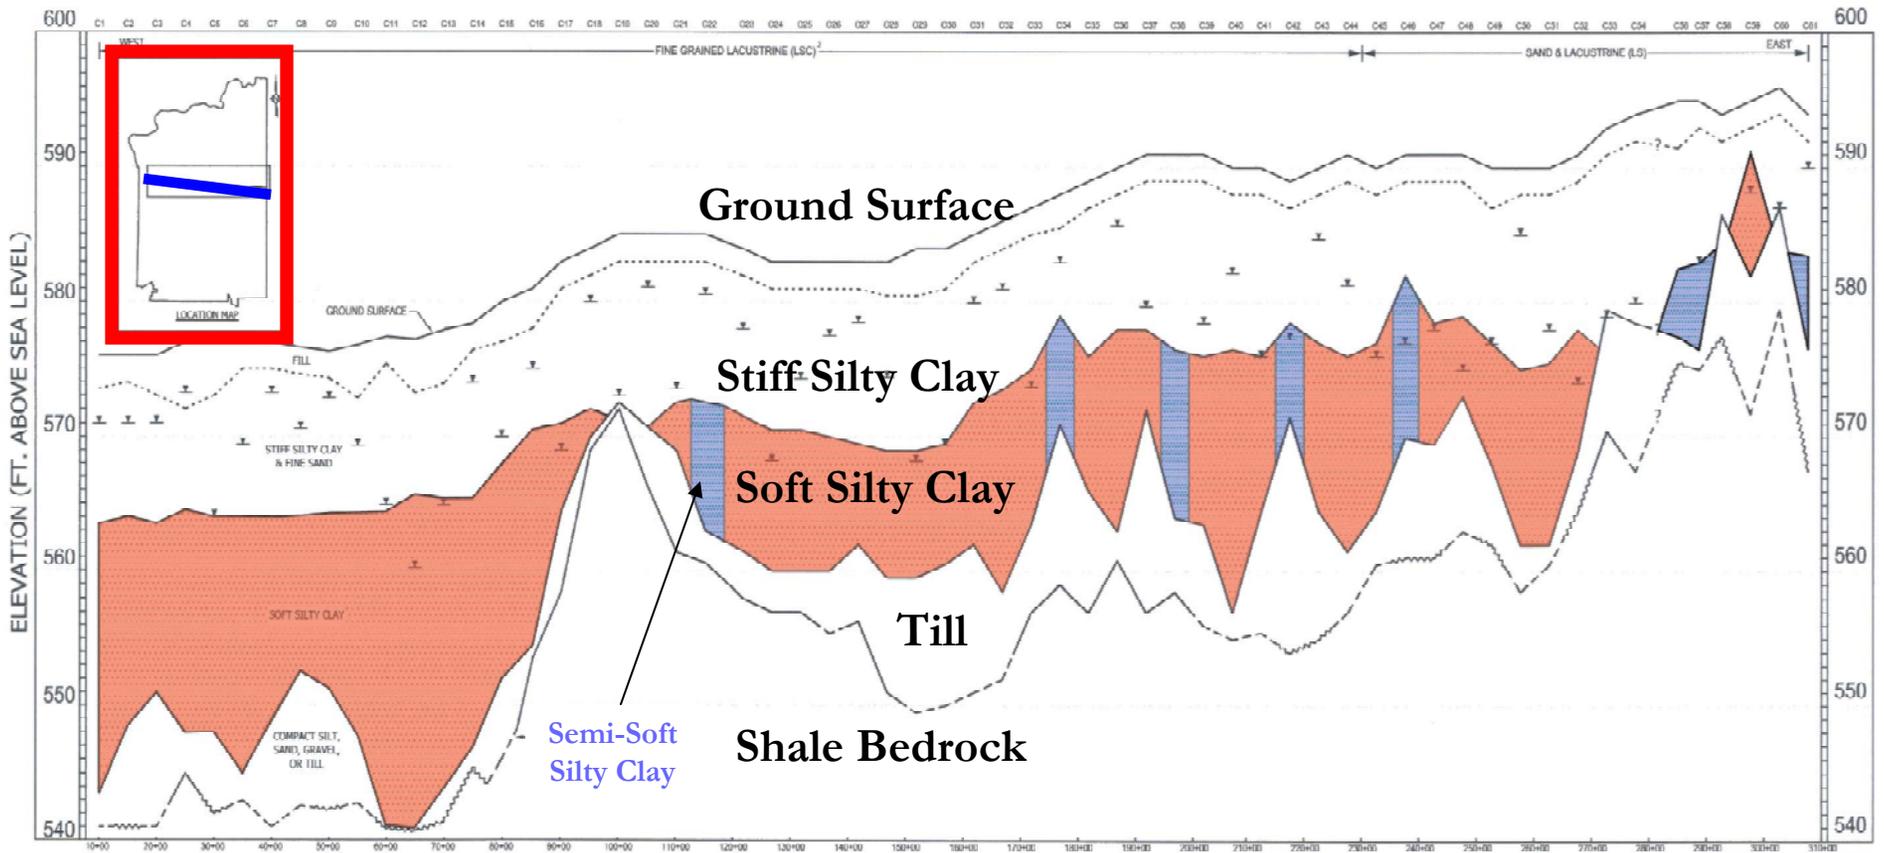
GEOTECHNICAL/GEOLOGIC CROSS SECTION - PEANUT LINE

- C20 BORE LOCATION ¹
- WATER LEVEL IN BORE HOLE (12 to 72 HRS. AFTER COMPLETION)
- N < 4
- 4 <= N <= 8

SUBSOIL PROFILE

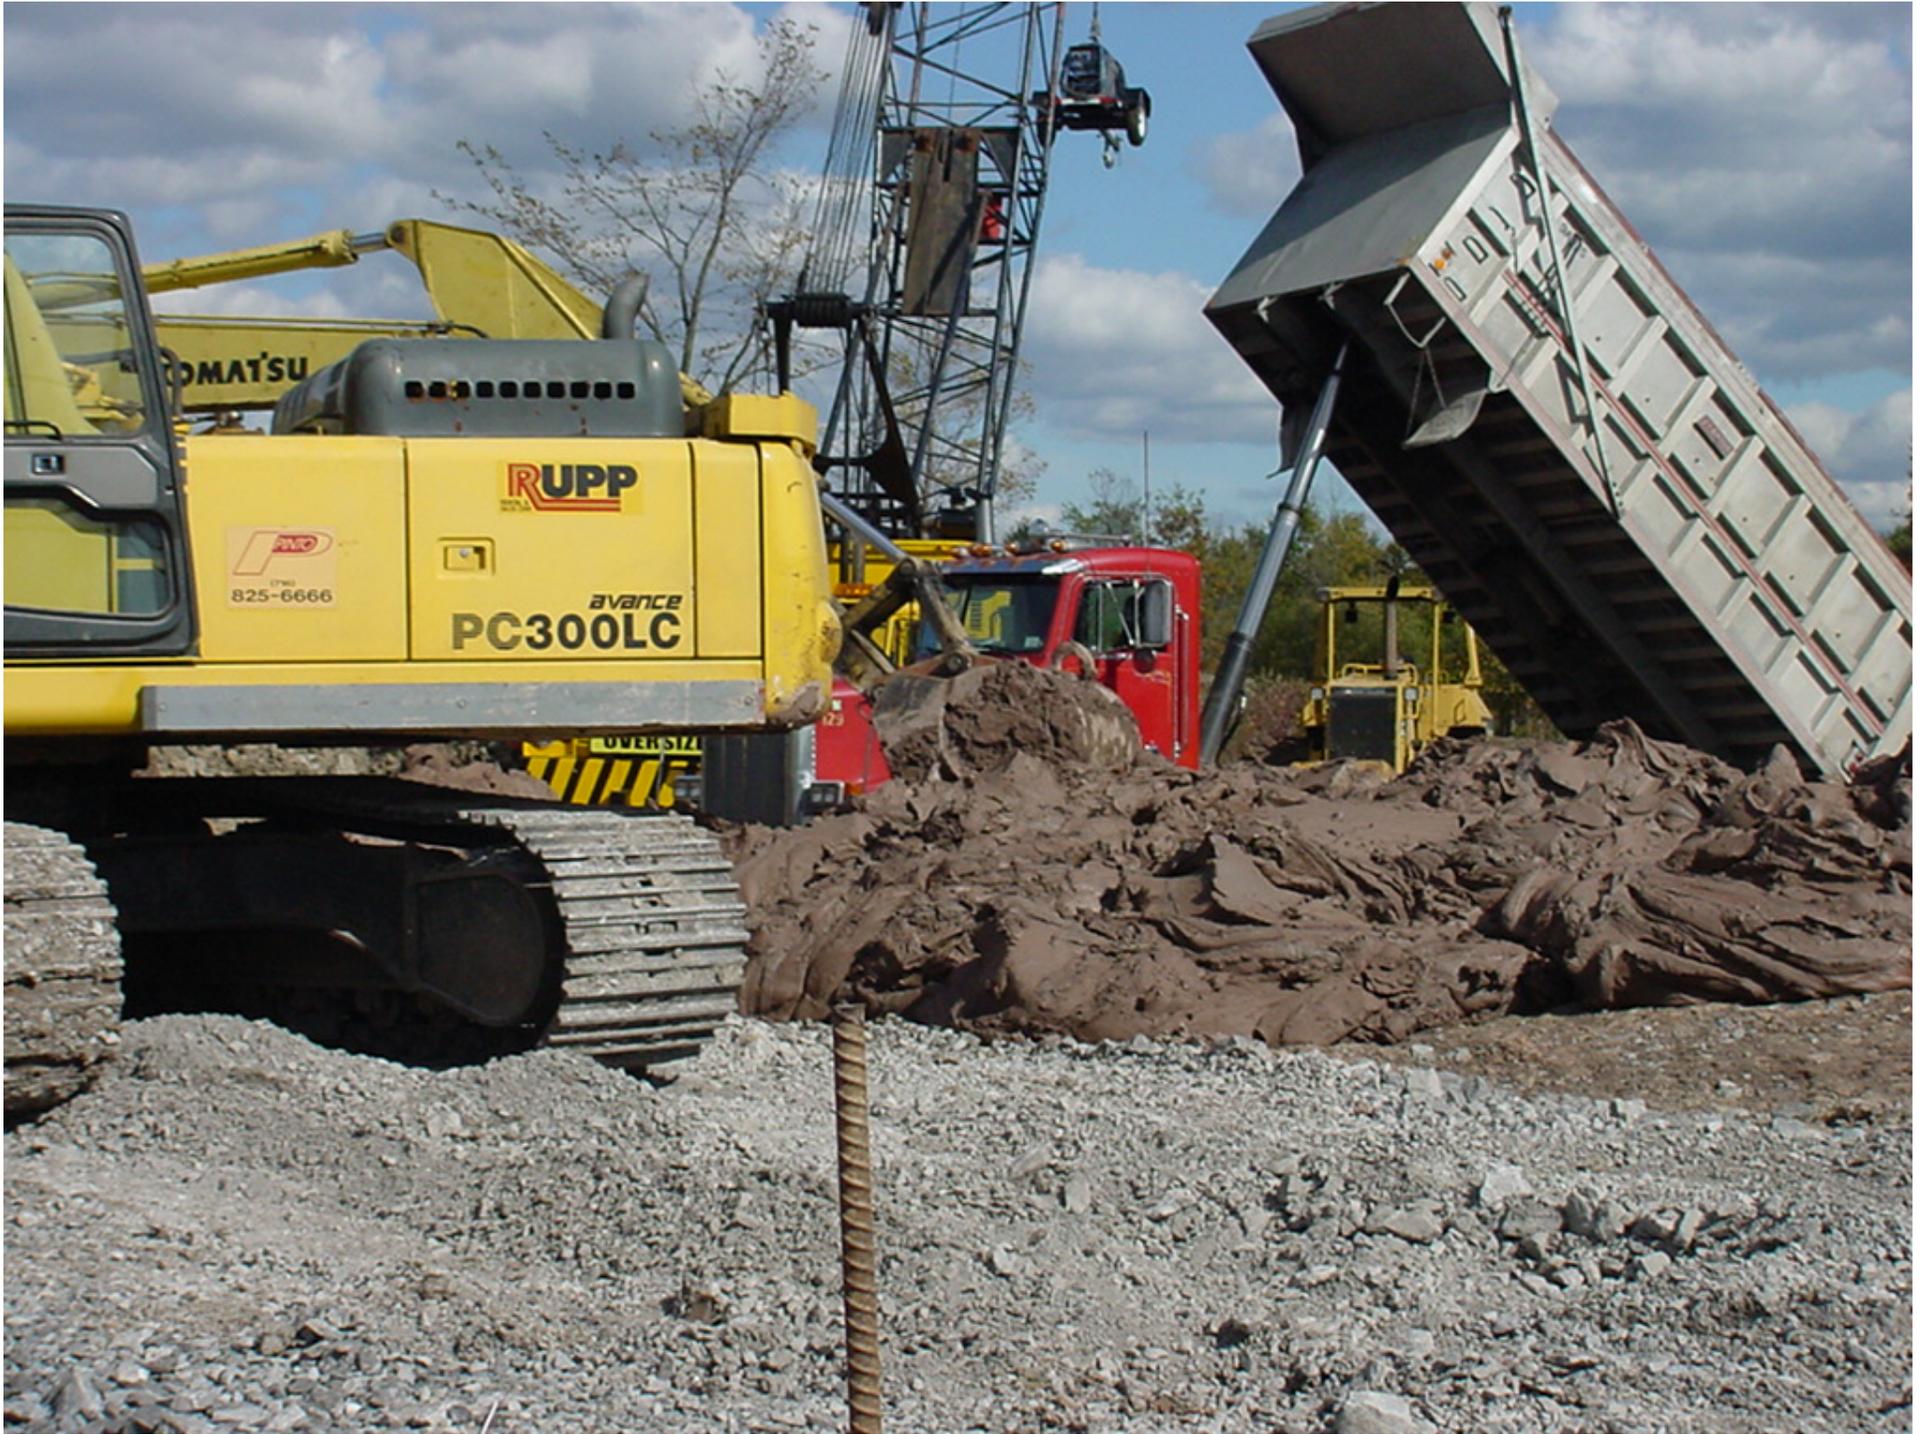
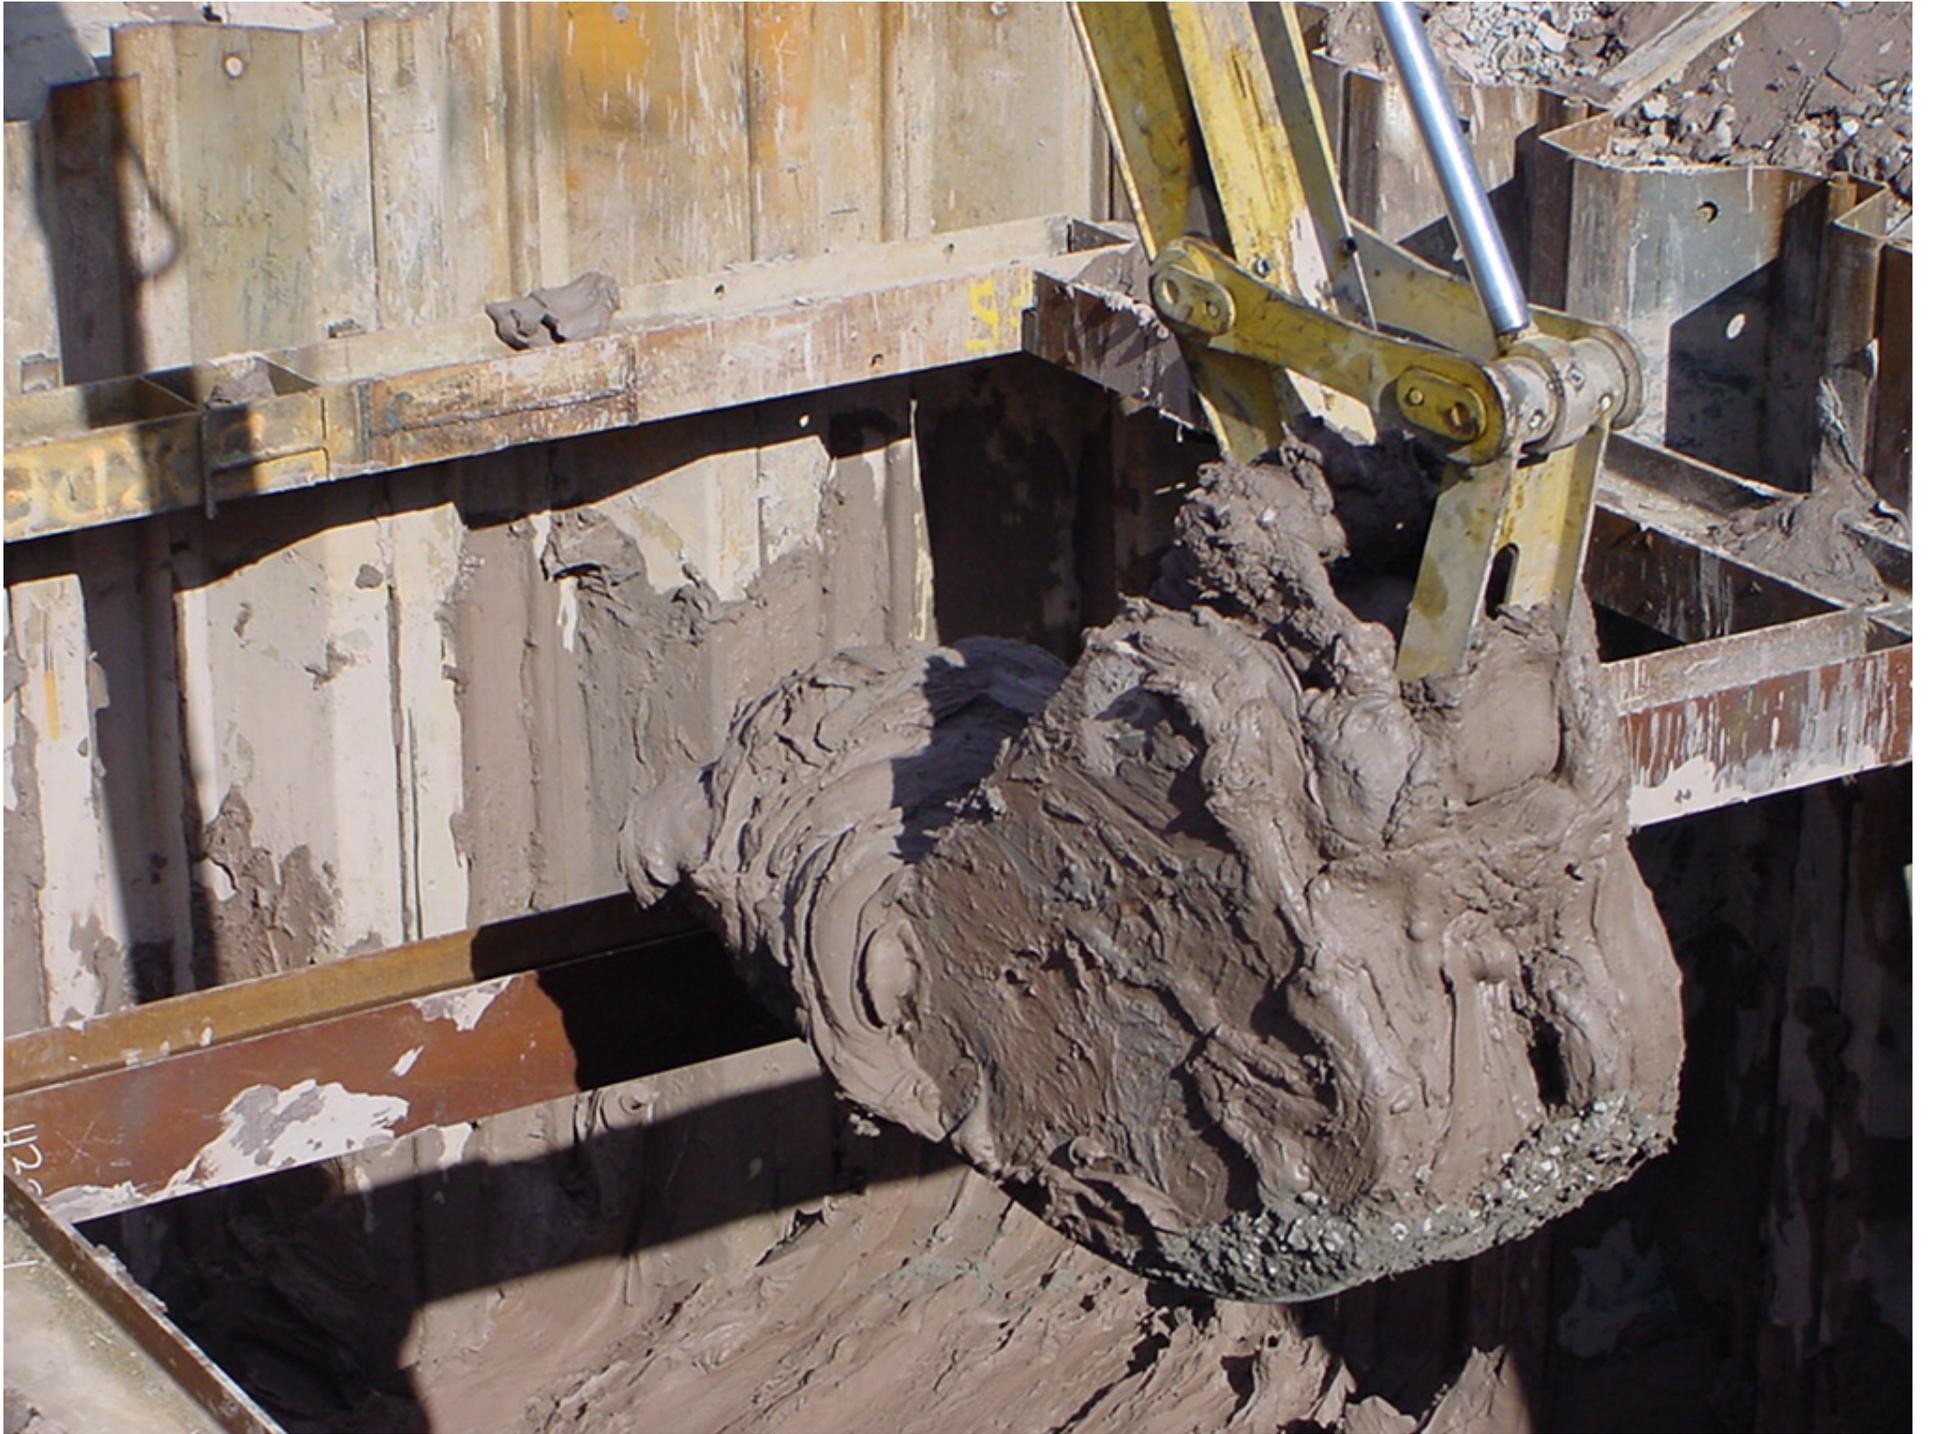
Soft Lacustrine Clays, Commonly Described as “Peanut Butter”

- $N = 0$ blows/foot $w = 50\%$
- $LL = 50-60$ $PL = 25$ $PI = 25-35$
- Unit weight (total) = 110 pcf
- Unified classification CL or CH
- Maximum shear strength = 300 psf
- Remolded shear strength = 50 psf
- Sensitivity 2-6.5

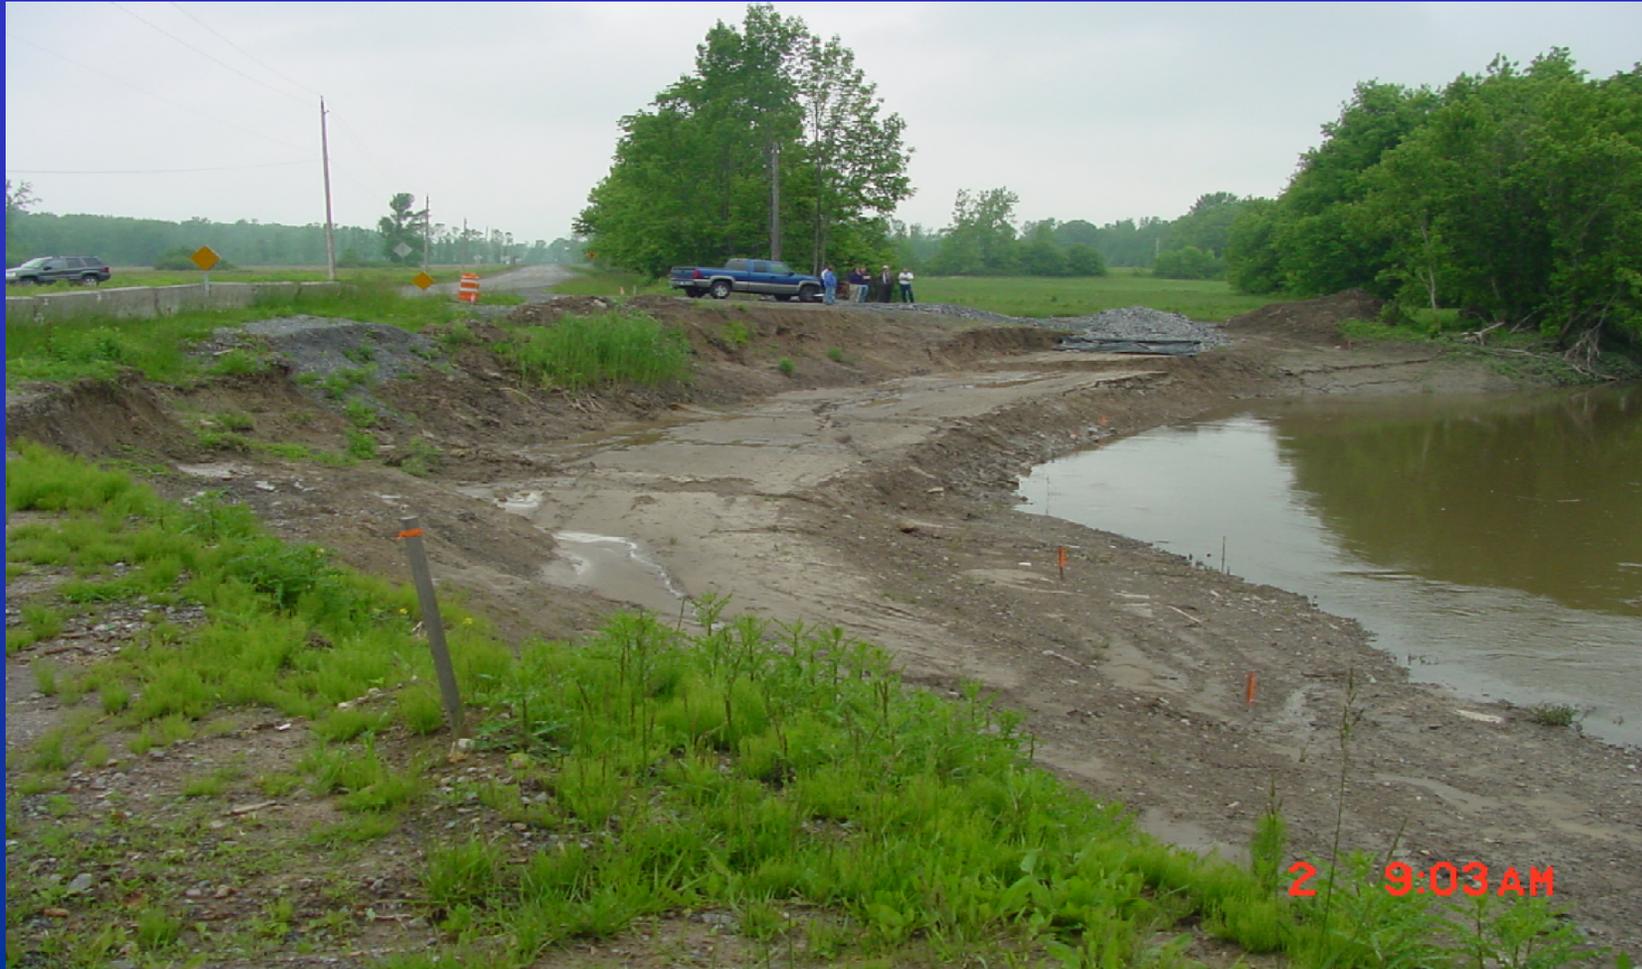
Slope Failure

- Long time frame between start and finish of project (11 years)
- No construction sequence specified
- Non-free-draining backfill
- No pre-construction meeting
- Lack of understanding the mode of failure

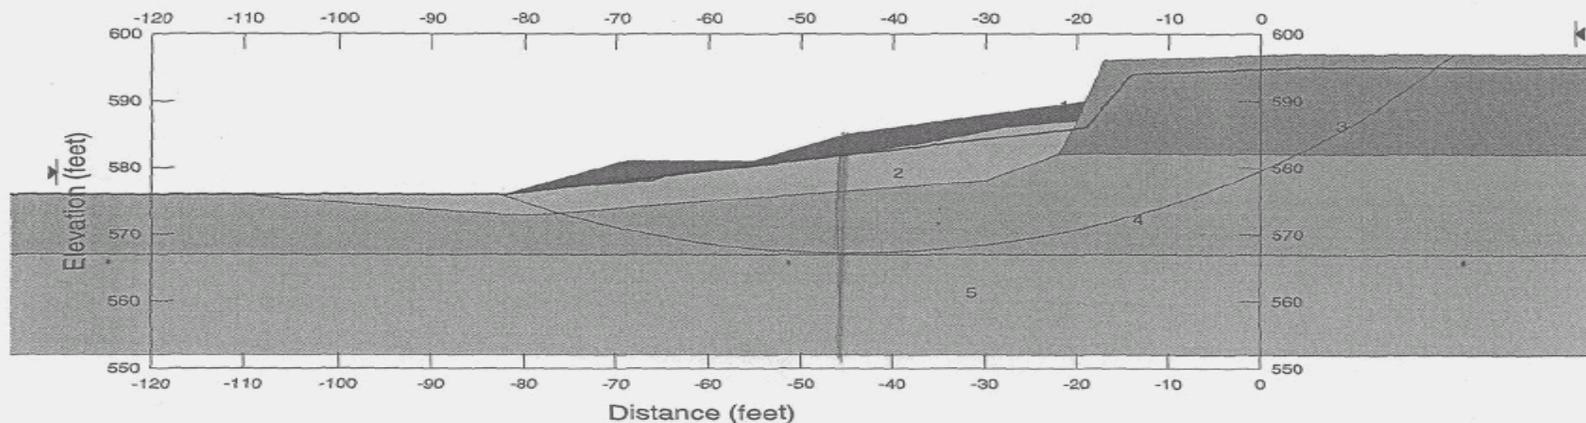
Slope Stability Analysis (Back-Figure Shear Strength at Failure)

Soil: 1
Description: Fill
Unit Weight: 120
Cohesion: 0
Phi: 36
Unit Wt. above WT: 105

Soil: 2
Description: old fill
Unit Weight: 125
Cohesion: 0
Phi: 25
Unit Wt. above WT: 120
Piezometric Line #: 1

Soil: 3
Description: upper non-plastic
Unit Weight: 125
Cohesion: 0
Phi: 29
Unit Wt. above WT: 120
Piezometric Line #: 1

Soil: 4
Description: soft clay
Unit Weight: 105
Cohesion: 290
Piezometric Line #: 0

Soil: 5
Description: stiff silt
Unit Weight: 125
Cohesion: 0
Phi: 26
Piezometric Line #: 1

0.867

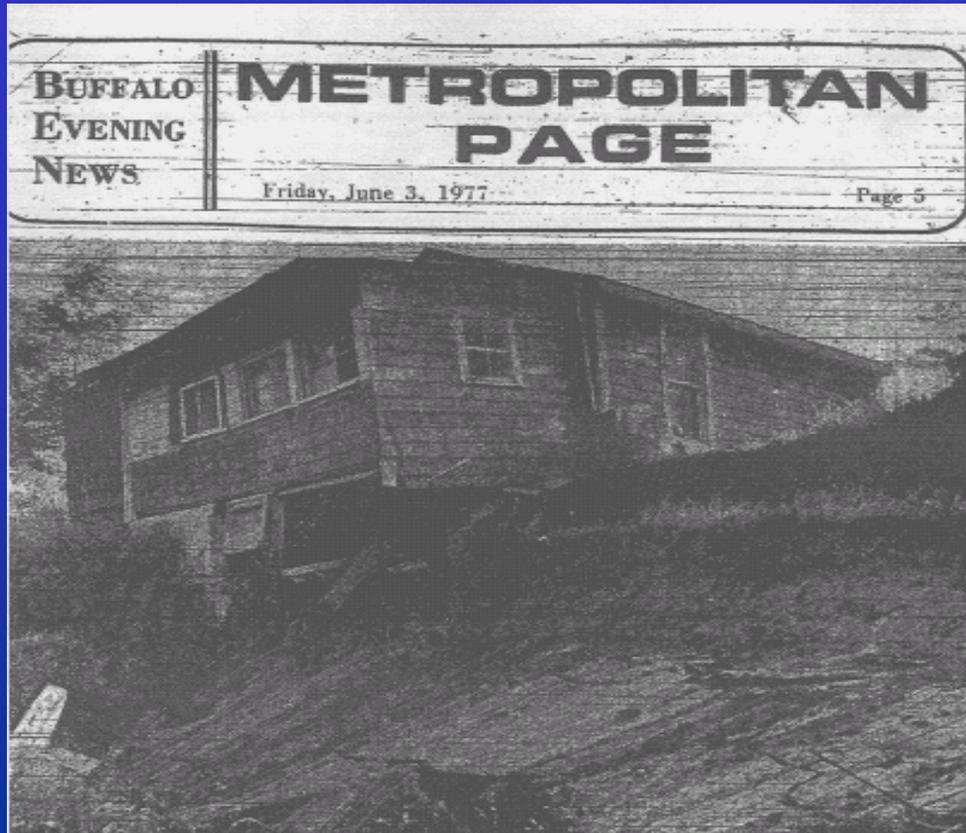
ON THE EDGE — The wandering path of Tonawanda Creek undermined three homes in the Town of Lockport Thursday afternoon, but the families, aware of the erosion, escaped. The U. S. Corps of Engineers is assisting local officials in assessing the damage. No injuries were reported.

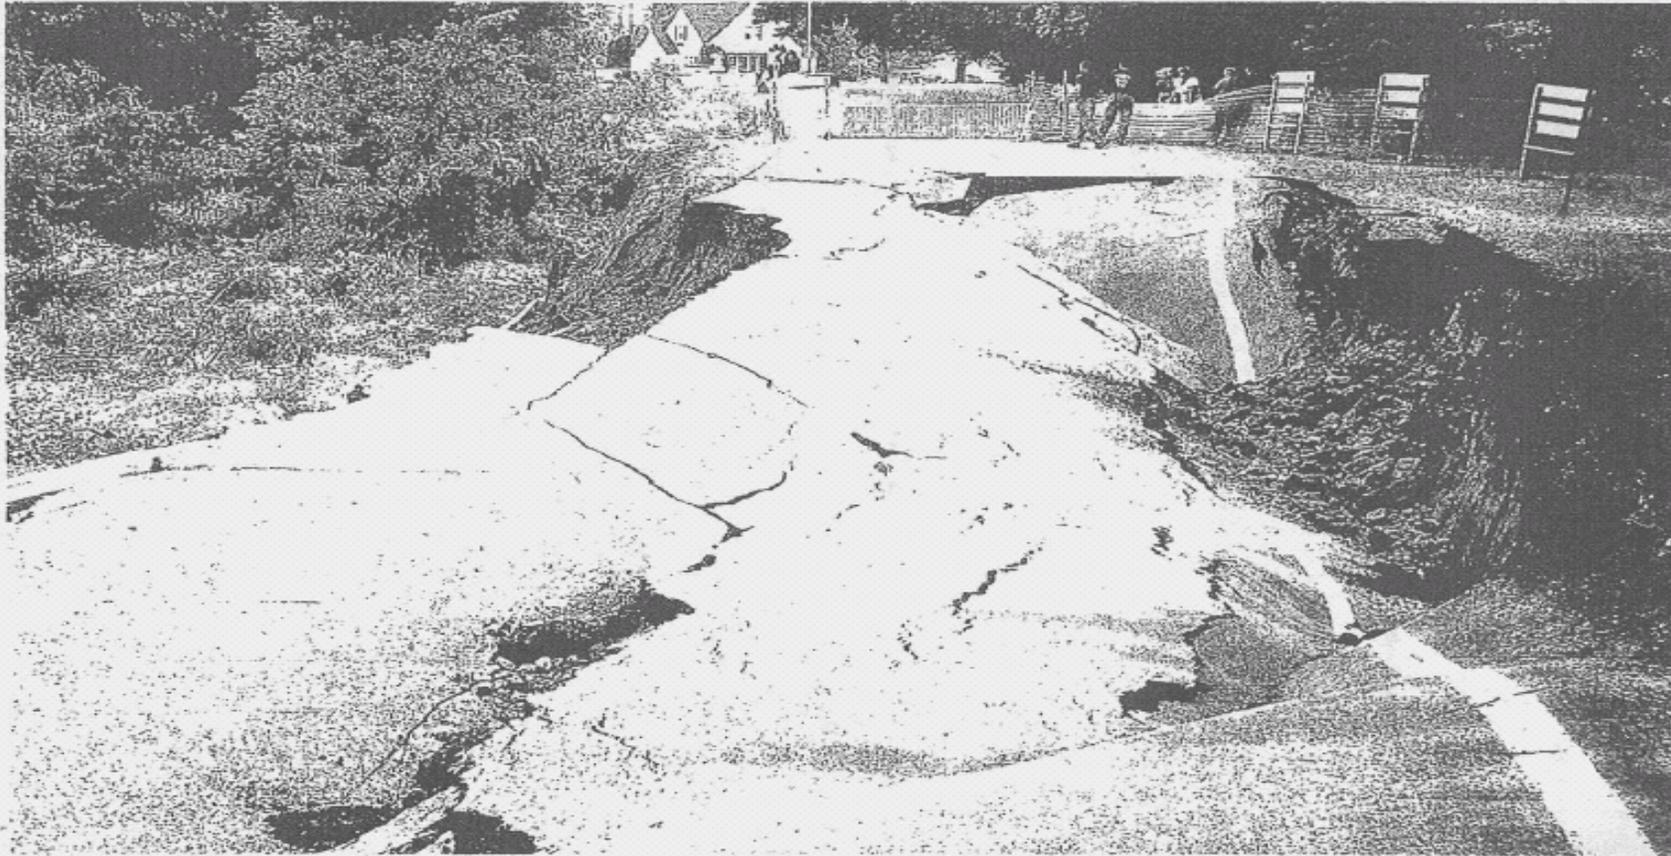
Rough Road: *Collapse in Clarence*

Closed for repairs: Town officials believe ground water pushing out clay soil may have buckled and broken this stretch of Tonawanda Creek Road in Clarence. A 150-foot section of the road, at the northeast edge of the town, began collapsing Friday, forcing at least two families to evacuate their homes.
