Phalanx Close In Weapon Support (CIWS) Dented Brass Dynamic Analysis

John Fletcher
March 30, 2006

NDIA Gun and Missile Systems Conference

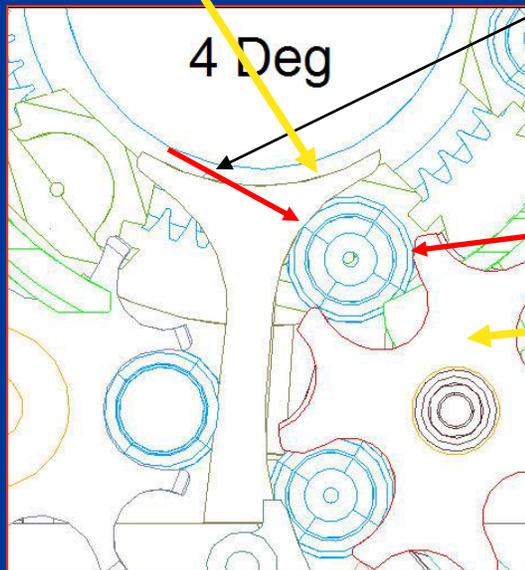
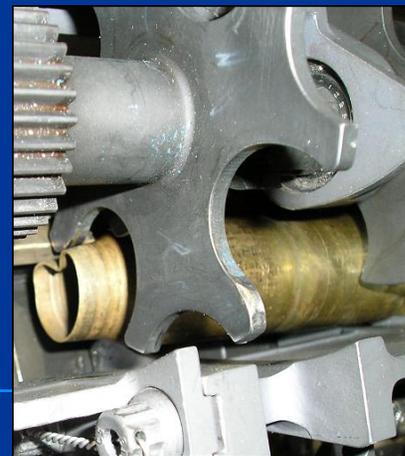
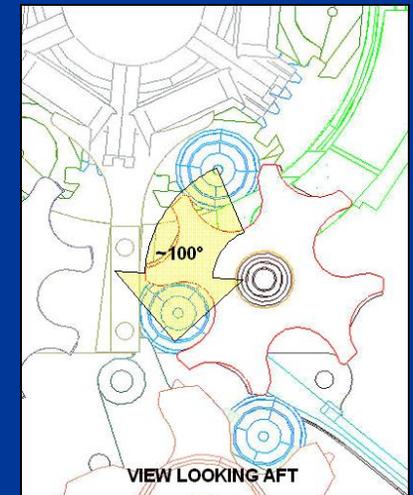
20mm Case Neck Denting

- Dents occur as the fired case is trapped between the feeder unload sprocket and the guide bar just after handoff from the gun bolt
- Root cause is a lack of control influenced by round dynamics

Guide bar

When these two forces acting on the case neck oppose each other denting of the case neck occurs

Dented occurring during handoff

Unload sprocket

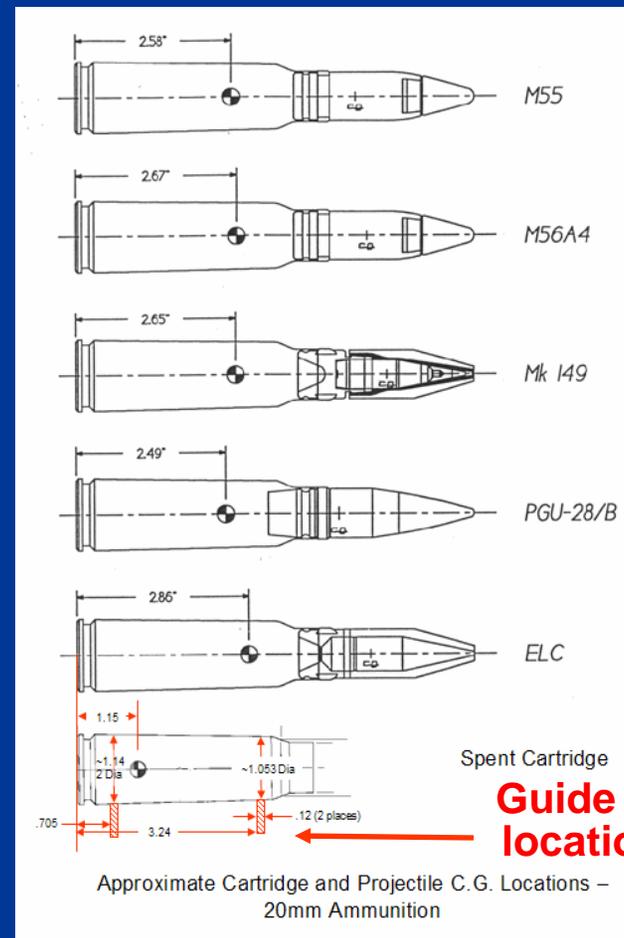
Ammunition Variations

- Ammunition characteristics
 - ELC round has significant difference in cg location compared to Mk149 round
- The case is the same for all types (M103)
- Potential exists that ELC case handoff adversely influenced due to dynamics of a full round on opposite side of guide bar
- ELC ammunition has a much greater impulse than Mk149 ($\approx 25\%$)

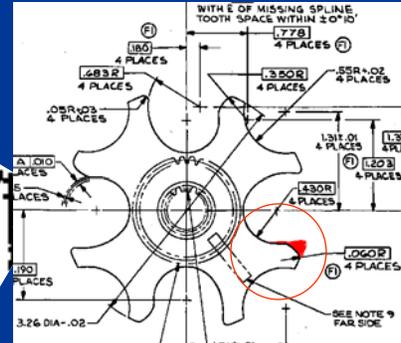
Proposed Fixes

Nose guide bar contour changes

Moved 0.05 closer to gun rotor OD

Nose unload sprocket contour change

Material removed at this corner

Material added

- Lessons learned on other systems identified improvements
 - ⇒ Reduce clearance between the guide bars (nose & base) and the gun rotor such that guide bar deflection under loading is reduced
 - ⇒ Extend the tips of the unload sprocket to gain control of the round earlier during handoff from the gun bolt
 - ⇒ Modify the nose guide bar contour on the unload side to delay impact of the case on the guide bar

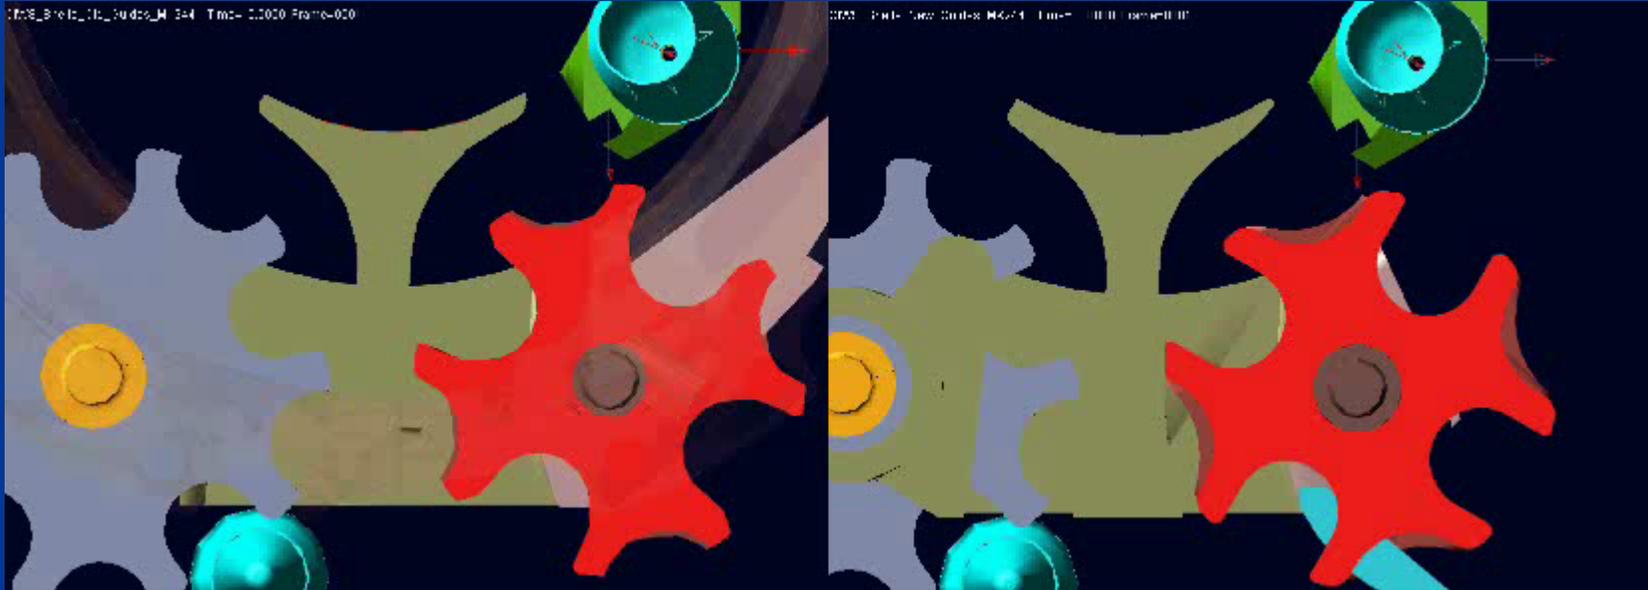
Dynamic Analysis Results Comparison

- Old configuration
- Notice case base lead
- Very late nose sprocket contact
- Large amount of case free fall
- Large contact forces generated during nose guide surf contact
- High force locking case into gun bolt

- Recommended configuration
- Lower nose guide contact forces
- Better drive angles on nose sprocket
- Earlier sprocket contact
- Less case angle in sprocket
- Less case base lead
- No gun bolt lockup force

**Note - Mk 244
shown**

- ADAMS® showed an identifiable improvement in round handoff due to the changes on the nose guide bar and marginal improvement with a modified unload sprocket
- A comparison between the original handoff and the modified handoff shows less case bumping around and lower forces acting on the case neck
- The decision was made to go forward and modify the guide bar and unload sprocket for testing at our range facility

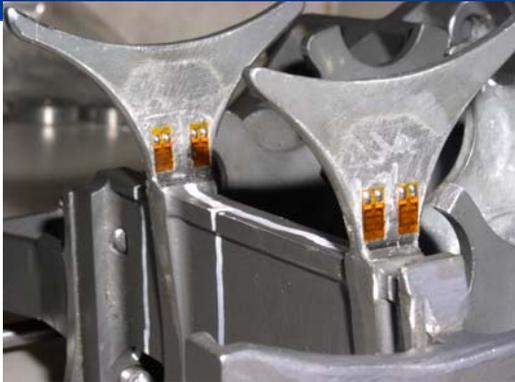
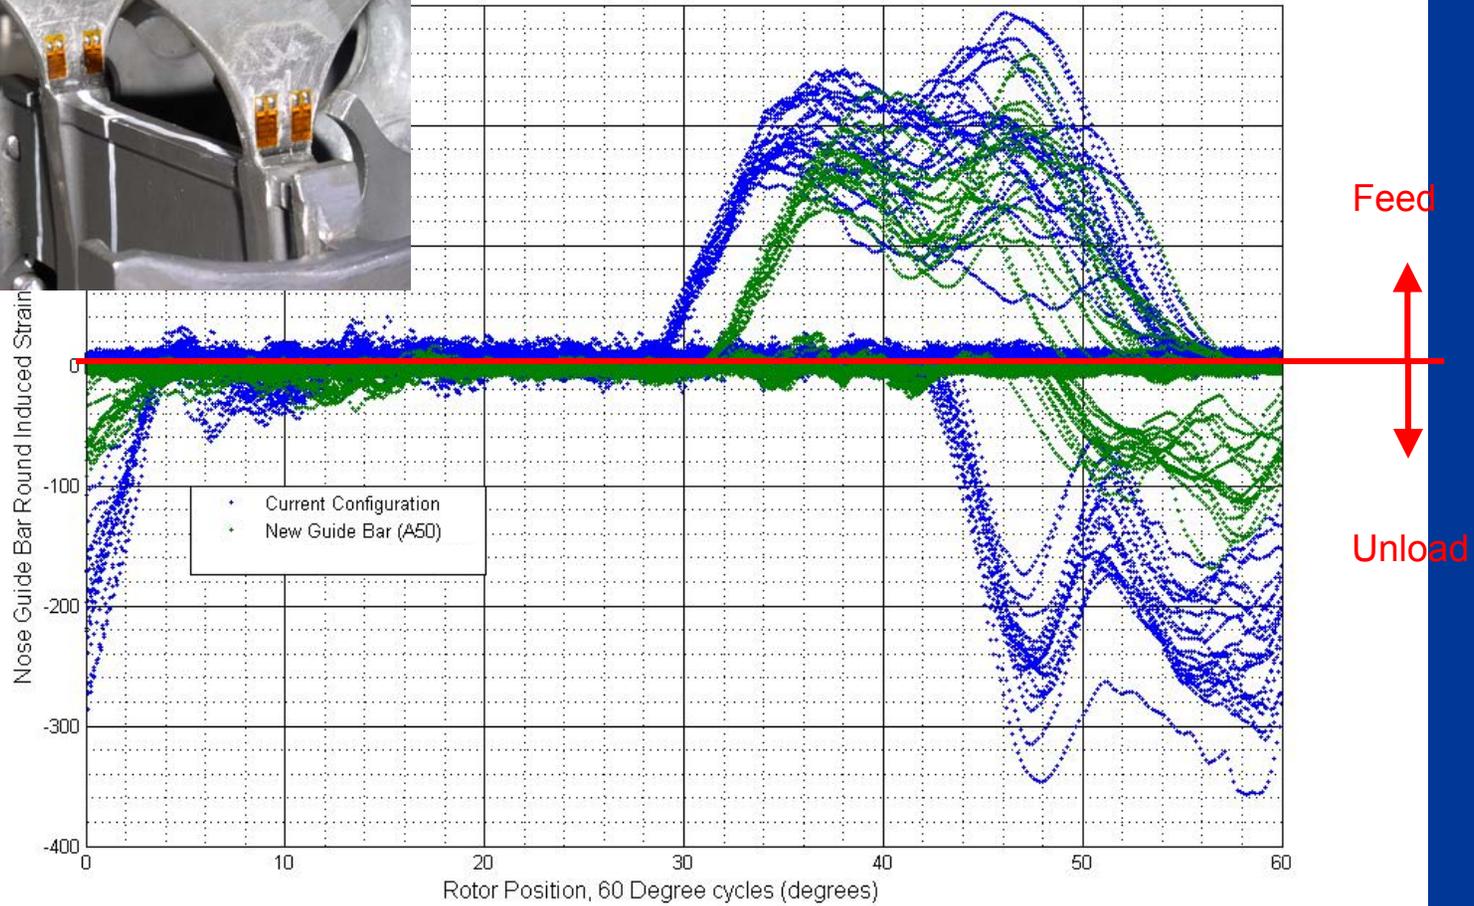
Mk 244 - 1 Skip 8 - Nose Guide Bar

- The instrumented gun system showed a small change in the behavior of the case due to the altered guide bar (initial contact between the case and the guide bar was slightly later, a good thing)
- When the modified case nose sprocket was included, the timing difference disappeared (initial contact time went back to original point, a bad thing)
