Channel Stability Problems, Pajaro River, Watsonville and Pajaro, California

U.S. Army Engineer Committee on Channel Stabilization Report of the 63rd Meeting

ERDC/CHL SR-00-3
CCS-00-1
August 2000

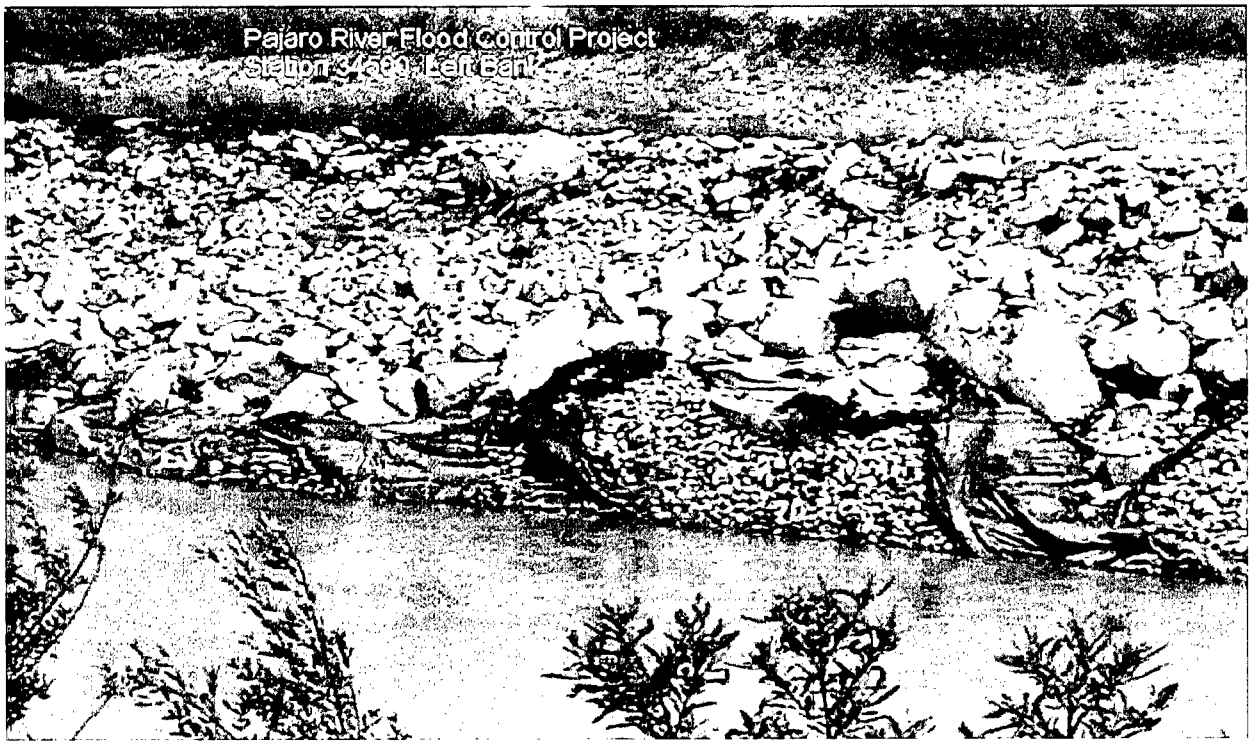
c. The locations where the banks have been stabilized are very steep. Also, the stone, although apparently well graded, is inconsistent in size. The erosion control mats have been installed incorrectly and/or have been applied to situations for which they were not intended (see Figure 6).

Figure 6. Incorrect installation of erosion control mats

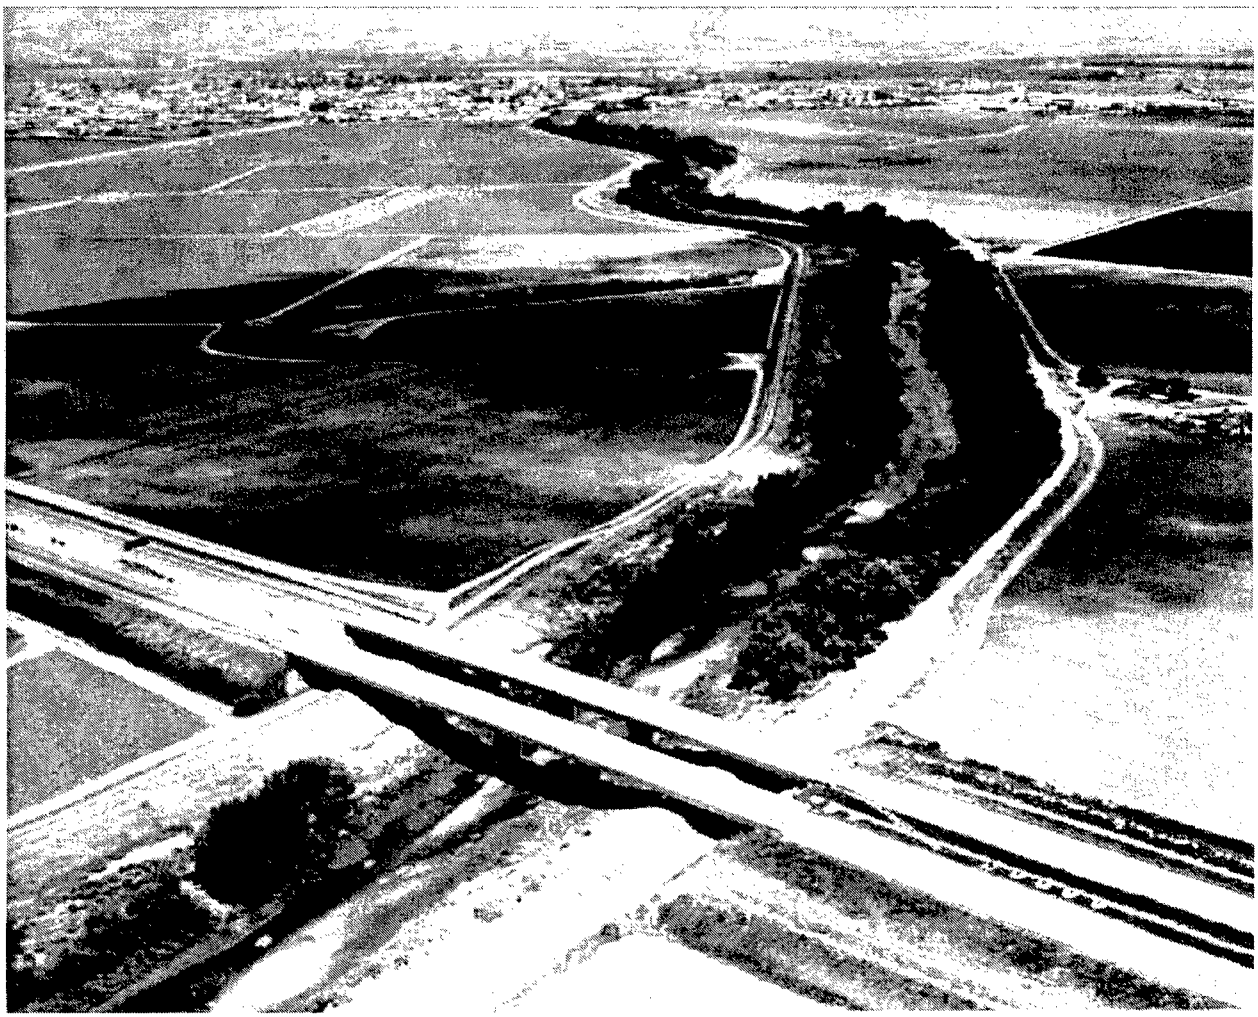
Plate 3
Aerial View of Project at Highway 1, June 1971

Plate 4
Upstream View of Project at Highway 1, May 1998

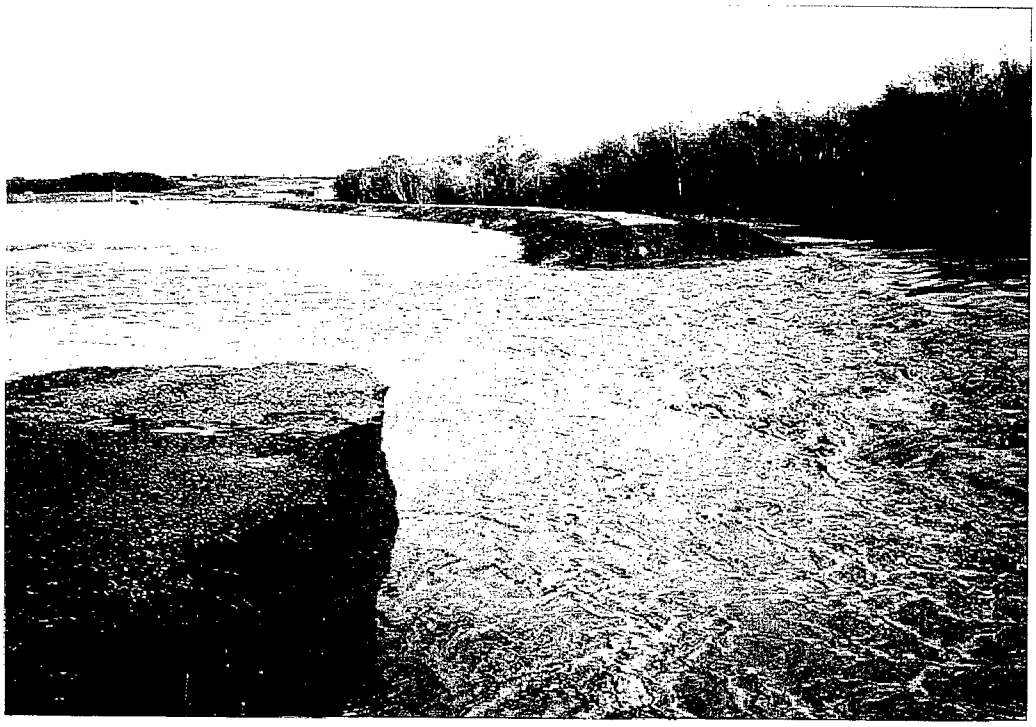
Plate 6
Site 1, Levee Breach and Repair Photographs
