Report 1855

RAPIDLY EMPLACED ANTIPERSONNEL OBSTACLE

May 1966

U. S. ARMY ENGINEER RESEARCH AND DEVELOPMENT LABORATORIES
FORT BELVOIR, VIRGINIA

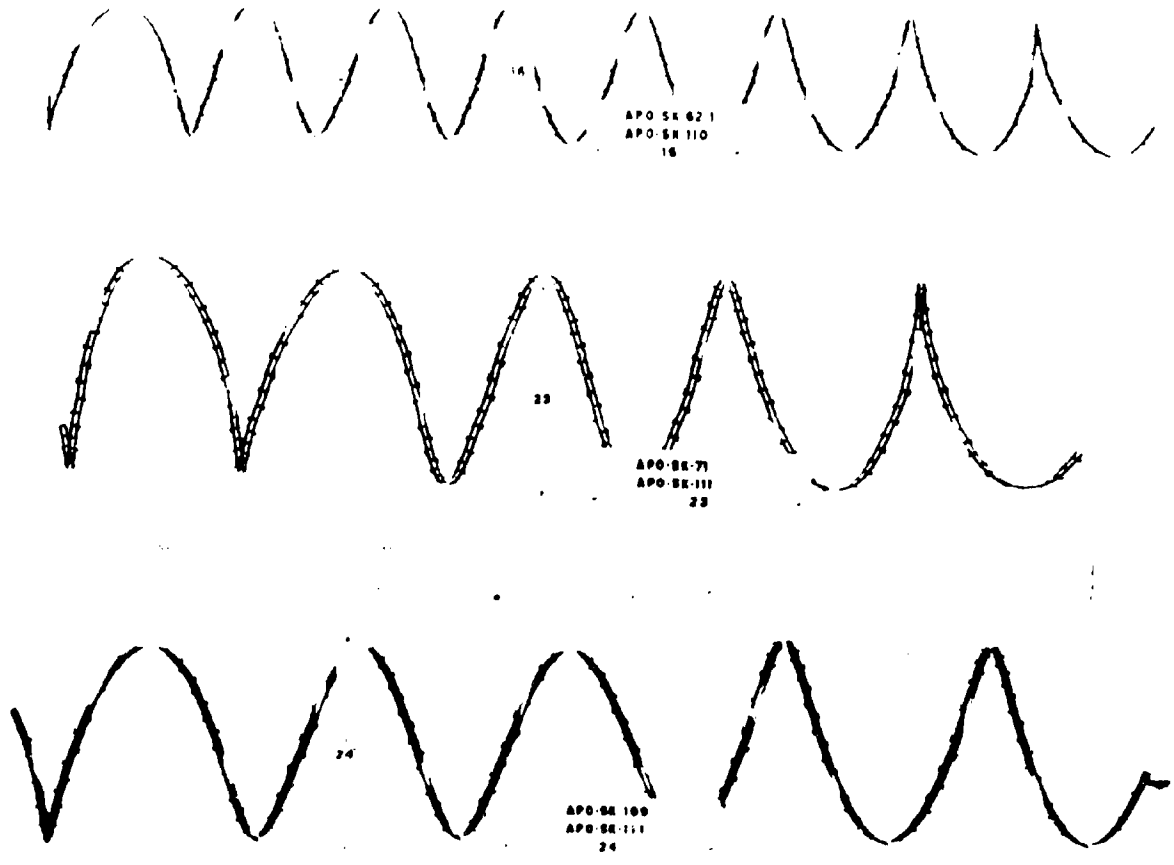
Fig. 4. The three tapes presented at 12 December 1962 In-Process Review. Each tape was judged to be effective.

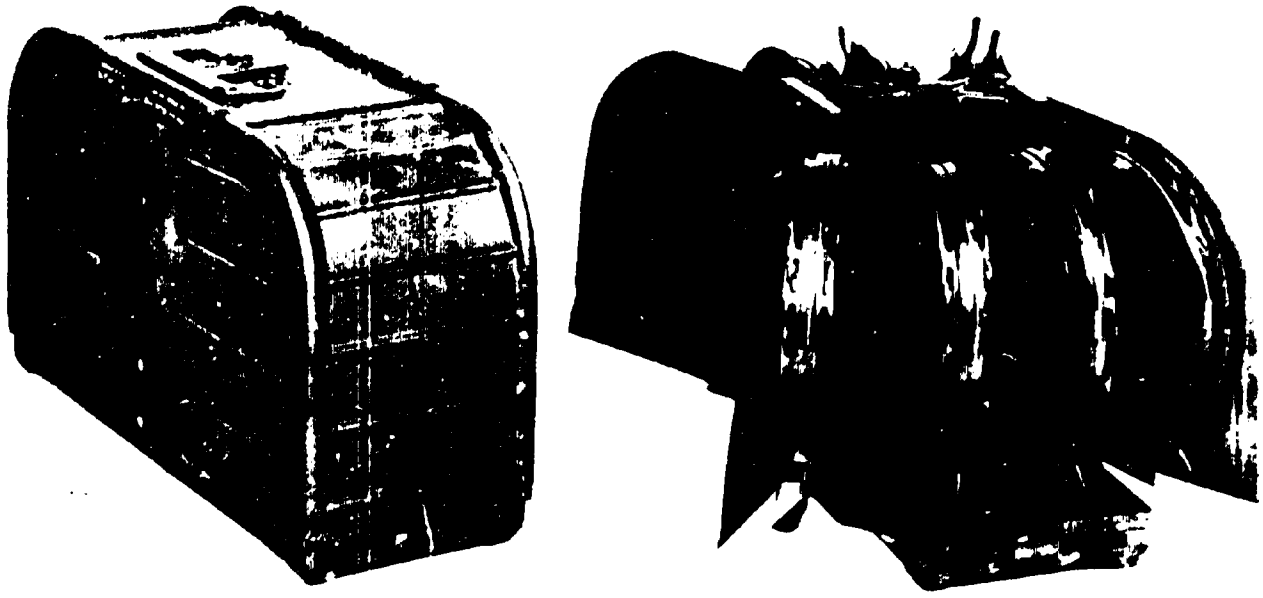
3. Description of Equipment. Eight reels of barbed tape, a release mechanism, and an actuator device, as shown in Fig. 6, are mounted on a base pan and packaged in a sheet metal container 19 inches long, $6\frac{1}{2}$ inches wide, and 10 inches high. The total weight of the obstacle unit is 31 pounds 4 ounces.

Fig. 6. Rapidly Emplaced Antipersonnel Obstacle completely assembled (left) and with top and end covers removed (right).

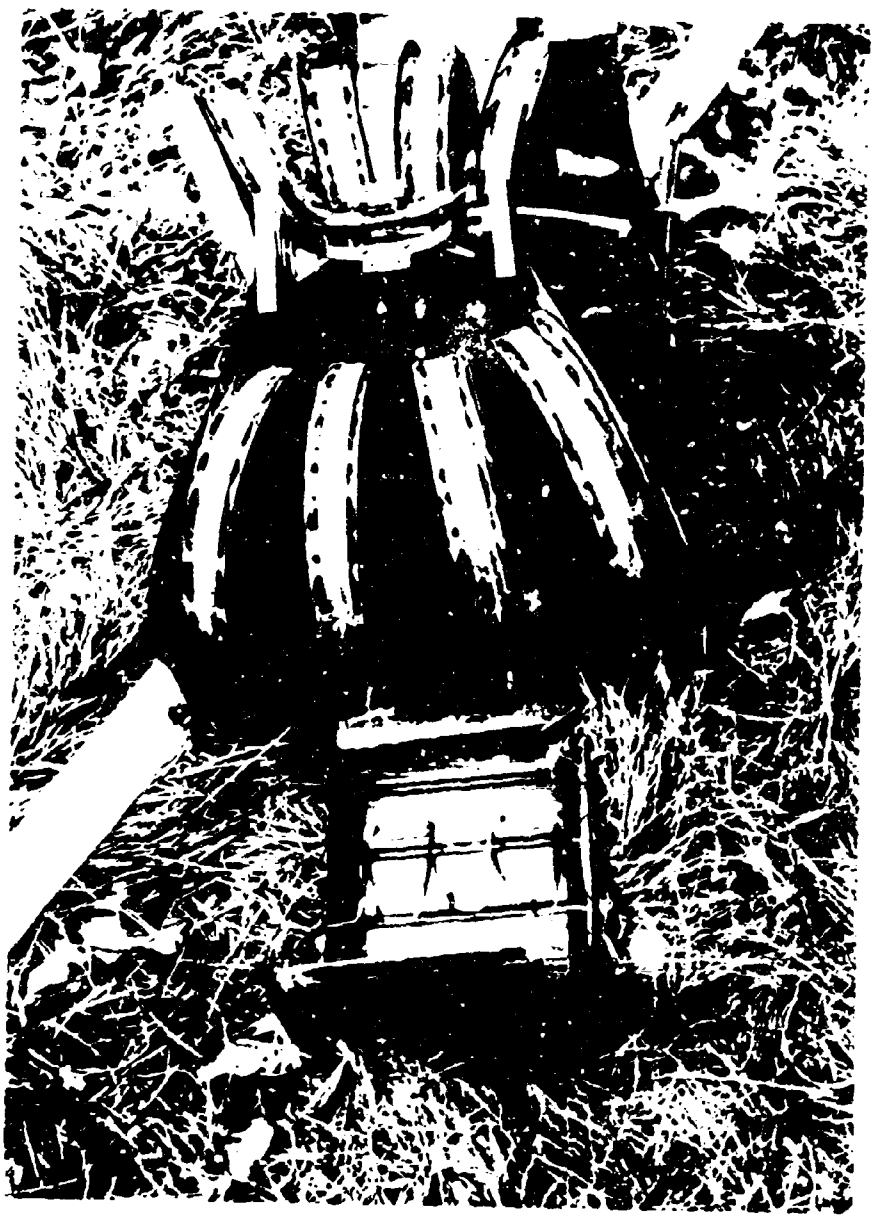
M12410

Fig. 16. Obstacle unit after salt spray and one week of weathering. Accumulation of salt on the reels had no effect on tape expansion.

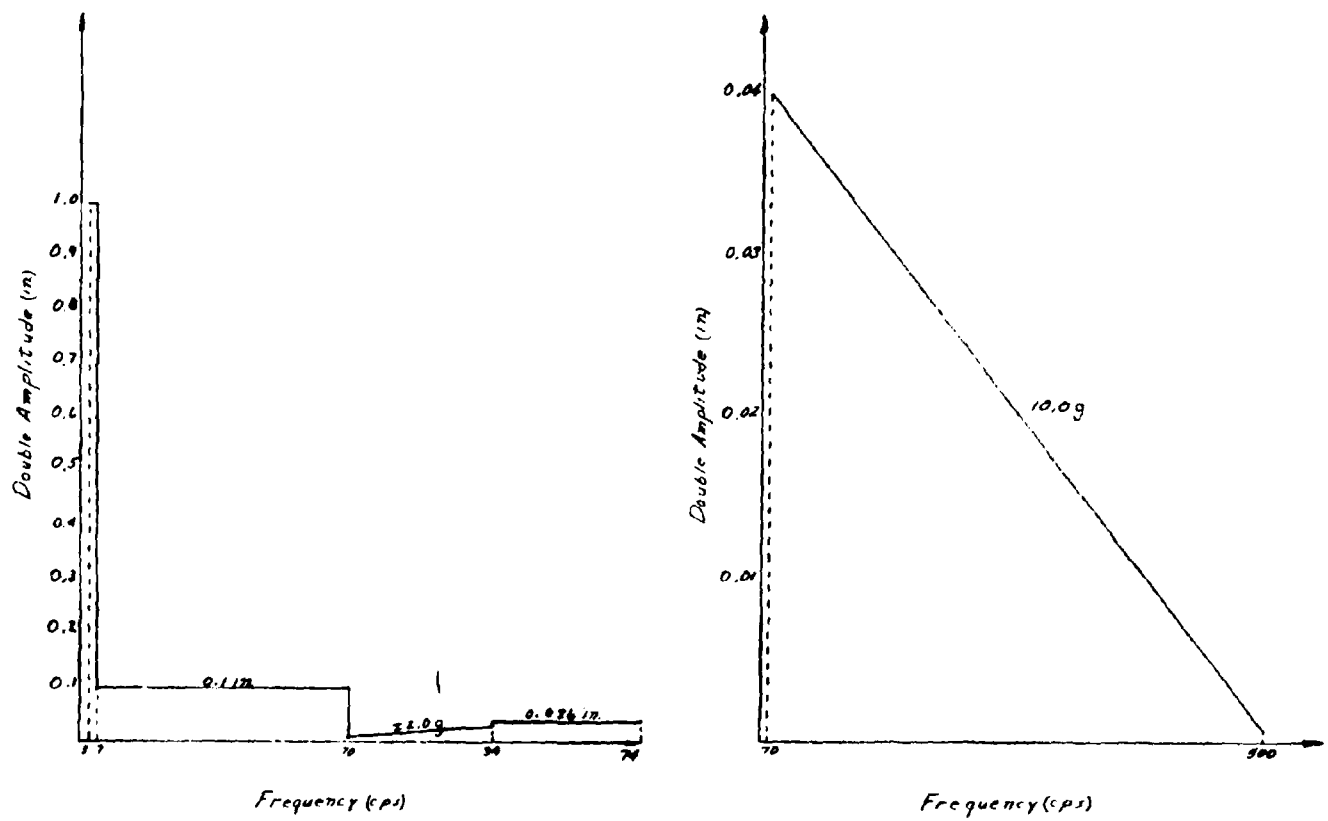
Fig. 18. Desired vibration curves.

vibration curves, shown in Fig. 18, could not be achieved because of the limitations of the vibration apparatus. The unit was actuated after the vibration was completed.

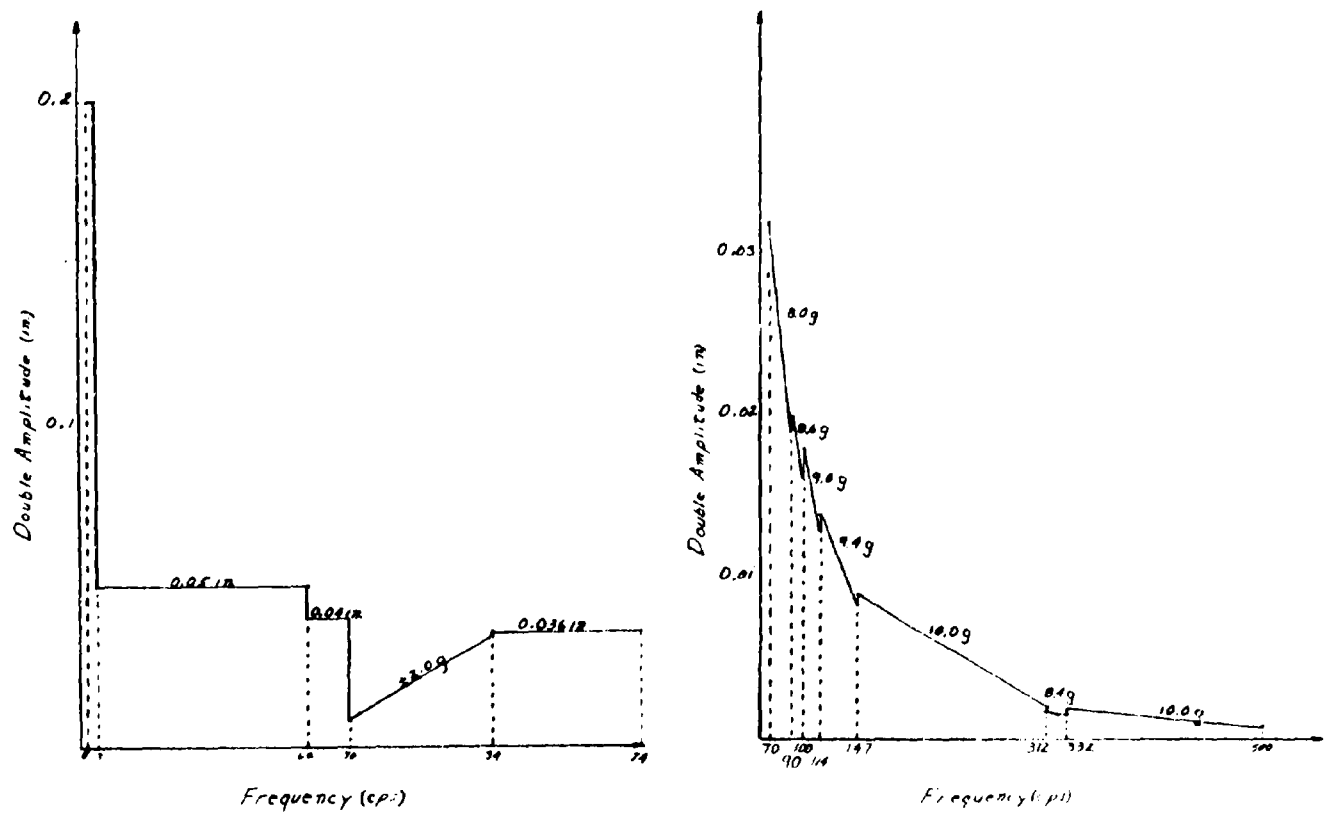
(a) X-Axis. The vibration achieved is shown in Fig. 19. No resonant frequency was detected, and no damage to the unit was evidenced.

Fig. 19. Vibration achieved along x-axis.

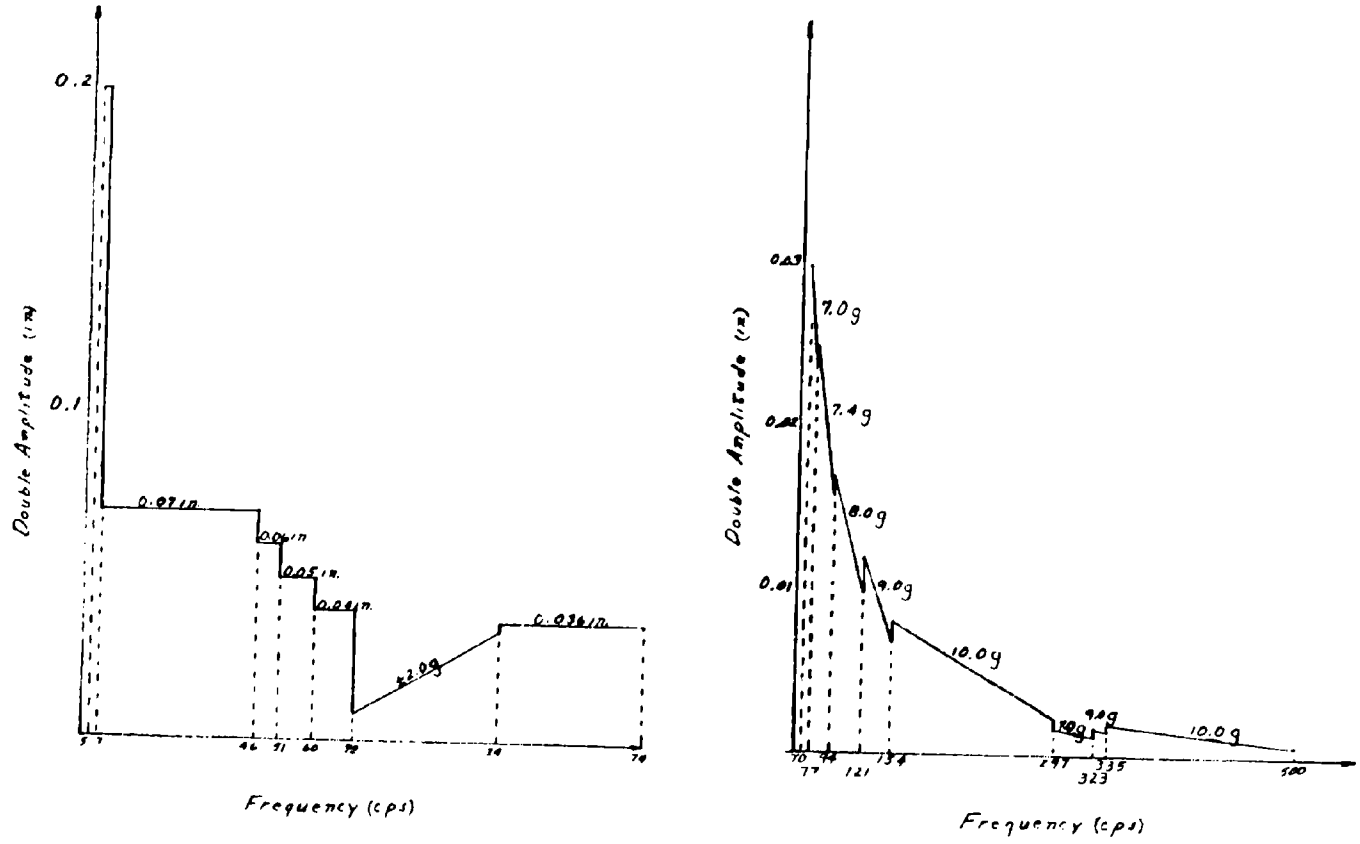
Fig. 20. Vibration achieved along y-axis.

(b) Y-Axis. The vibration achieved is shown in Fig. 20. Five resonant frequencies were detected. The results of 30 minutes dwell at each of these frequencies were as follows:

1. At 13 cycles per second at 0.07-inch double amplitude; no evidence of damage.

5. At 255 cycles per second with 10-g force; no evidence of damage.

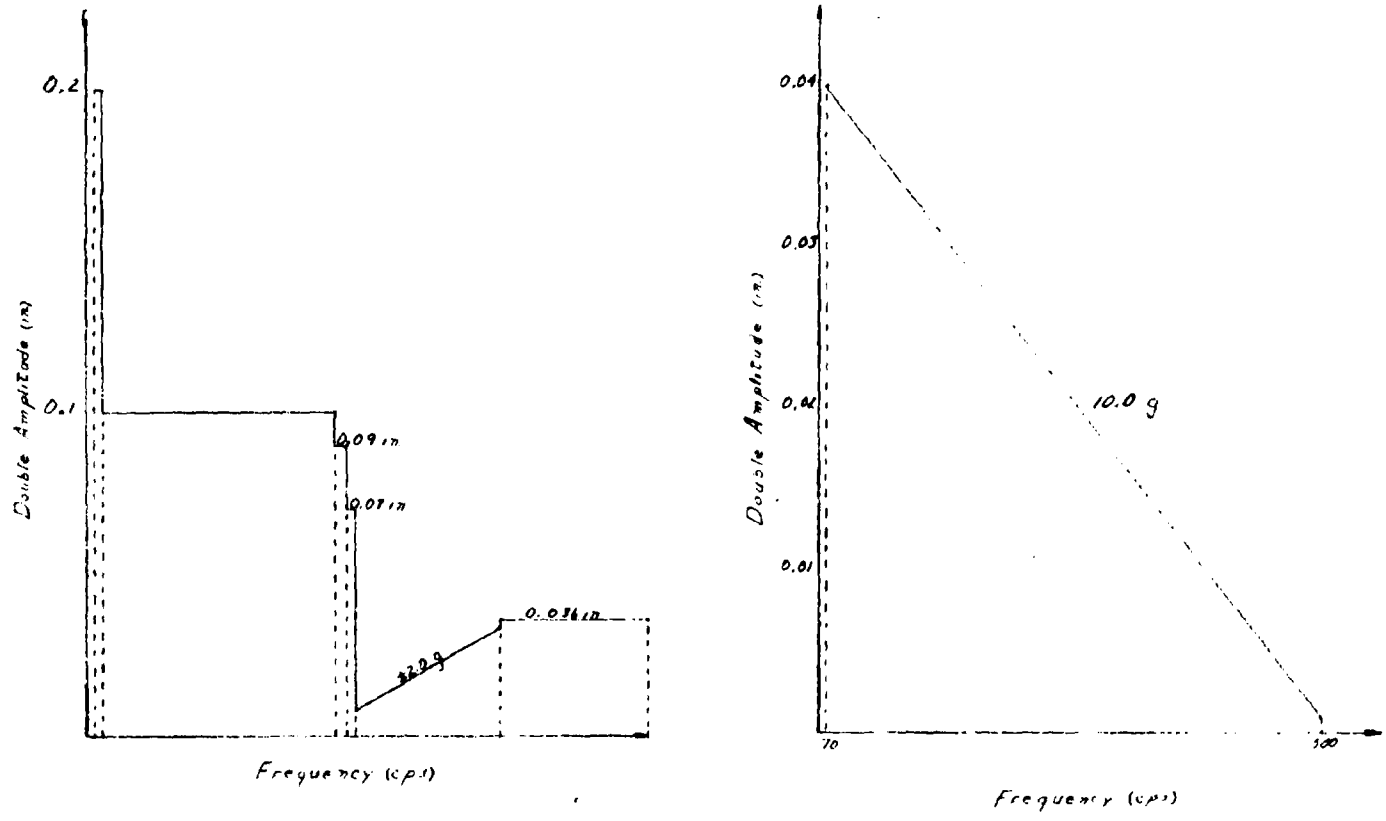
Fig. 21. Vibration achieved along z-axis.

(c) Z-Axis. The vibration achieved is shown in Fig. 21. Five resonant frequencies were detected. The results of 30 minutes dwell at each of these frequencies were as follows:

1. At 53 cycles per second with 0.1-inch double amplitude; no additional damage to the unit was evidenced.

2. At 61 cycles per second with 0.036-inch double amplitude; no additional damage to the unit was evidenced.

3. At 275 cycles per second at 10-g force; no additional damage to the unit was evidenced.
