USATRECOM TECHNICAL REPORT 65-6

CRASHWORTHINESS EVALUATION OF AN ENERGY-ABSORPTION EXPERIMENTAL TROOP SEAT CONCEPT

February 1965

U. S. ARMY TRANSPORTATION RESEARCH COMMAND
FORT EUSTIS, VIRGINIA

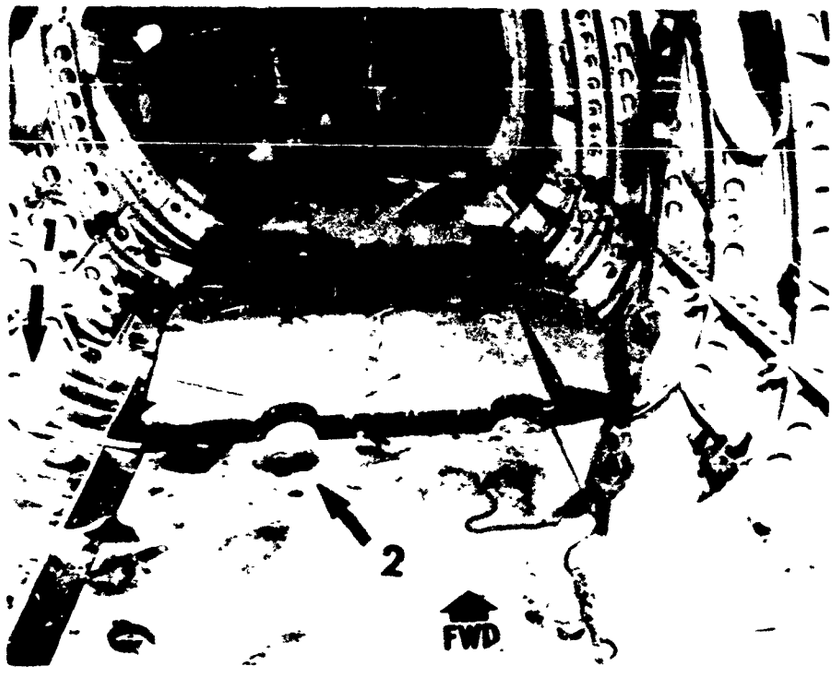
Figure 11. Passenger Compartment, Rear. (Apparatus used in internal experiments have been removed. Arrow 1 shows the buckling of fuselage frames. Arrow 2 shows location of experimental seat floor mount.)

A careful look at the wall of the passenger compartment (see Figures 11 and 12) revealed why the strut rotated through a 60-degree angle. The lower 17 inches of the fuselage was flattened parallel to the floor. As may be noted in Figure 14, which is a postcrash photograph showing the attachment of the seat to the lower support tube, there is no evidence of failure in the seat-to-support-tube area of the seat. The energy-absorbing strut had compressed through only 7 of its 12 inches of effective travel at the time the seat contacted the floor.

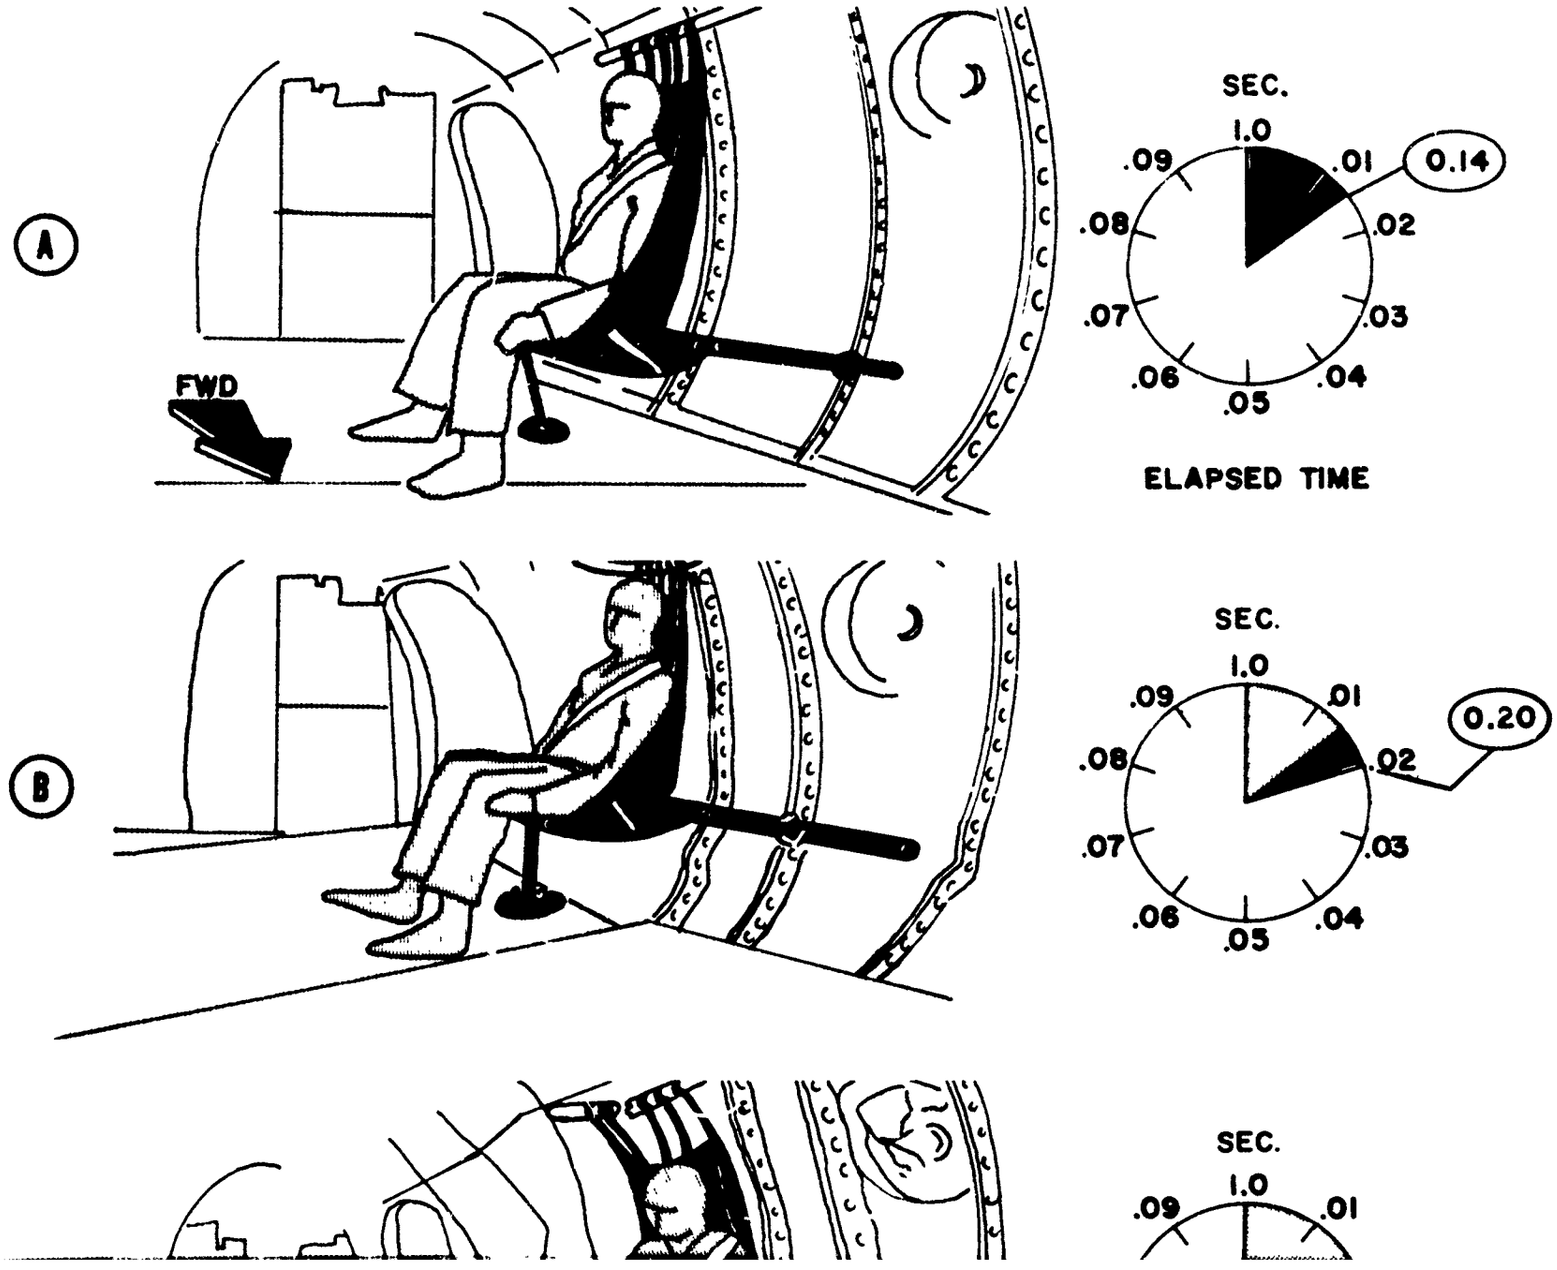
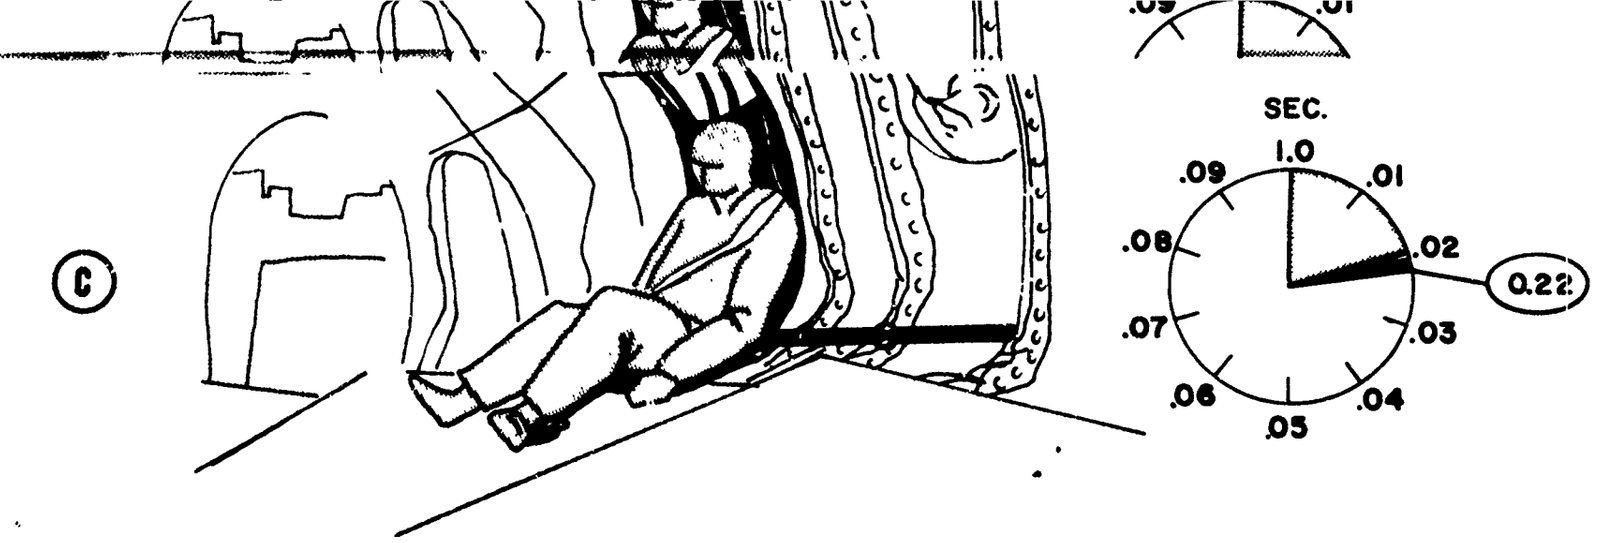
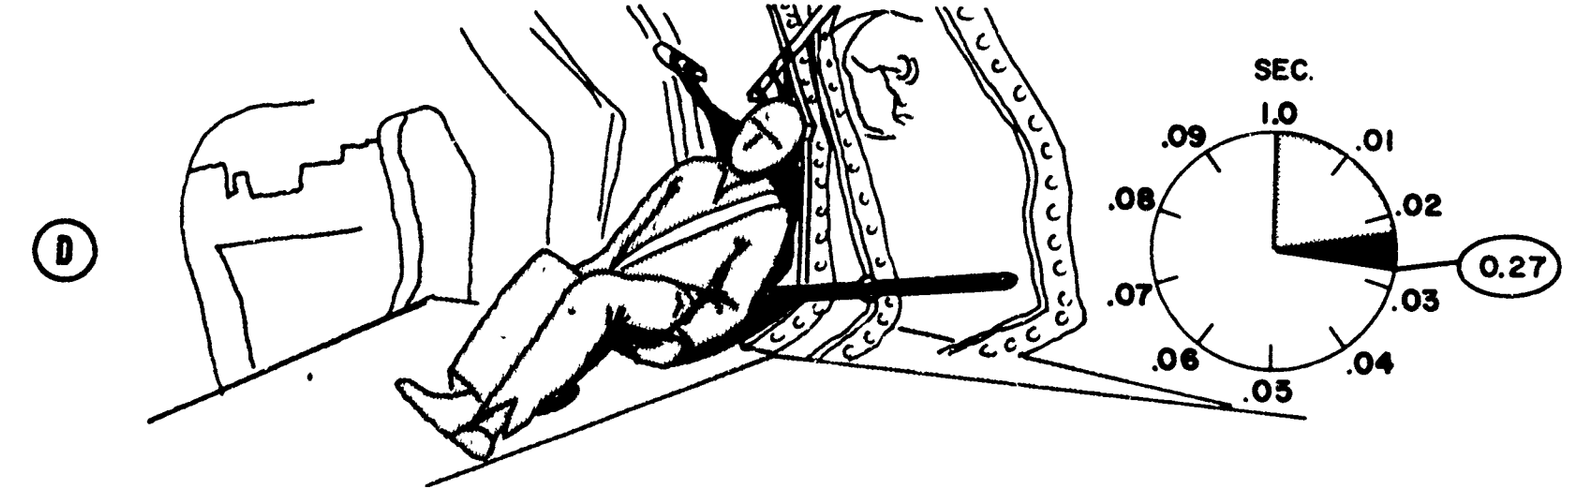
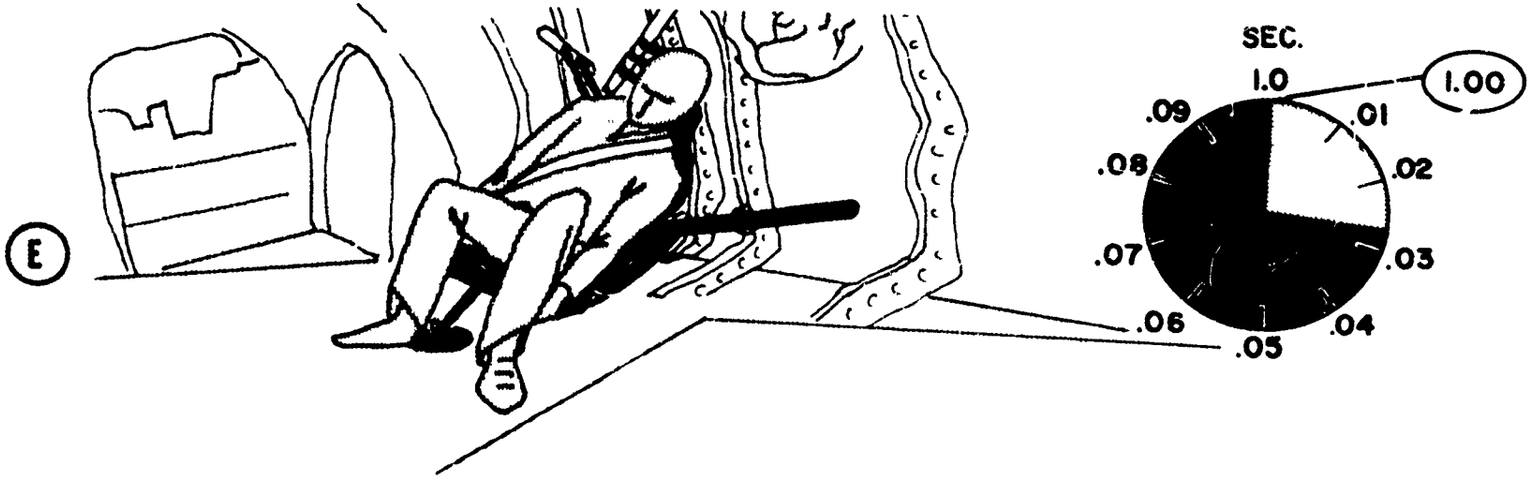
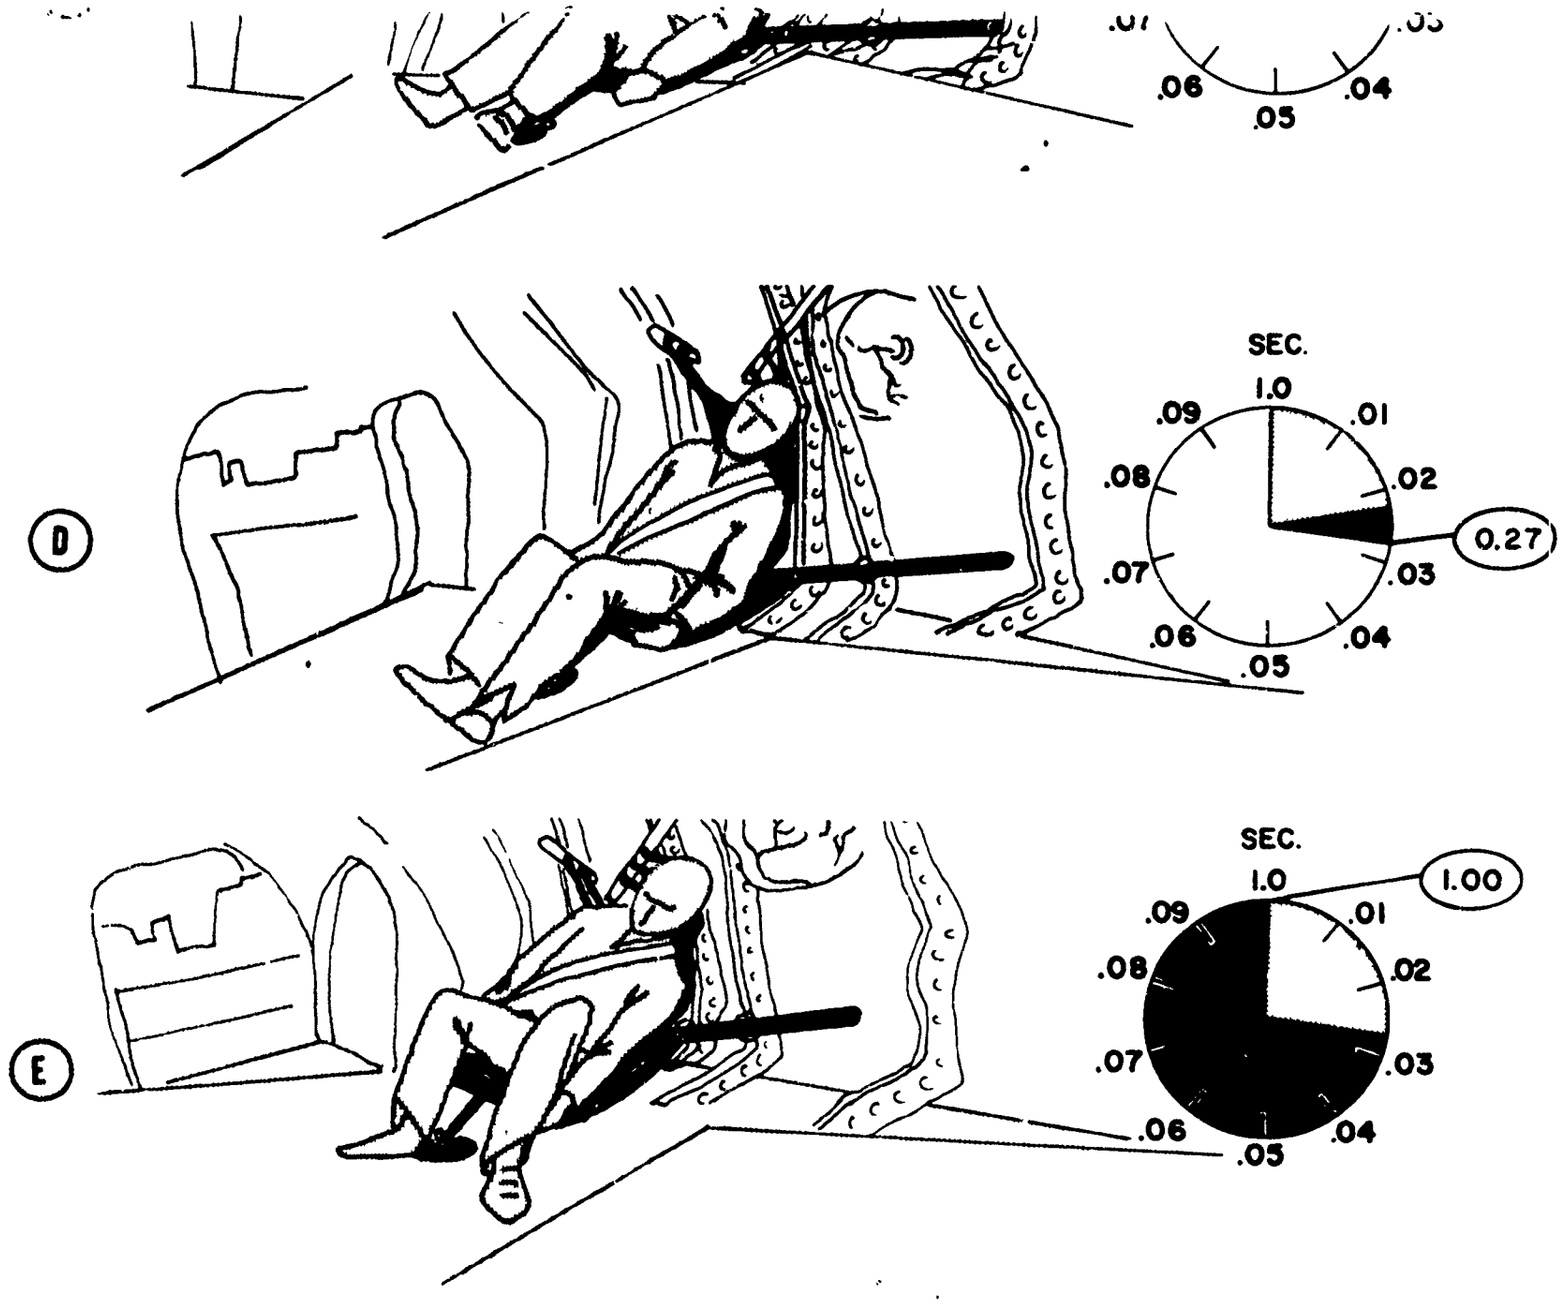
Figure 18. Kinematic Sketch of Seat 1 and Dummy During Crash Impact Sequence, T-7.

1. Figure 18A shows the seat after the helicopter has made ground contact but before significant forces have been sensed by the dummy.

2. Figure 18B shows the seat beginning to function while the support structure is still intact. The energy-absorbing strut is peeling. The bulkheads are beginning to collapse, and the upper support tube is bowing, since the casting has sheared from the wall.

3. Figure 18C shows that the upper support tube has failed and that the bulkhead has collapsed sufficiently to allow the seat to contact the floor.

4. Figure 18D shows that the dummy has fallen to the left sufficiently to allow head contact with the fuselage frame.

5. Figure 18E shows the seat and dummy in the final position.

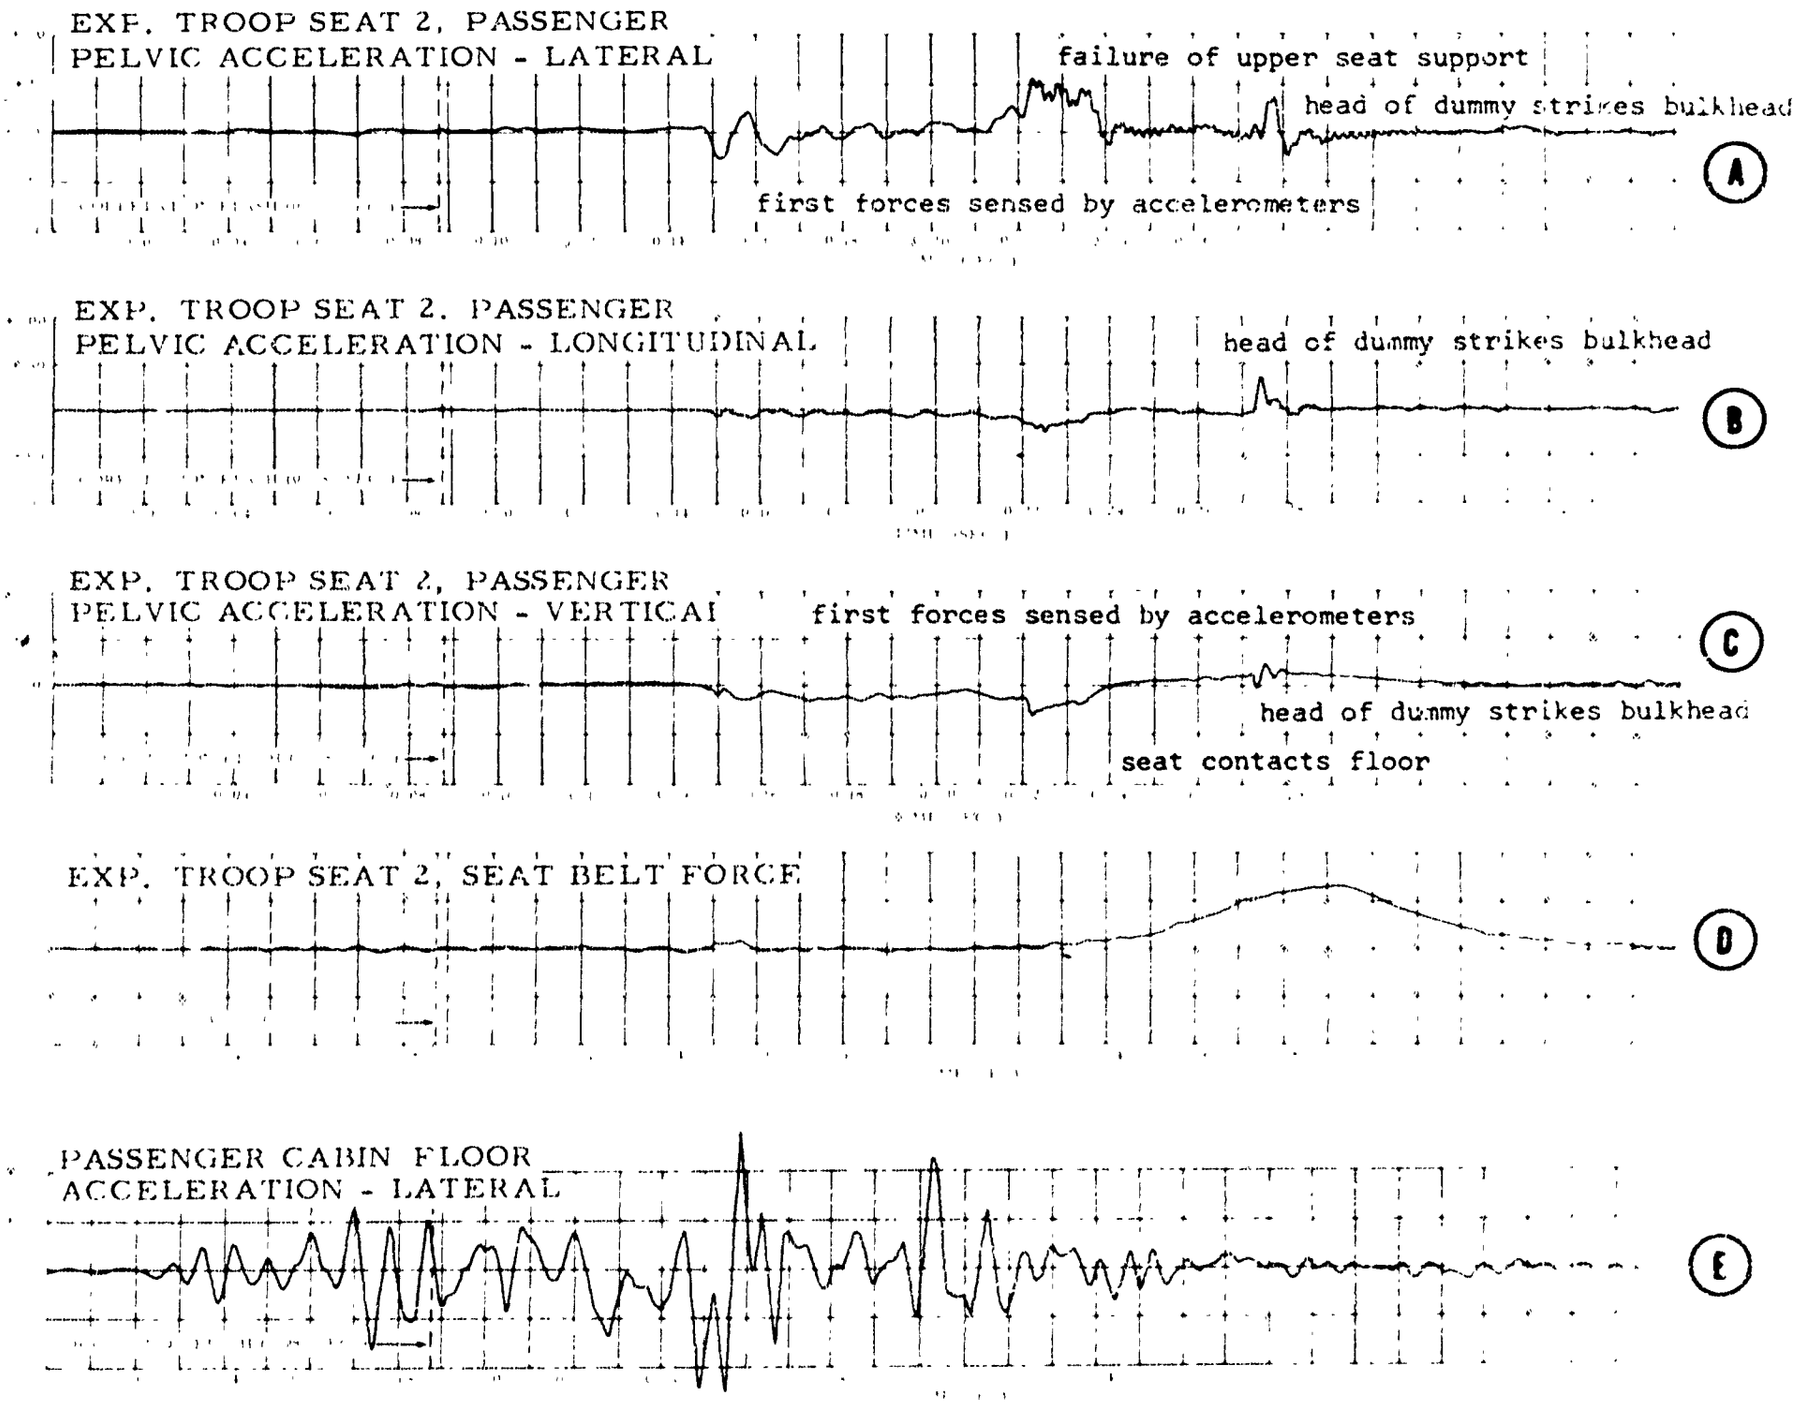
Figure 19. Accelerometer-Time and Force-Time Histories, Seat 1, During H-21 Helicopter Crash Test T-7.

The vertical trace (Figure 19C) showed a fairly steady 8G to 12G deceleration as the energy-absorbing strut deformed over its die, beginning at 0.148 second. This deceleration continued to 0.220 second, at which time two events occurred: first, the upper support failed, allowing the dummy to bottom out on the aluminum seat pan; second, the floor and the seat pan made contact. The peak pulse as the dummy contacted the seat pan was 28G at approximately 0.223 second. The total duration of the pulse was approximately 0.092 second. The peak vertical floor acceleration was approximately 175G at 0.147 second.

The longitudinal trace (Figure 19B) (lateral with respect to the dummy) showed a 2G to 5G deceleration up to 0.220 second and then increased for a short period to approximately 25G. This closely approximates the deceleration rate of the helicopter as a whole and indicates minimum movement of the dummy with respect to the aircraft in this plane.

The lateral trace (Figure 19A) (longitudinal with respect to the dummy) showed a 10G negative peak as the helicopter's ground contact was first felt, damping out sinusoidally until 0.214 second, when the upper support tube began to bow.

At 0.220 second, the upper support tube failed; this failure eliminated the restraint value of the nylon seat back. The seat belt and chest strap were still attached, which restricted the dummy's side movement but allowed the dummy to fall backward toward the left, against the fuselage wall. The failure of the tube is also distinguished by peak readings on the longitudinal and vertical traces. In the longitudinal direction, the G rise was due to the slack's being taken up in the chest strap as the dummy leaned to the left. The vertical peak, though partially caused by bottoming out on the aluminum seat pan, was primarily due to contact between the seat pan and the honeycomb floor.

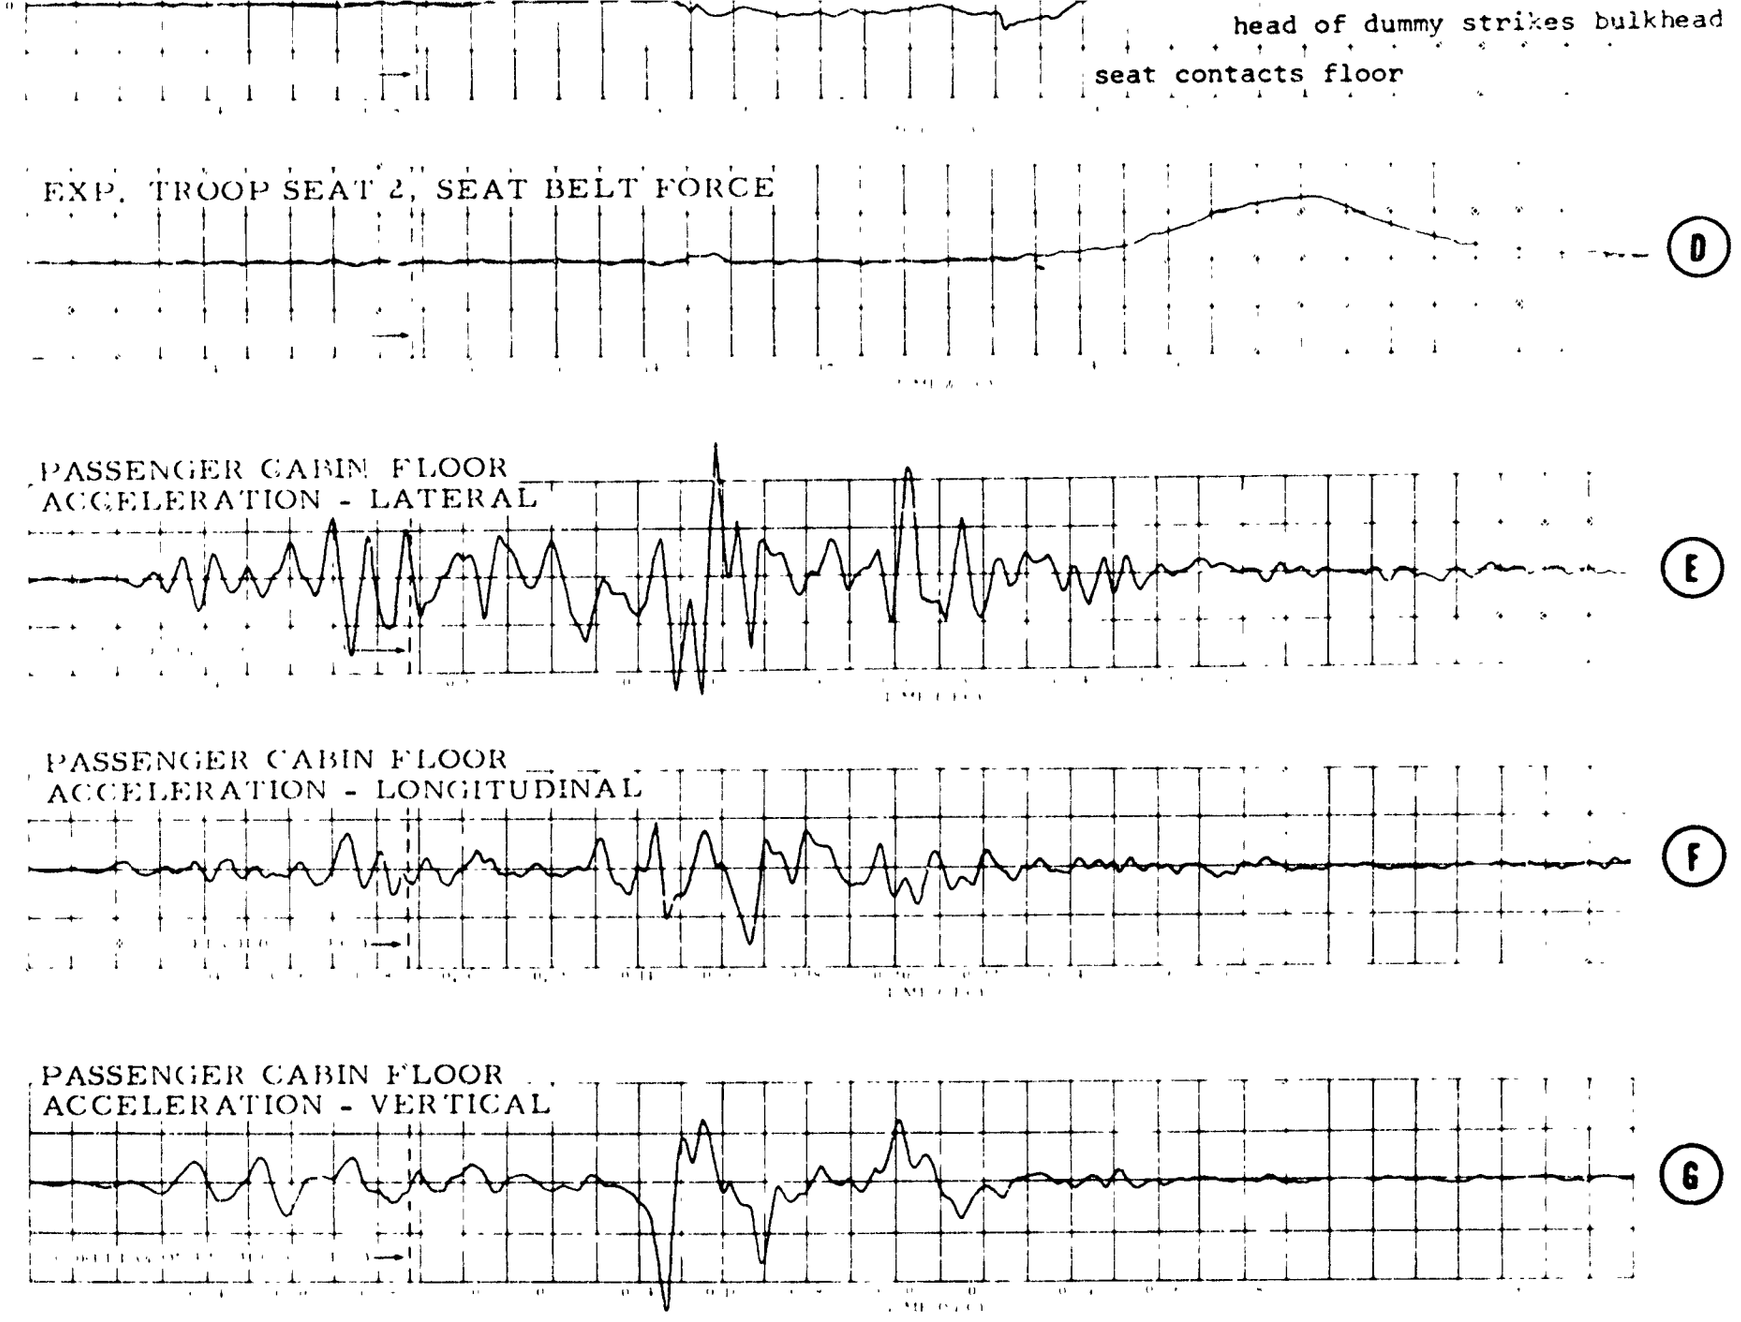
The restraint belt force showed a small spurt up to 100 pounds at 0.148 second, the instant when the accelerometers first indicated the results of the crash. The load dissipated as the dummy was driven down into the seat until the support failed at 0.220 second. From this time on, the force rose to a peak of 700 pounds as the dummy leaned to the left, stressing the chest strap.

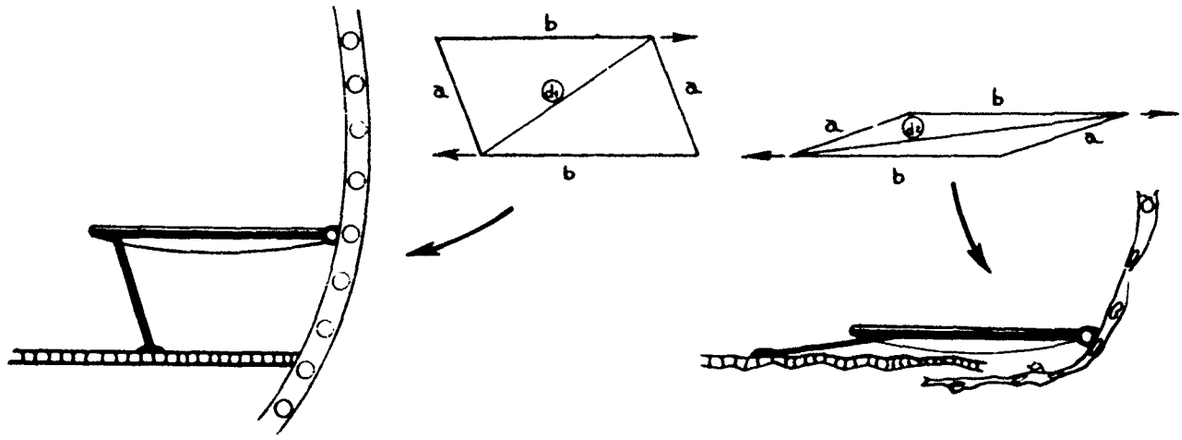
The evidence of the previous two paragraphs led to the conclusion that the seat itself did not collapse when the upper support failed. The sharp impact when the seat and floor contacted was due to failure of aircraft basic structure rather than failure of the seat. The impact was the result of an action analogous to pulling the opposite corners of a parallelogram as shown in Figure 20.

Figure 20. Relation of Seat Collapse to Aircraft Structure Failure.

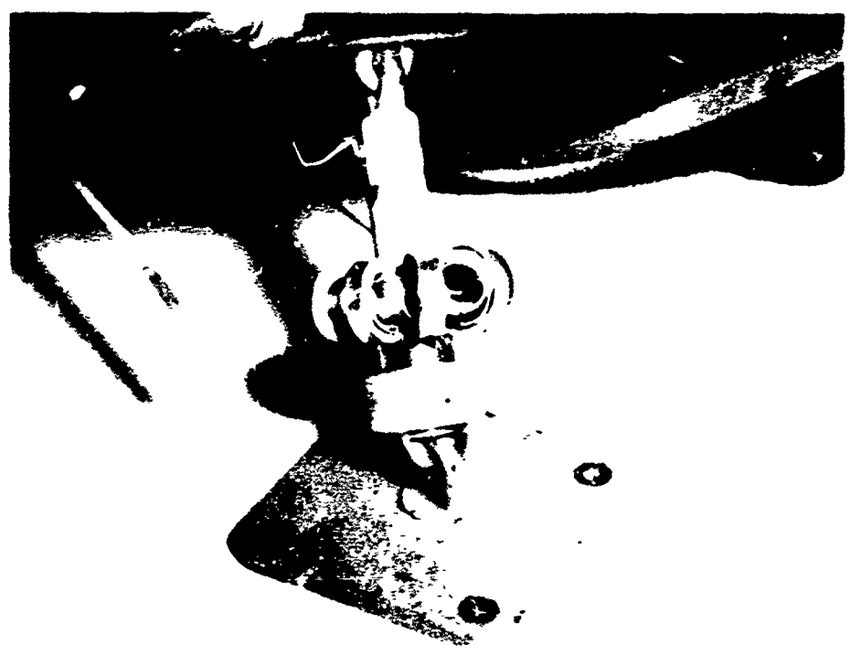
Figure 32. Closeup View of Energy-Absorbing Strut After Impact.

The high-speed pictures taken on board the aircraft indicate that after the energy-absorbing strut had deformed through its maximum stroke, the seat mounting hinge failed at the wall. Figures 33 and 34 are detail postcrash views of the seat and wall portions of the hinge.

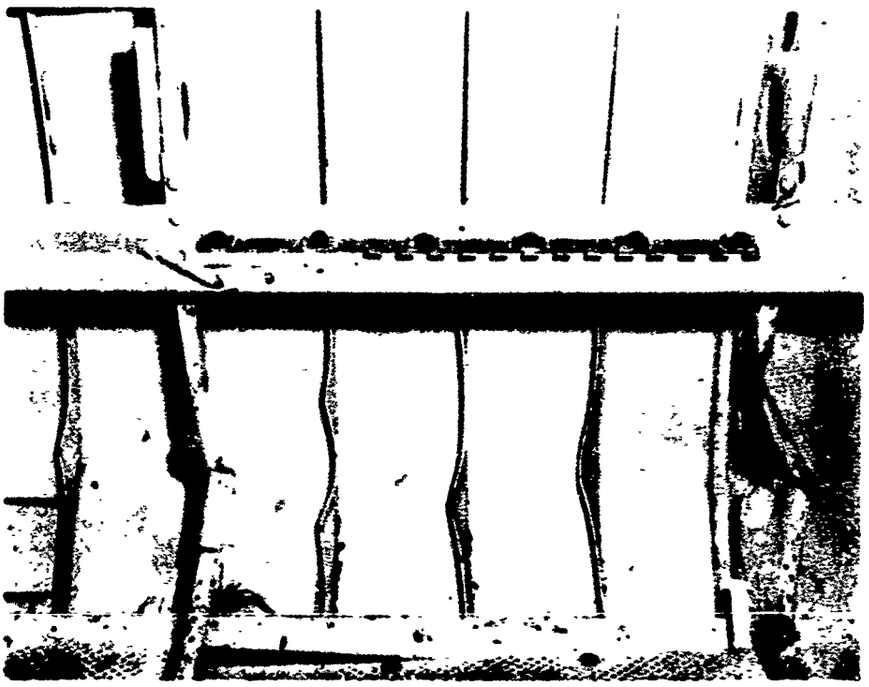
Figure 34. Postcrash View of Portion of Hinge Connection Remaining Attached to Wall.

The problem of the hinge shearing from the wall can be solved by using a stronger hinge. The other malfunction in the seat, i.e., the failure of the seat pan to remain parallel to the floor, is also a relatively simple problem.

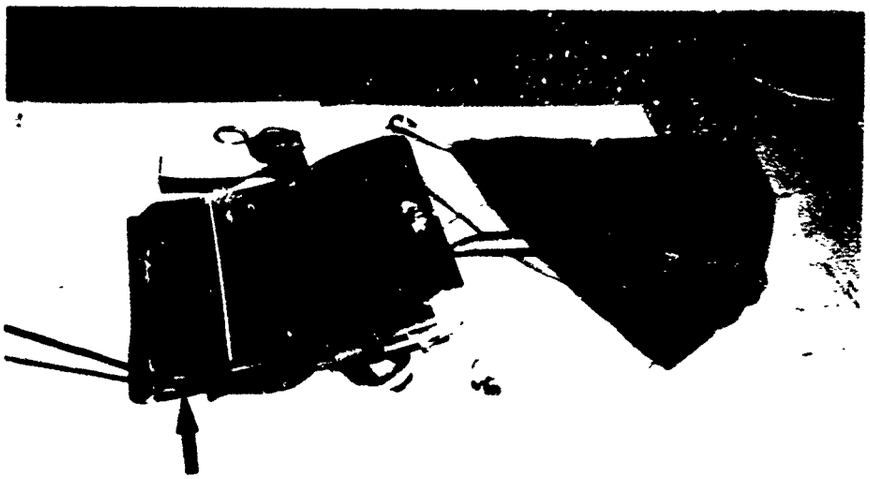
The seat pan was intact after the crash; however, extensive cracking of the fiber glass skin was evidence of the high stresses on the seat during the crash sequence. The designed "weak line", shown by the white line in Figure 36, showed no evidence of failure. The following series of photographs shows the effect of the crash forces on the seat pan. All of these photographs were taken after the seat had been removed from the test vehicle.

Figure 35. View of Right Side of Seat Pan. (White line indicates "weakened" portion of seat pan. Arrow indicates crack in fiber glass cover of seat pan.)

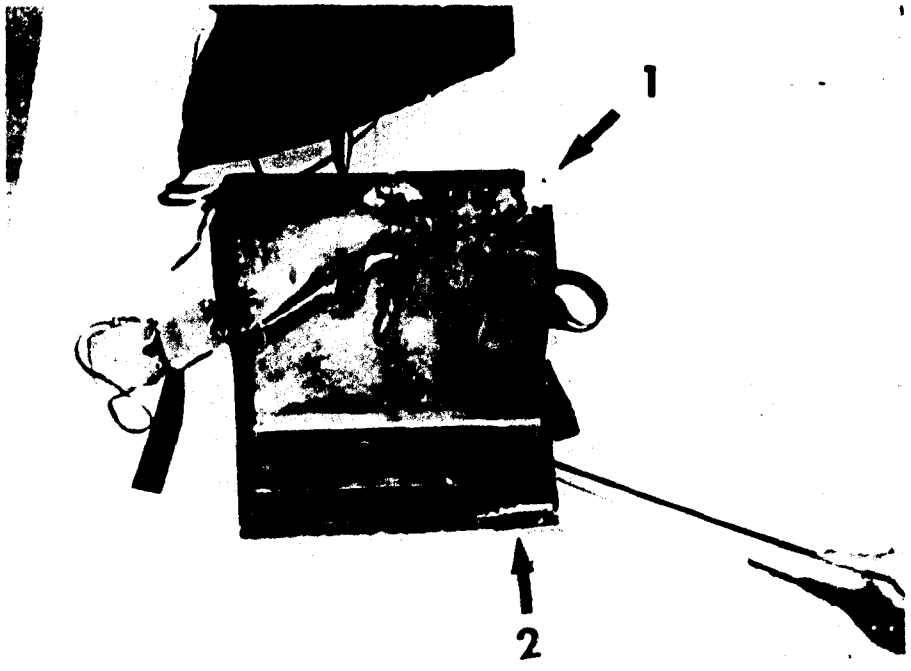
Along the line of the hinge connection, the right-hand 4 inches of the seat pan showed shattered fiber glass. There was evident cracking of the paint along the remainder of the hinge connection.

Figure 38. Top View of Seat Pan. (Pointer indicates "weak line". Arrow 2 shows shattered fiber glass at right side of hinge connection. Arrow 1 shows failed seat pan retainer.)

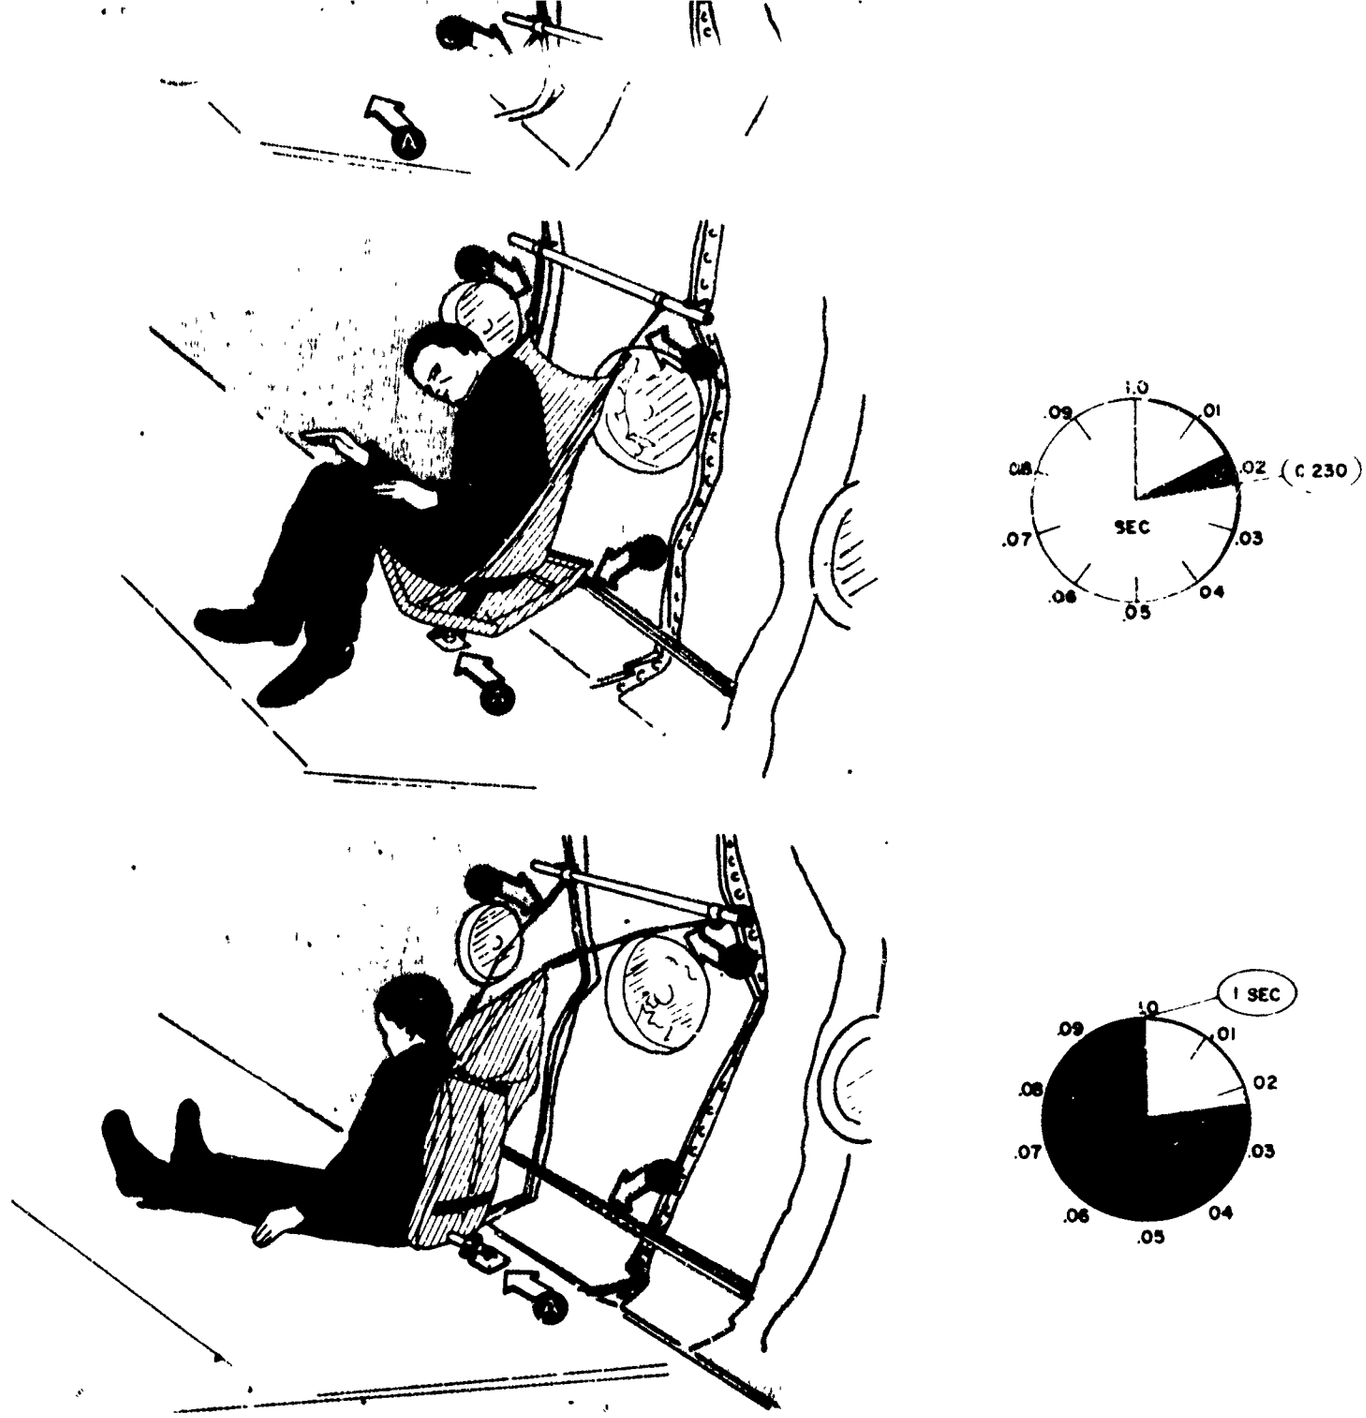
Figure 41. Kinematic Sketch of Seat 2 and Dummy During Crash Impact Sequence, T-9. Arrows A show the kinematics of the energy-absorbing strut; Arrows B show the kinematics of the energy-absorbing device in the upper supports; Arrows C show the sheared seat mounting hinge.

A kinematic sketch of the impact showing the behavior of the seat and dummy is presented as Figure 41. Significant occurrences during the crash sequence are shown along with the times at which these events occurred from initial impact. The times shown are also related to the accelerometer-time and force-time histories included and discussed later in this chapter.

The significant occurrences during the crash sequence, shown graphically on the kinematic sketch, Figure 41, are indicated by arrows on the accelerometer-time and force-time histories, Figure 42.

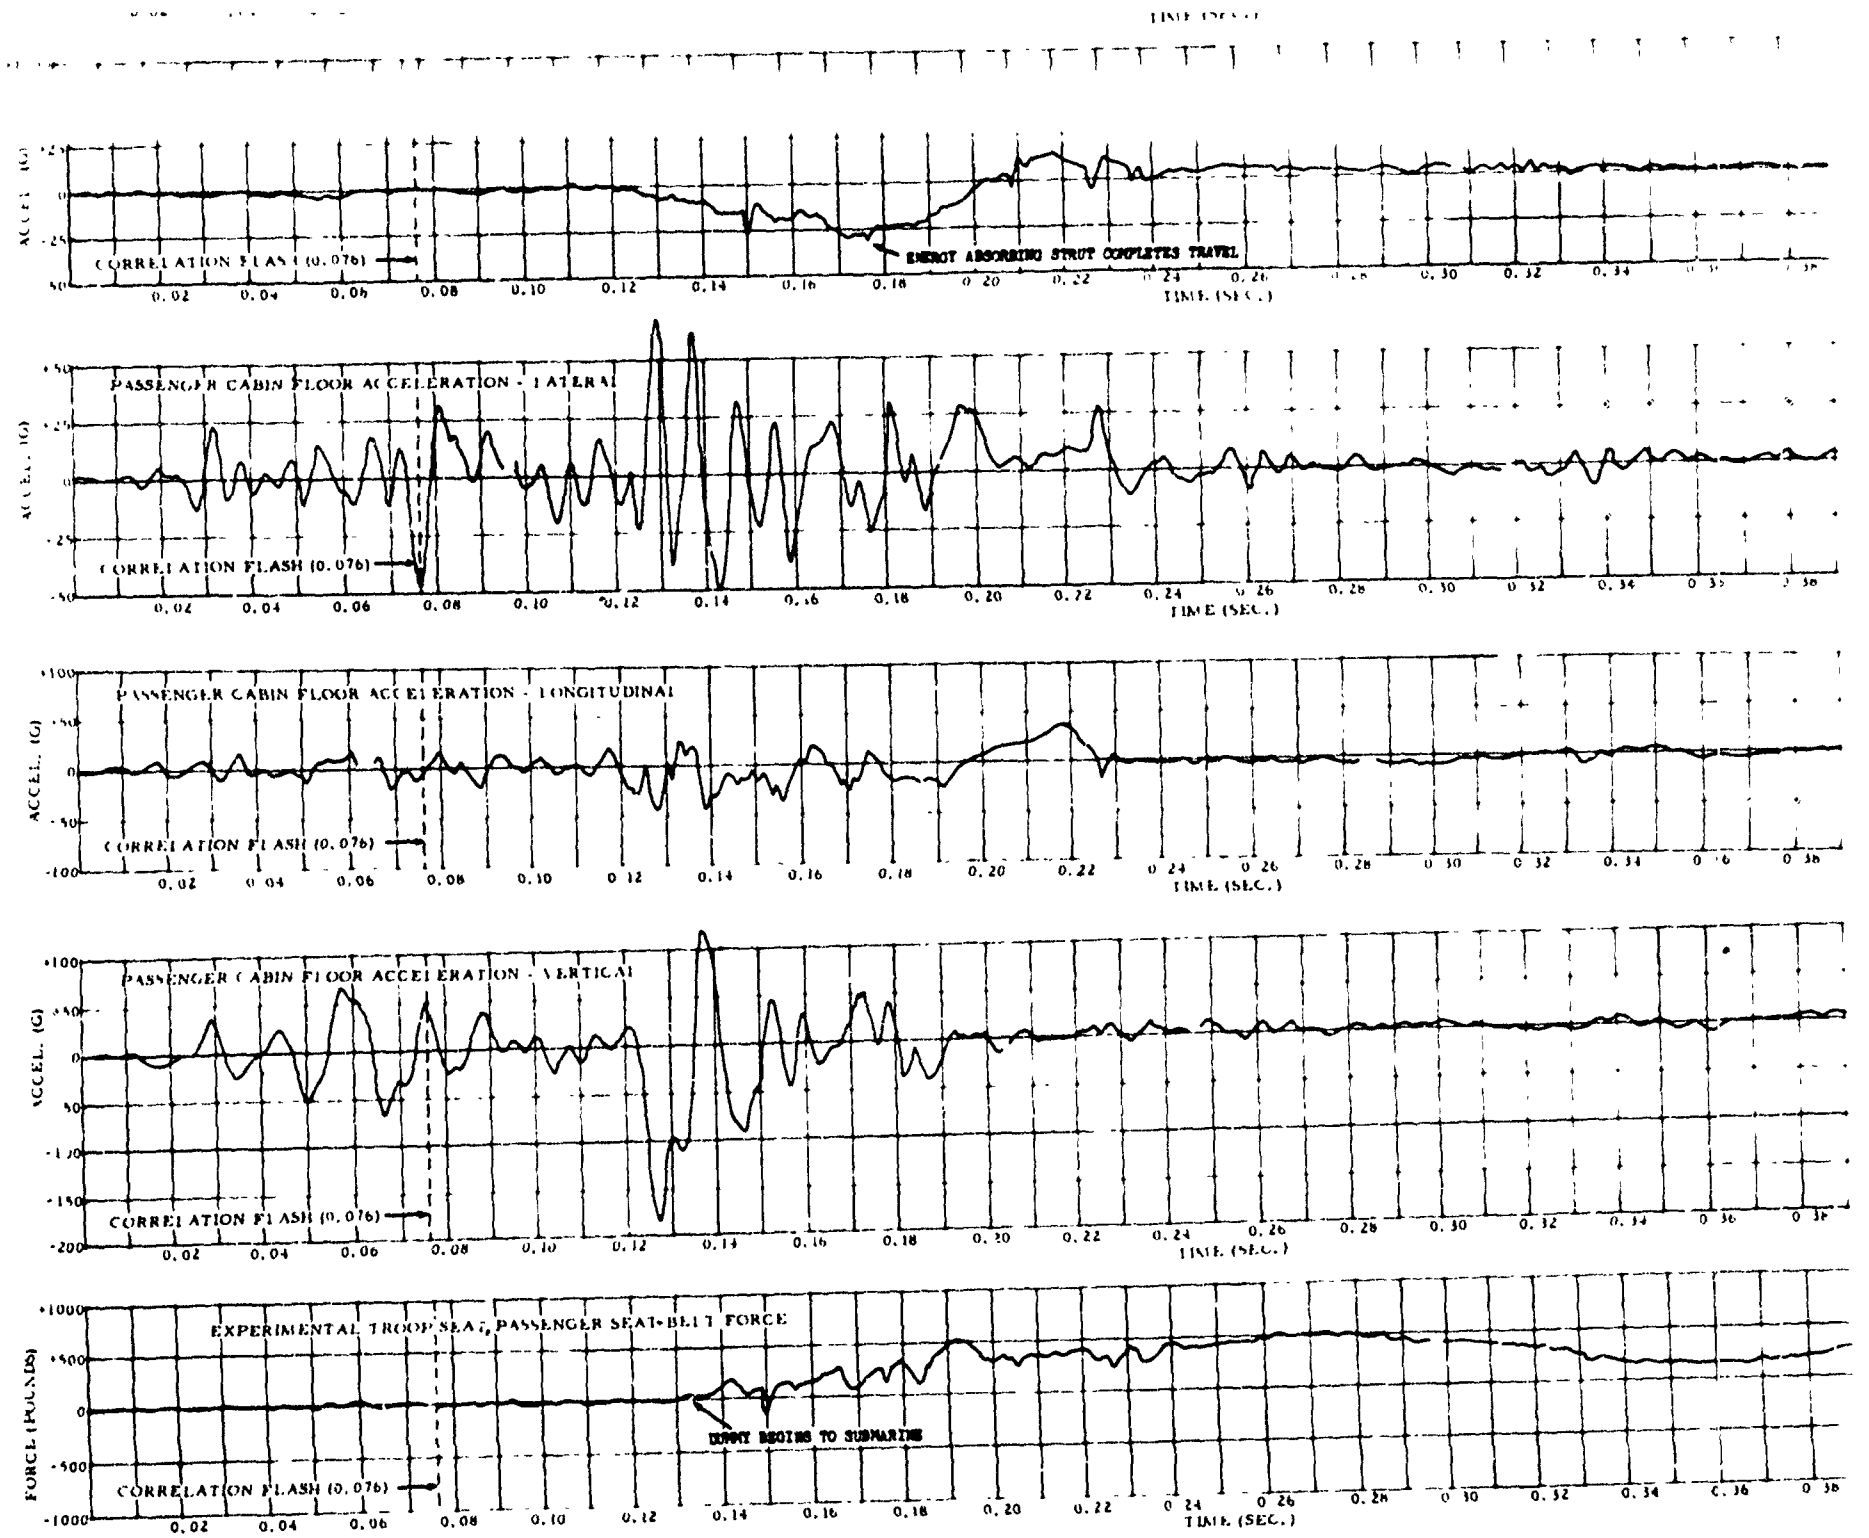
Figure 42. Accelerometer-Time and Force-Time Histories, Seat 2, During CH-21 Helicopter Crash Test T-9.

The seat belt force built up almost linearly to a maximum of 500 pounds from t = 0.13 second to t = 0.19 second as the depressing of the energy-absorbing strut allowed the dummy to shift toward the front of the seat. The seat-belt load remained at 400 to 500 pounds until the dummy contacted the floor after the seat hinge sheared from the wall. The seat-

belt load force reduced slightly to between 200 and 300 pounds as the dummy came in contact with the floor but rose again to 600 pounds at t = 0.46 second. After the dummy had slipped to the floor, the seat belt and friction on the floor were its only restraint. The seat belt load represents an acceleration force on the dummy of 2-1/2G to 3G. The seat-belt load roughly approximates the deceleration rate of the helicopter.

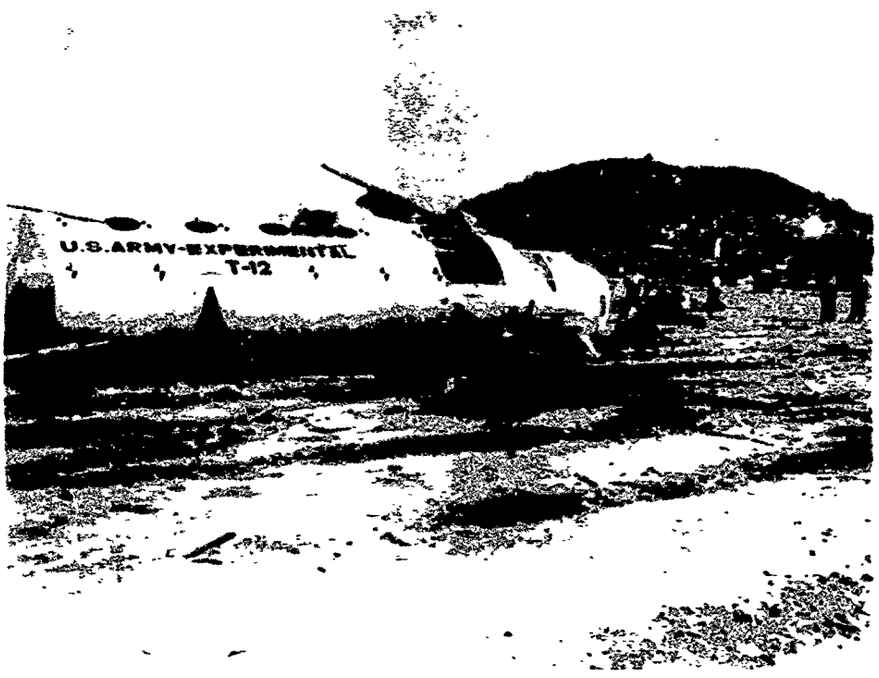
The underside of the passenger compartment was only slightly damaged, as shown in Figure 46.

Figure 46. Postcrash View of Underside of Passenger Compartment. (Arrow shows location of seat 3.)

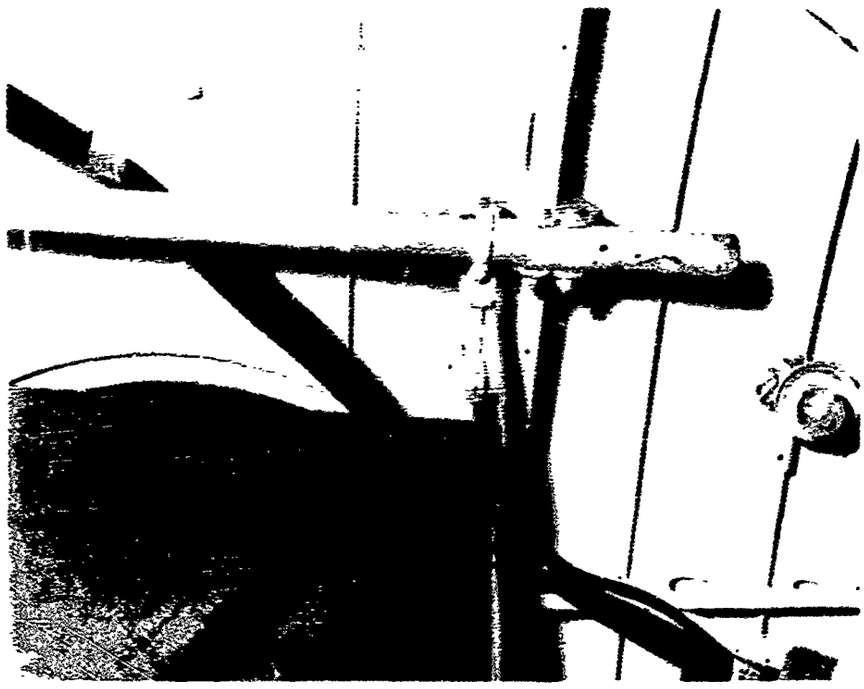
Figure 50. Closeup View of Upper Attenuators.

Figures 49 and 50 show the details of the critical areas in the energy-absorption system of seat 3. There was only the slightest evidence that the floor strut began to depress, and there was no sign that the upper attenuators were beginning to extend.
