USATRECOM TECHNICAL REPORT 65-6

CRASHWORTHINESS EVALUATION OF AN ENERGY-ABSORPTION EXPERIMENTAL TROOP SEAT CONCEPT

February 1965

U. S. ARMY TRANSPORTATION RESEARCH COMMAND
FORT EUSTIS, VIRGINIA

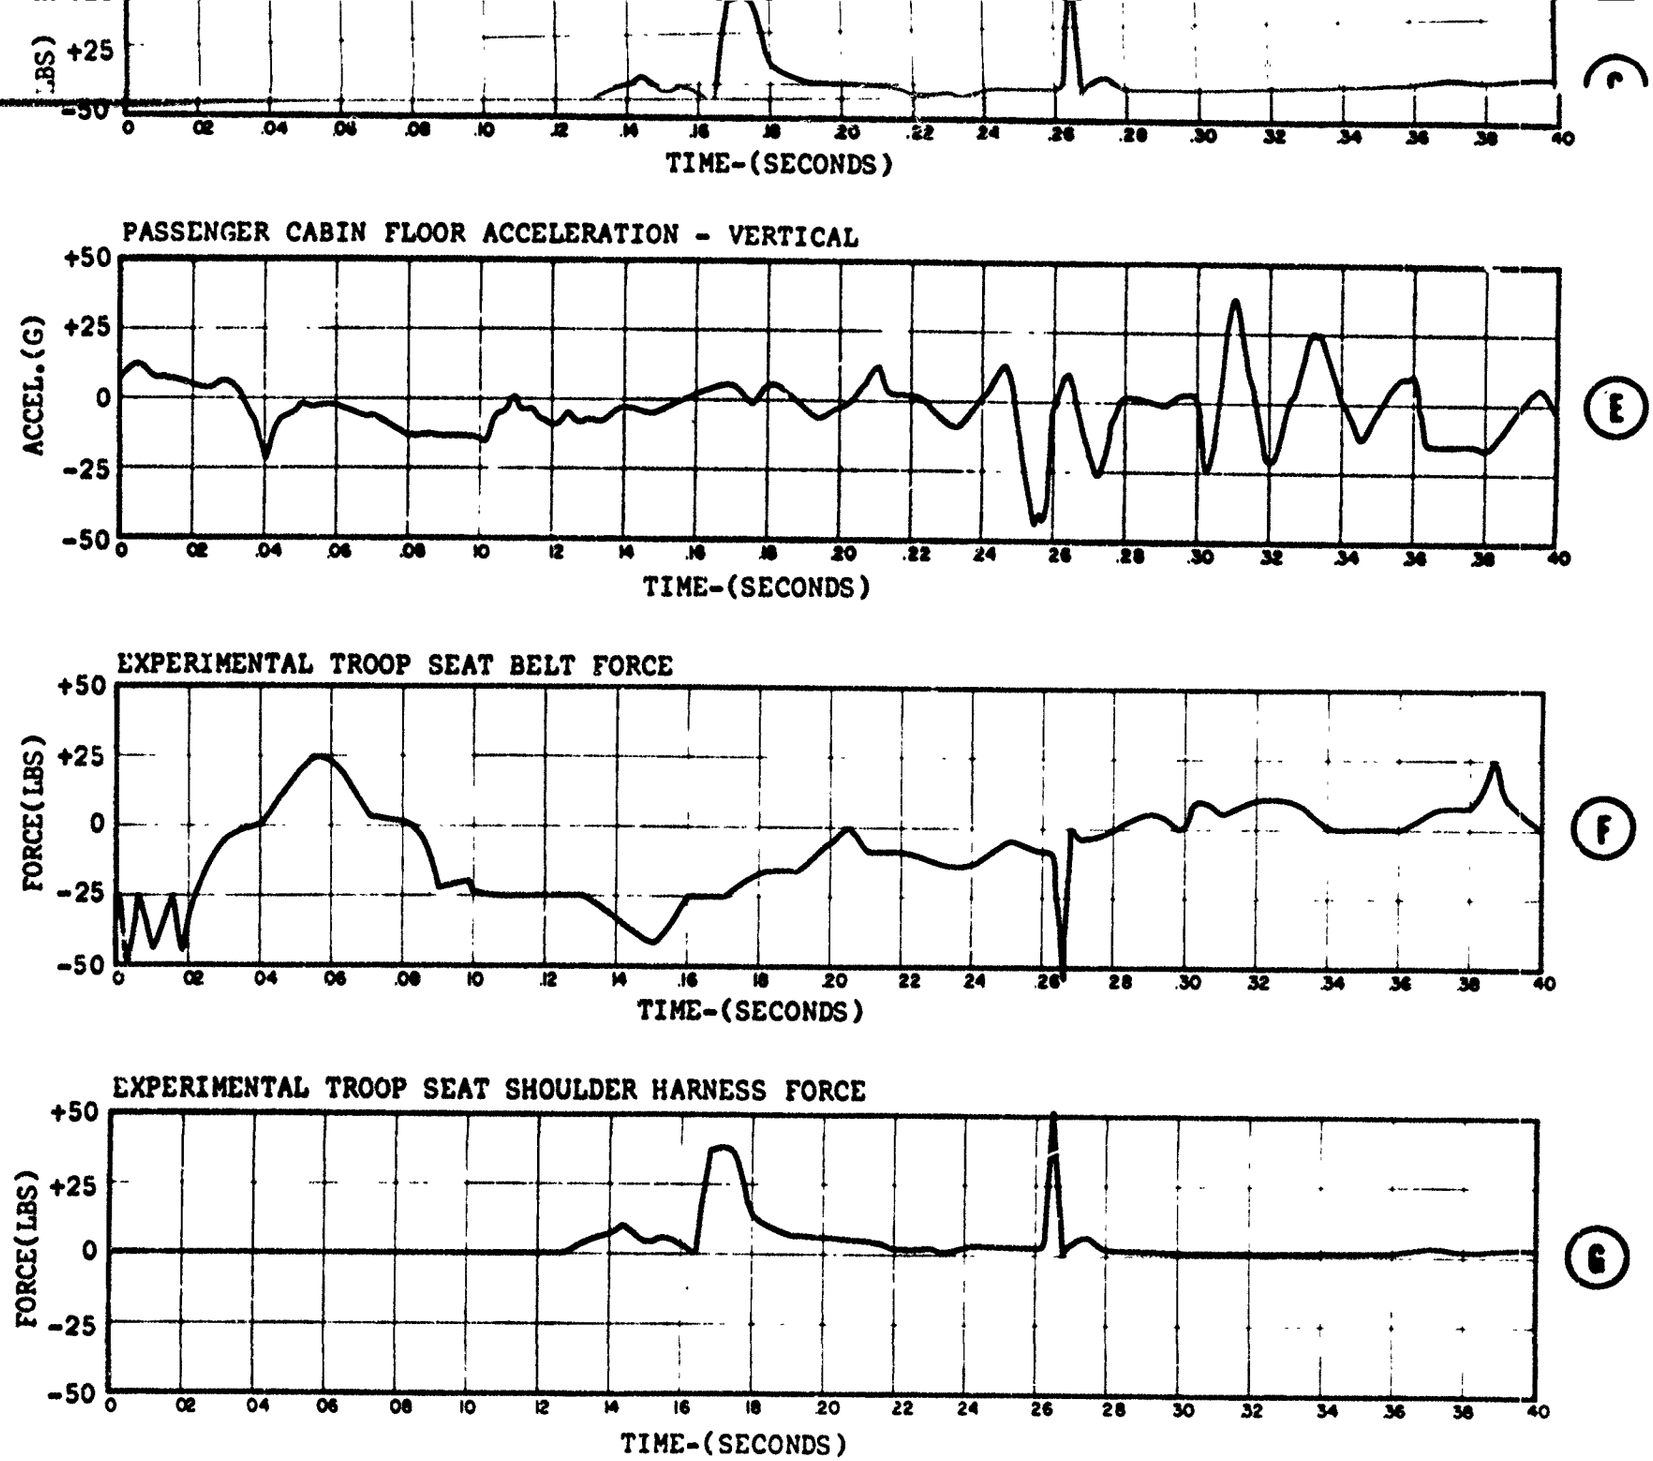
Figure 51. Accelerometer-Time and Force-Time Histories, Seat 3, During CH-21 Helicopter Crash Test T-12.

Due to the mild impact conditions encountered, a detailed analysis of this crash test and its effect on seat 3 would not be particularly significant. Further, the onboard camera coverage was lost, so that frame-by-frame analysis of the bent strut was not possible. The oscillograph records obtained in the crash are shown in Figure 51.

The only conclusions that can be drawn regarding the bending of the energy-absorbing strut are general and speculative. The possibility exists that the dummy's foot contacted the strut when the helicopter turned on its side or that the turning over of the helicopter created a combination of loads on the strut that caused the column collapse. The joints at the end of the strut could have bound up, thus preventing free movement. The latter possibility merits consideration in view of the close tolerances that were used in the strut manufacture, particularly in the strut-to-structure attachment areas on the floor and the underside of the seat.

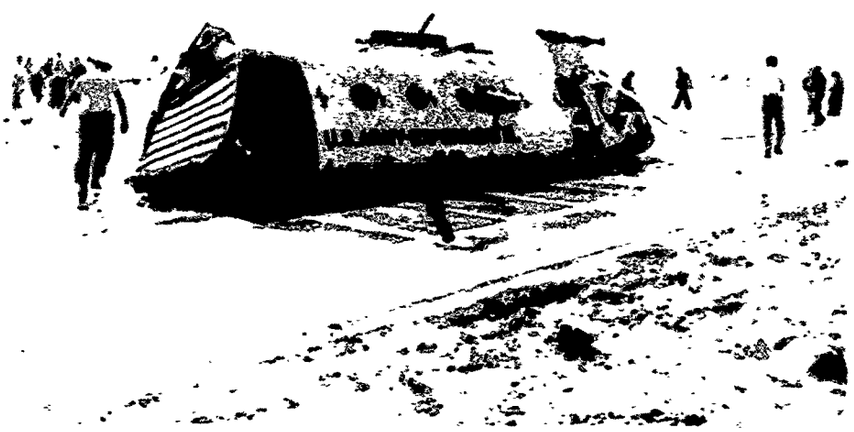
The crash conditions of the crane drop very closely duplicated the acceleration environment of the first drone crash, T-7, and the deformation of the fuselage was similar (see Figure 54). The crushing of the floor and the body frame collapse showed no significant difference between drone tests and crane drops of similar impact conditions.

Figure 54. Postcrash View of Crane Drop (T-13). (Arrow shows area of seat 4 installation.)

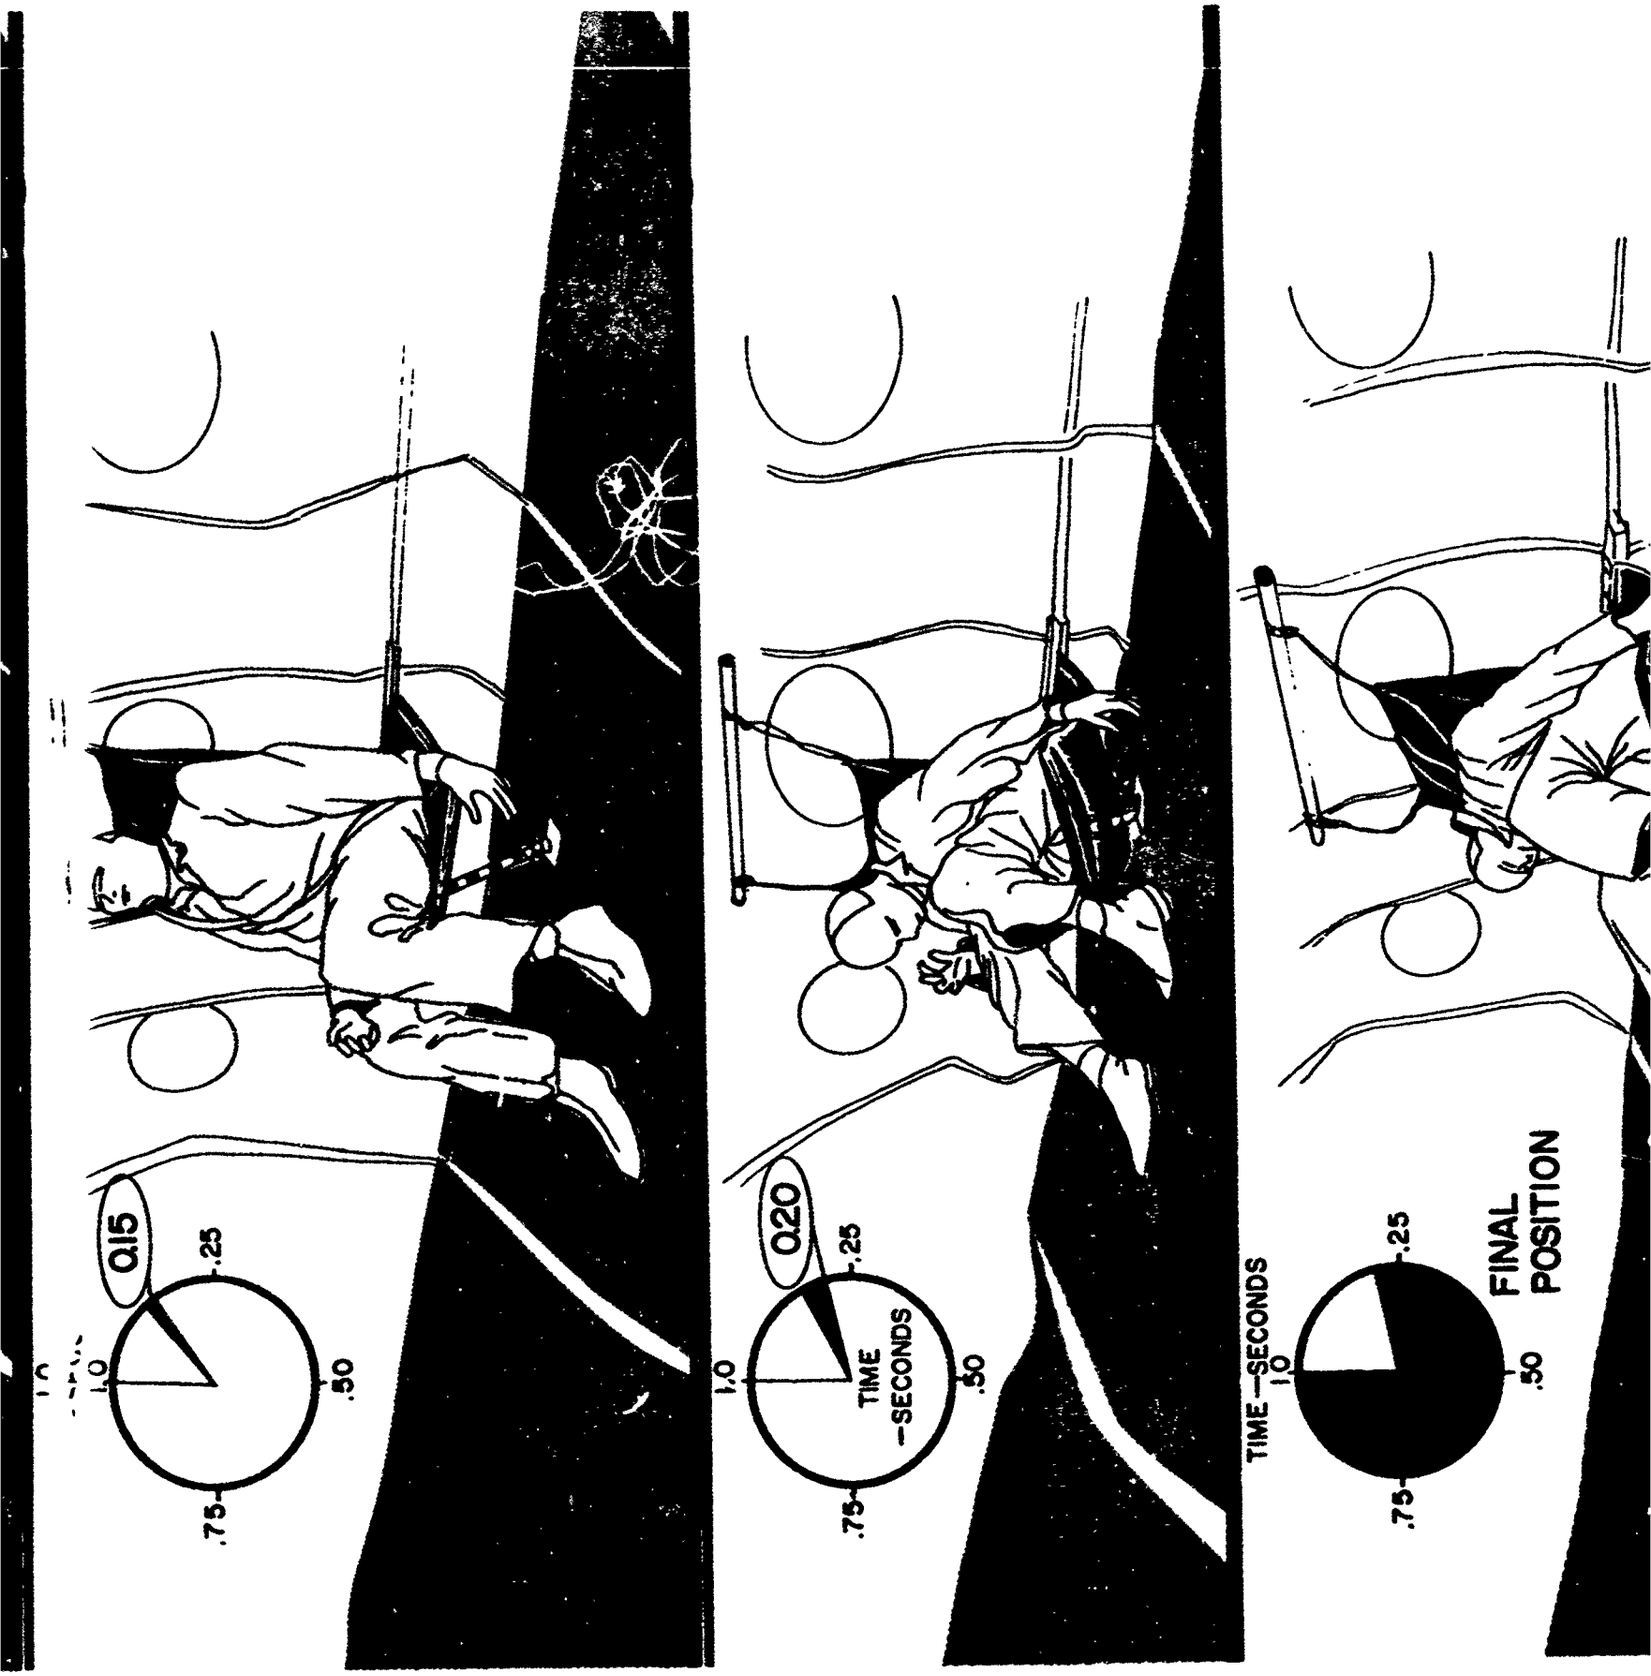
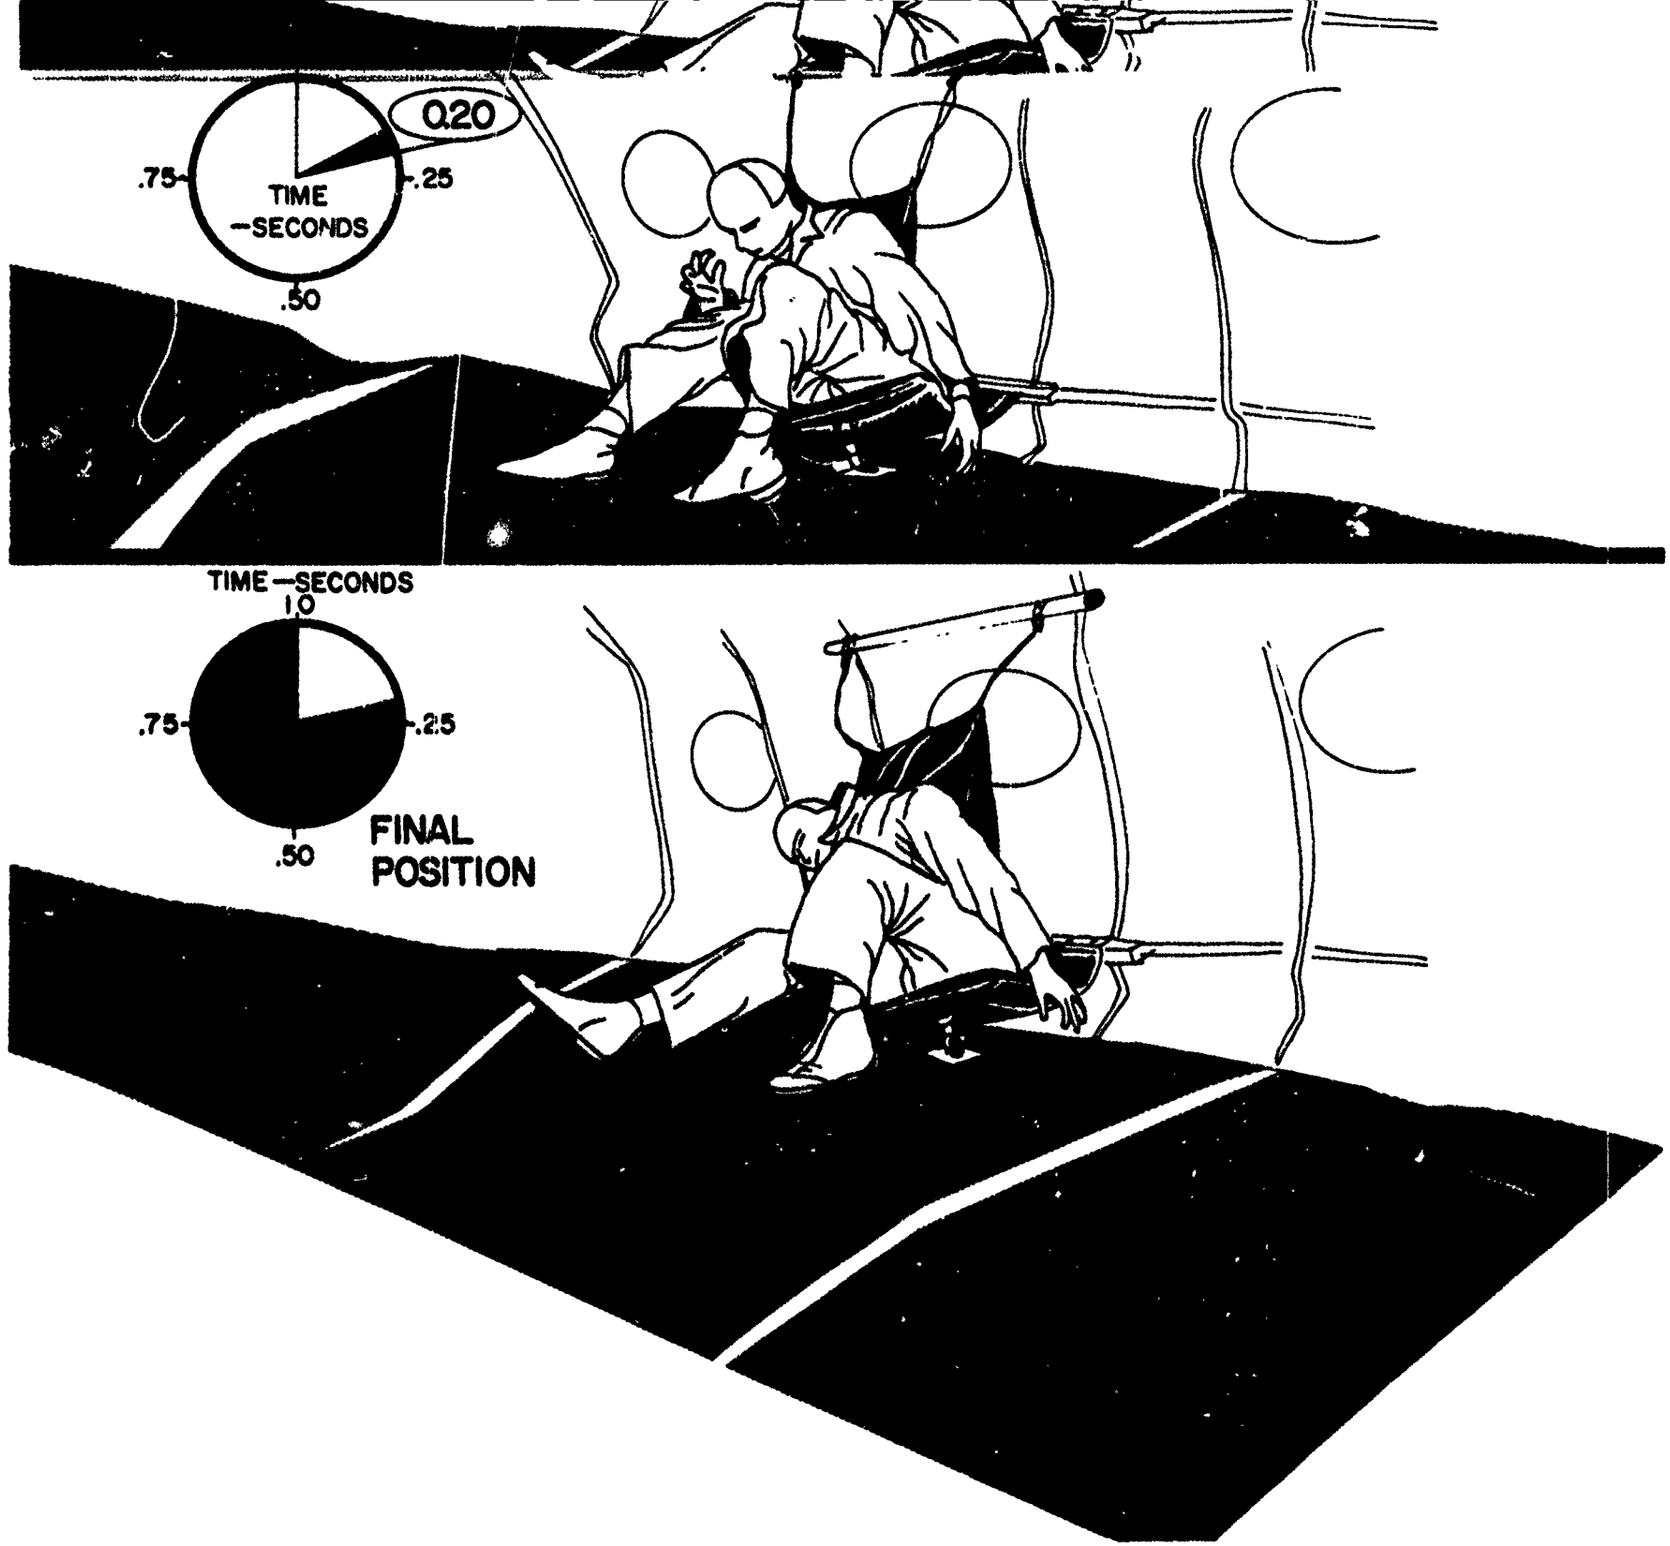
Figure 61. Kinematic Sketch of Seat 4 and Dummy During Crash Impact Sequence, T-13.

A kinematic sketch of the seat and dummy action during the crash is provided in Figure 61. The time shown in seconds to the left of each picture is correlated with the time at which the nose wheel contacted the runway, time zero, and also with the oscillograph records.

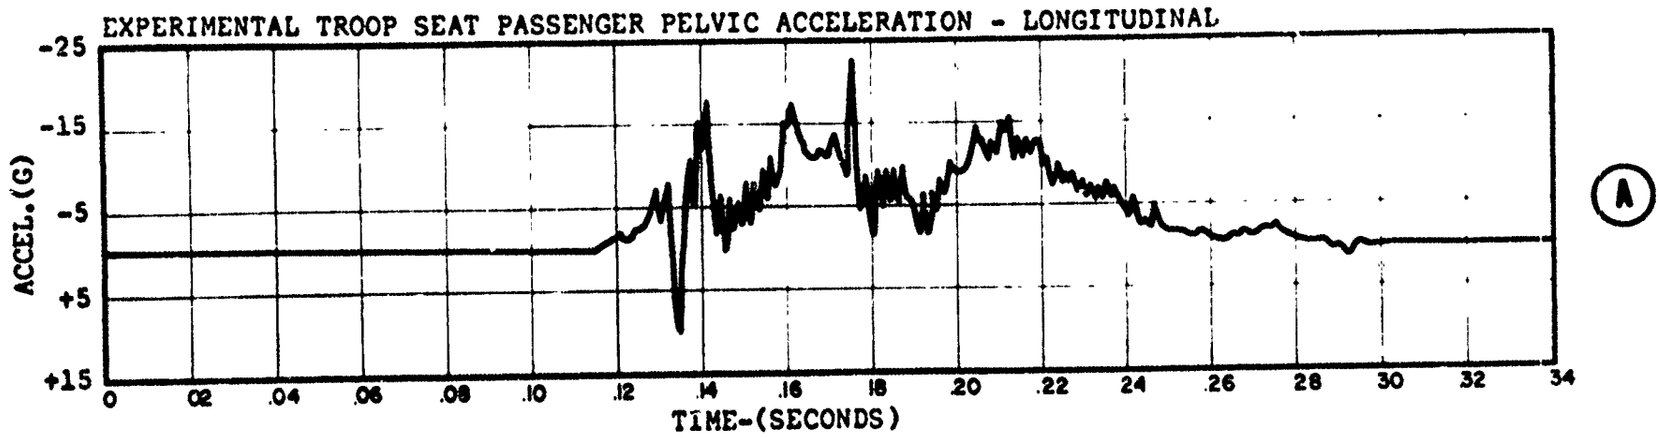
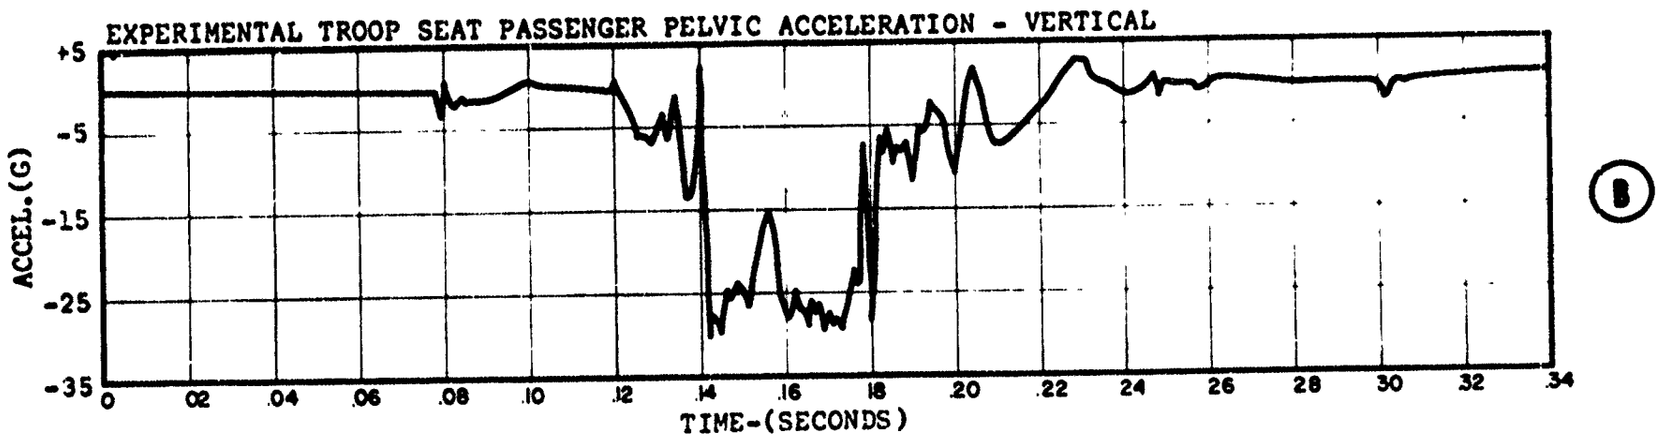
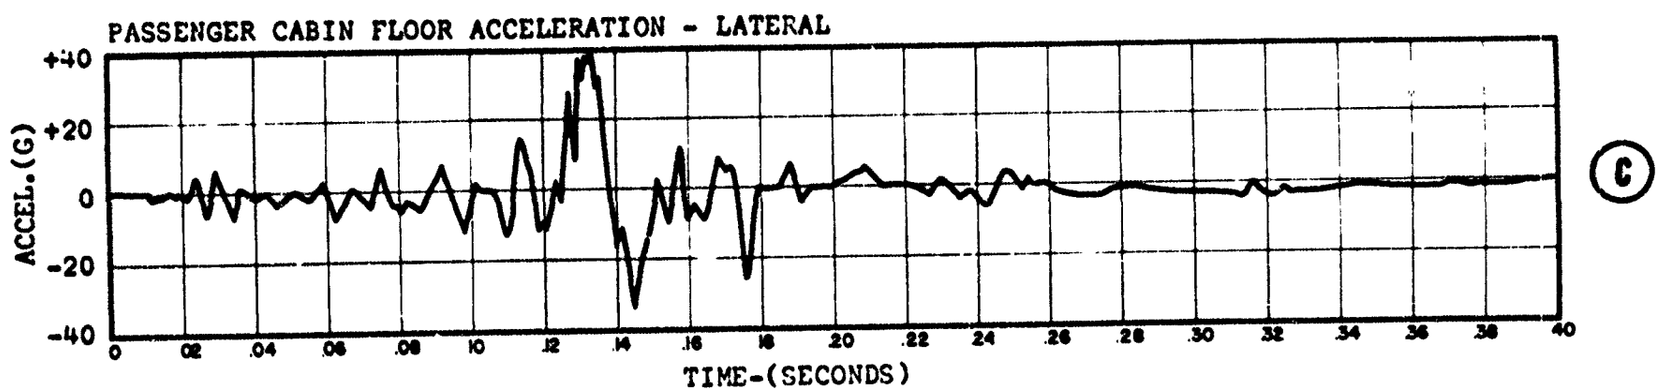
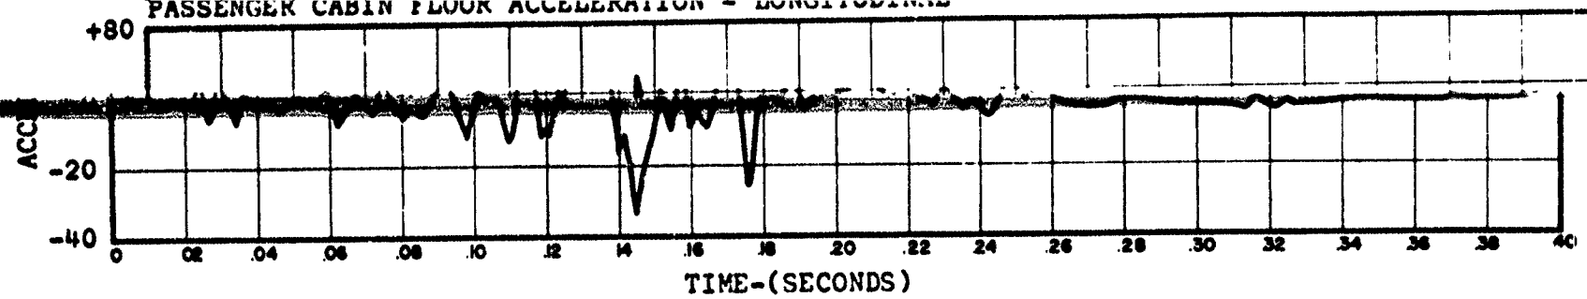
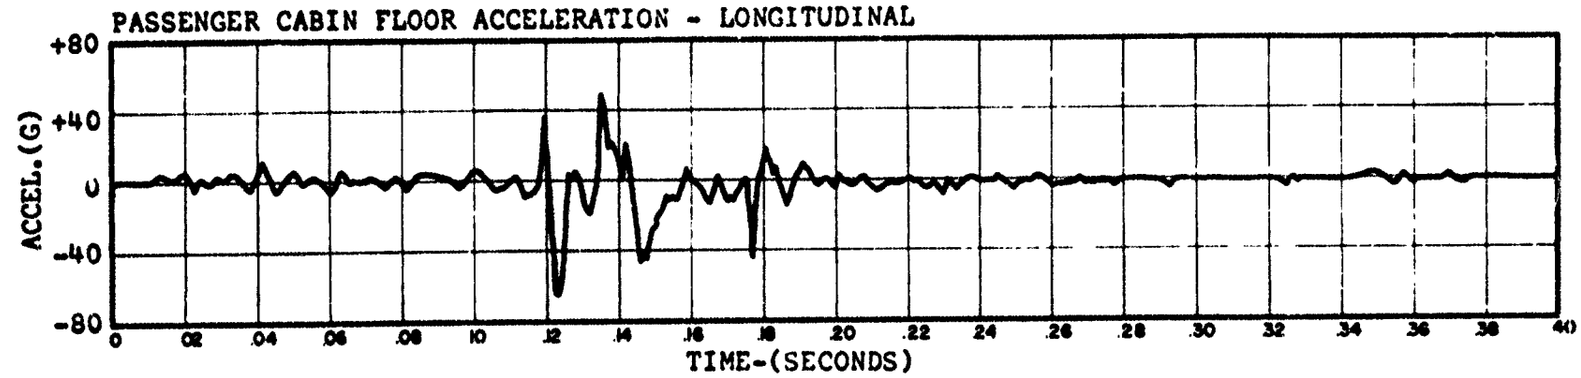
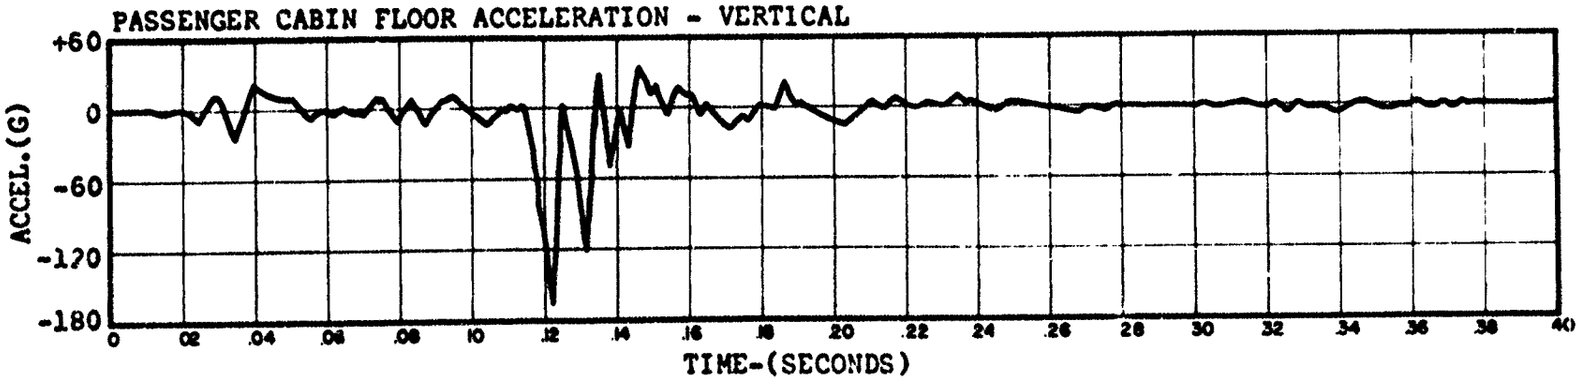
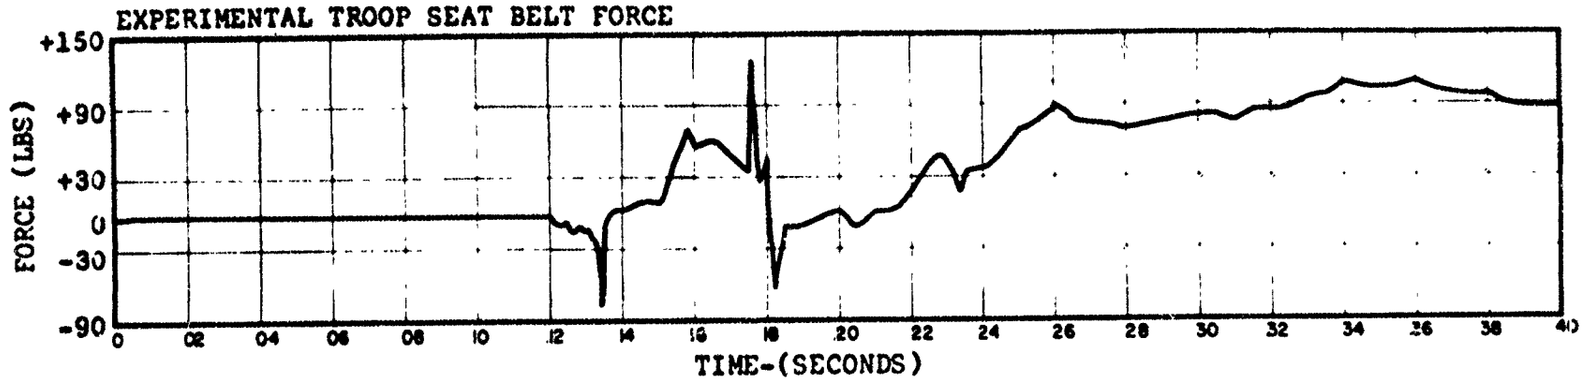
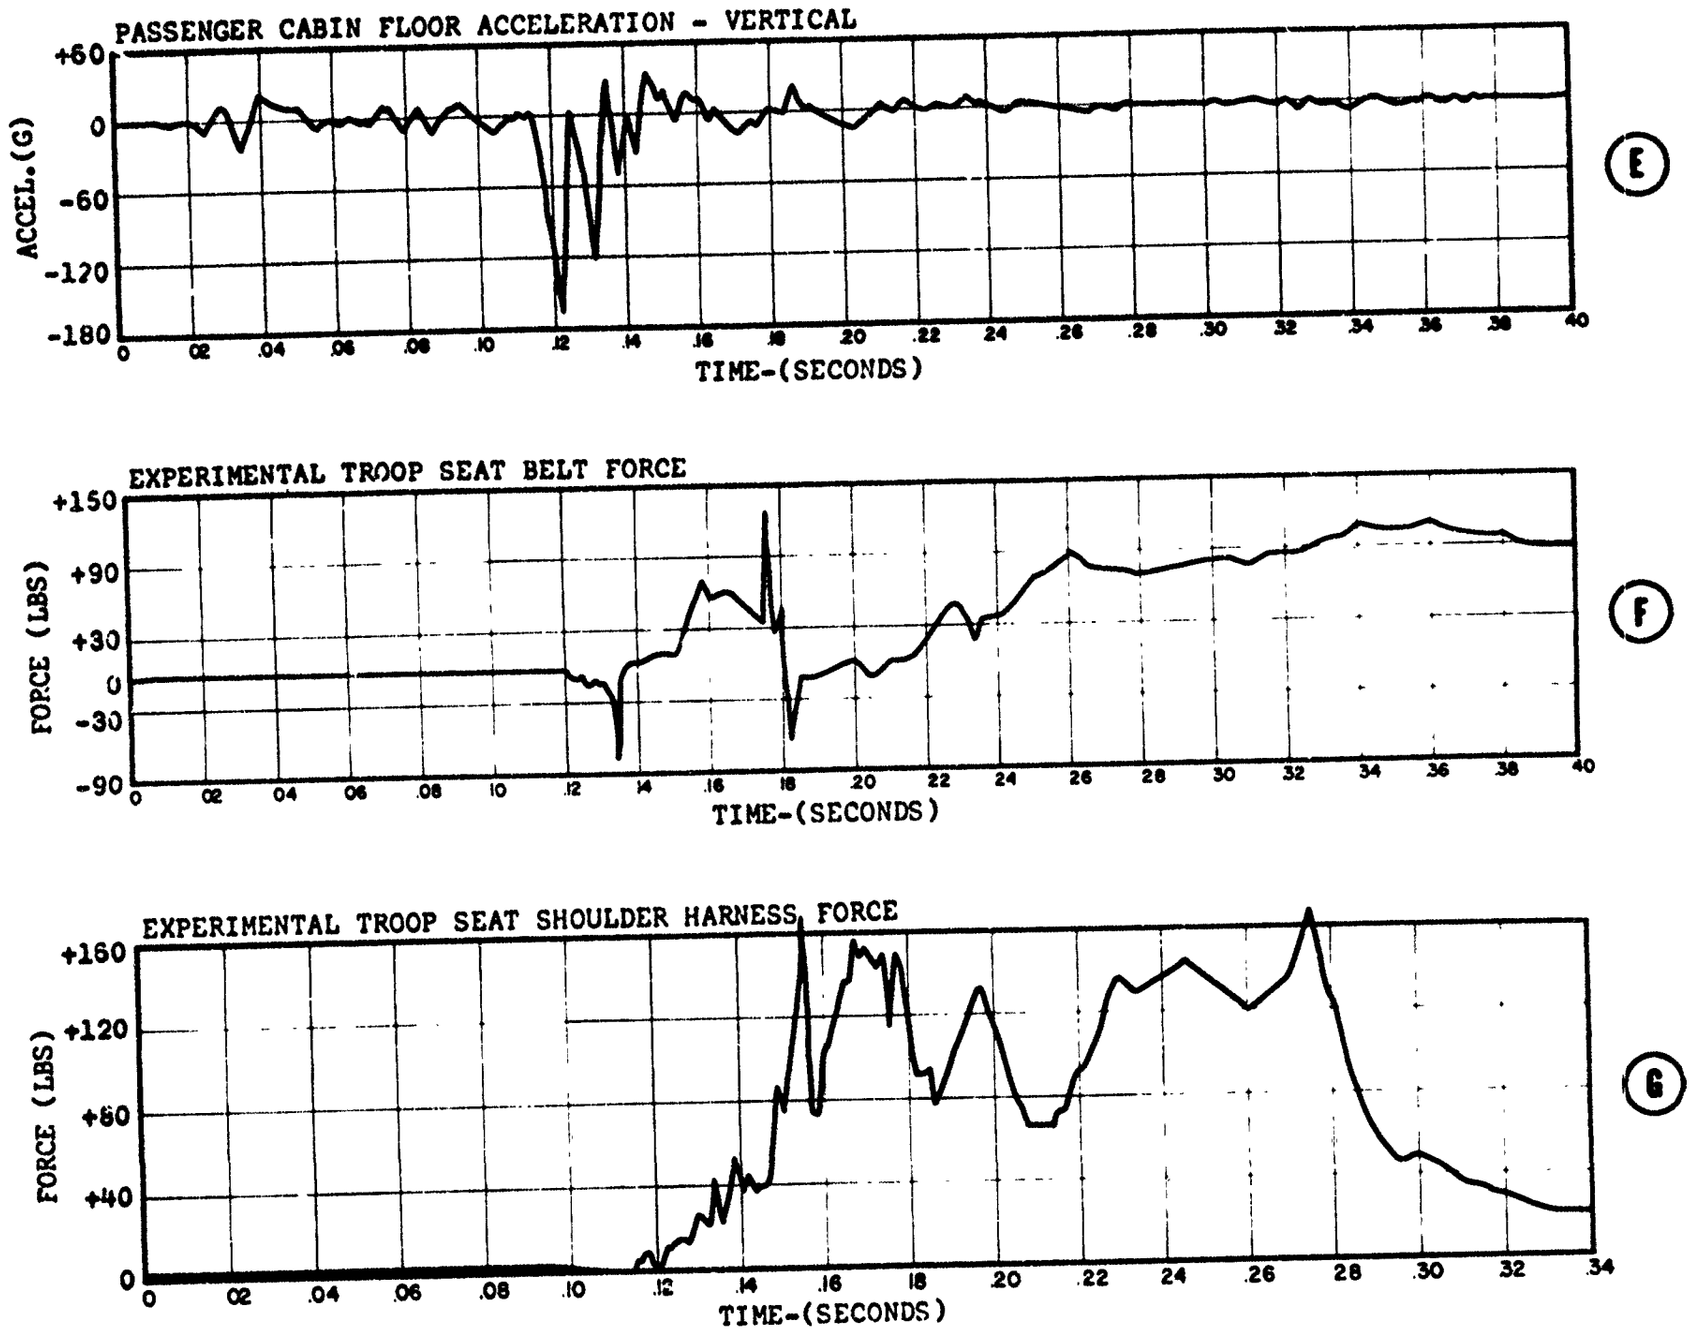
Figure 62. Accelerometer-Time and Force-Time Histories, Seat 4, During CH-21 Helicopter Crash Test T-13.

The oscillograph traces applicable to the seat used in the fourth test are shown in Figure 62. Time zero and accelerometer orientation remain the same as in previous tests.

The impact was first sensed by the instrumentation at approximately 0.12 second. This is apparent on all traces relevant to the seat and the passenger cabin floor in the area of seat 4 (see Figure 62).

The vertical acceleration recorded in the pelvis of the dummy shows a rapid rise at 0.12 second up to 30G and maintains this level for approximately 0.075 second. The velocity change represented by an integration of this curve shows a velocity change of over 38 feet per second, very close to the actual velocity change programmed for the drop test. The peak cabin floor vertical acceleration was approximately 175G at 0.123 second.
