AFFDL-TR-65-211

X-20 WINDOW TESTS

TECHNICAL REPORT AFFDL-TR-65-211

JANUARY 1966

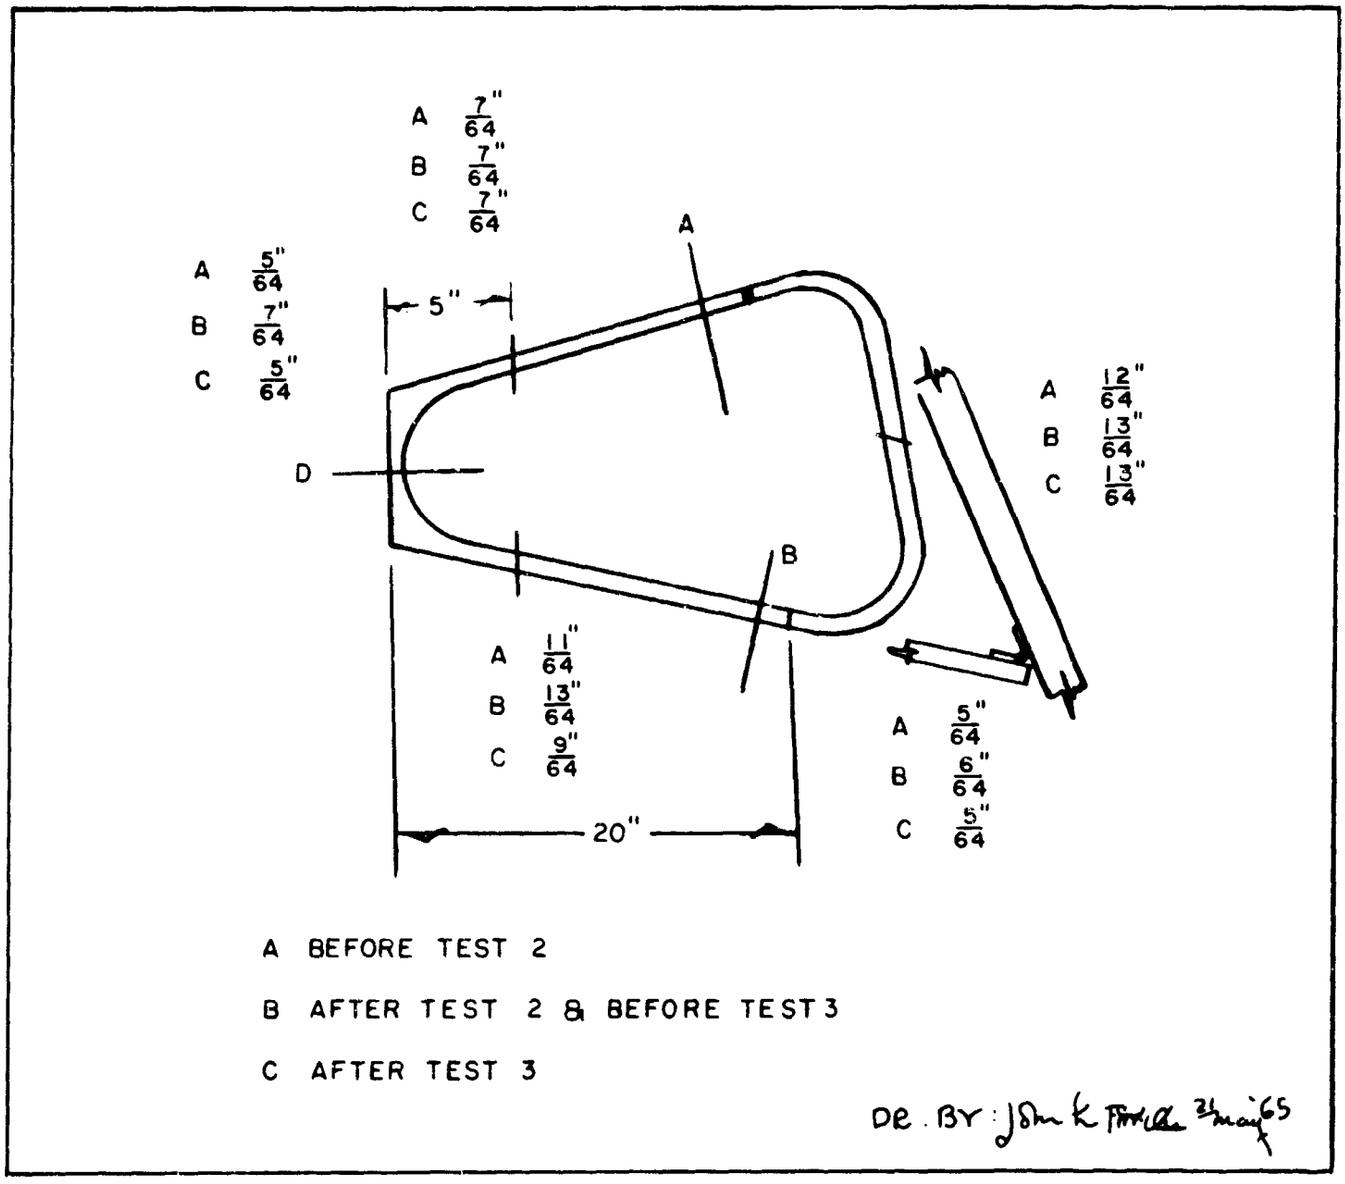
Figure 8. X-20 Window Gaps

The window gaps before and after both tests are shown in Figure 8.
