MPL PARTICIPATION IN *SEALAB II*

SIO REFERENCE 66-3

1 FEBRUARY 1966

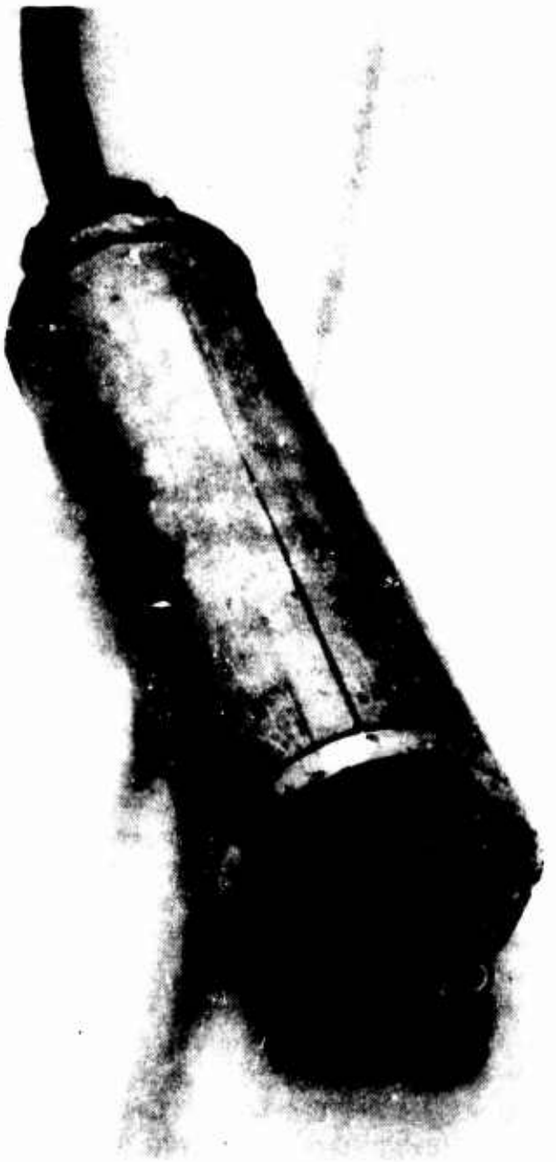
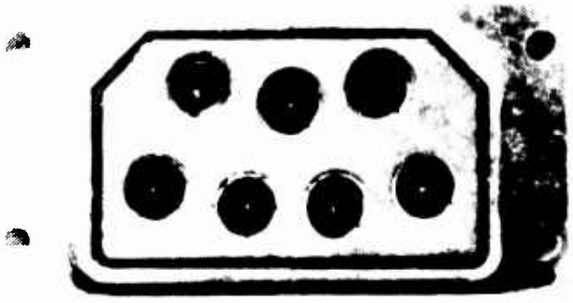
As mentioned previously, the majority of the malfunctions associated with the *SEALAB* project were attributed to connector failure associated with these sea cables. Figures 14, 15, and 16 show various degrees of corrosion and contamination which was observed on these connectors after recovery. In most cases, specific troubles can be traced to a particular connector-pin combination where the corrosion is severe. The cause of this corrosion is unknown; however, three hypotheses are offered:

(3) High ambient humidity and possible salt water splash in the environment near the *SEALAB* trunk.

In considering the above items it is interesting to note that: (1) Corrosion was also evident on the *SEALAB* rack-mounted connectors (see Figure 8b), and (2) the single connector associated with the communications cable, which is terminated only by floating transformer windings, showed no signs of deterioration.

Figure 14. Connector corrosion and contamination

Figure 15. Connector corrosion and contamination

Figure 16. Connector corrosion and contamination
