USAAVLABS TECHNICAL REPORT 66-27

AIRCRAFT LITTER RETENTION SYSTEM DESIGN CRITERIA

April 1966

CONTRACT DA 44-177-AMC-254(T)
AVIATION SAFETY ENGINEERING AND RESEARCH
A DIVISION OF
FLIGHT SAFETY FOUNDATION, INC.
PHOENIX, ARIZONA

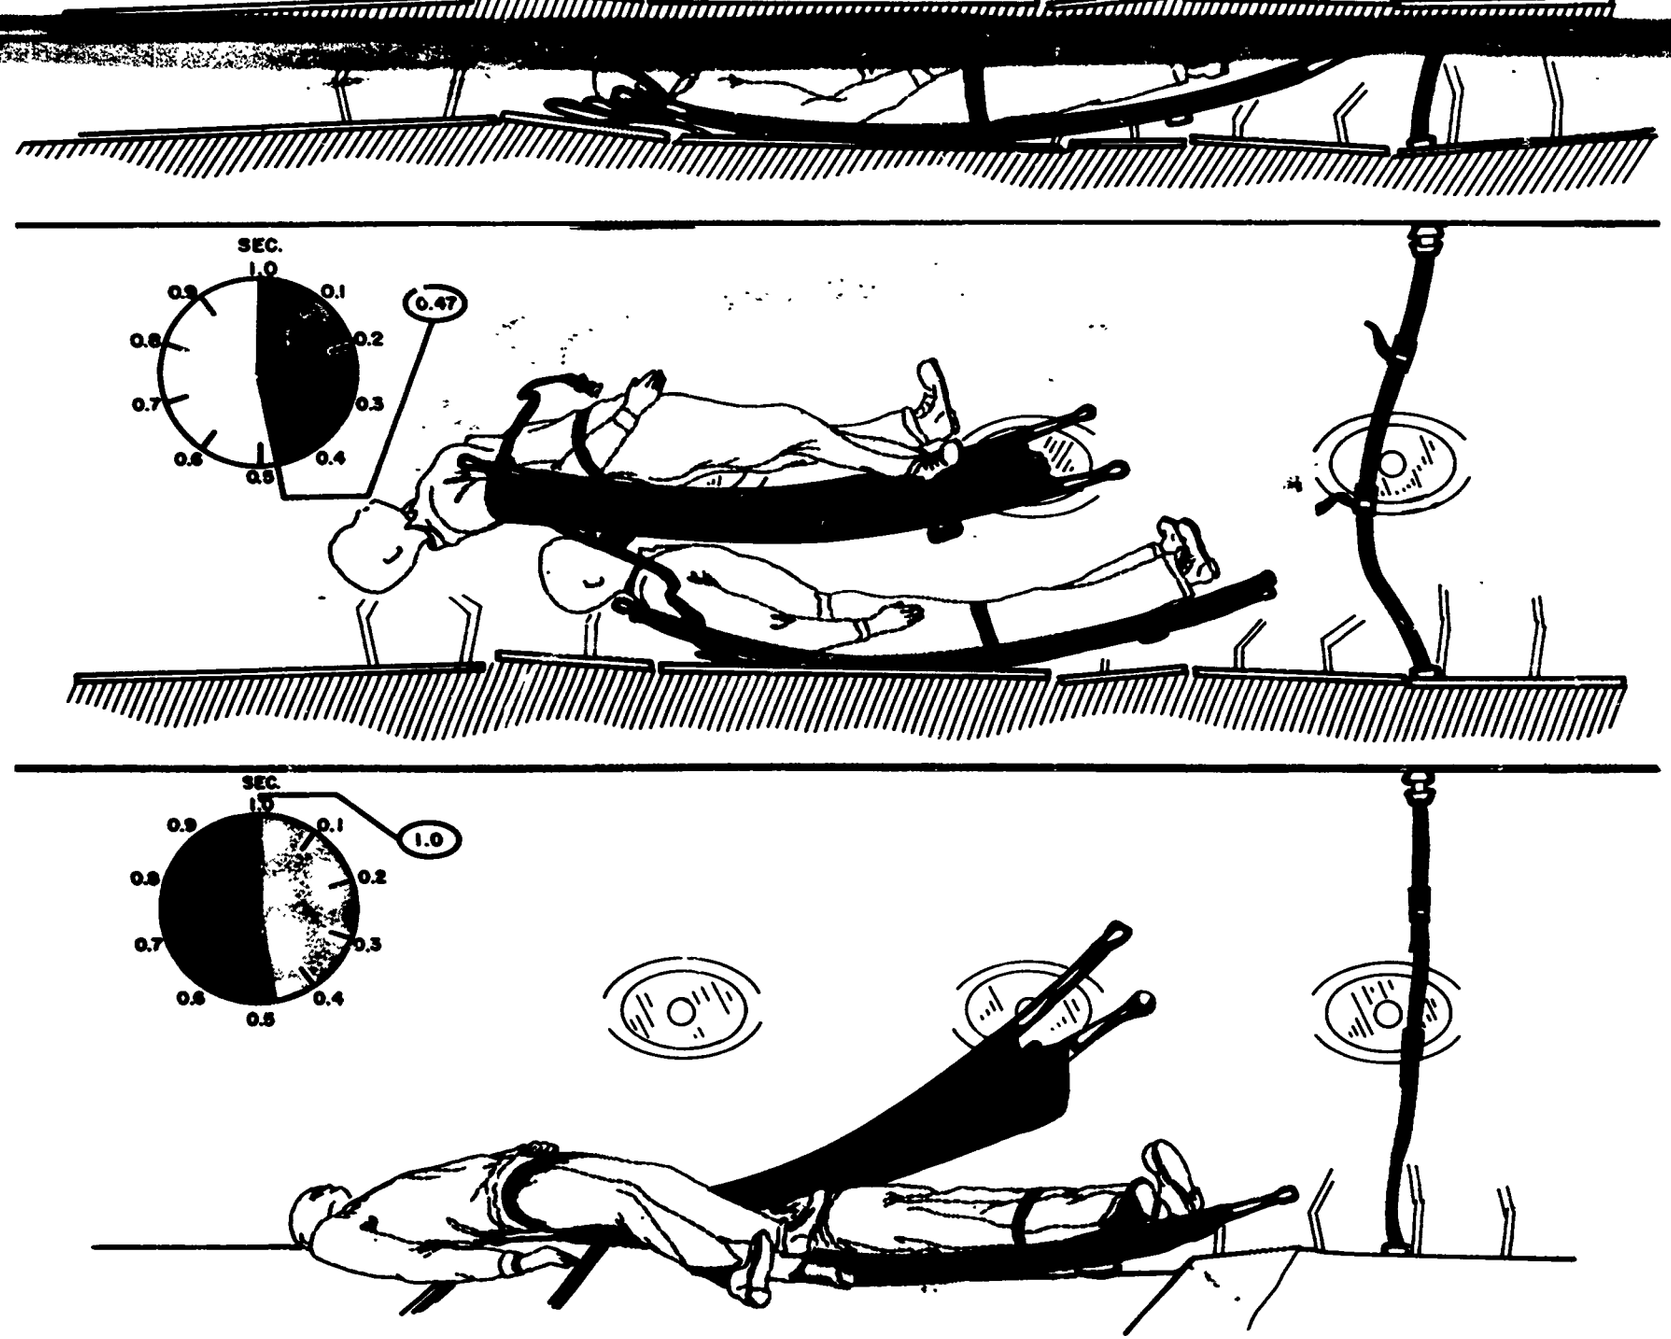
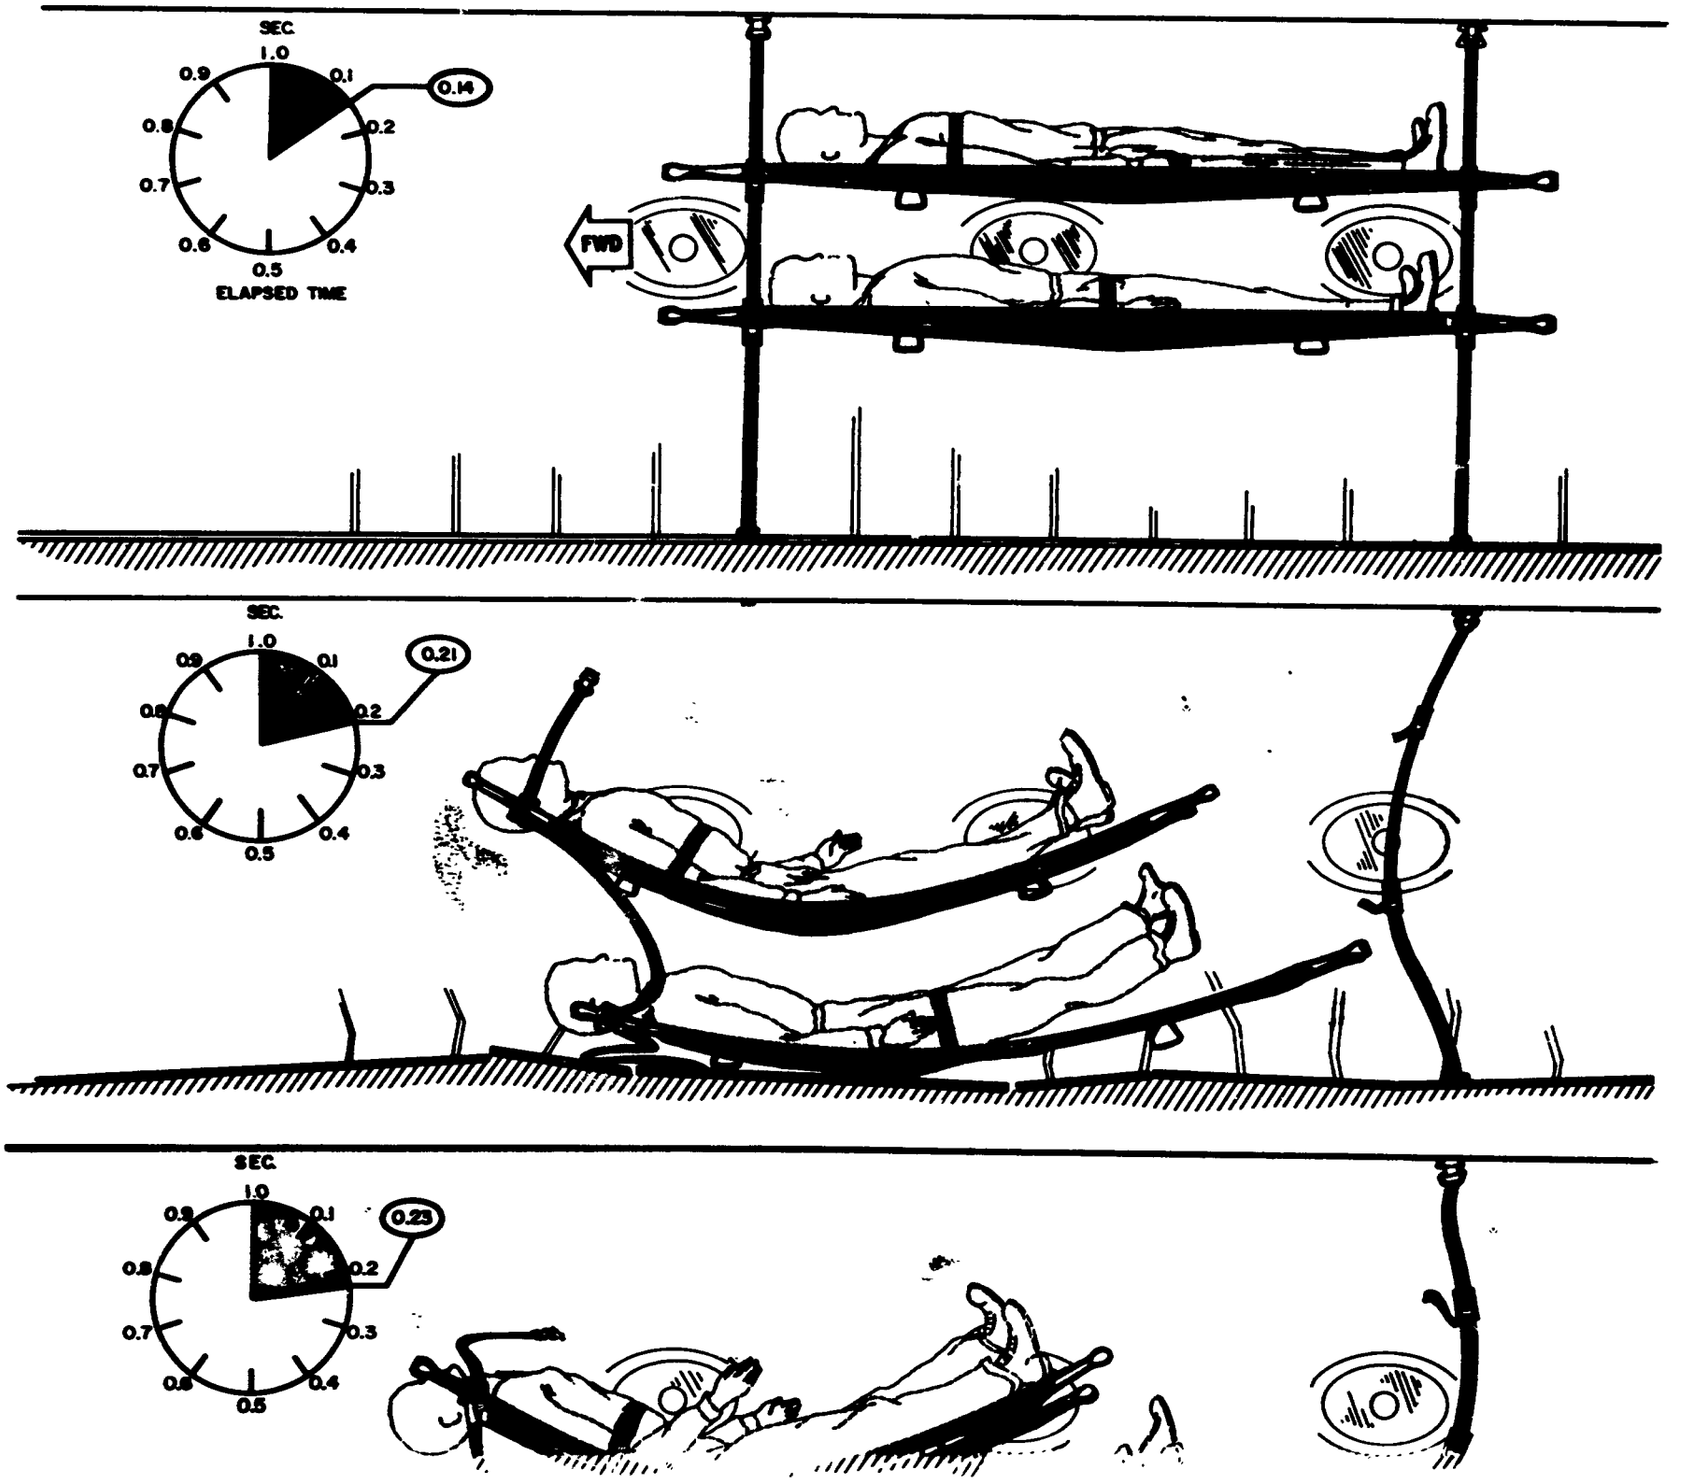
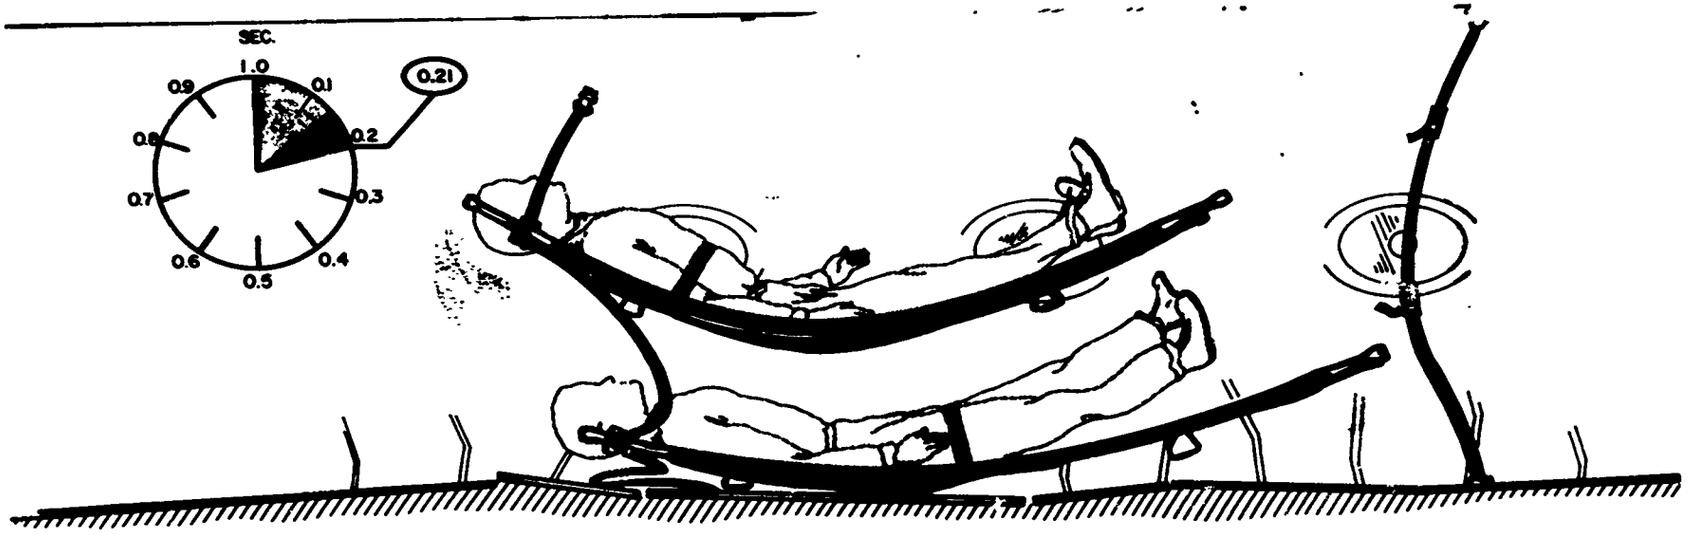
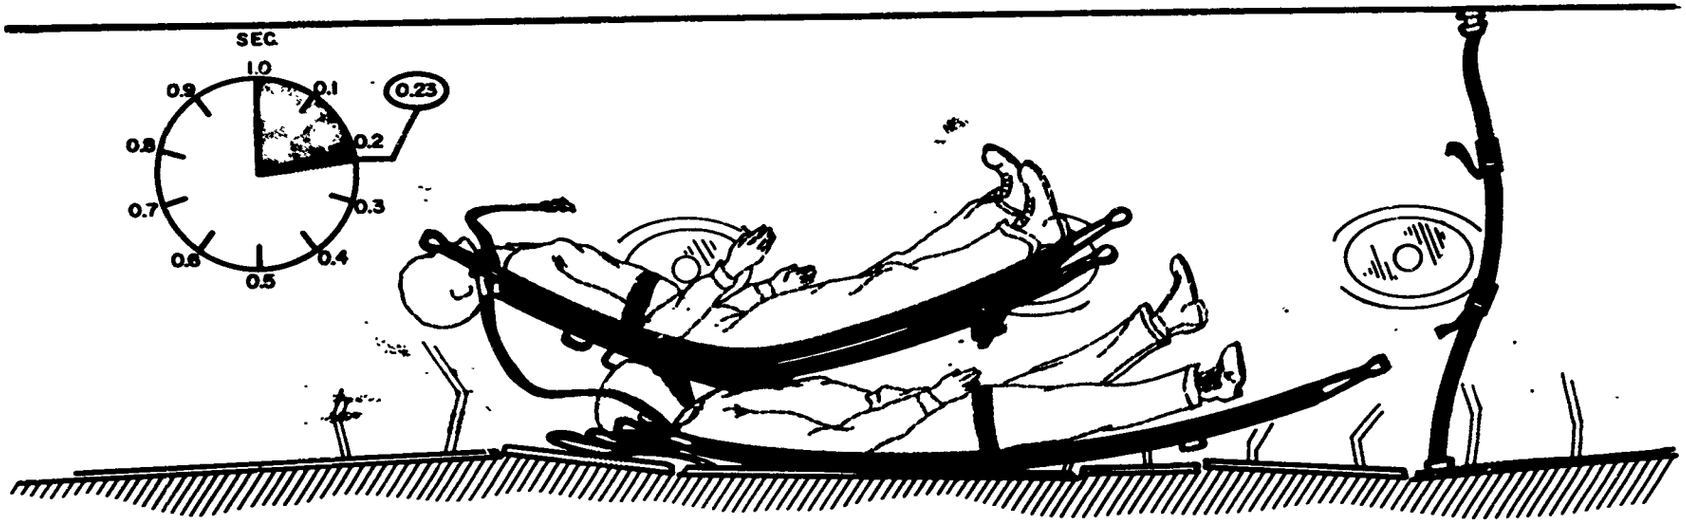
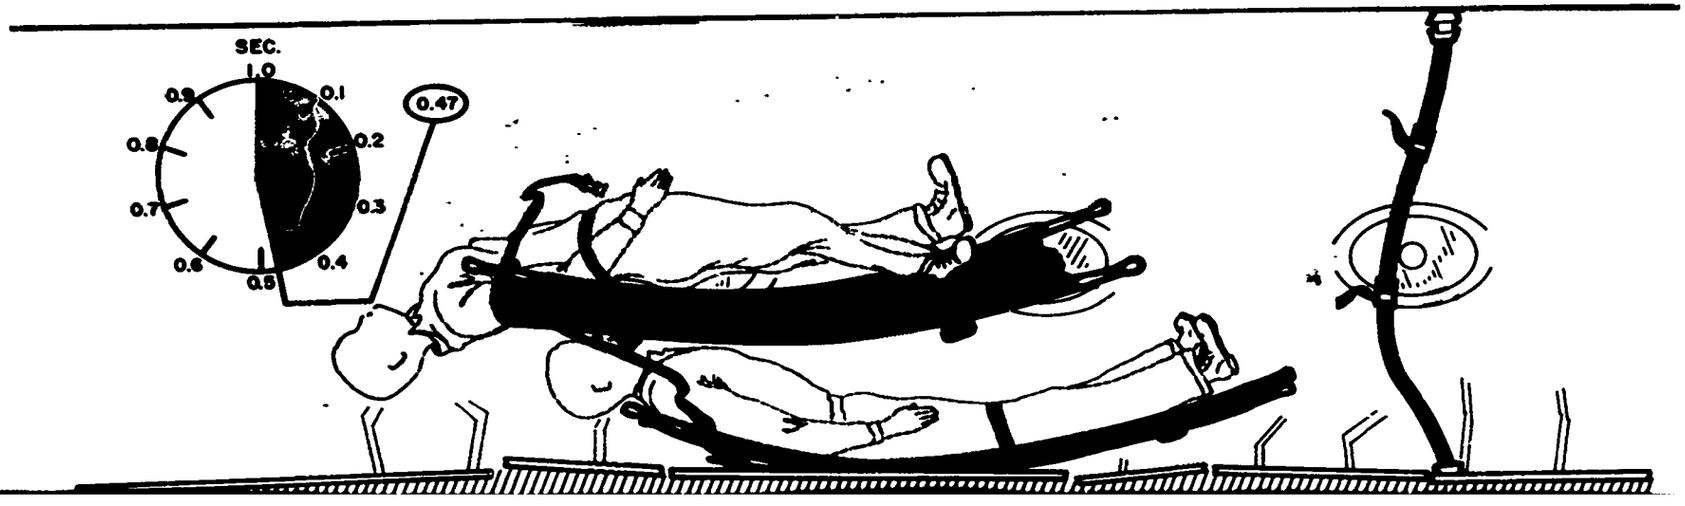
The results of an actual crash test of the litter system in Figure 1 are shown in the kinematic drawing, Figure 3. A description of the conditions that existed in the full-scale dynamic crash test (which included this litter system) is given in Reference 2. The results of the test of a standard UH-1D litter system installed in a modified CH-21 are described in Appendix I.

Figure 3. Kinematics of CH-21 Litter System Failure.

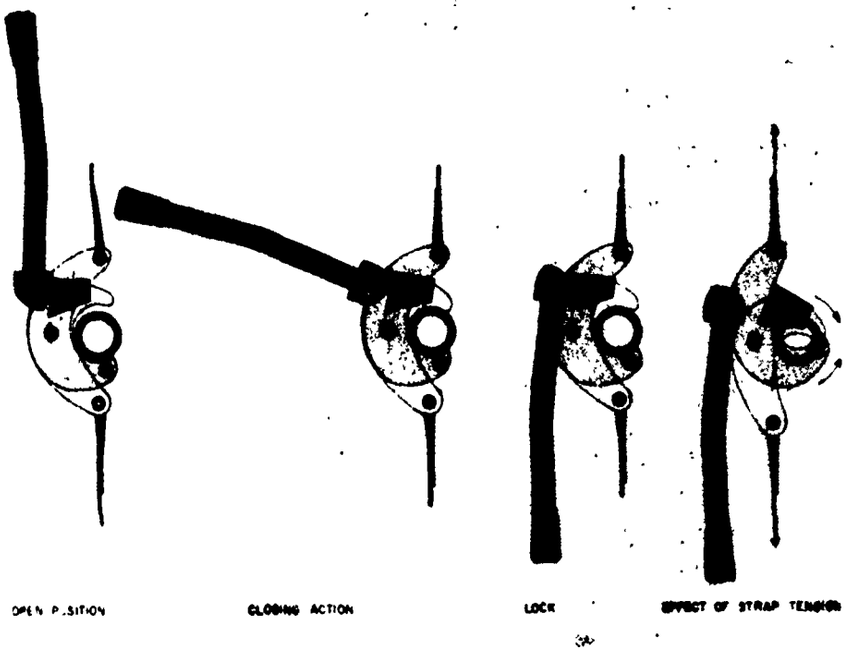
Figure 2 depicts a standard UH-1D litter system that has been modified to include experimental attachment fittings. These fittings, shown in Figure 4, were intended to provide increased litter retention during the high vertical and longitudinal forces known to occur in aircraft accidents.

Figure 4. Experimental Attachment Fitting.

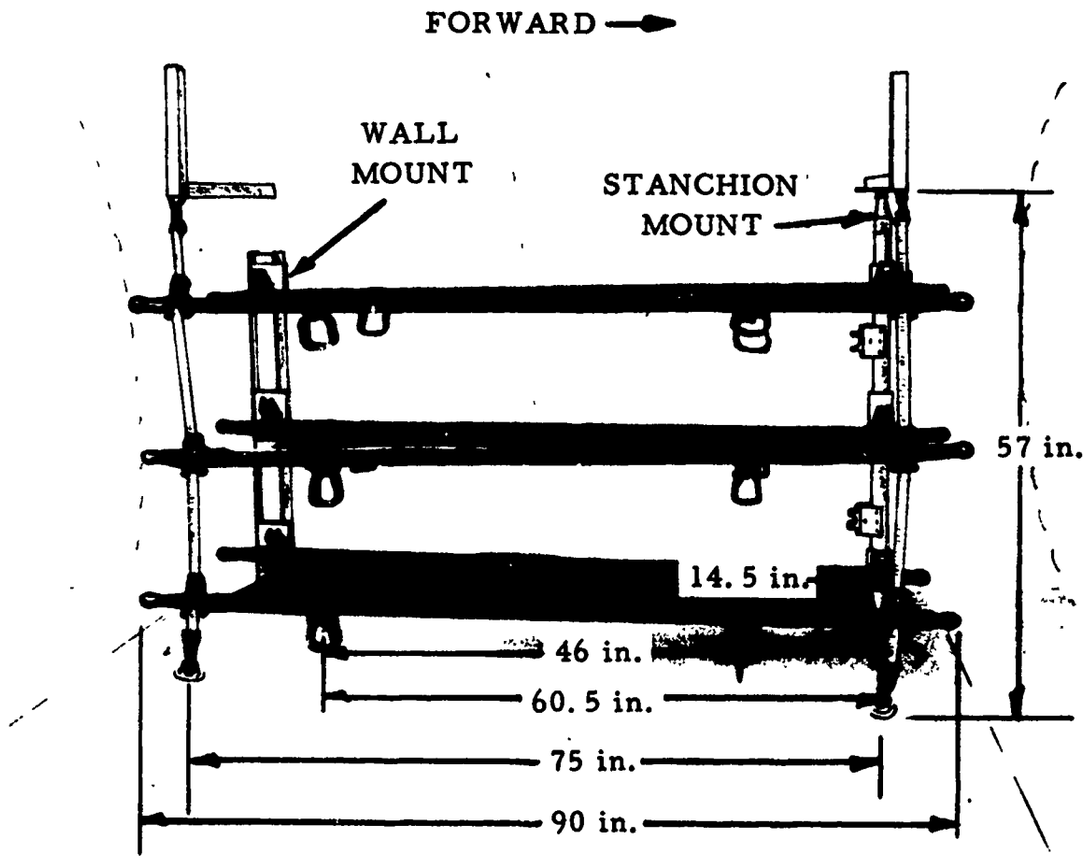
The litter stack was installed between fuselage stations 120 and 220 in the forward passenger compartment of the CH-21 used for this test, with the rigid supports outboard and the strap supports inboard. The height of the test installation was held at 57 inches by building a

supporting structure into the top of the CH-21 cargo compartment, 57 inches above the floor. A sketch of the installation is shown in Figure 13.

Figure 13. UH-1D Litter Installation in CH-21A Helicopter.

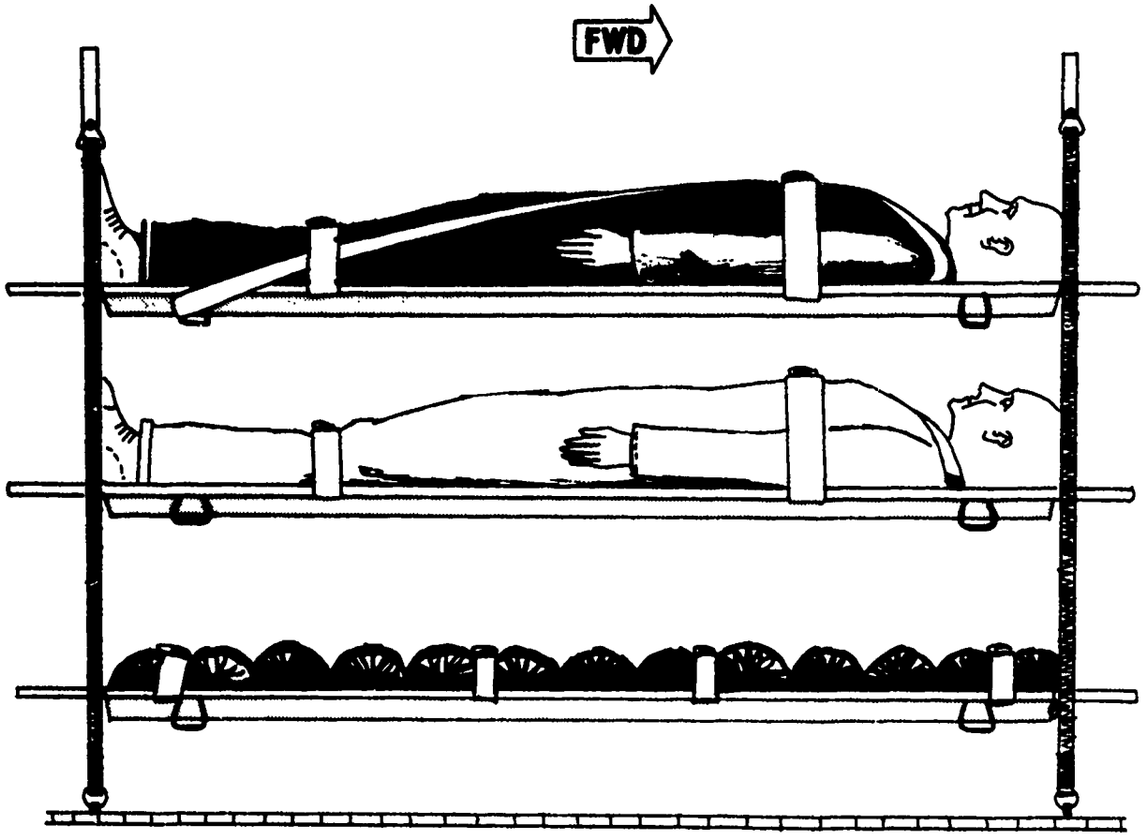
The upper and center litters carried anthropomorphic dummies, while the lower litter carried a canvas sandbag dummy with a lengthwise distribution of weight similar to normal human weight distribution. The placement of the anthropomorphic dummies and the sandbag dummy is shown in Figure 14.

Figure 14. Dummy Placement on Litters in CH-21A Test Helicopter.

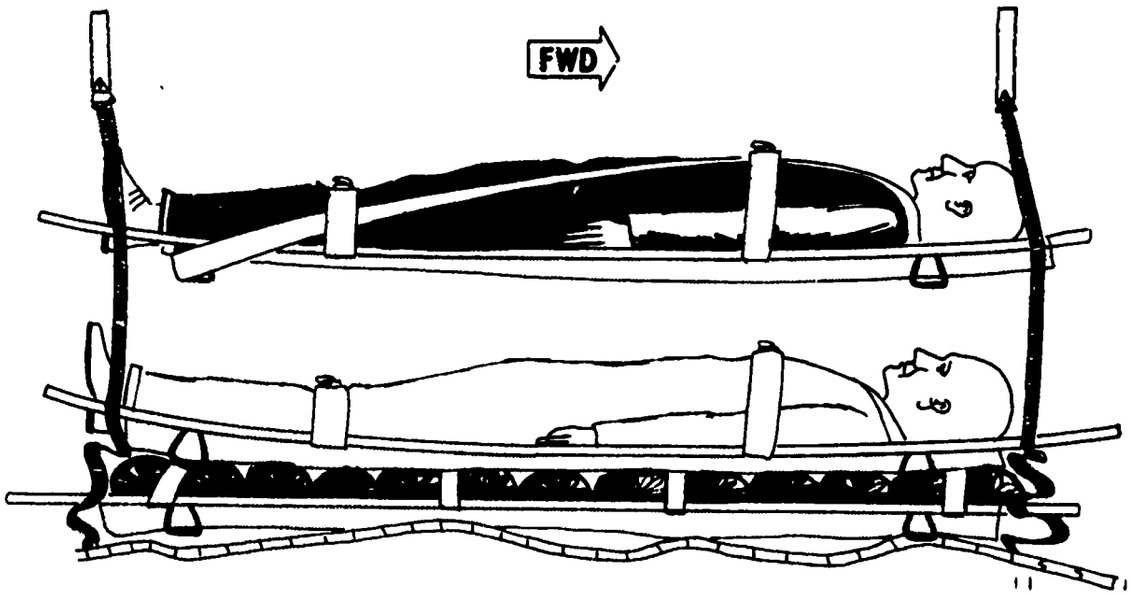
The overall effect of this vertical collapse of the fuselage structure during the crash was to lower the roof and the whole litter system toward the

floor. The bottom litter and dummy contacted the floor and were subjected to nonsurvivable acceleration levels. This condition is portrayed in Figure 17.

Figure 17. Lower and Center Dummy/Litter Contact.

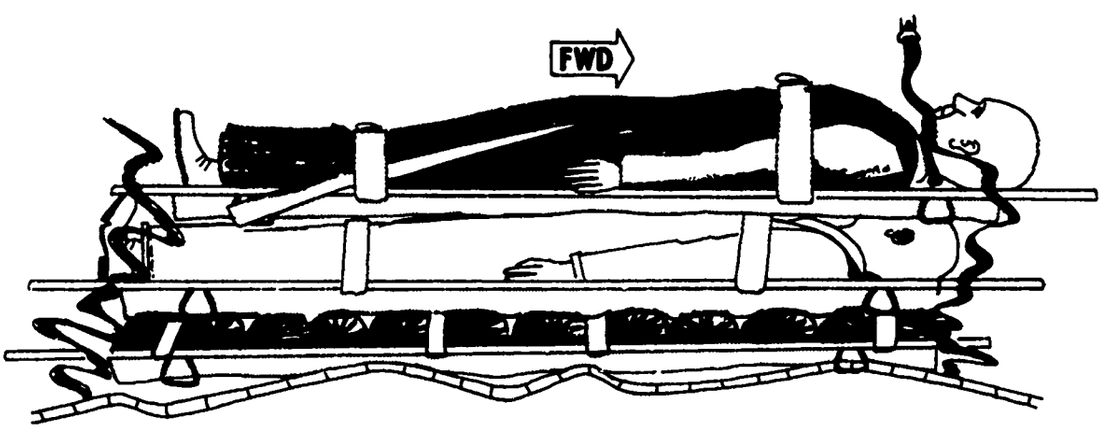
As the collapse continued, the middle litter and dummy impacted the lower dummy with resultant high accelerations imposed on the center litter dummy. The action continued until the top litter and dummy contacted the center dummy. The total effect is shown in Figure 18.

Figure 18. Progressive Impact on All Three Dummies.

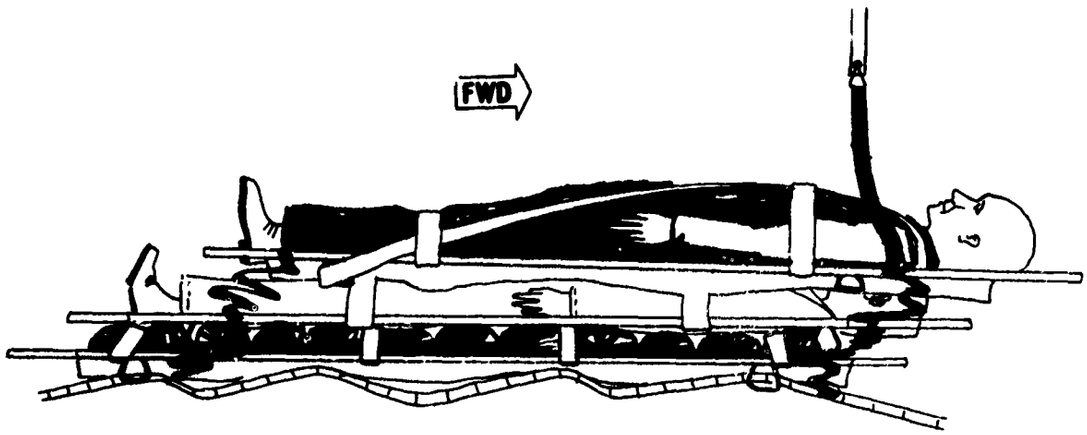
Figure 19. Final Position of Litters and Dummies.

All three litter positions were subjected to acceleration levels and crash conditions which would have been fatal to human occupants. In addition, severe injuries could have resulted from the litter stirrups and spreader bars as they contacted the middle and lower patients (dummies) during the collapse of the system.
