COMPACTED-SNOW RUNWAYS IN ANTARCTICA DEEP FREEZE 65 TRIALS

U. S. NAVAL CIVIL ENGINEERING LABORATORY

Technical Report R-480

E. H. Moser, Jr. and G. E. Sherwood

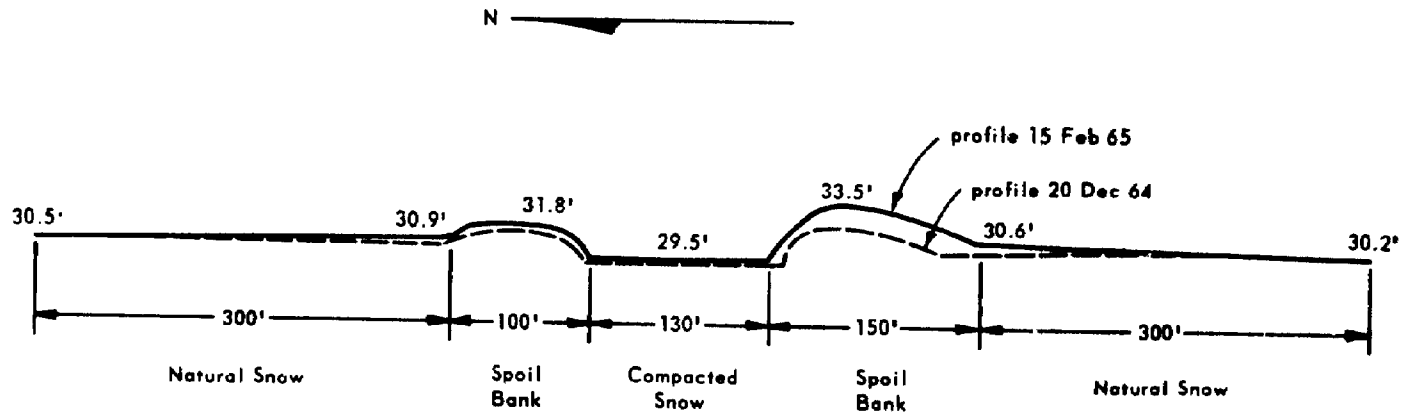
Figure 5. Cross section of 10-70 test area at Station 60+00 on 15 February 1965.

From time to time, additional drift was removed from the test area between 20 December 1964 and mid-February 1965. A transverse profile across the area at Station 60+00 on 15 February (Figure 5) shows that the south spoil bank was 4.0 feet above the compacted surface, for an increase of 0.9 foot in the 2-month period, but the north spoil bank was only 2.3 feet, for an increase of only 0.1 foot. The profile also shows that the heavy drifting along the south side reduced the usable width of the compacted area from 150 to 130 feet in mid-February.

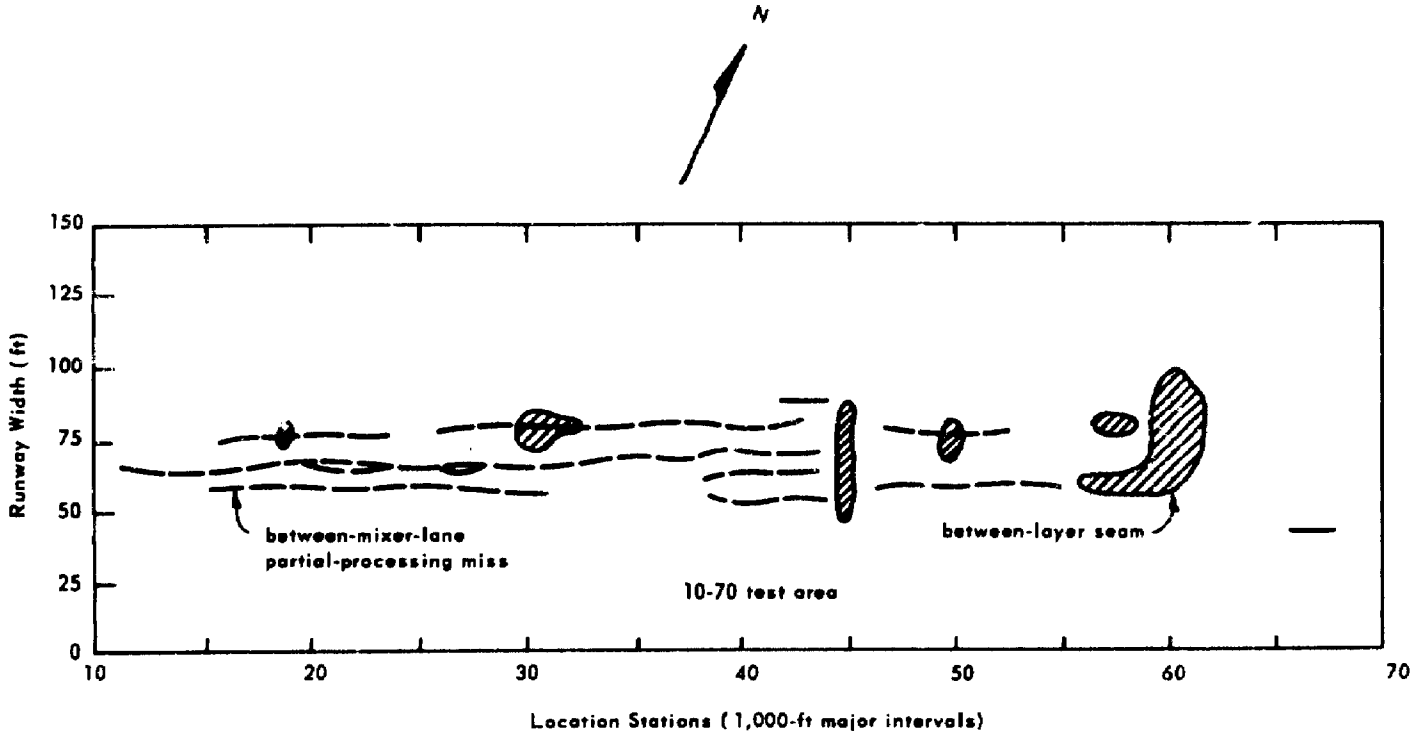
Figure 6. Location of processing misses in the DF-65 compacted-snow layer.

One type of low-strength snow in the DF-65 layer was caused by partial-processing misses between mixer lanes down the middle of the area (Figure 6). These misses resulted from sideslip of the snow mixers during construction; they were narrow and intermittent.

The other type of low-strength snow in the DF-65 layer was caused by seams of unprocessed snow between the DF-64 and DF-65 layers (Figure 6). These misses were caused by varying the cutting depth of the snow mixer rotors during construction; they were slightly crowned in cross section and varied in size and shape.

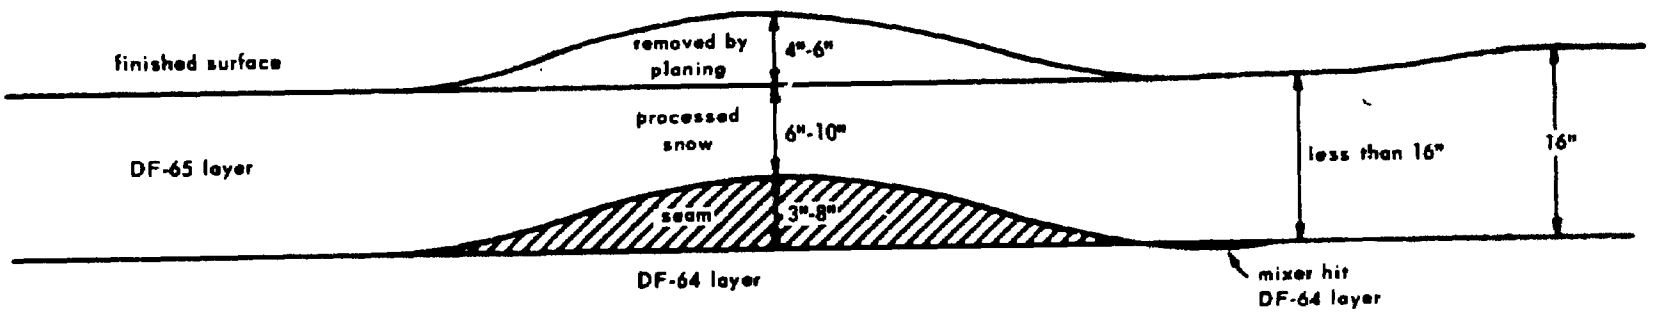
Figure 7. Cross section showing seam of unprocessed snow between the DF-64 and DF-65 layers of compacted snow.

As discussed under Construction of the DF-65 Layer, the snow cover down the middle of the area varied as much as 6 inches from place to place. To avoid stalling the mixer engines during processing, the depth of the rotor cut was varied as much as 4 inches, depending on the thickness of the snow cover. After processing, eight pronounced undulations up to 6 inches high were removed to level the surface of the DF-65 layer; they varied from 10 to 50 feet in width and from 50 to 700 feet in length. Examination showed that seams of unprocessed snow up to 4 inches thick existed under these pronounced undulations and, after leveling, the processed snow over these seams was only 6 inches thick in places (Figure 7). Some of the seams were found when testing the area with the snow test instruments. None were repaired until they failed during the aircraft tests, thus permitting observations on the bearing capacity of the compacted snow over the seams.

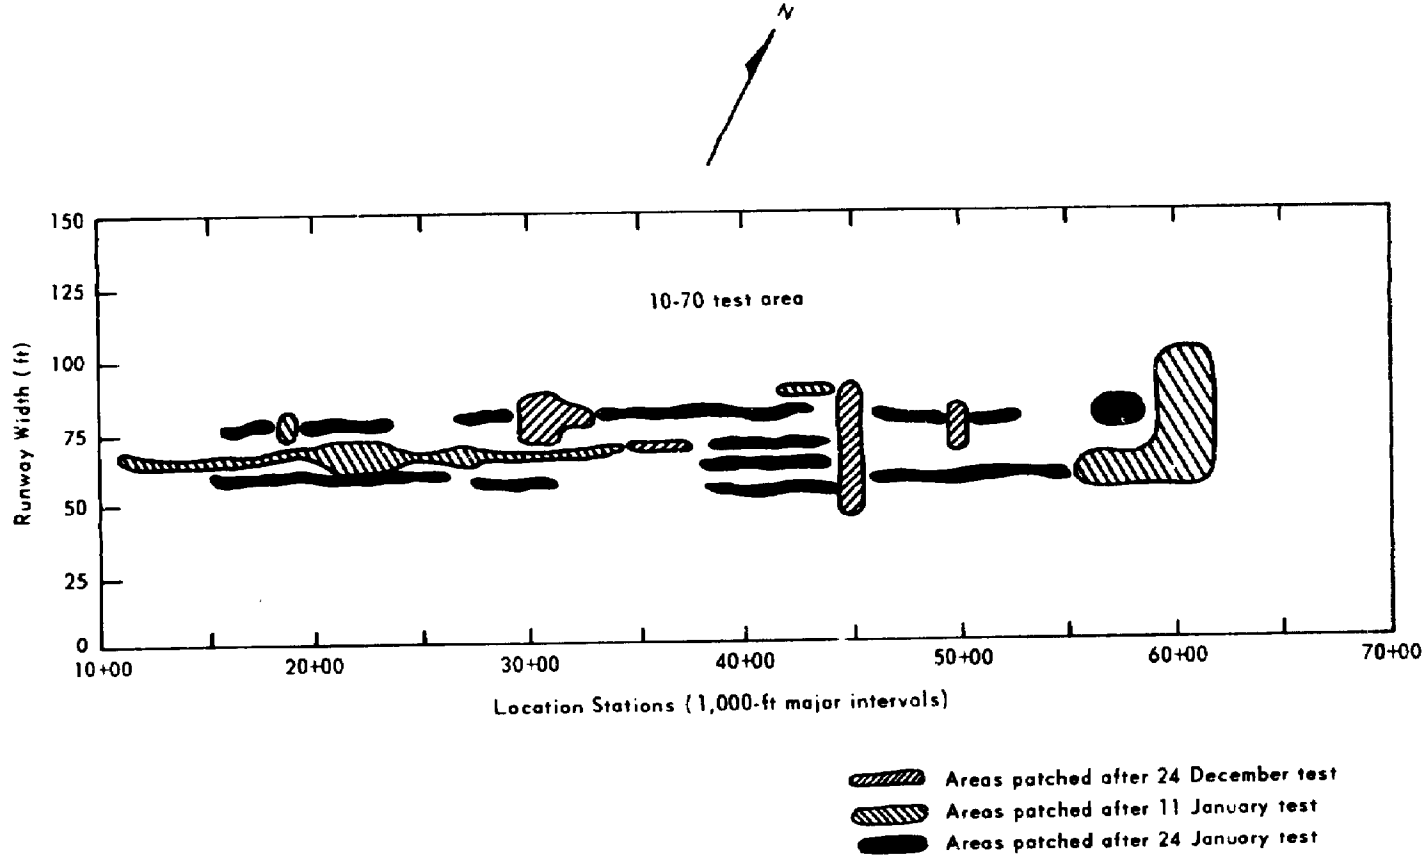
Figure 9. Location of areas patched with snow mixer following LC-130F aircraft tests to 24 January 1965.

During the 24 December LC-130F aircraft test, a between-mixer-lane partial-processing miss near Station 35+00 and three between-layer seams of unprocessed snow near Stations 30+00, 45+00, and 50+00 were detected by the main wheels of the aircraft. By Rammsonde probing, it was found that the partial-processing miss near Station 35+00 was 320 feet long and up to 2 feet wide. It was 70 feet from the south edge of the area and parallel with this edge (Figure 9). The between-layer seam of unprocessed snow near Station 30+00 was 330 feet long and 17 feet wide. The one at Station 45+00 was 100 feet long and 48 feet wide, and that at Station 50+00 was 100 feet long and 18 feet wide. All were located along the middle of the area, and the unprocessed seam of snow in all three was up to 4 inches thick.

During the 24 January aircraft test, four new between-mixer-lane partial-processing misses and one between-layer seam of unprocessed snow were detected by the main wheels of the aircraft. By probing with the Rammsonde, it was found that two parallel between-mixer-lane misses extended intermittently between Stations 15+00 and 55+00. One was located about 55 and the other about 80 feet from the south side of the area. In addition, two other parallel between-mixer-lane misses about 8 feet apart were found near the middle of the area between Stations 38+00 and 44+00. All these misses were less than 2 feet wide. The between-layer seam of unprocessed snow was found near Station 58+00. It was in the middle of the area, and had a maximum depth of only 3 inches.

The 24 December failures were repaired between 26 and 29 December with snow mixer patches using three-pass processing and the model 36/42 snow mixer fitted with the 36-inch-diameter rotor. To increase the percentage of fine snow particles in the patches and to avoid depressing these below the surface, a 3-inch layer of old natural snow from the south spoil bank was placed over each area before it was processed with the snow mixer. The first mixer pass was made in first gear at a rotor peripheral speed of 1,682 fpm, the second pass in second gear at a rotor peripheral speed of 4,756 fpm, and the third pass in fourth gear at the rotor peripheral speed of 5,937 fpm. The cutting depth of the rotor was set at 18 inches and the travel speed of the mixer train adjusted to maintain this cutting depth and the rotor peripheral speed selected for each pass. Each pass was made over the entire area being patched before proceeding with the next pass. At the start of each mixer lane, the rotor was positioned over the edge of the patch and forced down to its full cutting depth before the mixer train was moved forward. The mixer was stopped at the end of the patch and the rotor pulled straight up. Where more than one 8-foot-wide mixer lane was required for a patch, each new lane overlapped the preceding lane about 3 feet. Immediately after the third mixer pass, the patch was graded with the snow-plane and then rolled three times with the snow-compaction roller.

These five areas were repaired with snow mixer patches between 26 and 30 January. The repairs were similar to those previously described except, for lack of haul equipment, the 3-inch layer of old natural snow was omitted in these patches. This omission resulted in 3-foot-wide by 6- to 10-inch-deep concave depressions in the surface where the mixer entered and left the area being patched. These depressions were filled with processed snow on 31 January from a 100-foot-long strip of processed snow manufactured alongside the 10-70 area. The freshly processed snow was hauled to the patch by truck and shoveled and tamped into place by hand. It was then compacted with five passes of the snow-compaction roller towed with a size 2 snow tractor.

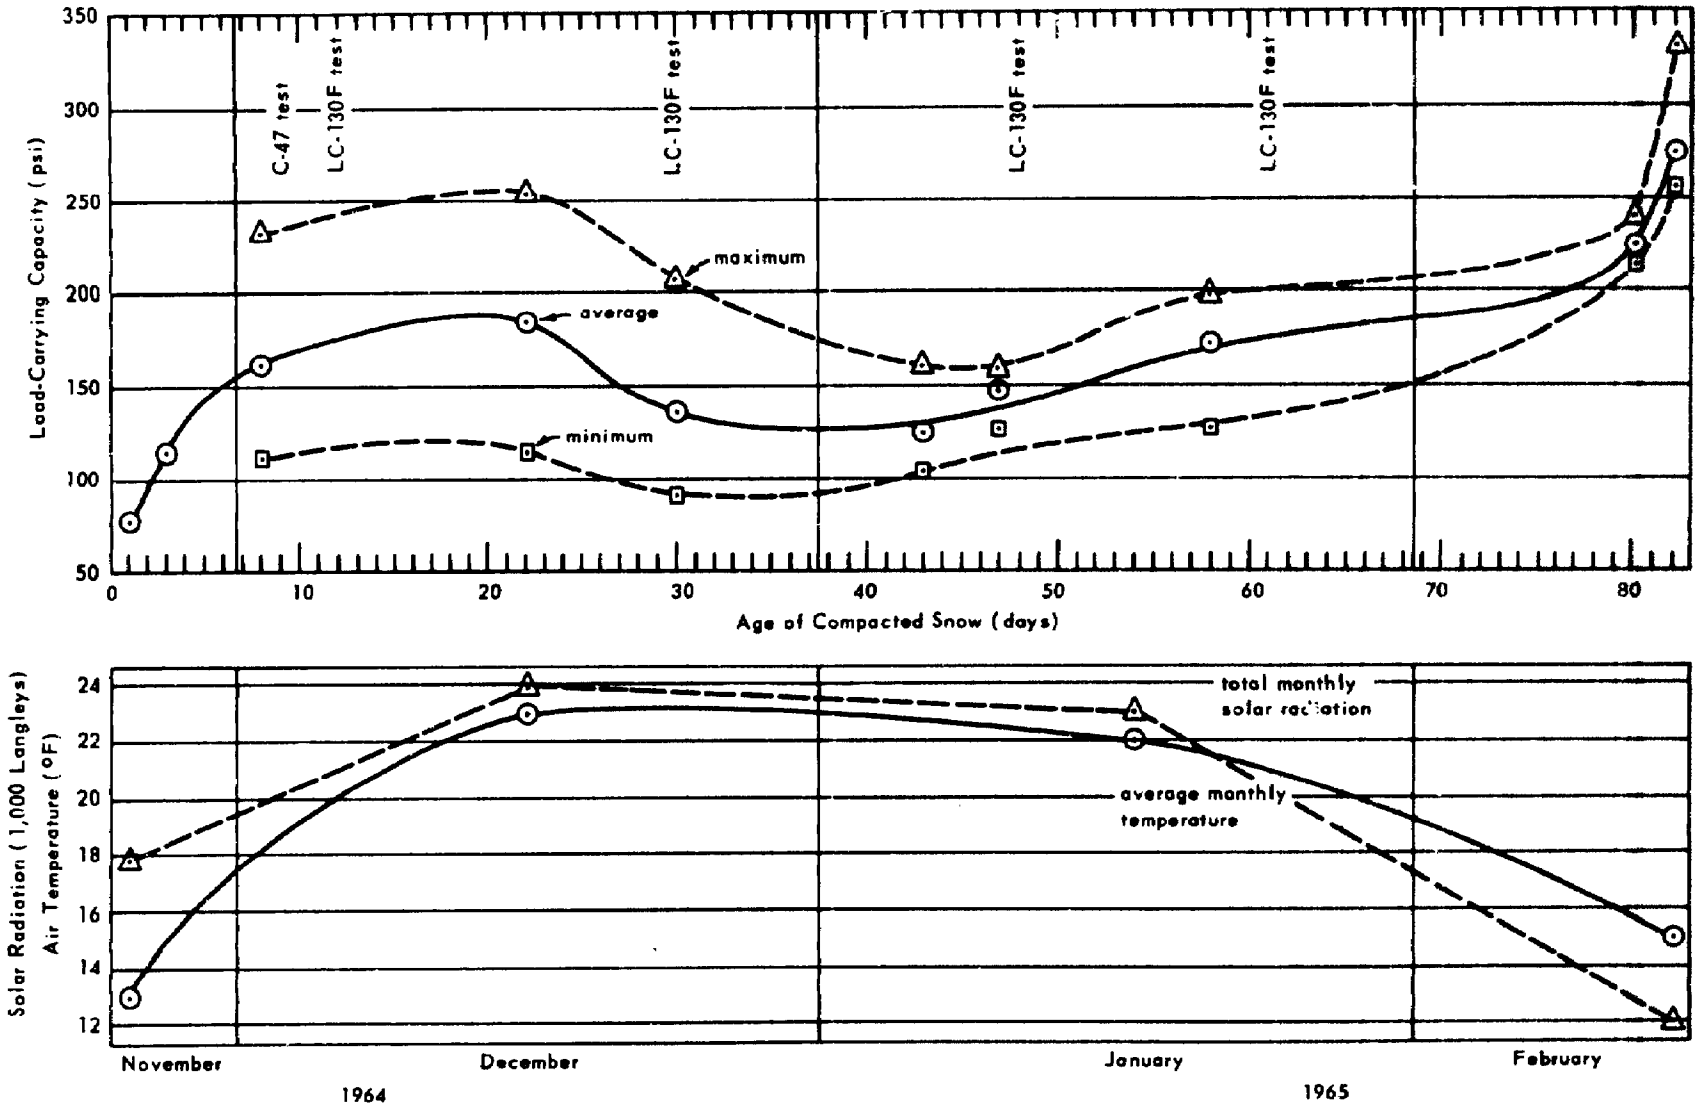
Figure 13. Maximum, minimum, and average load-carrying capacity in the DF-65 compacted-snow layer on the 10-70 test area from December 1964 to February 1965 as determined by confined shear.

On 2 December the maximum load-carrying capacity of the 8-day-old DF-65 layer as determined by 22 confined-shear tests was 235 psi, the minimum 112 psi, and the average 162 psi. By 16 December the maximum load-carrying capacity was 255 psi for an increase of 9%, the minimum 117 psi for an increase of 4%, and the average 184 psi for an increase of 14%. Between 16 December and 6 January, which covers the period of maximum solar radiation at the test site (Figure 13), the maximum load-carrying capacity decreased to 160 psi or 37%, the minimum to 104 psi or 11%, and the average to 124 psi or 33%. Between mid-January and mid-February the solar radiation and average air temperature decreased rapidly at the test site. By 12 February the maximum load-carrying capacity of the DF-65 layer was 237 psi for an increase of 48% since early January, the minimum 214 psi for an increase of 106%, and the average 226 psi for an increase of 82%. During the next 2 days, 12 to 14 February, there was a sharp rise in the strength of the DF-65 layer. The maximum load-carrying capacity increased 45% to 332 psi, the minimum 21% to 258 psi, and the average 22% to 276 psi.

Up to 24 December the difference between the maximum and minimum load-carrying capacities in the DF-65 layer was over 125%; by 6 January it was less than 60%, and by 14 February it was less than 30%. This decrease was attributed primarily to the repairs which eliminated most of the zones of low-strength snow in the DF-65 layer. These repairs also contributed to the overall increase of strength in this layer.

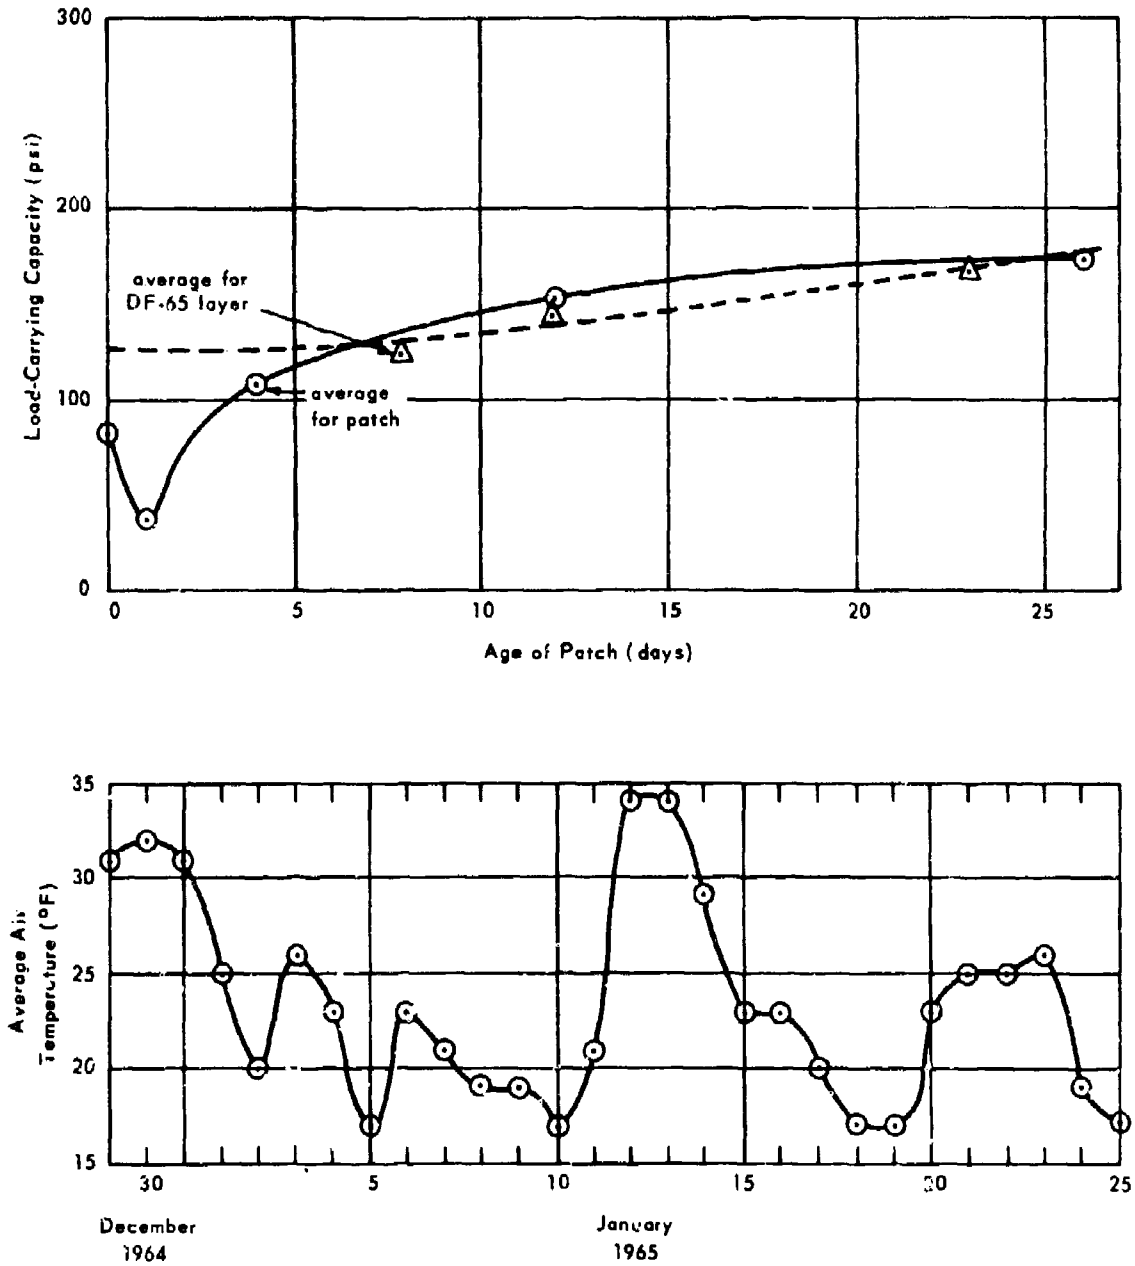
The growth of strength in the 29 December snow mixer patch at Station 30+00 is shown in Figure 14. The average load-carrying capacity in the 12-inch layer of compacted snow over the 4-inch-thick seam of unprocessed snow at this location was 80 psi before the repair. Fifteen hours after the patch was completed the average load-carrying capacity in the reprocessed snow was 39 psi; 3 days later it was 110 psi or nearly 40% more than before being patched. On 10 January, or 9 days later, it was 159 psi compared with an average load-carrying capacity of 148 psi in the 47-day-old compacted snow in the DF-65 layer. On 24 January, the average load-carrying capacity in the 26-day-old patch was 174 psi, or about the same as the average in the 61-day-old compacted snow. The growth of strength and load-carrying capacity in the other snow mixer patches on the DF-65 layer between late December and mid-January were similar to those at Station 30+00.

Figure 14. Growth of strength in the 29 December 1964 snow mixer patch at Station 30+00.

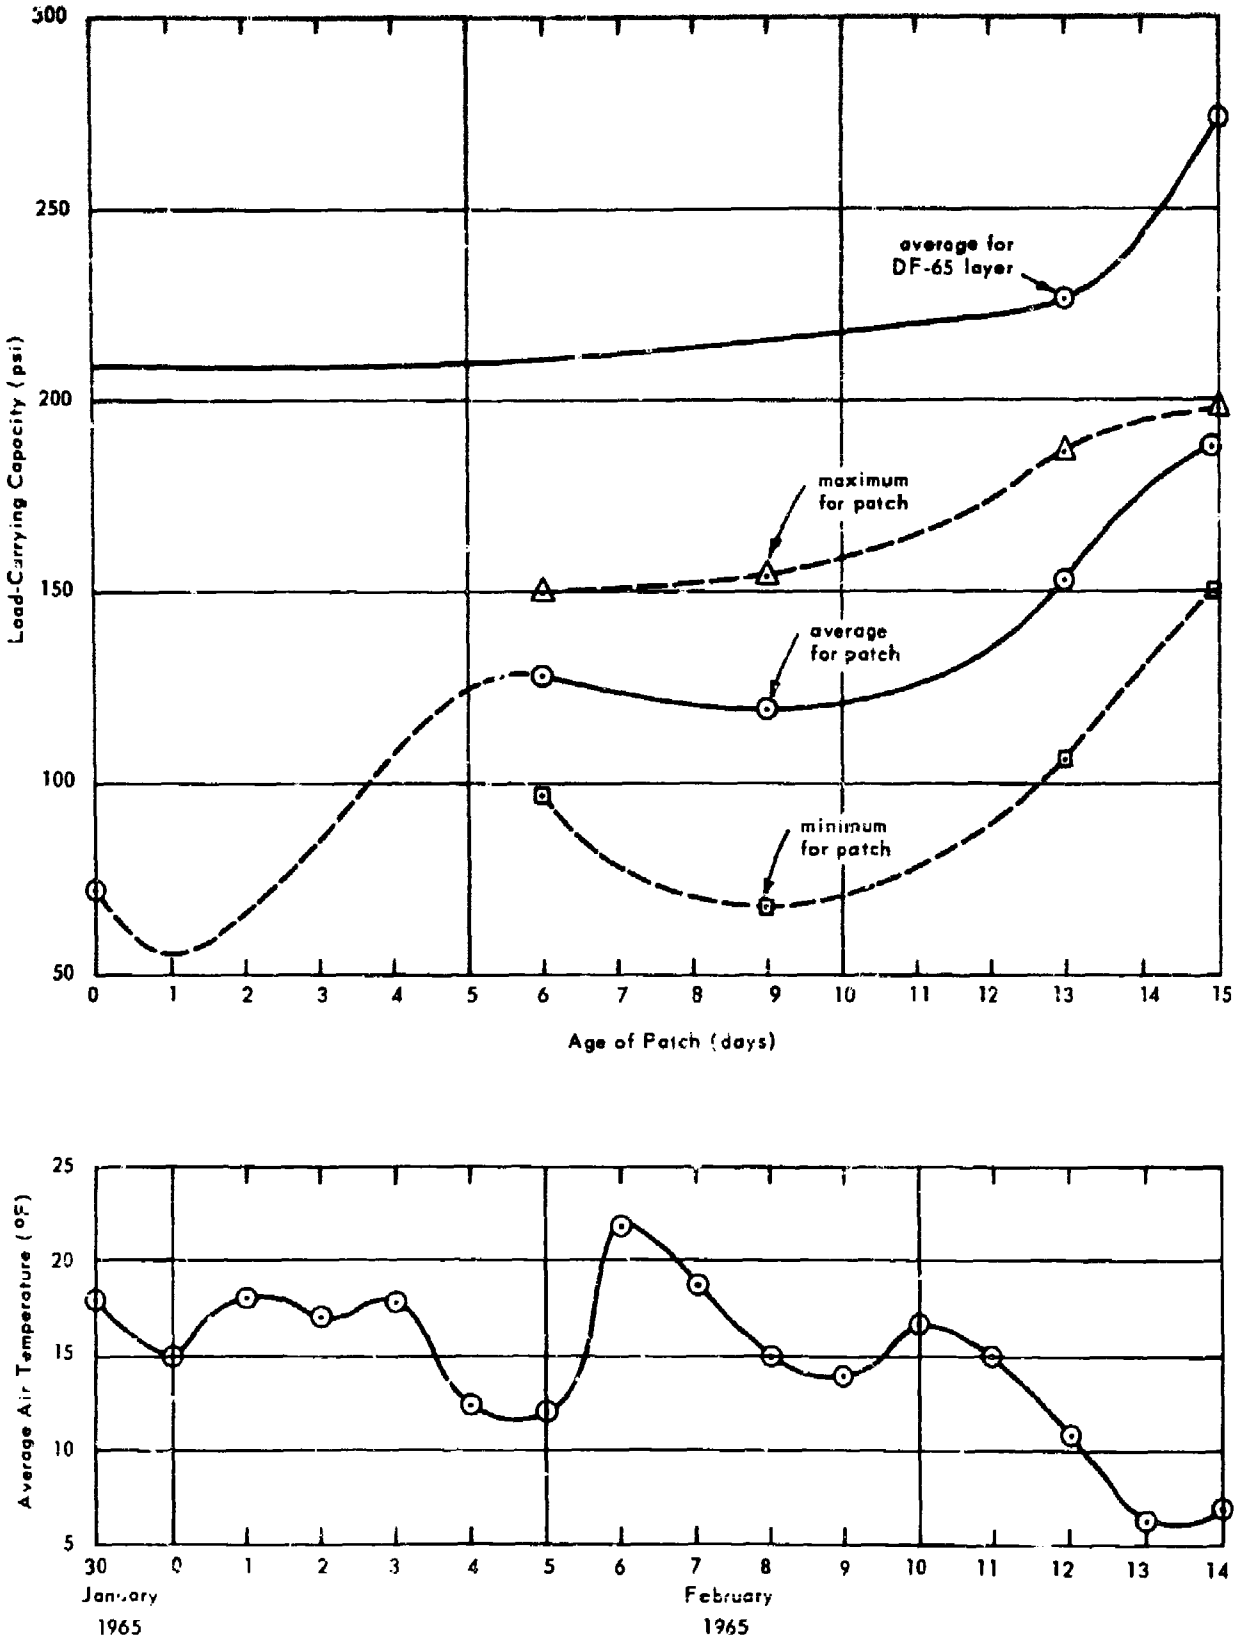
The average growth of strength in a 30 January snow mixer patch in the DF-65 layer is shown in Figure 15. The average load-carrying capacity for the zone of low-strength snow at the location of this patch was 70 psi before the repair. Six days later the average load-carrying capacity in the reprocessed snow was 129 psi. The maximum was 151 psi and the minimum 99 psi, representing a difference of about 34%. On 8 February, 9 days after the repair, the average load-carrying capacity in the patch was only 120 psi, or about one-half the average for the 76-day-old compacted snow in the DF-65 layer. In an attempt to increase the bearing capacity of the late January patches, they were rolled once a day with the 9-ton, 13-wheel, pneumatic-tired roller, starting on 10 February. Within 3 days the average load-bearing capacity in the 29 January patch increased nearly 30% to 154 psi, and within 5 days it increased nearly 50% to 178 psi. During this same period, however, the average load-bearing capacity in the 82-day-old compacted snow in the DF-65 layer increased 45% without the rolling.

Figure 15. Growth of strength in a 30 January 1965 snow mixer patch in the DF-65 layer.

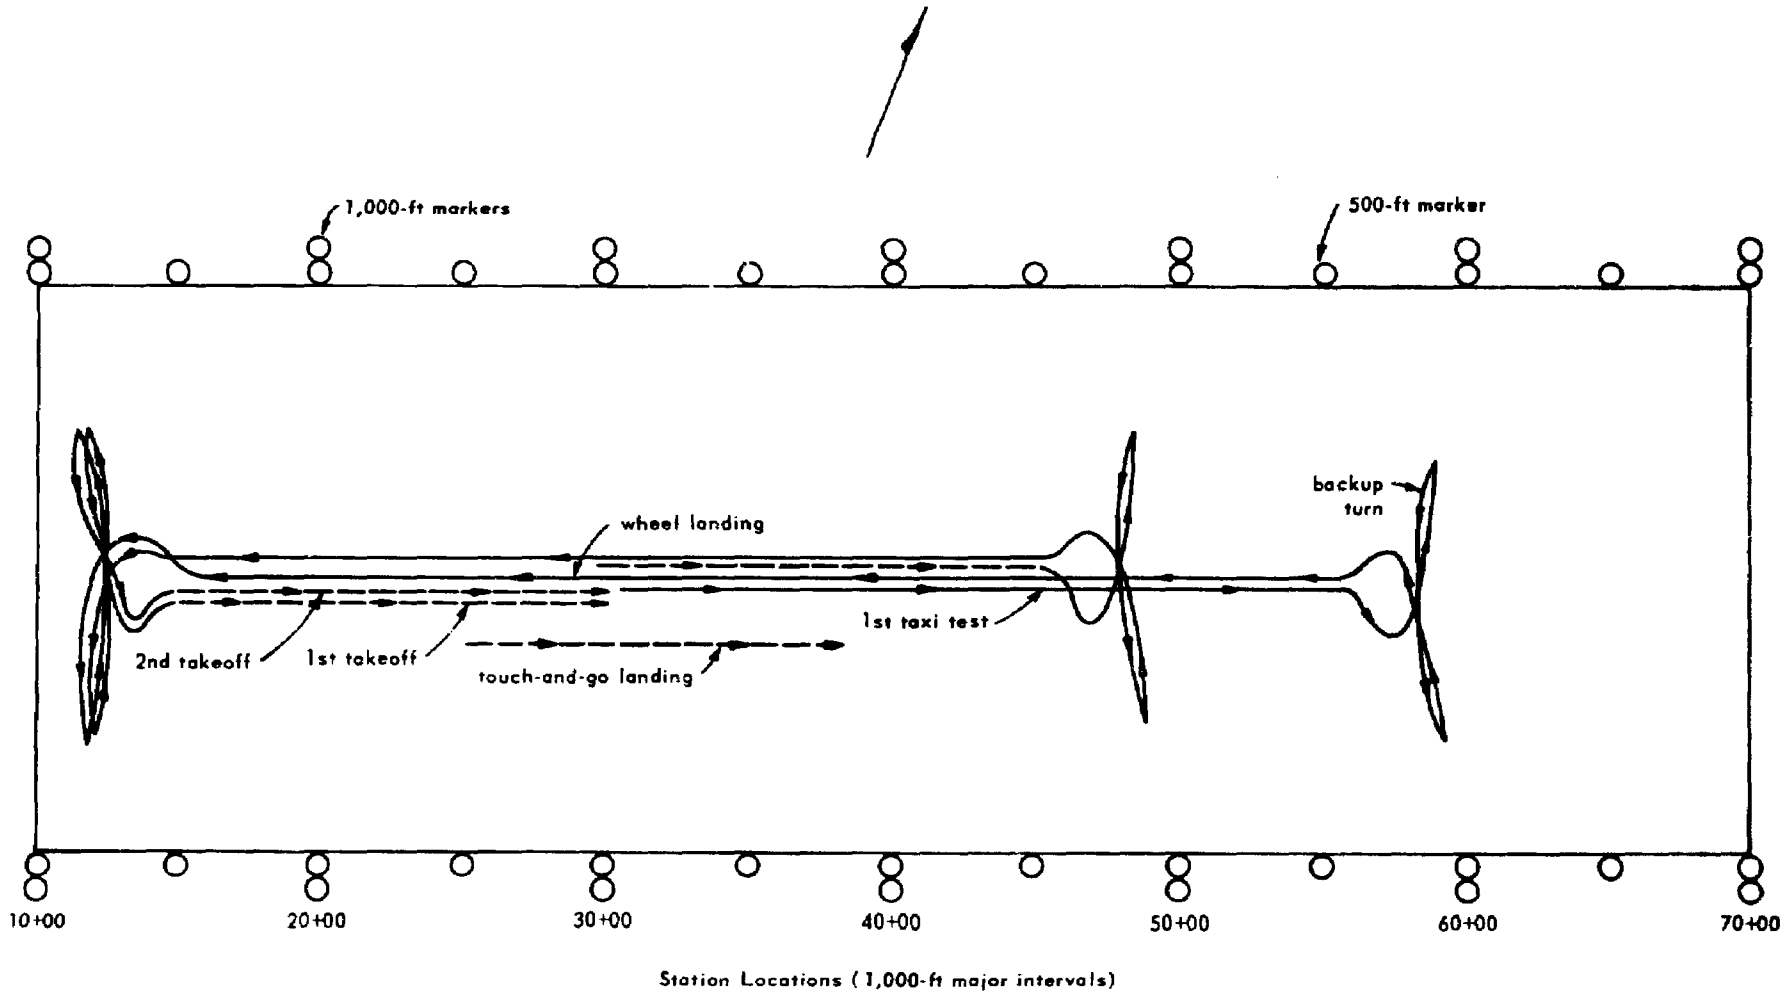
Figure 17. LC-130F aircraft traffic pattern on 10-70 test area in 6 December 1964 test.

Two failures occurred in the DF-65 layer during the 6 December aircraft test. One was near Station 45+00 where the aircraft was moving across the test area in a sharp turn, and another near Station 46+50 where one set of the tandem main wheels backed across its own tracks in a turn. Both failures were confined; that is, the aircraft crossed the areas where the failures occurred without a loss of speed or mobility.

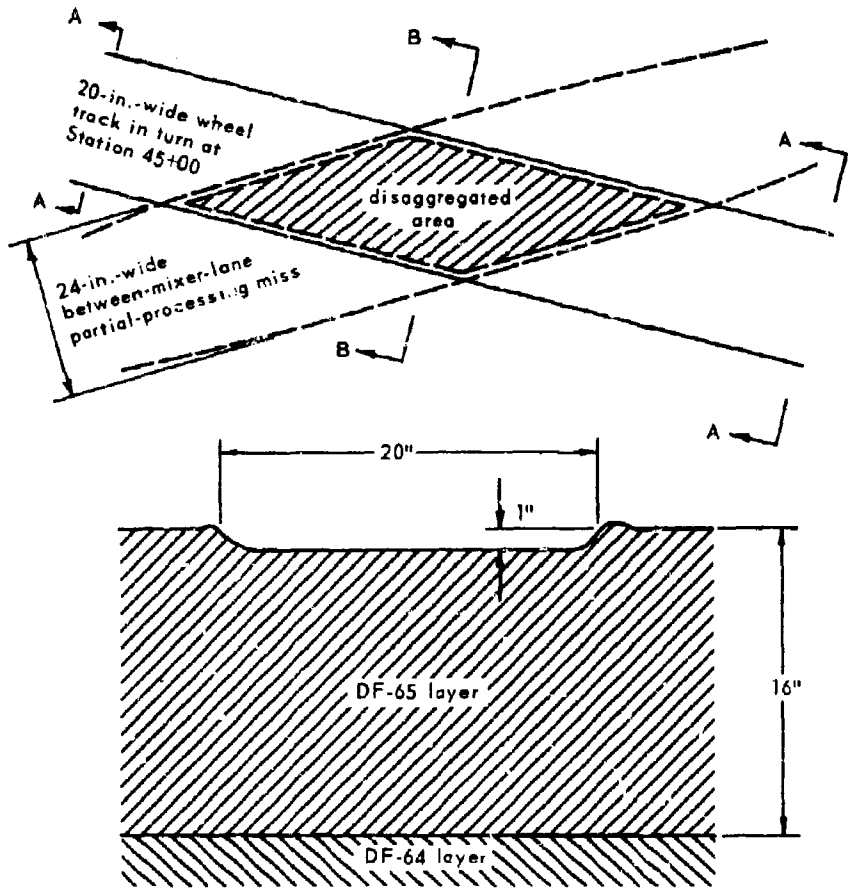
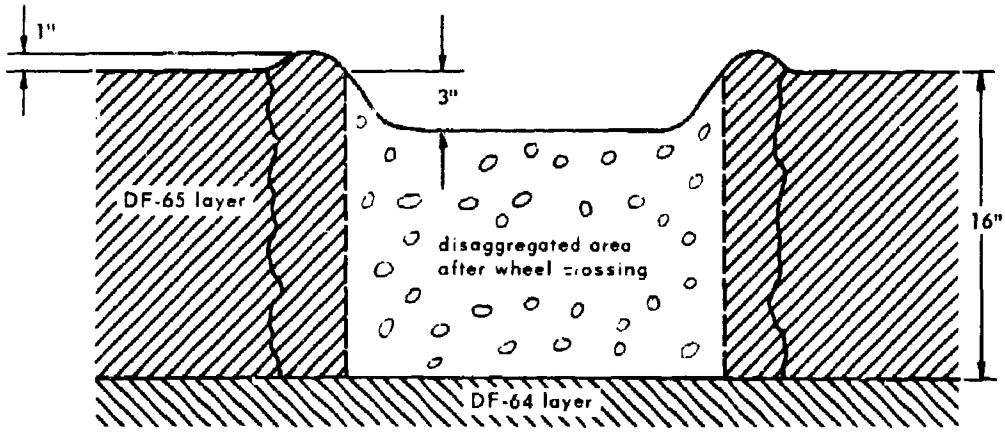
Figure 19. Failure under main wheels of LC-130F aircraft at Station 45+00 on 6 December 1964.

In the turn at Station 45+00, the aircraft was moving at a 30-degree angle to the centerline of the area when it crossed a 2-foot strip of snow where the 95-psi main wheels indented the surface to a depth of 3 inches (Figure 19). Examination showed that the aircraft crossed a between-mixer-lane partial-processing miss (see Repairs, Part II) in the DF-65 layer which tapered out and disappeared about 25 feet beyond either side of the crossing.

The snow in the miss was completely disaggregated and compacted at the wheel crossing, but the adjacent snow in the DF-65 layer and the underlying DF-64 layer of compacted snow was undisturbed. The size, orientation, and containment of the miss coupled with its relatively high-density snow permitted the aircraft to roll across the failure without difficulty. The nose wheels also crossed the miss but they only marked the surface with their tire prints.

As measured by confined shear, the load-carrying capacity of the partially processed snow in the miss at Station 45+00 was 79 psi, or only 62% of the 127-psi load-carrying capacity in the fully processed layer of snow adjacent to the miss. It was less than one-half of the 162-psi average load-carrying capacity established for the DF-65 layer on 2 December. The average density of the snow in the miss was 0.56 gm/cm^3, or the same as the average for the once-processed snow in the DF-65 layer.

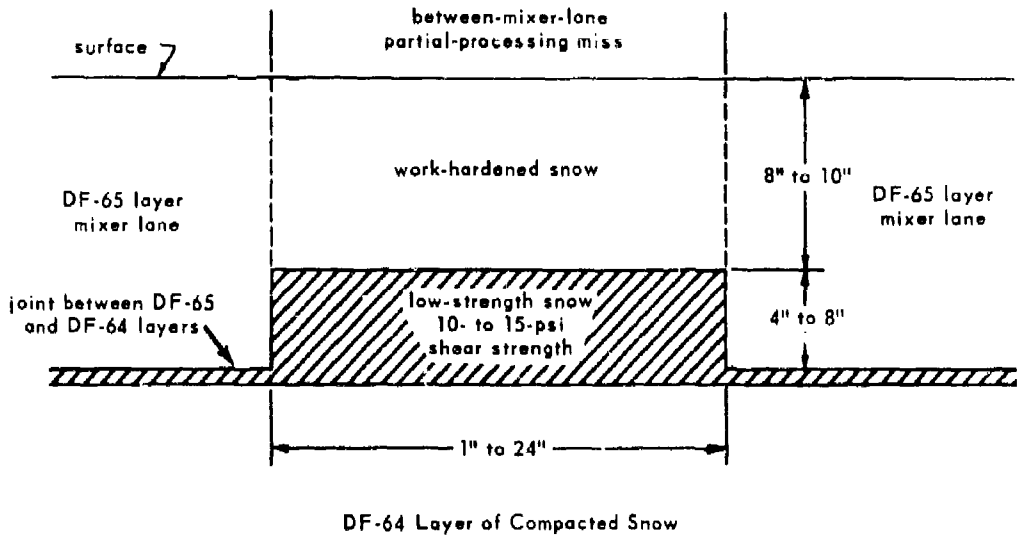
Figure 20. Cross section of a between-mixer-lane partial-processing miss in the DF-65 layer of compacted snow in 11 January 1965 test.

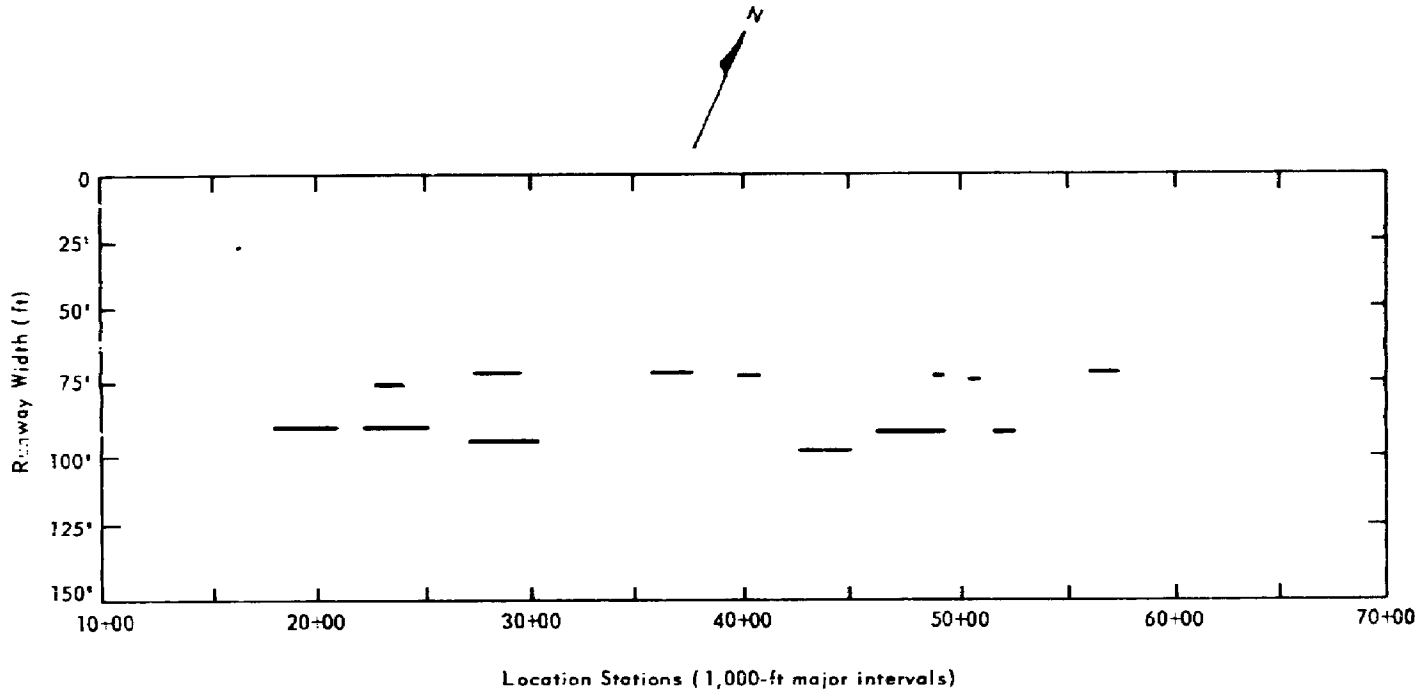
Confined-shear measurements were made along the breakthroughs that occurred at the between-mixer-lane misses. These measurements showed that the confined-shear strength in the top 8 inches of work-hardened snow in these misses (Figure 20) ranged from 22.6 to 34.0 psi for an average of 28.3 psi; but the confined-shear strength of the snow 8 to 12 inches below the surface was 10 psi or less. The breakthroughs occurred because the strength of the work-hardened snow was not sufficient to support the load, and the shear strength of the underlying 4-inch layer of snow was not sufficient to transmit this load to the compacted snow in the DF-64 layer. When the main wheels of the aircraft passed over one of these misses, the layer of low-strength snow compacted and the work-hardened snow failed in shear and disaggregated under the wheels.

Figure 22. Location of the 13 wheel breakthroughs on the 10-70 test area in the LC-130F aircraft test on 24 January 1965.

Confined-shear measurements in the between-layer miss near Station 58+00 showed that the DF-65 layer of compacted snow was only 6 inches thick, and the seam of unprocessed snow between it and the DF-64 layer was up to 3 inches thick. The load-carrying capacity of the 6-inch layer of DF-65 compacted snow ranged from 53 to 83 psi for an average of 66 psi, and the confined-shear strength of the underlying 3-inch seam of unprocessed snow was 10 psi or less. This combination resulted in the same type of failure that occurred in the between-mixer-lane misses.
