FINAL REPORT ON

DEVELOPMENT OF INFLATABLE

FRAME FOR ARCTIC SURVIVAL

SHELTER

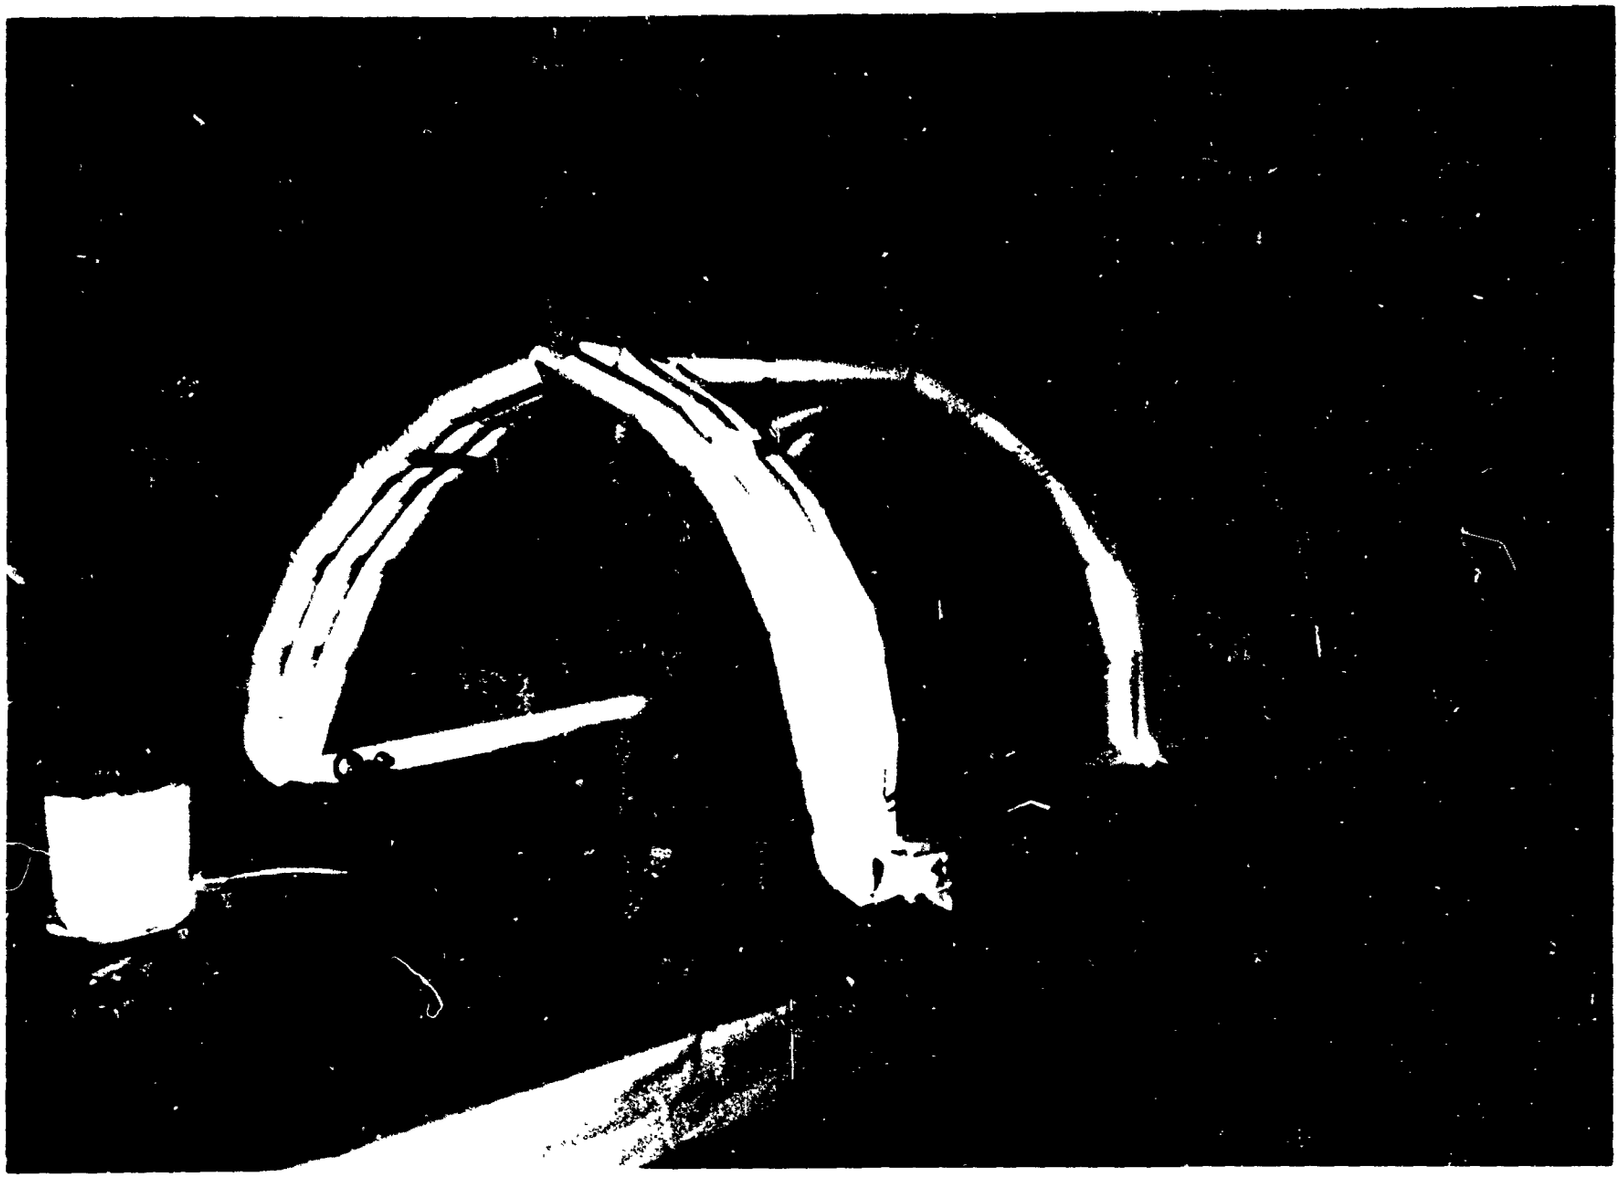
Figure 1 Frame and Pump Configuration

By fabricating with a continuous tube it was possible to reduce the number of openings in the frame and therefore decrease the probability of leakage. Figure 1 shows the single tube configuration. Two additional sets of legs were added to the first pair of legs in an attempt to give additional load-bearing capability. The two tube ends were joined with a butt joint seal at the apex of the first set of legs.

Frame fit had improved but still offered some trouble in the door area, and the load-bearing capability was still under the 5-pound goal. The load attachment strap on the rear had been eliminated through a mutual design change agreement with the Aeromedical Laboratory. Due to the minimum height in the shelter, use of the load strap in the rear was rather unlikely.

The leak integrity of this replacement unit was excellent. A slight problem was encountered with leakage at 0 and -30 F caused by a loose fit of the rubber tubing at the inlet valve. Some freezing of the check-valve was encountered at +32 and 0 F because of the high moisture content in the air.
