UNITED STATES ARMY HELICOPTER ACCIDENTS INVOLVING FIRE

Report No. 1-64

UNITED STATES ARMY BOARD FOR
AVIATION ACCIDENT RESEARCH
Fort Rucker, Alabama

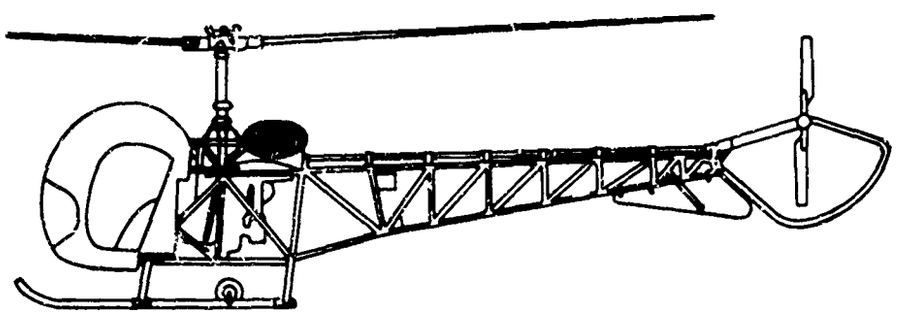
FIGURE 1

OH-13 models D and E single fuel cell

During FY 1958 - FY 1960, the OH-13D's and E's made up 15% of the Army's helicopter inventory and flew 12% of the hours and attained the lowest fire-impact survivable accident rate of all models listed (Table 3). During the next three years, an increase of one accident and a 30% reduction in flying hours caused the rate to more than double that of the previous three years, reaching 2.4/100,000 hours. In addition to showing a change in trend, this change illustrates the variability of rates and emphasizes the need for caution in their use.

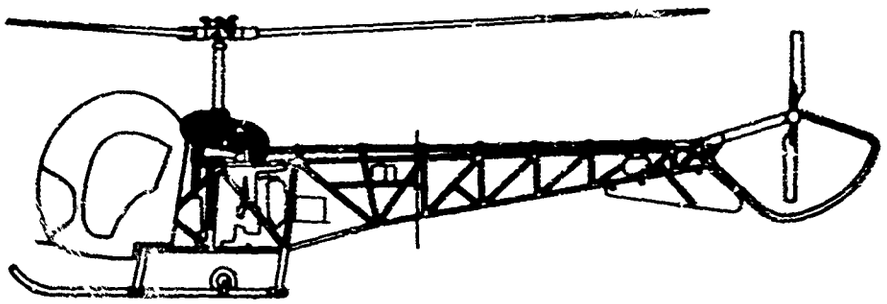
FIGURE 2

OH-13 models G and H twin fuel cells

The susceptibility of fuel cells to rupture when located in a position similar to those of the OH-13G and H series is reflected in this statement: "The main rotor blades struck the ground six times and stopped revolving. The impact of the main rotor blades caused the aircraft to roll to its left and strike the ground with the left gasoline tank, then bounce and come to rest on its right side. As it came to rest, the fuel tank and lines were ruptured allowing fuel to contact the hot engine. . ."[7]

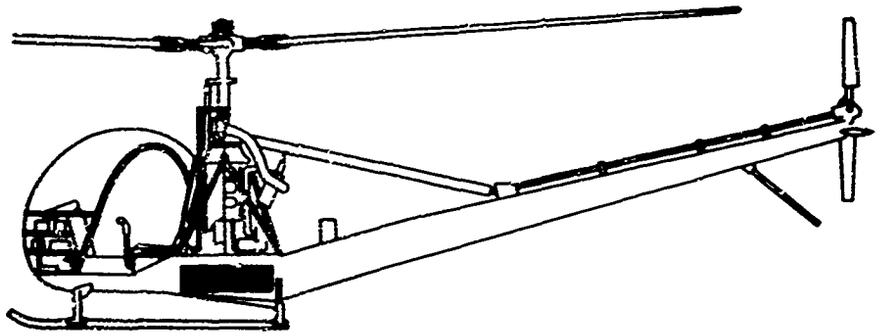
FIGURE 3

The record of the OH-23 suggests that the protective location of blades,

OH-23 single bladder-type fuel cell

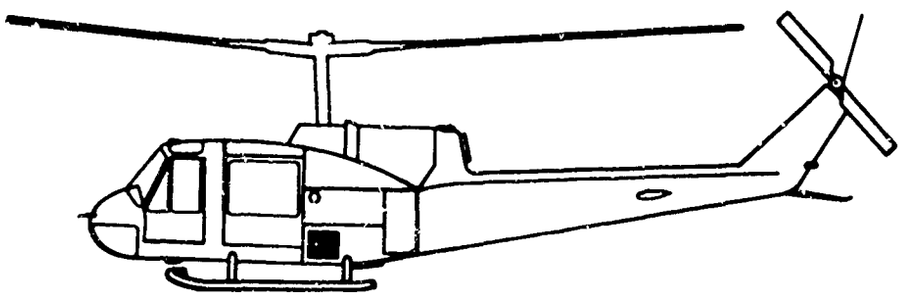
FIGURE 4

The UH-1 bladder-type cells located aft and outboard of the cockpit with most of the cells above the cockpit floor provide added protection (Figure 4). The lower portion of the cells are extra strength self-sealing, while a layer of energy-absorbing honeycomb surrounds the lower portion of cells adjacent to the skin. As a result, statements taken from a UH-1D, FY 1964, accident report read: "Sharp object (tree trunk) penetrated the fuselage bottom under the left forward fuel cell and crushed the protective honeycomb layer without affecting fuel cell integrity."[2]

UH-1 bladder-type fuel cells aft and outboard of the cockpit

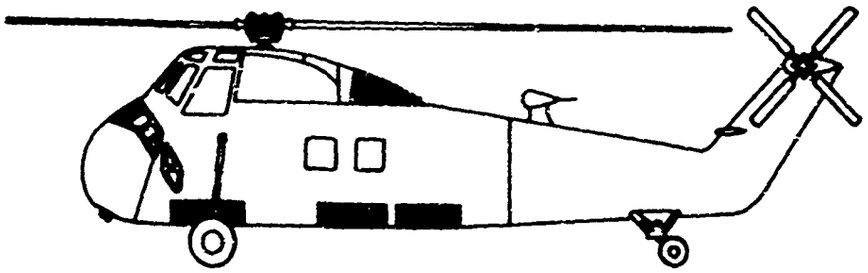
FIGURE 5

CH-34 with three fuel cells in the belly of the helicopter

In contrast, a CH-34 (Figure 5) accident report of the study period reads: "Tree trunk penetrated the belly of helicopter, rupturing the fuel tanks. Explosion and fire ensued."[3]

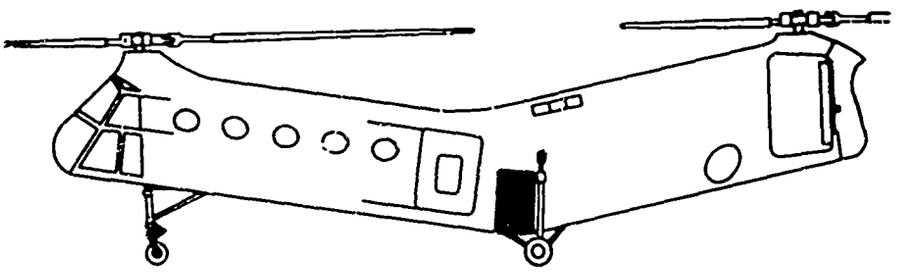
FIGURE 6

Fire erupting due to the landing gear penetrating the fuselage and puncturing the fuel cells is not an unusual experience for the CH-21 and UH-19. Figures 6 and 7, respectively, show the relative location of the fuel cells and landing gear in these aircraft.

CH-21 fuel cell location in relation to landing gear

The fire hazard in this type of installation is evident in the following statement: "The aircraft (CH-21) contacted the ground with an excessive rate of descent resulting in a hard touchdown which caused both main gear struts to detach at the upper end and the fuel cells to rupture. The aircraft immediately burst into flames."[8] Fire in the two CH-21 roll-over type accidents listed in Table 5 are also the result of gear punctured fuel cells.

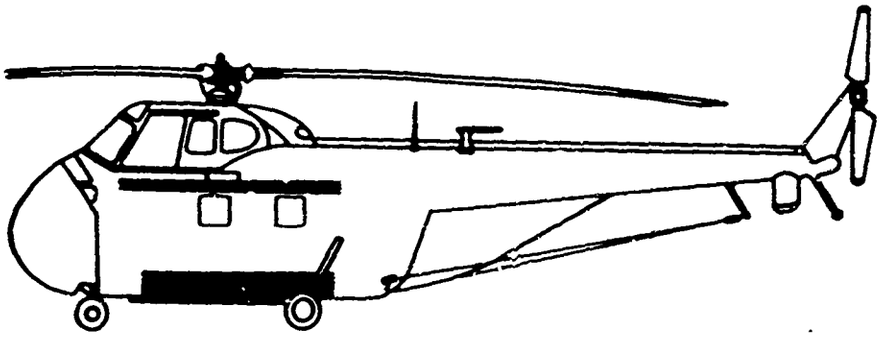
FIGURE 7

UH-19 fuel cell location in relation to landing gear

The UH-19 and CH-34 experience, as the following statement from a UH-19 report illustrates, are quite similar. In addition, the fire origin is pinpointed—a fact seldom determined. "The left main gear was forced upward by the impact and punctured the left side of the aft tank. Subsequent pitching motion caused fuel from the punctured tank to splash forward making contact with either the engine exhaust or the engine itself, causing the fire."[9]
