USAAVLABS TECHNICAL REPORT 68-30

INSPECTION, REPAIRS AND MODIFICATIONS, AND FLIGHT TEST OF THE FLEXIBLE-WING MANNED TEST VEHICLE XV-8A

RYAN AERONAUTICAL COMPANY
SAN DIEGO, CALIFORNIA

Final Report

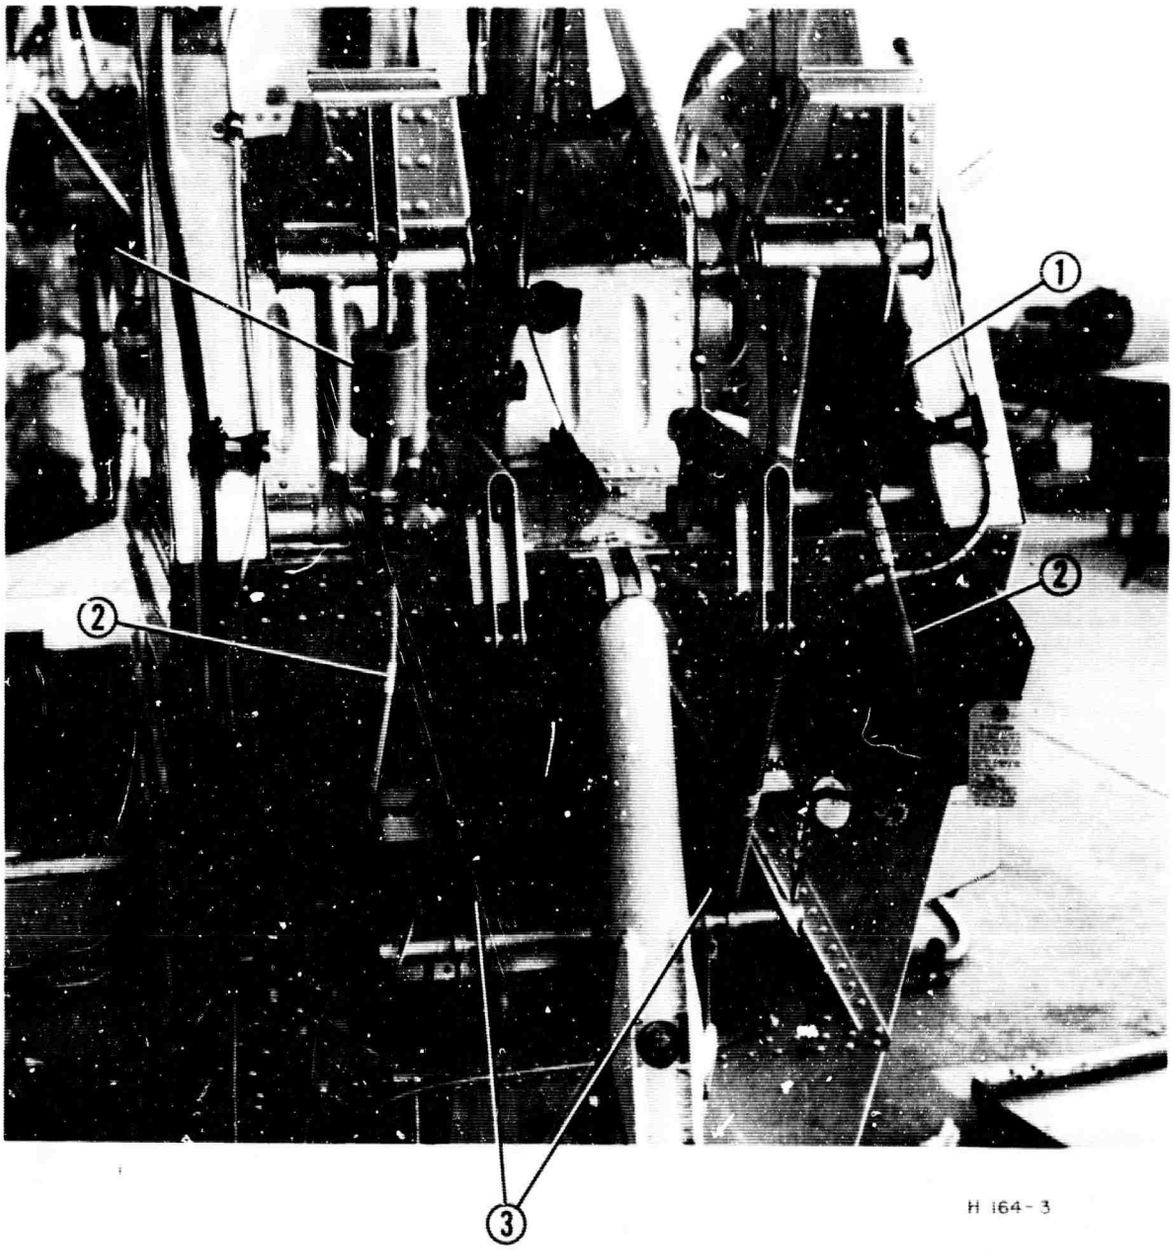
Figure 3. Brake and Rudder Force Gradient Modifications

Legend: 1 - Differential Braking Cylinders
2 - Hydraulic Brake Lines
3 - Rudder Force Gradient Springs
