NRL Memorandum Report 1950

Analysis of the Failure of the AUTEC TOTO II Deep Sea Moor and the Performance of its Cathodic Protection System

R. E. Groover

November 1968

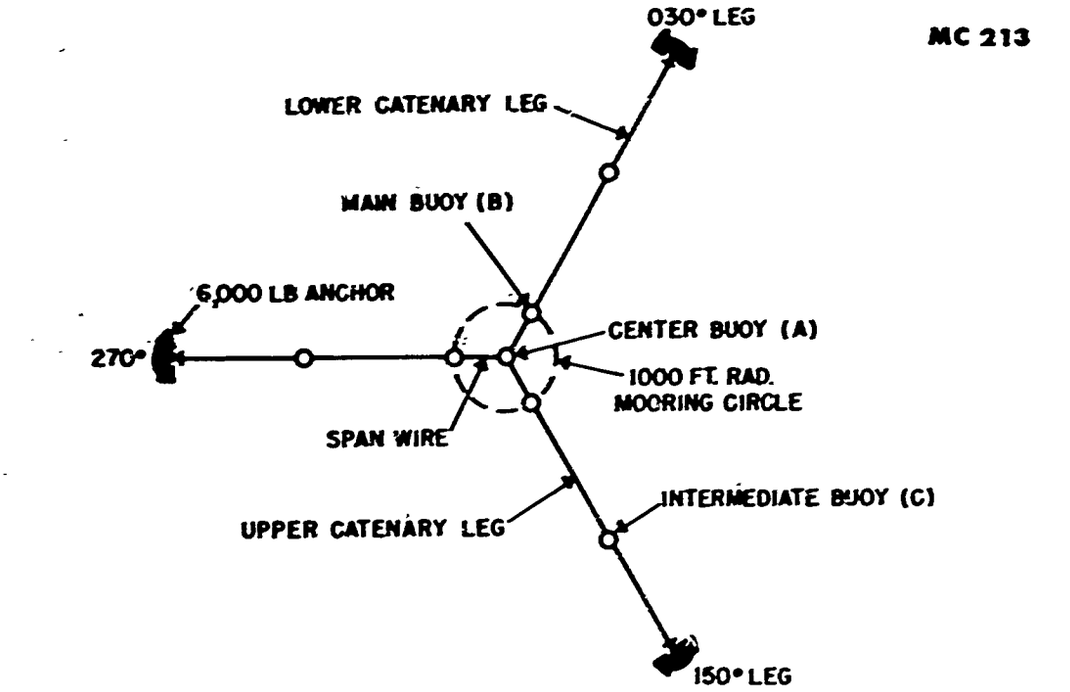
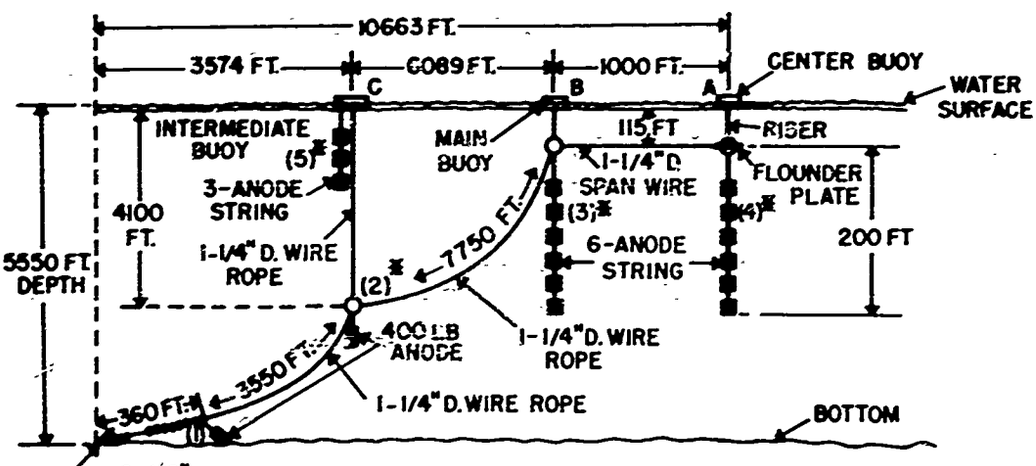
Fig. 1 - Plan view of the moor in the upper sketch and a typical mooring leg elevation in the lower sketch (not to scale).

(1) 400 LB ANODE AT END OF ANCHOR CHAIN
(2) 400 LB ANODE AT GROUND RING UNDER INTERMEDIATE BUOY
(3) SIX-60 LB ANODE STRING AT GROUND RING UNDER MAIN BUOY
(4) SIX-60 LB ANODE STRING AT FLOUNDER PLATE UNDER CENTER BUOY
(5) THREE-60 LB ANODE STRING ATTACHED TO INTERMEDIATE BUOY
(*) 17-19 NOV. 1965, REPLACED BY SIX-120 LB MAGNESIUM ANODES. 400 LB ANODES WERE LOST DURING REPLACEMENT.

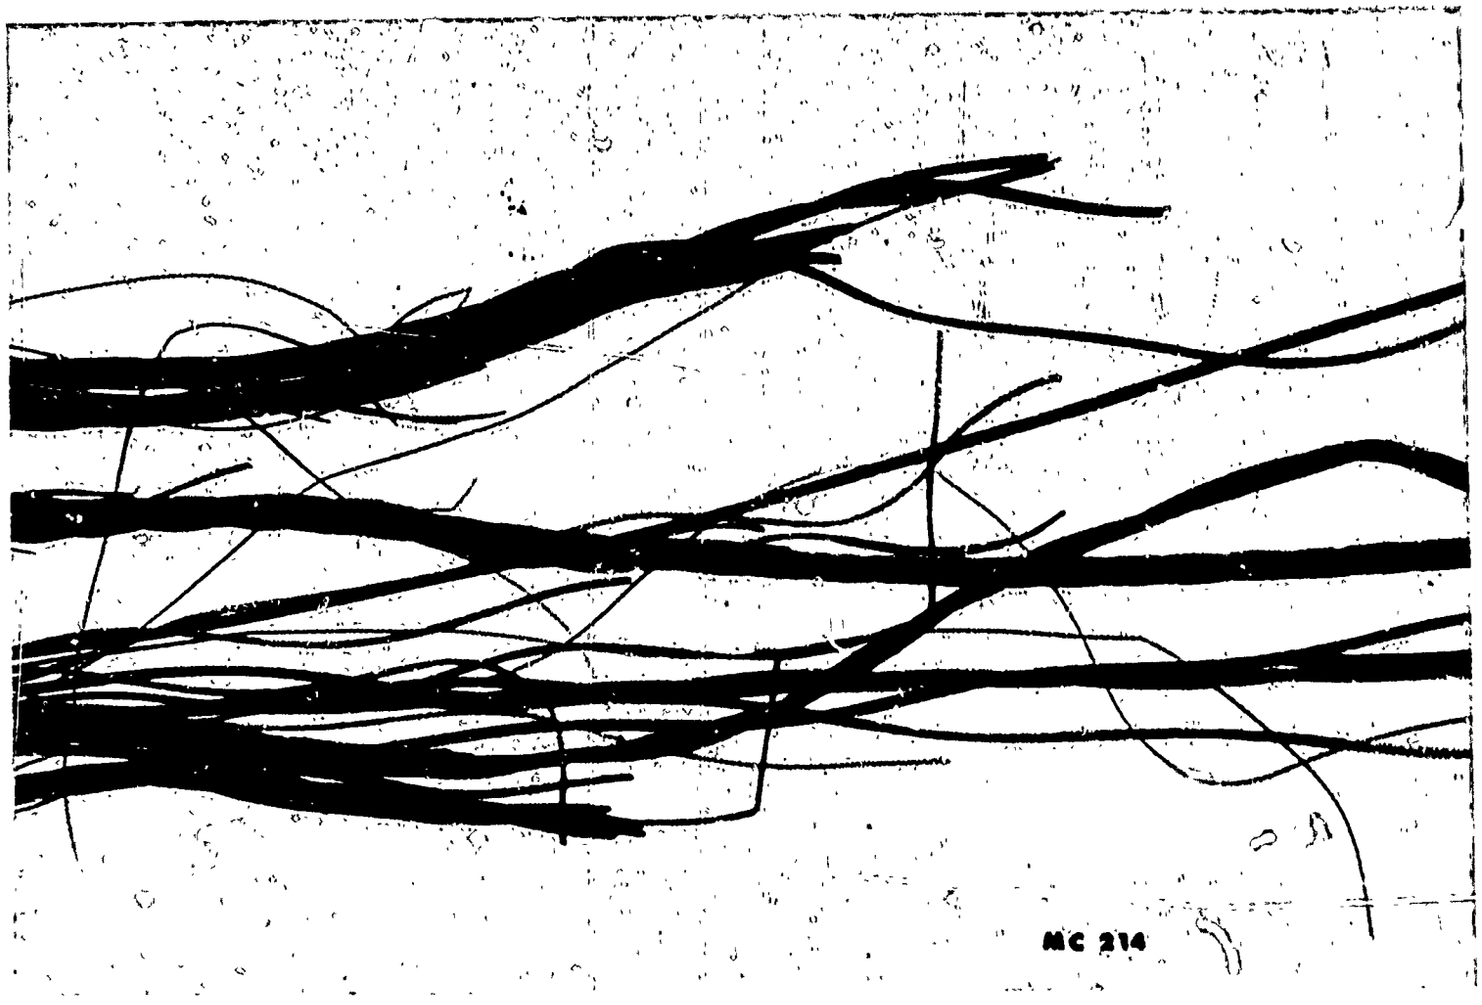
Multiple broken wires and a failure of the wire rope occurred 680 ft from the lower anode connection on the 270° lower catenary. The wire rope was severely corroded at and above the point of failure (Fig. 2). All other multiple broken wires and failures were at least 1000 ft from the nearest anode connection. Field observations relative to broken wires are given in Table 1.

Fig. 2 – Failure of the 270° leg lower catenary 680 ft from the nearest intended anode connection. The 400 lb anode was probably lost when the moor was laid (based on relative condition of other lower catenaries). (a) The failed end of the catenary. Many outer wires are missing.

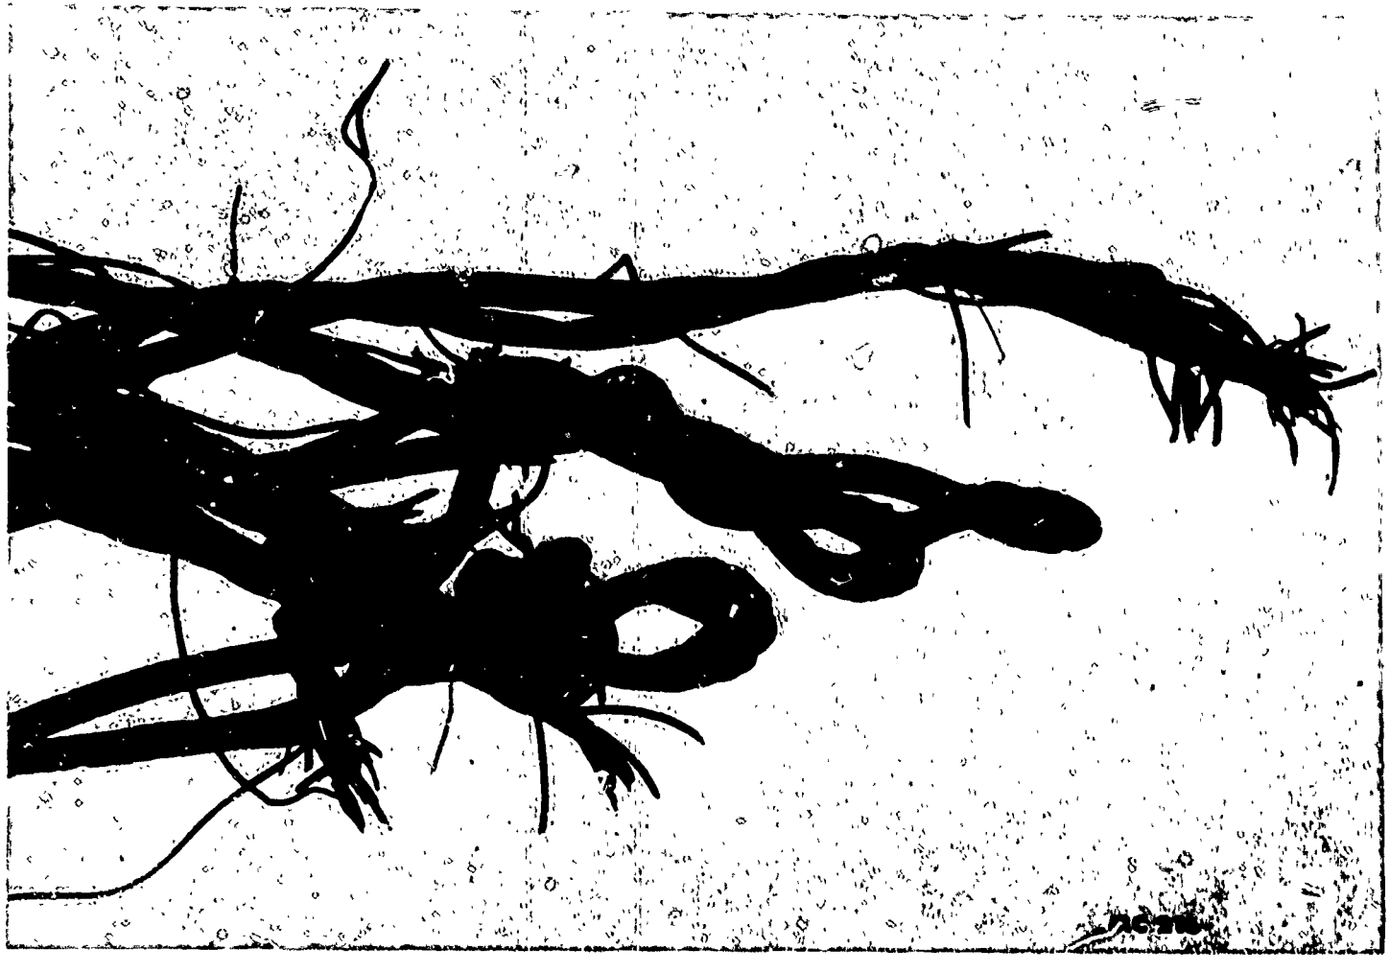
The upper and lower catenaries on the 030° leg failed prior to salvage. Corrosion on the catenaries was not severe and is not believed to have been the cause of the failures. The 25-ft section of the upper catenary in which failure occurred had been twisted prior to failure. Color photographs are available at NRL (Code 6325) which show in detail the twist and failure. The lower catenary appeared to have kinked before or during failure (Fig. 3). It can be surmised that the 030° catenaries failed as a result of ships improperly mooring to the intermediate buoy rather than to the main buoy.

Fig. 3 - Failed end of the 030° leg lower catenary 1350 ft from the nearest anode connection. Note twists and kinks; severe corrosion had not occured.

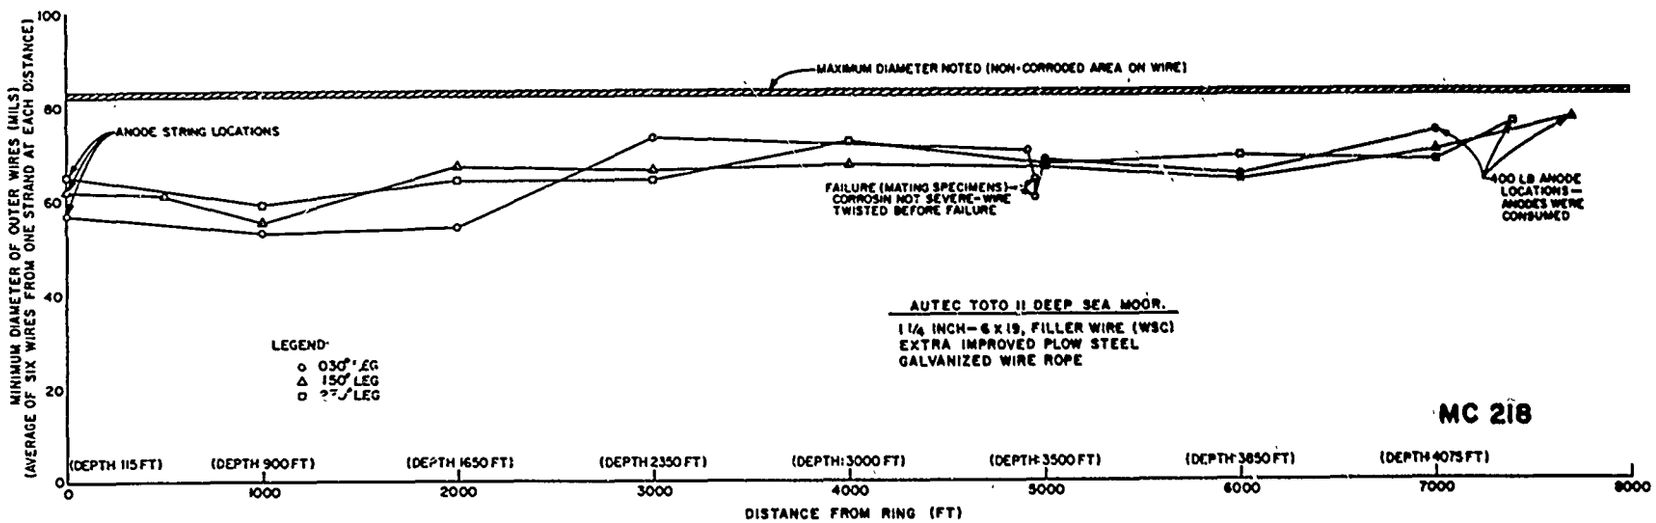
Figure 5 shows that the average minimum diameter of outer wires from the upper catenaries ranged from 53 to 77 mil. The wires having smaller residual diameters were located about 1000 ft from the upper anodes, and those having larger residual diameters were at the lower ends of the catenaries near the 400-lb anode connections. The 030° leg upper catenary twisted and failed at the location shown in the figure. It is apparent that the point of failure was not associated with minimum wire diameter or the point of highest natural stress since both would be towards the upper end of the catenary. The appearance of failed ends of wires from the 030° leg upper catenary is shown in Fig. 6.

Fig. 5 - Minimum diameter of outer wires from the upper catenaries. Distances are relative to the ring located 115 ft below each main buoy as zero. Approximate depths of water are shown in parentheses.

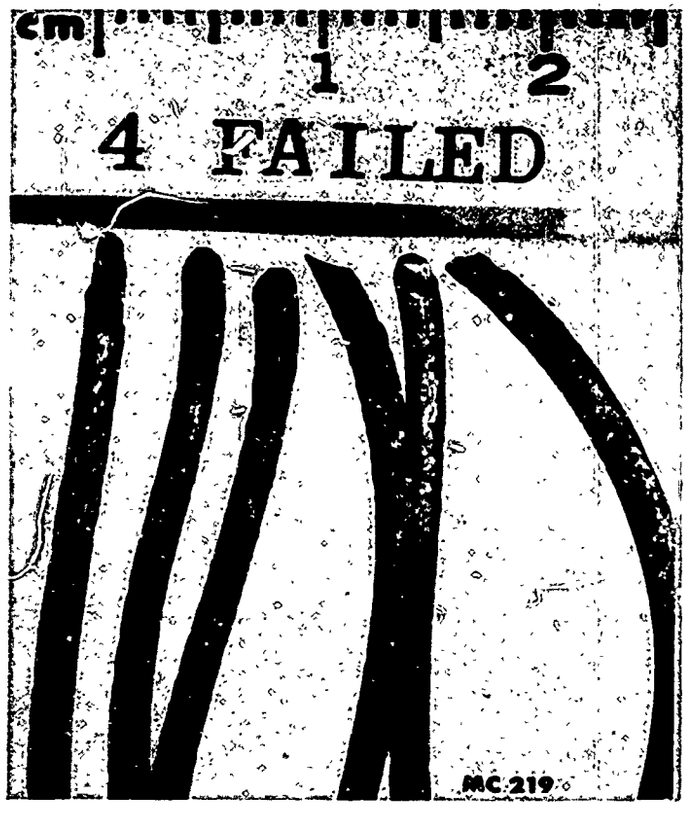
Fig. 6 – Failed ends of wires from the 030° upper catenary. Fractures on individual wires varied in appearance and wire diameters were not severely reduced.

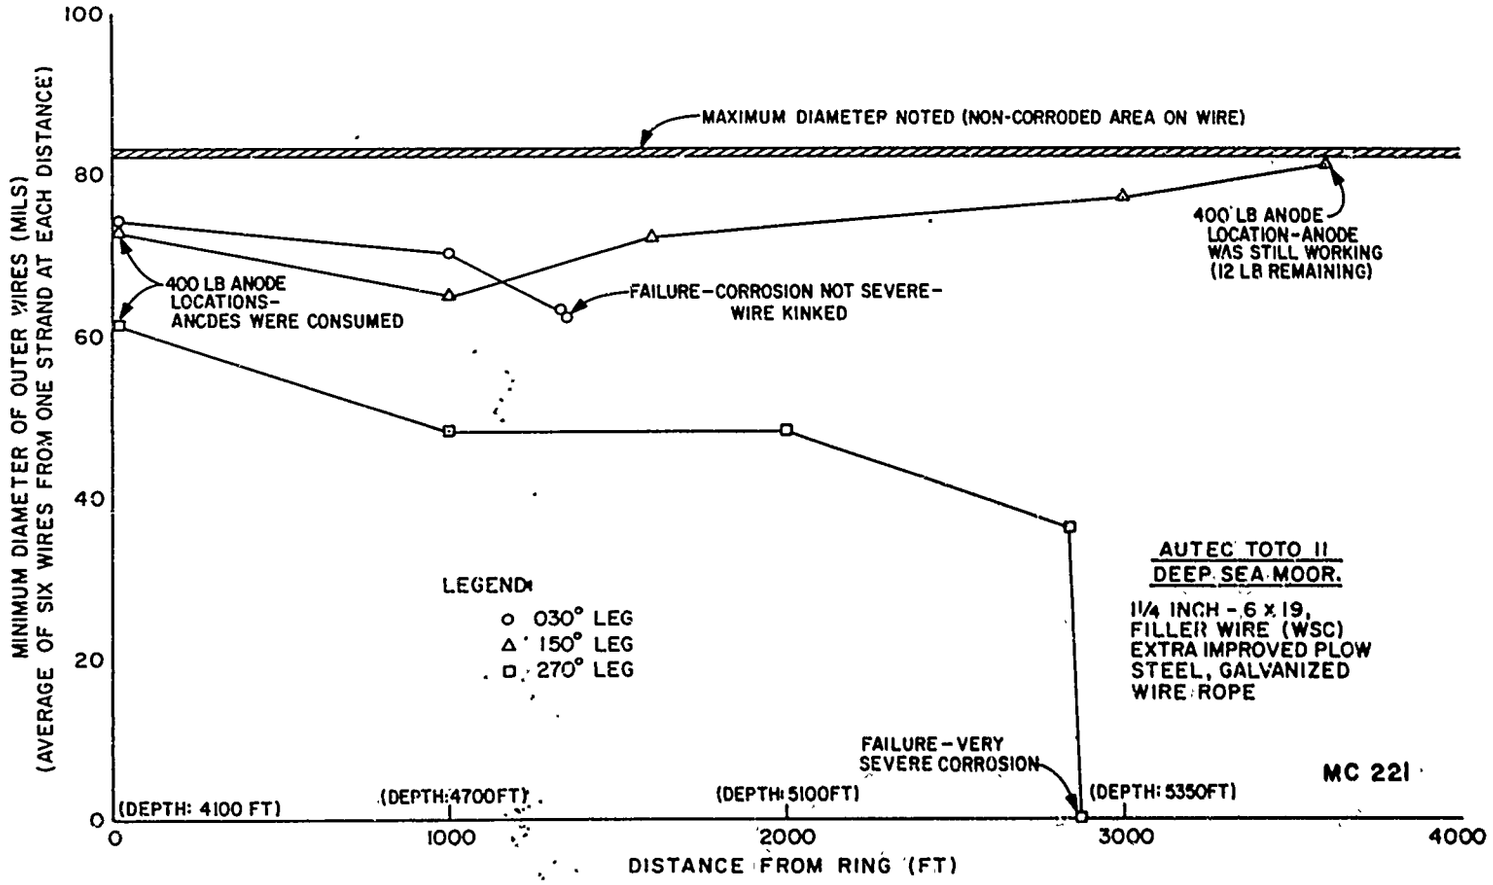
The average minimum diameter of the outer wires of the lower catenary ranged from 0 to 81 mil as shown in Fig. 7. The outer wires from the 270° lower catenary at the point of failure were completely severed by corrosion. Severe corrosion was also noted on the core strand of the 270° lower catenary at this point. Severe reduction of the diameter of the outer wires was not noted on the 030° lower catenary which failed or on the 150° lower catenary. This suggests that the 400-lb anode at the lower end of the 270° lower catenary was lost when the moor was laid and thus permitted severe corrosion to occur. Another significant factor which contributed to the severe corrosion of the 270° lower catenary was the relatively poor coverage of bituminous coating on the strands (Table 2). The appearance of failed ends of wires from the 030° leg lower catenary is shown in Fig. 8.

Fig. 7 - Minium diameter of outer wires from the lower catenaries. Distances are relative to the ring located about 4100 ft below each intermediate buoy as zero. Approximate depths of water are shown in parentheses.

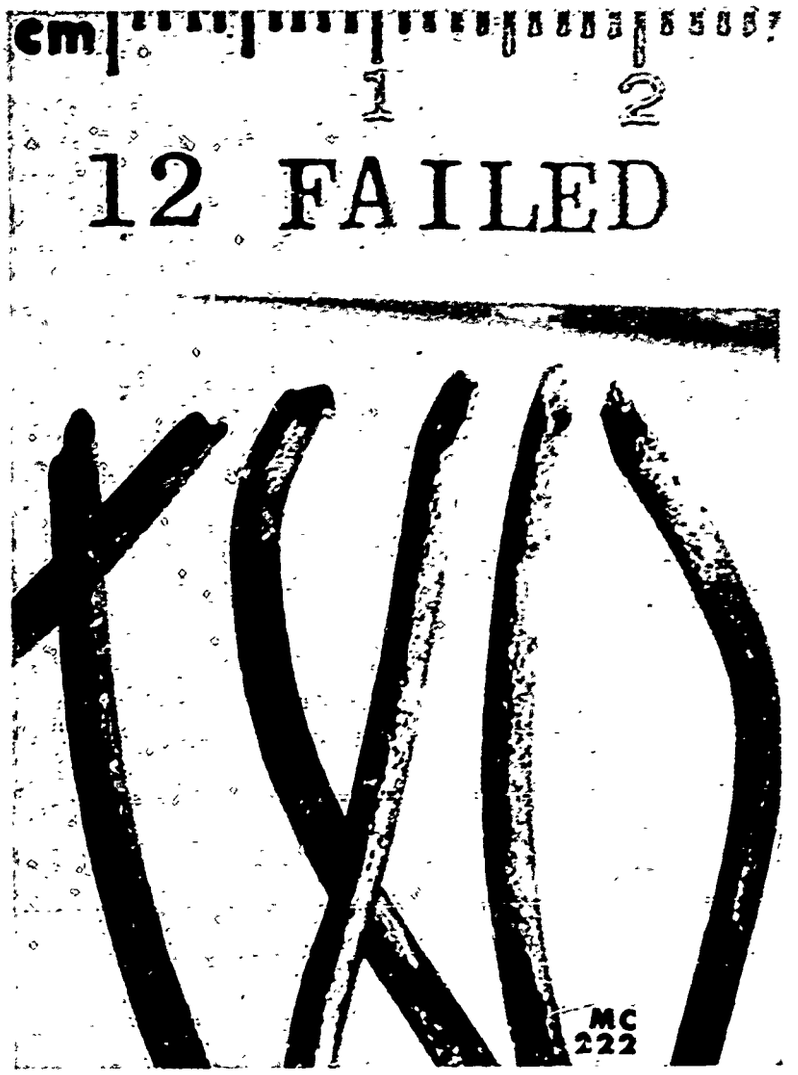
Fig. 8 - Failed ends of wire from the 030° lower catenary. The fracture appearance on individual wires varied and wire diameters were not severely reduced.

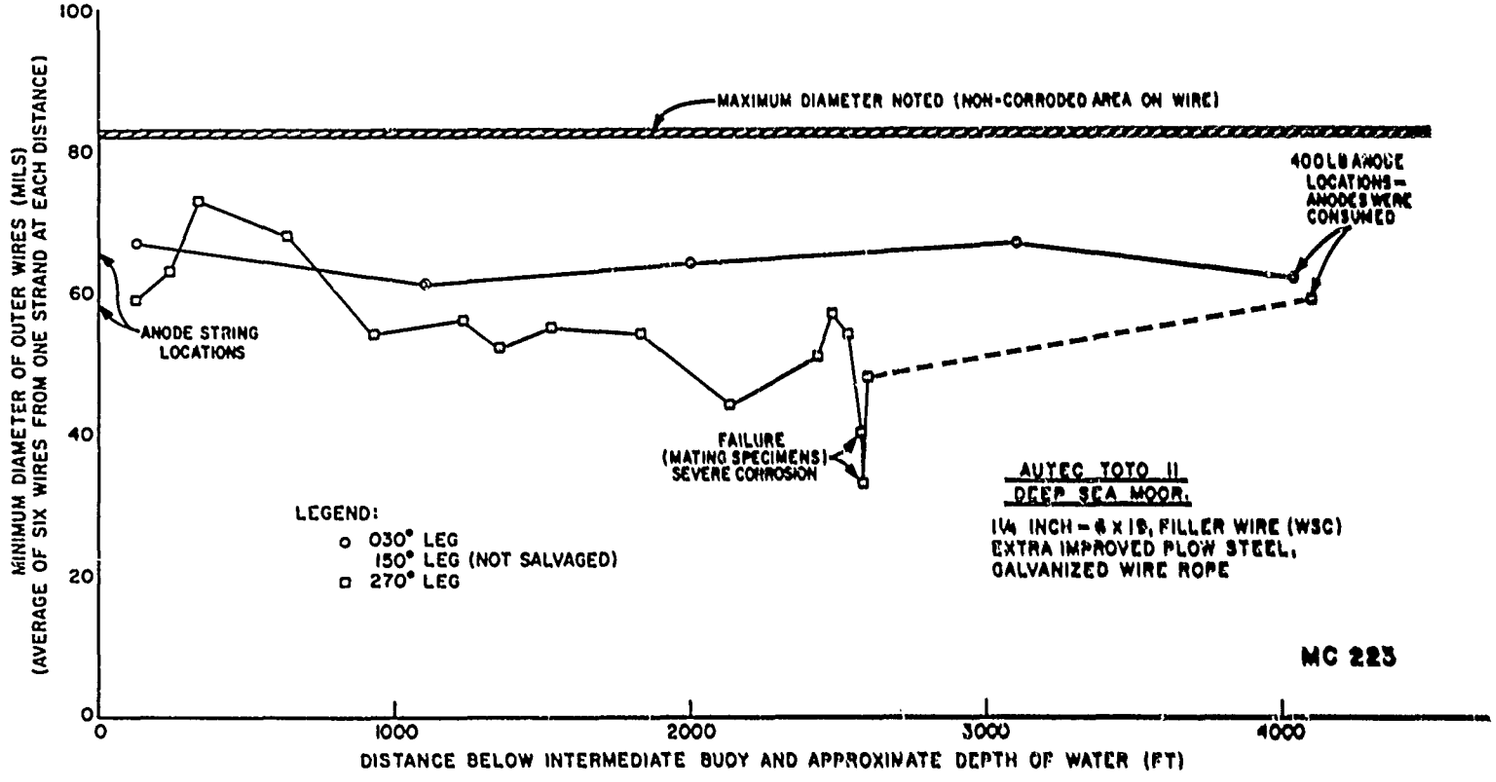
The contrast in performance of the risers beneath the intermediate buoys of the 030° and 270° legs is shown in Fig. 9. Data from the failed 150° leg riser are not shown because samples were not available. It is evident from Fig. 9 that the diameters of outer wires from the 030° leg riser were not drastically reduced, but the opposite effect was noted for the 270° leg riser which failed because of severe corrosion. The only apparent explanation for the divergent behavior of risers is that the 030° leg riser was relatively well protected by the bituminous coating (Table 2). A cross section of the 270° leg riser approximately 50 ft above the failure is shown in Fig. 10, and the appearance of failed ends of wires from this riser is shown in Fig. 11.

Fig. 9 - Minimum diameter of outer wires from the vertical risers beneath the intermediate buoys. Distances are relative to each intermediate buoy as zero.

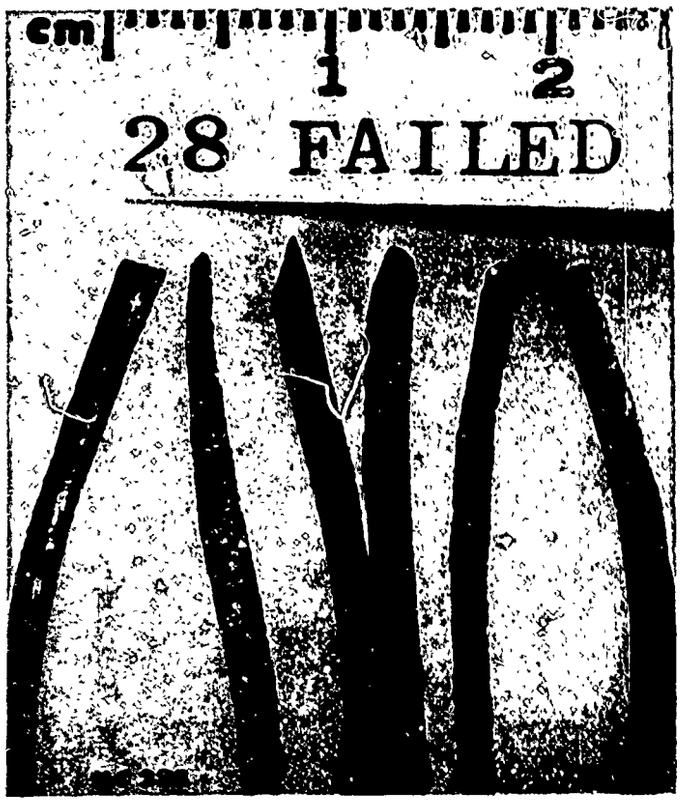
Fig. 11 - Failed ends of wires from the 270° leg intermediate buoy riser. Fracture appearance on individual wires varied and the diameter of some wires was severely reduced.
