Technical Report

AIRFIELD MARKING PAINTS FOR ASPHALTIC PAVEMENTS

December 1970

NAVAL CIVIL ENGINEERING LABORATORY

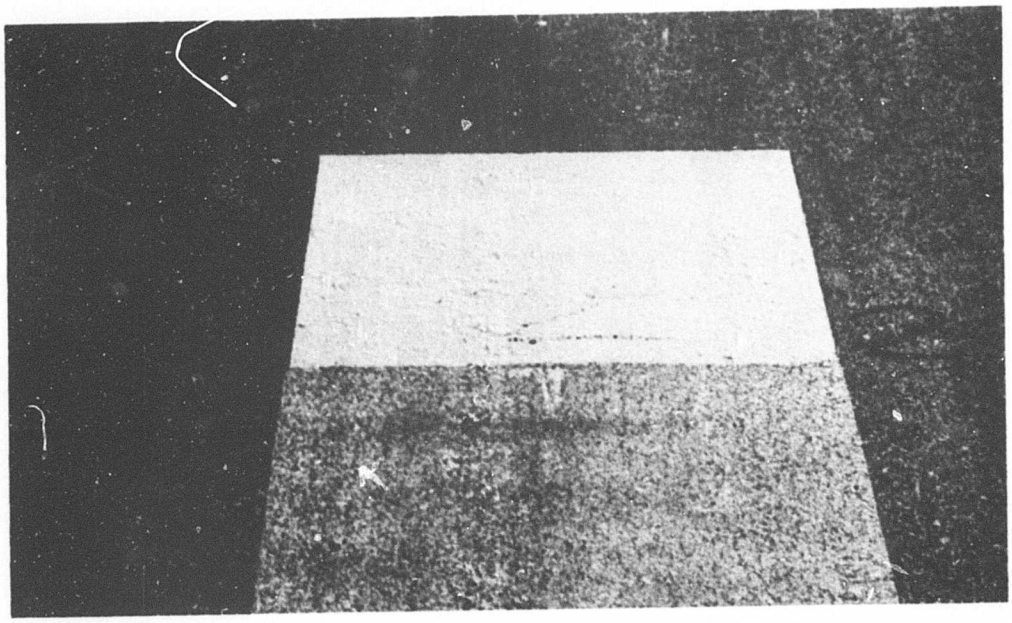
Figure 3. Test plot of Formulation 109 at NAS, Agana 1 year after application.

Formulation 109, long oil oleoresinous phenolic varnish. This paint (Figure 3) performed quite similarly to Formulation 108 but had slightly more cracking and less reflectivity.

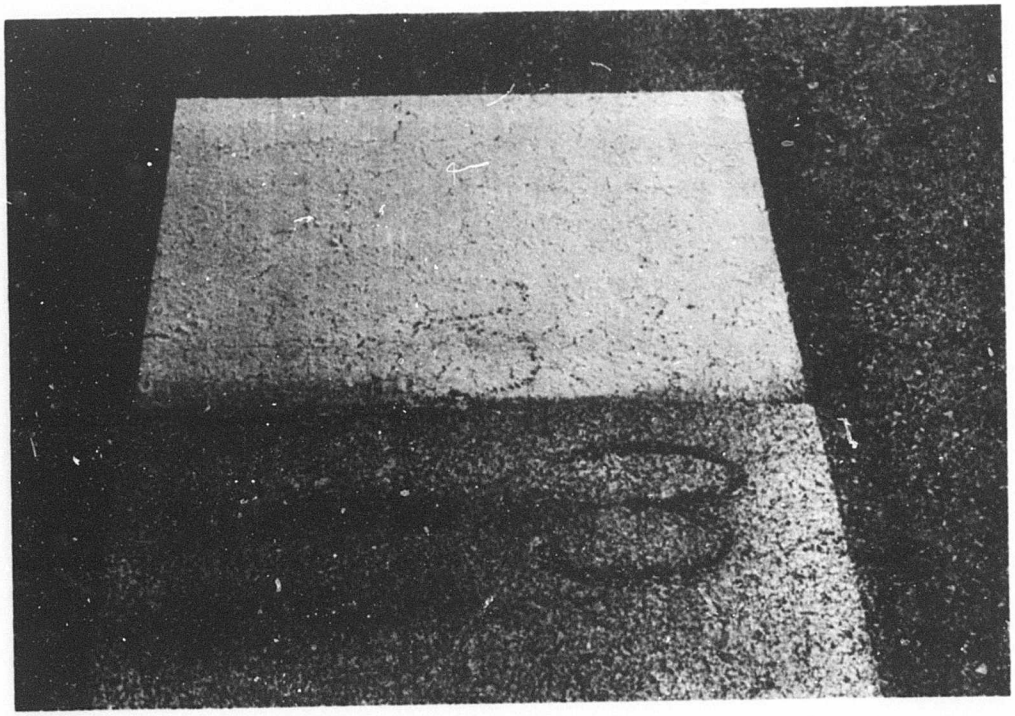
Figure 4. Test plot of Formulation 110 at NAS, Agana 1 year after application.

Formulation 110, medium oil oleoresinous phenolic varnish with plasticizer. This paint (Figure 4) performed quite similarly to Formulation 109 but had slightly more cracking.

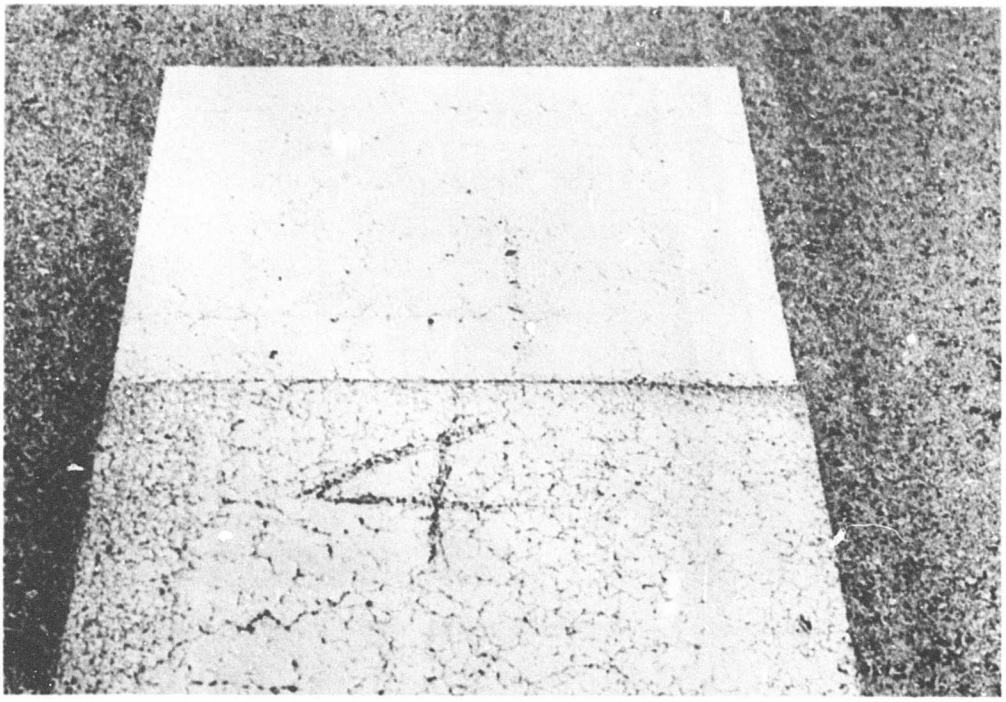
Formulation 101, medium oil alkyd. This paint (Figure 5) performed similarly to Formulation 110.

Figure 5. Test plot of Formulation 101 at NAS, Agana 1 year after application.

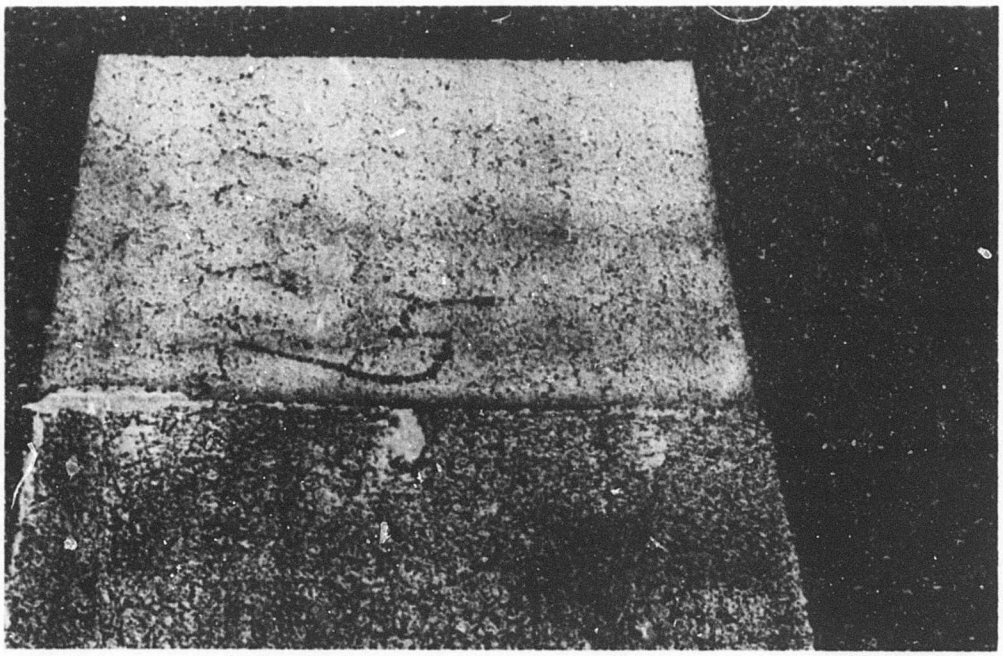
Figure 6. Test plot of Formulation A at NAS, Agana 1 year after application.

Formulation A, alkyd. This paint (Figure 6) lost virtually all of its glass spheres and was the dirtiest of all.

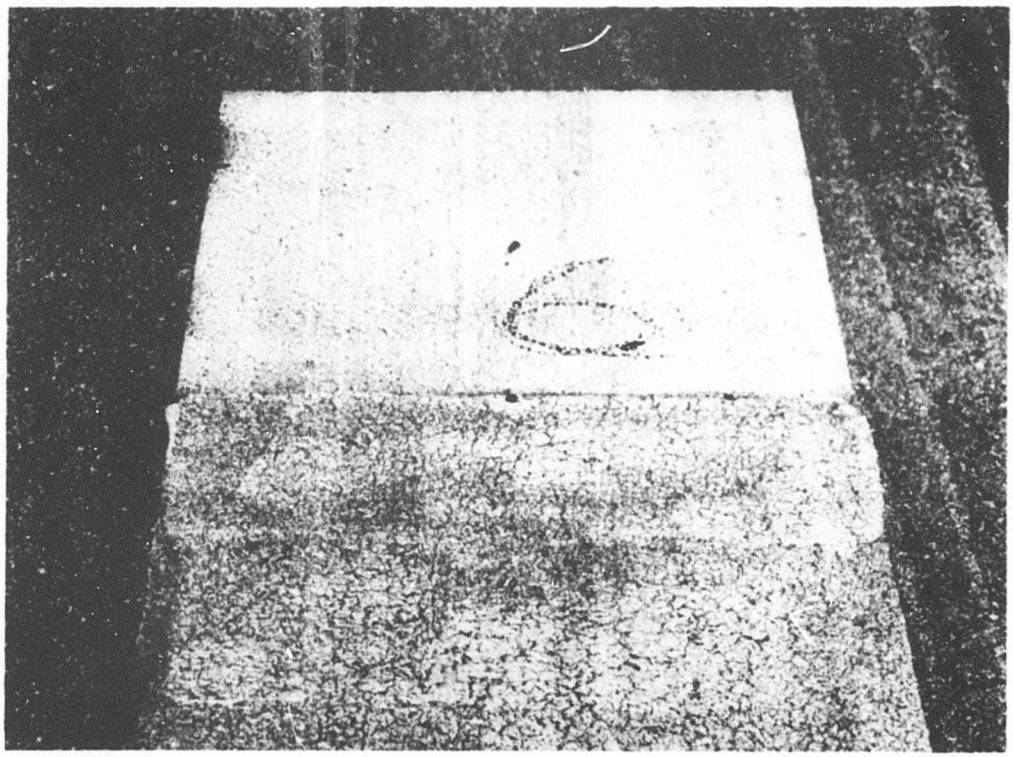
Figure 7. Test plot of Formulation 115 at NAS, Agana 1 year after application.

Formulation 115, vinyl toluene-butadiene. This paint (Figure 7) lost virtually all of its glass spheres and had the worst chipping and erosion of all.

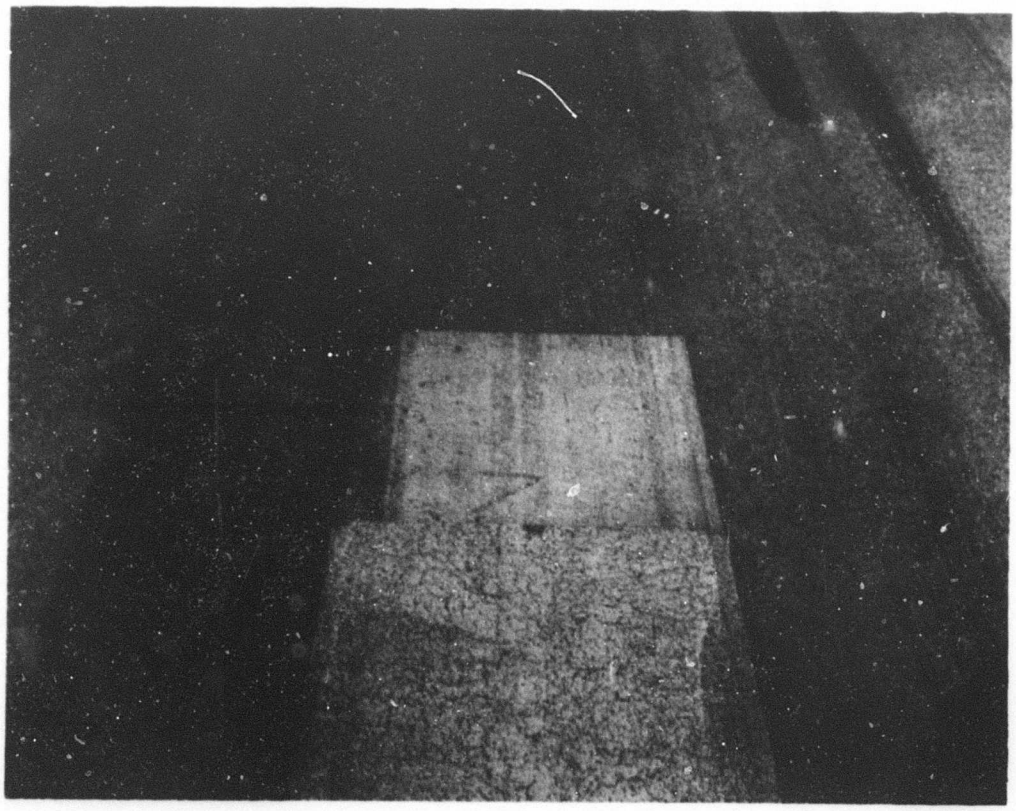
Figure 8. Test plot of Formulation 114 at NAS, Agana 1 year after application.

Formulation 114, water-emulsion polyvinyl acetate. This paint (Figure 8) had no cracking or chipping, and it had the best retention of glass spheres. Its erosion rating was as high as any of the others. Its reflectivity and general appearance ratings were probably affected more adversely by its greater touchdown of aircraft than those of the other paints.

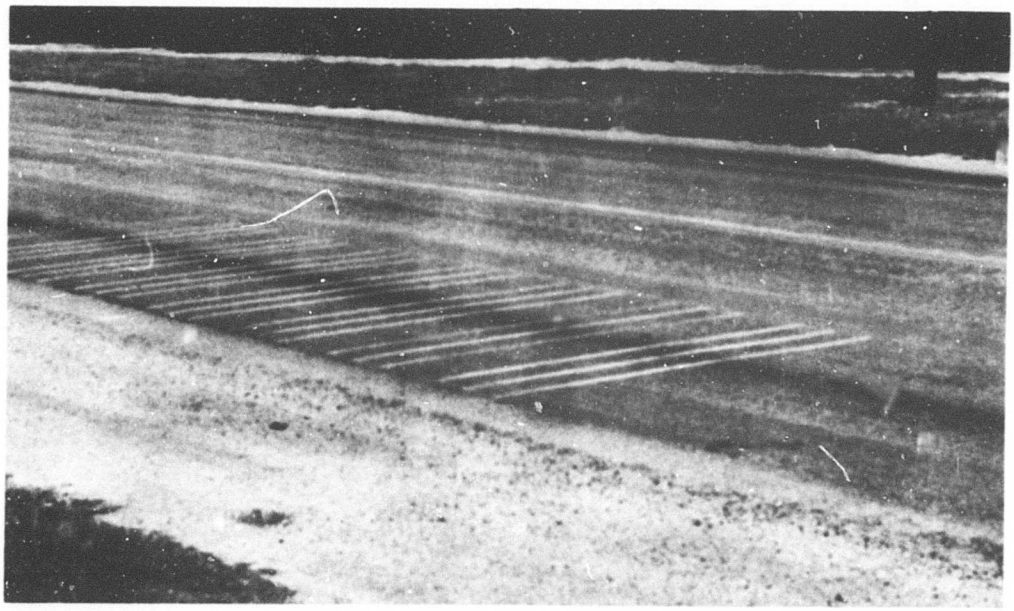
Figure 9. Roadway at USNS, Guam with the seven sets of painted stripes 1 year after application.

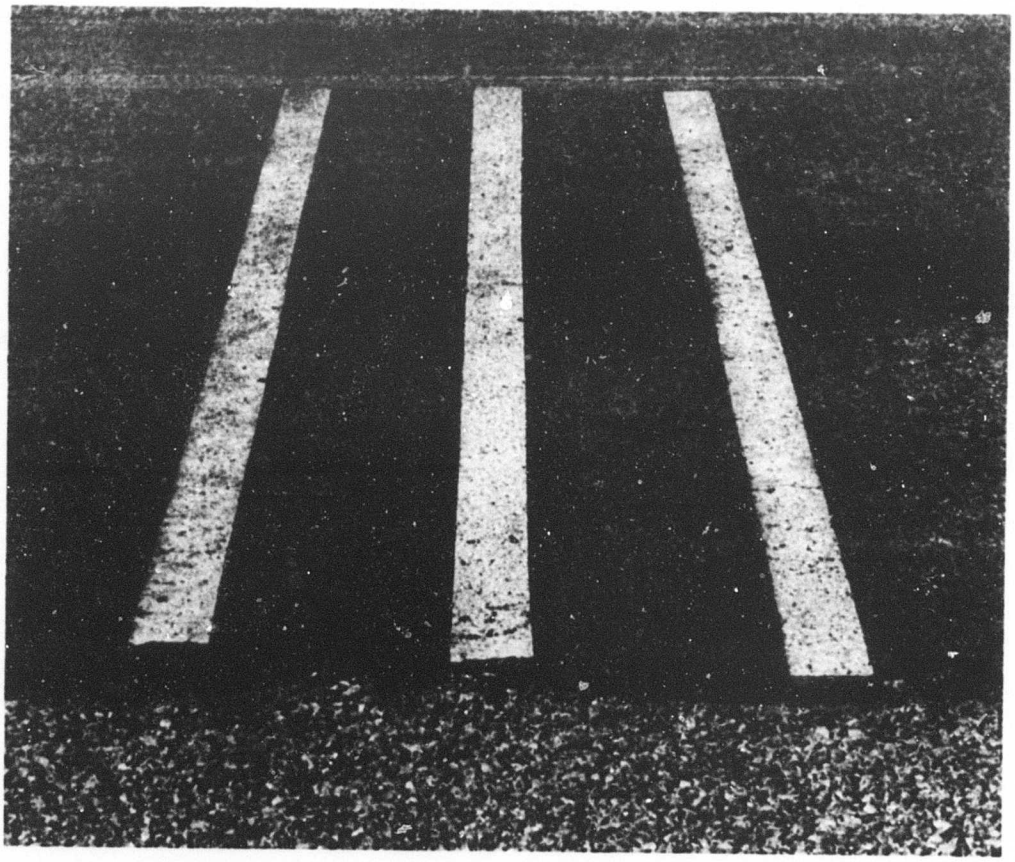
Formulation 110, medium oil oleoresinous phenolic varnish with plasticizer. These stripes (Figure 10) were the cleanest and had little chipping or erosion.

Figure 10. Set of stripes of Formulation 110 at USNS, Guam 1 year after application. Left to right: single-thickness, reflectorized; double-thickness, reflectorized; single-thickness, unreflectorized.

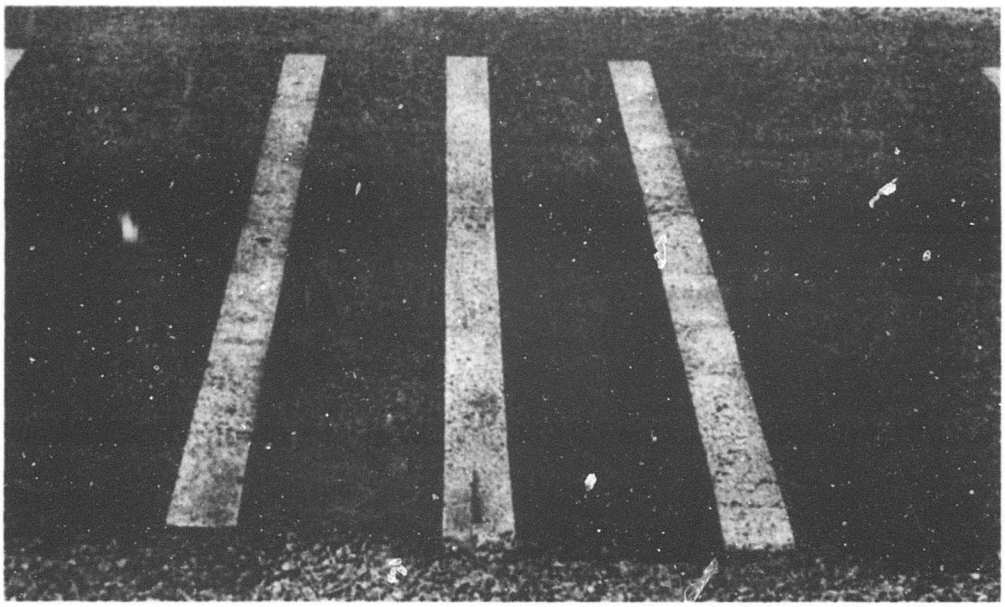
Formulation 108, medium oil oleoresinous phenolic varnish. These stripes (Figure 12) looked almost as good as those of Formulation 109.

Figure 12. Set of stripes of Formulation 108 at USNS, Guam 1 year after application. Left to right: single-thickness, reflectorized; double-thickness, reflectorized; single-thickness, unreflectorized.

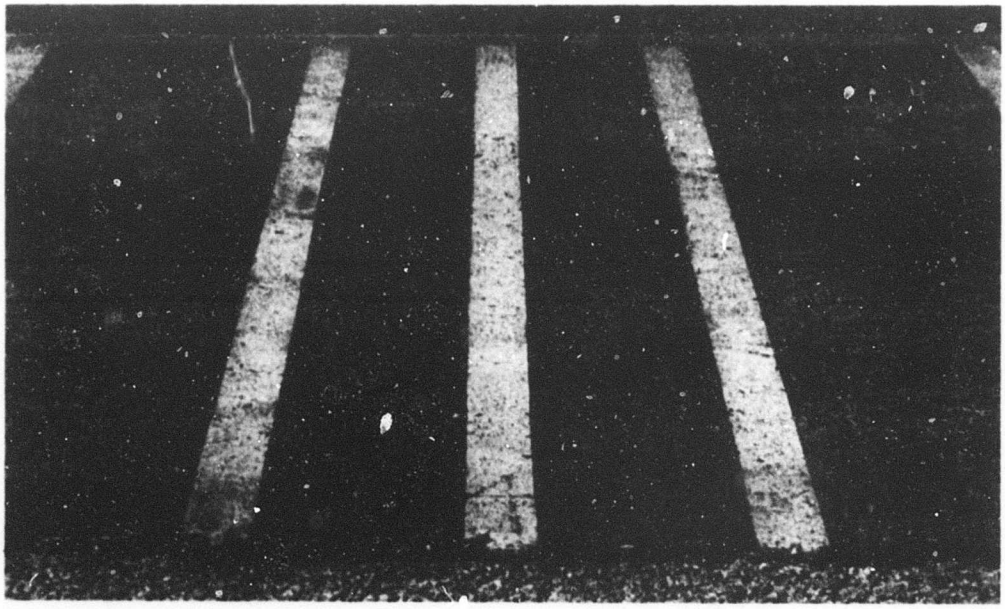
Formulation 101, medium oil alkyd. These stripes (Figure 13) looked almost as good as those above but had slightly more cracking.

Figure 13. Set of stripes of Formulation 101 at USNS, Guam 1 year after application. Left to right: single-thickness, reflectorized; double-thickness, reflectorized; single-thickness, unreflectorized.

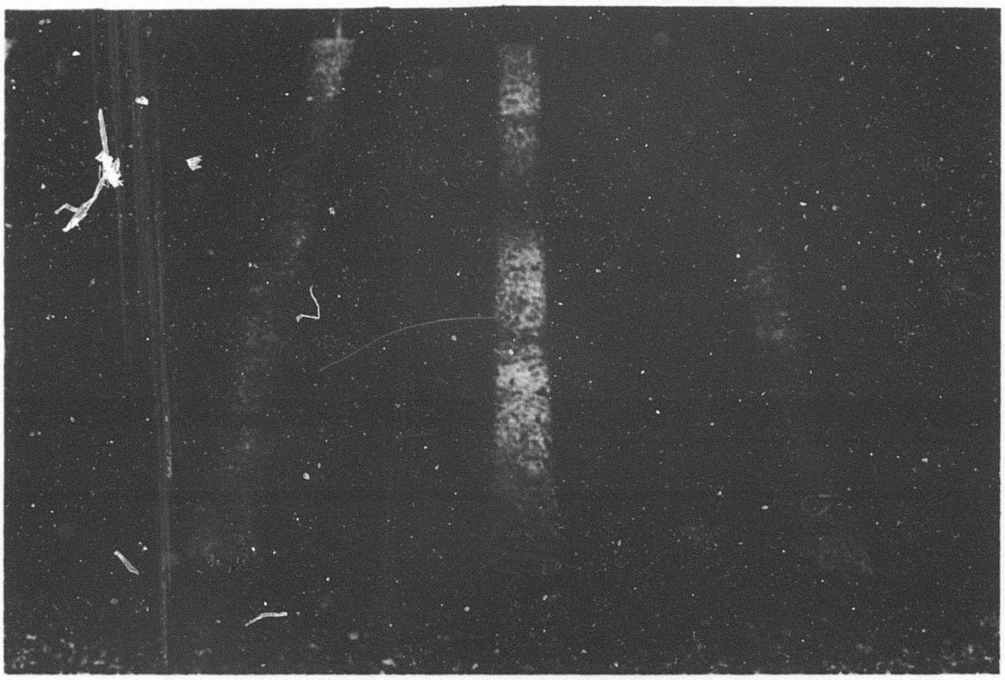
Formulation 115, vinyl toluene-butadiene. These stripes (Figure 16) were very dirty and had extensive erosion.

Figure 16. Set of stripes of Formulation 115 at USNS, Guam 1 year after application. Left to right: single-thickness, reflectorized; double-thickness, reflectorized; single-thickness, unreflectorized.

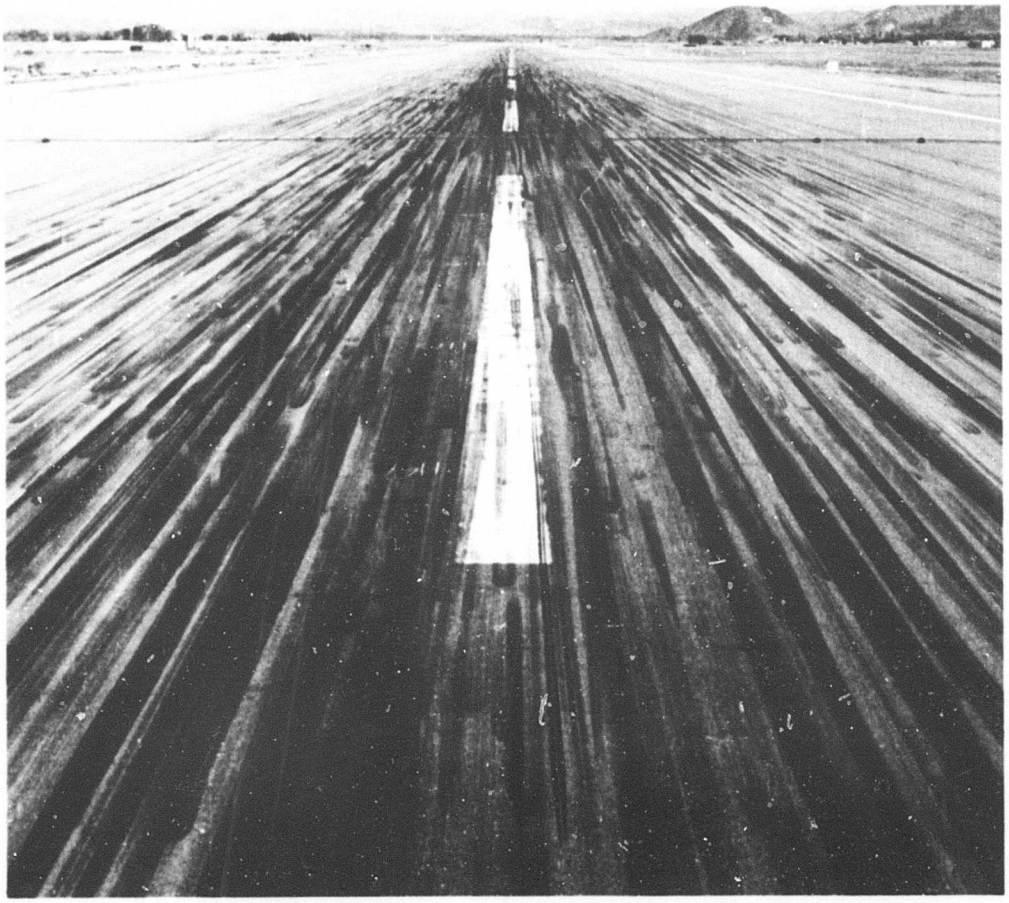
Figure 17. Sections of test paints at NAS, Point Mugu after 26-1/2 months.

The test sections deteriorated very slowly, but rapidly received black tire markings (Figure 17) from touchdown of aircraft. Ratings received after 8-1/2 and 26-1/2 months are listed in Table 9. The rating totals were weighted

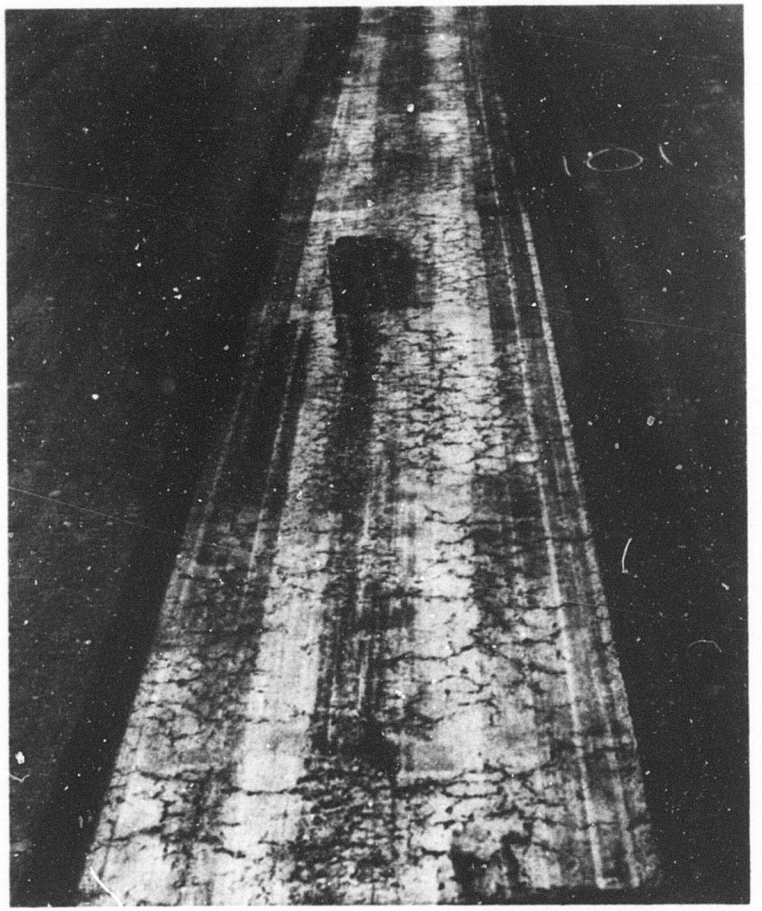
Figure 18. Formulation 101 at NAS, Point Mugu after 26-1/2 months.

Formulation 101, medium oil alkyd. This paint (Figure 18) had excessive loss of reflective spheres. It also had some localized damage from oil spillage.

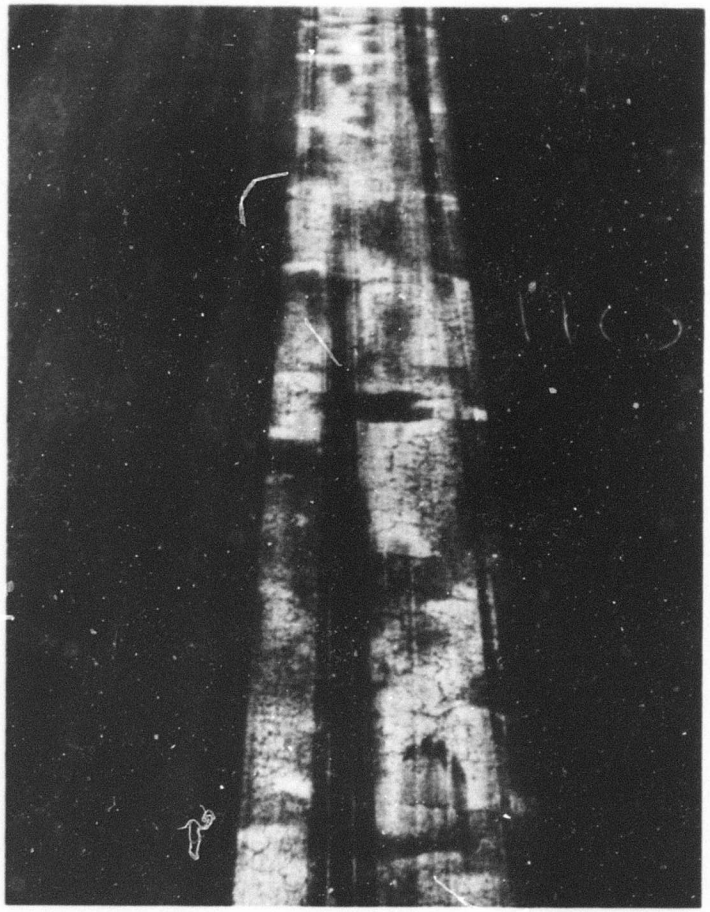
Figure 22. Formulation 110 at NAS, Point Mugu after 26-1/2 months.

Formulation 110, medium oil oleoresinous phenolic varnish with plasticizer. This paint (Figure 22) performed relatively poorly and had the most chipping of all.

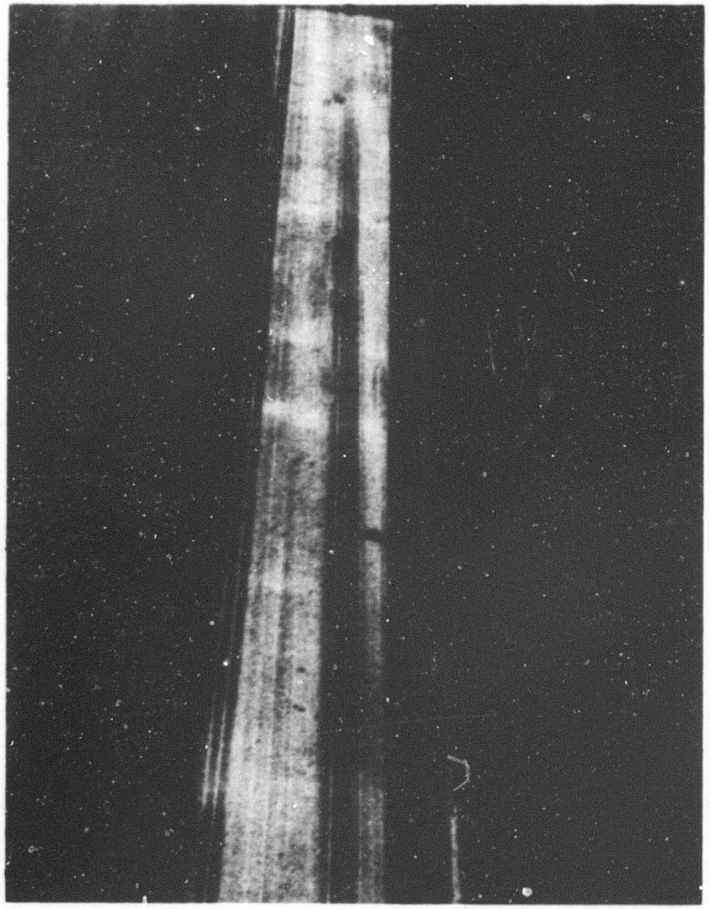
Formulation 114, water-emulsion polyvinyl acetate. This paint (Figure 23) performed better and was noticeably whiter than the other test paints on the centerline throughout the 26-1/2 months of exposure.

Figure 23. Formulation 114 at NAS, Point Mugu after 26-1/2 months.

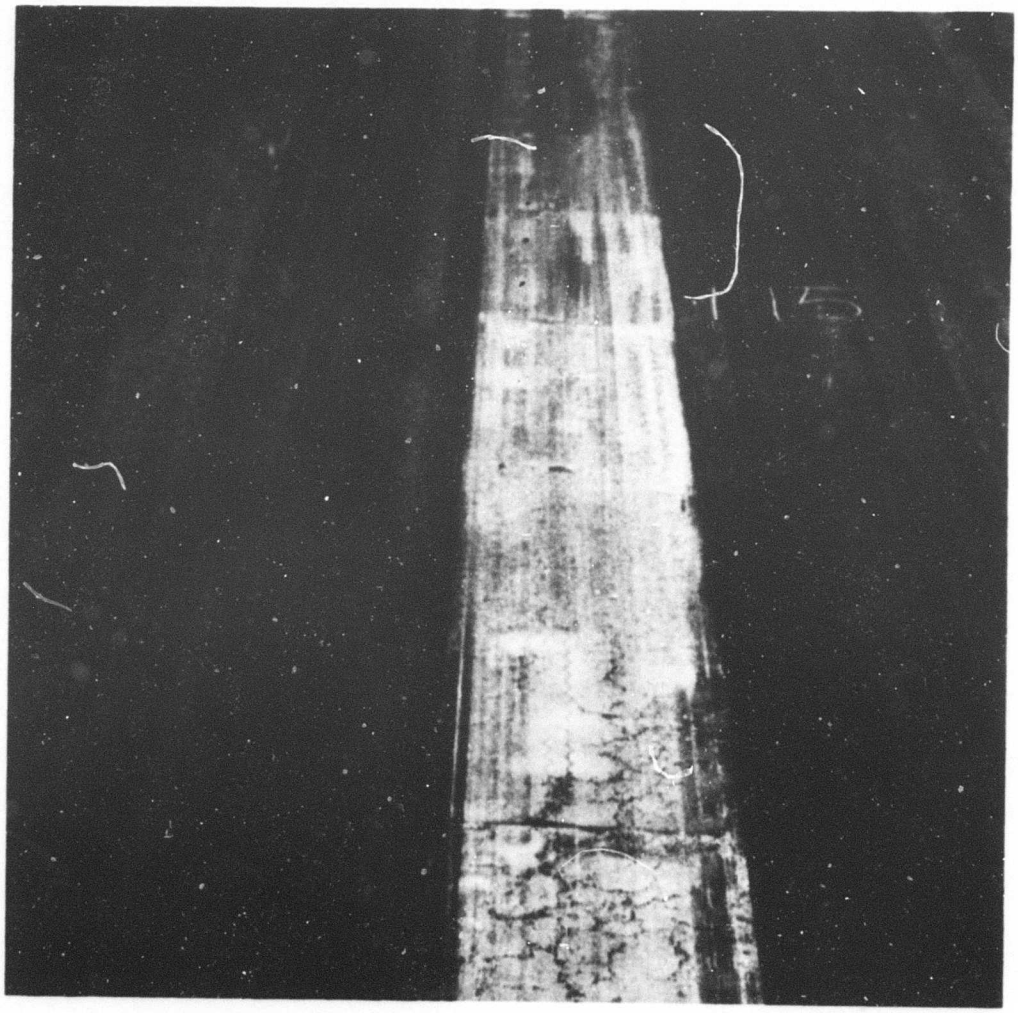
Figure 24. Formulation 115 at NAS, Point Mugu after 26-1/2 months.

Formulation 115, vinyl toluene-butadiene. This paint (Figure 24) performed poorest of all through 26-1/2 months of exposure with low cracking, chipping, and glass sphere retention ratings.

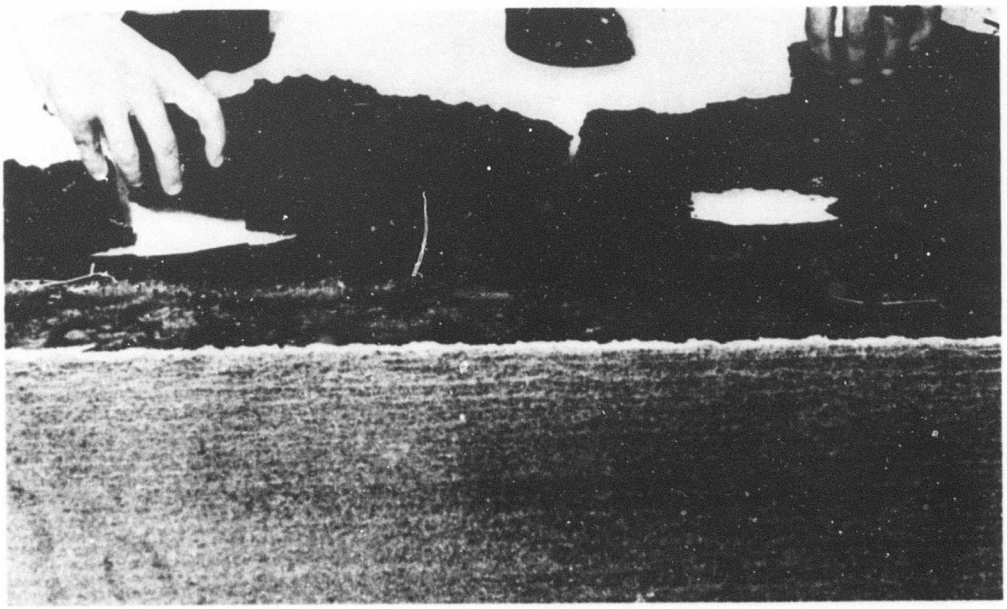
Figure 25. Peeled alkyd paint and slurry seal on side line striping of asphaltic runway at Oxnard Air Force Base, spring 1965.

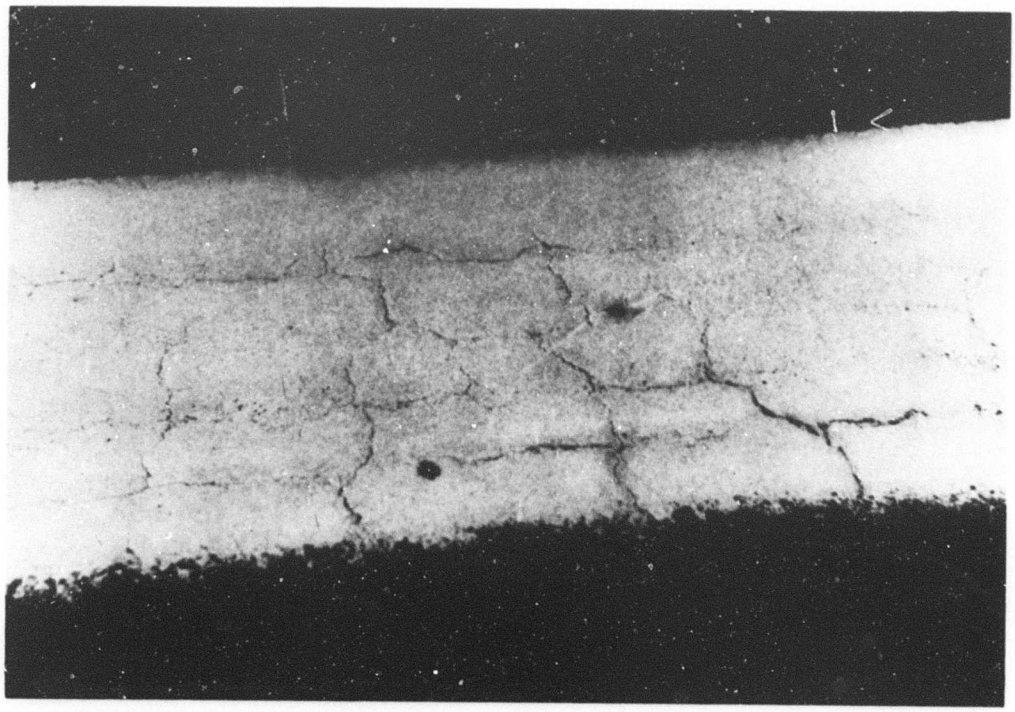
The oleoresinous phenolic varnish paint performed in a most satisfactory manner. When examined in September 1967, the side line stripes were still in good condition and had retained good retroreflectivity, but the centerline required restriping due to deposition of rubber from touchdown of aircraft tires onto the paint. This was especially noticeable on the section of portland cement concrete; the black tire markings had reduced both visibility and retroreflectivity. The side line stripes on the overlay had reflection cracks (Figure 26) of the underlying portland cement concrete but showed none of the peeling associated with the previously used alkyd paint.

Figure 26. Oleoresinous phenolic varnish striping on side line of asphaltic runway at Oxnard Air Force Base, September 1967.

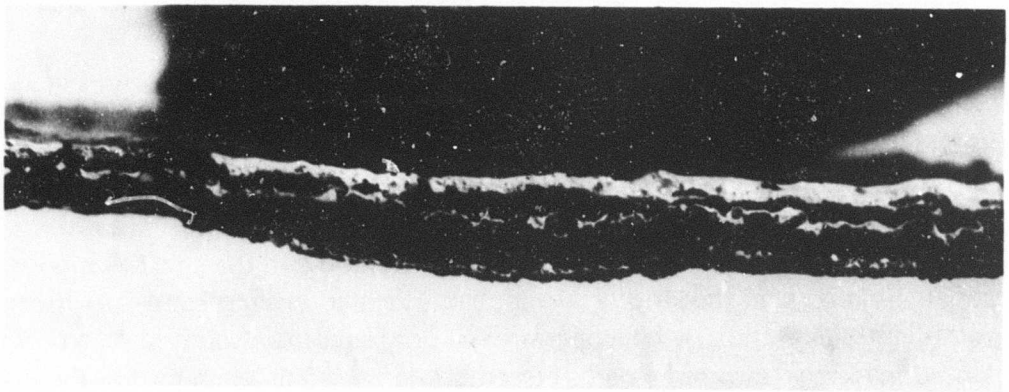
Figure 29. Edge view of peeled runway striping from Oxnard Air Force Base showing three alternate layers of paint and asphalt.

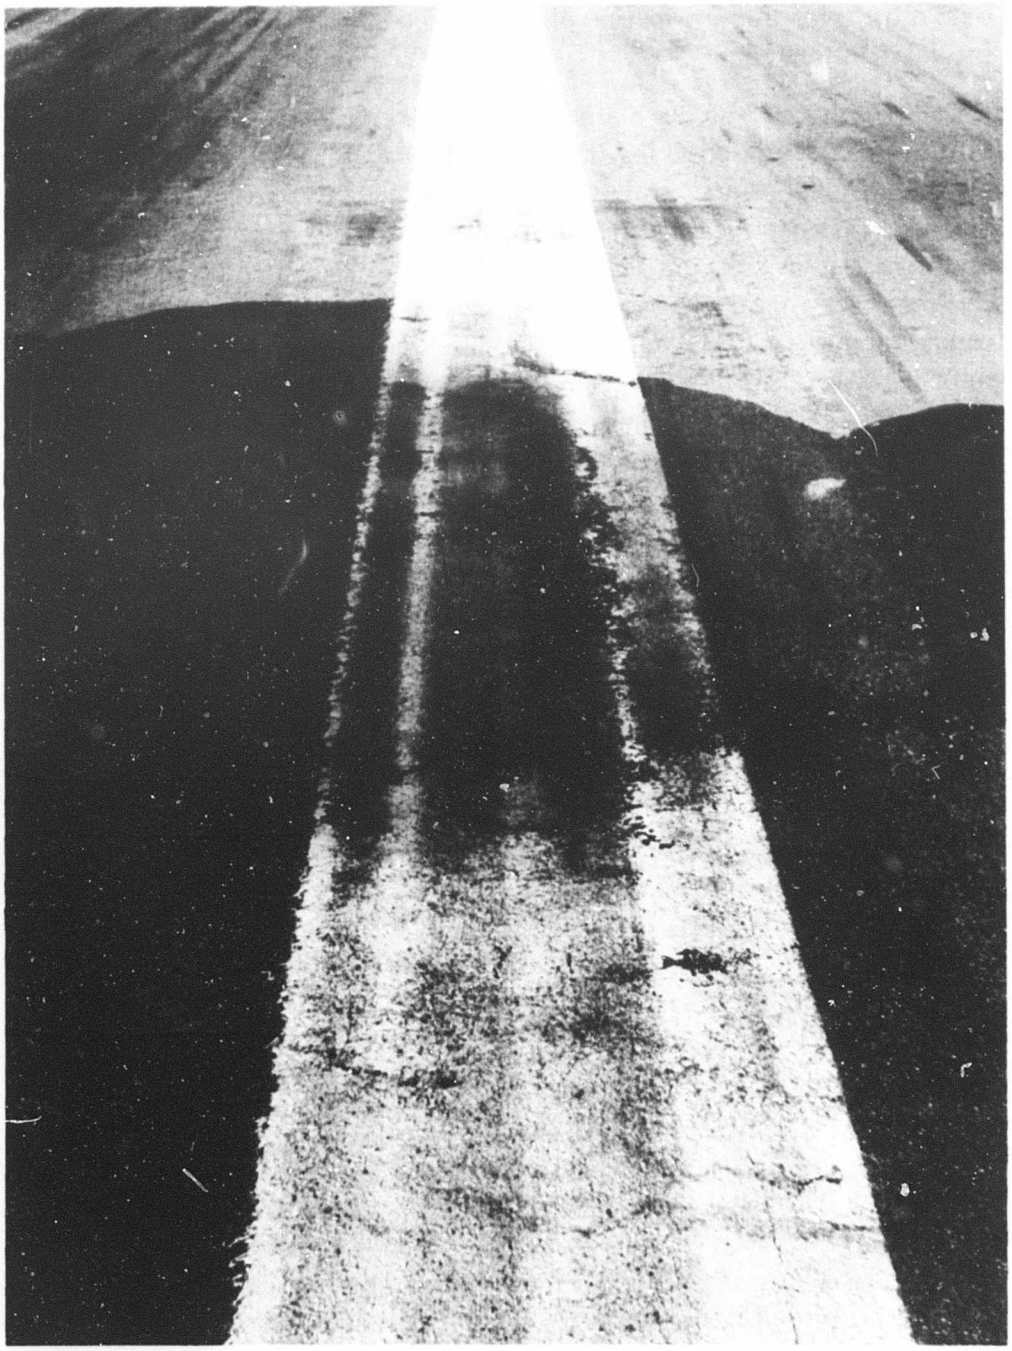
Figure 35. Paint deterioration on centerline at NAS, Imperial Beach where it passes through a bird bath.

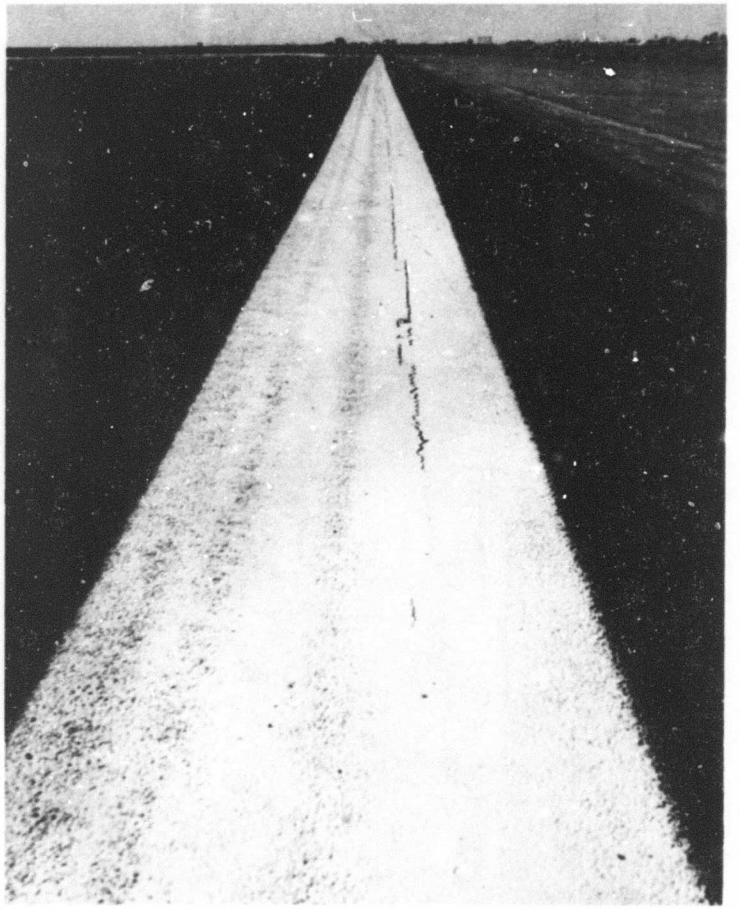
This appeared to be due to a seam in the underlying pavement, and there was no peeling associated with the cracking. The glass spheres that had been dropped into the wet paint to impart retroreflectivity were concentrated in the center one-third of the striping with very few, if any, occurring in the outer sections.

Figure 37. Striping on Runway 8-26, MCAS, Yuma, in October 1968. Note long crack parallel to direction of striping.

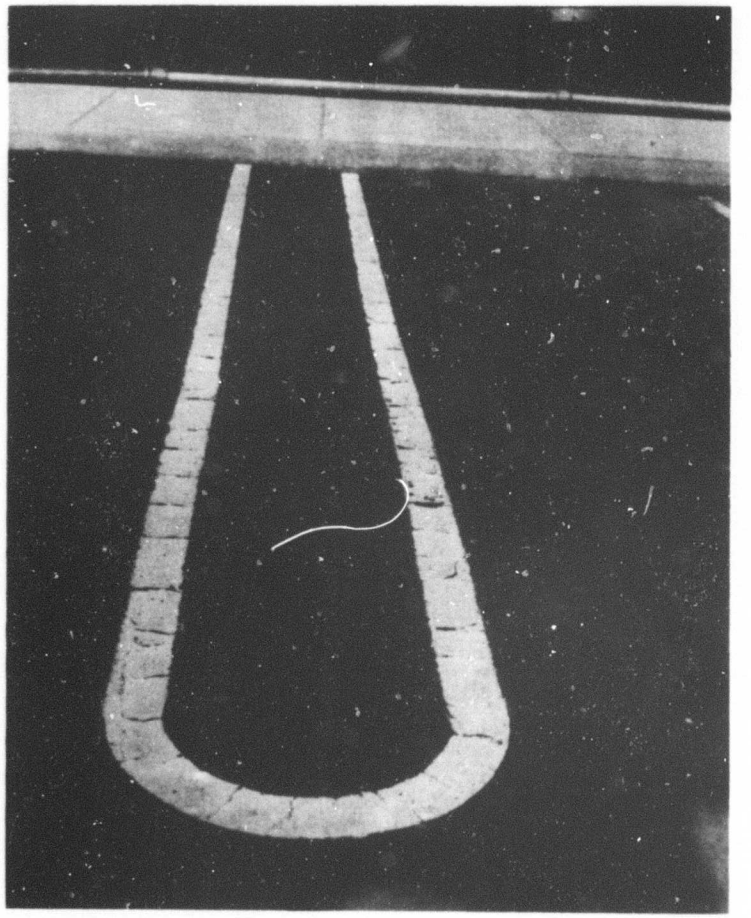
Asphaltic parking areas were constructed in 1969 at the gymnasium and chapel at MCAS, Yuma. For these areas, striping paint was applied by the contractor 38 and 87 days, respectively, after installation. The contractor reportedly used an alkyd paint conforming to TT-P-115, type I. Within 2 to 4 months after striping, there was extensive deterioration of the painted markings and the underlying asphalt (Figure 38). The contractor attributed the damage to an incompatibility of the asphalt pavement and the alkyd paint, referring to previous problems on Runway 17-35. An analysis of the paint used was made by NCEL in order to determine the cause of the extremely premature failure. The analysis, shown in Table 10, indicated that the damage was associated with the great deviation of the paint from the specification requirements—notably the great deficiency in percent nonvolatile vehicle and the great excess of thinner. This resulted in extremely poor paint flexibility. In light of the vehicle composition, the high viscosity must be attributed to heavy loading with absorbent filler pigments and/or excessive bodying of the resin.

Figure 38. Deteriorated painted marking and underlying asphaltic substrate in parking lot at MCAS, Yuma.
