RDTR NO. 164
MARCH 1970

MK 45 AIRCRAFT PARACHUTE FLARE OPTIMIZATION PROGRAM

EVALUATION OF EXPERIMENTAL PARACHUTES AND PARACHUTE MATERIALS

FLIGHT TEST SERIES NO. 2

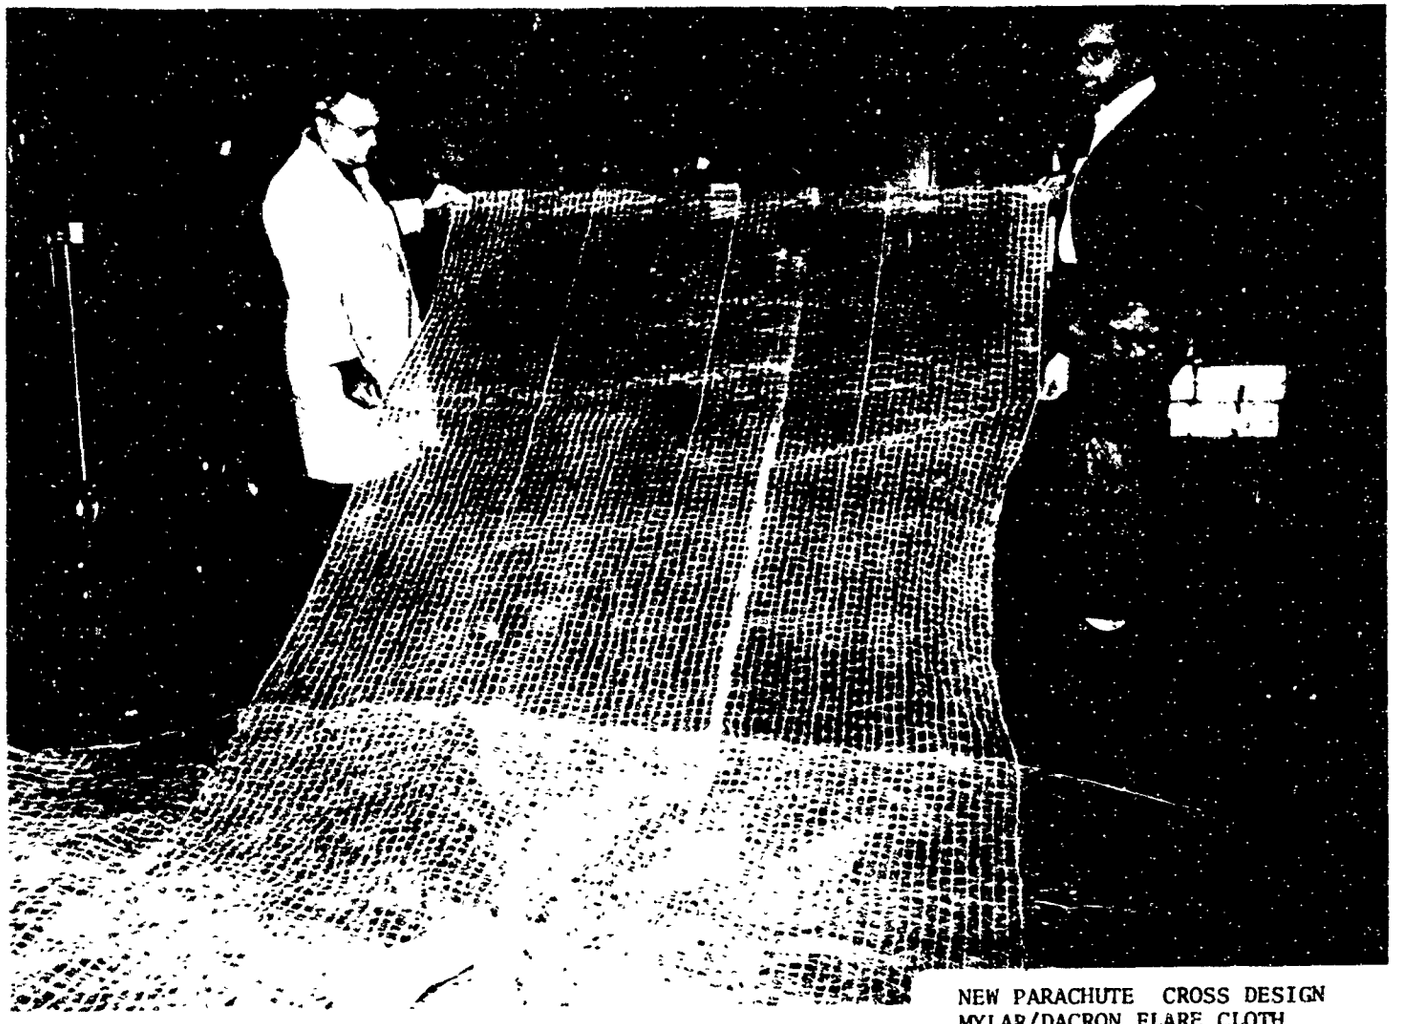
NEW PARACHUTE CROSS DESIGN
MYLAR/DACRON FLARE CLOTH
SHOWS ONE GORE OF NEW CHUTE

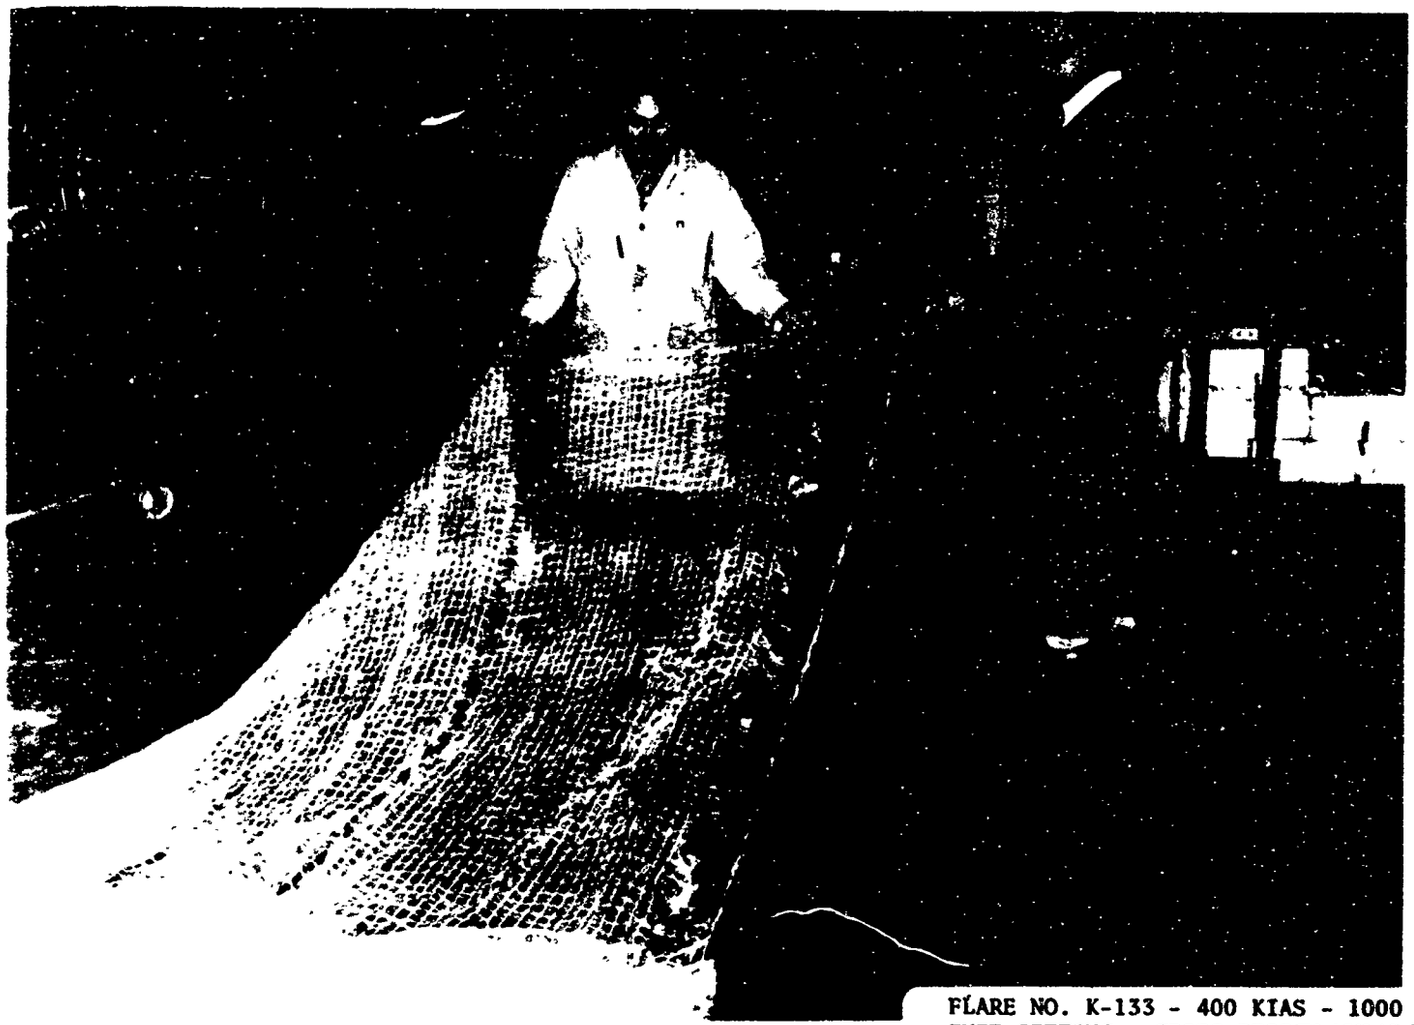
FLARE NO. K-133 - 400 KIAS - 1000 FT.
FUZE SETTING - CROSS DESIGN MYLAR/
DACRON FLARE CLOTH - SHOWS TAPE PULLED
LOOSE & OTHER TAPE DAMAGE TO ONE GORE.
DEPLOYED AT 210 FT/SEC

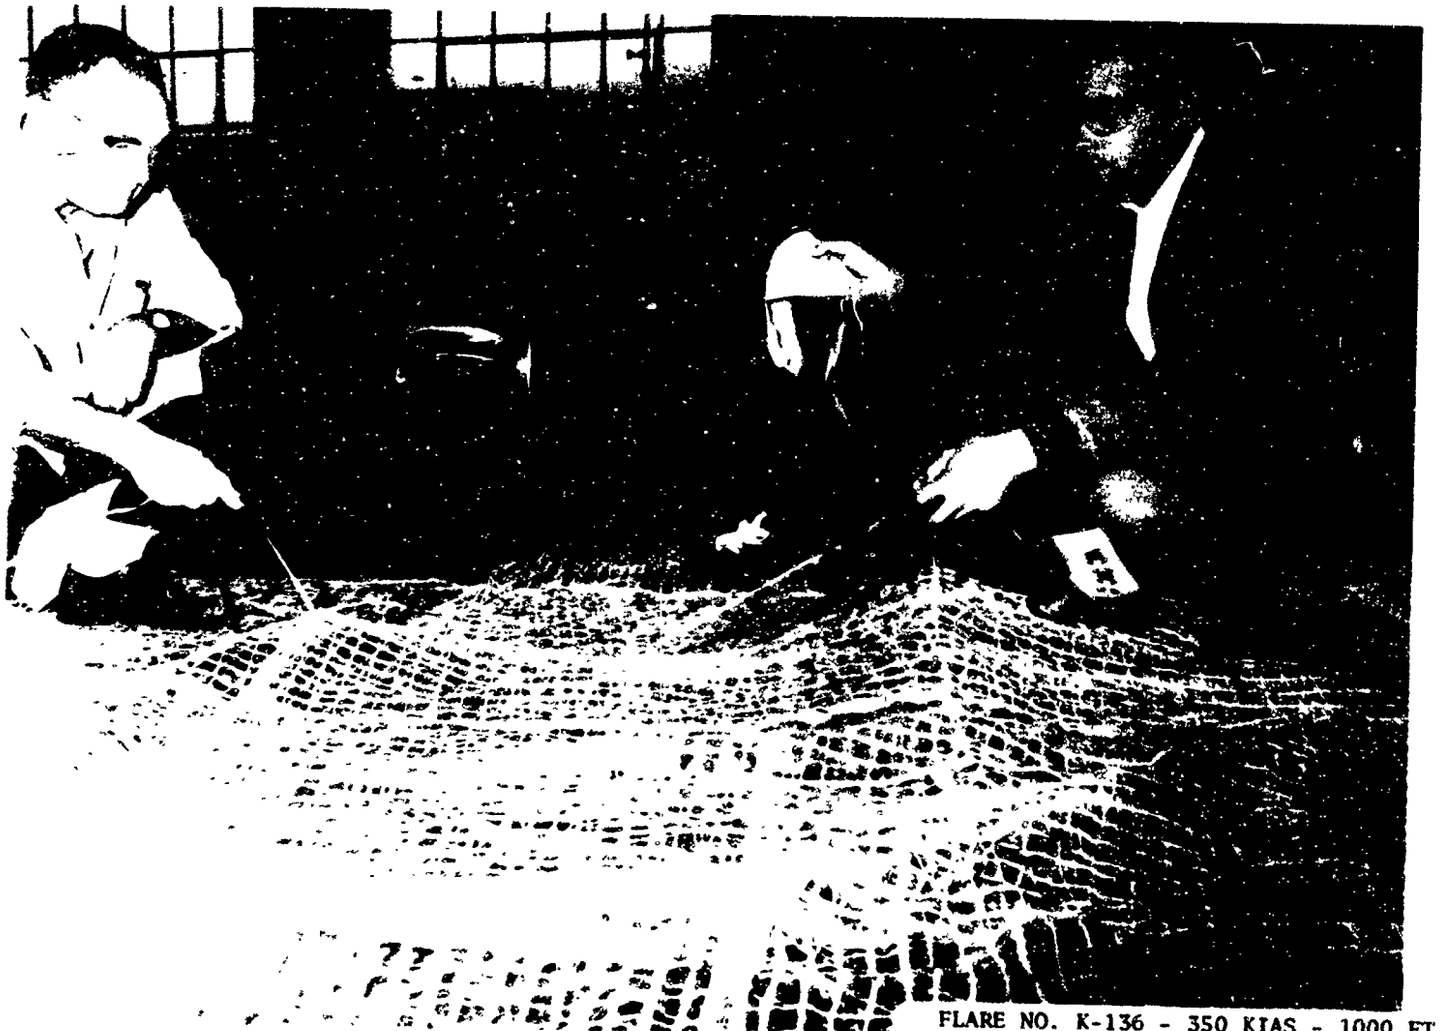
K-135	"	"	"	9.7	205	10.2	10.9	175	184	C	±2°-±3°. 1 Panel Damaged. Candle up into Smoke last 9 sec of B.T. Fast Burning Candle
K-136	"	"	"		205	10.5			215		Damaged Chute. 150 seconds to impact.
K-137	"	"	"							C	Dud. Lanyard Broke at Release.
P-162	MK-45	"	"	9.9	205	10.2	12.6		243	7.6	±45° Oscillation. Dropped too low ground Impact at 210 seconds.
P-163	"	"	"	9.9	205	10.2	11.9		245	C	Dropped too low. Ground impact at 82 sec. May have been Chute damage. Chute Burned.
K-138	CROSS	"	300	8.9	205	9.5	10.0	167	176	5.0	±2°-±4° Oscillation. Fast Burning Candle.
K-139	"	"	"	10.1	205	11.2	11.0	168	183	C	±2°-±3° Oscillation. Damaged Panel on Opening Candle up into Smoke Last 8 seconds of B.T.
K-140	"	"	"	8.7	205	9.4	10.1	168	186	6.1	±2°-±4° Oscillation - Good Stability
K-141	"	"	"	10.4	205	11.0	11.6	180	181	C	±2°-±3° Oscillation. Damaged Panel on Opening Candle up into smoke last 6 sec. before Dump
K-142	"	"	"	8.3	205	8.5					Candle Tore Off Chute on Opening. 28 Sec to Impact. Burned out on Ground.

FLARE NO. K-136 - 350 KIAS - 1000 FT
FUZE SETTING - CROSS DESIGN MYLAR/
DACRON FLARE CLOTH - SHOWS DAMAGE TO
DEPLOYMENT BAG AREA.
DEPLOYED AT 205 FT/SEC

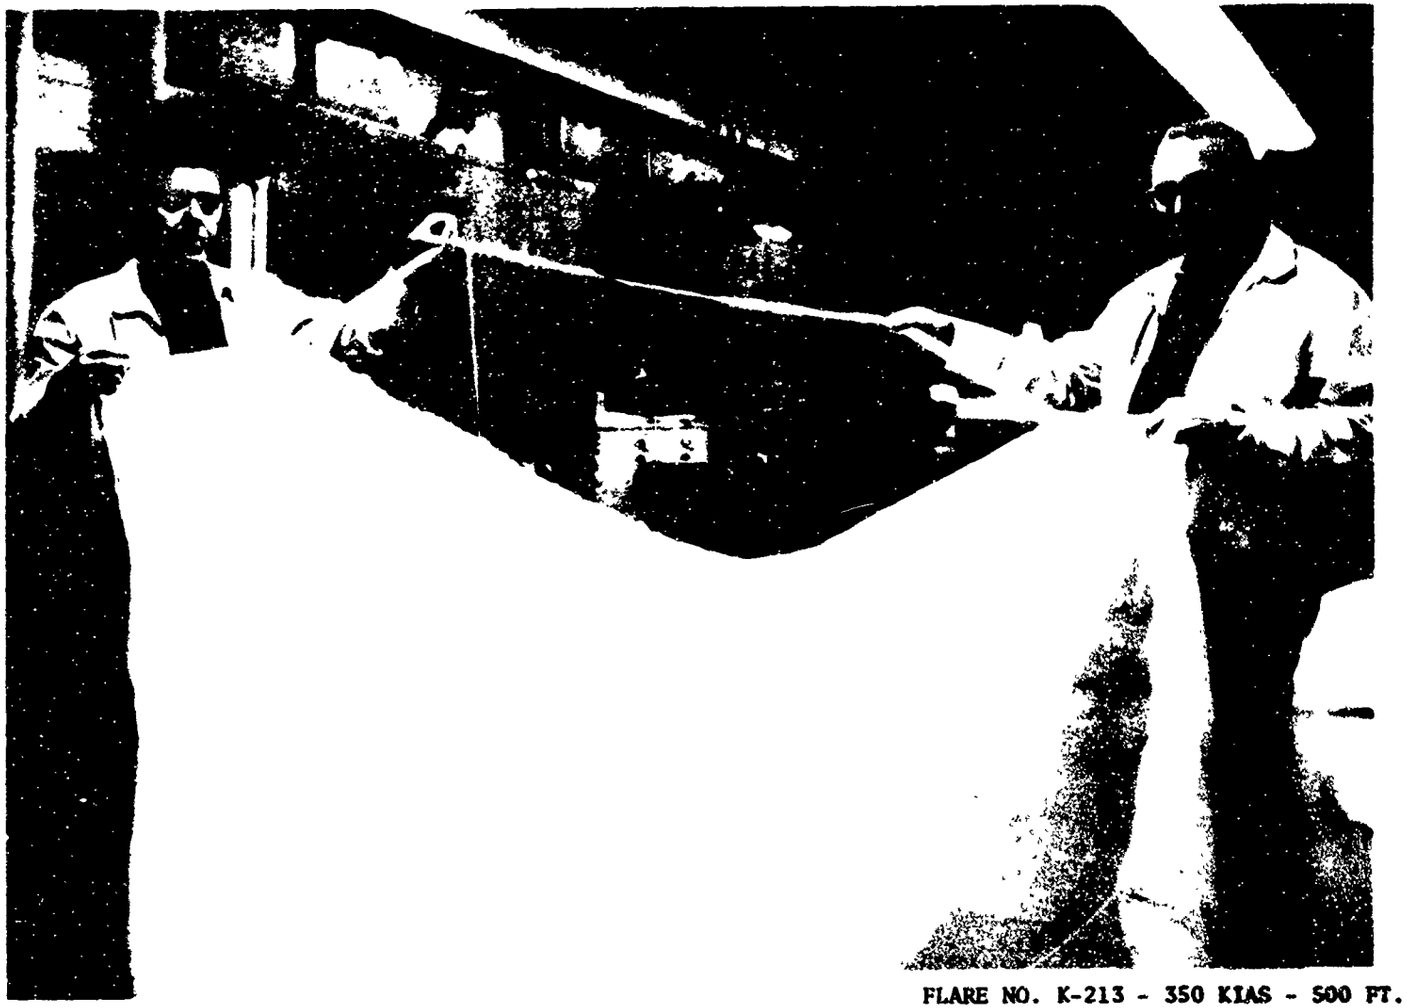
(c) One flare released at 350 (KIAS) with 500 ft. fuze setting, deployed chute at 195 ft/sec. The cloth on this chute tore about 1 inch above the top stitching in the hem tape, a distance of approximately 4 feet around the periphery of the chute.

(1) A potential strength problem was found in the present MK 45 parachute configuration when the Cerex cloth was substituted for present woven nylon cloth. Although only one chute failure was found, it was at a deployment velocity of only 215 ft/sec. It should be noted that a 350 KIAS aircraft release and a 3.5 sec.

K-213	"	"	"	6.4	215	7.4	7.0	147	193	C	Stable. 4 Ft. Tear in Chute along Bottom Hem Seam. Early Exp. Bolt. Finished Burning on Ground.
K-214	"	"	400	7.9	210	8.0	9.2	201	210	7.7	Unstable.
K-215	"	"	"	7.0	215	7.5	7.8	210	210	C	Unstable.
K-216	"	"	450								Lanyard Broke Approx. 1 Foot from Fuse Dud. Never Pulled Pin out of Striker.
K-217	"	"	"	6.2	230	7.0	8.0	202	202	C	Stable First Half of Burning Time Then Unstable.
P-176	MK-45	"	200	7.2	195	7.9	8.5	219	220	7.0	Unstable.
P-177	"	"	"	7.0	195	7.2	7.4	192	214	C	Unstable. Lost Large Amount of Comp. When Exp. Bolt Fired.
K-220	CROSS	500	"	6.5	195	7.3	8.0		204	5.7	Stable. Looked Like Burned Shroud Lines. Early Collapse.
K-221	"	"	"	6.6	195	7.3	7.4	201	216	C	Stable. Upward last 20 seconds before Exp. Bolt Fired.

FLARE NO. K-213 - 350 KIAS - 500 FT.
FUZE SETTING - FLAT CIRCULAR DESIGN
CEREX FLARE CLOTH - SHOWS DAMAGE TO
ONE GORE -
DEPLOYED AT 215 FT/SEC

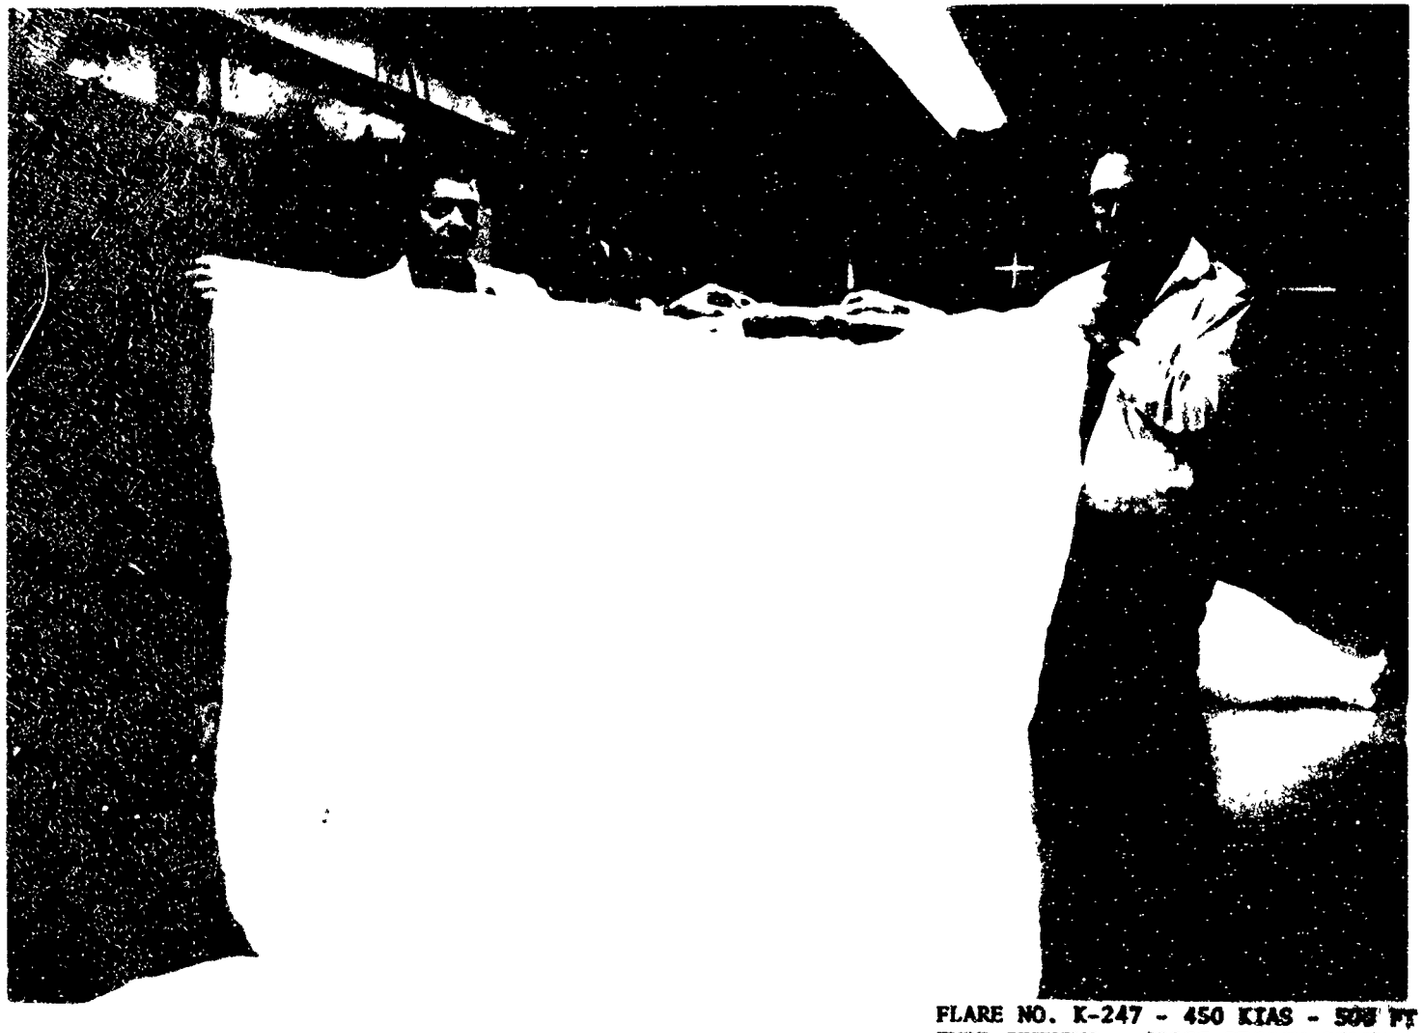
(c) A second flare released at 450 (KIAS) and 500 ft. fuze setting, deployed chute at 215 ft/sec. The cloth on this chute tore (as above) a distance of approximately 20 inches along the hem.

(2) The Cross parachute fabricated of the same Cerex cloth performed very well. Slight damage (hem tears) was found on two chutes which were deployed at 205 and 215 ft/sec. This damage was very minor and it is felt that it is not a problem at present. This chute and material had very good stability ±5° from vertical axis in most cases. This chute exhibited a much slower corrected average descent velocity 5.14 ft/sec vs. 8 ft/sec for the production MK 45 chute, a 36% reduction.

FLARE NO. K-247 - 450 KIAS - 505 FT
FUZE SETTING - CROSS DESIGN CHEX FLARE
CLOTH - SHOWS DAMAGE TO ONE GORE -
DEPLOYED AT 215 FT/SEC

It is recommended that a smaller cross parachute (approximately 16 ft. panel length, Do = 13-13.5 ft) fabricated of .85 oz/yd. 425 ± 70 CFM Cerex flare cloth be further evaluated. This program indicates that Cerex cloth exhibits the strength to withstand the snatch loading required for this diameter parachute. A parachute of this diameter, fabricated of Cerex cloth, should provide the same average descent velocity as the present production MK 45 APF chute, plus exhibit a sizable reduction in parachute cost and increase the flare's stability.
