DEVELOPMENT OF A FIXED, PERMANENT MOORING SYSTEM ON THE PINNACLE OF COBB SEAMOUNT

FINAL REPORT
BY THE
OCEANOGRAPHIC INSTITUTE OF WASHINGTON

25 April 1971

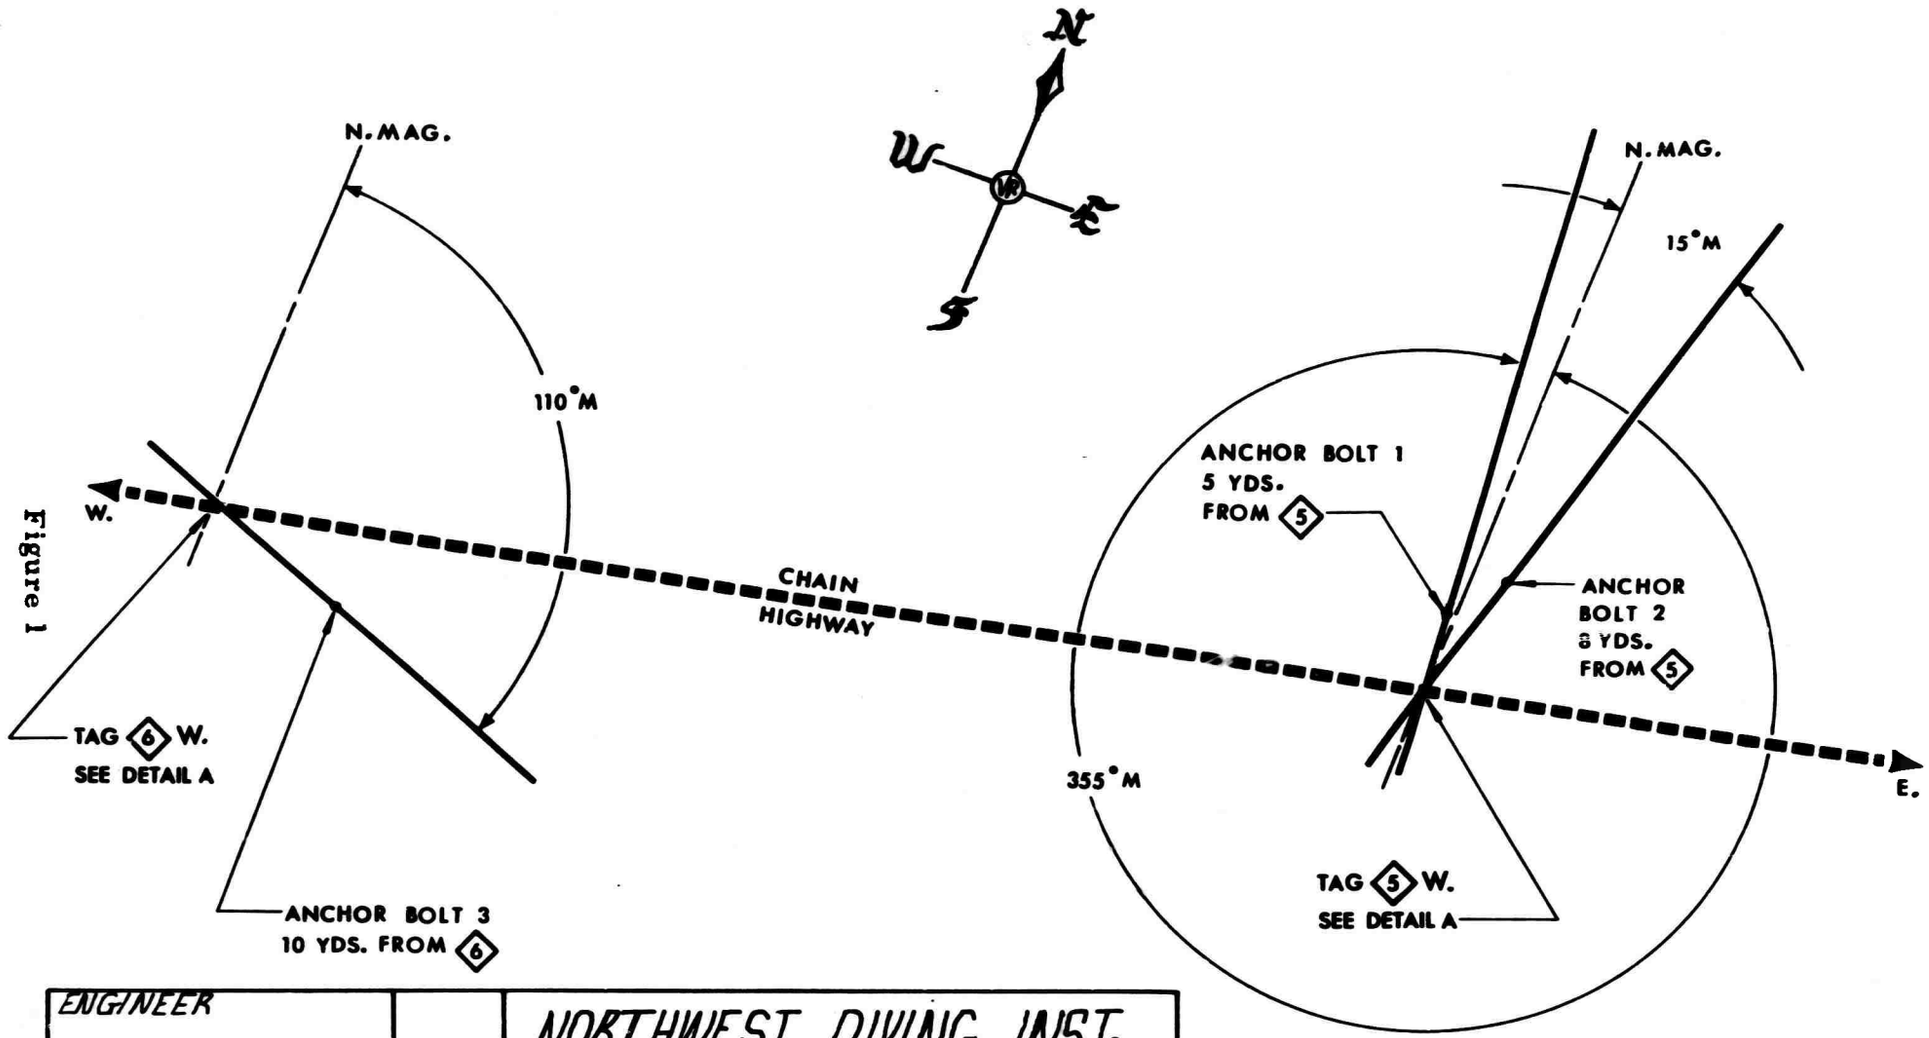
Figure 1

2. Implantment of three anchor bolt assemblies in the core holes. Each of the rock bolts was inserted to a depth of approximately 55 inches and grouted into place. The foot of the first bolt was not separated; however, the foot of the second bolt was separated ¼ inch and that of the third was separated 3/8 inch (see Figure 1).

the ship to kedge herself up wind. Using the SEA USE aquanauts, this third point moor was achieved, and FS-313 was able to resume a position sufficiently in line with the Class A and reflector buoys to permit lifting and re-implanting the Ocean Systems coring rig. A second core was promptly begun and successfully completed by day's end, and this included the implant of the second rock bolt, complete with collar assembly. In the remaining daylight, FS-313 kedged up to within 20 feet of the reflector buoy, remaining in a three-point moor, and obtaining approximately a 250-foot separation between the first two rock bolts and that point (see Figure 1).

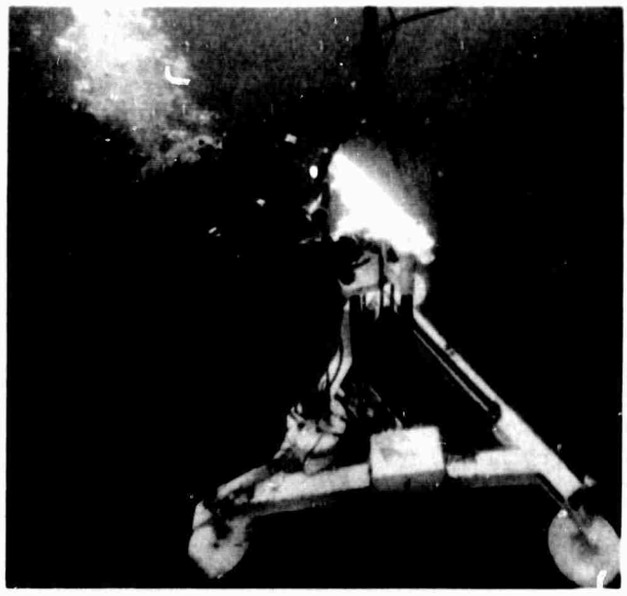
A diver from Ocean Systems, Inc. descends with the coring rig to the pinnacle. With a diamond bit, OSI drilled and extracted three basalt cores. Divers then pneumatically forced cement grout into the holes and inserted the 2½" x 5' steel bolts. Marked with arrows to indicate magnetic north, the cores are now under study by geologists.

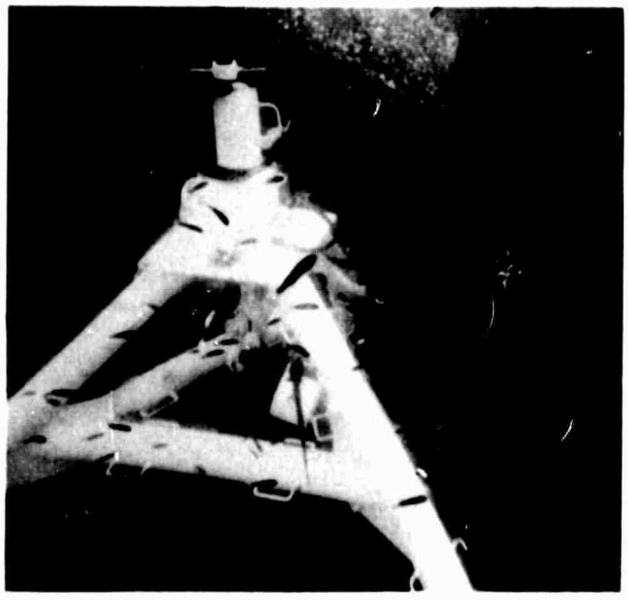
Figure 2

A diver from Foundation Sciences, Inc. of Portland, Oregon, operates the hydraulic test rig during tests of one bolt assembly. At about 110 tons of vertical pull, failure occurred between the bolt and the grout. The yield strength was 50 tons and the safe load 35 tons. Although it withdrew about one and a half inches, the bolt still had some 20 tons of residual strength.

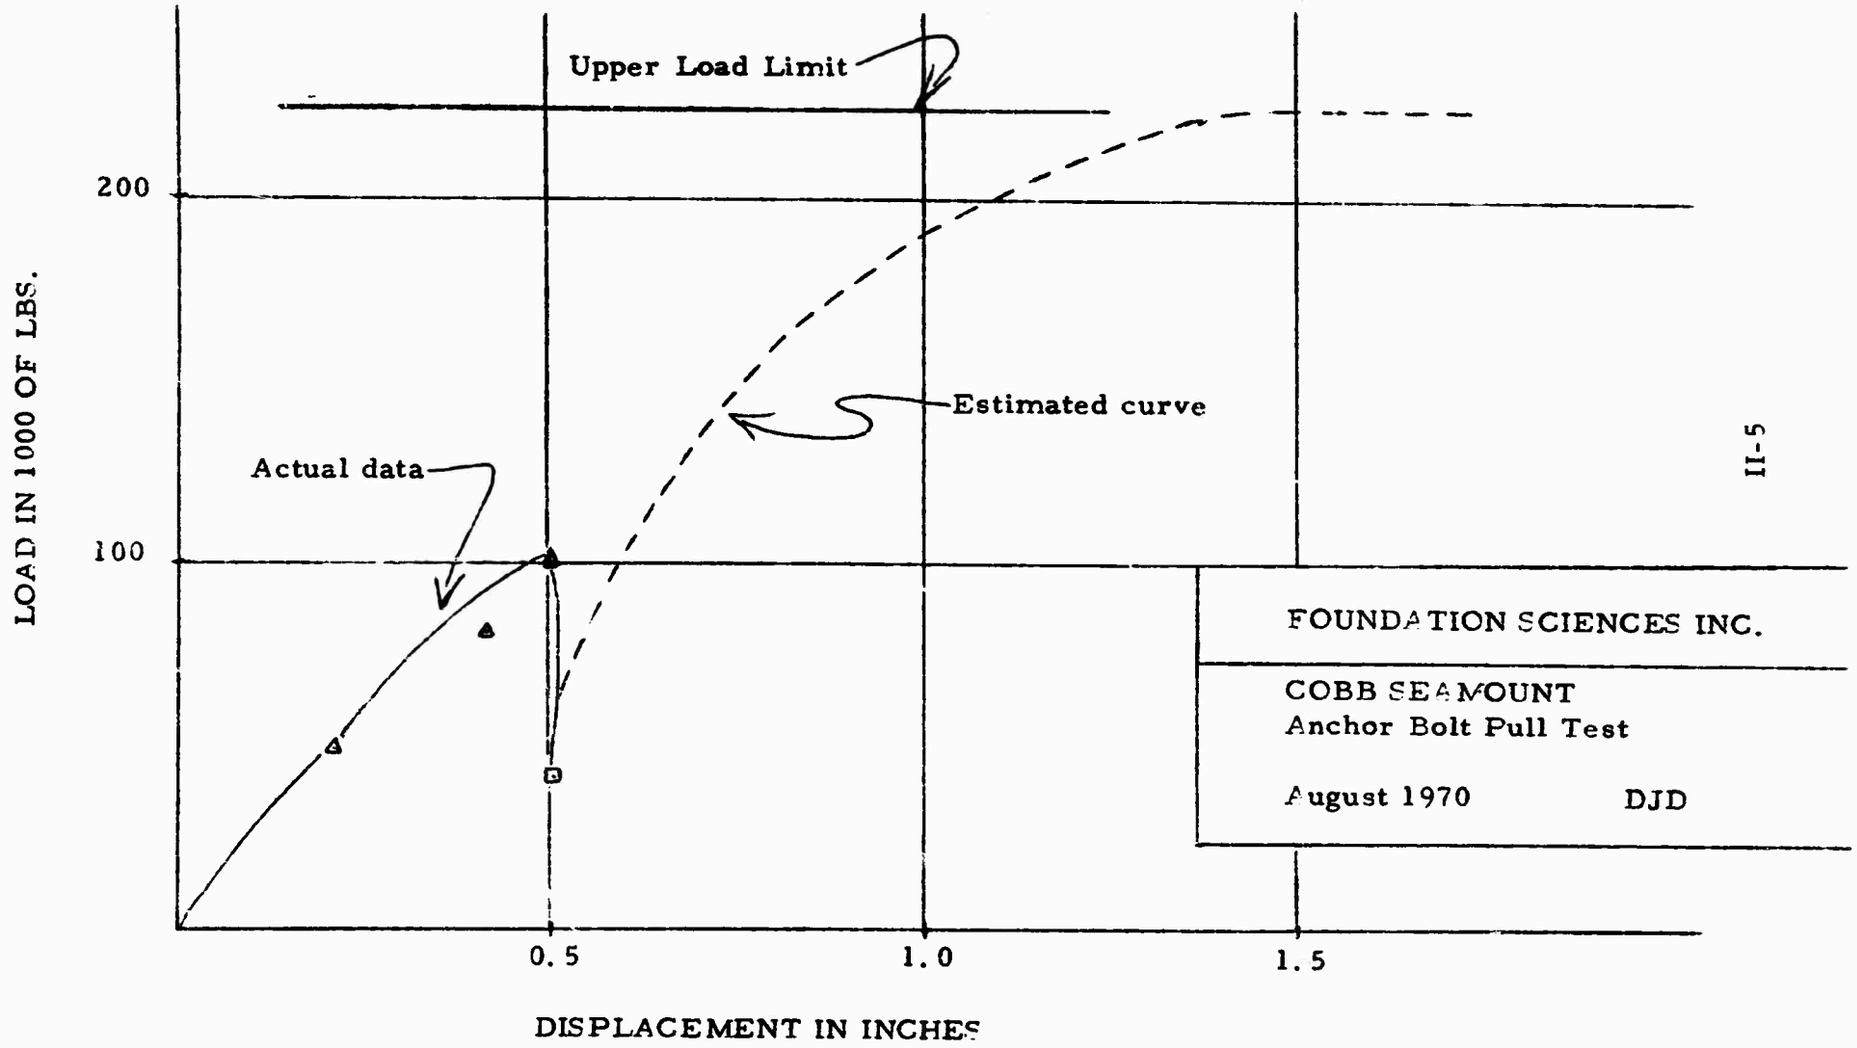
It is believed that there was bond failure between the cement grout and bolt, and that after this mode of failure much of the load was transferred to the spread foot of the bolt, which accepted the load. Thus, failure continued as the foot of the bolt crushed the cement above.

Figure 1 is a plot of the results of the rock bolt moorage pull test. The failure of the moorage was between the rock bolt and the grout.

Prior to failure, the bolt was loaded twice to loads in excess of 50 tons and each time, during diver team changes, the load dropped to 20 tons. This indicates that the non-creep load of the tested moorage is about 20 tons.

1. The moorage system failed along the bond between the bolt and the grout. This was primarily due to the short depth of embedment of the bolt. Future moorage systems of this type should have a minimum of 60 rod diameters of embedment in grout.
