Final Report

EXISTING STRUCTURES EVALUATION

Part V: Applications

STANFORD RESEARCH INSTITUTE
Menlo Park, California 94025 · U.S.A.

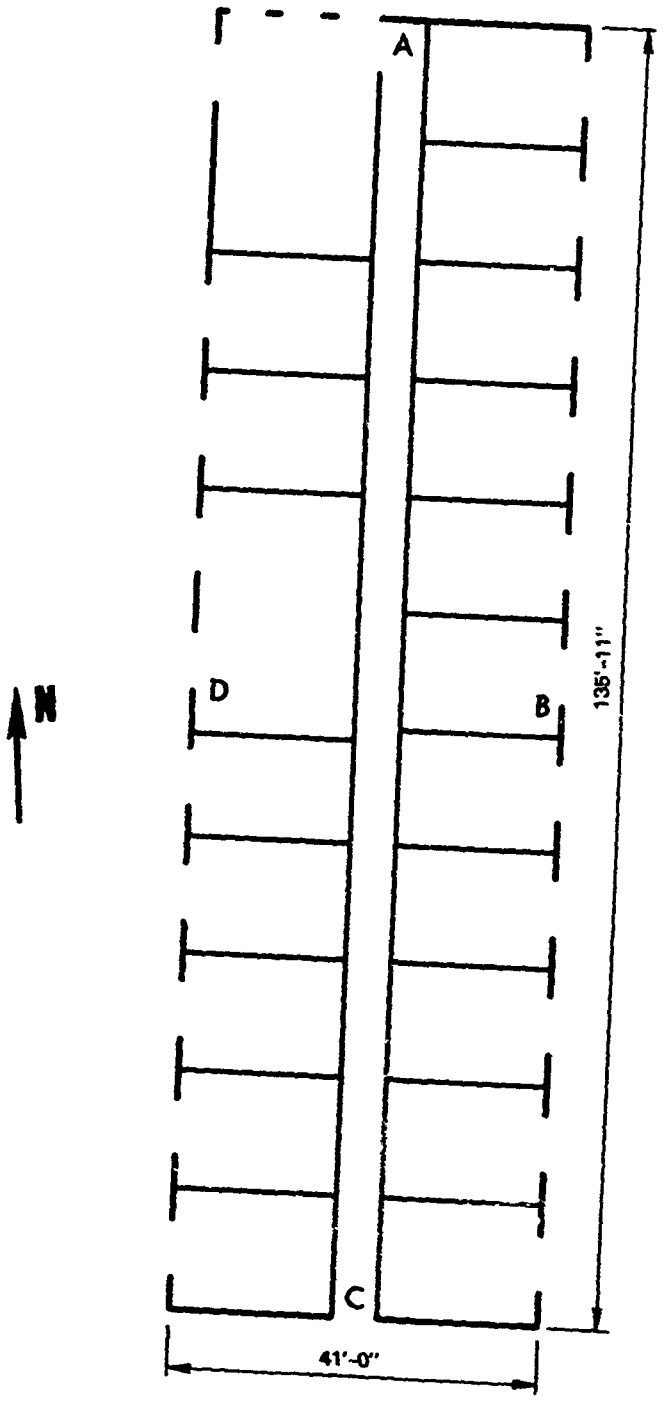
FIGURE 2 FIRST FLOOR PLAN VIEW OF WILBUR HALL #6

As noted in the plan view in Figure 2, the layout of the building consists of a central hallway, with student rooms or lounge areas on both sides. The 5 ft 5 in. wide hallway was the only area designated as shelter space in the NFSS. The first and second floor hallways each contained 60 shelter spaces. The dimensions of a typical student room are 12 ft wide by 17 ft long and contain a 5 ft 4 in. by 4 ft 8 in. window, glazed with double strength glass.

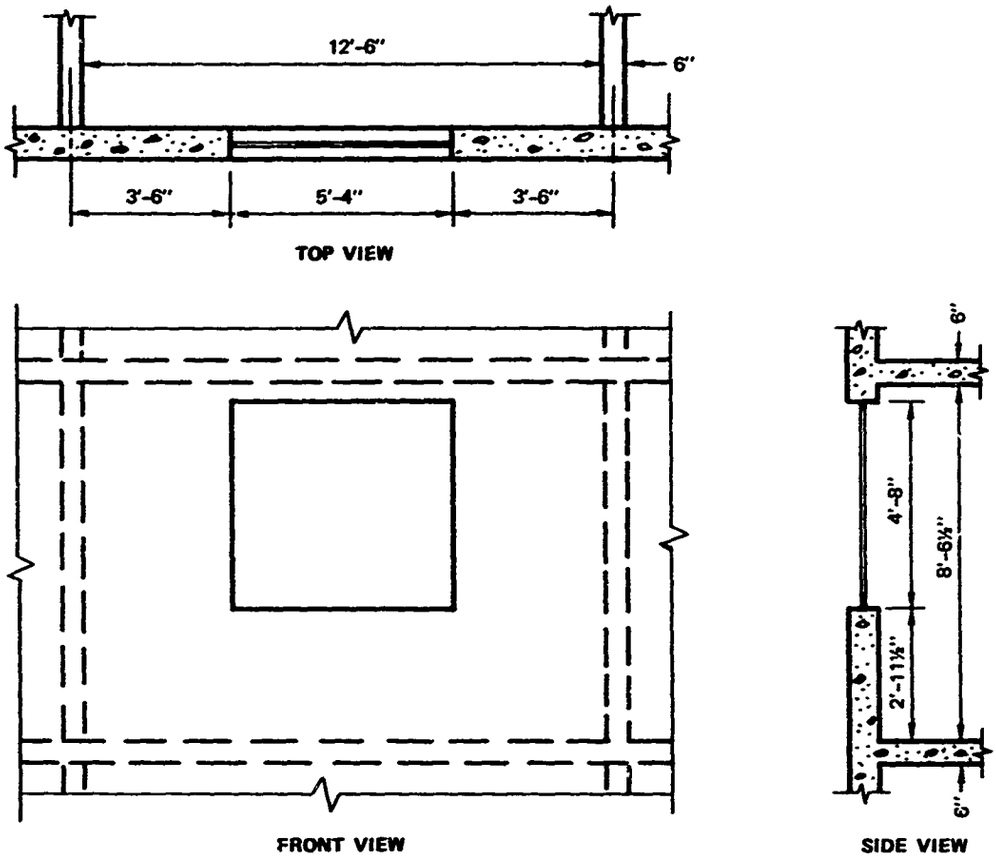
FIGURE 3 TYPICAL EXTERIOR WALL PANEL DETAIL FOR WILBUR HALL #6

floor levels and at the interior partitions dividing the rooms. Each of these supports was assumed to be nonyielding, and the panels were therefore analyzed as two-way reinforced concrete walls, fixed on four edges. One panel on each of the three stories was analyzed. Since the geometric and physical properties were the same for each story, only the axial load on the wall and the clearing distance were considered to change from story to story. Details of a typical wall panel are shown on Figure 3.

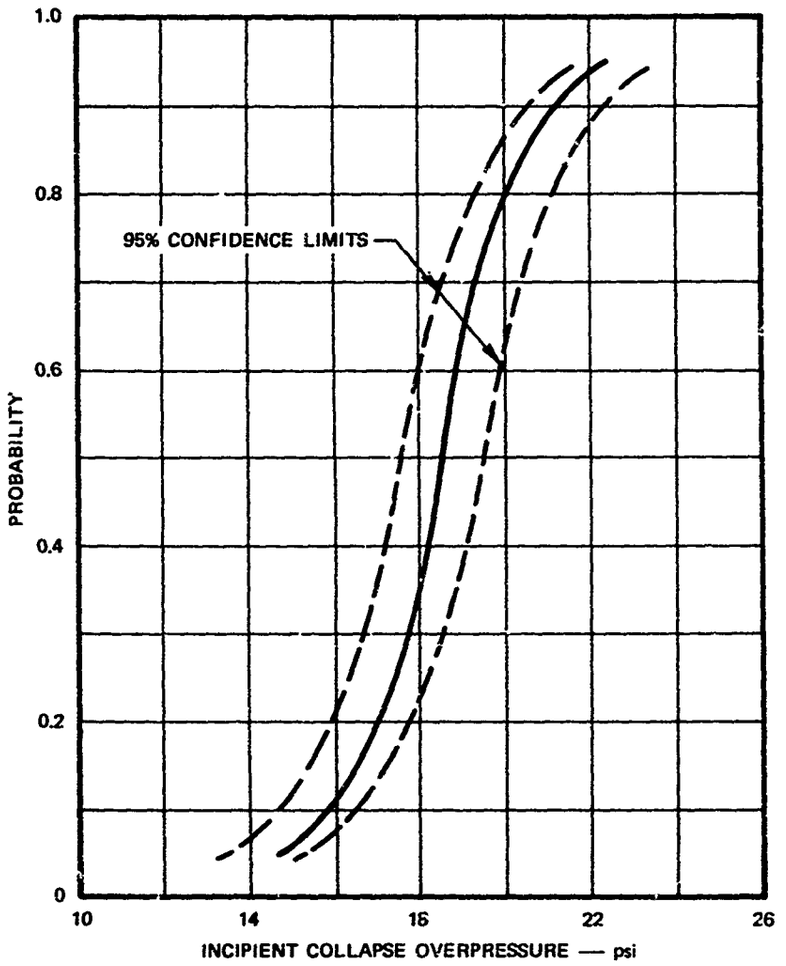
FIGURE 4 PROBABILITY OF OCCURRENCE OF PEAK INCIDENT OVERPRESSURE AT INCIPIENT COLLAPSE FOR WILBUR HALL #6

These results are shown graphically on Figure 4.

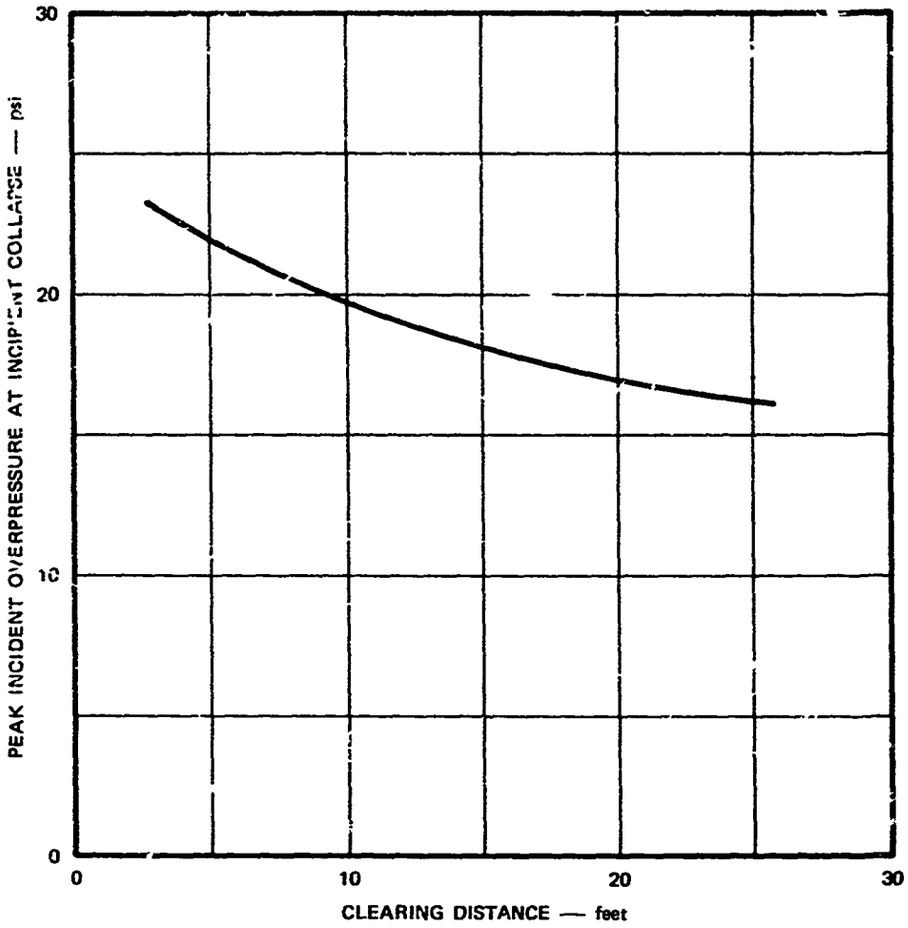
FIGURE 5 EFFECT OF CLEARING DISTANCE ON INCIPIENT COLLAPSE OVERPRESSURE FOR WILBUR HALL #6

Because of the uncertainty of the actual distribution of the clearing distance, a series of analyses was made varying S between the minimum and maximum values that would be expected. These results are shown in Figure 5. As can be seen, the value chosen for S has a large effect on the incipient collapse overpressure obtained.

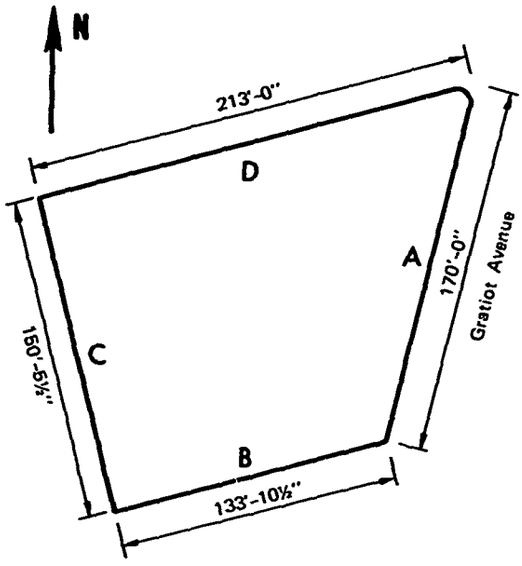
The exterior walls are constructed of a 4-in. brick facing backed with an 8-in. structural clay tile, with a decorative stone treatment on sides A and D. The walls are unreinforced, and the 8-in. clay tile is inset in the structural frame, while the brick facing is continuous over the columns and beams. The first floor exterior wall below the mezzanine floor on sides A and D consists of 3-ft wide wall elements backed by columns with the 15-ft wide windows between. The interior partitions in the basement are 8-in. concrete or unreinforced concrete block and on all other floors are 4-in. timber studwall.

Field Survey Data. During the on-site survey, the exterior walls were classified as tile panel walls with masonry veneer. Since the support conditions for the walls were not given and since panel walls are defined as "nonload bearing walls that [illegible] supported by the structural framework of the building at each floo[illegible]l," it could not be determined from the survey data whether the walls could arch between columns and beams. Therefore, the wall support was treated as an unknown parameter, and it was necessary to perform an analysis for both an arching and non-arching wall.

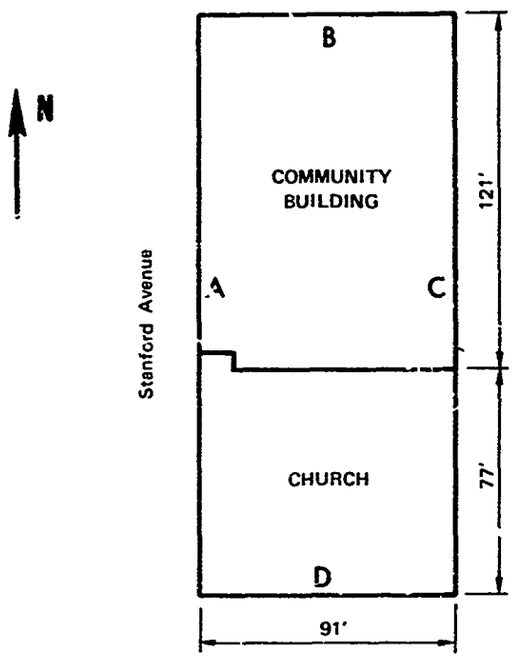
FIGURE 7 PHOTOGRAPHS AND PLOT PLAN OF ST. STEPHEN A.M.E. CHURCH AND COMMUNITY BUILDING

The exterior walls are constructed of a 4-in. brick facing backed with an 8-in. cinder block. The walls are unreinforced, and the 8-in. cinder block is inset in the structural frame, while the brick facing is continuous over the columns and beams. The interior partitions were constructed of 8-in. unreinforced concrete block.

Building Plan Data. An examination of the building plans indicated two major differences between the design of the walls of the Community Building and the wall data obtained in the survey. First, the exterior walls on sides B and C have an overall thickness of 12 in. instead of the 8 in. as noted during the survey. The unreinforced masonry walls were constructed with a 4-in. brick facing bonded to an 8-in. concrete or cinder block backing. Second, the 8-in. masonry block backing is inset between the structural steel columns and beams, and the 4-in. brick facing is continuous over the frame members.

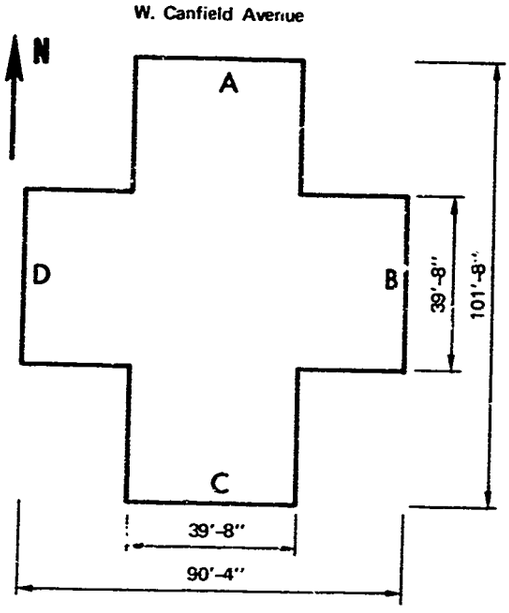
Field Survey Data. During the on-site survey, the exterior walls were classified as concrete panel walls with masonry veneer for the ground floor, and tile panel walls with masonry veneer for all upper floors. Even though the walls were described as panel walls, it was stated in the field survey that the observed and estimated support conditions were that the tile was inset in the frame and the brick facing was continuous over the supports. Because of this apparent anomaly, it was decided to analyze the unreinforced masonry walls on the upper floors for both arching and nonarching supports.

Although it was stated in the survey data that the walls on the upper floors were constructed with a 4-in. thick brick facing backed with an 8-in. thick tile, it was also noted that the overall wall thickness was measured as 14 in. For the analysis, it was assumed that this difference in thickness was because of the thickness of the interior wall finish and that the brick and tile were well bonded with a mortar joint.

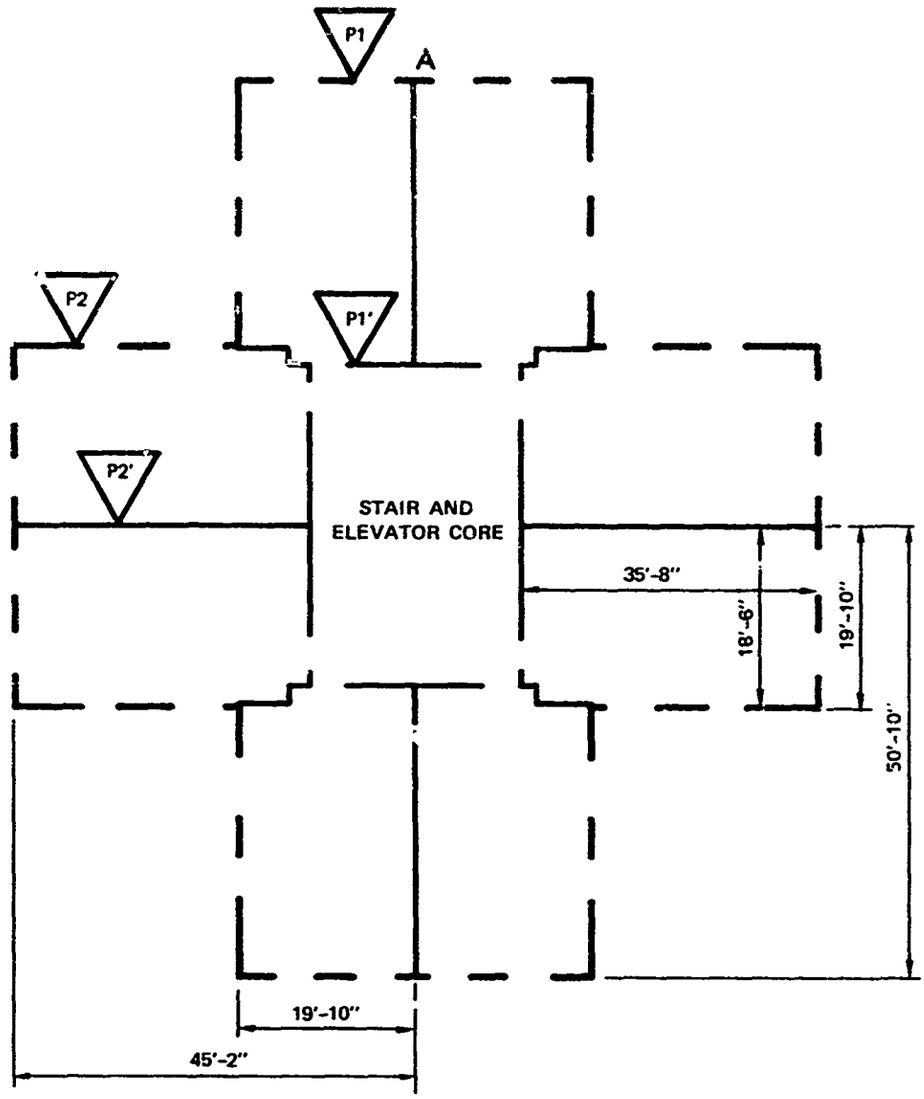
FIGURE 9 PLAN VIEW OF INTERIOR WALLS ON UPPER STORIES
DETROIT HOUSING COMMISSION APARTMENTS

Since mortality predictions in a large multistory building were of special interest to OCD, the interior walls of these apartments were also analyzed. The interior walls analyzed were the 4-in. concrete block walls separating adjacent apartments and between each apartment and the hall or stairway. Figure 9 is a plan showing the location of these interior walls on the upper stories; the interior studwalls within each apartment are not shown. Because of symmetry, it was only necessary to analyze the walls for a blast wave approaching from one direction. However, since the interior walls are loaded by the room pressure and since the room pressure is influenced by the orientation of the room within the

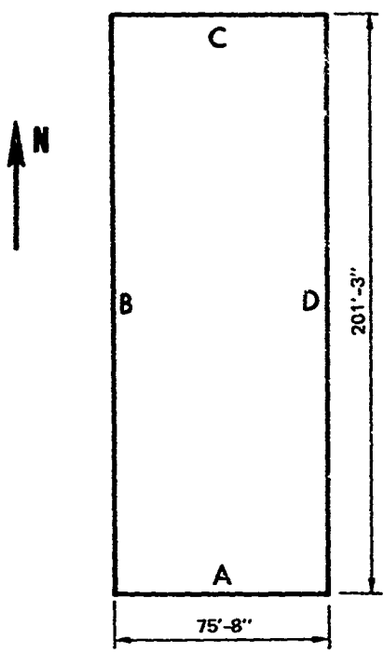
FIGURE 10 PHOTOGRAPHS AND PLOT PLAN OF GENERAL ELECTRIC SERVICE BUILDING

Field Survey Data. During the on-site survey, the exterior walls were classified as 12-in. thick concrete curtain walls without masonry veneer. However, under the type of frame category, the survey data also described wall columns that were 24-in. thick by 49-in. wide reinforced concrete members. Because of this apparent anomaly, and since the support conditions were described as curtain wall, it was assumed for the analysis that the exterior walls were 24-in. thick nonload bearing reinforced concrete curtain walls that were continuous over the floor supports. It was also assumed that the 12-in. thick reinforced concrete curtain walls described in the survey data were the spandrel walls under the large window openings.

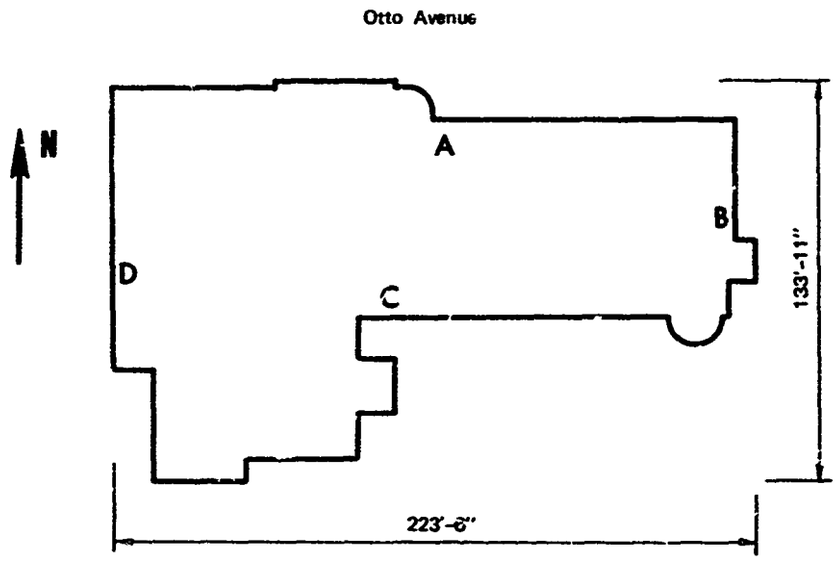
FIGURE 11 PLOT PLAN OF CLARA BARTON ELEMENTARY SCHOOL

The Clara Barton School is located at 8535 Otto Avenue, Detroit, Michigan, and was constructed in 1946. The building consists primarily of one-story classrooms, although there is a mezzanine floor and an unexposed basement over part of the building area. The overall height of the school varies from 16 ft to 22 ft, with overall plan dimensions of 134 ft by 224 ft, which provide an area of about 19,400 sq ft for the first floor, 2,300 sq ft for the basement, and 1,200 sq ft for the mezzanine floor. Figure 11 shows a location plan for the school, and Figure 12 shows the window and wall area on the four sides of the building.
