LONG-TERM STORABILITY OF PROPELLANT TANKAGE

TECHNICAL REPORT AFRPL-TR-71-113

NOVEMBER 1971

AIR FORCE ROCKET PROPULSION LABORATORY

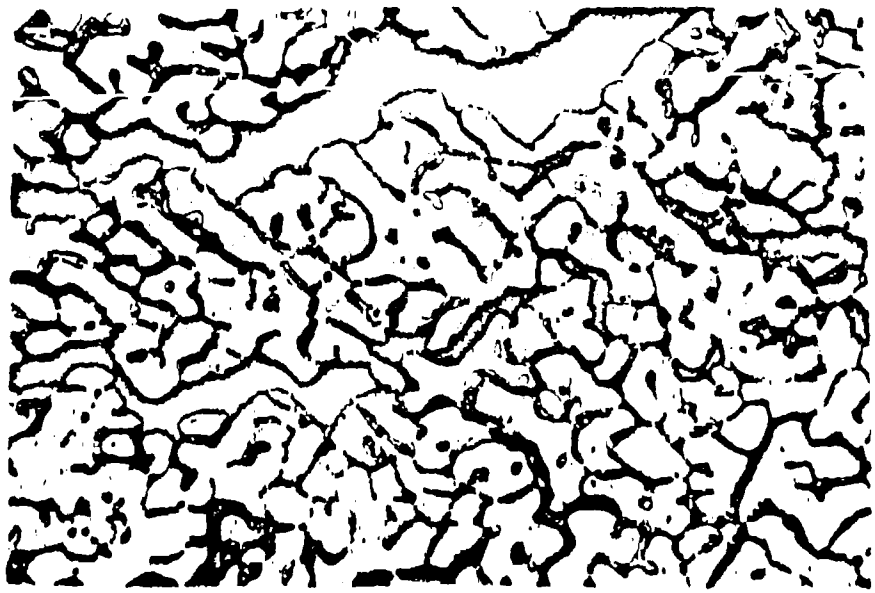
Fig. 3 Spec.No. 243092 Neg. 181288A Mag. 500X Etch: Keller's

Shows the coring present in the corroded region of the lug end weld.

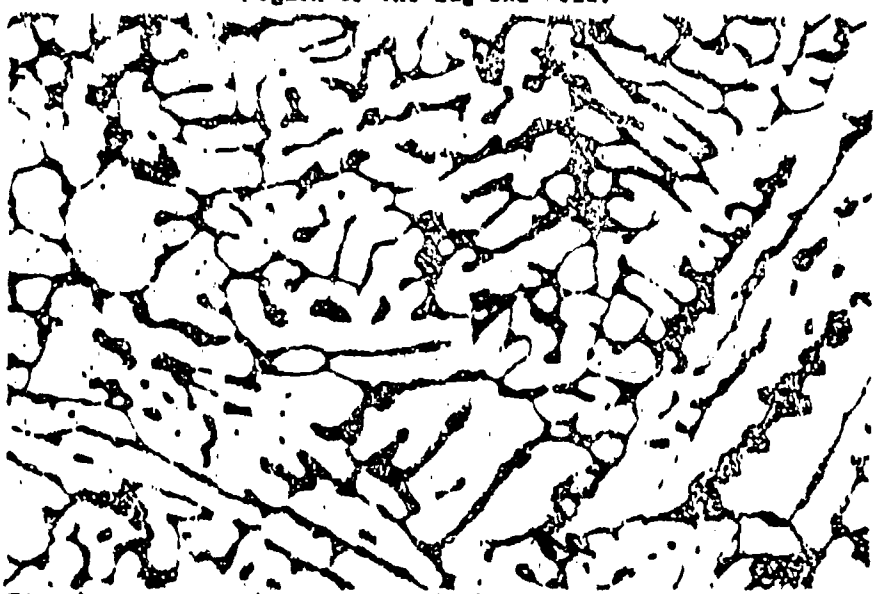
Fig. 4 Spec.No. 243092 Neg. 181289A Mag. 500X Etch: Keller's

[illegible] but also showed a surface layer having a typical 4043 alloy weld structure as illustrated by Figure [illegible]. This uncorroded region may have been in a start-stop region since one area showed a sharp line of demarcation between the body of weld with coring and a lower area of 4043 alloy as illustrated by Figure 5.

Shows a weld structure representative of a typical 4043 alloy bead.

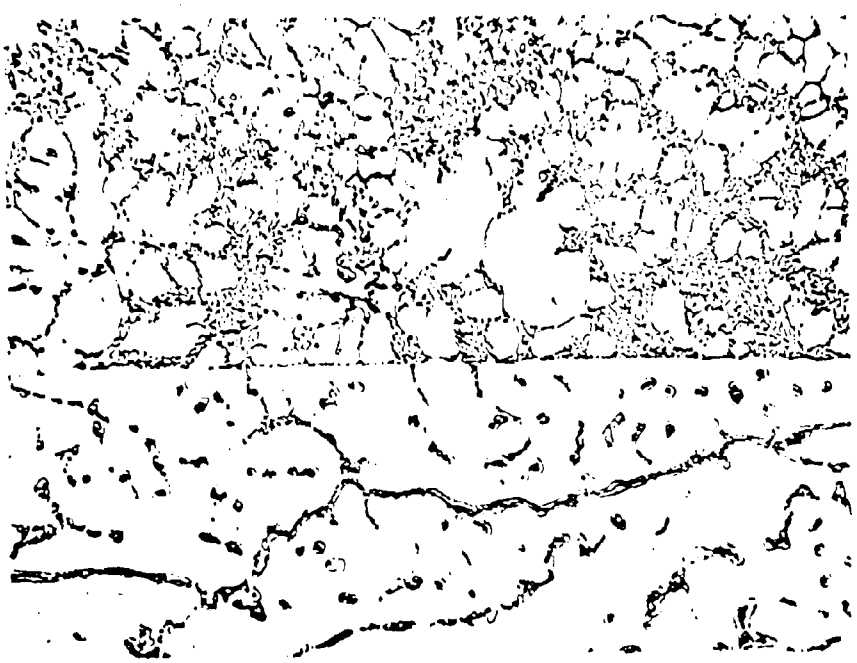
Fig. 5 Spec.No. 243092 Neg. 101290A Mag. 500X Etch: Keller's

Shows aluminum-silicon alloy structure
covering a portion of the dilute 4043 weld metal.
