MISCELLANEOUS PAPER S-72-27

EROSION CONTROL AT THE ARES FACILITY KIRTLAND AIR FORCE BASE, NEW MEXICO

June 1972

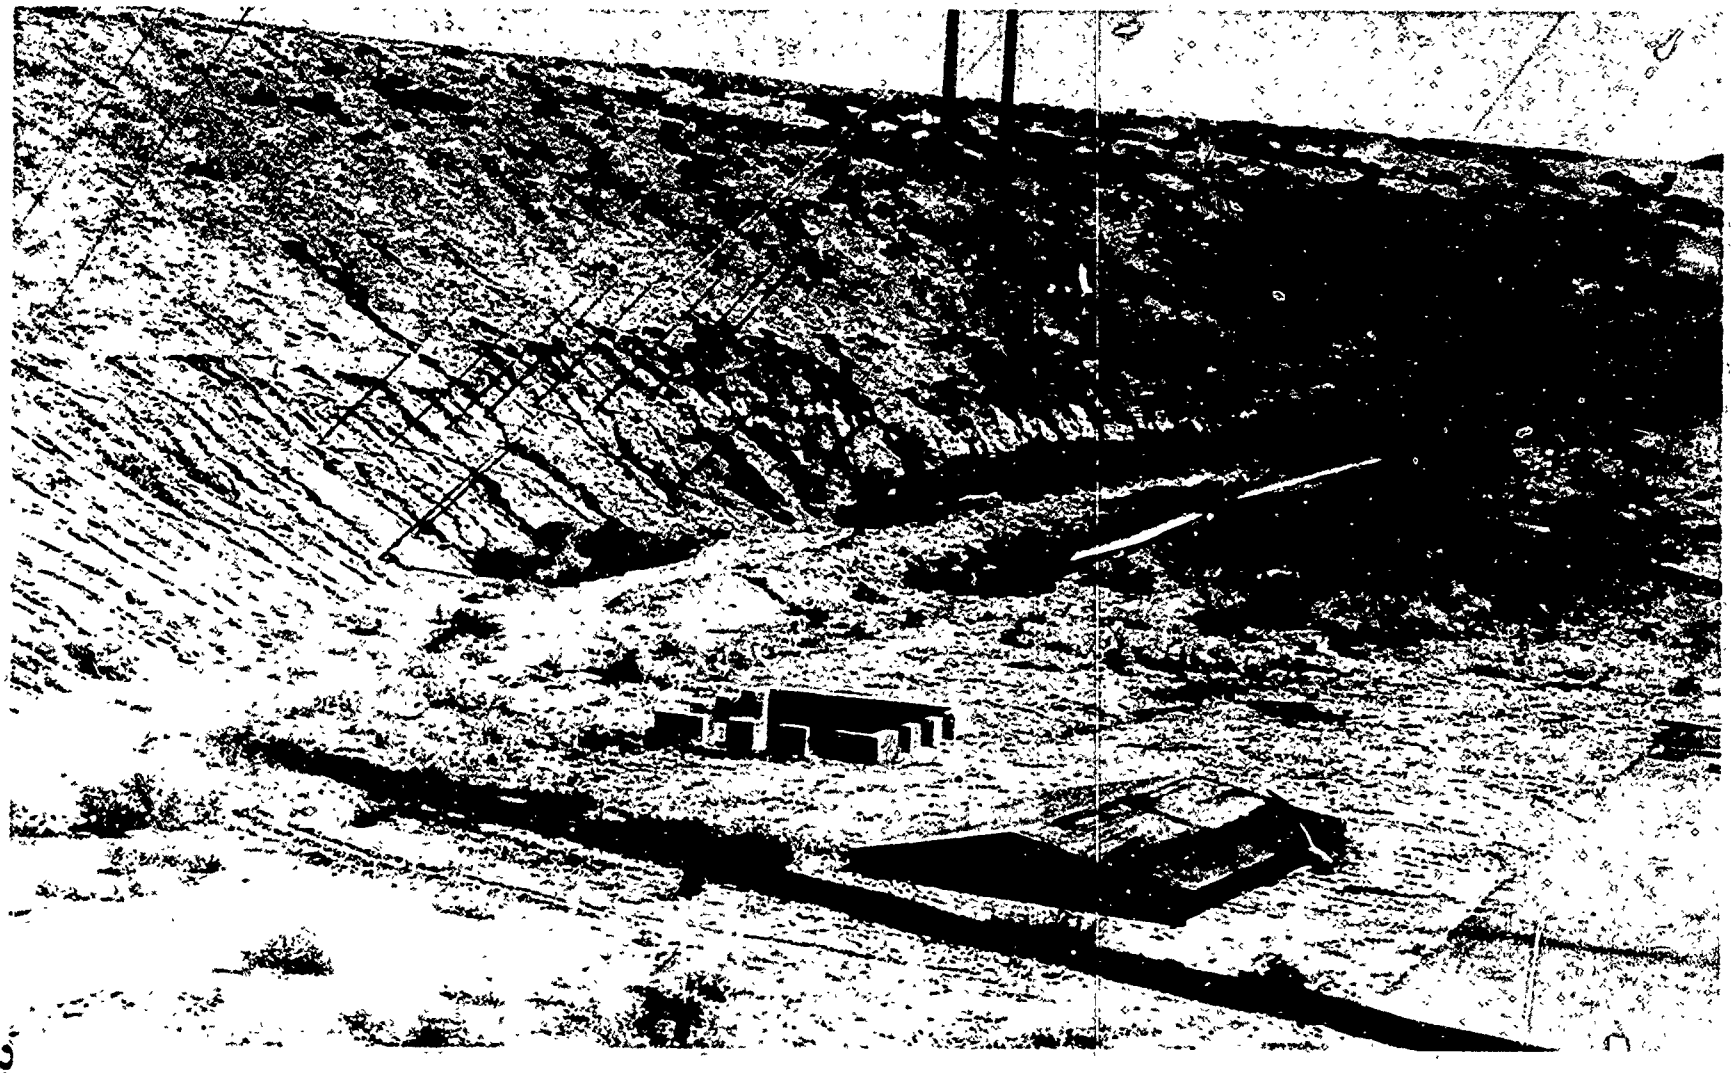
25. The general site layout is shown in plate 1, and a section of the project area showing sparse vegetation cover and state of erosion is shown in photo 1.

Photo 1. Typical section in project area. Note the sparse vegetation and evidence of erosion

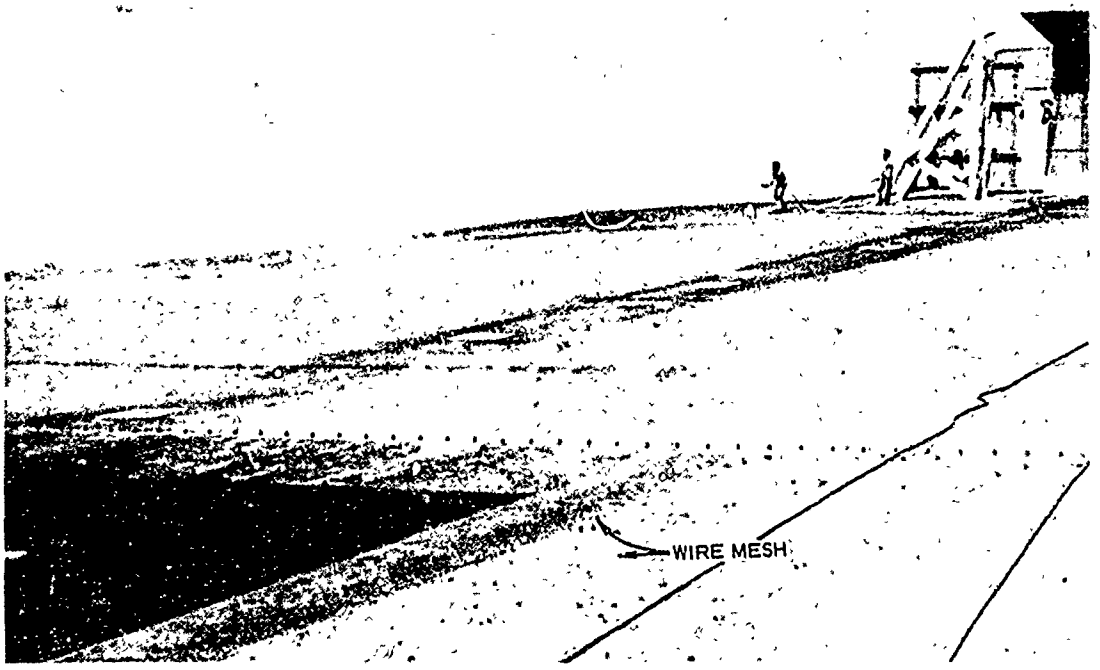
a. East slope

b. West slope

Photo 2. East and west slopes of project area

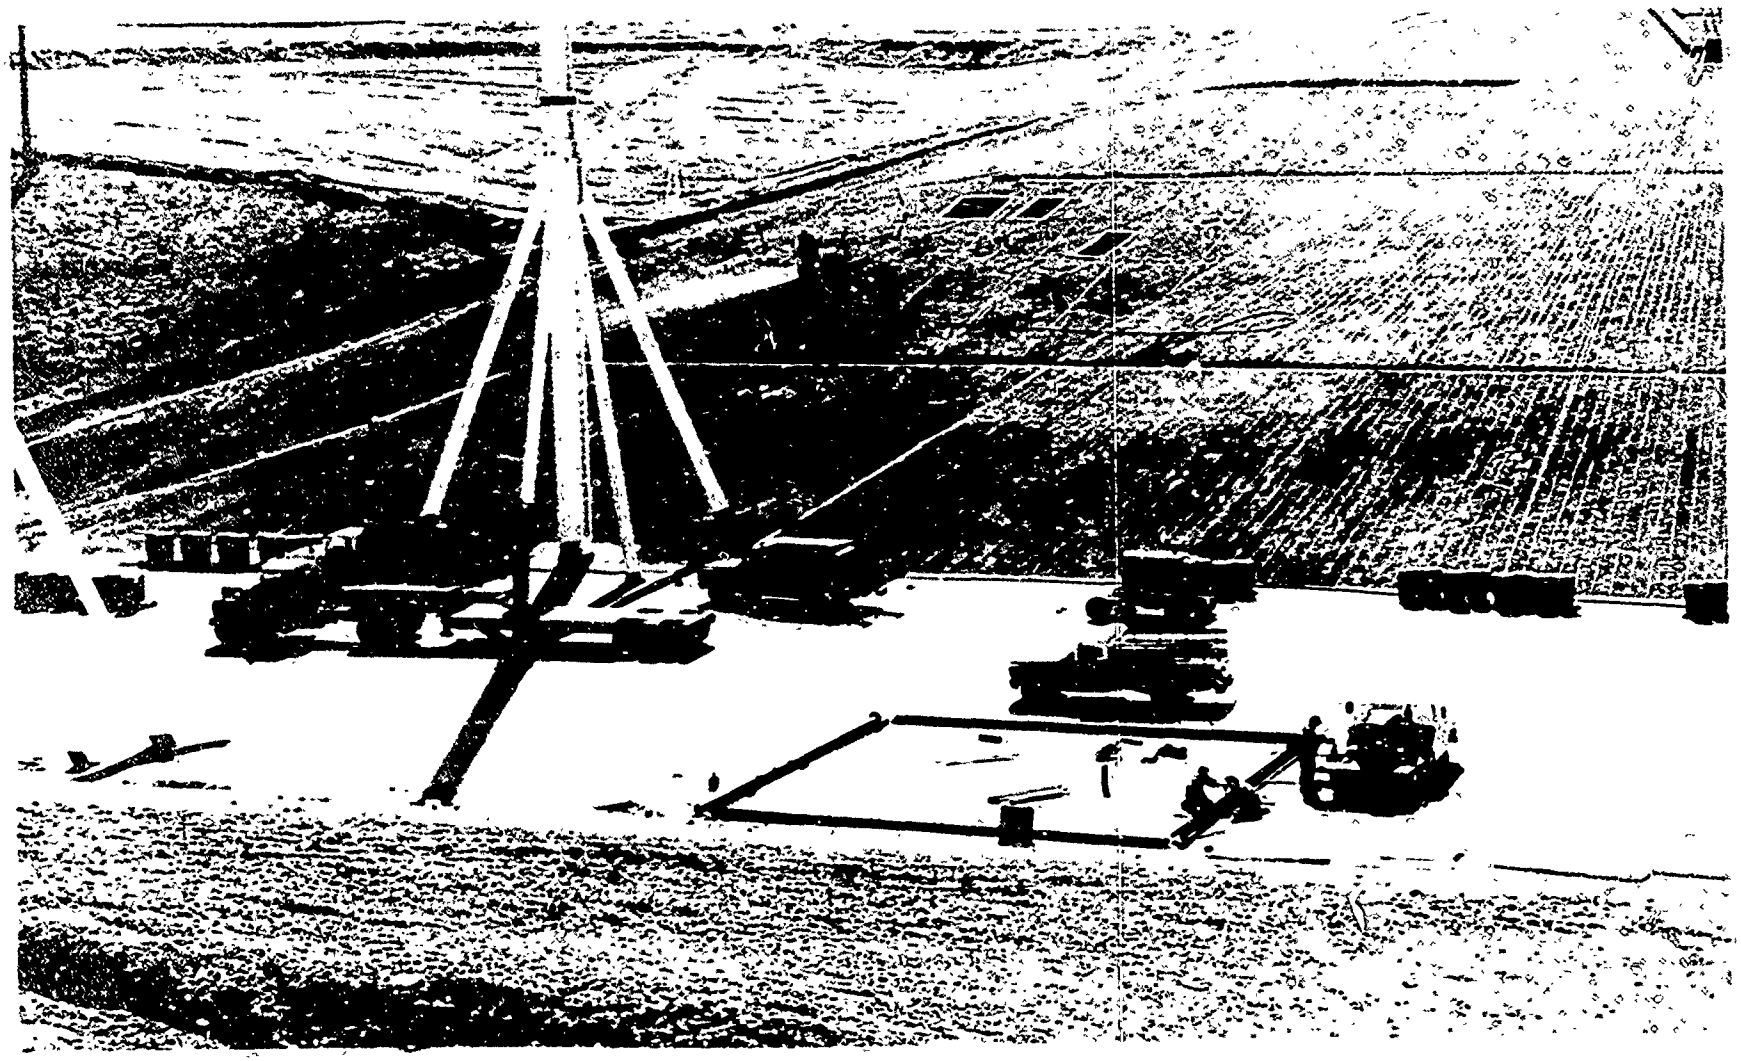
A full tank load was mixed prior to spraying each plot to ensure complete coverage with the recommended amount. In all, more than 80 lb of Hyvar X were spread over the 3.55-acre plot (22.5 lb per acre). The east slope was sprayed first, then the west, and finally the north slope (photo 6).

Photo 6. Application of the soil sterilant

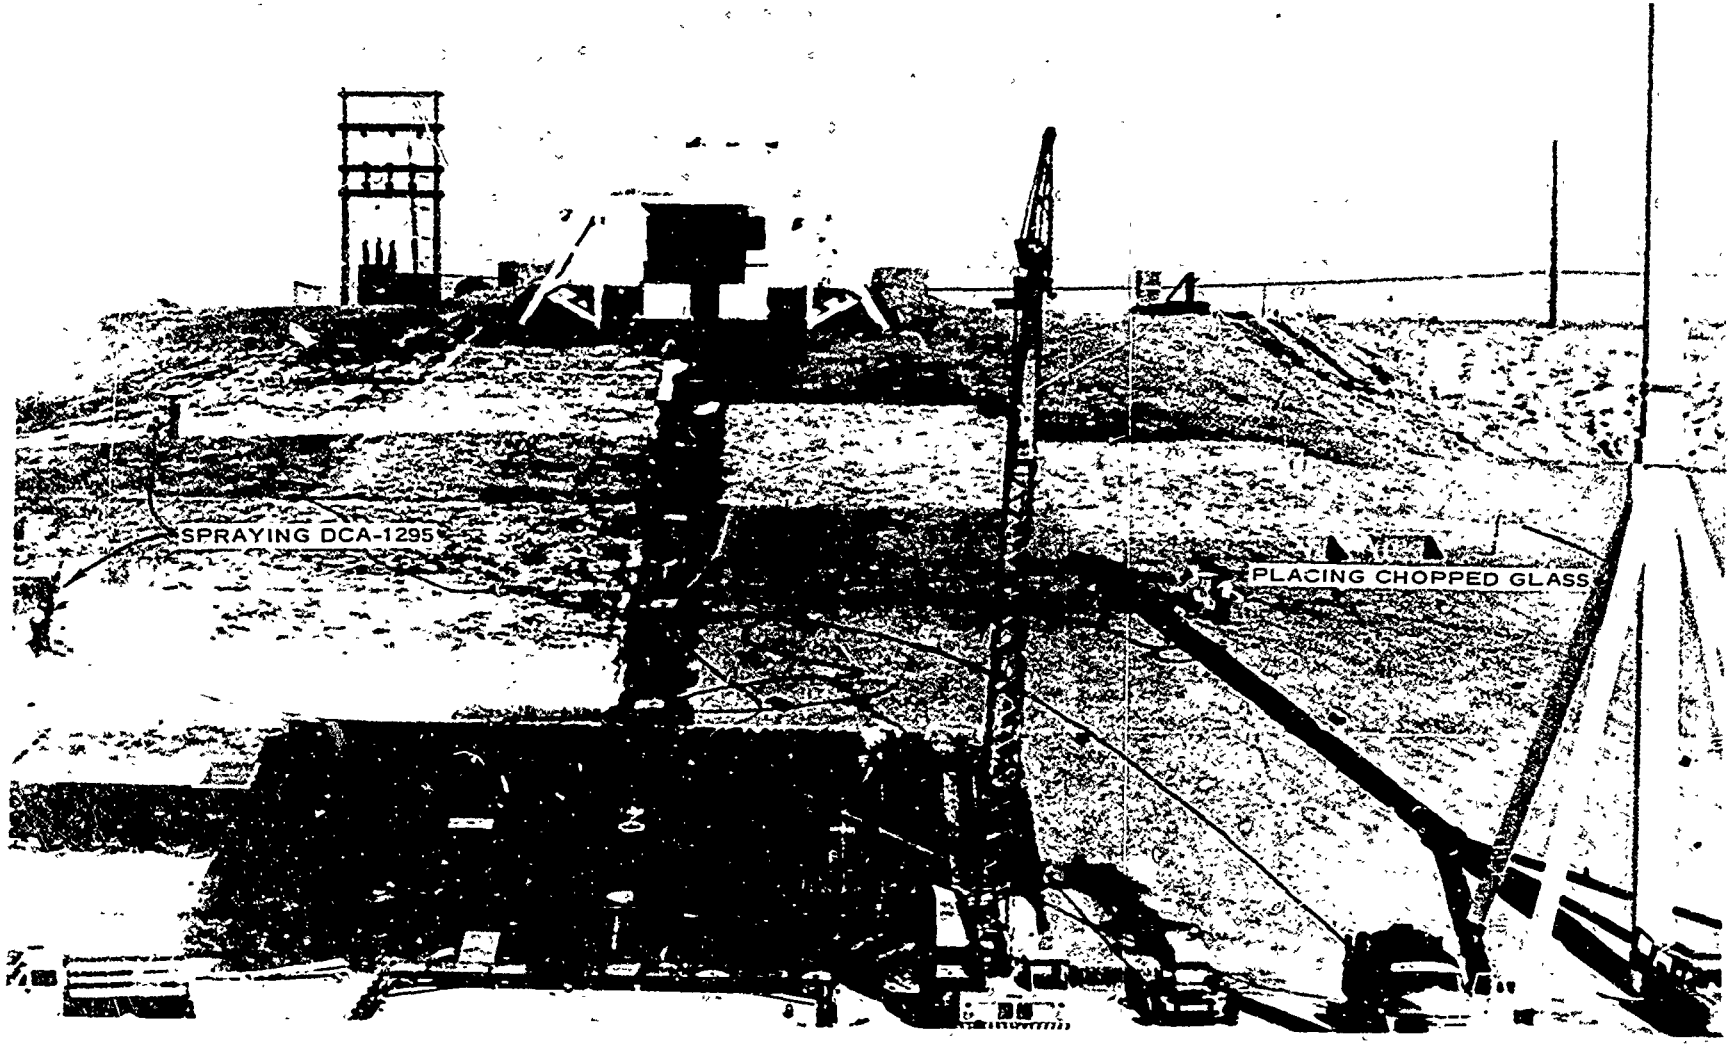
38. An operator and one laborer placing chopped glass and two teams spraying the DCA-1295 over the west slope where the chopped glass has already been placed are shown in photo 10. Close examination of this photograph will reveal the boxes of continuous-strand fiberglass roving positioned on the slope to increase production rates by having material stockpiled in areas close to chopper operations. One box is just to the right of the two men placing the chopped fiberglass. Photo 11 shows a close-up of the chopped fiberglass and DCA-1295 placed in a section covered by 4-in.-grid wire mesh. A broader view of a typical area adjacent to the wire mesh is shown in photo 12.

Photo 10. Placing chopped glass and spraying DCA-1295 on west slope

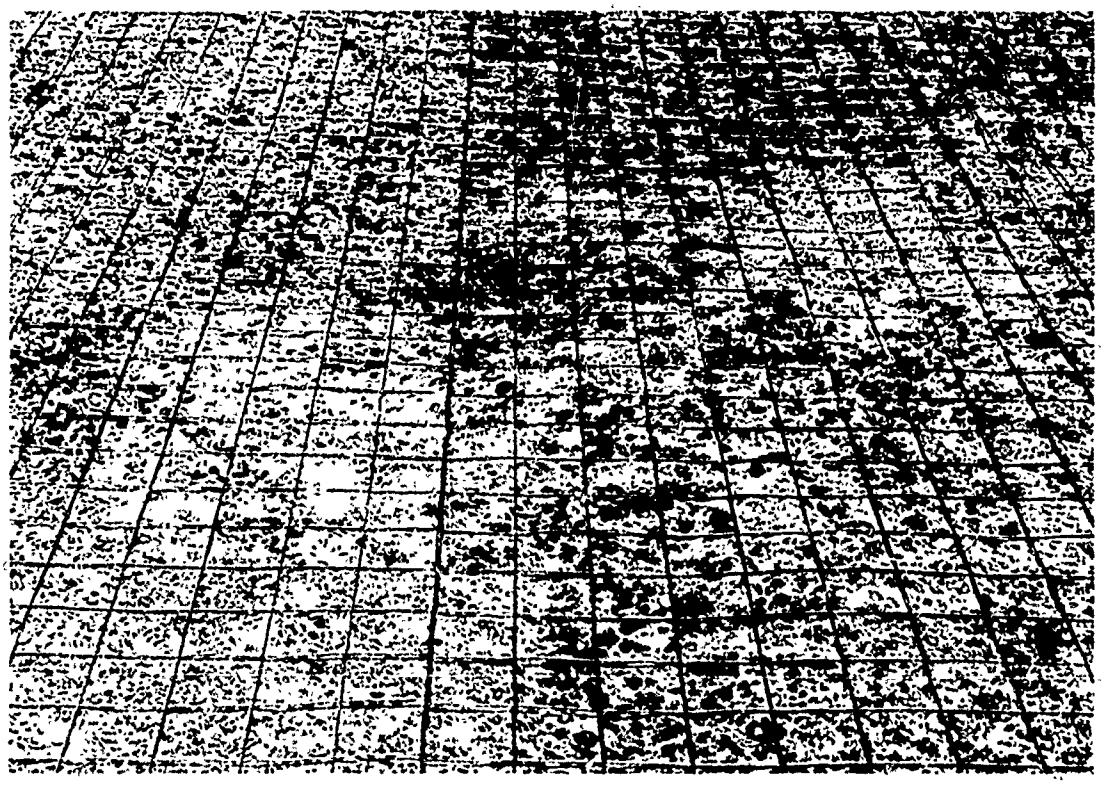
Photo 11. Chopped glass and DCA-1295 in wire mesh area

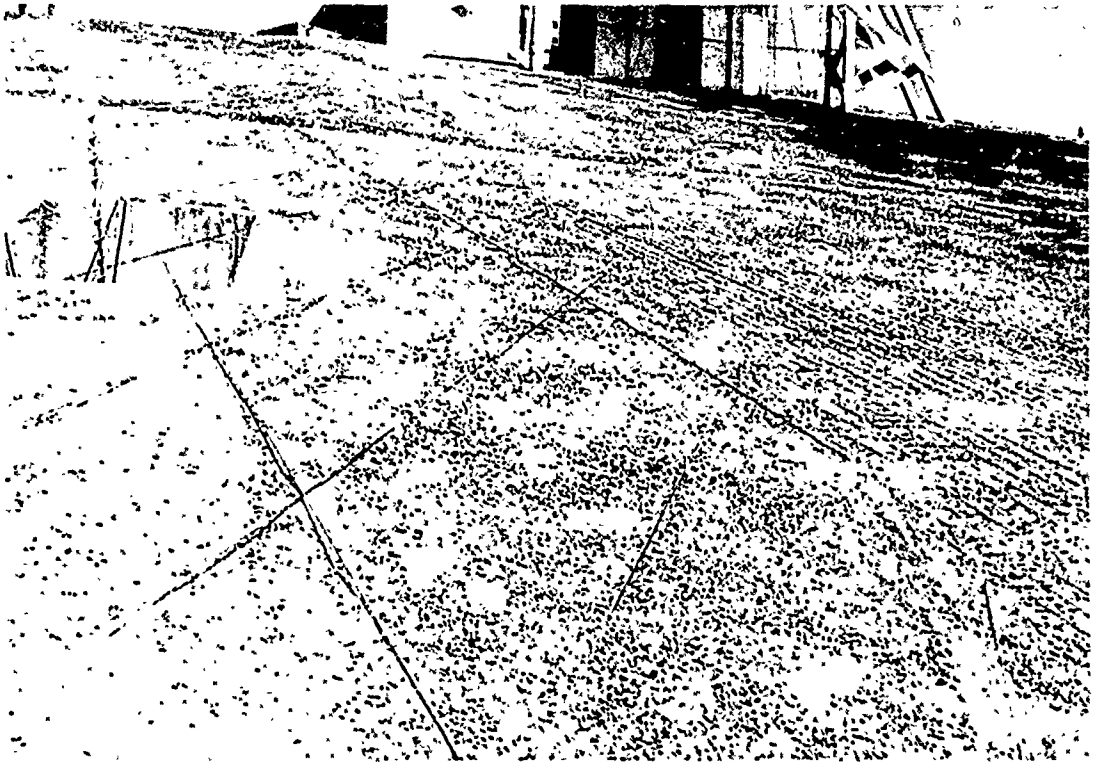
Photo 12. Chopped glass and DCA-1295 in area adjacent to wire mesh

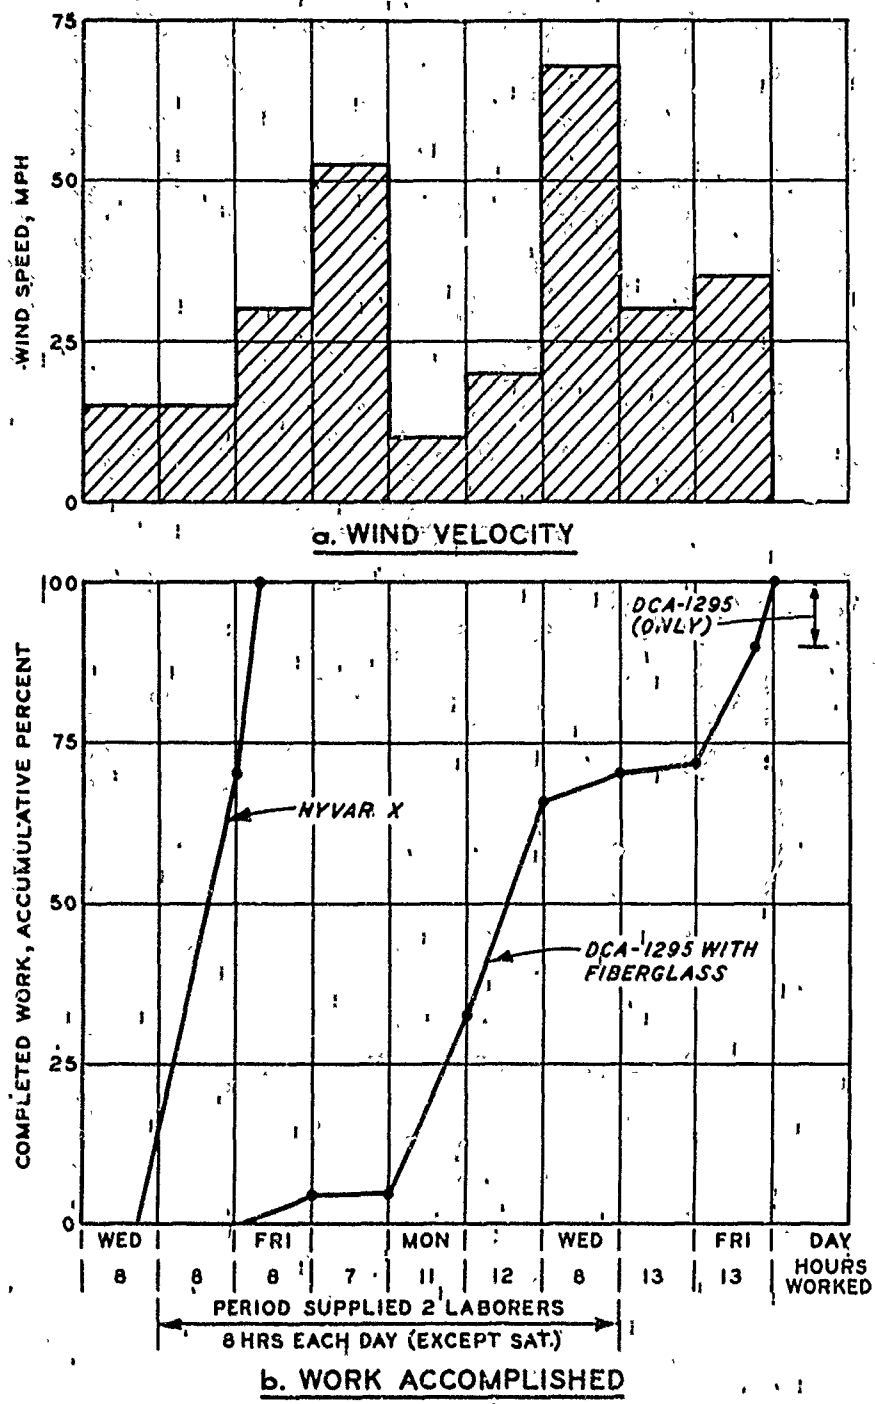
PLATE 2

42. The wind proved to be a major obstacle during the entire project. The need for restricting placement of the scrim/DCA-1295 system to periods in which wind velocity is below an established limit is well illustrated in plate 2 where the daily wind velocity is superimposed on a chart representing the accumulative percent of work completed versus days worked at the ARES facility. Actually, the Qualitative Materiel Requirement for Dust-Control Materials excludes application during periods when the wind velocity is greater than 20 knots (23 mph). Since this project was authorized by another agency under a contract bid with a firm deadline for the completion of all work, a determined effort was made to place the materials regardless of the wind.

EFFECT OF WIND VELOCITY ON WORK ACCOMPLISHED
