FTD-MT-24-1301-71

DEFECTS IN INGOTS

V. I. Dobatkin, N. F. Anoshkin, et al.

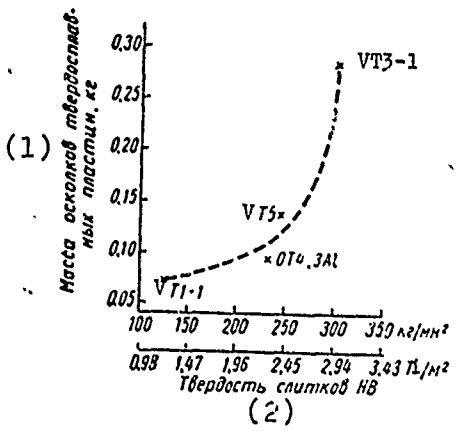
During the processing of ingots under the effect of thermal and impact stresses, the hard-faced bits gradually disintegrate and their particles remain as shaving fragments. The harder and tougher the alloy being worked the more shaving fragments fall (Fig. 98).

Fig. 98. The quantity of fragments of hard-faced bits of alloy VK8 entering, per 1000 kg of shavings in the machining of ingots of various titanium alloys. KEY: (1) Mass of fragments of hard-faced bits. (2) HB hardness of the ingots.

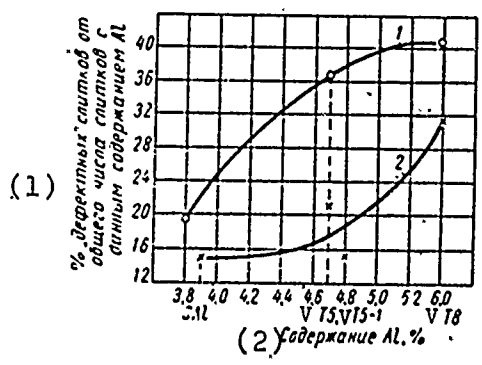
1. <u>The content of aluminum in ingots.</u> As was noted earlier, with an increase in the content of aluminum in an alloy, tensile stresses increase in the central part of the cross section of the ingot, which is explained by the increase in the heat resistance of the alloy and correspondingly an earlier (i.e., at elevated

Fig. 113. Dependence of the number of defective ingots upon the aluminum content of alloys: 1 – diameter of ingots 350 mm; 2 – diameter of ingots 450 mm. KEY: (1) % of defective ingots from the total number of ingots with the given content of Al. (2) Al content, %.

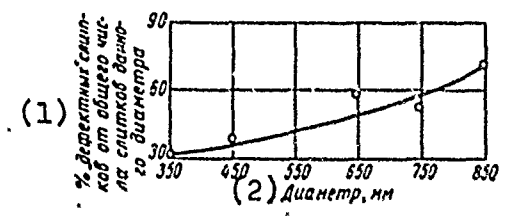
Fig. 114. Dependence of number of defective ingots upon the diameter of ingot. KEY: (1) Defective ingots from the total number of ingots of given diameter; (2) Diameter.

The presented regularities speak persuasively about the direct connection between tensile stresses of shrinkage origin in ingots and the process of crack formation.
