CYCLE TESTING OF ACS VALVES IN CLF_5
FINAL REPORT

TECHNICAL REPORT AFRPL-TR-72-82

AUGUST 1972

AIR FORCE ROCKET PROPULSION LABORATORY
DIRECTOR OF LABORATORIES
AIR FORCE SYSTEMS COMMAND
UNITED STATES AIR FORCE
EDWARDS, CALIFORNIA

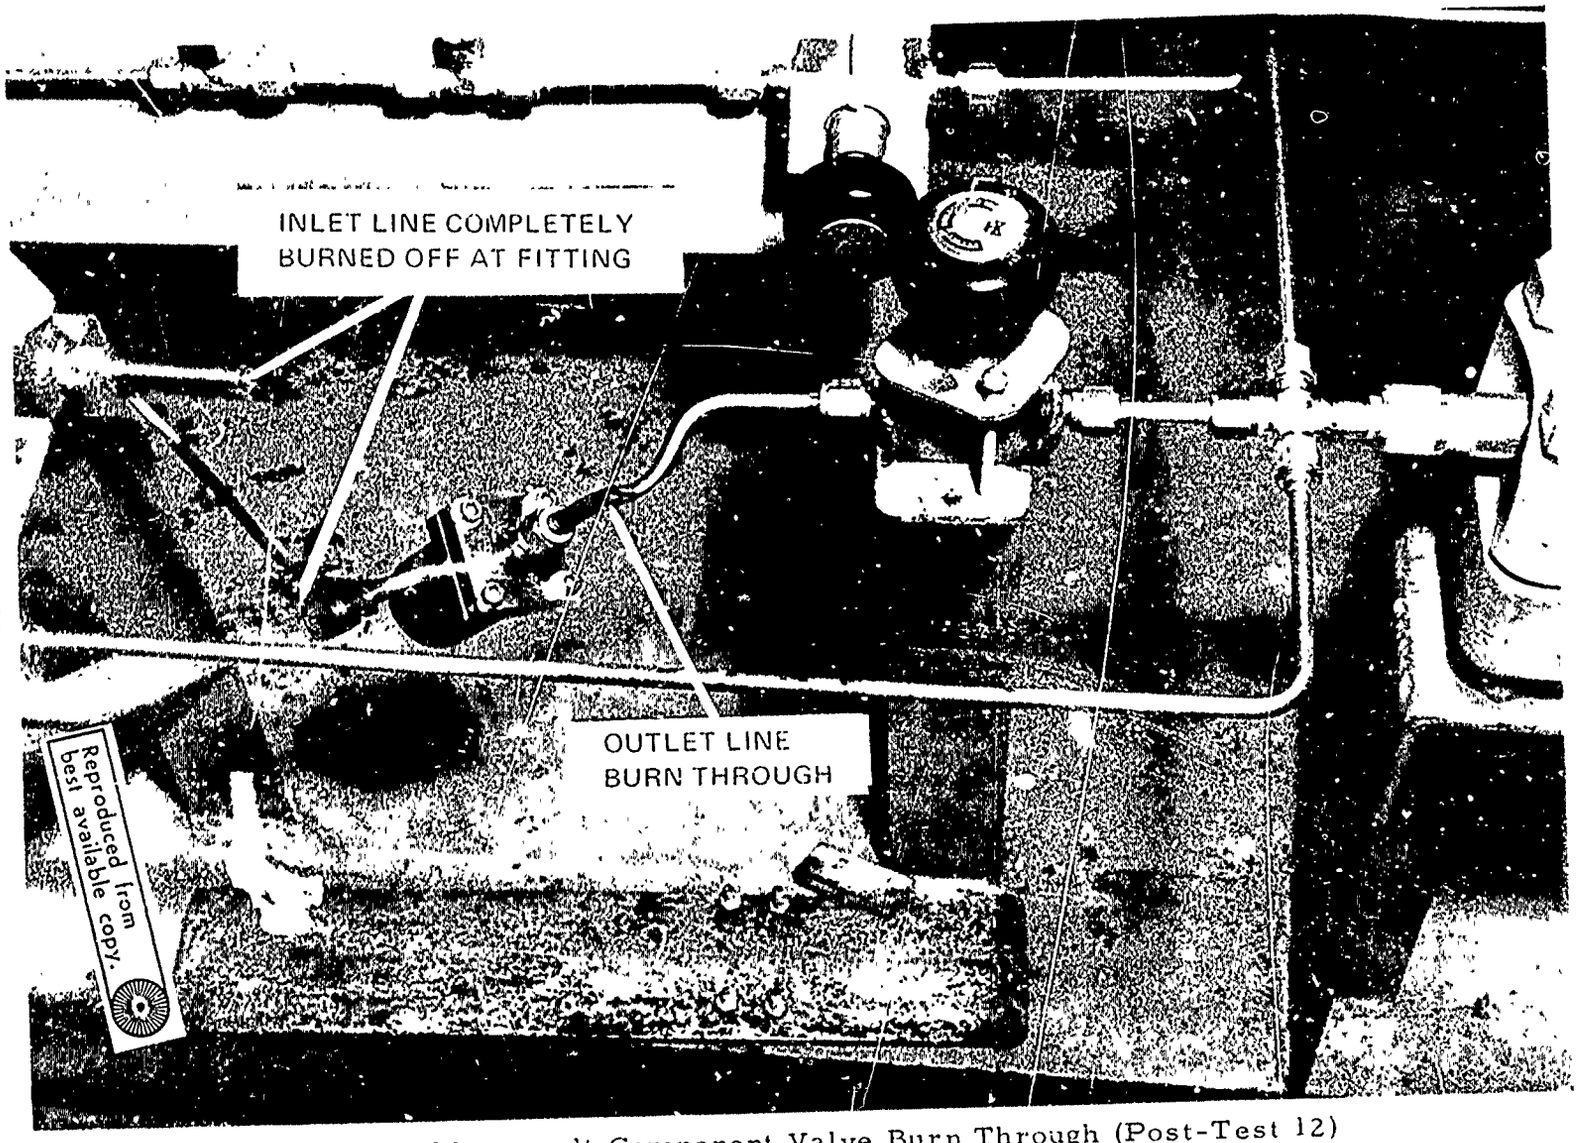
Figure 8. Marquardt Component Valve Burn Through (Post-Test 12)

In an attempt to duplicate the initial highly successful results of the K-801 material (test No. 11), a second set of seat and poppet hardware was installed for evaluation in test No. 12. Prior to cycling in ClF_5, a small fluorine fire in the test section of the system ruined the second set of K-801 seat and poppet specimens and halted the test at the passivation point. The fire appeared to originate in a contaminated inlet filter and quickly passed through the test item itself and out the stainless steel run line downstream of the valve. The fire completely destroyed the component valve's armature assembly and fused the seat and poppet specimens together. A photo of the test item and test section is shown in Figure 8.

The fire which occurred during the previous test fortunately left the valve's body and coil housing in workable condition. although the armature/poppet assembly and seat and poppet set were destroyed. The valve was returned to the manufacturer for refurbishment with spare component parts. A Duranickel 301 seat and poppet set was installed for this test to demonstrate the failure mode in GF_2 cycling instead of in ClF_5.

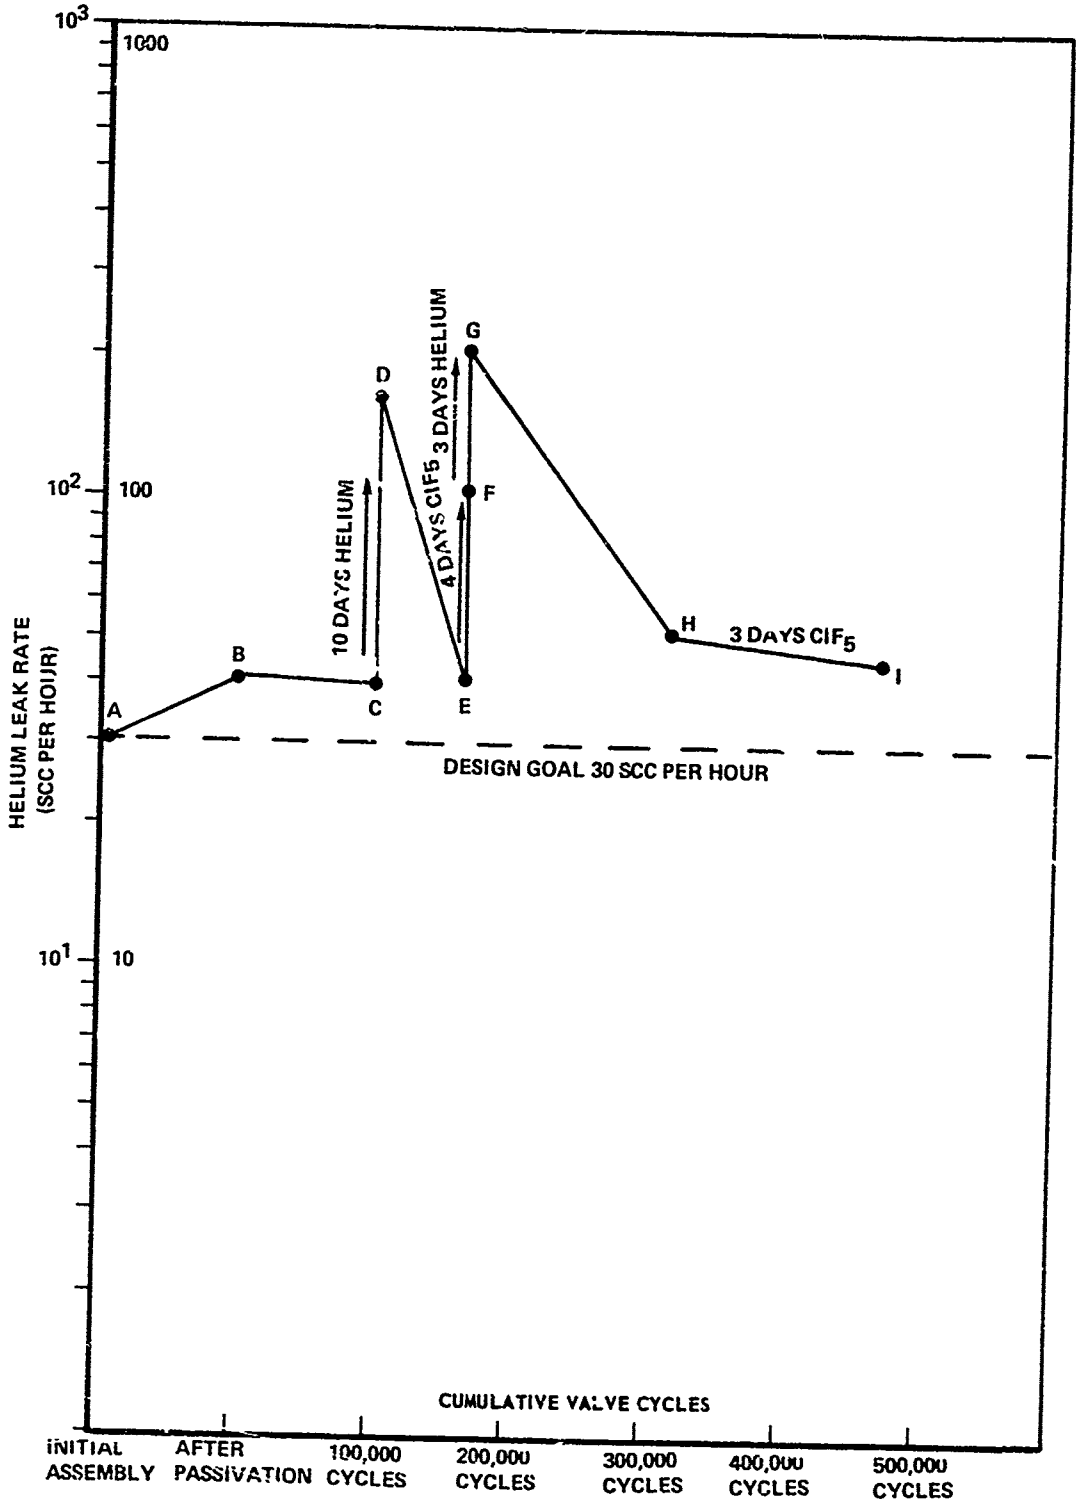
Figure 11. Leakage versus Valve Cycles, Test No. 14.

This test encompassed a 23-day period during which 10 days of ClF_5 exposure and 470,000 cycles were accumulated. Figure 11 depicts the leakage characteristics of the valve throughout the test.

Upon initial assembly, the valve leaked 30 scc helium per hour (Point A), and the leakage increased to 41 scc/hour (Point B) upon GF_2 passivation. During the first day's testing in ClF_5, approximately 100,000 cycles were accumulated, resulting in a leak rate of 40 scc/hour (Point C). The valve was then left pressurized with helium for a 10-day period. For some reason, the leak rate measured at the end of this 10-day period increased to over 150 scc/hour (Point D). Cycling in ClF_5 was begun and an additional 63,000 actuations were accumulated. Leakage returned to a level of about 40 scc/hour after this day's test (Point E).

The valve was then exposed to ambient temperature ClF_5 (Reference 1) at the normal vapor pressure for a period of 4 days. Again, without further cycling of the valve in ClF_5, the leakage increased, this time to about 100 scc/hour (Point E). The lines were drained and the valve purged, dried and pressurized with helium. After a 3-day exposure to the helium, leakage measured slightly over 200 scc/hour (Point G), and cycling in ClF_5 was begun again. As had happened before, after an additional

153,000 cycles in ClF_5, the internal leakage returned to an acceptable 51 scc helium/hour (Point H). A total of 316,000 cycles in ClF_5 had now been accumulated on this hardware during this test.

After a 3-day exposure to static ClF_5, cycling was resumed to a cumulative total of 471,000 actuations in propellant. The final leakage rate on the valve was an acceptable 46 scc/hour (Point I).

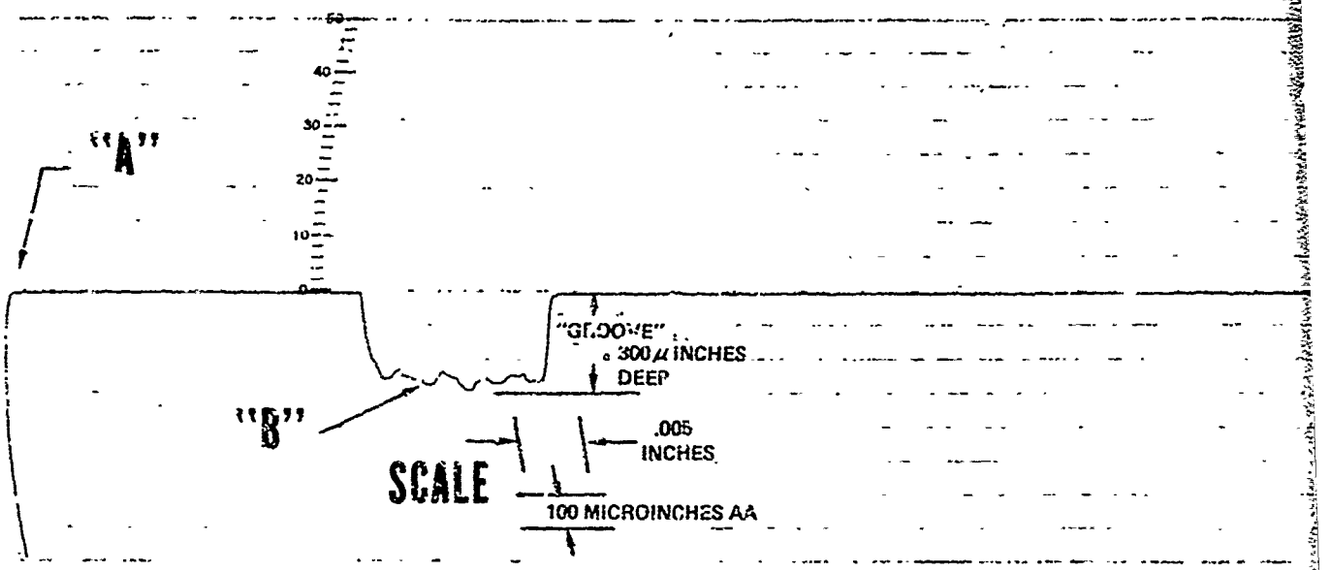
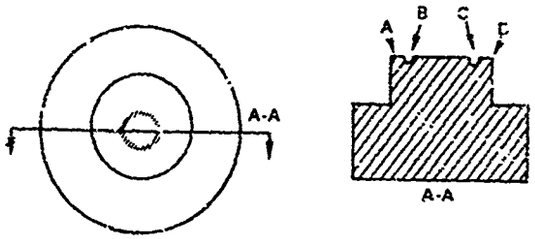
Figure 14. Proficorder Trace, K-96 Poppet, Post-Test 14.

WORN AREA ON POPPET FACE
WHERE SEAT CONTACT IS MADE

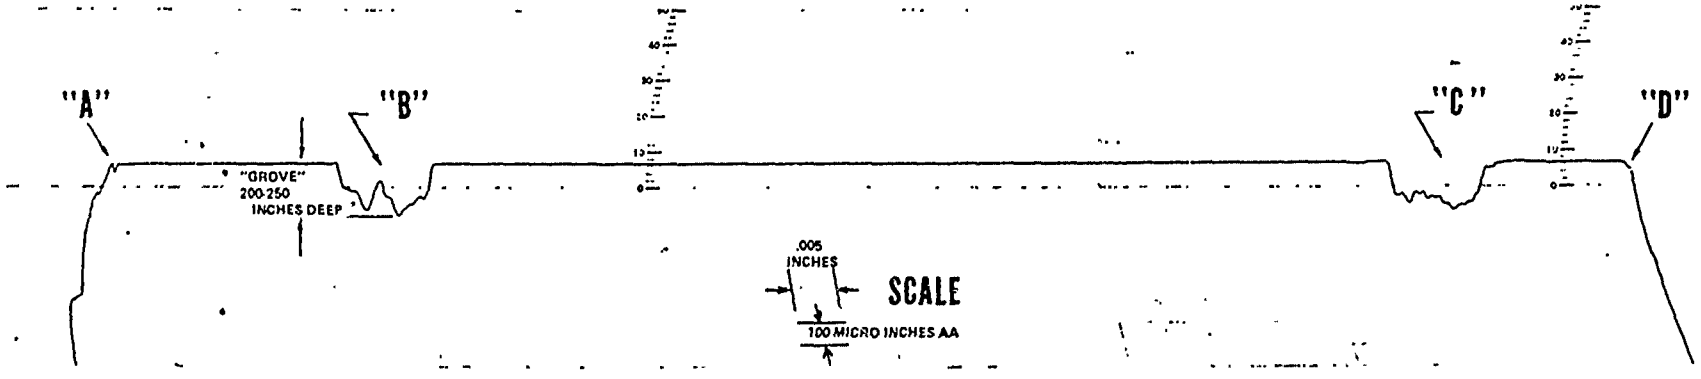
Figure 46. Proficorder Trace, Aluminum on Ni 301 Poppet, Post ClF_5 Testing

WORN AREA ON POPPET FACE
WHERE SEAT CONTACT IS MADE

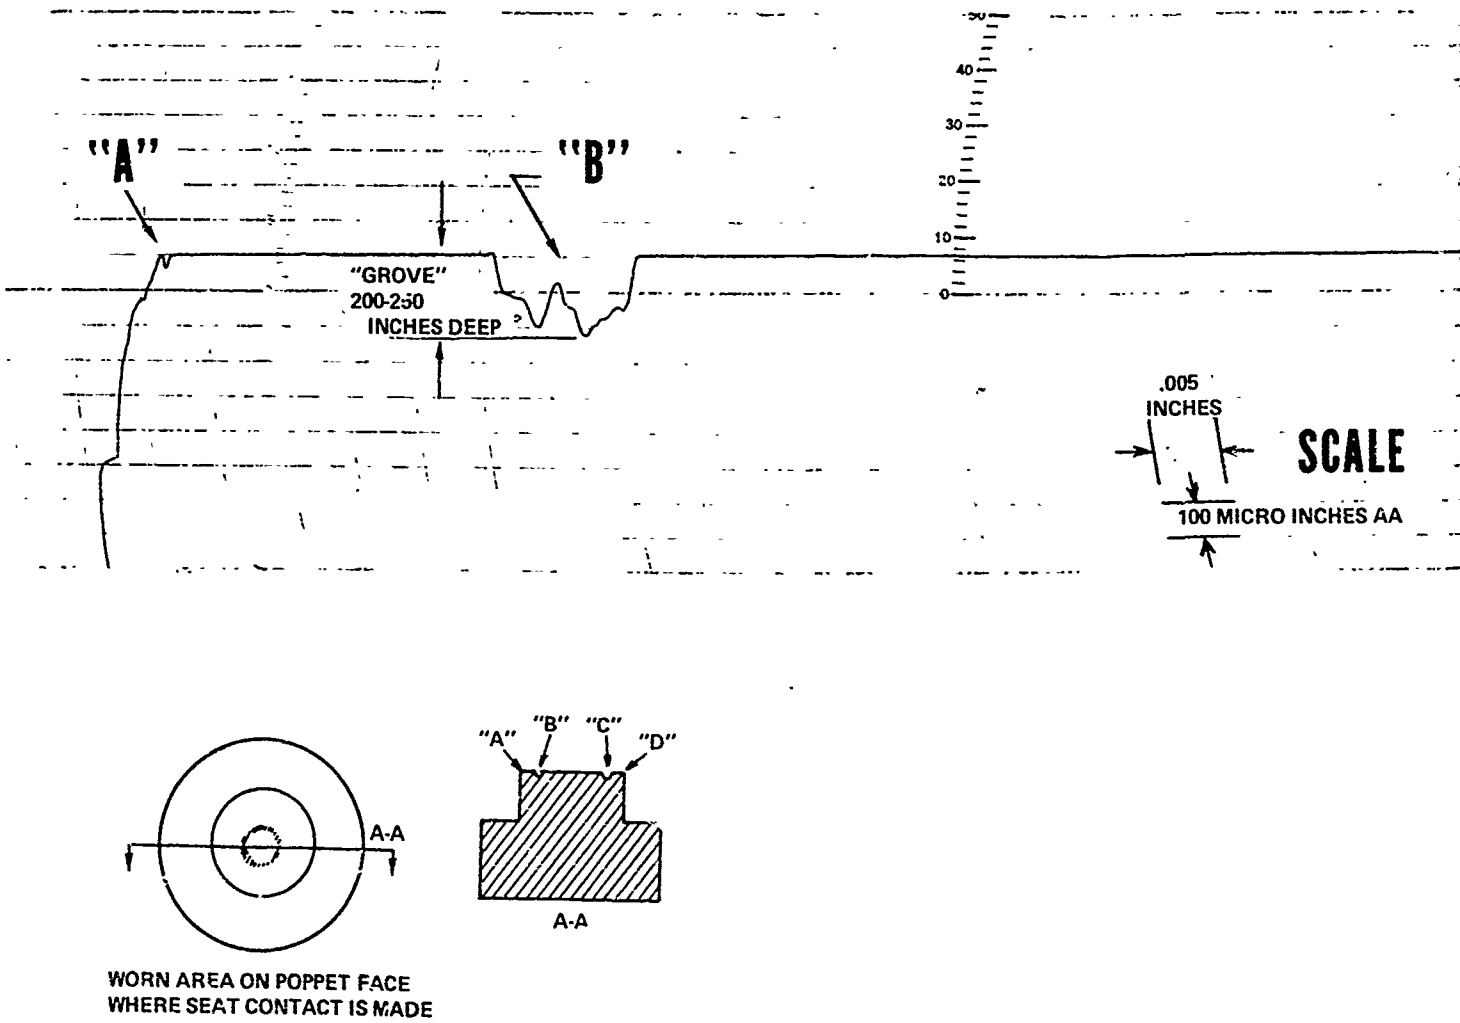
The valve was disassembled and photographs of the failed seat and poppet were taken. As Figures 44 and 45 explicitly show, the sealing surfaces in the area of impact were severely degraded. It appears that the coating was literally "eaten through" by the repeated impacts in the ClF_5 environment. A proficoder trace of the poppet is approximately 200μ inches deep (Figure 46).

Figure 46. Proficorder Trace, Aluminum on Ni 301 Poppet, Post ClF_5 Testing

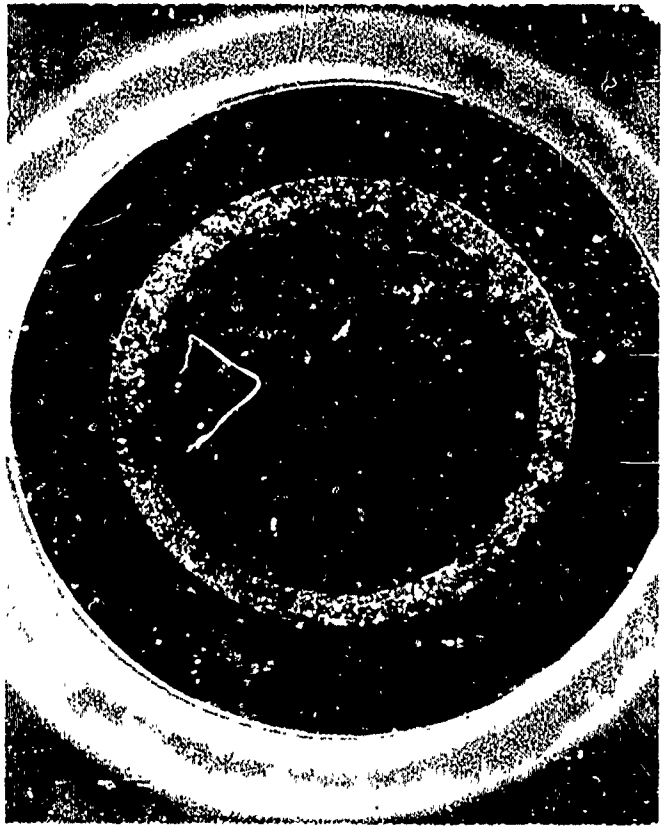
The first leakage measurement was made during a normal propellant transfer operation at the 20,000-cycle point. The valve was found to be leaking at a rate of 1200 scc/hour. The test was halted and the valve was removed from the test system. The failed seat and poppet are shown in Figures 49 and 50. Clearly, there was a severe degradation of the sealing surfaces at the poppet/seat interface which caused the excess leakage. Close examination of those areas revealed that the exposed metal resembled Duranickel 301 after similar cycle tests in ClF_5. It was concluded that the repeated impact in ClF_5 (20,000 cycles) resulted in a steady removal of the thin tungsten coating ($\approx 4\ \mu$ inches) in those contact areas and eventual exposure of the incompatible substrate. The next test was to evaluate a heavier coating weight.

Figure 50. Poppet, Sputtered Tungsten (1000Å) on Ni 301 Post-ClF_5 Testing (20X)

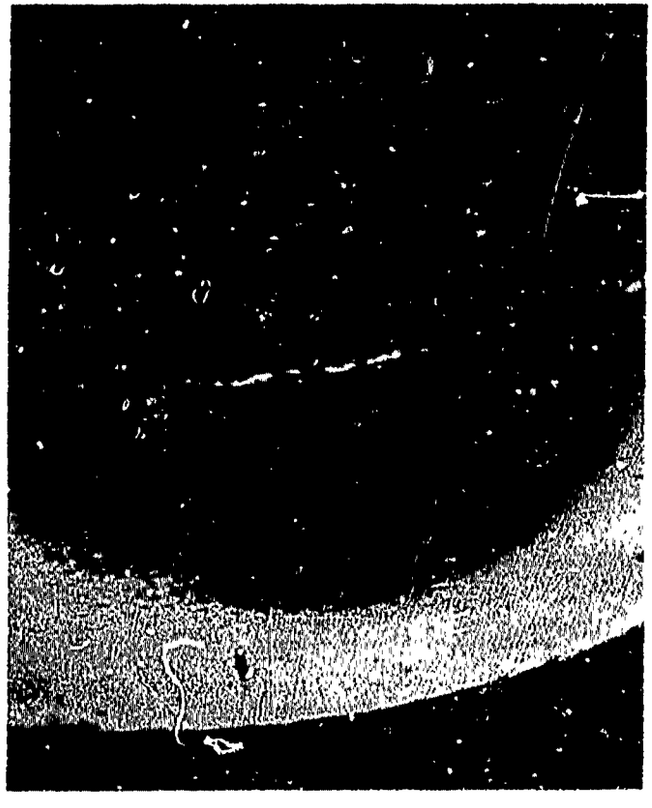
Figure 52 is a close-up of one of the three burn areas. It indicates fairly severe discoloration and degradation near the center of the poppet (within the groove) and extreme surface roughening at the impact area itself. Except in the three burn areas, the outermost area of the poppet face seemed relatively unaffected. Though the precise explanation for this phenomenon will probably never be known, the author suggests the following.

Figure 52. Poppet, 6000Å Tungsten on Ni 301, (80X), Pre-Passivation (Close-Up Seal Area)

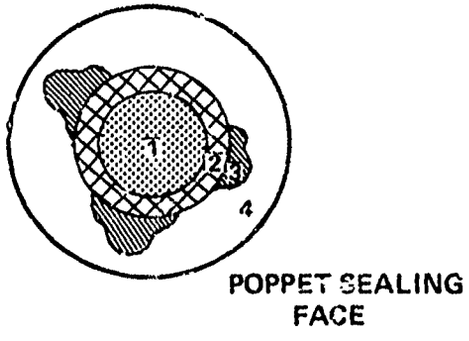
The valve was closed (normally-closed) when installed in the test system. Contamination of an unknown type and origin was introduced somehow downstream of the seat/poppet interface. This contamination reacted (burned) with small amounts of residual ClF_5 in the outlet line and a minute, yet extremely intense fire of short duration existed. This intense heat made its way upstream to the poppet face (central area) and radially outward across the contact surface before diminishing. This explanation accounts for the appearance of the poppet face depicted in Figure 53 with the key areas numbered for reference. Area No. 2 was

directly exposed to the fire, while most of Area No. 4 was not, being "upstream" of the seat/poppet interface. A simplified schematic of the seat and poppet in the closed position is shown in Figure 54. Damage to the seat and poppet prevented cycle testing of the hardware in ClF_5.

Figure 53. Schematic, Poppet Face "Burn Areas"

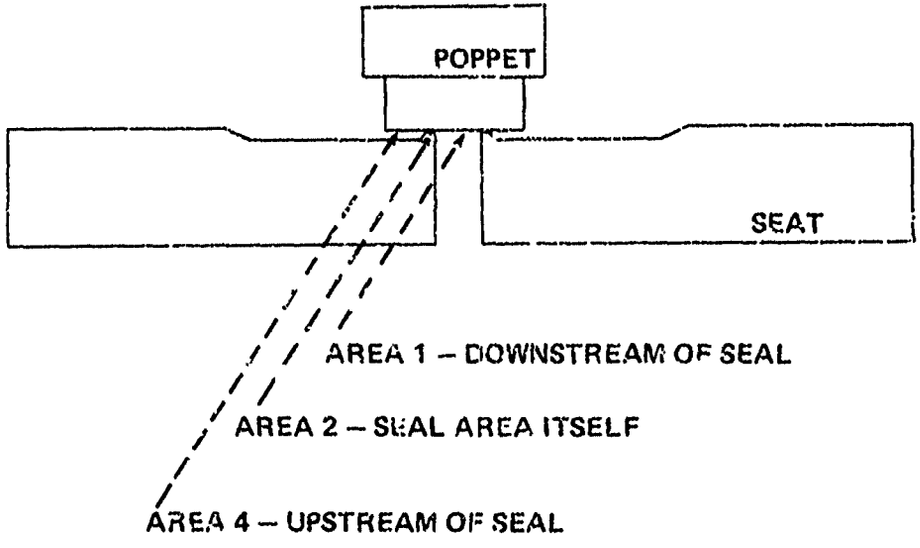
Figure 54. Schematic, Seat/Poppet In Closed Position

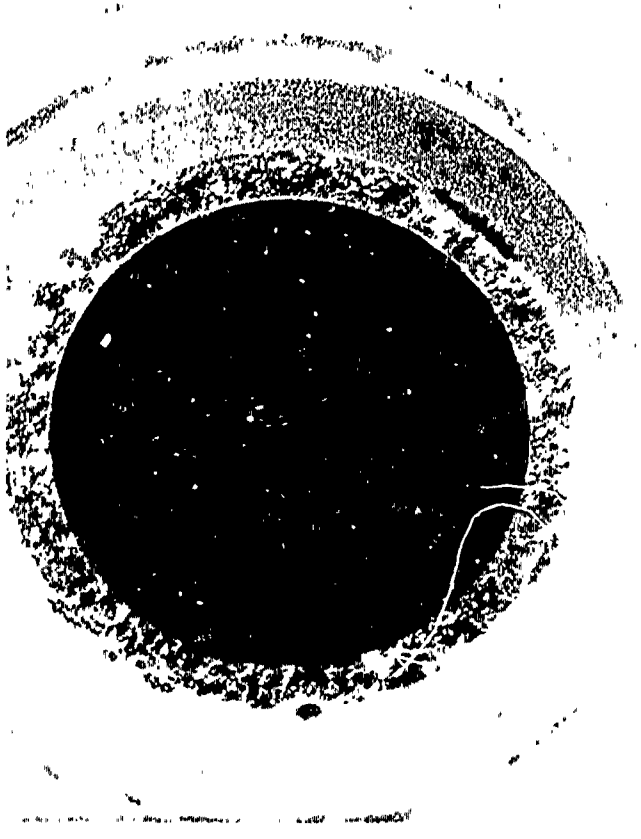
This final attempt to meet the 100,000-cycle requirement with coated seat and poppet hardware again involved sputter-deposited tungsten. In this case, the substrate material was chosen to be the original fuel-side, iron-based alloy, Pyromet X-15. The objective of the test was to note any significant increase in cycle life due to greater substrate hardness. After 23,000 cycles in ClF_5, helium leakage went from 20 scc/hour to over 3000 scc/hour, and the test was halted. Figures 57 and 58 show the failed seat and poppet.

Figure 57. Seat, 6000Å Tungsten on Pyromet X-15, Post-ClF_5 Testing (25X)

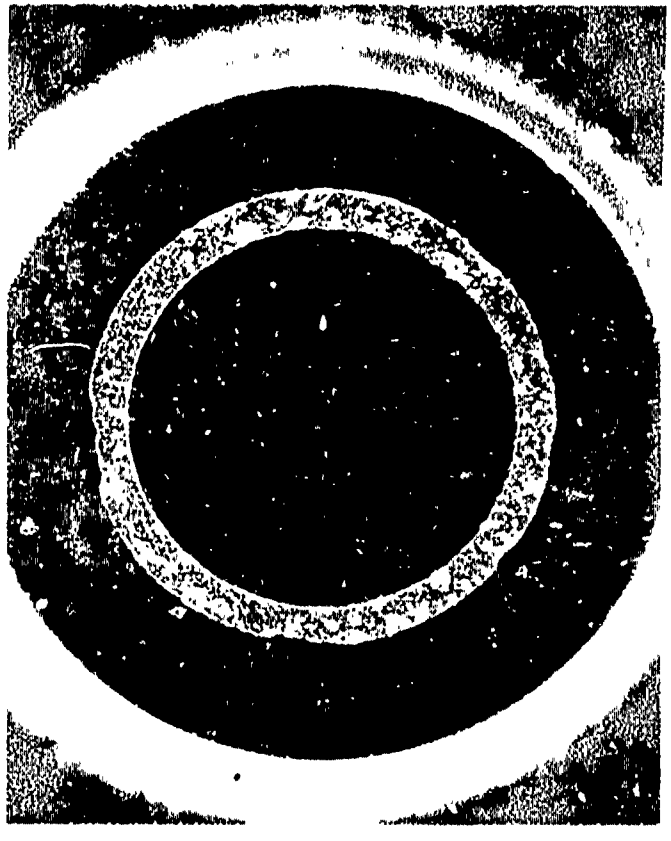
Figure 58. Poppet, 6000Å Tungsten on Pyromet X-15, Post-ClF_5 Testing (20X)
