EVALUATION OF A DEWATERING SYSTEM FOR HASTY FUEL STORAGE RESERVOIRS

October 1972

Report 2040

4. DESCRIPTIVE NOTES *(Type of report and inclusive dates)*
An interim report on a continuing hasty fuel storage reservoir problem.

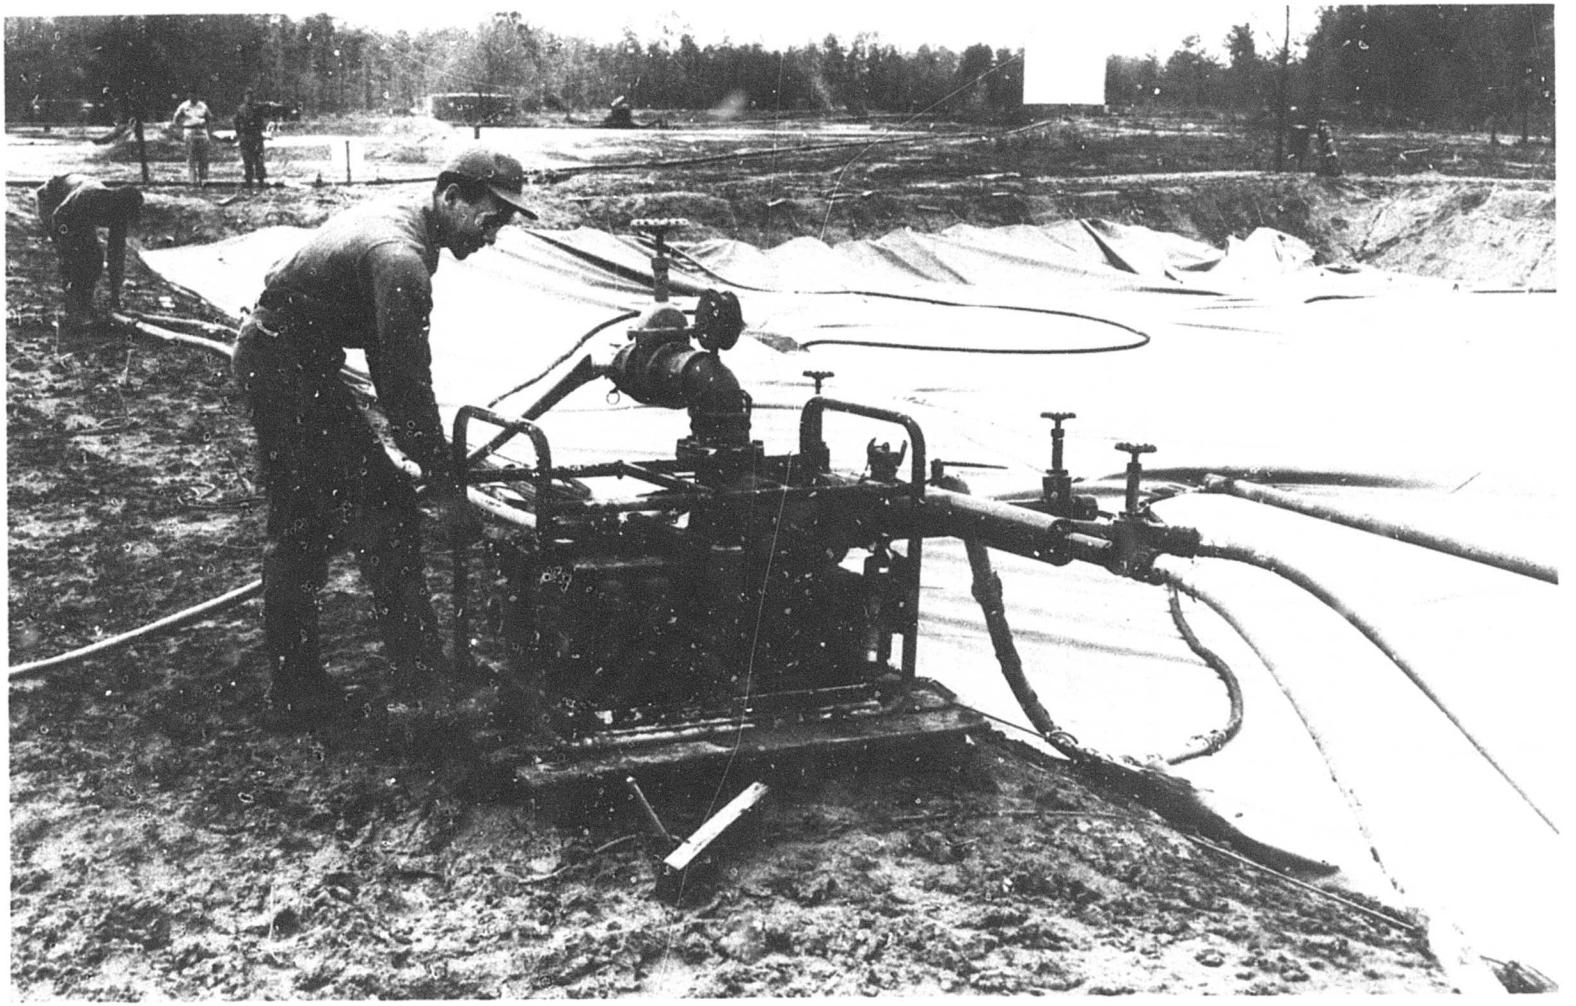
Fig. 1. A 25,000-bbl hasty fuel storage reservoir installation with dewatering system.

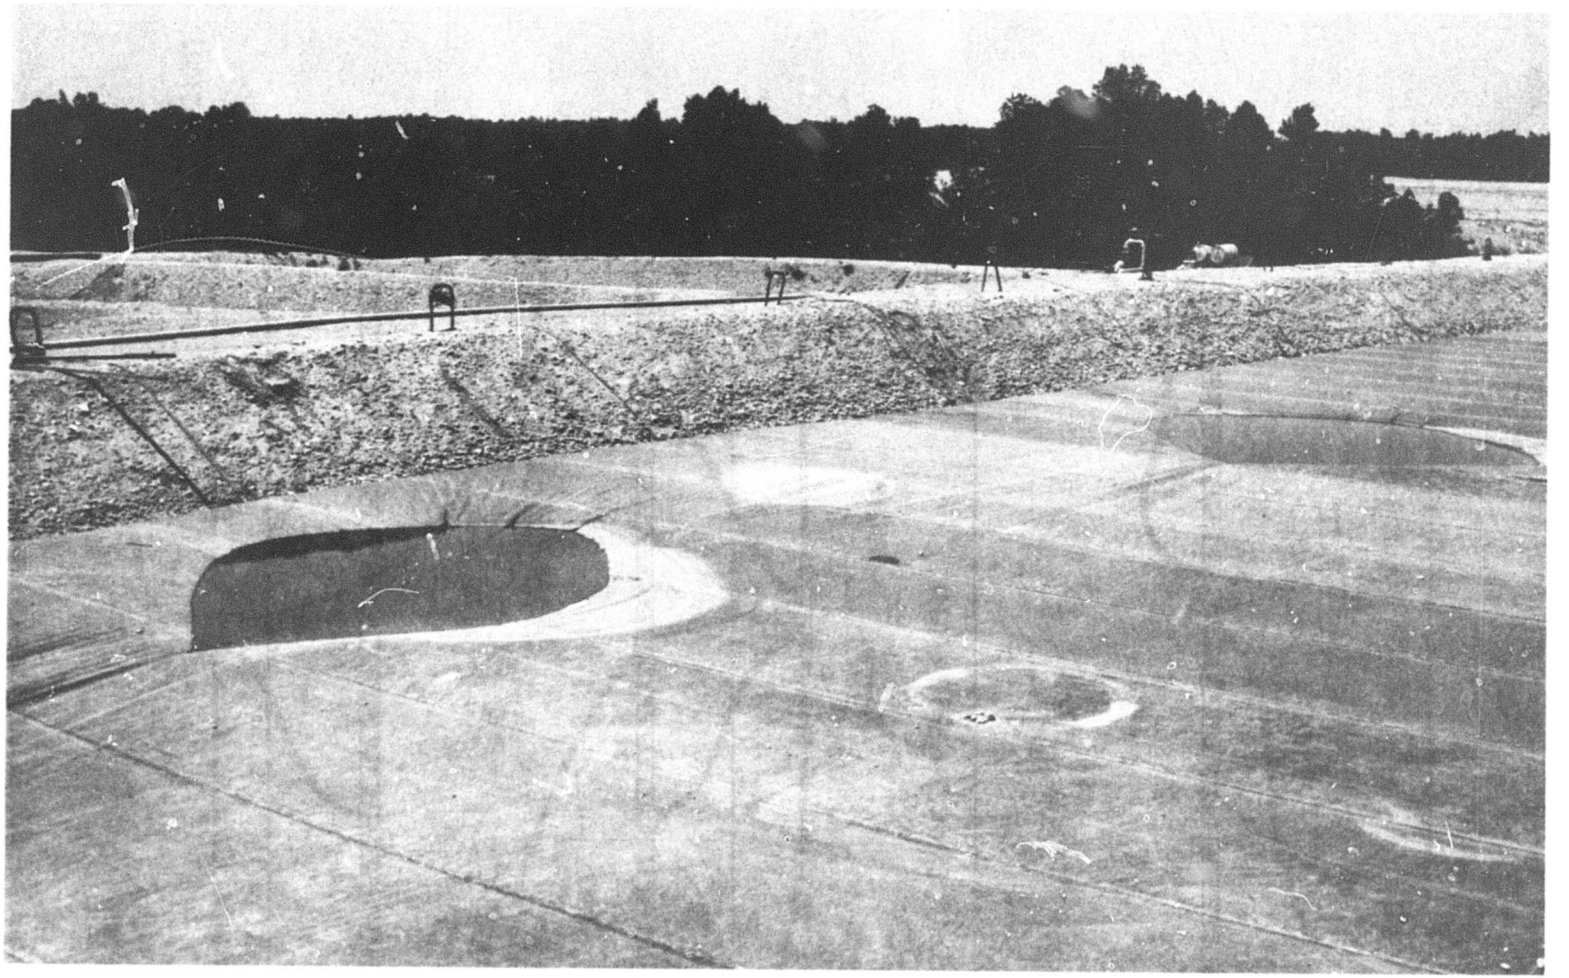
Fig. 3. Typical rainwater pool formation on top of tank surface.

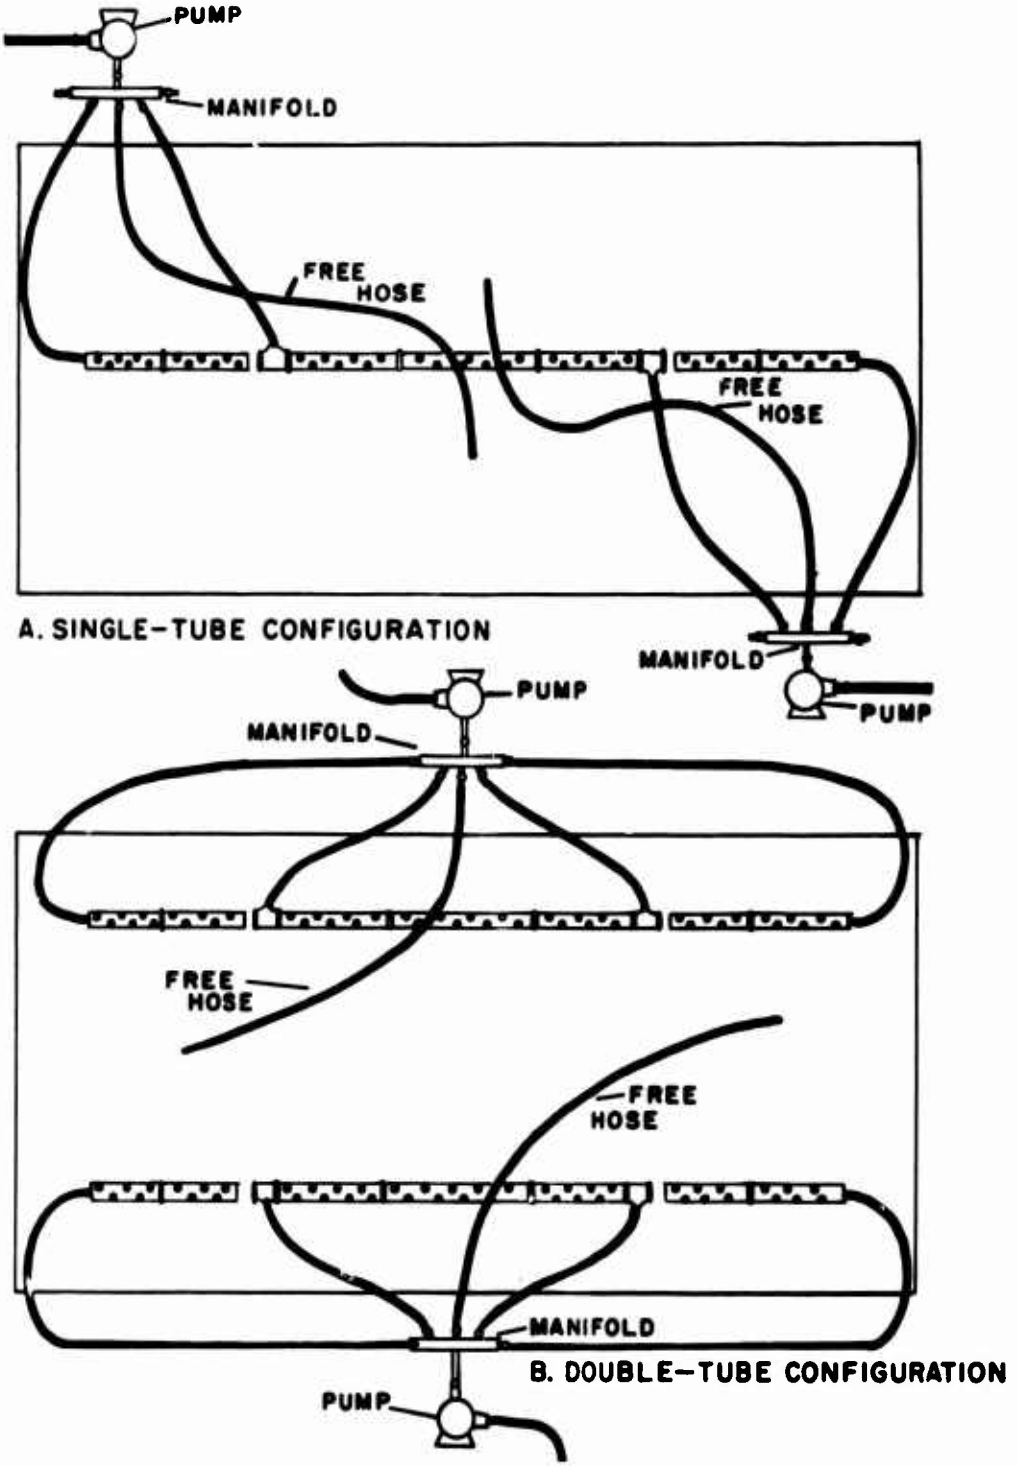
Fig. 4. Dewatering system test configurations.

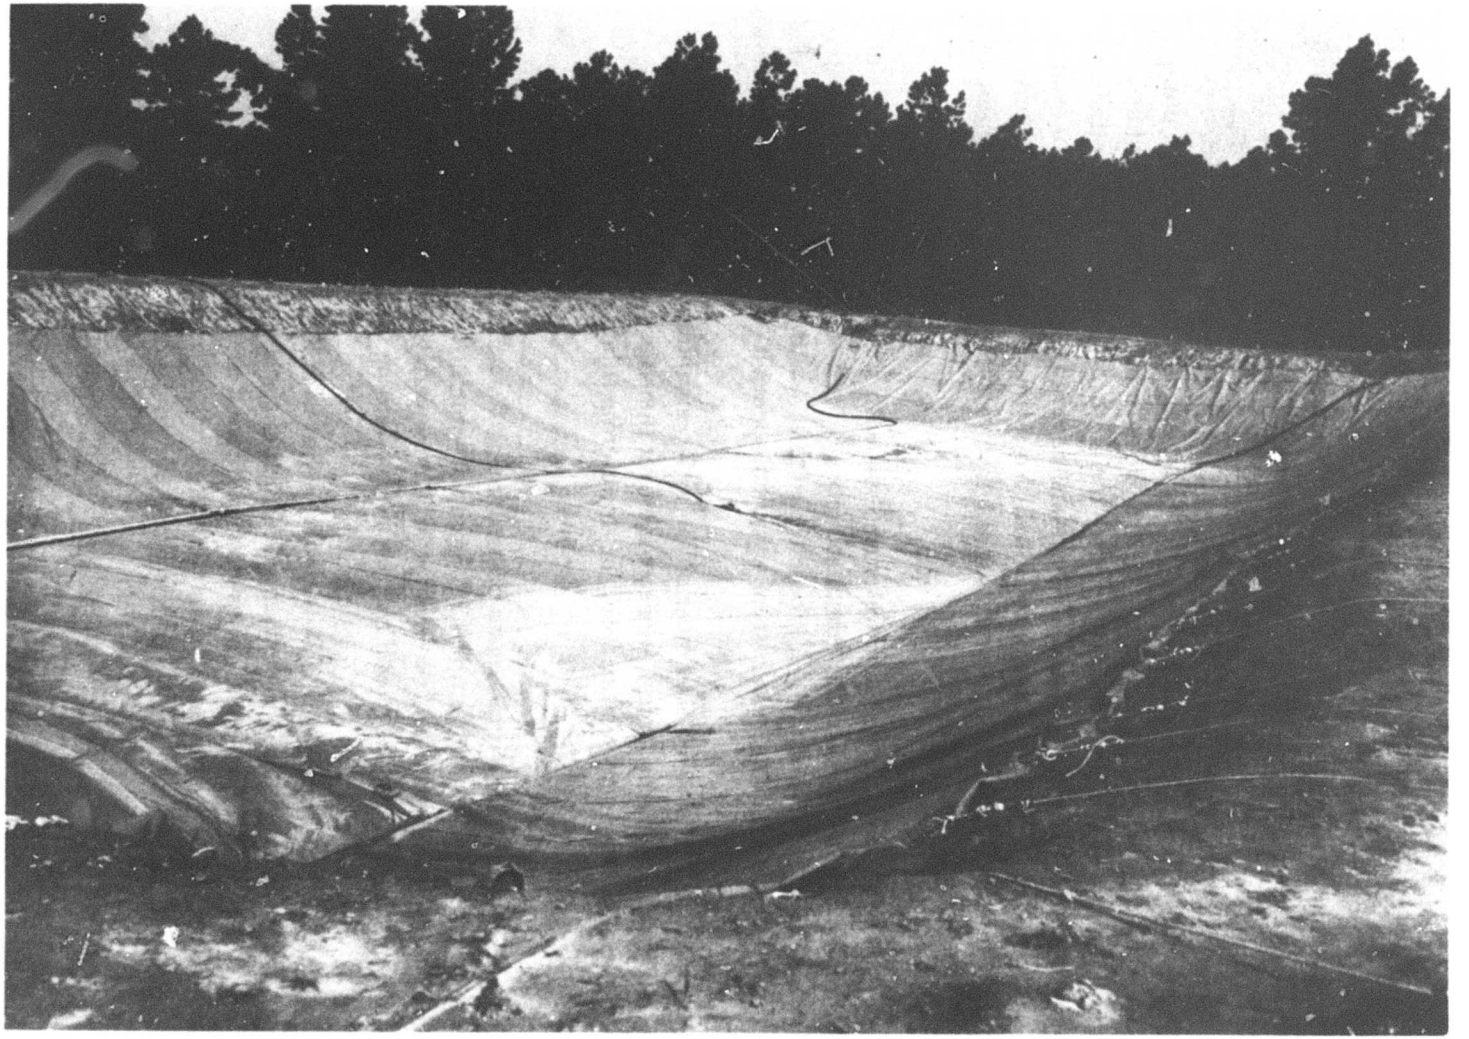
The test showed that the major portion of rainfall accumulation occurred on the center of the reservoir instead of along the dewatering tubes. Water had to be pumped out using the free hose. At one point one set of tubes submerged when enough water had collected and caused the second set of tubes to come up to the top

Fig. 5. Double dewatering tubes on reservoir filled to approximately one-third capacity.

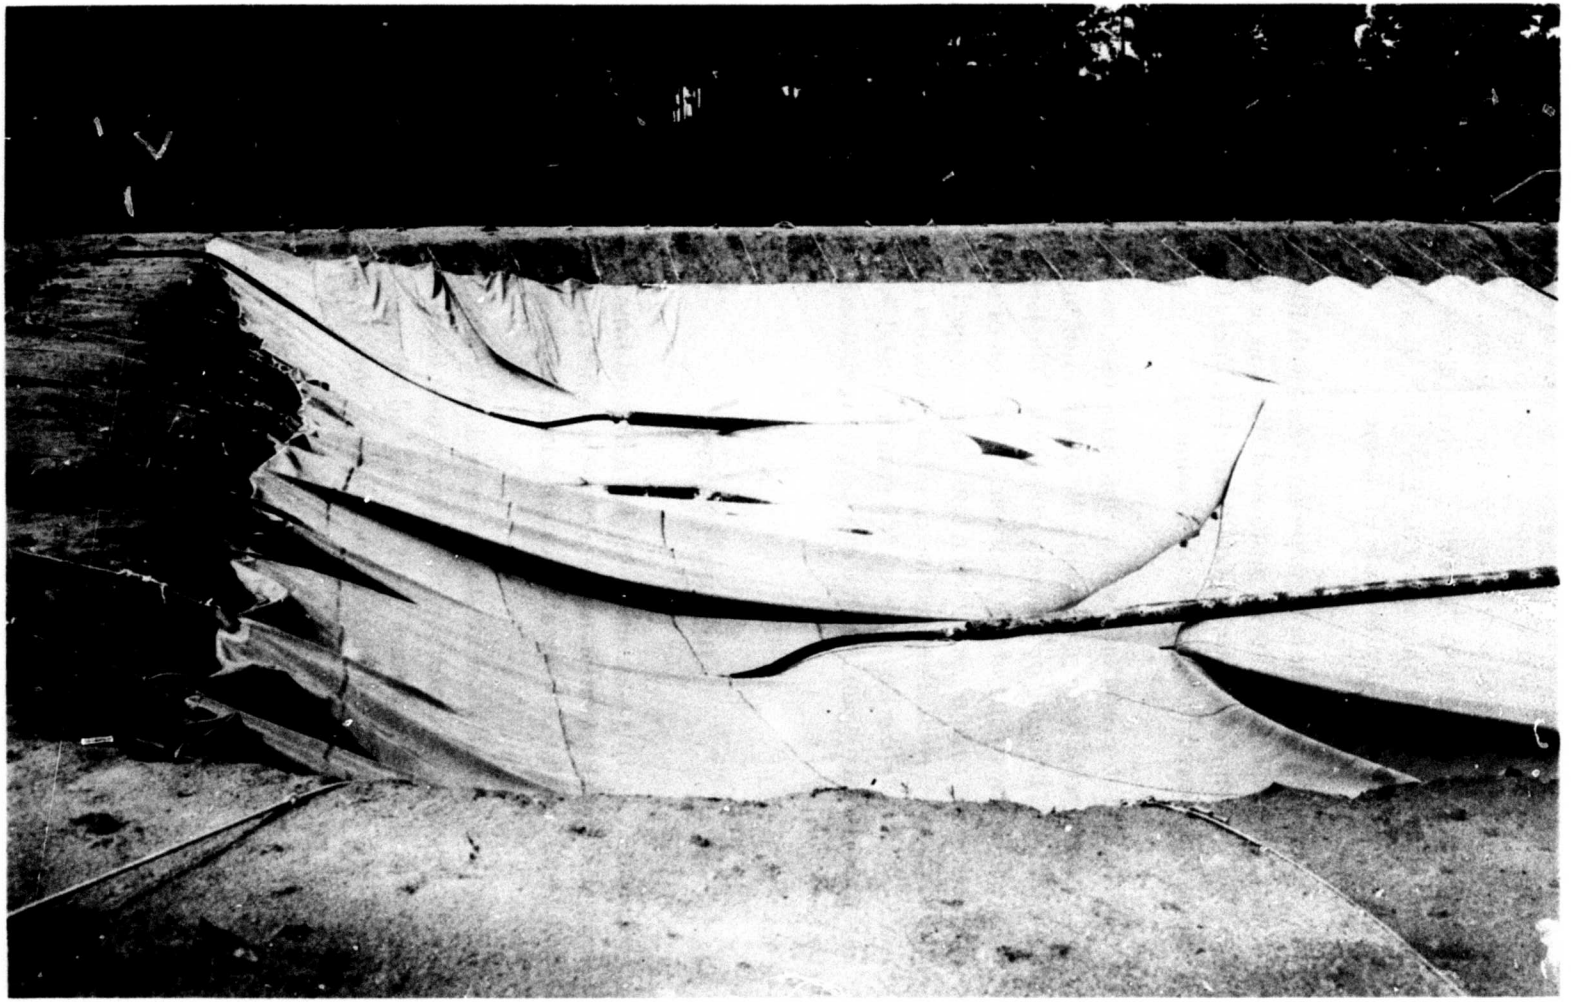
surface of the tank. Both dewatering tubes shifted position and became misaligned during dewatering operation as water from one pool emptied into a larger pool. One set of tubes bridged over pools of water could not be pumped using the dewatering tubes (Fig. 6). Some pools began to "tear drop" after a large volume of water had collected and could be pumped off only using the free hose. It was noted that the rate of rainfall simulation greatly exceeded the rate of removal.

Fig. 6. Dewatering tube bridging over pool of water.

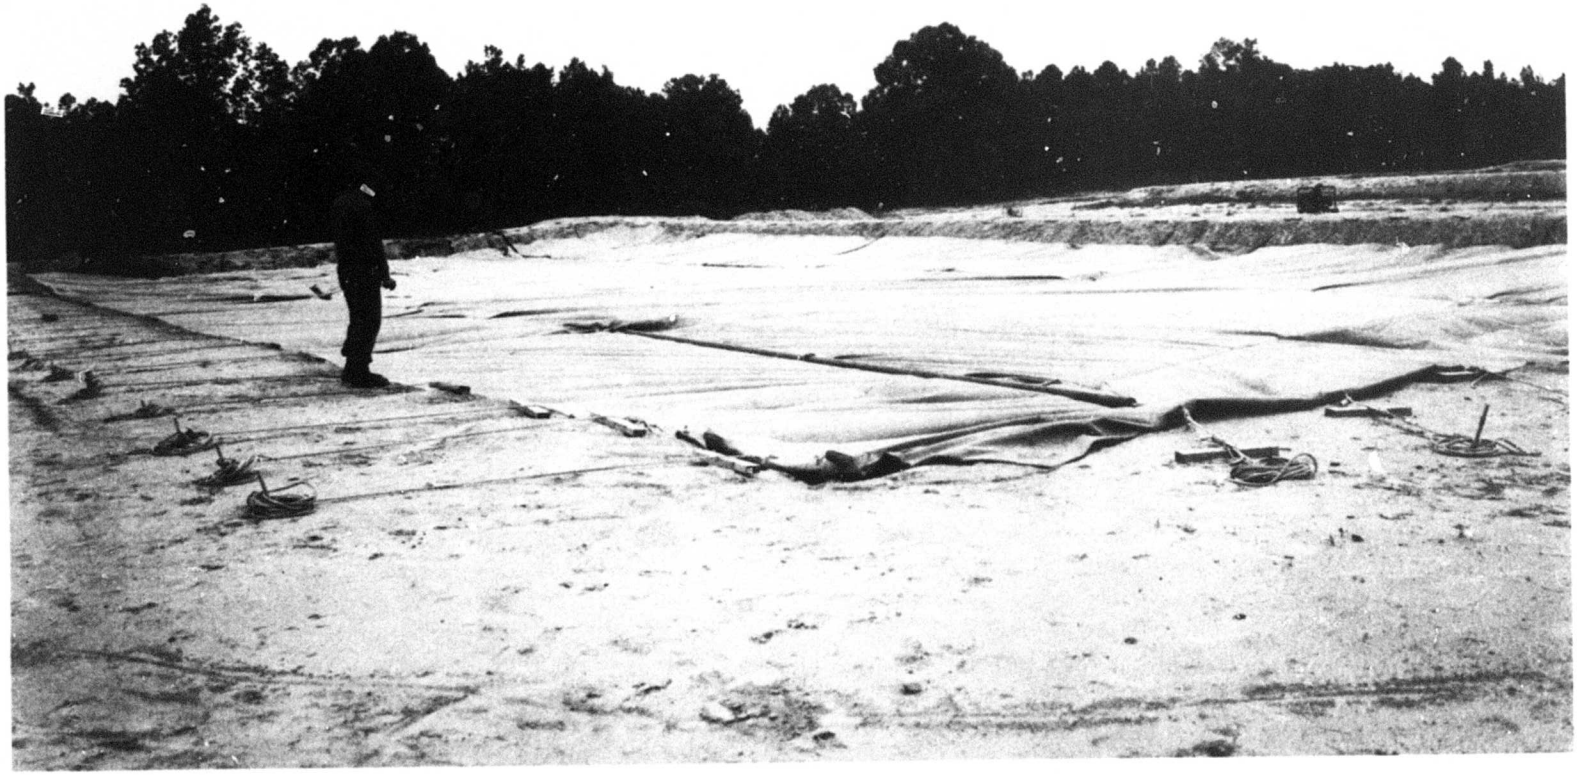
The test showed that, as in the previous test, one set of tubes became completely submerged with large pools while the other set of tubes remained on the top surface of the tank, bridging over large water pools. The largest pools were noted directly over the fill-draw fitting of the reservoir. A section of tubes was misaligned during the operation and in another area the tank fabric slipped over the tube but no damage to the tank was noted. Pump prime could be obtained from one tube through only two hoses. A dewatering flow rate of 180 gpm was established during the dewatering operation. It was noted again that the rate of accumulation greatly exceeded the rate of water removal.

Fig. 7. Dewatering tubes on reservoir filled less than full capacity.

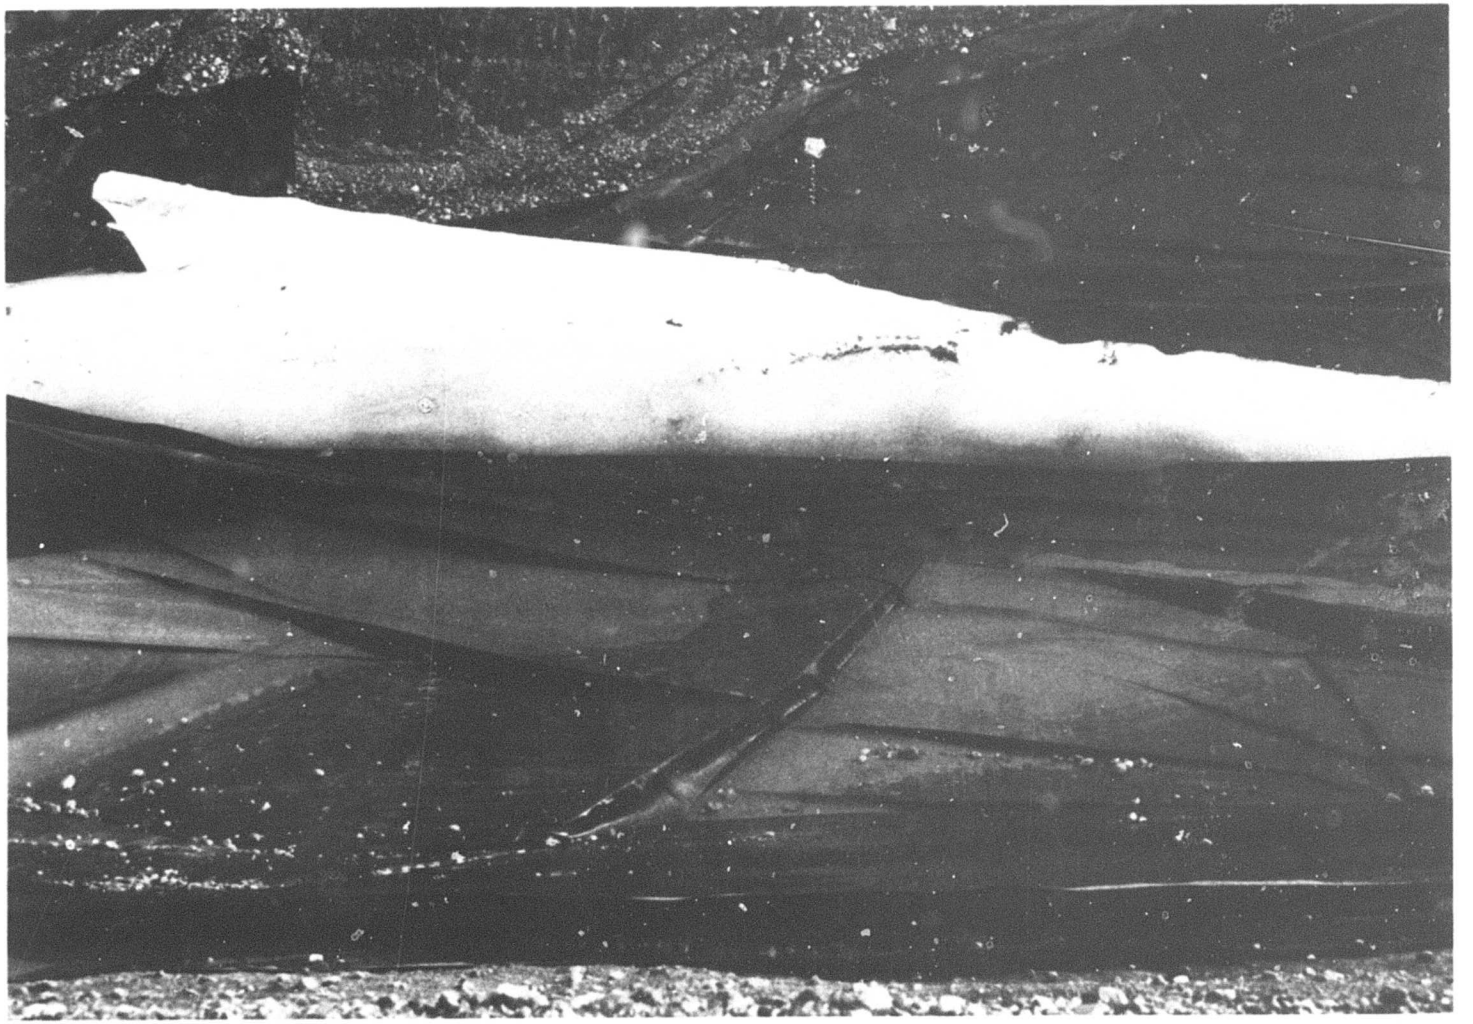
Fig. 10. Ice formation from water pool on the top surface of a hasty fuel storage reservoir.

When the snow melted, a different problem existed. When the temperature was above freezing, the melted snow formed pools of water that could be pumped off using the dewatering system. During freezing temperatures, the pools of water froze (Fig. 10). Ice formation over the tank surface near the fill-draw fitting prevented fuel from being withdrawn from the reservoir. The tank fabric was also susceptible to puncture by sharp protruding edges of the ice formation, especially when the ice sheets broke up. The dewatering system is incapable of removing any amount of snow accumulation or ice formation from the top surface of the reservoir.
