# Second Breakdown in Germanium Gold-Bonded Diodes

Naval Ordnance Laboratory

JUNE 1972

NOLTR 72-56

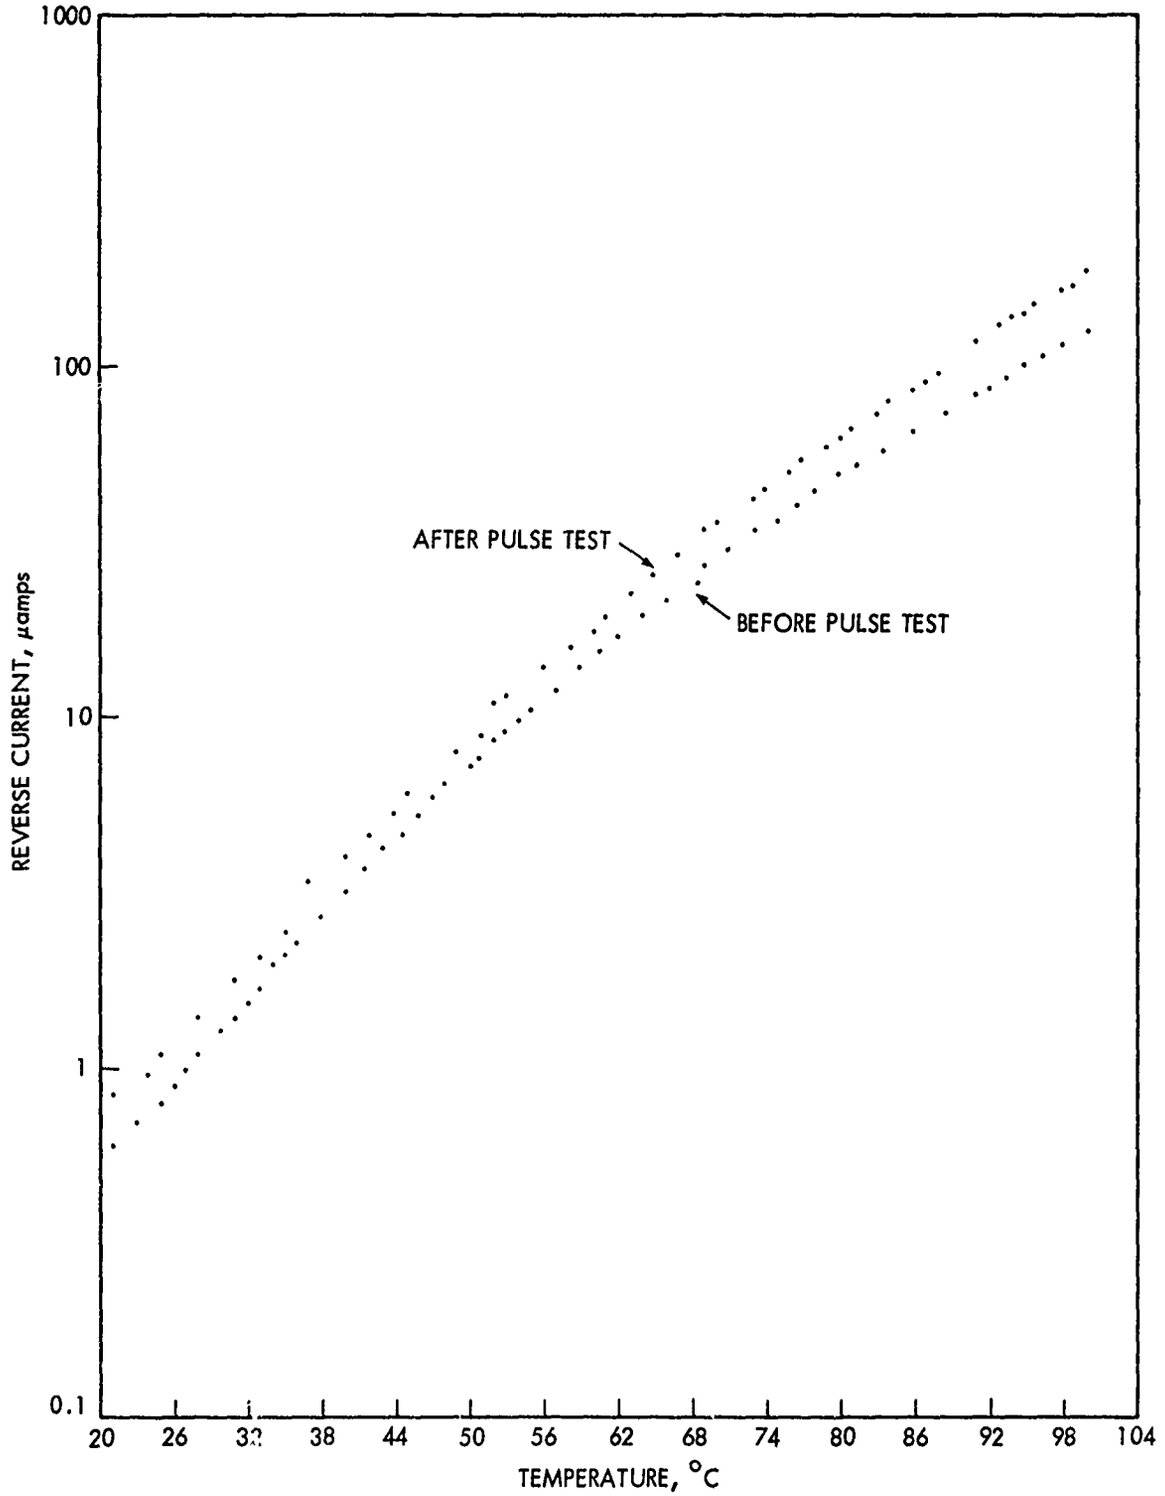
FIG. 8 REVERSE CURRENT VS. TEMPERATURE AT 1 VOLT BIAS

TEMPERATURE MEASUREMENTS. Before and after pulsing, several units were tested to determine the reverse current as a function of temperature at a constant one volt reverse bias. Figure 8 shows the results. The most striking feature is that the two curves are approximately parallel when the current is plotted on a logarithmic scale. Thus at all temperatures tested the current at one volt reverse bias after pulsing is larger than the current before pulsing by a constant multiplicative factor of 1.3.

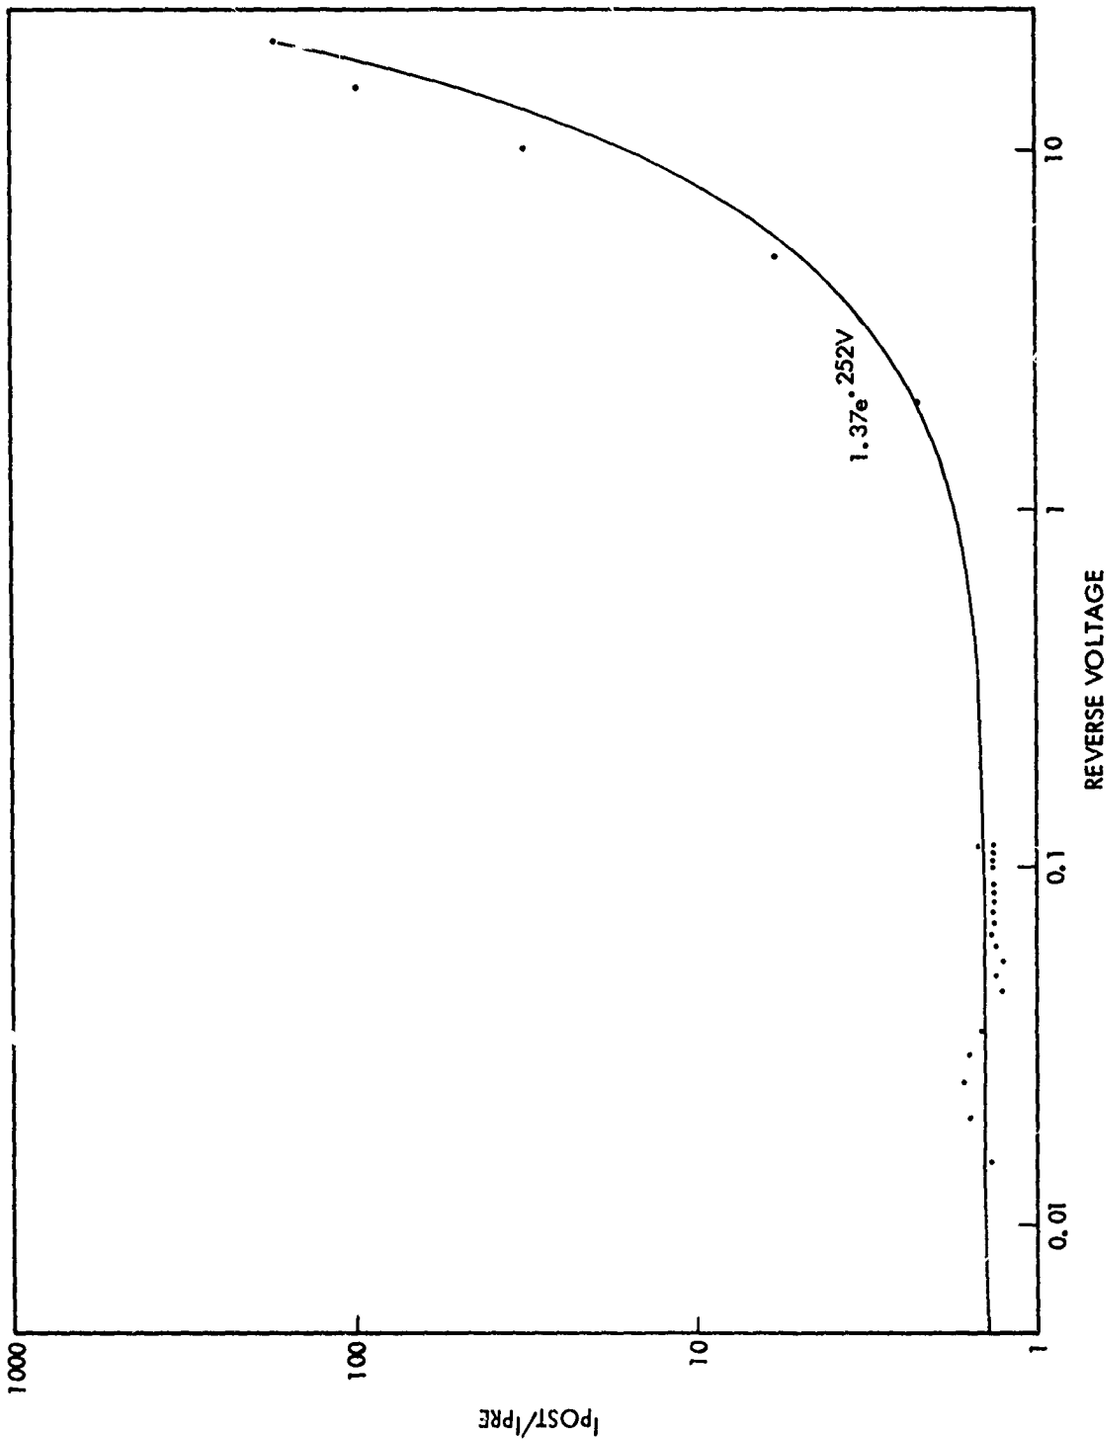
Another current-voltage measurement was performed at constant (room) temperature. The ratio of post- to pre-damage current was a constant (1.37) in the reverse-bias millivolt range, i.e., from one to one hundred millivolts. The same ratio, taken at voltages above one volt, was emphatically not a constant. The change of this ratio with voltage was so rapid above one volt that we attempted to fit the current ratio versus voltage curve to an exponential function containing the voltage. A least squares fit to the data, assuming a simple exponential variation, yields

where $I_2$ and $I_1$ are the currents after and before pulse induced damage, and V is the voltage across the diode. The fit is excellent from one millivolt to 20 volts, at which point the exponential function increases much more rapidly than the current ratio. This is due to the voltage drop in the bulk of the diode. The curve is shown in Figure 9. The slow variation of the

FIG. 9 ($I_R$ POST-PULSE/$I_R$ PRE-PULSE) VS. REVERSE VOLTAGE. EXPERIMENTAL POINTS AND LEAST SQUARES FIT CURVE (SOLID LINE).

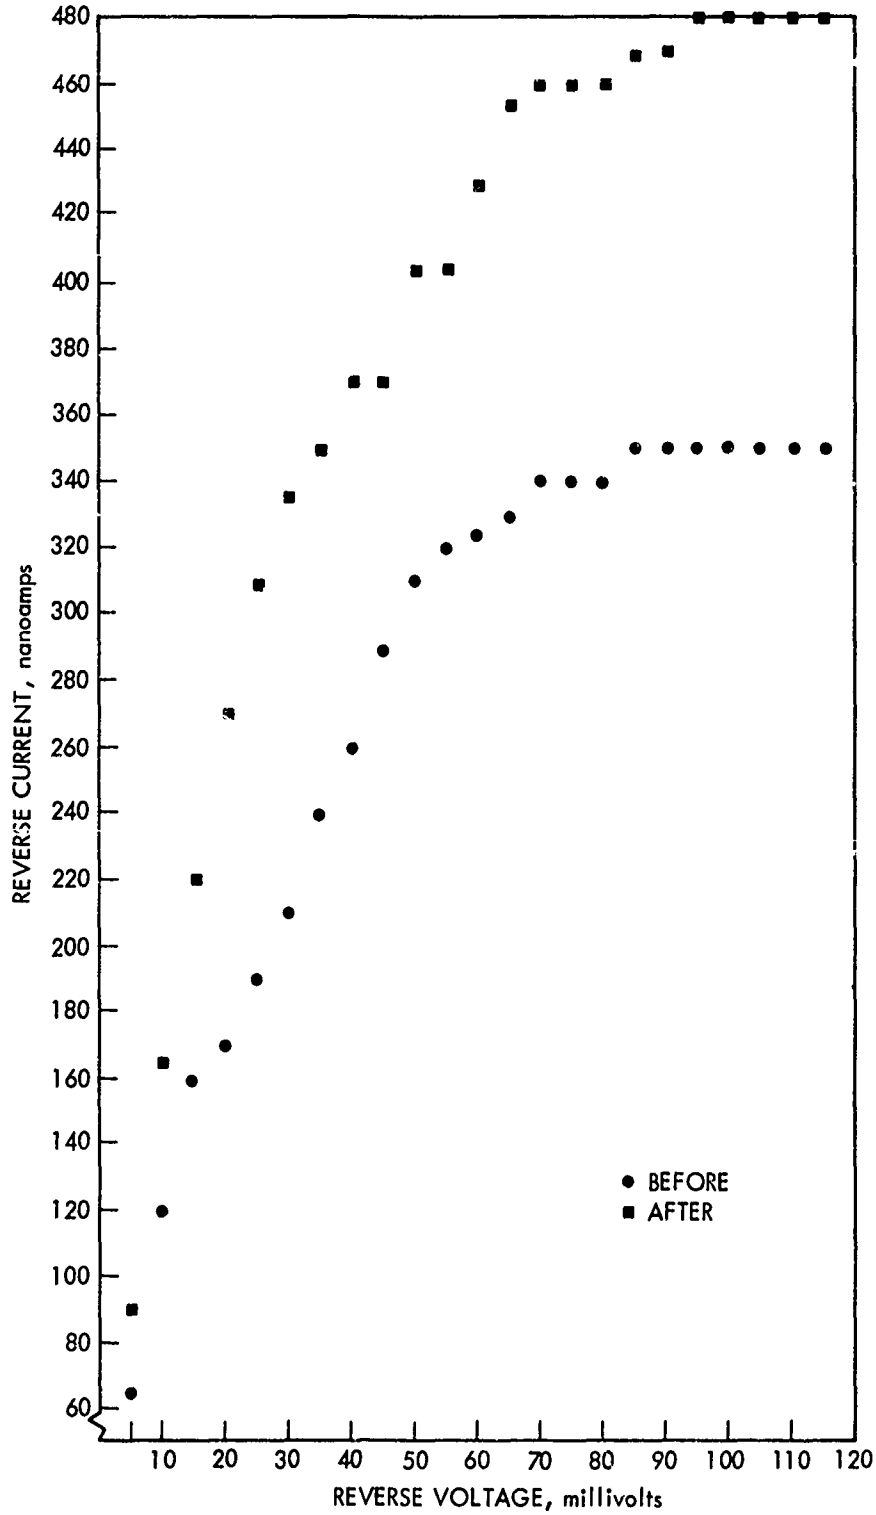
FIG. 10 LOW CURRENT-VOLTAGE TEST, BEFORE AND AFTER PULSE TEST

conduction does not begin before the application of approximately two volts forward bias. Nor can the parallel resistance explain the phenomenon shown in Figure 10, where we show the reverse current-voltage characteristic before and after damage. In both cases there exists a range of constant current with varying voltage*, i.e., $dI/dV = 0$. With a parallel resistance the current would always be expected to increase at least linearly with voltage. Finally, as shown in Figure 9, the ratio of reverse currents before and after damage varies exponentially with the applied voltage over five decades. Such behavior is hardly characteristic of a shunt resistance. Thus the addition of ohmic resistances is clearly unable to explain the experimental observations.
