REVIEW OF OBSERVATIONS FROM HYDROSTATIC PRESSURE MEASURING DEVICES, WAPPAPELLO DAM, WAPPAPELLO, MISSOURI

W. C. Sherman, et al

Army Engineer Waterways Experiment Station
Vicksburg, Mississippi

TECHNICAL REPORT NO. 3-460

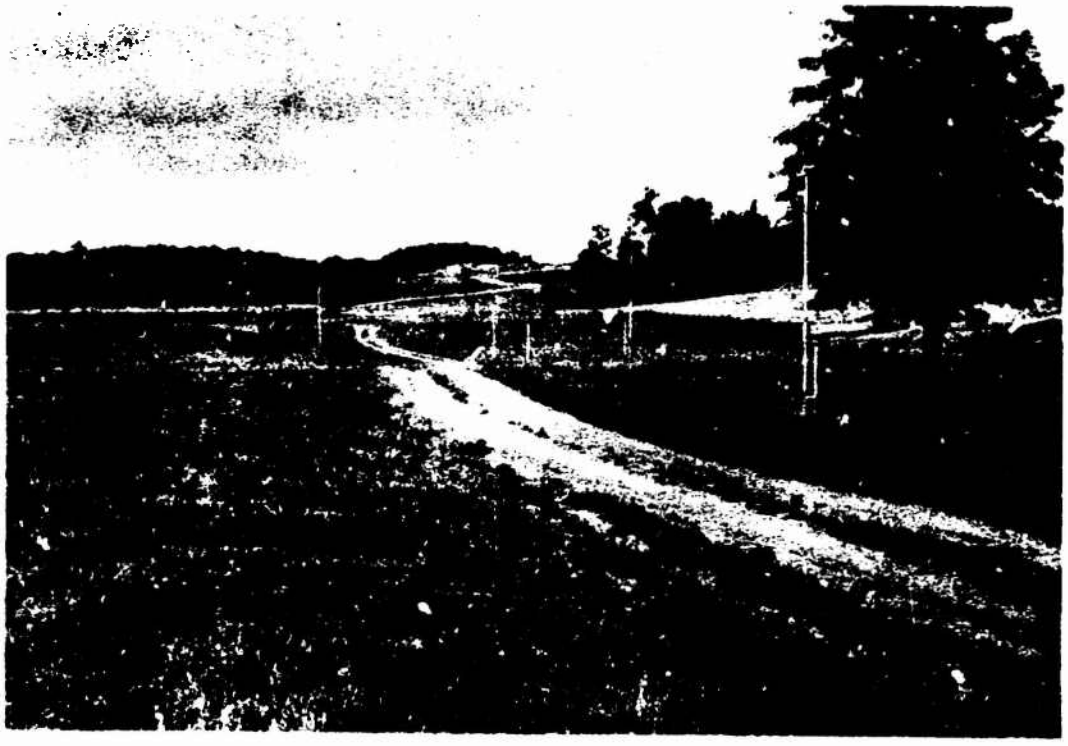
Fig. 10. View of piezometers along downstream toe of dam

25. During an inspection trip in July 1955 it was noted that piezometer T-3 was flowing. It was pointed out that this was undesirable, as the readings obviously would be affected and continuous

flow might also be conducive to more rapid corrosion of the piezometer. It was also noted that piezometer T-5 had a leaking discharge valve; the discharge past the closed valve was almost the same as when it was open. Leakage of this discharge valve probably accounts for the fact that piezometer T-5 shortly before 1955 read generally lower than other piezometers installed in the same stratum. Questionable readings of piezometer T-5 were not used in pertinent analyses in this report. All other piezometers appeared to be leakproof and operating satisfactorily.

c Valves on the piezometer riser pipes be checked periodically to insure that they do not leak.
